# FINAL Preliminary Assessment Report Army Aviation Support Facility #2, Wheeling, West Virginia

Perfluorooctanesulfonic Acid (PFOS) and Perfluorooctanoic  
Acid (PFOA) Impacted Sites  
ARNG Installations, Nationwide

August 2020

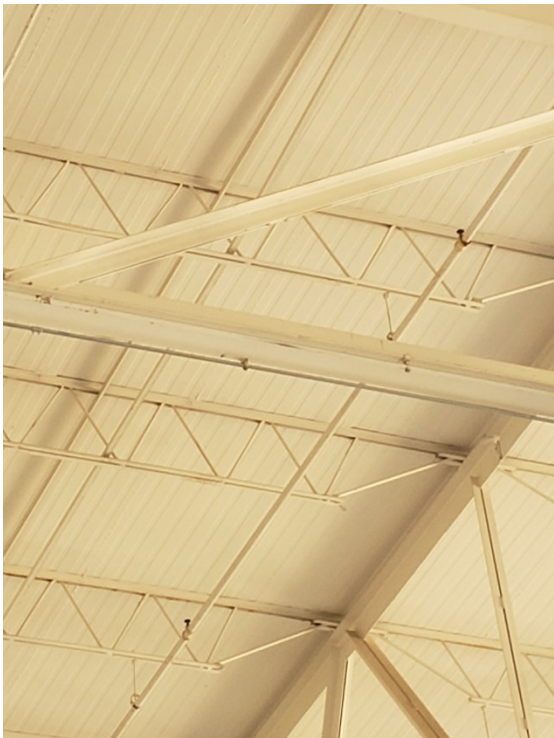
Army National Guard, Preliminary Assessment for PFAS	Wheeling AASF #2	Wheeling, West Virginia
<p><b>Photograph No. 3</b></p> <p><b>Description:</b></p> <p>Hangar's water deluge fire suppression system</p> <p>Photo Date: 10/3/2019</p>

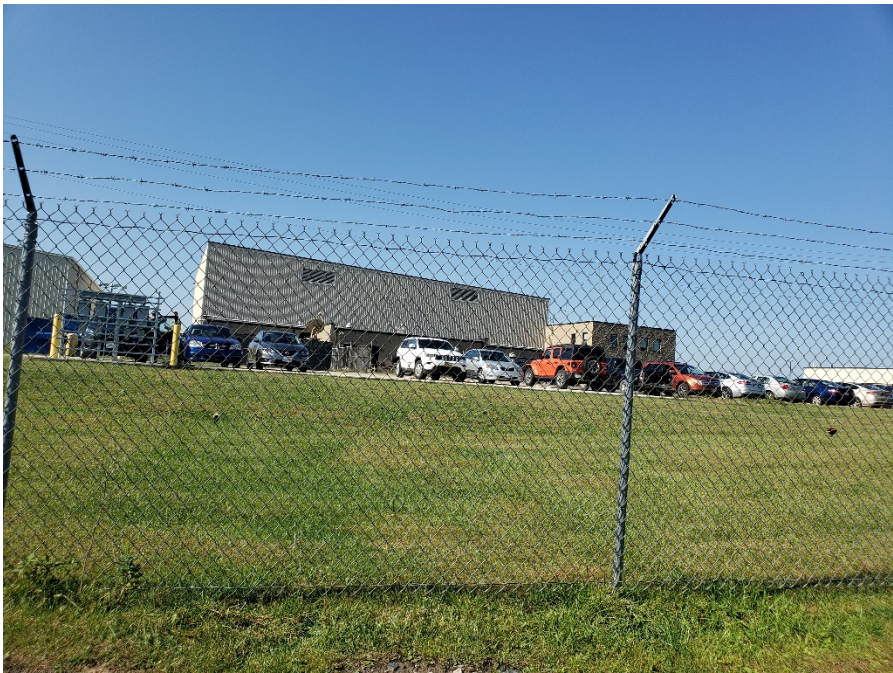
<p><b>Photograph No. 4</b></p> <p><b>Description:</b></p> <p>View of Wheeling AASF from surface water outfall off-property. Photograph shows location of surface water outfall.</p> <p>Photo Date: 10/3/2019</p>

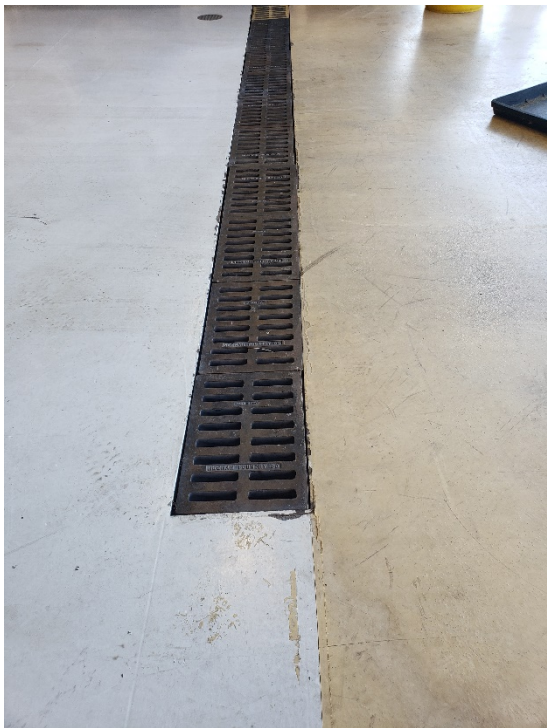
Army National Guard, Preliminary Assessment for PFAS	Wheeling AASF #2	Wheeling, West Virginia
<p><b>Photograph No. 5</b></p> <p><b>Description:</b></p> <p>Drains at the hangar doors</p> <p>Photo Date: 10/3/2019</p>

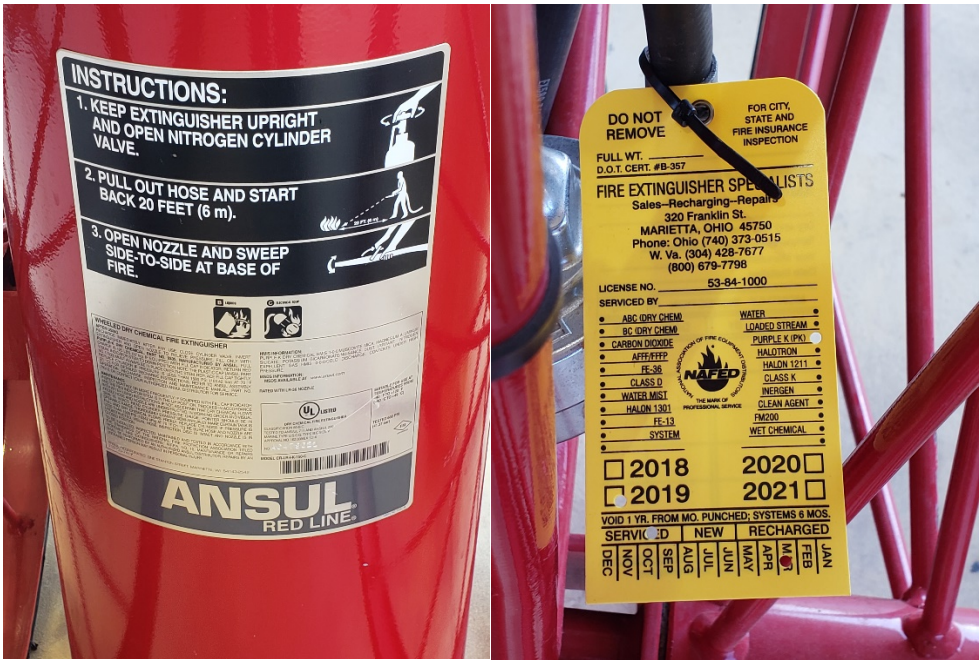
<p><b>Photograph No. 6</b></p> <p><b>Description:</b></p> <p>Purple K fire extinguishers that replaced Tri-Max™ at AASF #2.</p> <p>Photo Date: 10/3/2019</p>

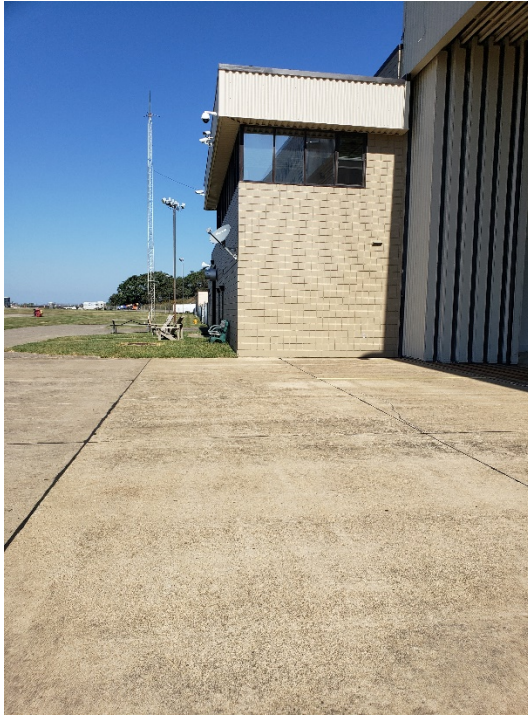
Army National Guard, Preliminary Assessment for PFAS		Wheeling AASF #2	Wheeling, West Virginia
<b>Photograph No. 9</b> <b>Description:</b> Hangar ramp FTA. Barrel burn trainings occurred on the concrete in the foreground. AFFF was sprayed on the wall facing the camera. Photo Date: 10/3/2019

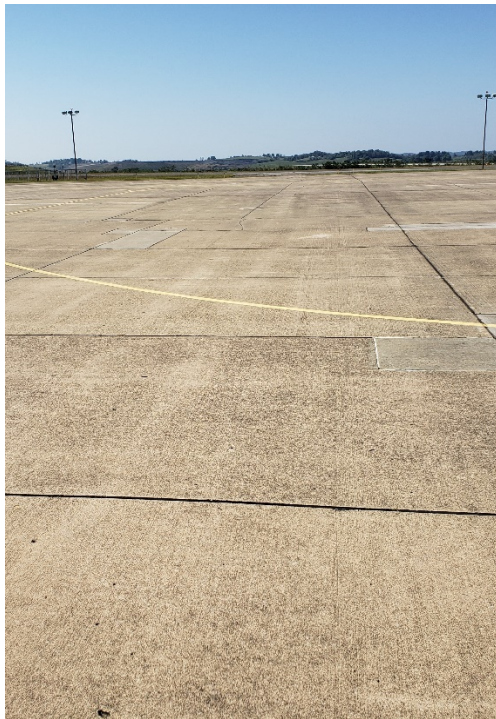
<b>Photograph No. 10</b> <b>Description:</b> Helicopter FTA in the center of the landing pad. Photo Date: 10/3/2019

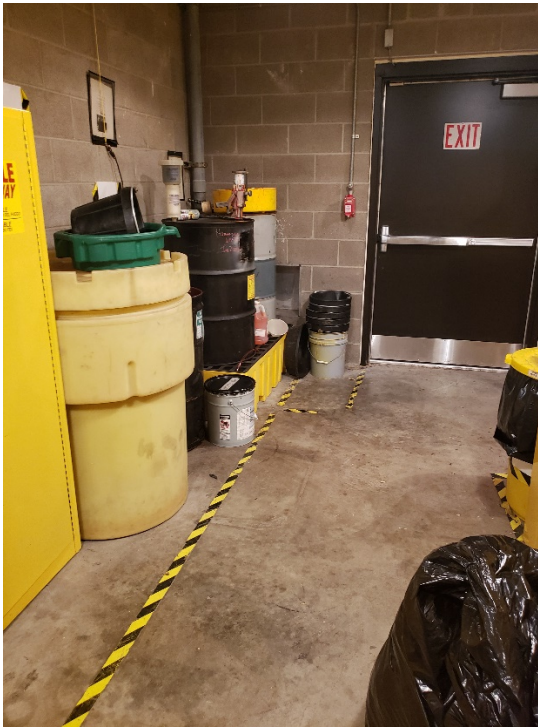
Army National Guard, Preliminary Assessment for PFAS	Wheeling AASF #2	Wheeling, West Virginia
<p><b>Photograph No. 11</b></p> <p><b>Description:</b></p> <p>Hazmat room where AFFF was stored.</p> <p>Photo Date: 10/3/2019</p>

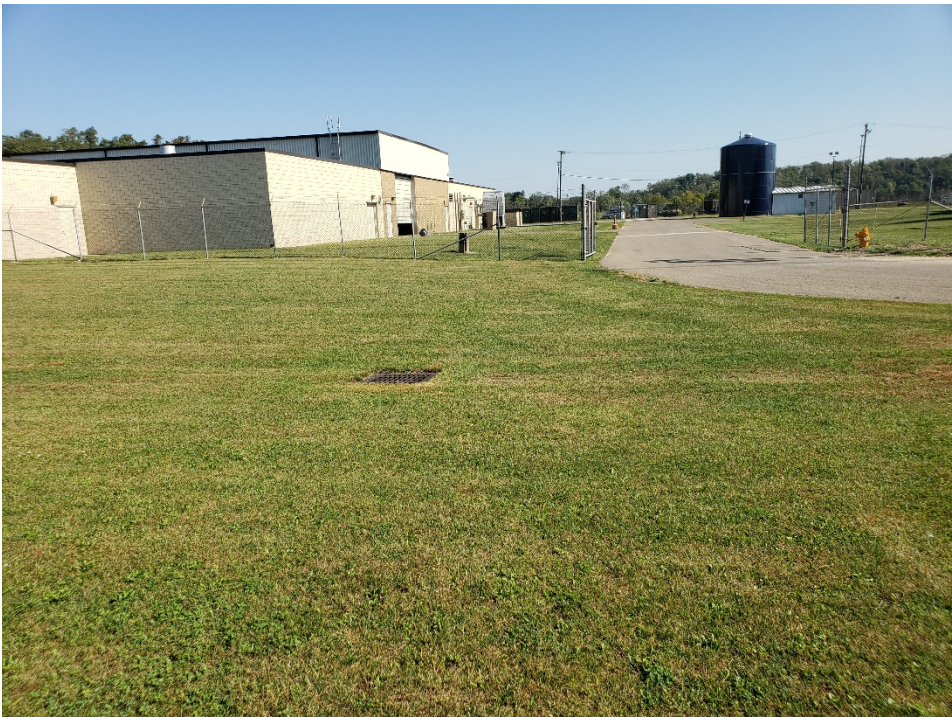
<p><b>Photograph No. 12</b></p> <p><b>Description:</b></p> <p>Stormwater intake closest to FTAs on the facility.</p> <p>Photo Date: 10/3/2019</p>
