FINAL Preliminary Assessment Report Camp Dawson Kingwood, West Virginia

Perfluorooctane-Sulfonic Acid (PFOS) and Perfluorooctanoic
Acid (PFOA) Impacted Sites
ARNG Installations, Nationwide

May 2020

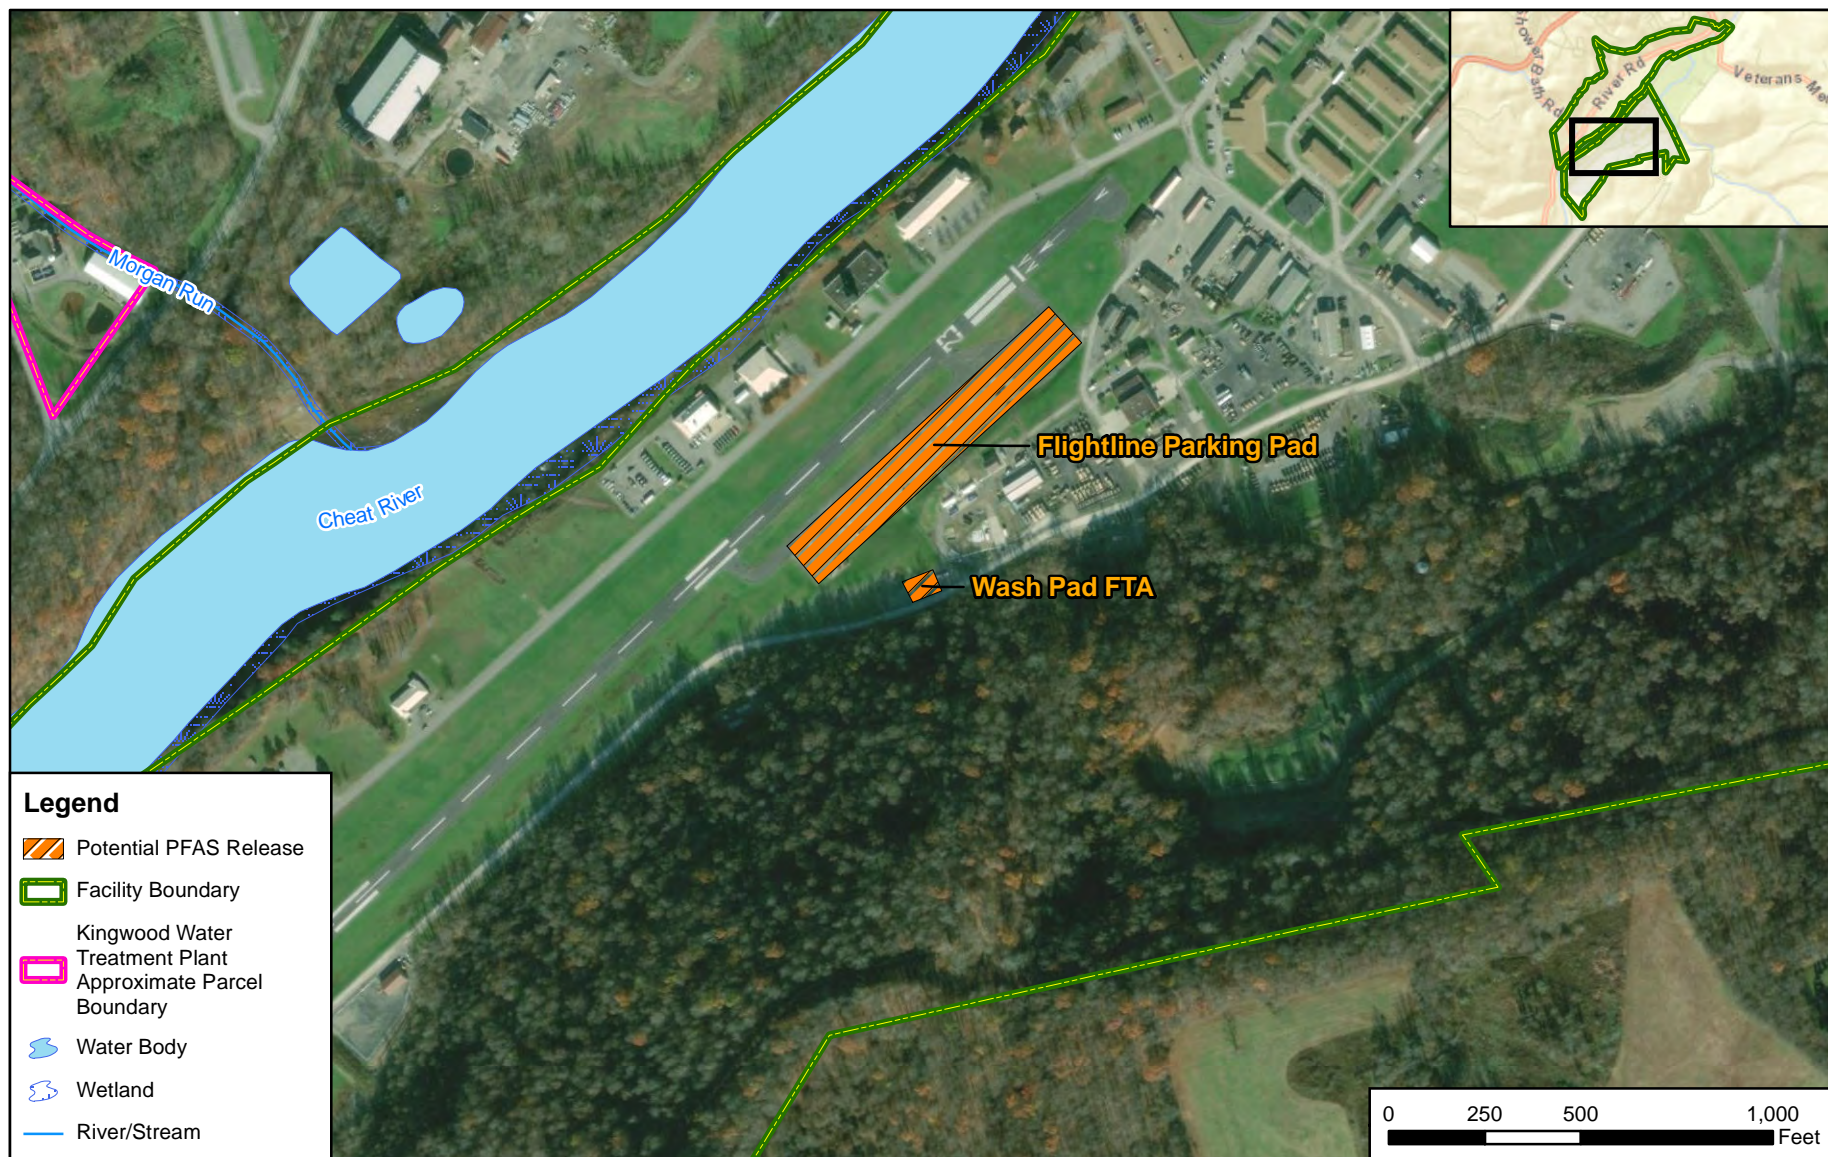
2.2 Flightline Parking Pad

During follow-up interviews, it was discovered that former fire training activities occurred at Camp Dawson near the Flightline Parking Pad. Interviewees recall barrel burns, similar to the burn described at the Wash Pad above, occurring near the Flightline Parking Pad, near where aircraft are usually parked. Barrels containing fuel were ignited and extinguished using AFFF. Following the training, the foam was left to dry on the concrete, pavement, and surrounding grassy areas near the Flightline Parking Pad. However, the exact location of the fire training activities is unknown. Additionally, the timeframe of these fire training activities, how often these trainings occurred, and the quantity of AFFF used during these fire training activities are unknown.

AOI 5 is the Flightline Parking Pad. During follow-up interviews, it was determined that previous fire training activities occurred in and around the Flightline Parking Pad, adjacent to the aircraft parking area, that involved the release of AFFF. These trainings involved barrels of fuel being ignited and then extinguished with AFFF for fire training purposes. Interviewees recall barrel burns at this location being separate from the known barrel burn that occurred at the Wash Pad AOI; however, the timeframe of these fire training activities, how often these trainings occurred, and the quantity of AFFF used during these fire training activities are unknown.

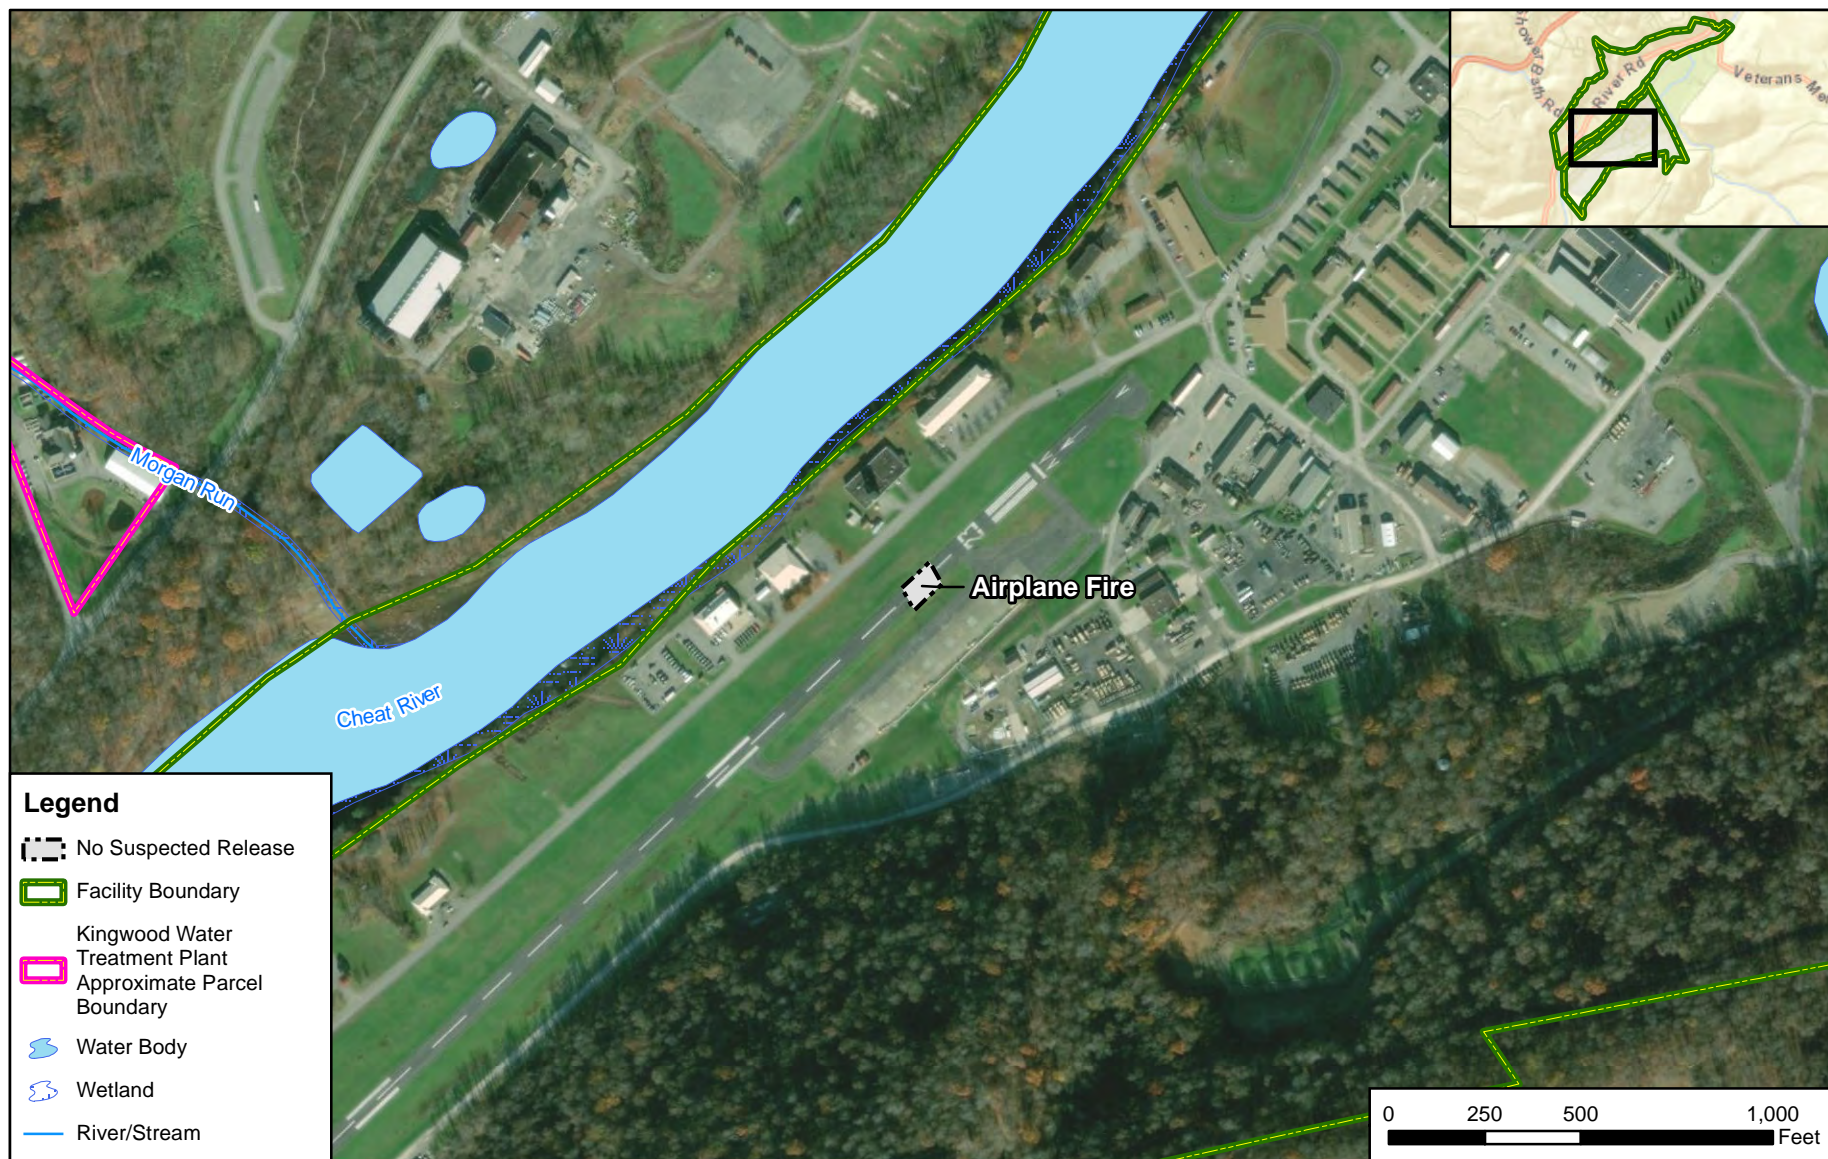
4.1 Airplane Fire

According to interviewees, in approximately 1995, an airplane caught fire along the Army Airfield owned by WVARNG; however, only Purple K dry chemical was used for fire suppression during the emergency response incident. No AFFF was used during this emergency response incident. The quantity of Purple K used during this incident is unknown, and Purple K is a non-PFAS-containing material.

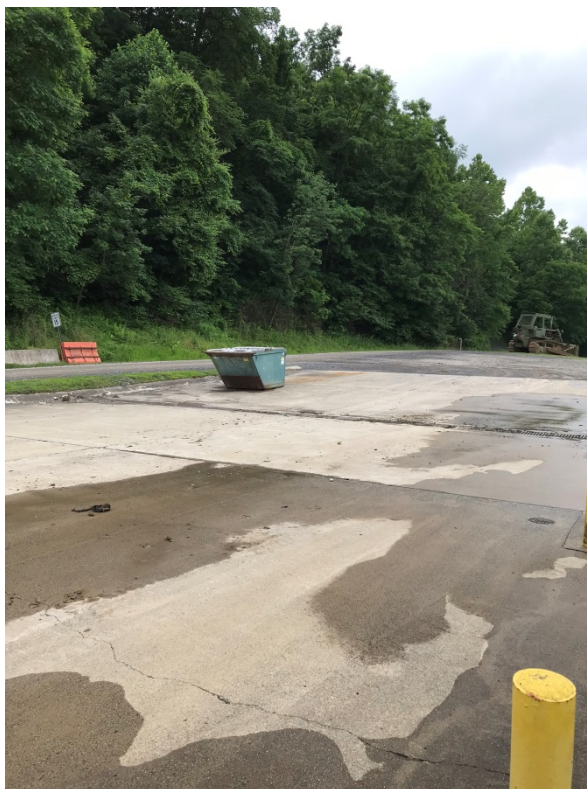
Looking west. Wash pad located on southern border of facility. Residual from the wash pad collects in the drains which lead to an oil water separator, and eventually discharges into the nearby Cheat River.

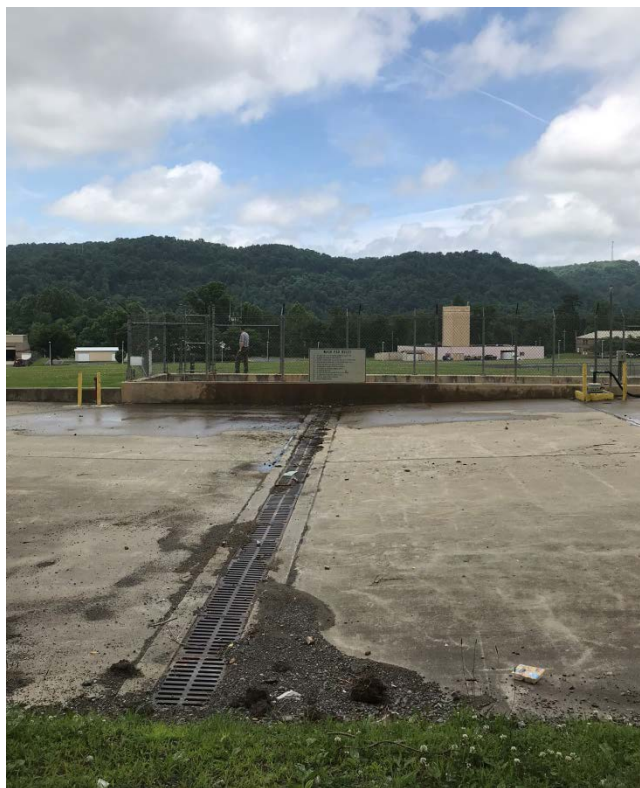
Photograph No. 2

Looking northwest. Wash pad located on southern border of facility. Residual from the wash pad flows northwest, filters through an oil water separator, and discharges to the Cheat River.

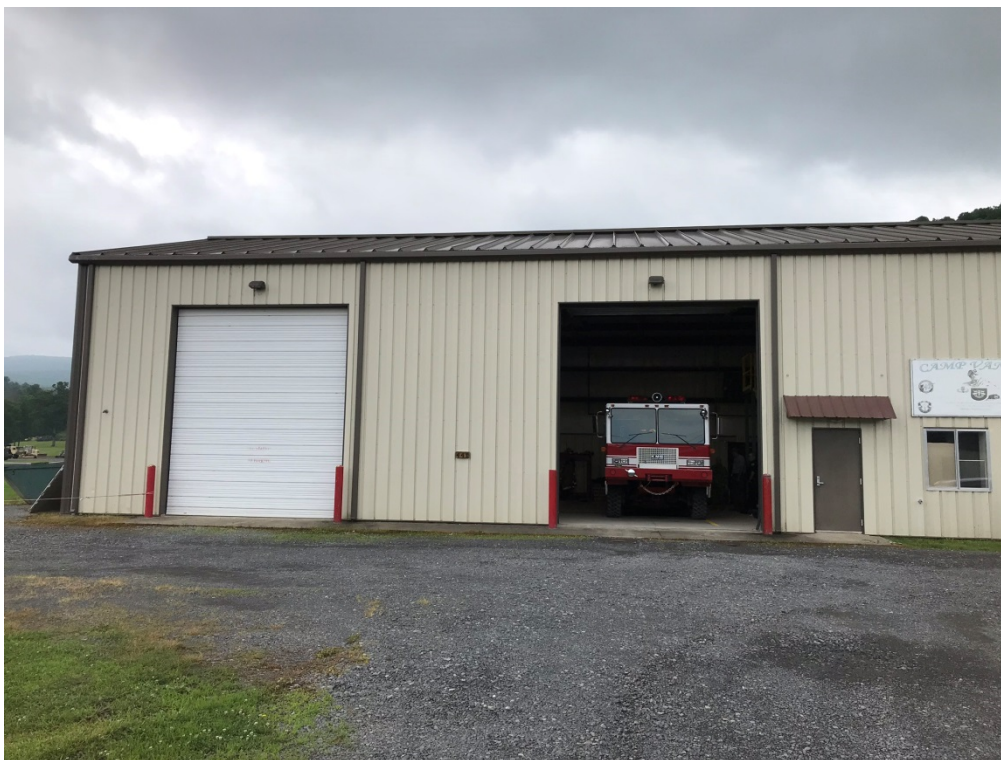
Looking southeast. The Vance Building (Building 441), also known as the Post-Fire Department Building, served as the former storage location of an AFFF-filled firetruck for approximately 18 months to three years starting in 2014.

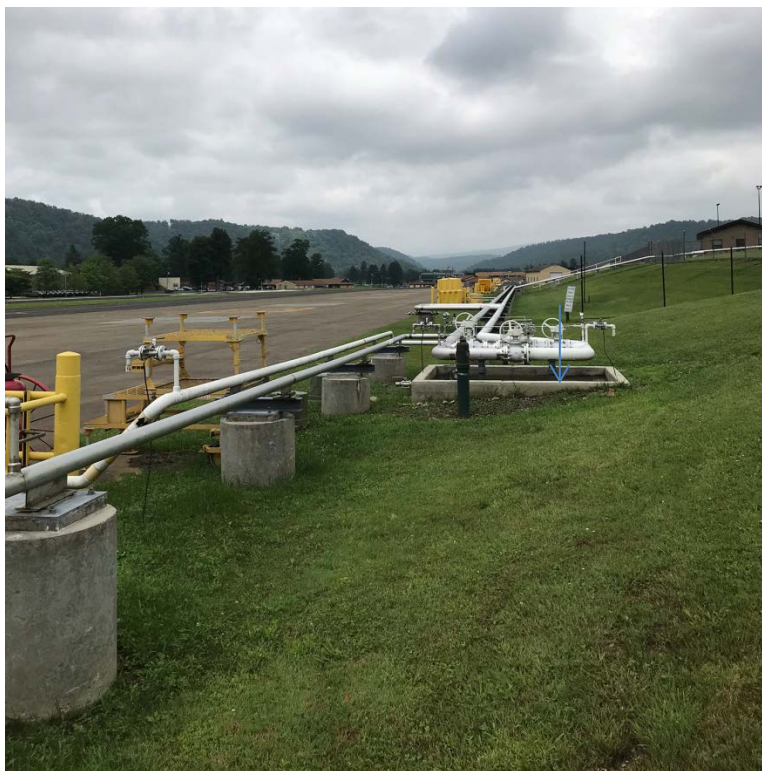
Photograph No. 4

Looking northeast. Just east of the aircraft parking area and north of the wash pad FTA. Portable sodium bicarbonate extinguishers, portable and handheld Purple K fire extinguishers, can be found along the perimeter of the aircraft parking area.

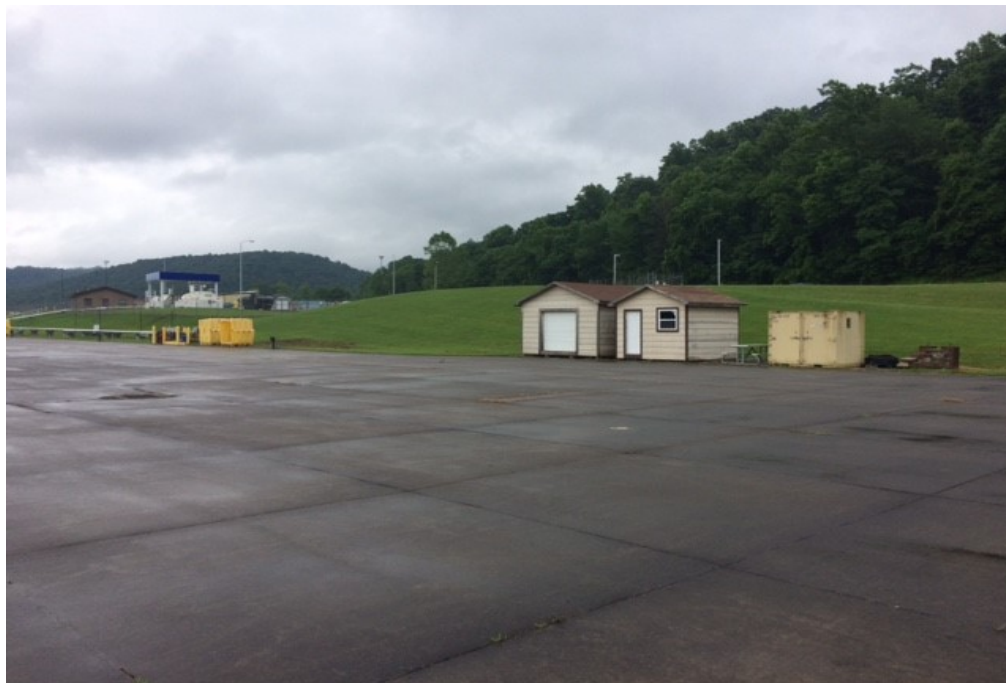
Facing east. Aircraft maintenance and wash pad area. A drain can be seen on the left side of the picture that leads to the 4,000-gallon OW.

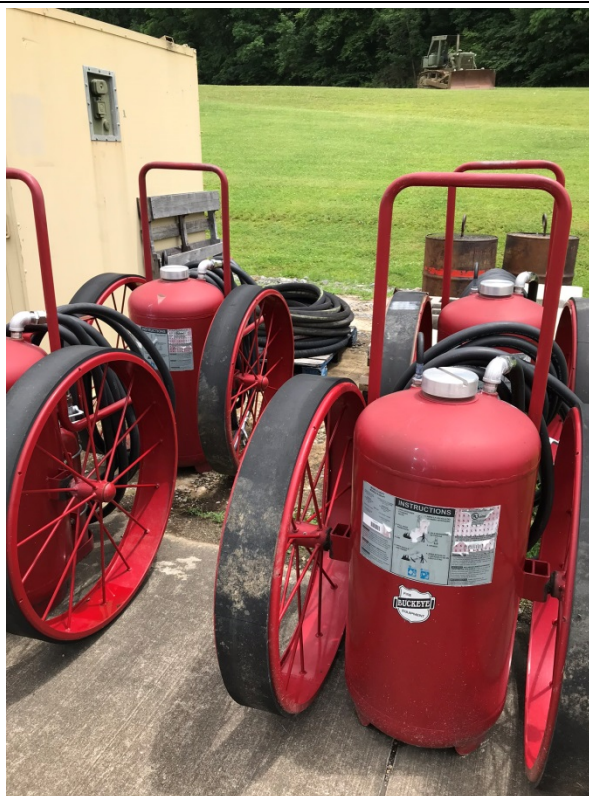
Photograph No. 6

Facing southeast. Portable potassium bicarbonate fire extinguishers; which non-PFAS containing.

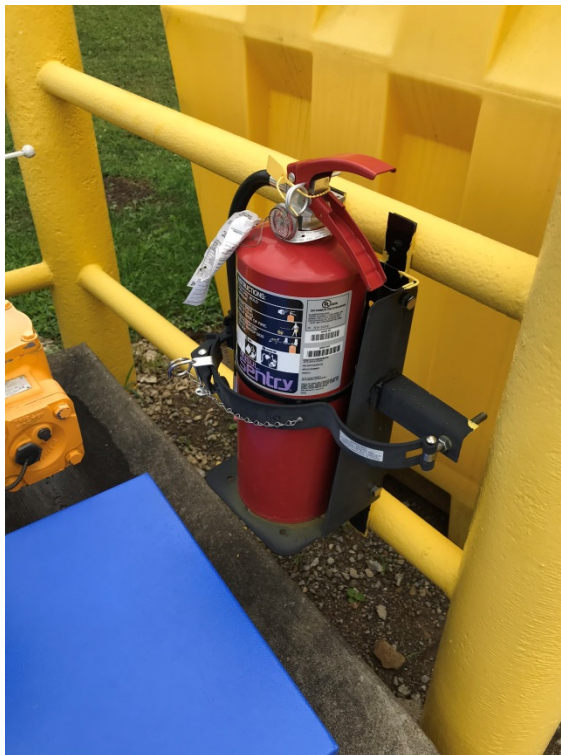
Facing northwest.
Handheld Purple K fire
extinguishers located
around perimeter of the
aircraft parking area.

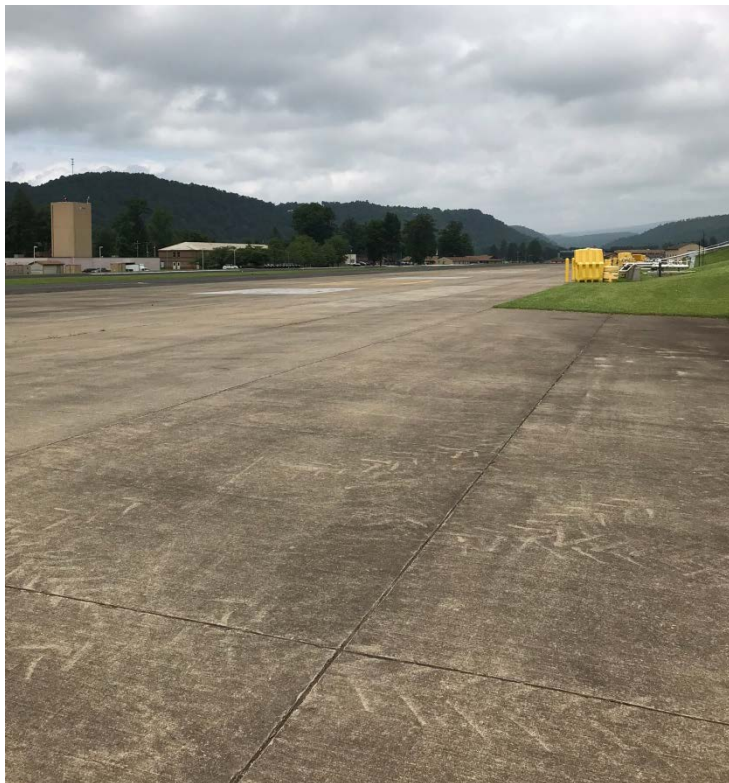
Photograph No. 8

Facing northwest. Aircraft
parking area, airplane fire
occurred adjacent to this
location.

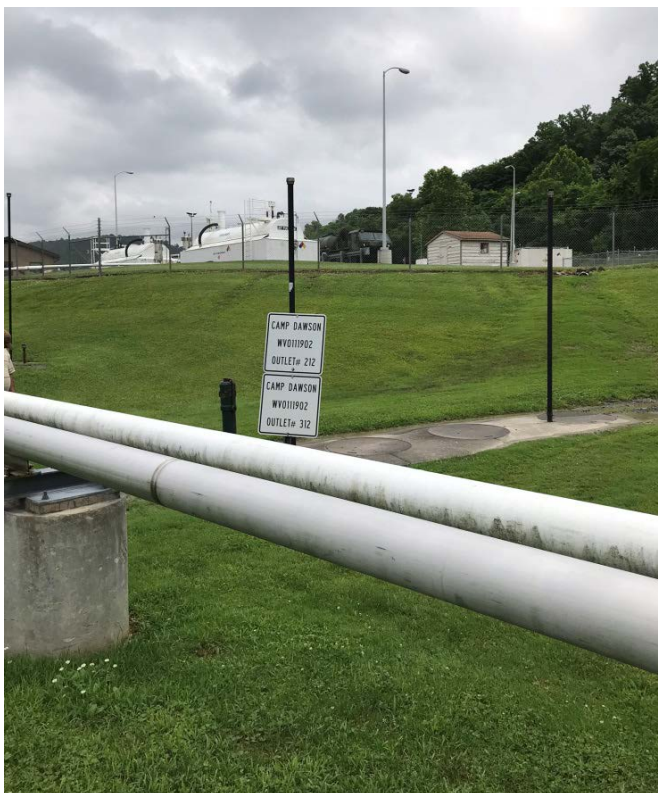
Looking east. Concrete pad with circular manholes is the oil water separator that connects to the wash pad FTA. This oil water separator connects to Outfall 012 which discharges to the Cheat River.

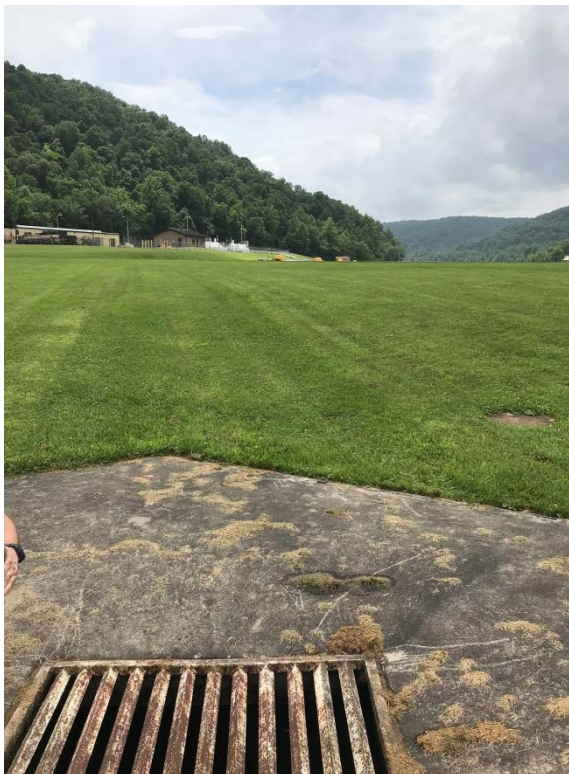
Photograph No. 10

Looking south. The main sewer grate that connects all stormwater and waste from the oil water separator before being discharged to the Cheat River.

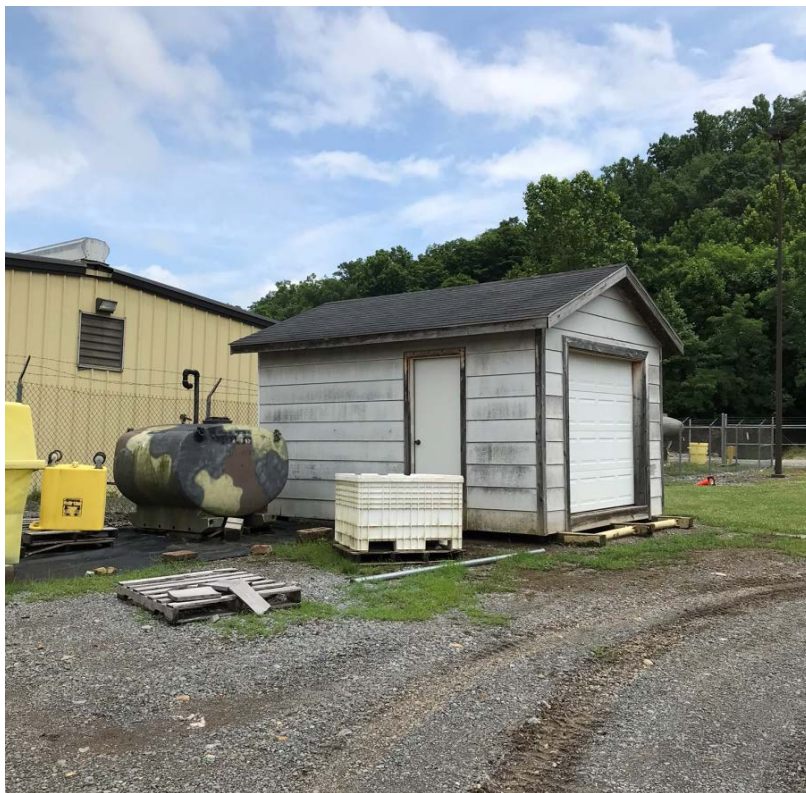
Facing south. Old fuel shed
that used to store unused
and unwanted AFFF.

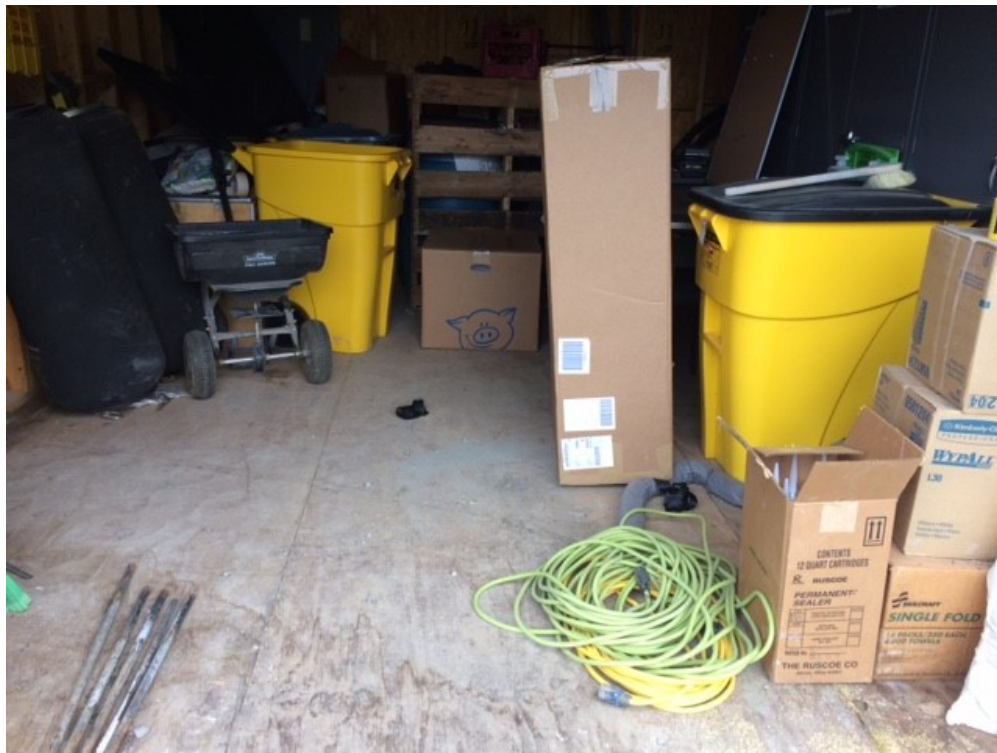
Photograph No. 12

Looking inside the Fuel
Farm Shed that shows
absence of floor drains.

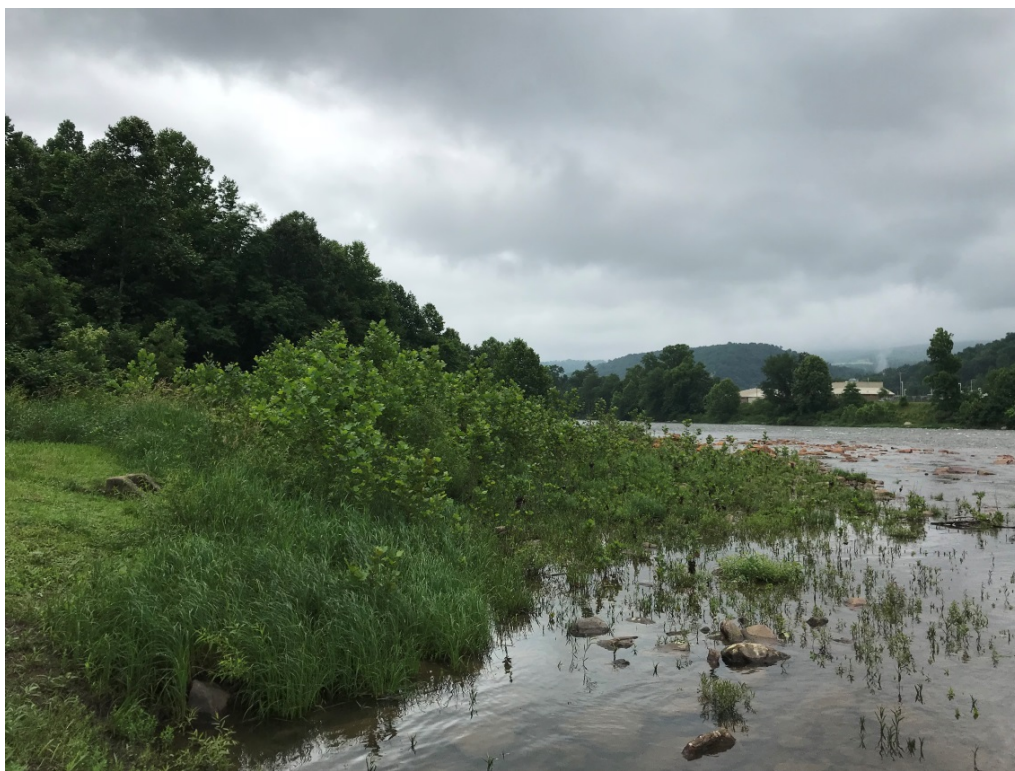
Photograph No. 14

Looking southeast. General vicinity of the Cheat River surface water intake in relation to Camp Dawson, which can be seen across the river.

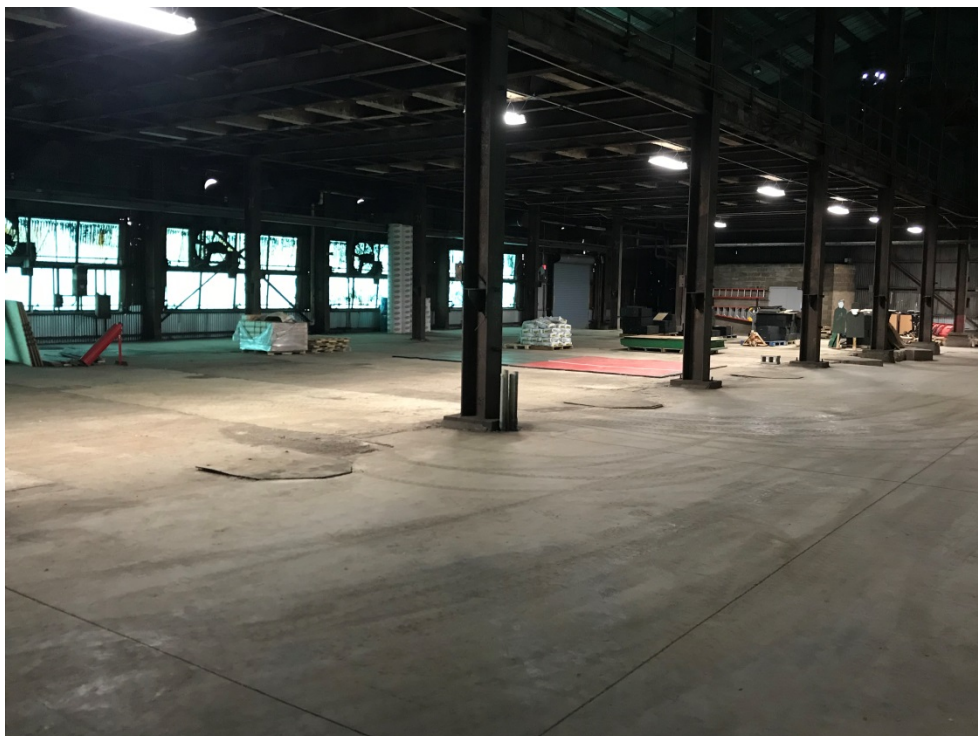
Inside one of the remaining buildings from the former manganese smelting plant, located across the Cheat River.

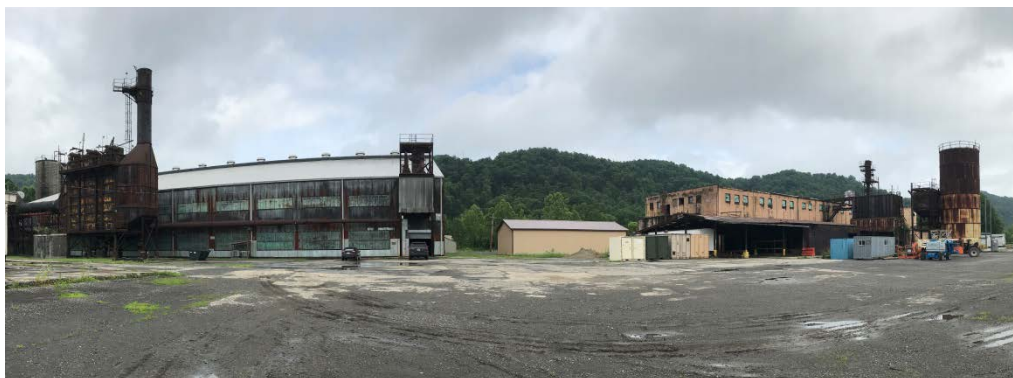
Looking North. Remnants of the remaining buildings from the former manganese smelting plant, now leased to Camp Dawson for training purposes.

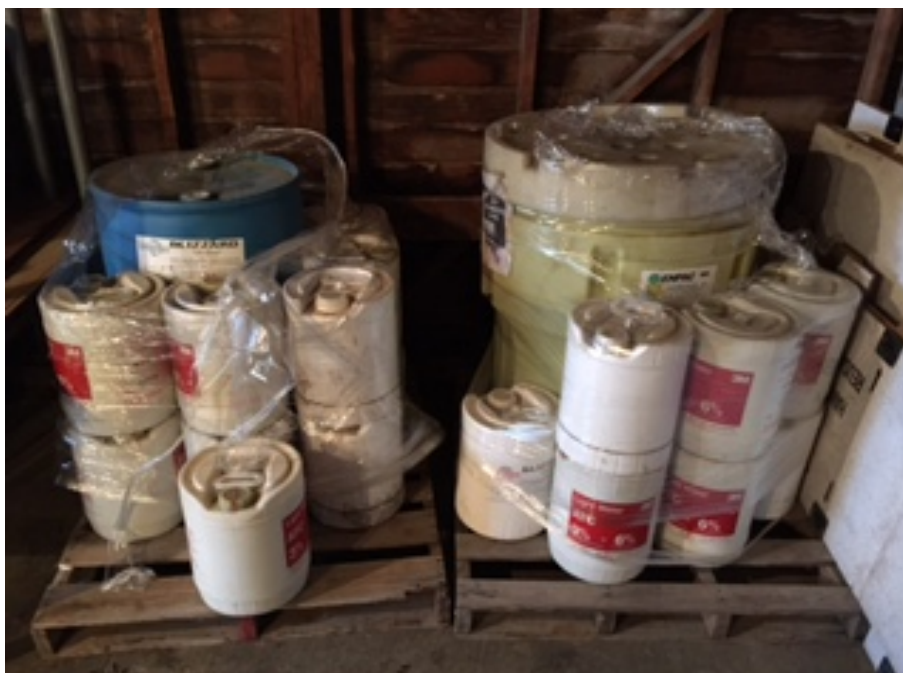
Photograph No. 16

Former AFFF storage area inside of Building 403, Stalls 17/16. The AFFF stored here was previously stored in the Fuel Farm Shed as well as containerized AFFF from the former firetruck stored in the Vance Building.

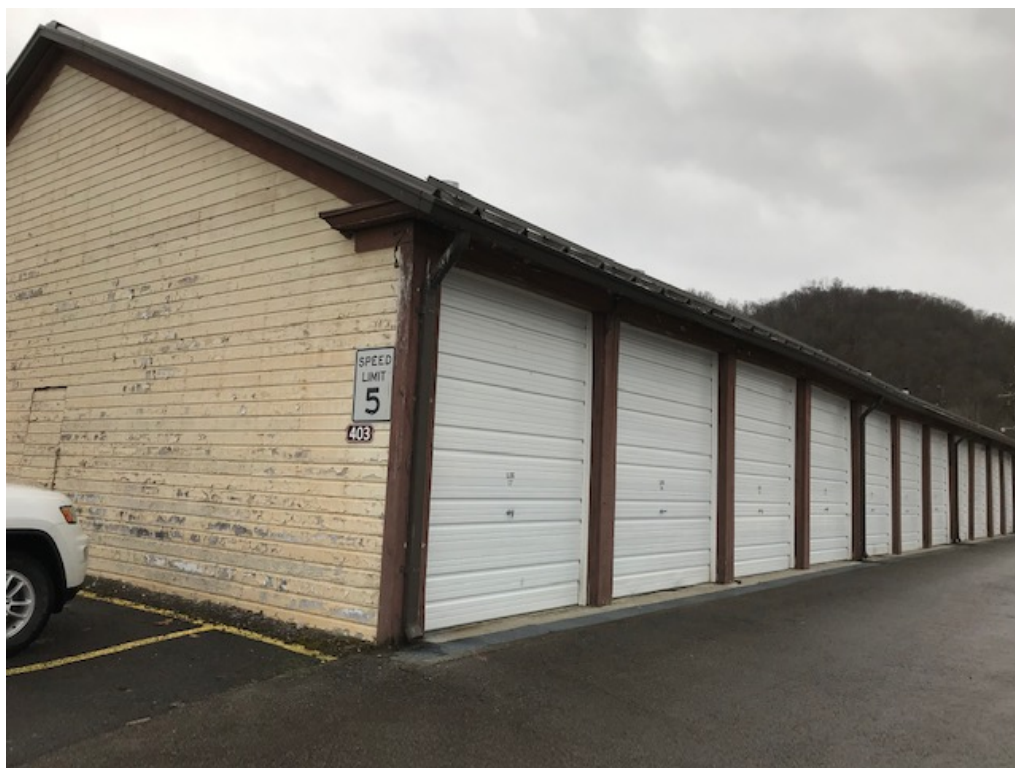
Outside of Building 403, Stall 17/16. This stall was the former storage location for the AFFF on site at Camp Dawson until 2017.
