FINAL Preliminary Assessment Report Madison Army Aviation Support Facility #2 Madison, Wisconsin

Perfluorooctane-Sulfonic Acid (PFOS) and Perfluorooctanoic
Acid (PFOA) Impacted Sites
ARNG Installations, Nationwide

August 2020

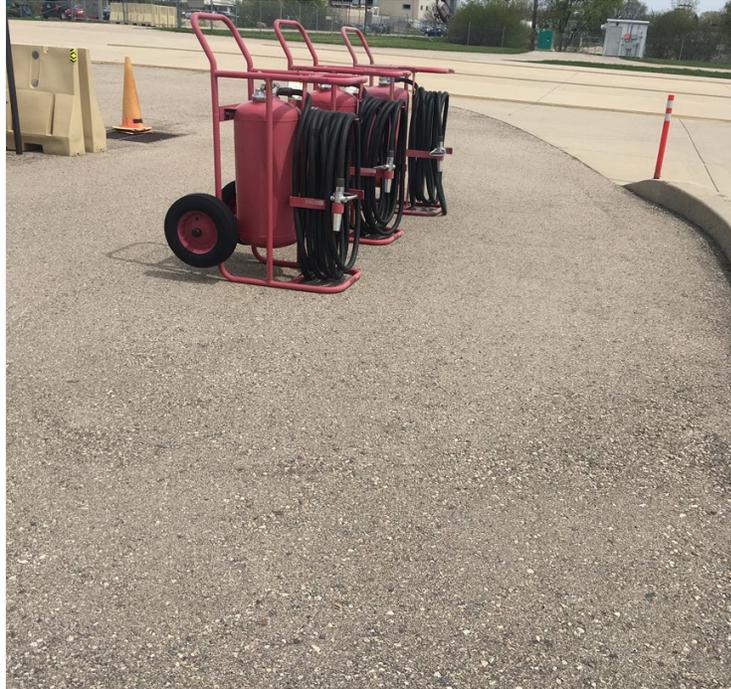
The mobile Purple K fire extinguishers that are placed around the ramps at the AASF.

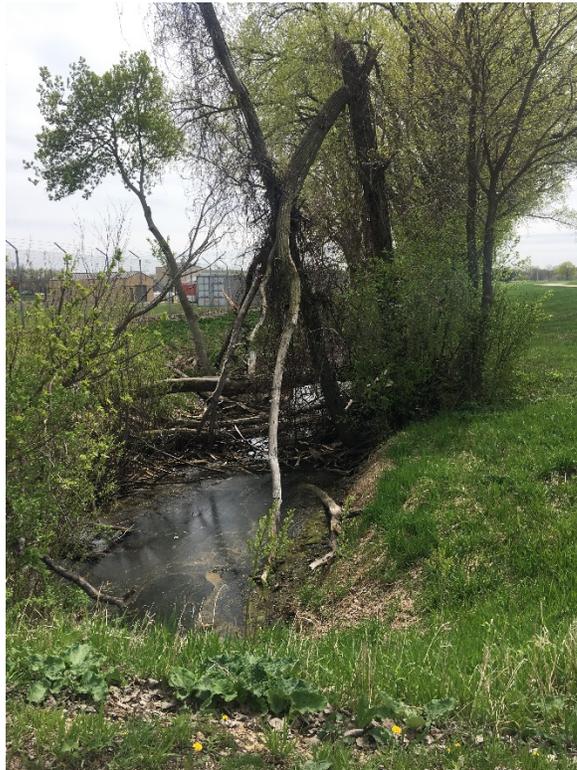
Photograph No. 2

Starkweather Creek that runs on the east side of the facility.

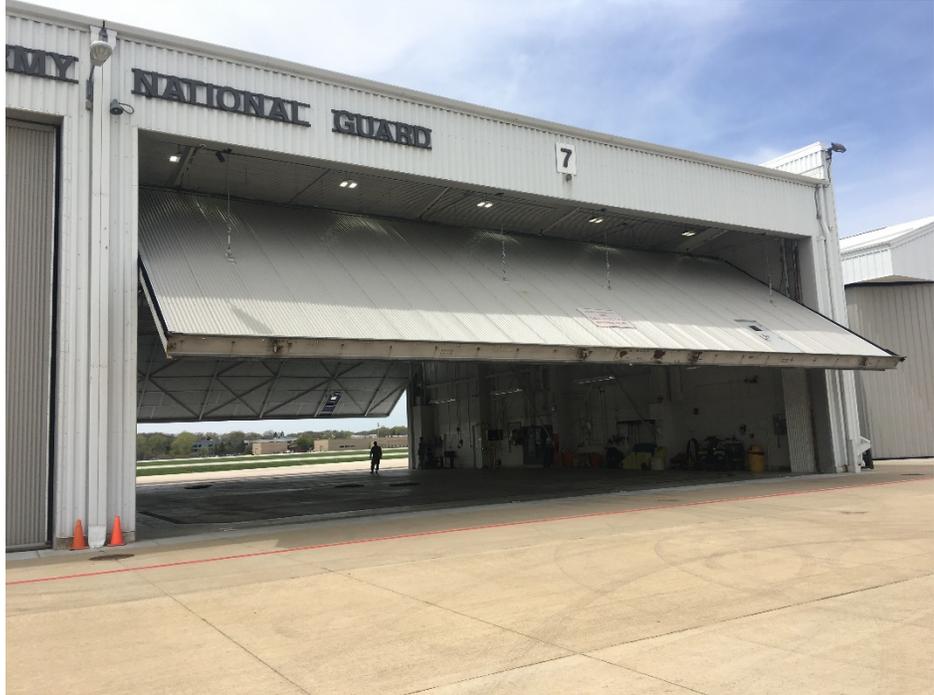
Hangar Pod 7. These hangars were built in the 1950's and do not contain fire suppression systems.

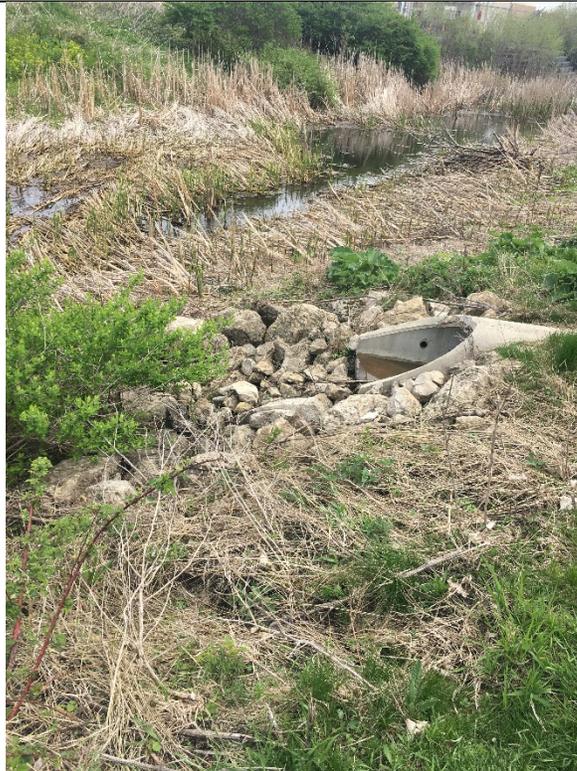
Photograph No. 4

A stormwater drain to direct surface water off the ramps and into Starkweather Creek.
