## Site Inspection Report

### Madison Army Aviation Support Facility #2

### Madison, Wisconsin

Site Inspection for Perfluorooctanoic Acid (PFOA), Perfluorooctanesulfonic Acid (PFOS), Perfluorohexanesulfonic Acid (PFHxS), Perfluorononanoic Acid (PFNA), Hexafluoropropylene Oxide Dimer Acid (HFPO-DA), and Perfluorobutanesulfonic Acid (PFBS)  
ARNG Installations, Nationwide

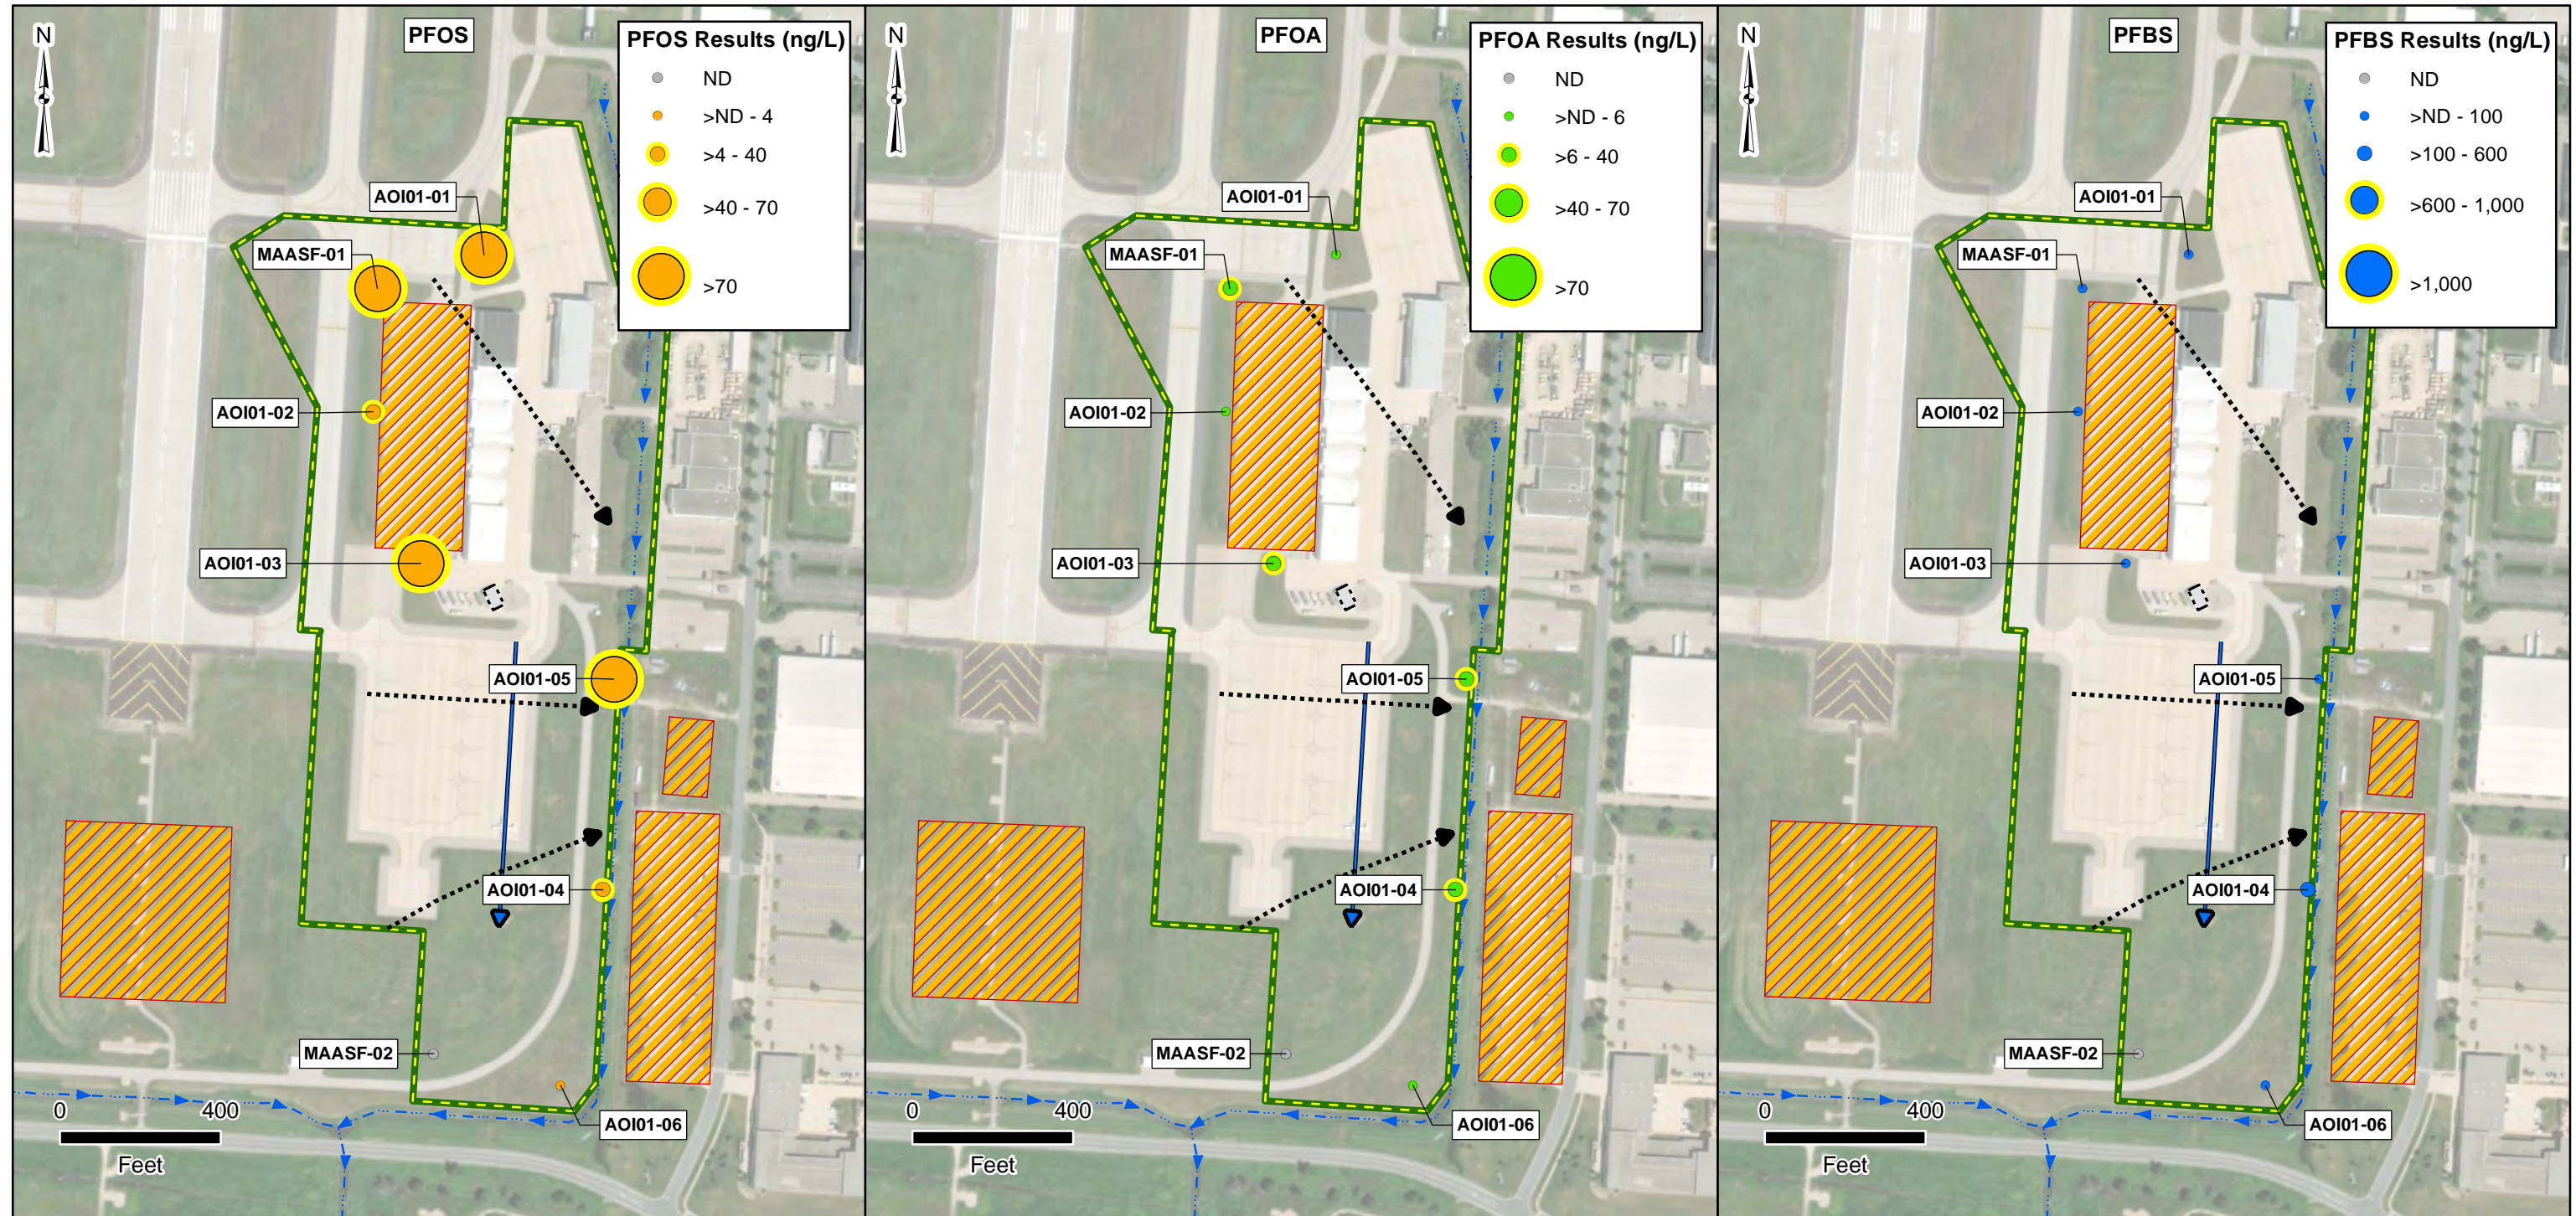
Figure 6-6  
 PFOS, PFOA & PFBS Detections in Groundwater

NOTES:  
 PFOS = perfluorooctanesulfonic acid  
 PFOA = perfluorooctanoic acid  
 PFBS = perfluorobutanesulfonic acid  
 ND = Non-Detect  
 ng/L = nanogram(s) per liter  
 Exceedances of the OSD SL are depicted with a yellow halo
