FINAL Preliminary Assessment Report River Road Training Site, New Castle, Delaware

Perfluorooctanesulfonic Acid (PFOS) and Perfluorooctanoic
Acid (PFOA) Impacted Sites
ARNG Installations, Nationwide

July 2020

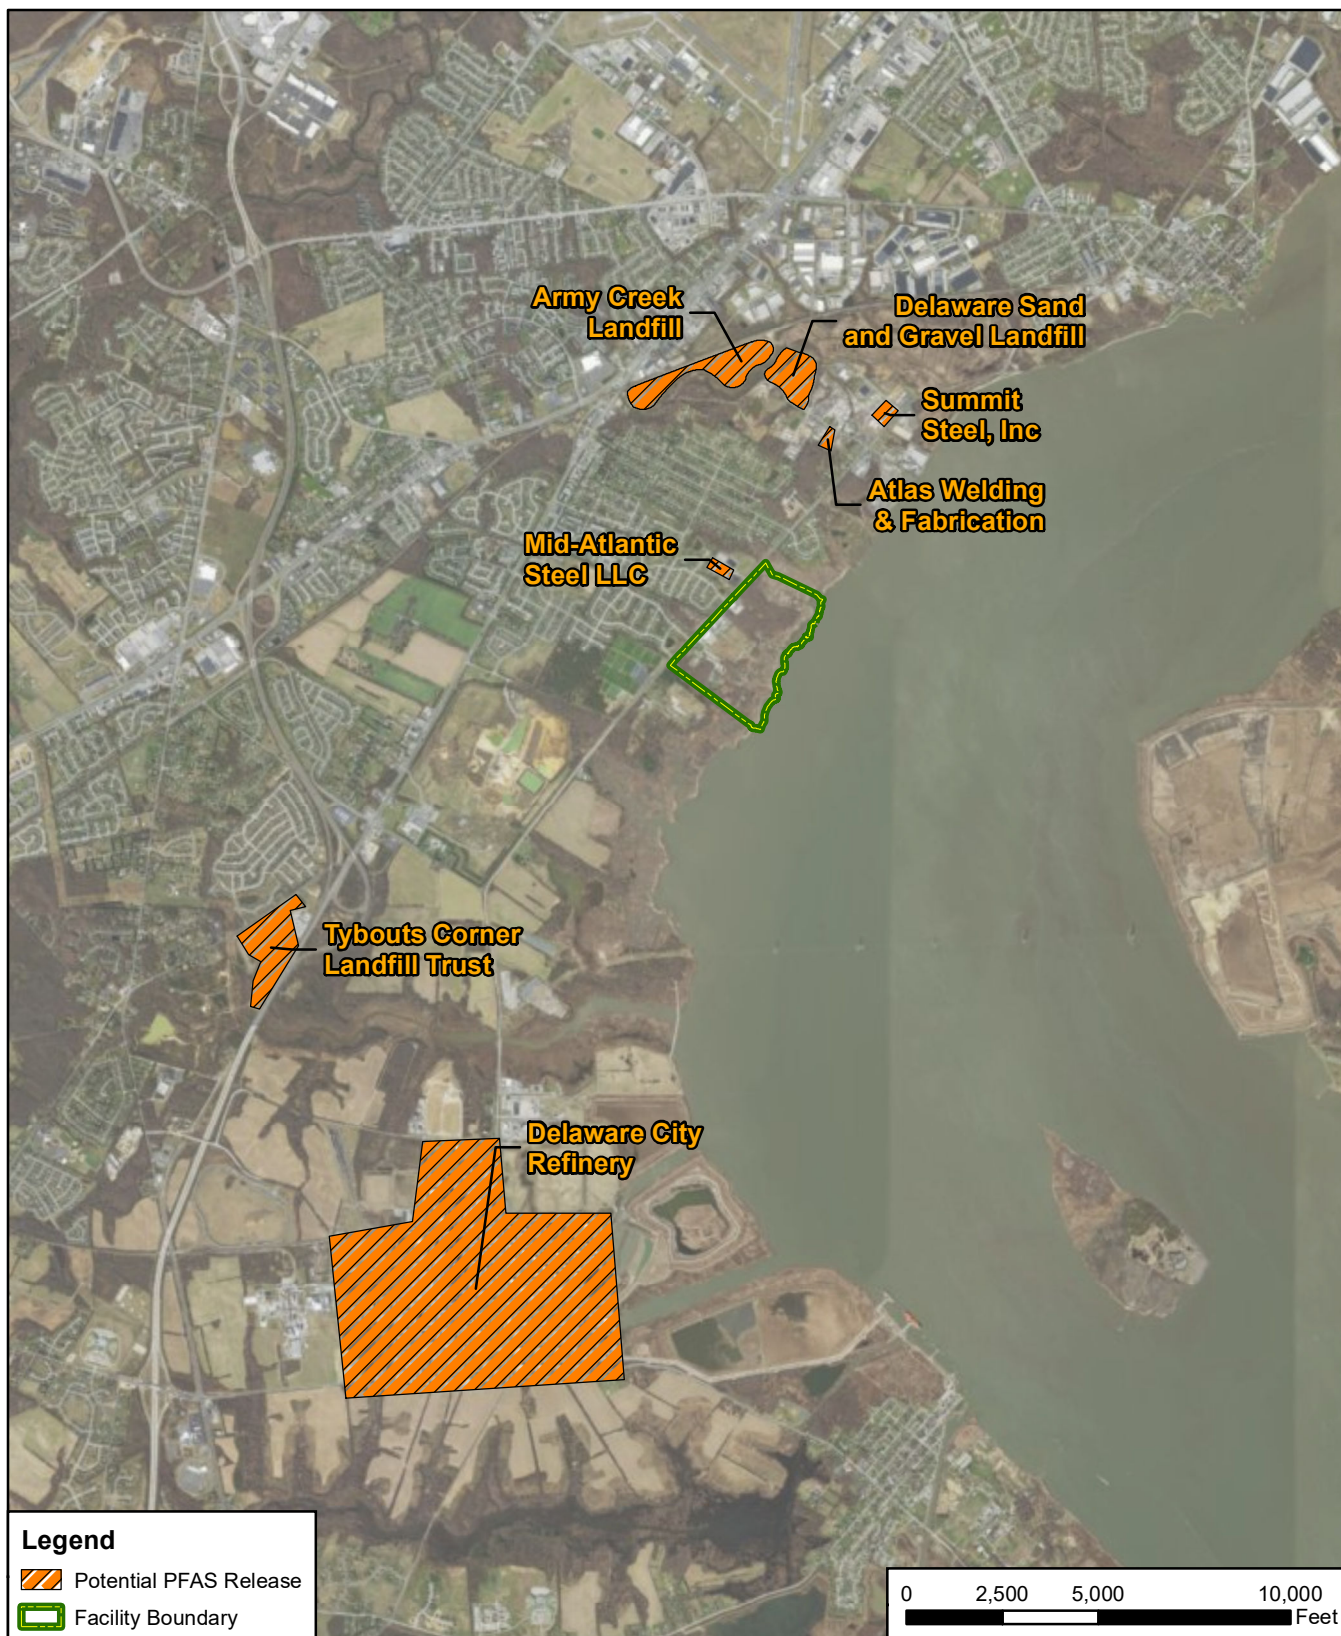
12420 Milestone Center Drive Germantown, MD 20876	Figure 5-1	
SCALE	1:60,000	CHK BY	LS	2/4/2020				
Base Map: Source: Esri, DigitalGlobe, GeoEye, Earthstar Geographics, CNES/Airbus DS, USDA, USGS,		PM	RG	2/4/2020

Five potential off-facility sources of PFAS located adjacent to RRTS, not under the control of ARNG, were identified during the PA through interviews and news reports. A description of each adjacent source is presented below, and the adjacent sources are shown on **Figure 5-1**.

Delaware City Refinery is located approximately 3.5 miles southwest of the facility (**Figure 5-1**). In both February and April of 2019, there were fires at the refinery. During the fire in February, flames were contained to the refinery with the help of local emergency response units (Delaware Online [DO], 2019). News reports did not mention the use of AFFF, and interviewees are unsure of what was used to control the fire. The fire in April was smaller and did not require outside emergency response from local fire departments. Though there is no definite information provided as to the use of AFFF in either of these emergency responses, AFFF is commonly used at refineries in the event of fuel related fires. As such, there is a possibility that AFFF was released during one or both of these occurrences, making the Delaware City Refinery a possible adjacent source of PFAS. Emergency Response personnel were not interviewed during the PA because the focus of the assessment was to evaluate potential PFAS related activities and sources at DEARNG properties.

Tybouts Corner Landfill Trust is located 2.6 miles west-southwest of the facility (**Figure 5-1**). Initially, this location housed a sand and gravel quarry until 1968 and was subsequently converted to a landfill (USEPA, 2019). The landfill was operational until 1971 and accepted municipal and household waste. In 1983, after it was determined that the landfill was the source of contamination in drinking water wells, it was added to CERCLA's national Priorities List. The landfill has since been capped and is monitored semi-annually, with reports ensuring the remedial efforts are, "protective of human health and the environment" (USEPA, 2019). Though there are remedial efforts in place at this site, PFAS-containing materials may have been disposed of in the landfill and may not have been properly contained during the process of remediation. PFAS were not known to be harmful at the time of the remedial action plan and were not taken into account during planning. It is possible that the landfill could be a potential adjacent source of PFAS.

Mid-Atlantic Steel LLC sits 0.3 miles northeast of RRTS. While there is no confirmation of the use of PFAS-containing materials at this steel fabrication plant, PFAS are commonly used in the metals and metals plating industries. As such, Mid-Atlantic Steel LLC is a possible adjacent source of PFAS. **Figure 5-1** shows the location of Mid-Atlantic Steel LLC.

Summit Steel, Inc is located 1.4 miles northeast of RRTS (**Figure 5-1**). There is no confirmation of the use of PFAS-containing materials at this steel erecting company in New Castle, Delaware; however, materials containing PFAS are commonly used in metals industries. As a result, Summit Steel, Inc is a possible adjacent source of PFAS.

Atlas Welding & Fabrication, Inc is located 1.2 miles from RRTS (**Figure 5-1**). There is no confirmation of the use of PFAS-containing materials at this location; however, PFAS are often

The Delaware Sand and Gravel landfill is a 27-acre superfund site located 0.8 miles north of RRTS and is shown in **Figure 5-1** (USEPA, 2017). Formerly a sand and gravel quarry, the site was converted to a landfill and was operational from 1968 to 1976. The landfill consisted of four disposal areas, three of which held waste materials including hazardous substances in unlined gravel pits. The fourth area was used for temporary chemical waste storage where spillage of hazardous substances occurred (USEPA, 2017). The landfill housed 550,000 cubic yards of both municipal and industrial wastes, including 15,000 drums of chemical production, petroleum, and manufacturing liquids (USEPA, 2017). Contaminants leaking from this site were found in public groundwater supplies in 1971. Since that time, a slurry wall system was installed to prevent contaminants leaking to groundwater, the landfill was capped, and extraction wells were installed to capture and remove contaminants for transfer to the nearby wastewater treatment plant. PFOA and PFOS were detected in groundwater samples from the landfill's monitoring wells in 2013. Monitoring for PFAS began at the landfill in fall 2016 (USEPA, 2017). Because groundwater testing has shown PFAS contamination from the landfill, this location is considered an adjacent source of PFAS.

Adjacent Sources		
NOTES		Preliminary Assessment for PFAS at River Road Training Site, DE						
REVISED	2/4/2020	GIS BY	GC	2/4/2020

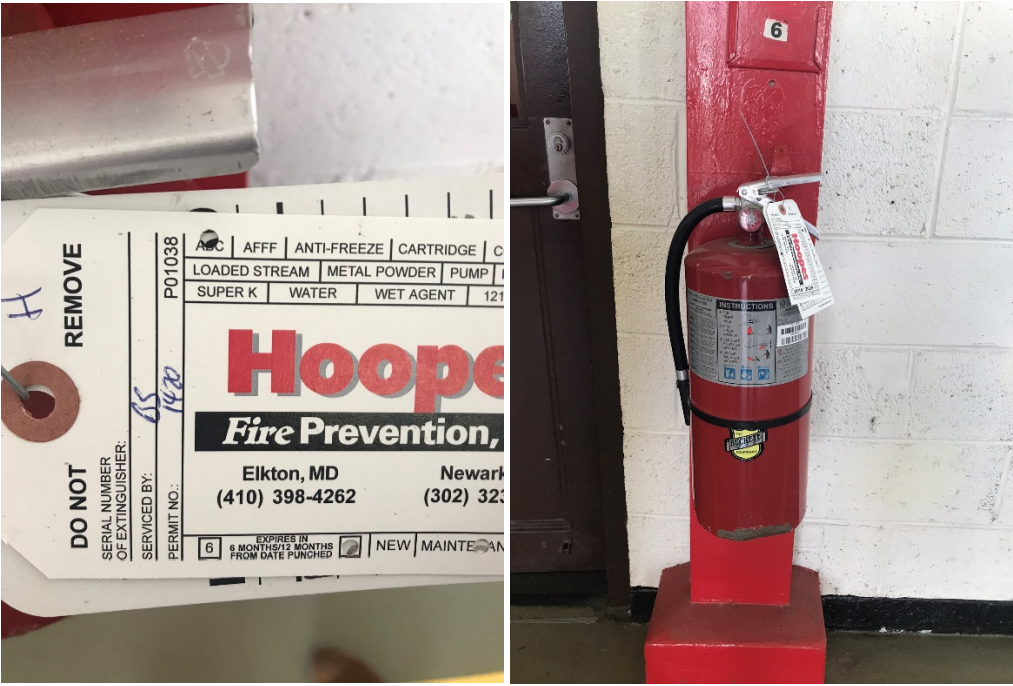
Army National Guard, Preliminary Assessment for PFAS	River Road Training Site	New Castle, Delaware
<p>Photograph No. 1</p> <p>Description:</p> <p>Fire Extinguisher and tag inside administrative building. Extinguishers in building are all ABC, non-PFAS fire suppressants.</p> <p>Photo Date: 8/5/2019</p>

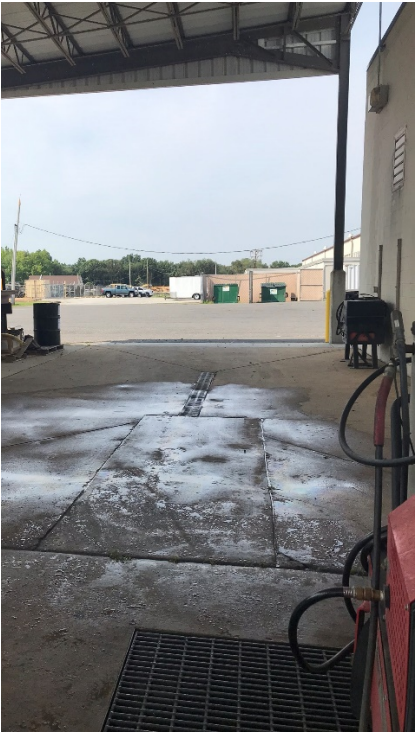
<p>Photograph No. 2</p> <p>Description:</p> <p>Wash rack drain that leads to oil/water separator.</p> <p>Photo Date: 8/5/2019</p>

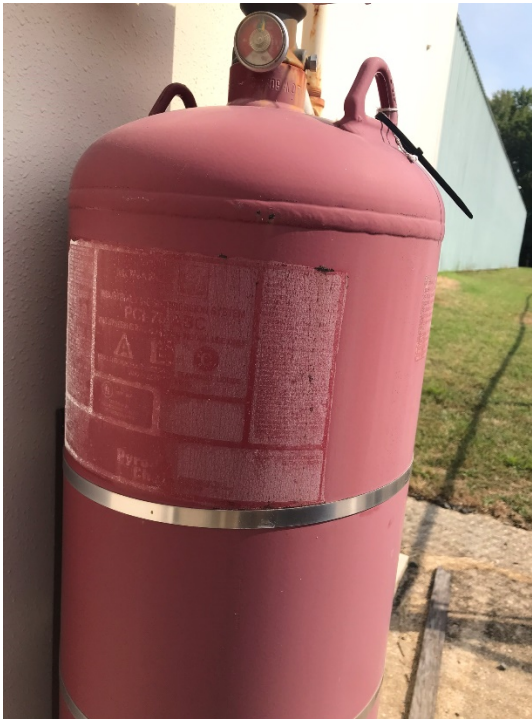
Army National Guard, Preliminary Assessment for PFAS	River Road Training Site	New Castle, Delaware
<p>Photograph No. 5</p> <p>Description:</p> <p>Dry chem Fire Extinguisher kept on side of the HAZMAT storage shed.</p> <p>Photo Date: 8/5/2019</p>

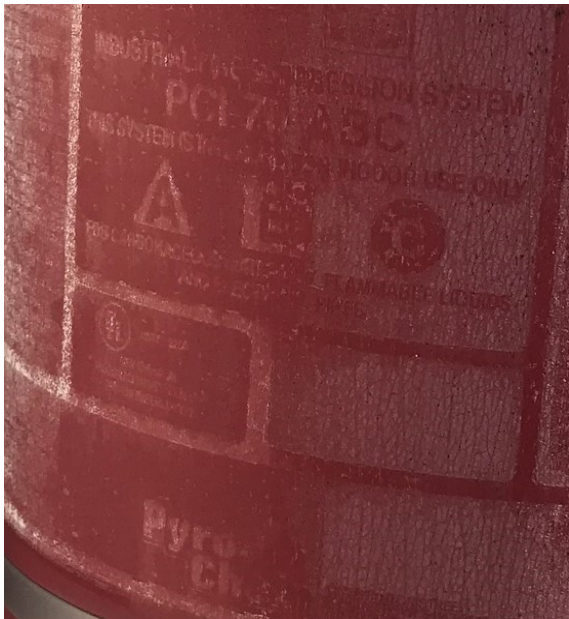
<p>Photograph No. 6</p> <p>Description:</p> <p>Label from extinguisher in the previous photograph. It is a Pyro Chem PCL 75 ABC dry chem extinguisher.</p> <p>Photo Date: 8/5/2019</p>
