Final Preliminary Assessment Report Camp Johnson Colchester, Vermont

Perfluorooctane-Sulfonic Acid (PFOS) and Perfluorooctanoic
Acid (PFOA) Impacted Sites
ARNG Installations, Nationwide

April 2019

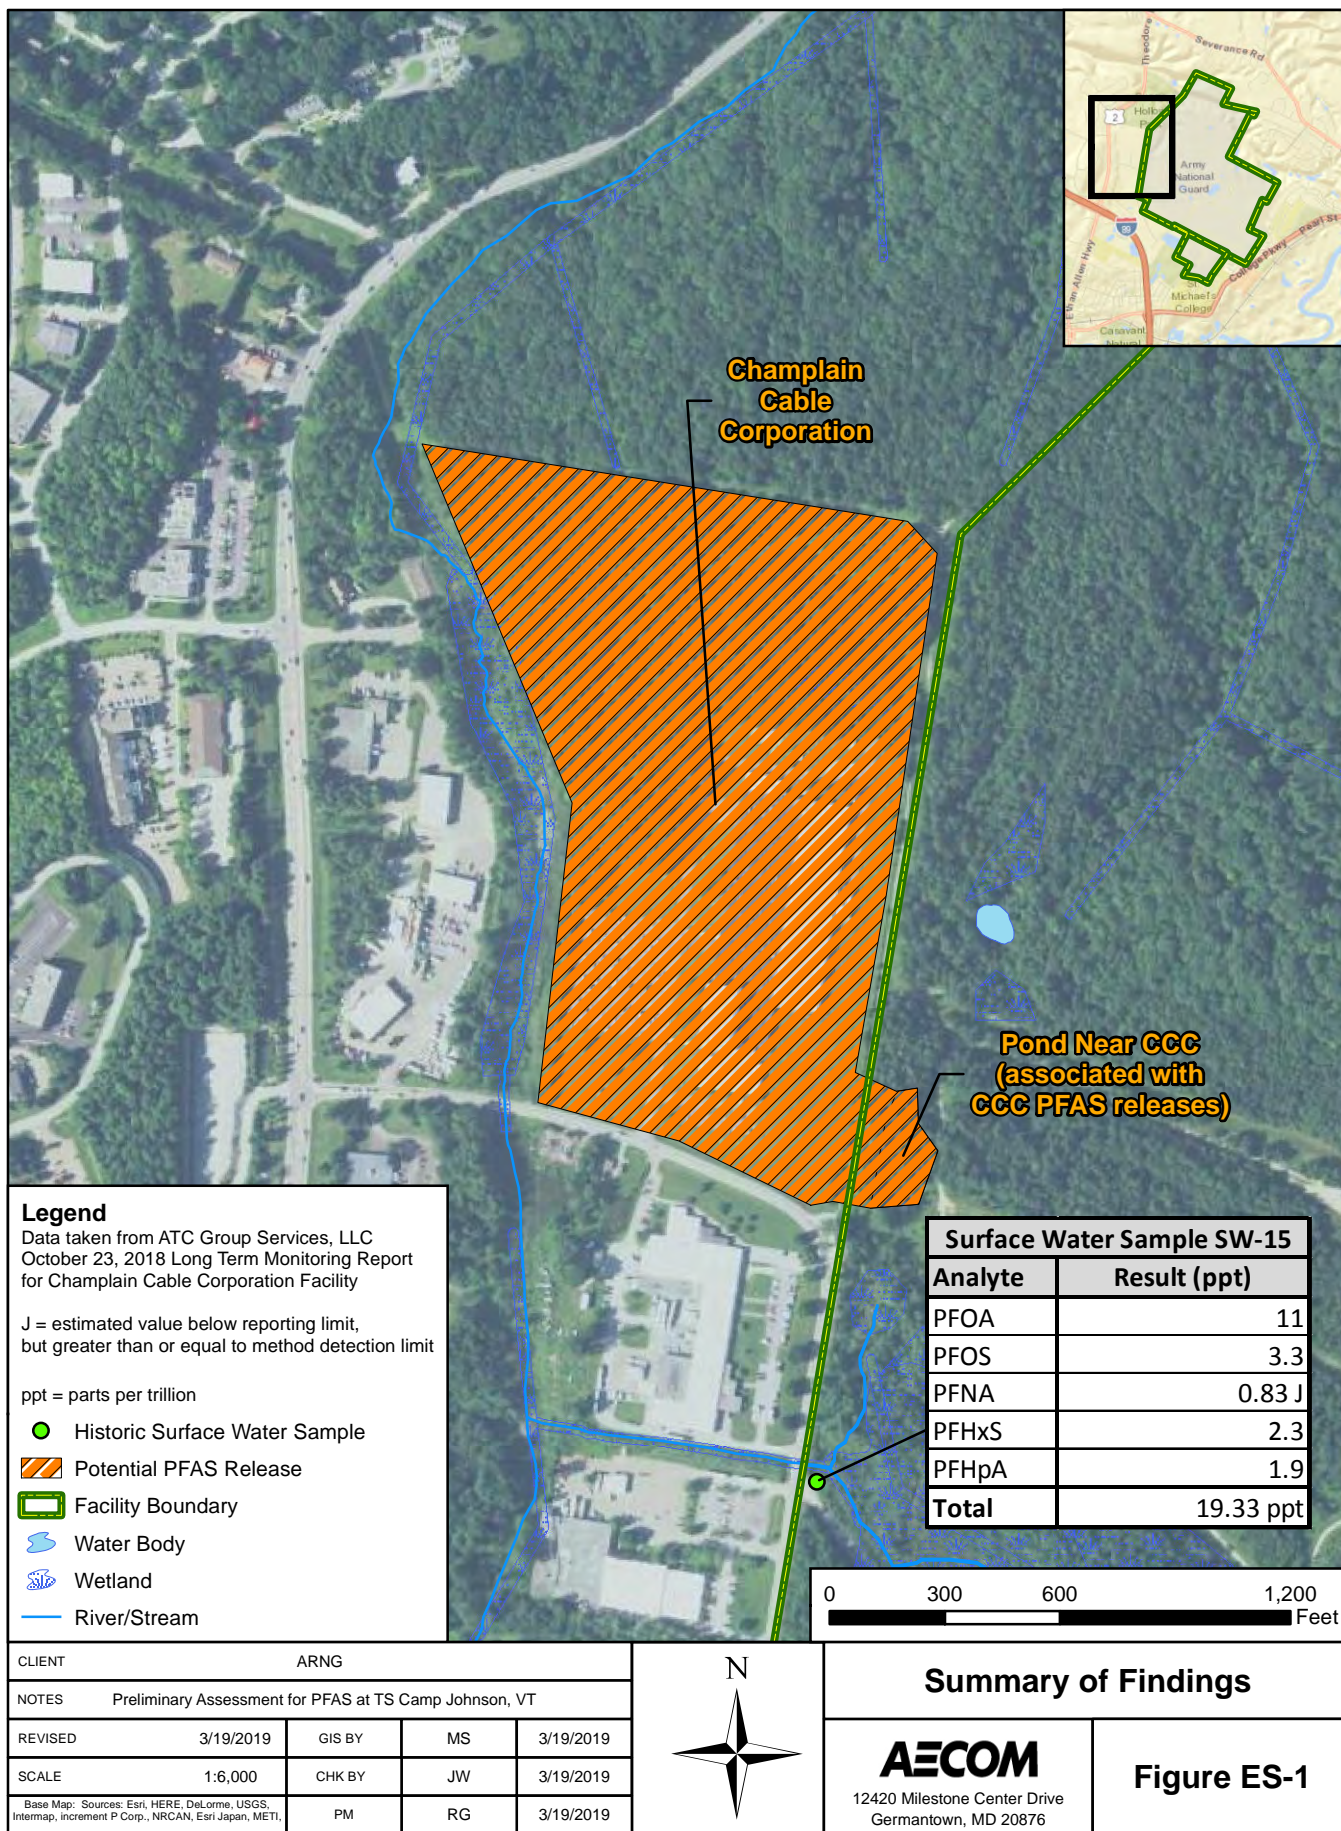
However, off-facility PFAS releases were confirmed at the adjacent Champlain Cable Corporation (CCC) property. The CCC manufactures wire and cable coatings. These manufacturing processes have been found to use PFAS. Between 1966 and 1977, CCC liquid wastes were poured onto the ground along the roadway to the east of the CCC property and in an area to the northeast of the facility. PFAS was detected in groundwater at the CCC property and in surface water in a small pond at CJ, adjacent to the CCC property. The CCC property adjacent source and affected surface waters on CJ are shown on **Figure ES-1**.

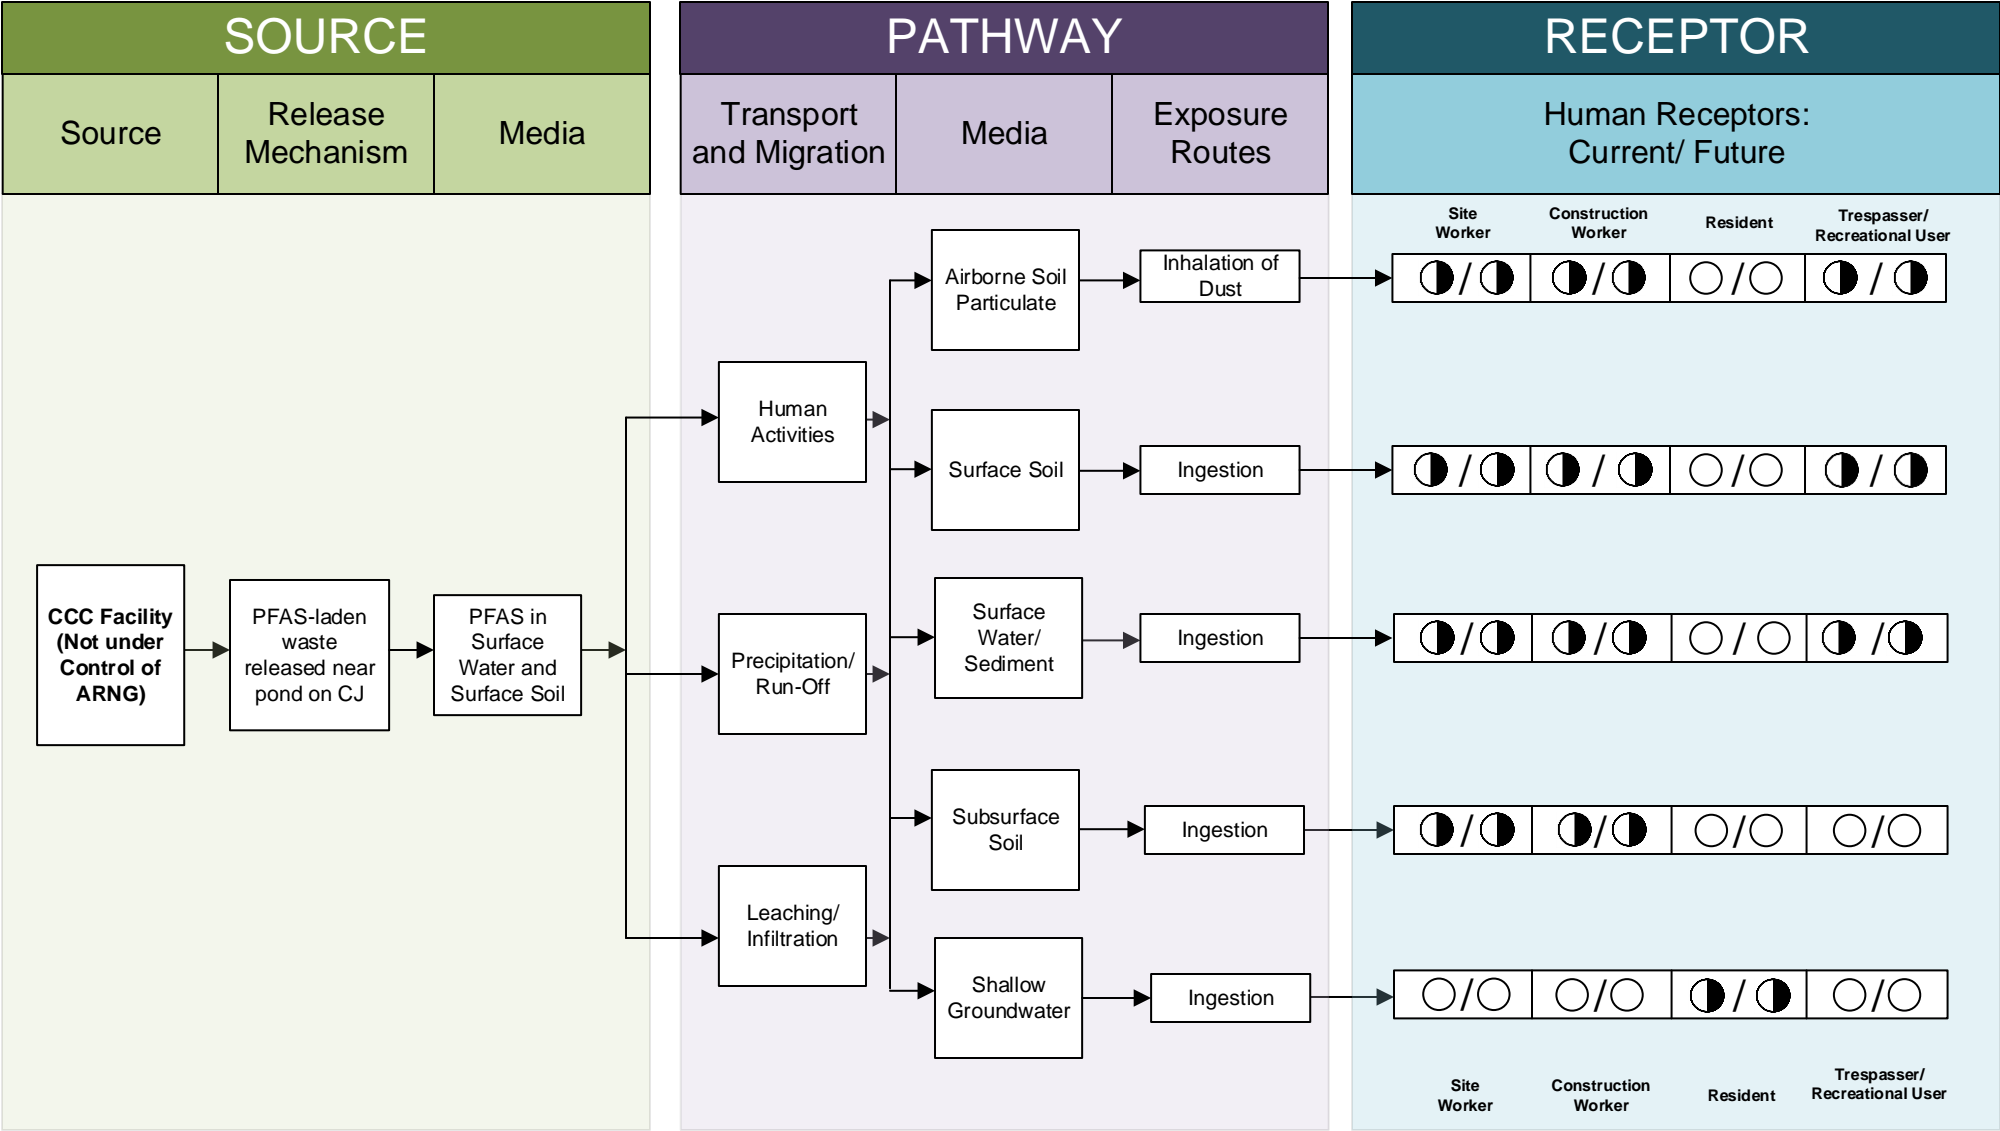
Figure ES-2
Conceptual Site Model
Camp Johnson

Given the PFAS-laden waste releases by the CCC, it is presumed that PFAS is migrating to CJ in surface water and possibly groundwater. Thus, there is potential for CJ site and construction worker exposure to PFAS contamination in surface and subsurface soils, and recreational user/trespasser exposure to PFAS contamination in surface soil. There is also potential for exposure to PFAS contamination in surface water via the small pond at CJ to site and construction workers, and recreational users/trespassers via ingestion. Although groundwater is not used for drinking water at CJ, groundwater may be used off-facility by residents for drinking water. As such, off-facility residents may be exposed to PFAS contamination in groundwater via ingestion. The CSM for CJ is shown on **Figure ES-2**.

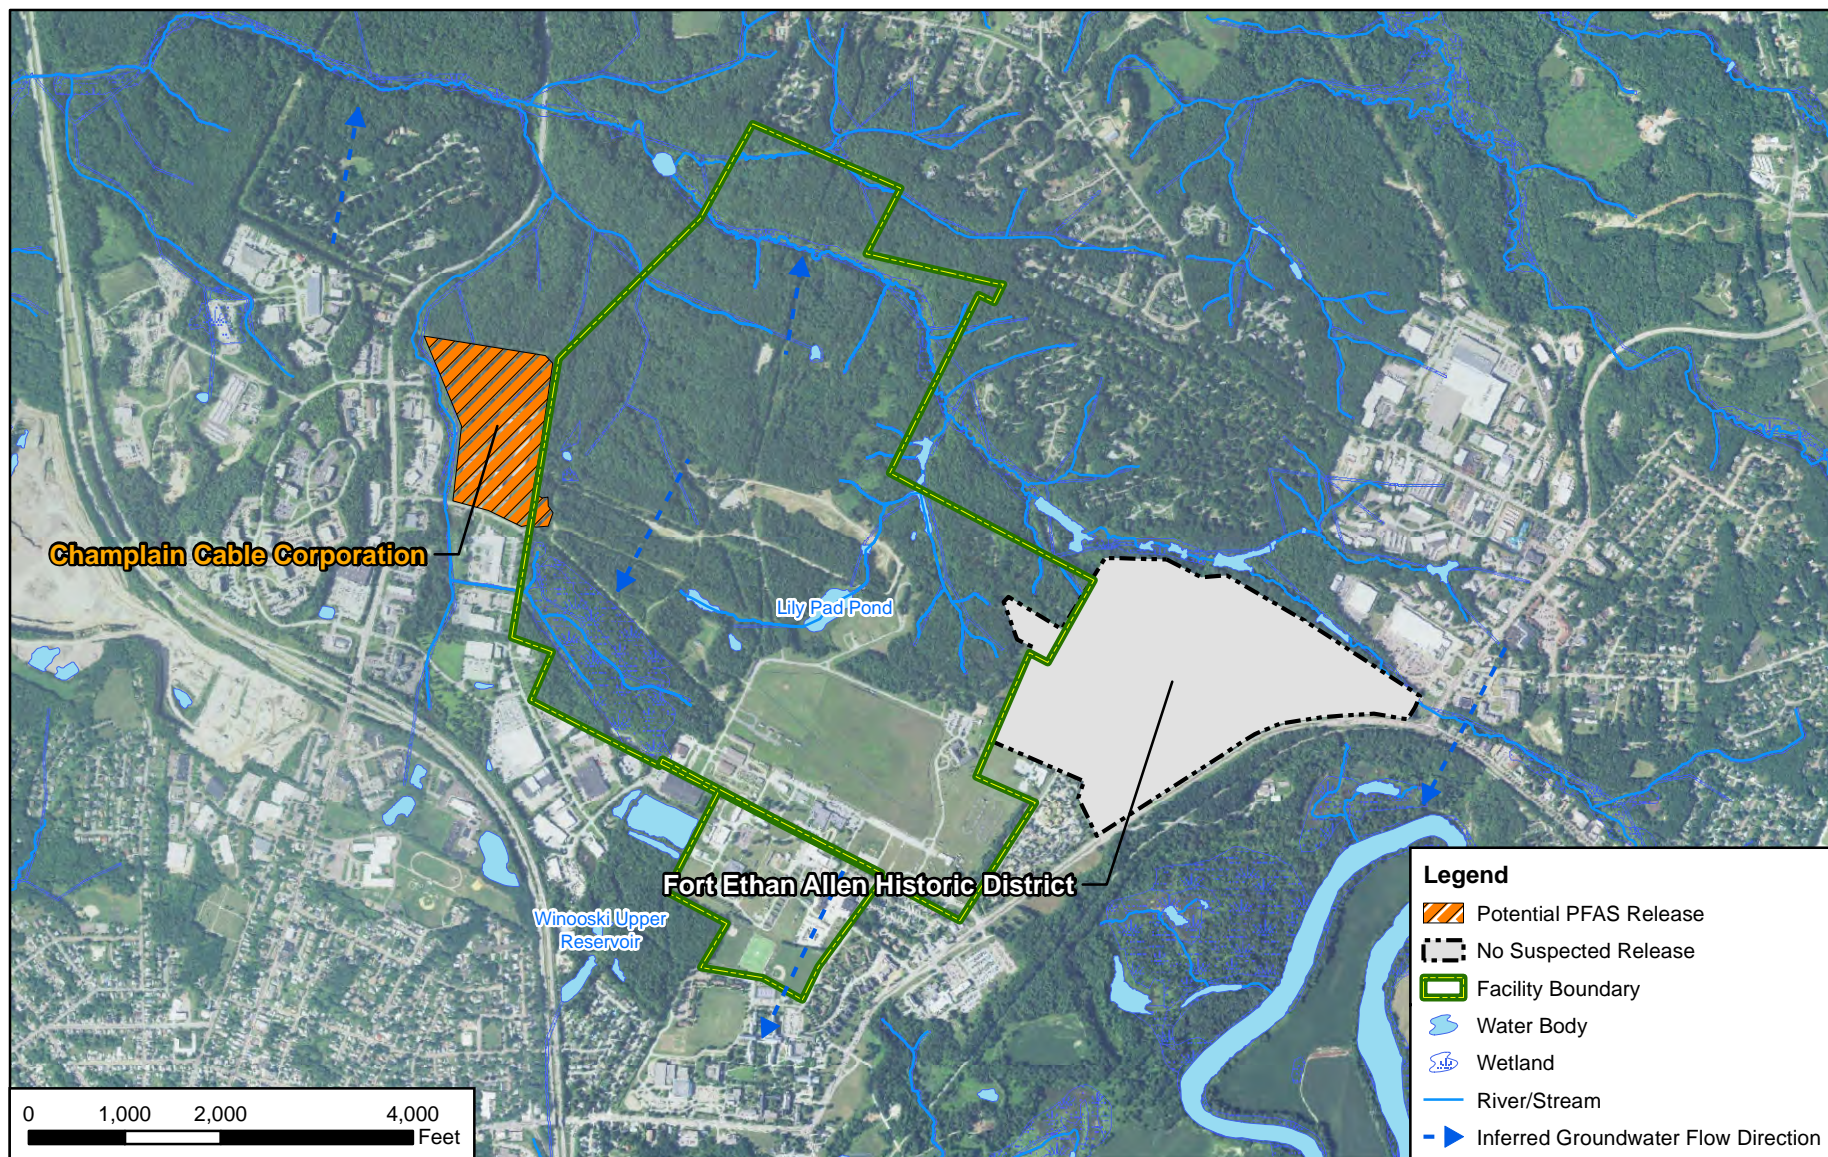
Figure 5-1

The CCC occupies a 39-acre property at 175 Hercules Dr, Colchester, VT 05446, which is about 400 feet west of the CJ western property boundary (**Figure 5-1**). Founded in 1955, the CCC manufactures wire and cable coatings for aircraft, computer, and energy industries. Industrial processes include metal cleaning and degreasing operations, thermoplastic extrusion of wire insulation, lacquer coating, tape wrapping, and cold drawing of wire to produce wire of various sizes. The waste products have historically contained lubricating solutions, degreasing solvents and liquid corrosives. These manufacturing processes have been found to use PFAS.

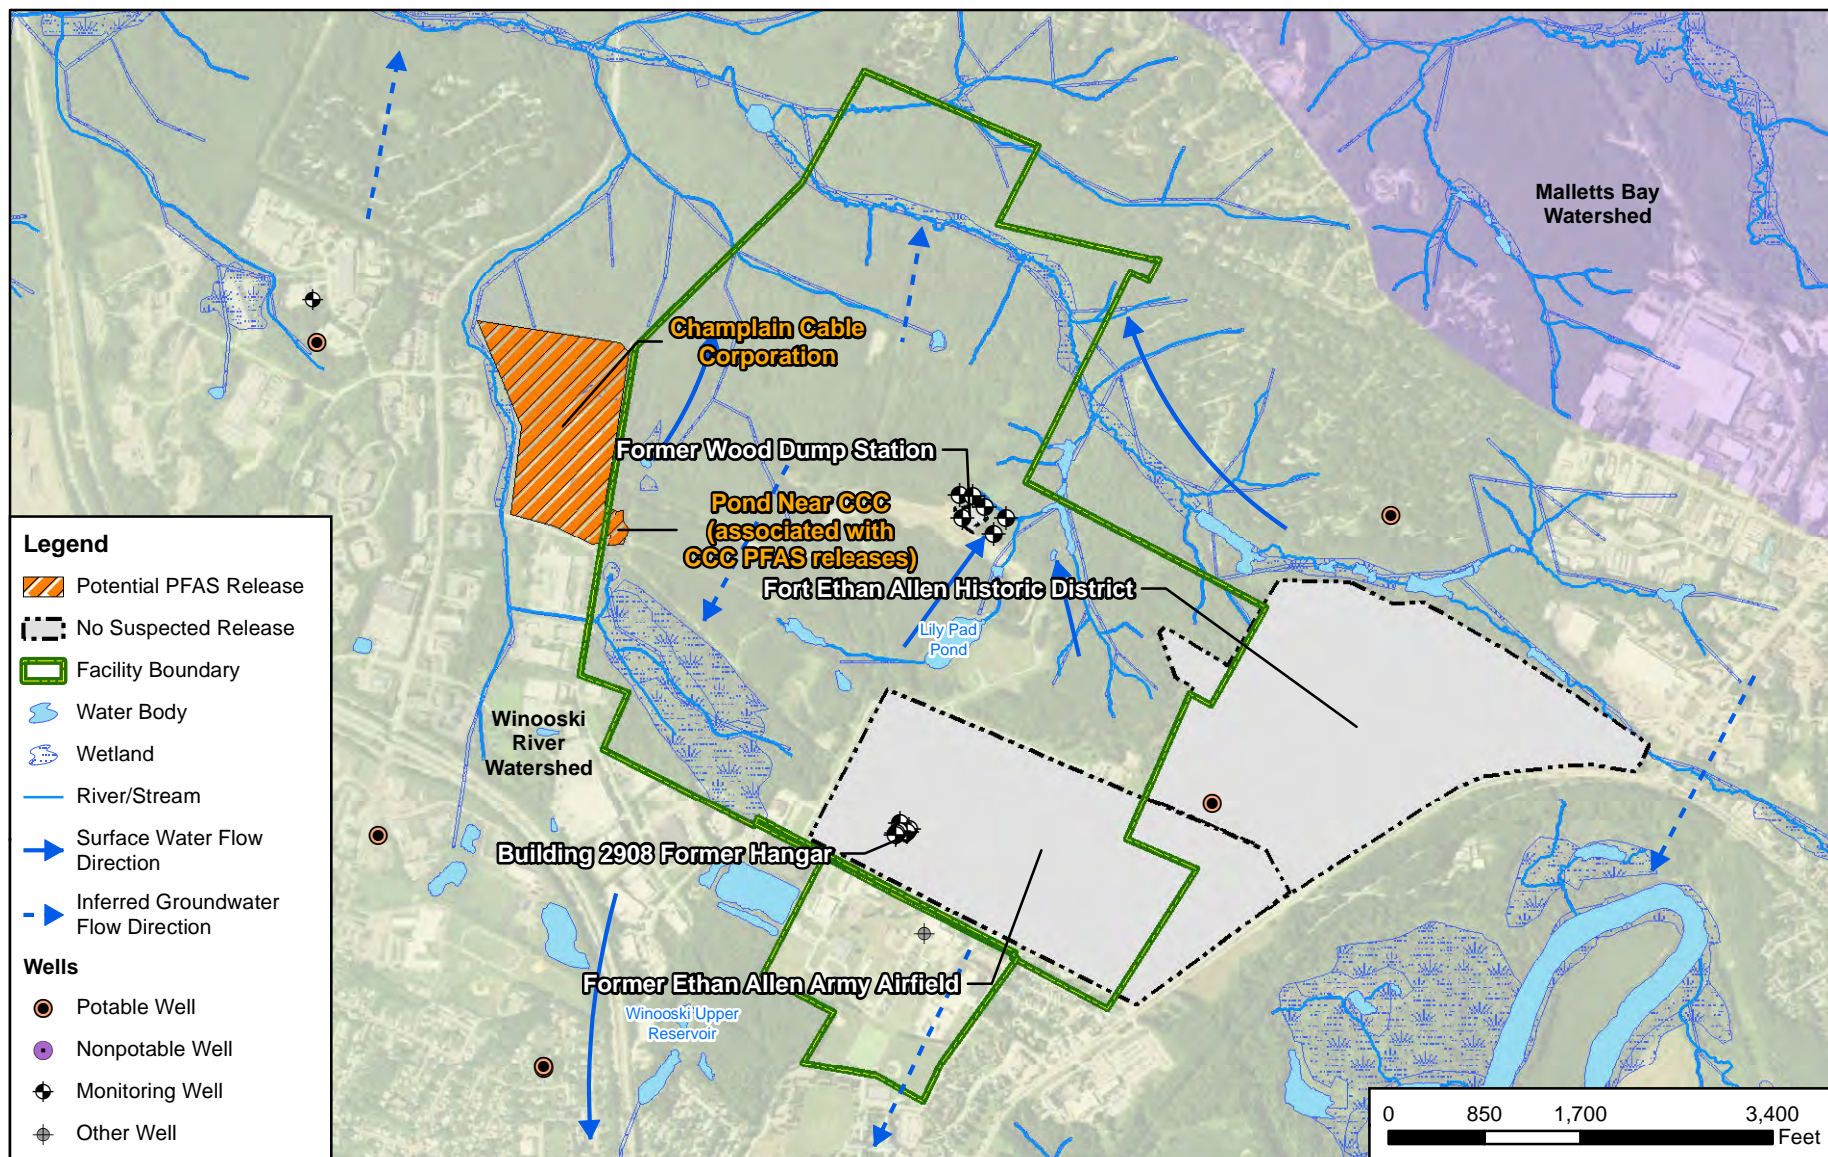
12420 Milestone Center Drive Germantown, MD 20876		Figure 6-1
SCALE	1:20,400	CHK BY	JW	3/19/2019				
Base Map: National Agricultural Imagery Program, 2016		PM	RG	3/19/2019

Based on the PA findings, potential release areas were identified at the Pond Near CCC; however, this area is not considered an AOI because its release is associated with the adjacent CCC property. The pond location is shown on **Figure 6-1**. The following section describes the CSM components and the specific CSM developed for the areas adjacent to the CCC property. The CSM identifies the three components necessary for a potentially complete exposure pathway: (1) source, (2) pathway, (3) receptor. If any of these elements are missing, the pathway is considered incomplete. Potential PFAS receptors at CJ include site workers, construction workers, and trespassers. Off-facility potential PFAS receptors include residents and public recreation area users. The CSM indicates which specific receptors could potentially be exposed to PFAS.

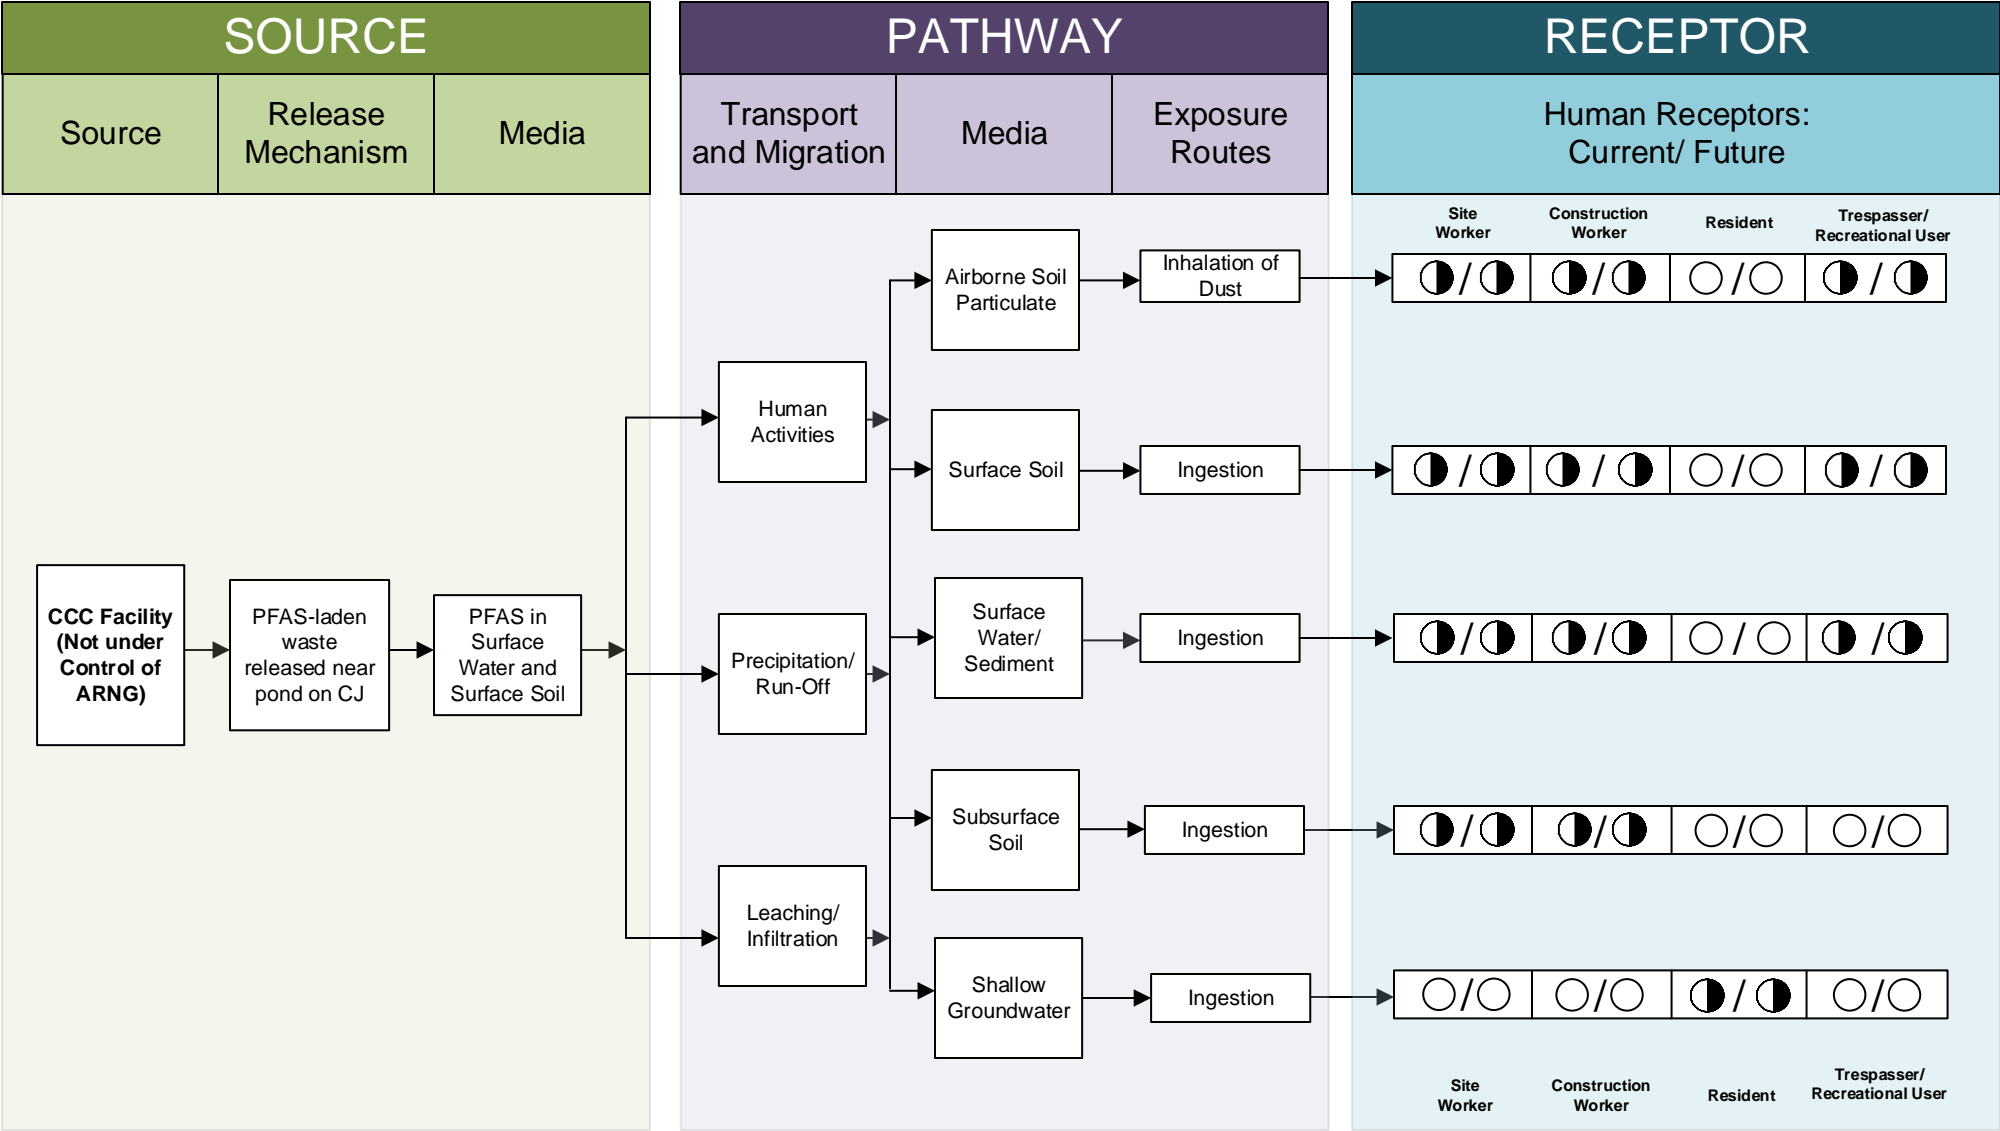
PFAS has been detected in surface water at the pond, with the most recent samples exhibiting a total concentration 19.33 ppt for the five state-regulated compounds (PFOA, PFOS, PFHxS, PFHpA, and PFNA) in surface water (ATC Group Services, LLC, 2018), which is below the 20 ppt Drinking Water Health Advisory. Surface water from precipitation may infiltrate in areas with permeable surface soils. Precipitation on paved surfaces will generally flow overland or be collected by the facility's storm and sewer drain infrastructure, where it exists, and ultimately discharge to the ponds and tributaries of Sunderland brook located on the northern property of CJ. CJ site workers, construction workers, and trespassers may be exposed to PFAS contaminated surface water at or near the pond.

The primary exposure pathway for PFAS from groundwater would be through ingestion of drinking water; however, potable water at CJ is supplied to the facility by the CWD. The distribution system includes a main line that enters the CJ from the south. Groundwater from active CJ monitoring wells has not been analyzed for PFAS; therefore, it is unknown whether PFAS is present in groundwater. Because wells at CJ are not used as a drinking water source, the pathway for potential PFAS in groundwater to receptors via ingestion is incomplete. Although no receptors for PFAS exposure to groundwater via ingestion exist at CJ, residents using private potable wells

near the CCC property may be exposed to PFAS in their drinking water. The CSM for the pond is shown on **Figure 6-2**.

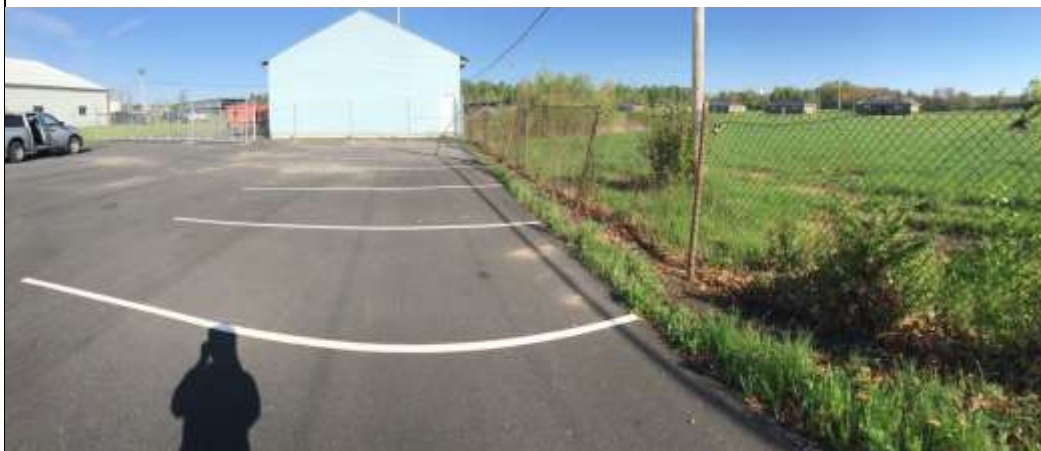
View of Building 2908. View to the northwest.

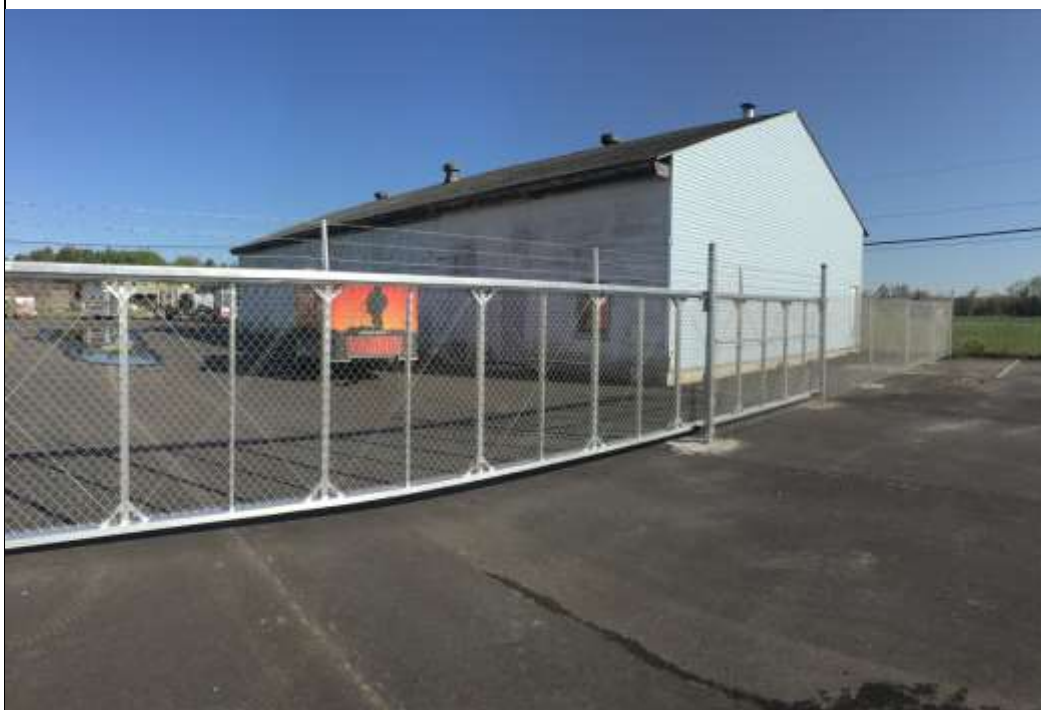
Photograph No. 2

Building 2908. View to the north.

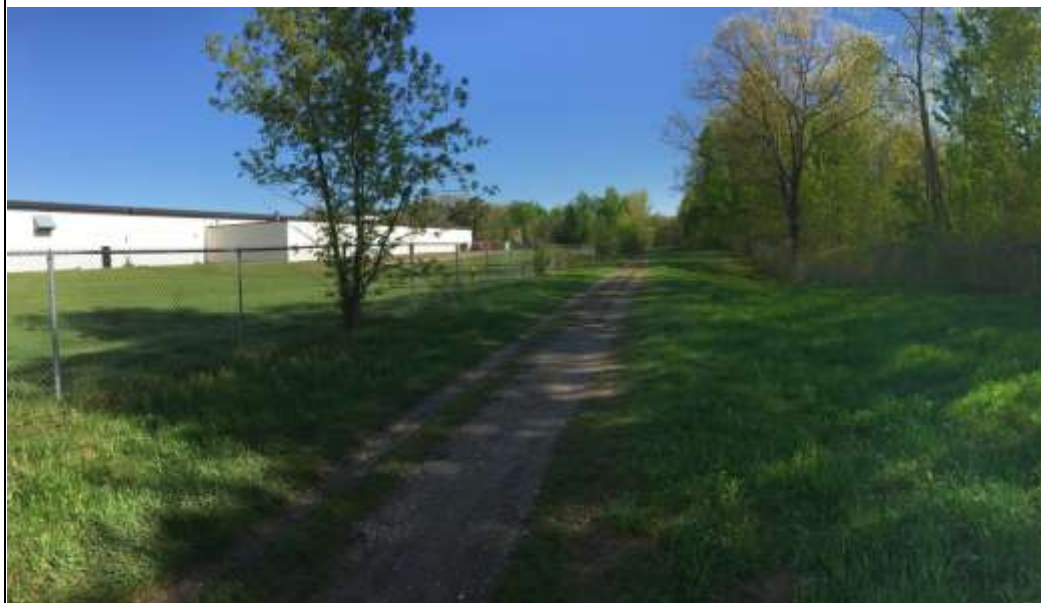
Sunny Hollow Trail between Champlain Cable Company (left side of photograph) and Camp Johnson (right side of photograph). View to the north.

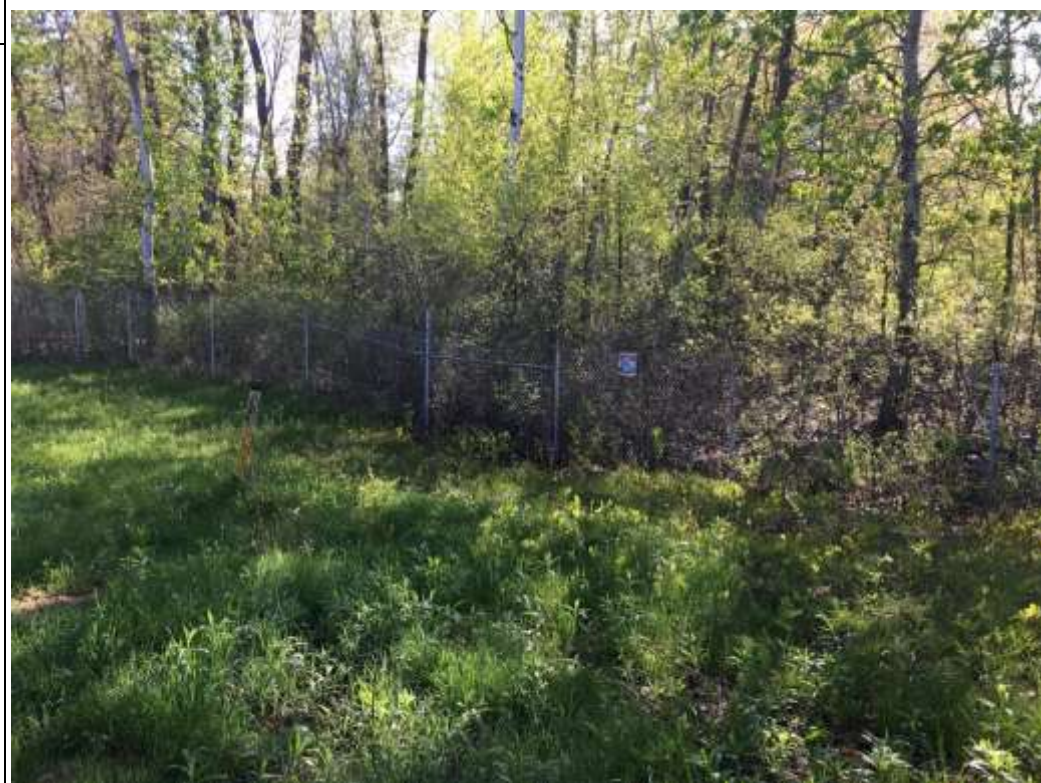
Photograph No. 4

View of Camp Johnson's western property boundary adjacent to Sunny Hollow Trail.

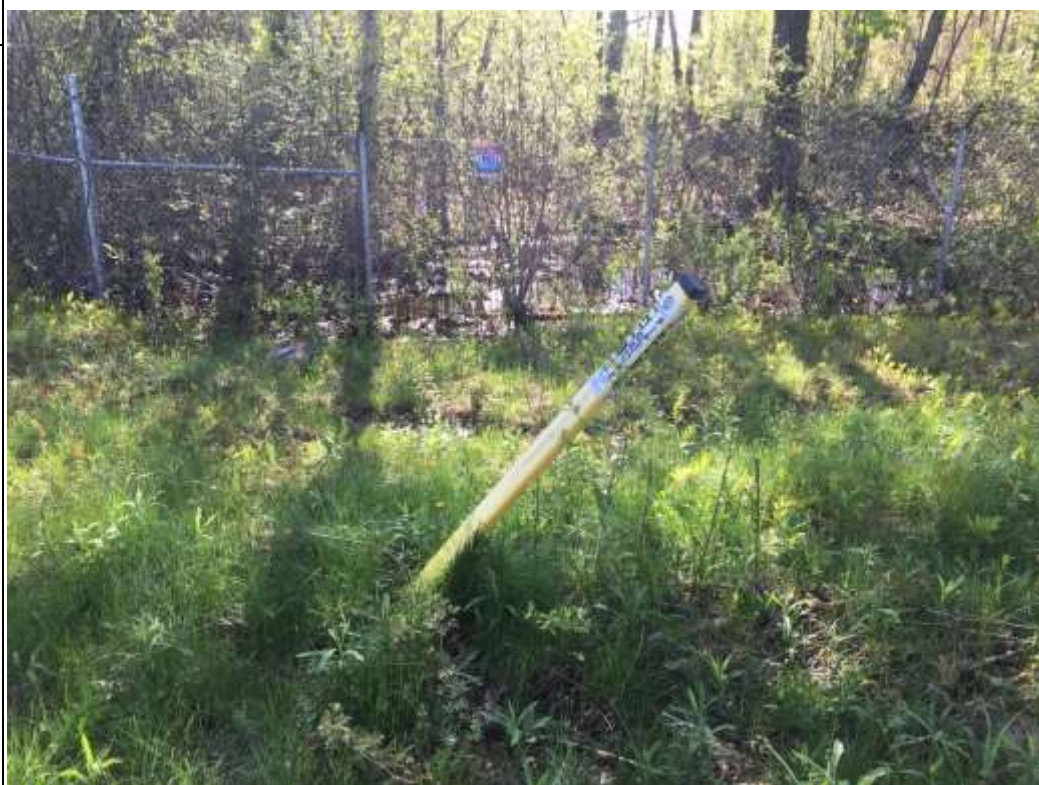
View of low lying areas with
ponded water adjacent to
Sunny Hollow Trail and Camp
Johnson's western property
boundary.
