FINAL Preliminary Assessment Report Nome Army Air Operating Facility Nome, Alaska

Perfluorooctanesulfonic Acid (PFOS) and Perfluorooctanoic Acid (PFOA) Impacted Sites ARNG Installations, Nationwide

August 2020

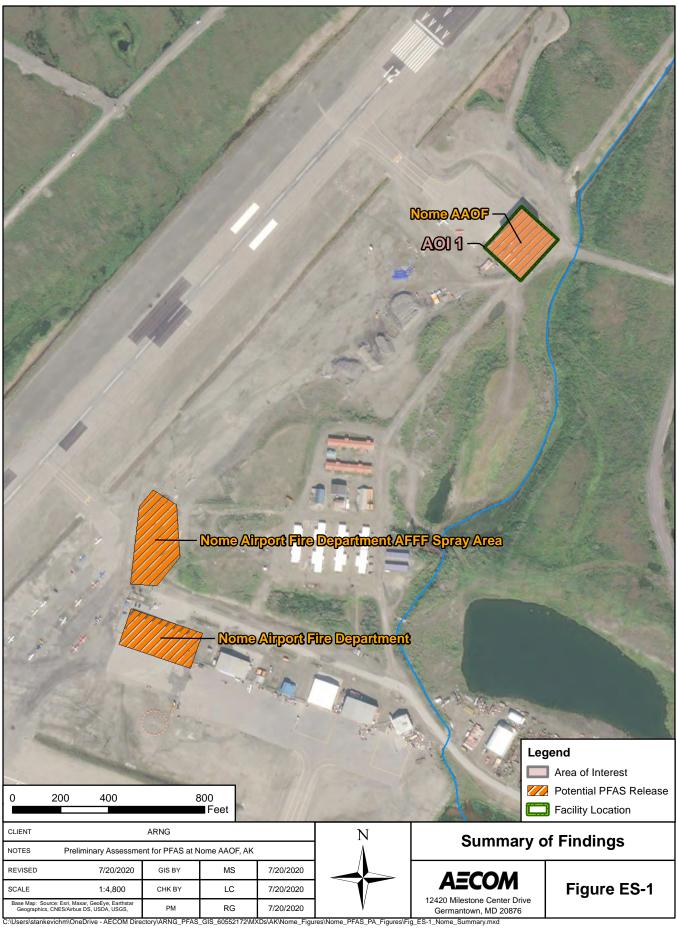
One AOI related to a potential PFAS release was identified at the facility during the PA. The AOI is shown on **Figure ES-1** and described in **Table ES-1** below:

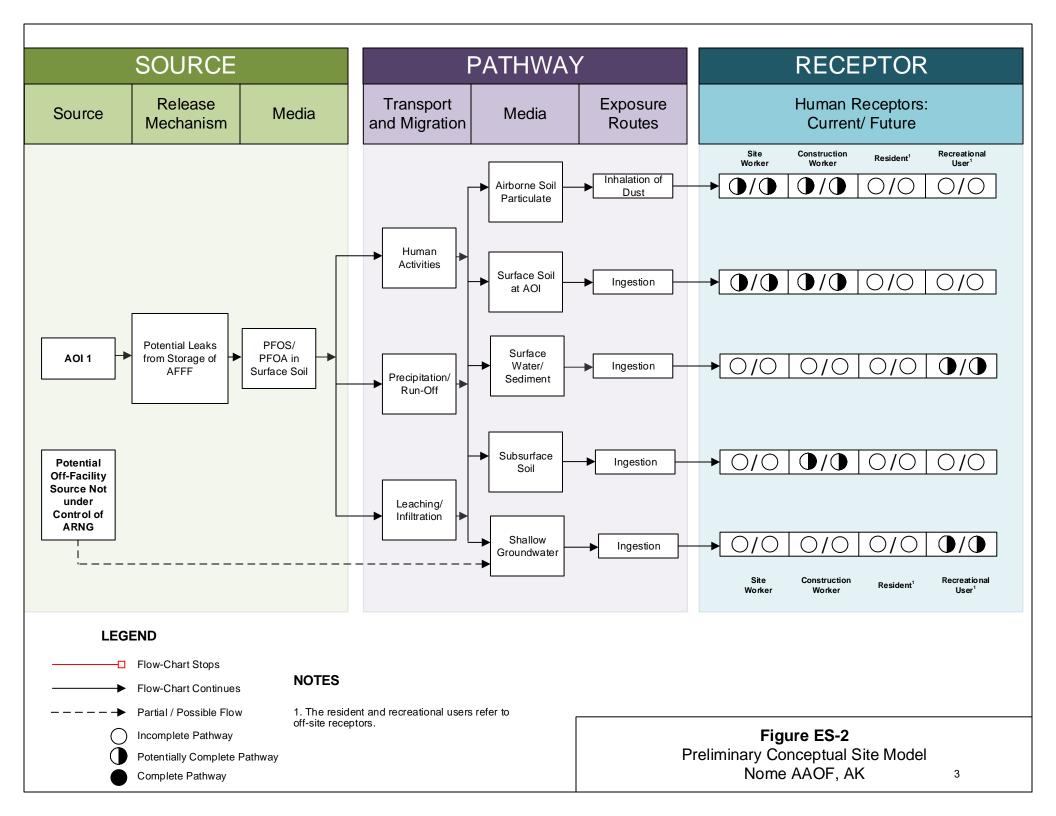
Based on potential PFAS releases at AOI 1, there is potential for exposure to PFAS contamination in media at or near the facility. The preliminary CSM for AOI 1, which presents the potential receptors and media impacted, is shown on **Figure ES-2**. Based on the US Environmental Protection Agency (USEPA) Unregulated Contaminant Monitoring Rule 3 (UCMR3) data, it was indicated that no PFAS were detected in a public water system above the USEPA's lifetime Health Advisories (HAs) within 20 miles of the facility. The HA is 70 parts per trillion for PFOS and PFOA, individually or combined. PFAS analyses performed in 2016 had method detection limits that were higher than currently achievable. Thus, it is possible that low concentrations of PFAS were not detected during the UCMR3 but might be detected if analyzed today.

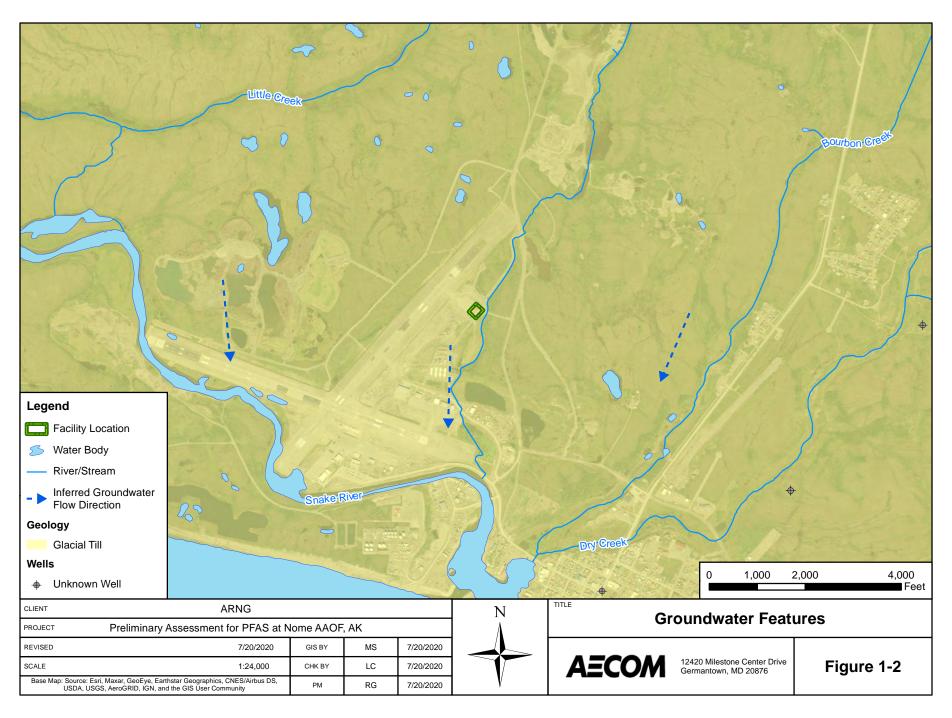
Due to the local permafrost, groundwater in the Nome area is generally restricted along coastal areas as permafrost will confine groundwater flow to units above or below the frozen sections (**Figure 1-2**). Coastal sections of unfrozen ground may be hydraulically connected to marine water and therefore wells typically yield poor quality or insufficient quantities of potable water (Dorava, 1995).

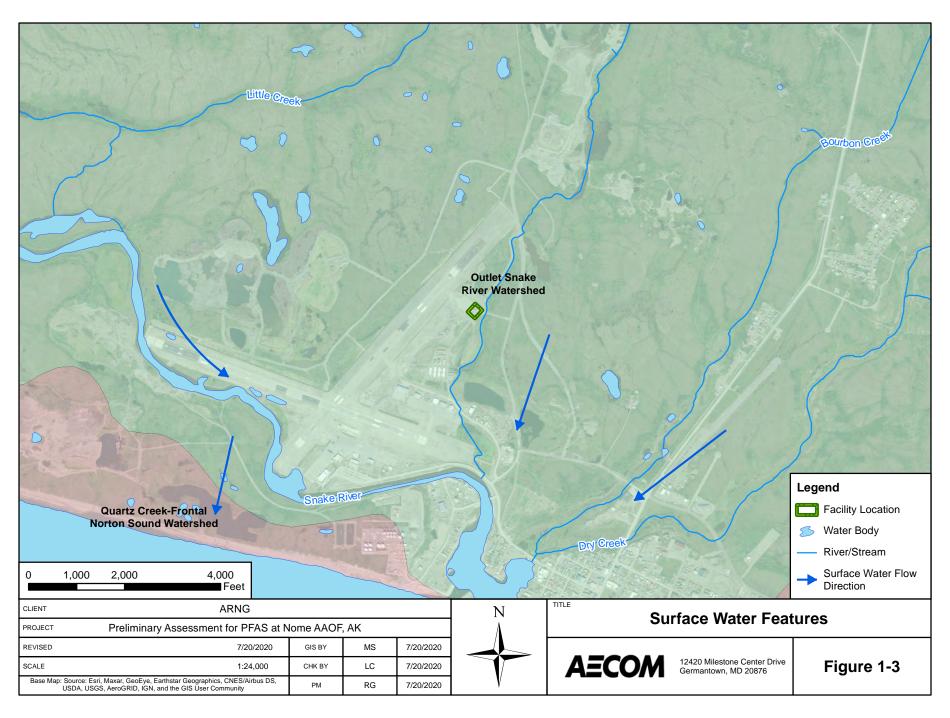
Nome is approximately a quarter mile from open, navigable marine waters (**Figure 1-3**). These waters of the Norton Sound provide wave action which works the sediments of the shore into beach deposits. Despite its proximity to the shore, the AAOF is not within the 100-year flood plain (City of Nome, 2010).

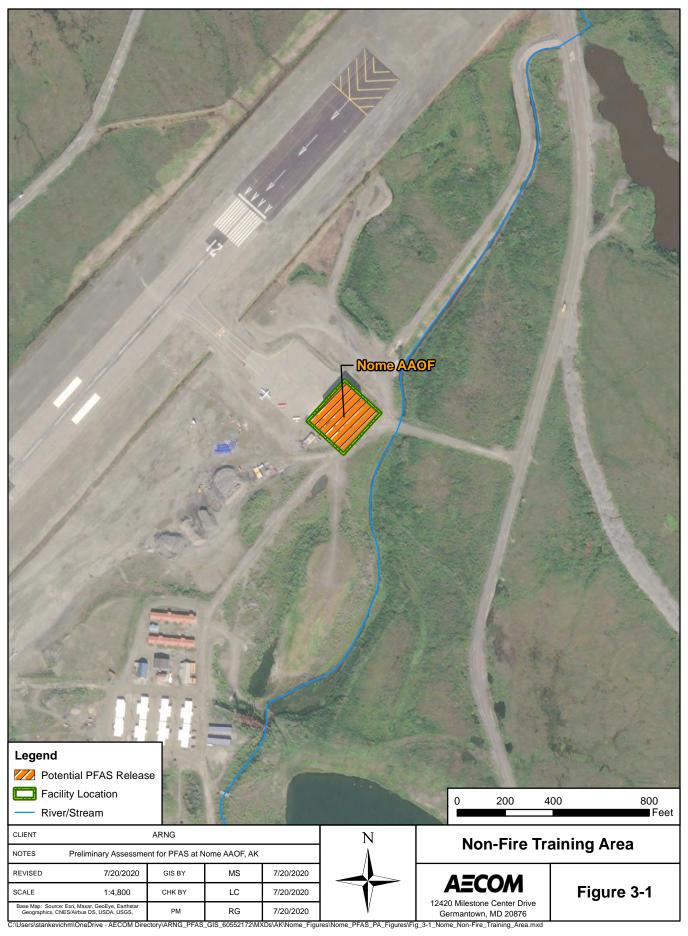
The AAOF was constructed in 1992, and comprises a hangar, concrete pad, asphalt apron, boiler room, closed-loop wash water recycling system, and several 100-gallon above-ground storage tanks. The geographic coordinates are 64°30′58.25″N and 165°25′33.46″W. There are floor drains within the hangar that drain to a 500-gallon below ground storage tank. The concrete pad outside has several above and below ground storage tanks ranging from 2,000- to 30,000-gallons which store sewage, water, and jet fuel. The hangar is not equipped with an AFFF fire suppression system. Five 5-gallon buckets of Chemguard 3% AFFF concentrate are stored in the hangar. No AFFF solution has been mixed or sprayed within the hangar. A single Tri-Max™ 30 emergency response cart is onsite at the AAOF. The AKARNG interviewees do not recall the Tri-Max™ cart being used or discharged at the facility. The cart is sent to Anchorage for hydrostatic testing and replaced with an upgraded model every few years. Based on the storage of AFFF in 5-gallon buckets and the Tri-Max™ cart, the AAOF Hangar is considered a potential PFAS release area.

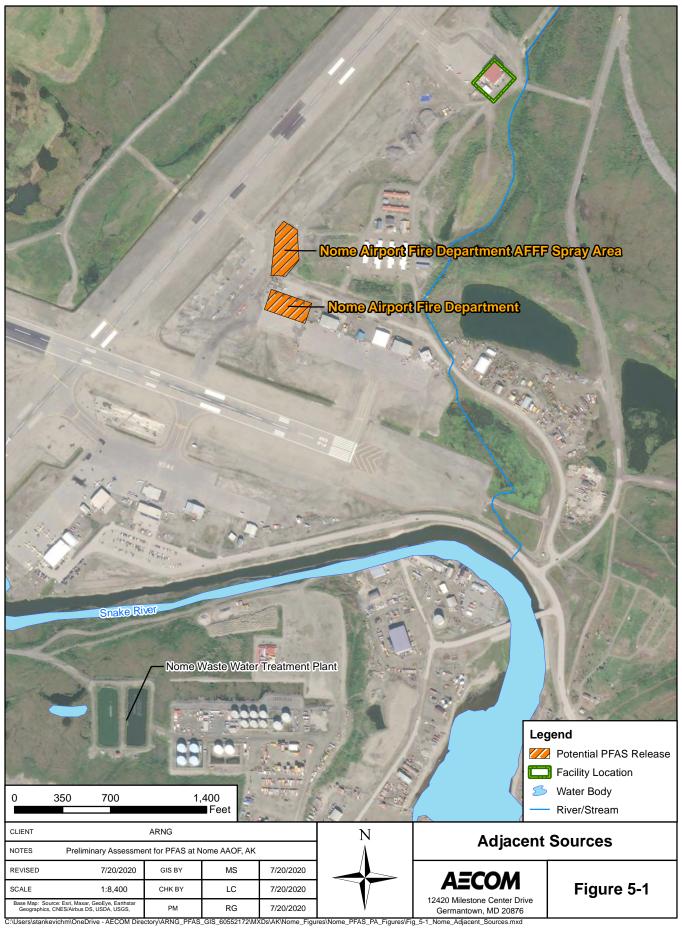
Three potential off-site PFAS sources were identified adjacent to the Nome AAOF during the PA interviews (**Appendix B**) and the EDR[™] report (**Appendix A**). **Figure 5-1** shows the location of the NAFD, NAFD AFFF Spray Area, and the nearby Nome Wastewater Treatment Plant (WWTP).

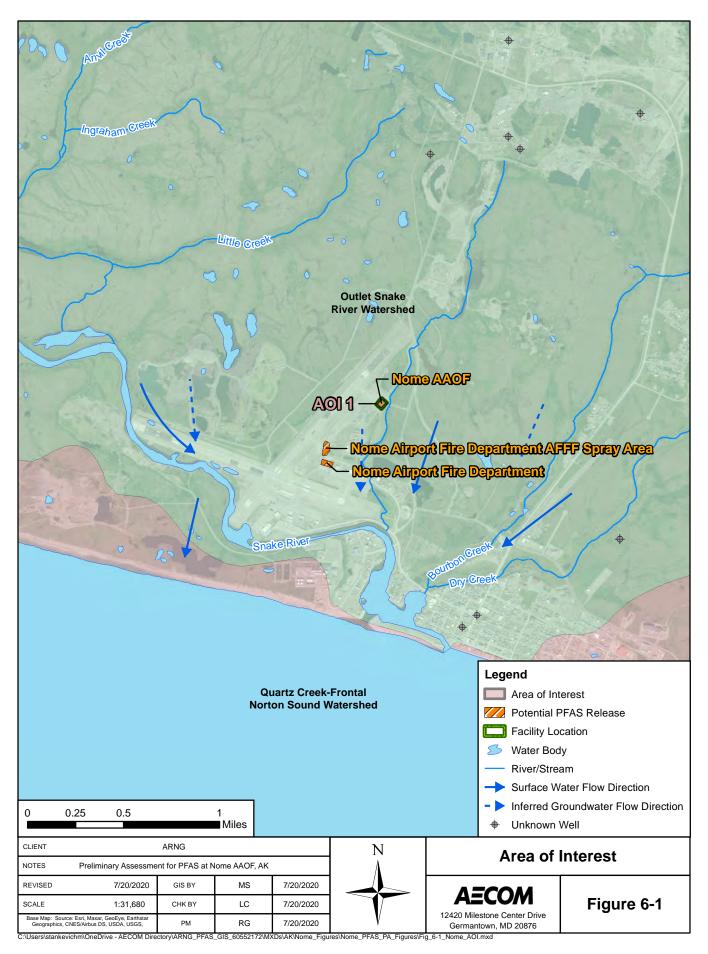
Based on the PA findings, one non-FTA was identified where PFAS may have been incidentally spilled or discharged to the ground surface: AOI 1 AAOF Hangar. As such, this area is determined to be an AOI and may be a potential PFAS source area. The AOI location is shown in **Figure 6-1**.

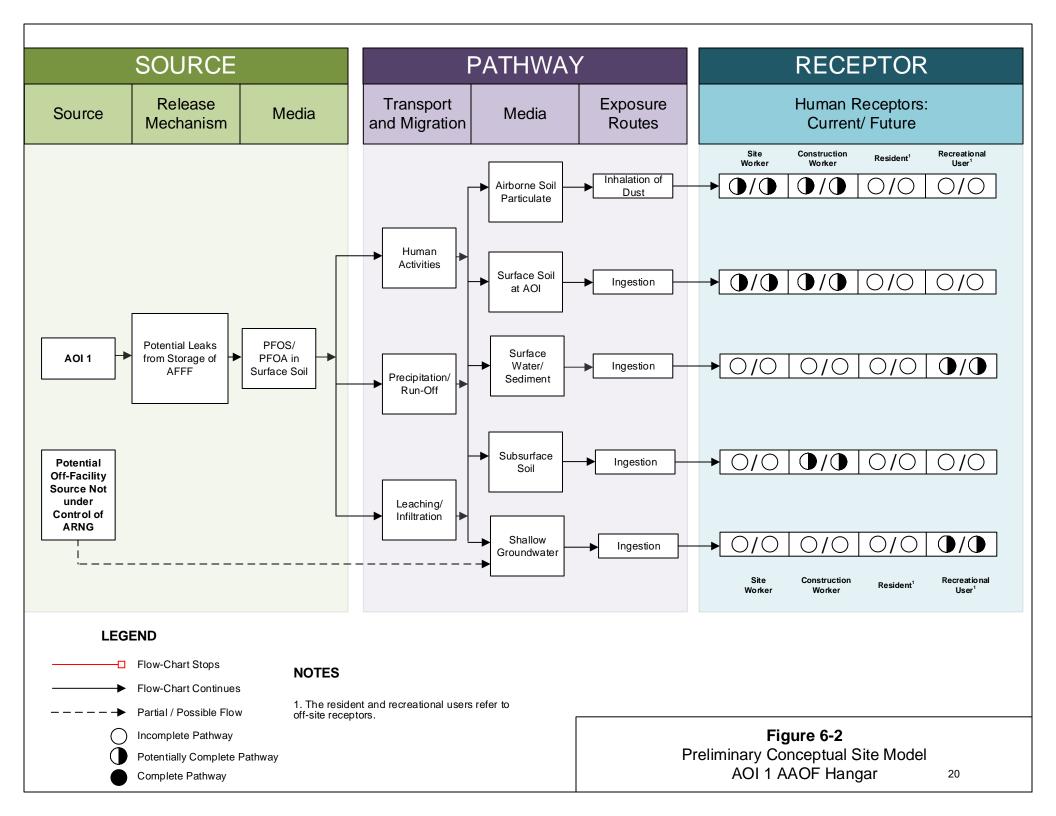
The following section describes the CSM components and the specific preliminary CSM developed for AOI 1. The CSM identifies the three components necessary for a potentially complete exposure pathway: (1) source, (2) pathway, (3) receptor. If any of these elements are missing, the pathway is considered incomplete. The preliminary CSM for AOI 1 is shown in **Figure 6-2**.

to the nearby surface waters. Recreational users of these surface waters may be potentially exposed to PFAS via the ingestion of PFAS-impacted surface water and/or sediment. Additionally, the unconsolidated sediments of the plain are believed to be hydrologically connected to marine water in the water table where permafrost has not precluded access. Therefore, the shallow groundwater ingestion pathway for recreational users is considered potentially complete. The preliminary CSM for AOI 1 is shown on **Figure 6-2**.

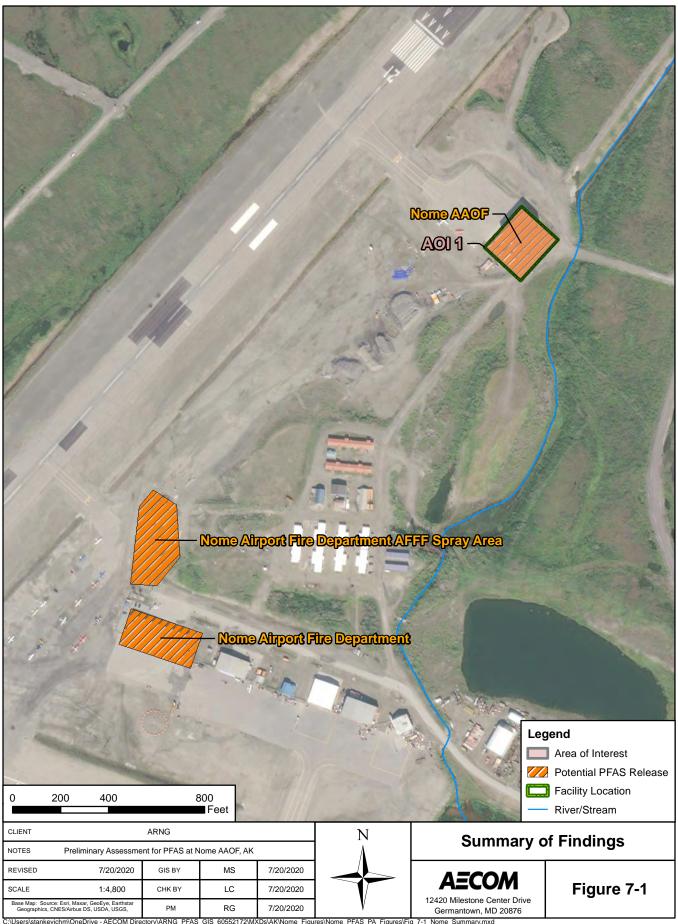
s\AK\Nome_Figures\Nome_PFAS_PA_Figures\Fig_7-1_Nome_Summary.mxd

One AOI related to a potential PFAS release was identified at Nome AAOF during the PA. The AOI is shown on **Figure 7-1** and described in **Table 7-1** below:

Interviews and records (covering 1980s to present) indicate that ARNG activities may have resulted in a potential PFAS release at the one AOI identified during the PA. Based on the preliminary CSM developed for the AOI, there is potential for receptors to be exposed to PFAS contamination in media at or near the facility. **Table 7-3** summarizes the rationale used to determine if the AOI should be considered for further investigation under the CERCLA process and undergo an SI.

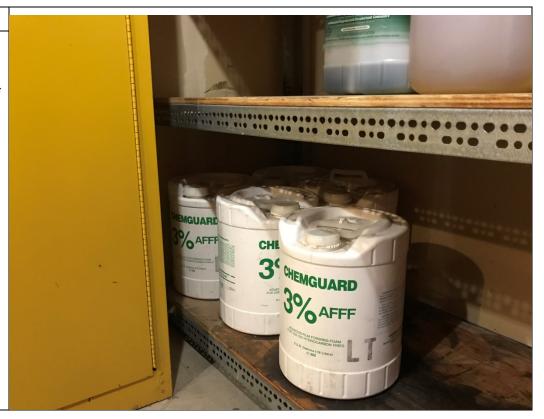
Photograph No. 2

Five 5-gallon buckets of AFFF stored next to the flame cabinet in the Nome AAOF, near the south corner of the hangar.

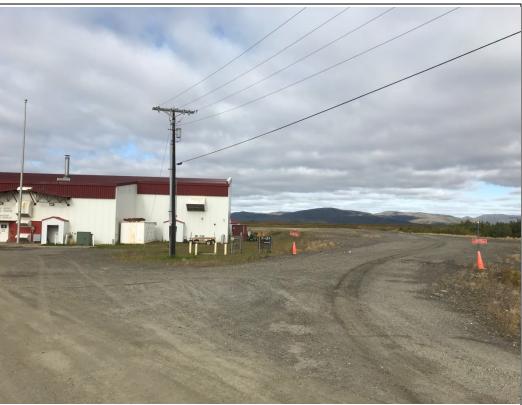
Photograph No. 4

Outside front of the Nome AAOF, looking southeast.

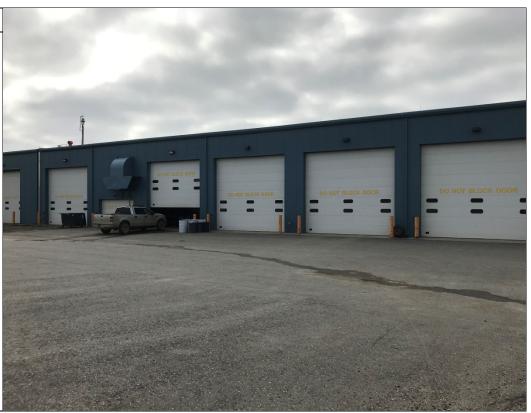
Photograph No. 6

Noma Airport Fire Department (about 200 -300 yards from the Fire Department's AFFF training area), looking south.

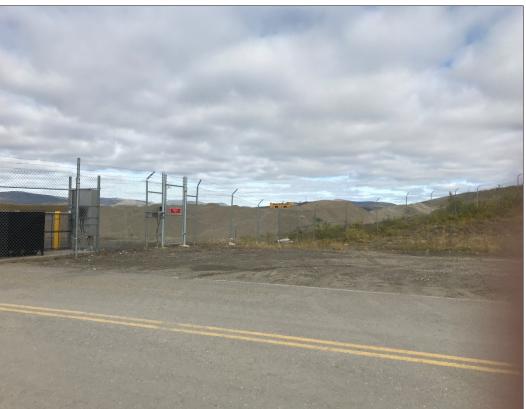
Photograph No. 8

Nome Airport Fire Department AFFF training area (piles of sand/gravel on the other side of the fence), looking north from the fire station.

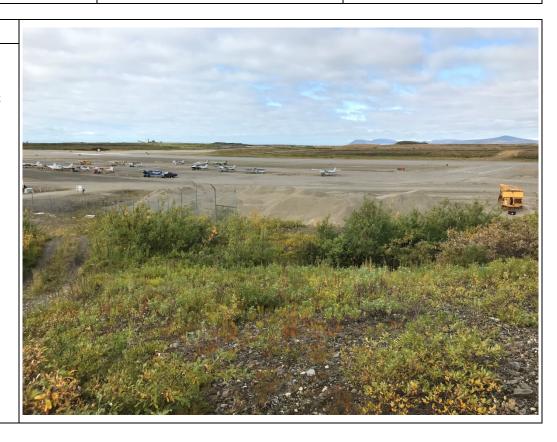
Nome Airport Fire Department's AFFF training area (piles of sand/gravel on the other side of the fence), looking west from a hilltop north of the fire station.
