# FINAL Preliminary Assessment Report Camp San Luis Obispo San Luis Obispo County, California

Perfluorooctane-Sulfonic Acid (PFOS) and Perfluorooctanoic  
Acid (PFOA) Impacted Sites  
ARNG Installations, Nationwide

January 2020

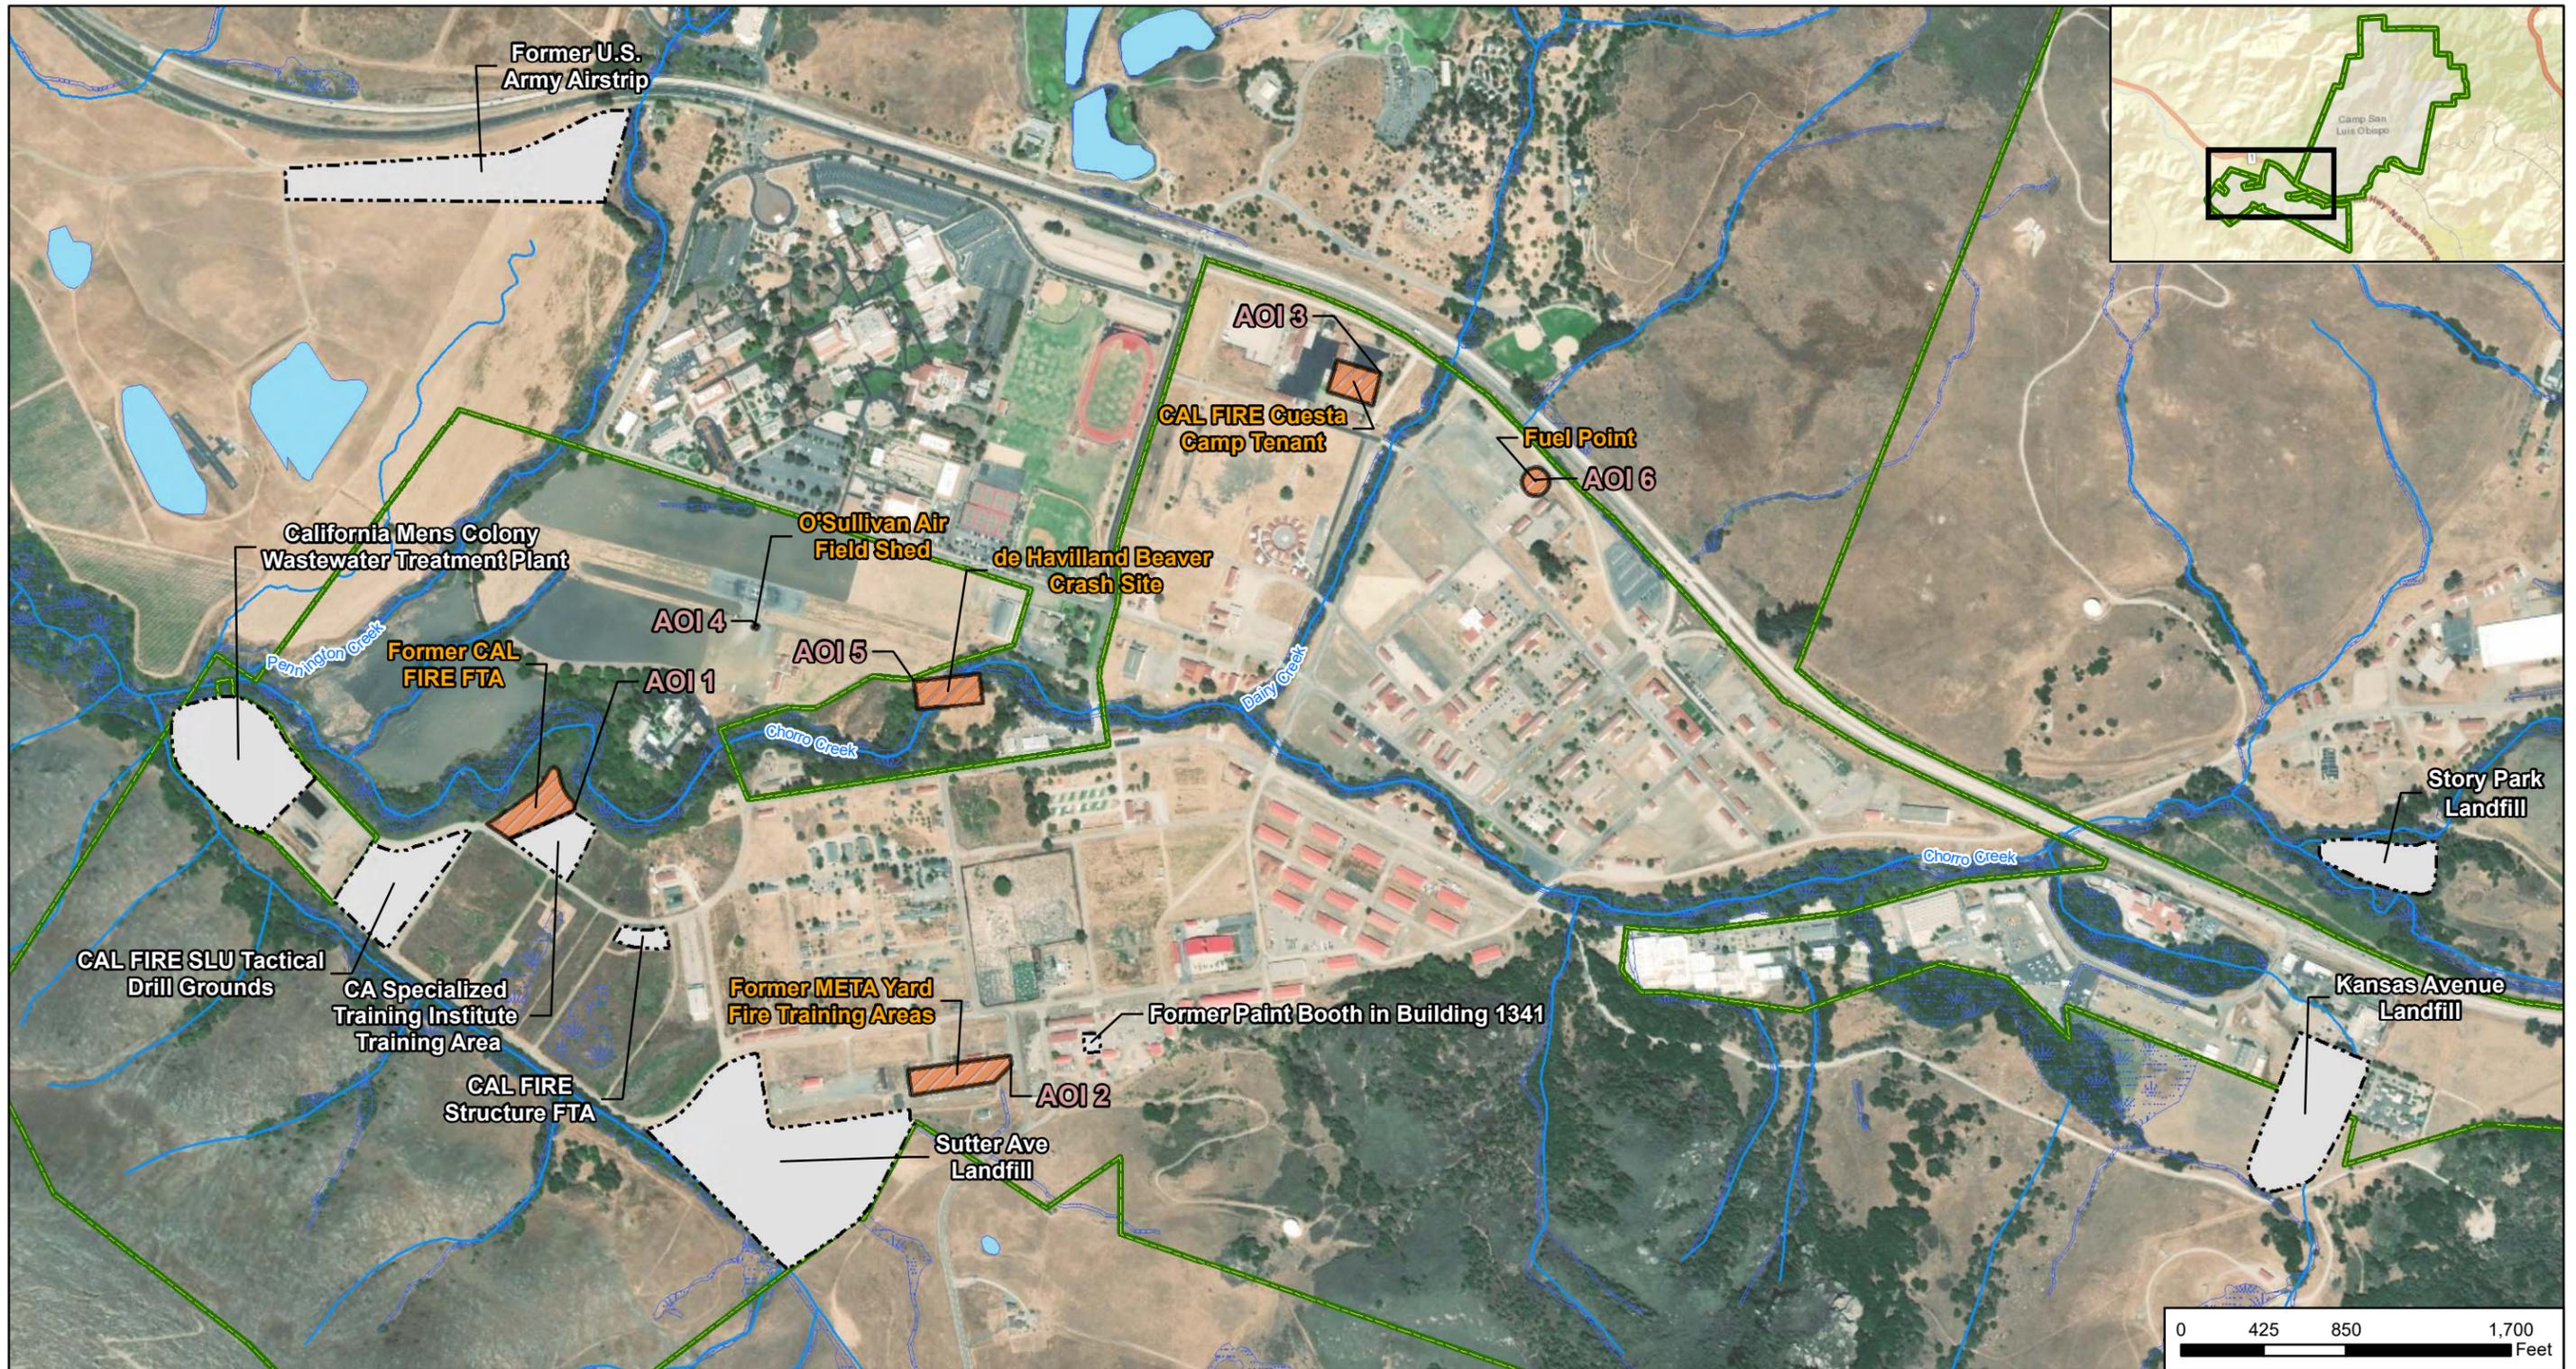
**Figure ES-1**

Based on documented PFAS releases at these AOIs, there is potential for exposure to PFAS contamination in surface soil and intermittent surface water and sediments to site and construction workers and trespassers via ingestion and inhalation, subsurface soil to site and construction workers via inhalation, and groundwater to residents via ingestion. The preliminary CSM for Camp SLO is shown on **Figure ES-2**.

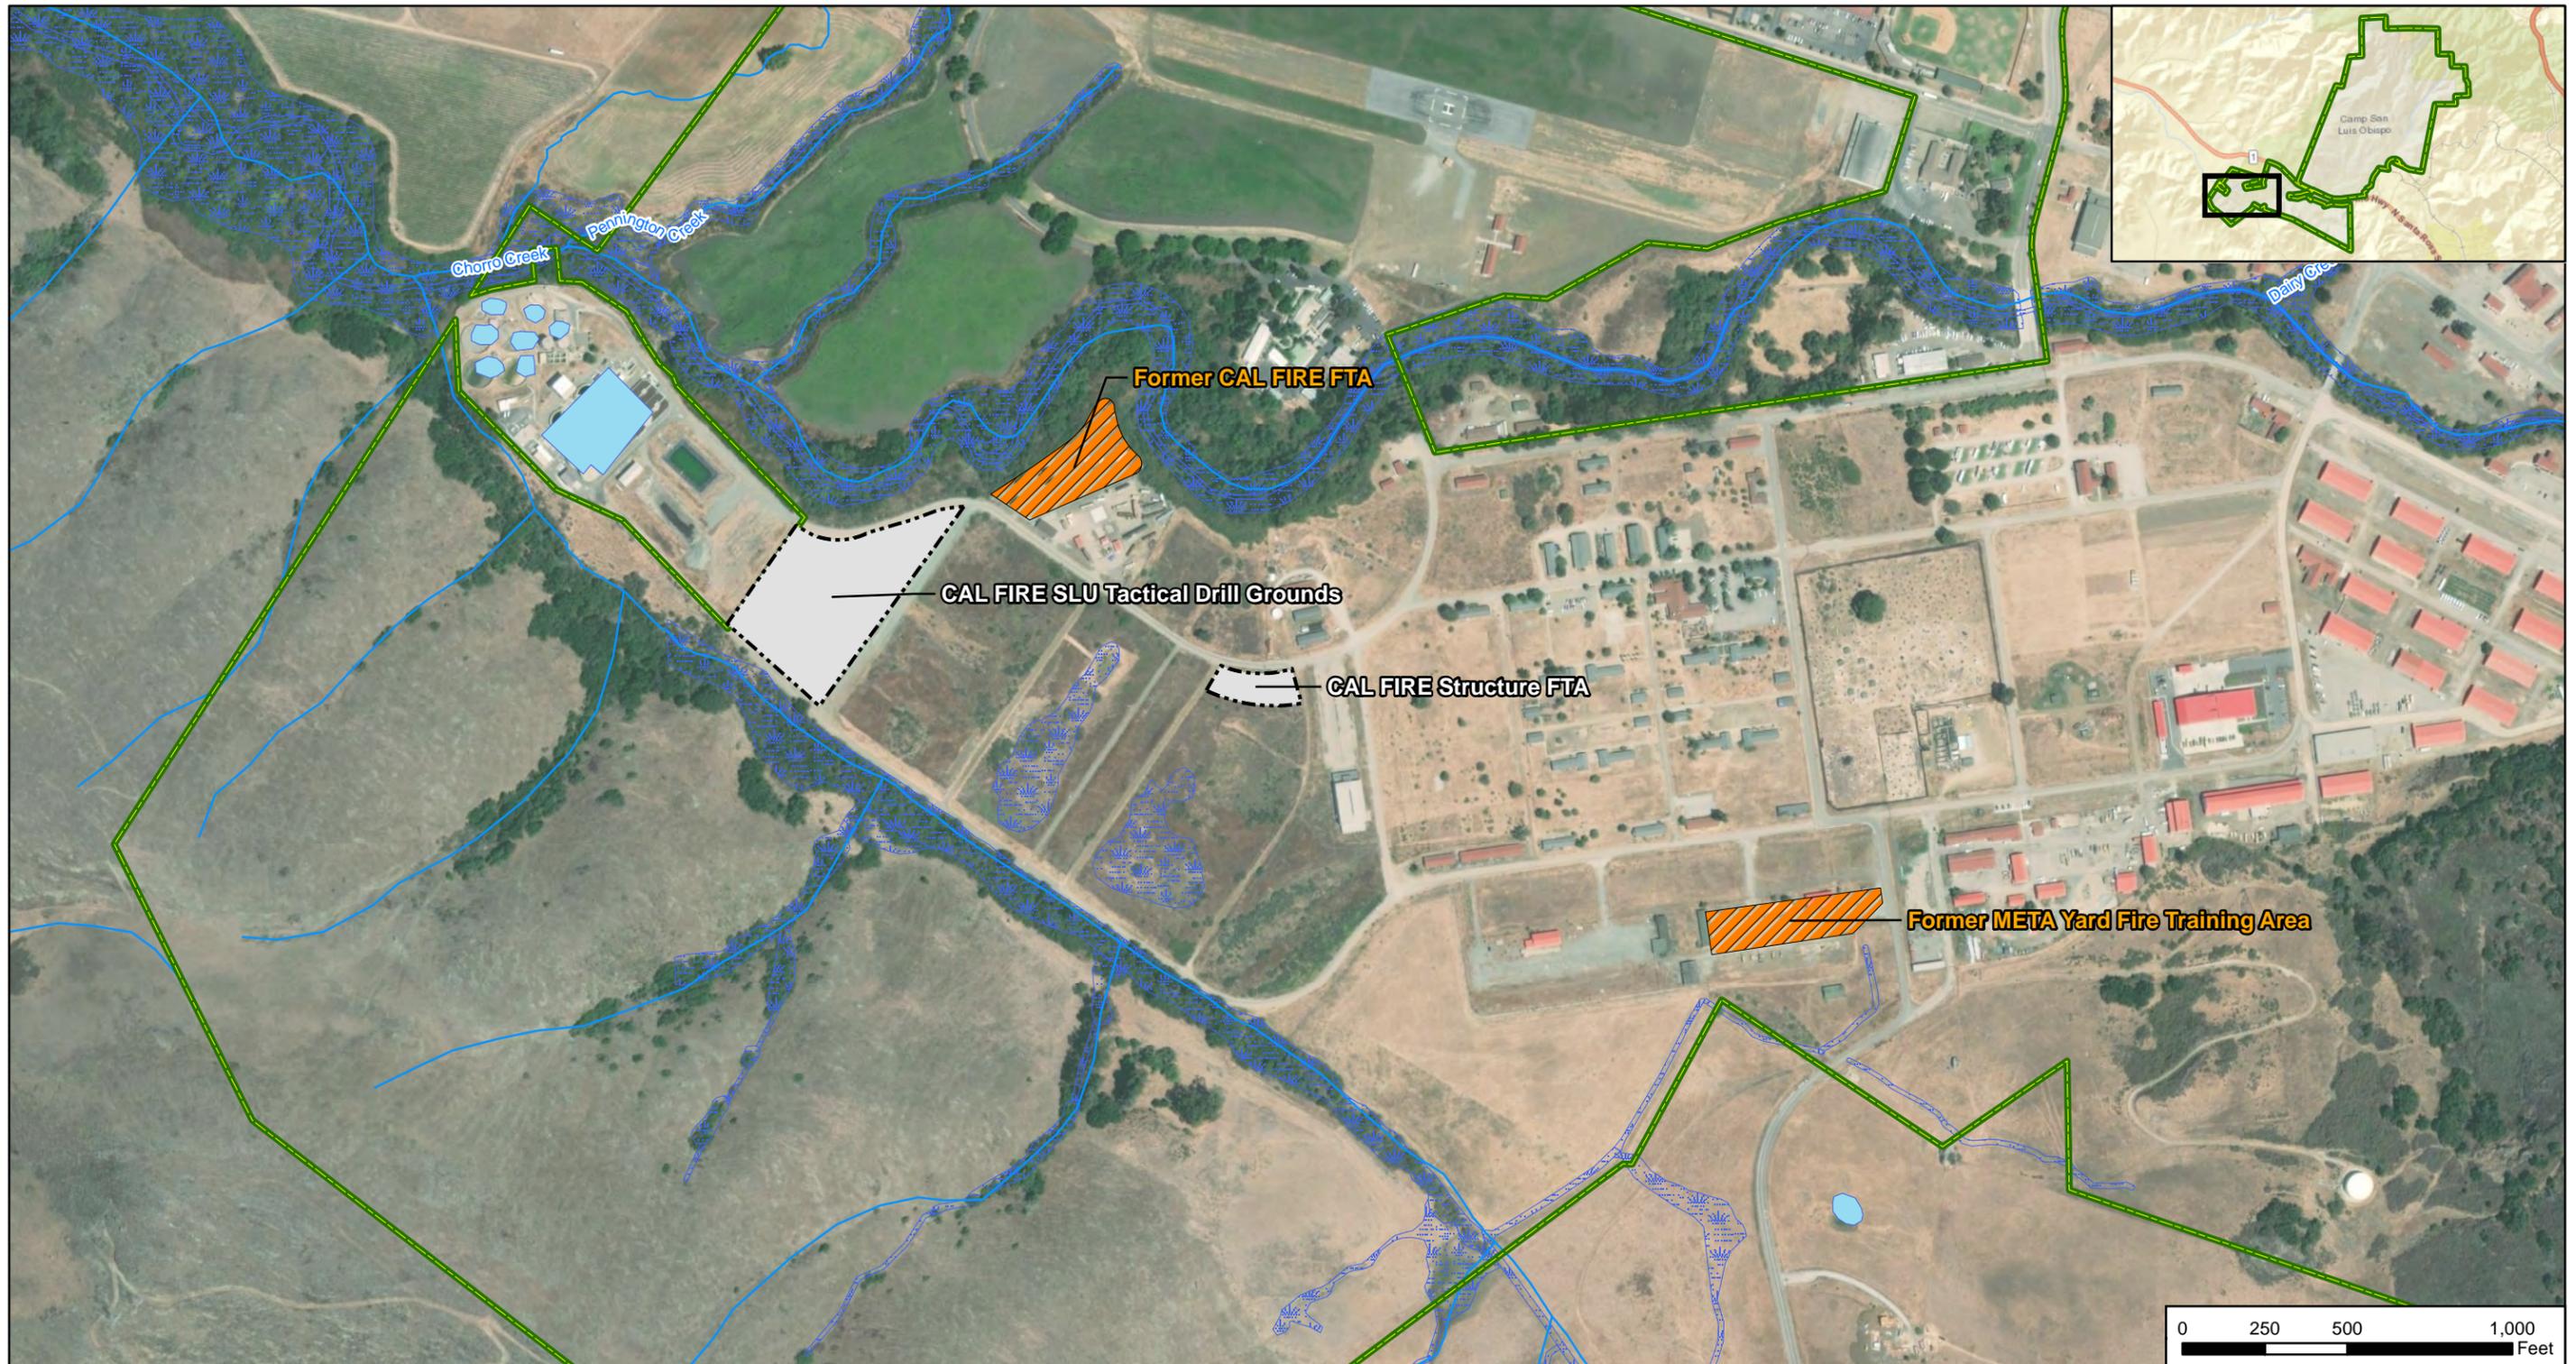
No information is available as to whether actual fires were set, and no information is available on the final disposition of AFFF after the training was completed. There is no stormwater drainage infrastructure in the area where the training event occurred. If the training event took place, the plan was to use AFFF on pavement, contain it, and process the recovered material at the WWTP (however, it should be noted that the WWTP did not become operational until approximately late 2007). Thus, if the applied foam were not contained, runoff from the area is via a small ditch flowing south then southwest to a tributary that then flows northwest to Chorro Creek (**Figure 2-1**).

Two burned out structures were observed during the PA site visit. The location of the burned structures and photographs of the burned building remnants are presented in **Figure 2-1** and **Appendix C**, respectively. In late September 2018, subsequent to the PA site visit, the Camp SLO Environmental Manager reported that CAL FIRE burned 7 additional structures for fire training purposes including three structures at area 2.2, the former META training yard.

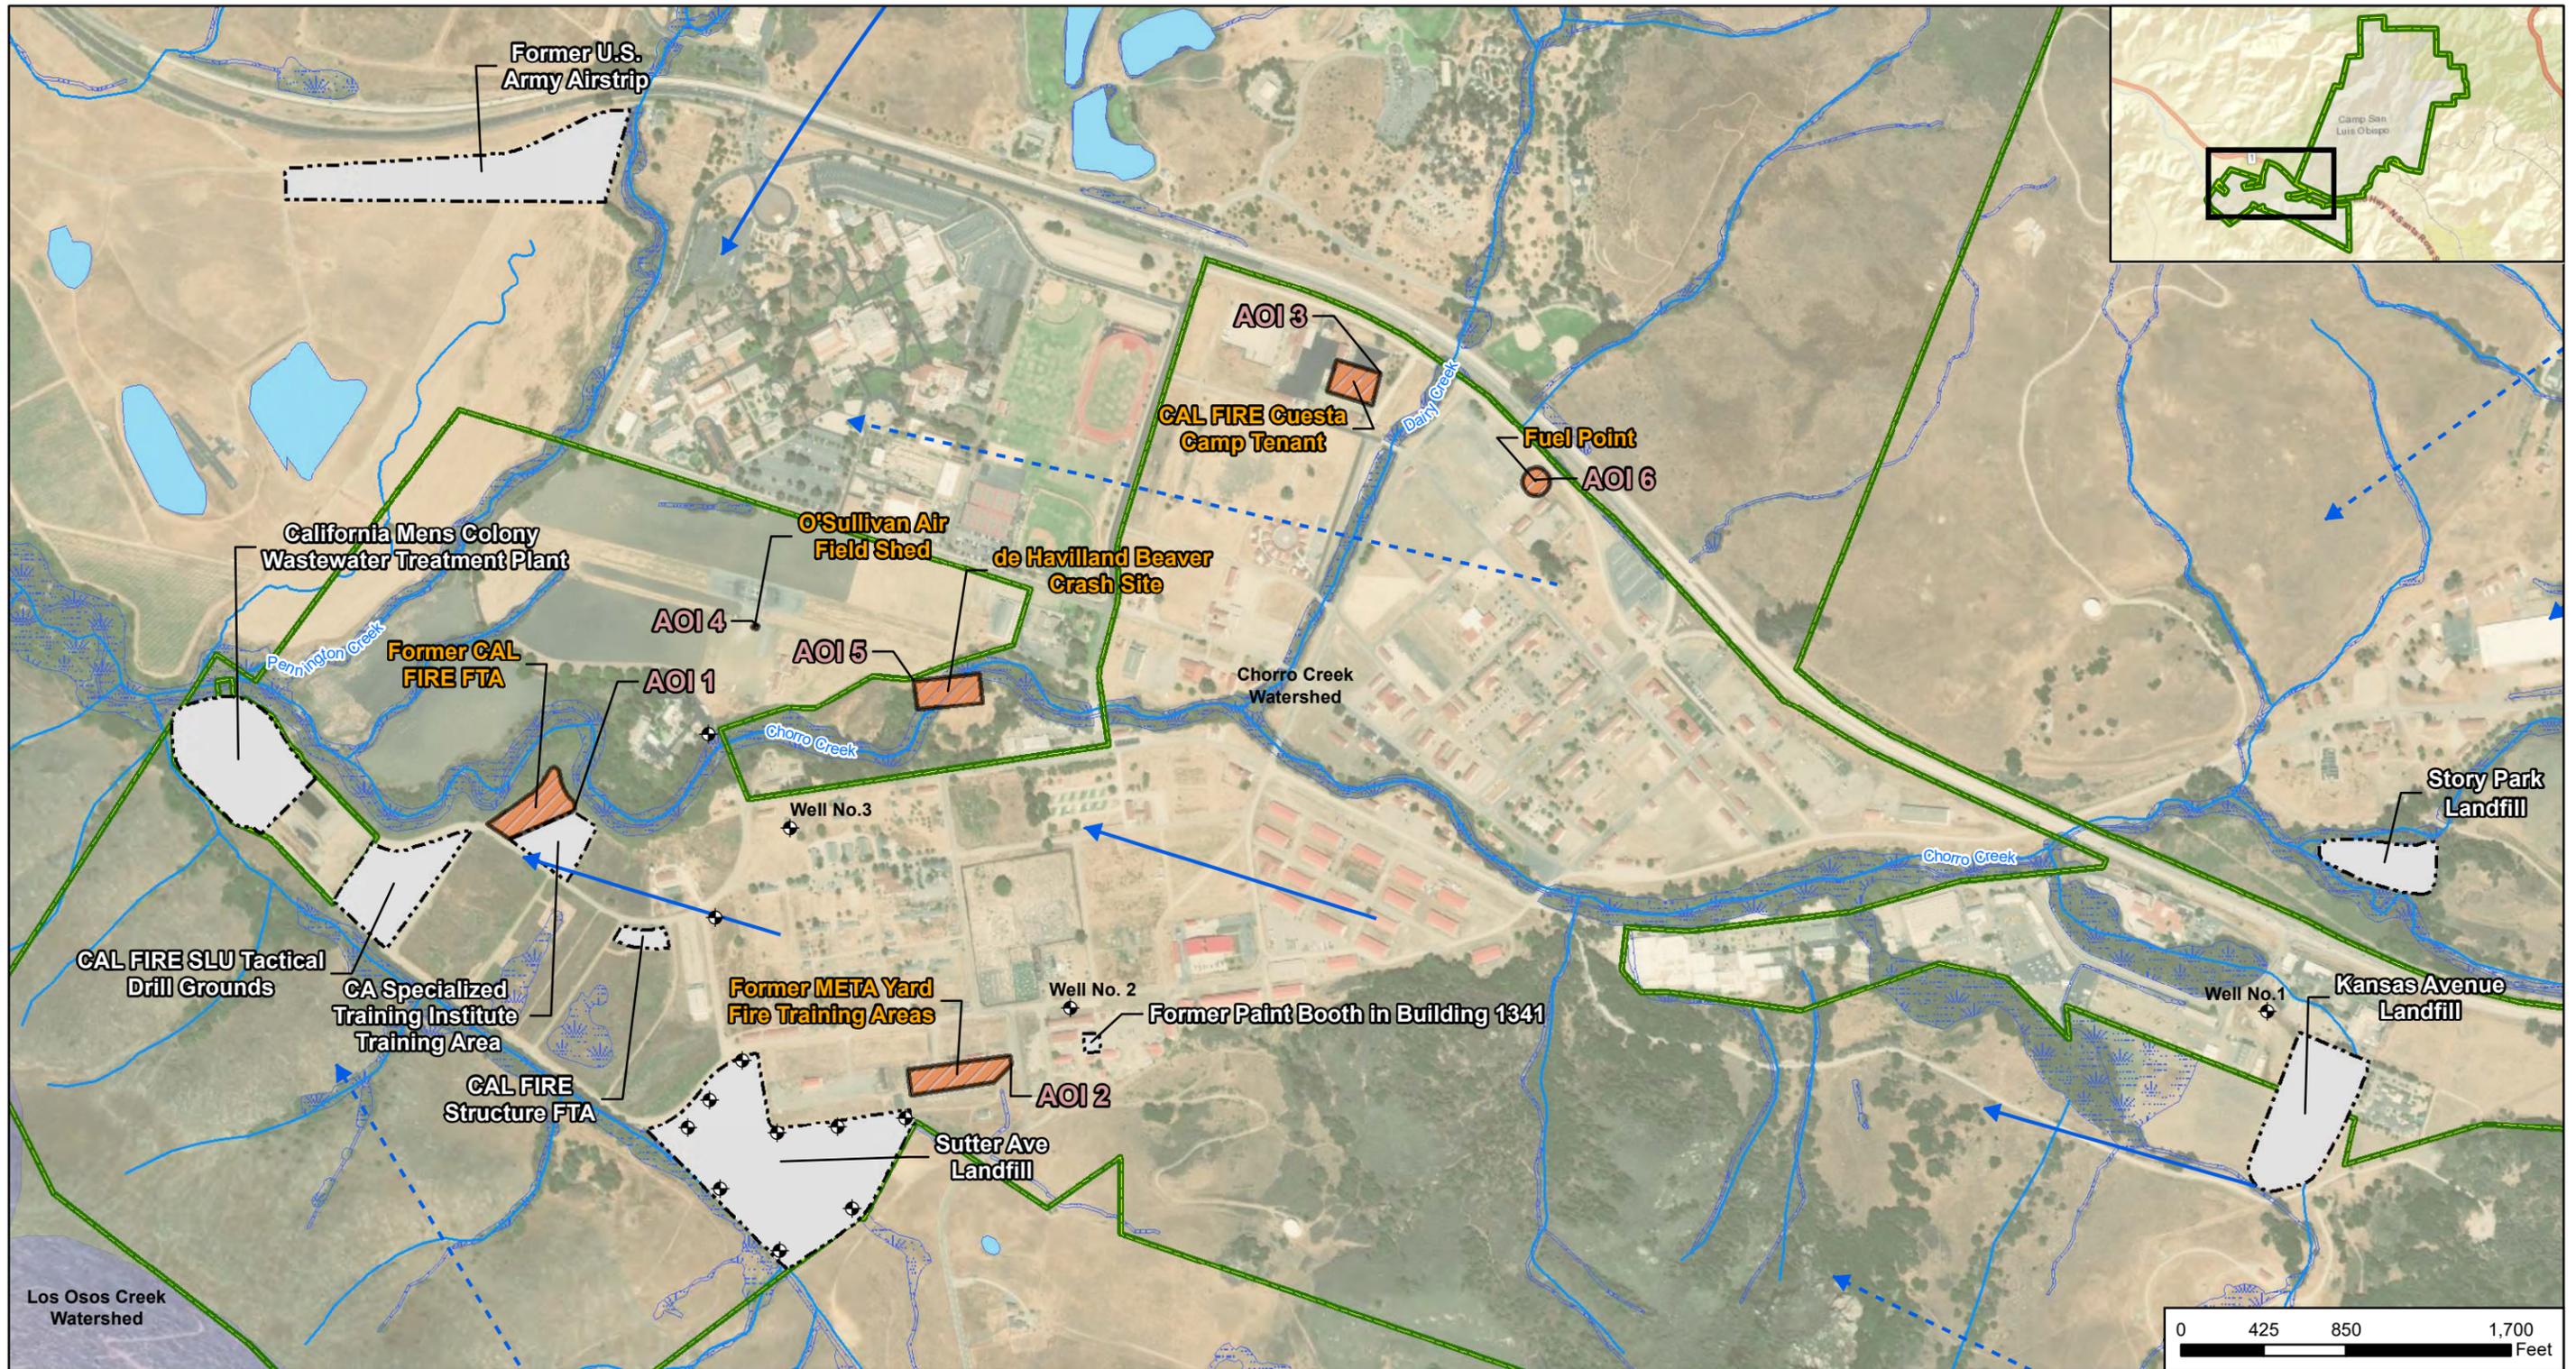
AOI 1 is the former CAL FIRE FTA, now used by Phillips for a once-annual fire training session (**Figure 6-1**). Potential PFAS releases to soil by CAL FIRE occurred at AOI 1 during fire training activities from 1995/1996 to 2005/2006. On a once-annual basis during these years, one 5-gallon container of 3% AFFF was reported to have been used to train fire fighters on how to apply foam. The foam was directed at various props and a concrete cinder-block structure. AFFF was expelled from equipment nozzles during the training and released to the ground surface, which was observed in aerial photographs and during the PA site visit to be gravel covered.

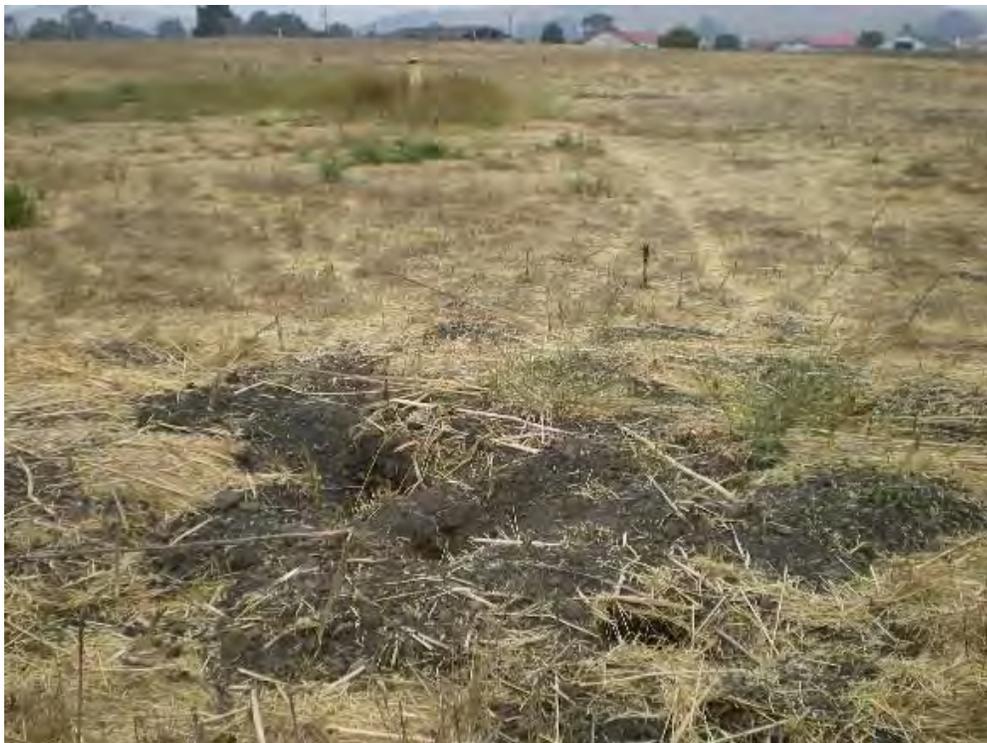
**4. Animal Burrowing on the Landfill Cap. Some of the burrows are large in size**

The landfill cap and the immediately surrounding areas are occupied with animal burrows (Photographs 1 through 4 in Appendix E). Some of the burrows are very large in size creating areas where water can pool in a rain event. These items will be corrected through the replacement of the landfill cap, which already has been contracted by CSLO in the related Landfill Corrective Action Work Plan (Tetra Tech, 2016) which is in progress and tentatively approved by CCRWQCB. This field procedure is planned to be started during the construction season of 2017.

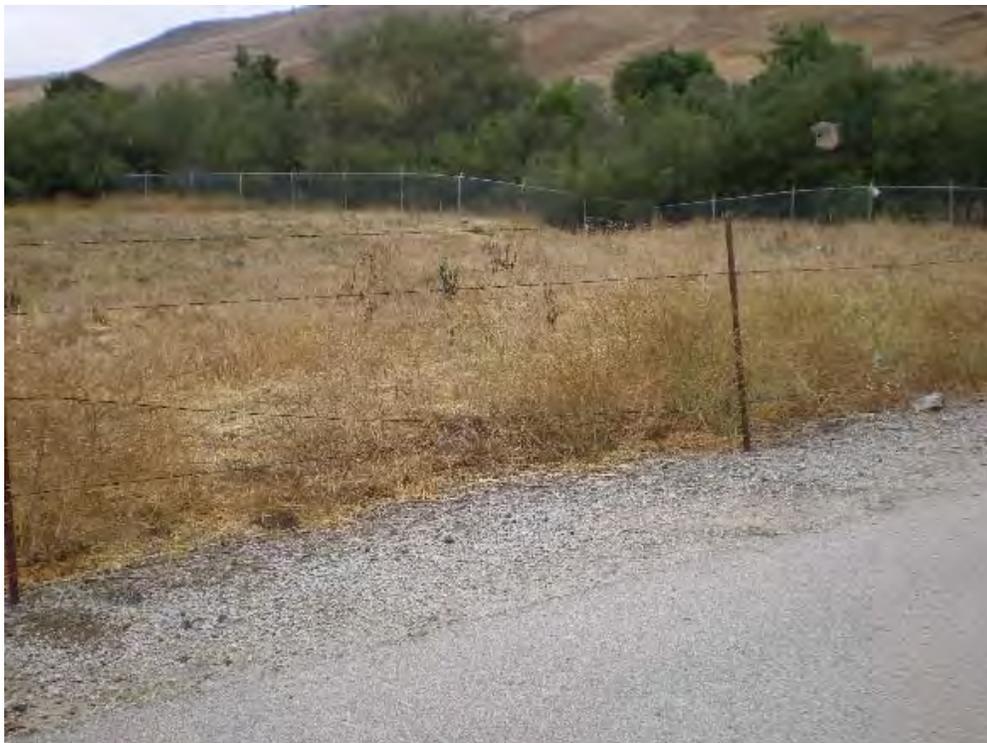
**8. Barbwire fence along Sutter Avenue in Disrepair**

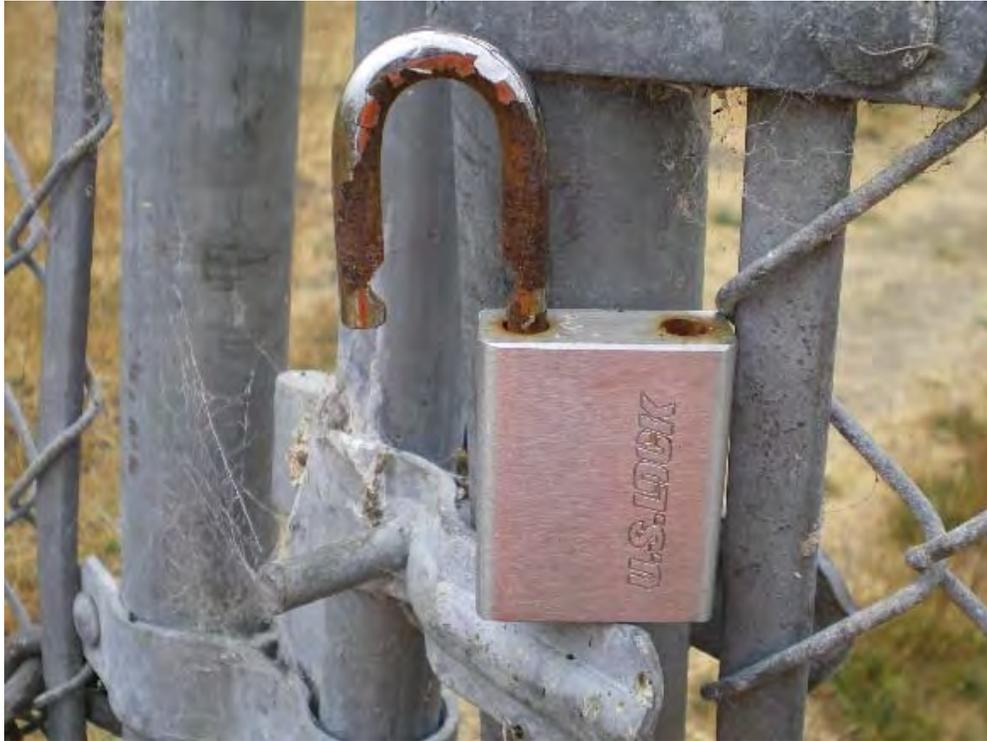
**9. Lock on Access Gate is Rusty and Difficult to Open**

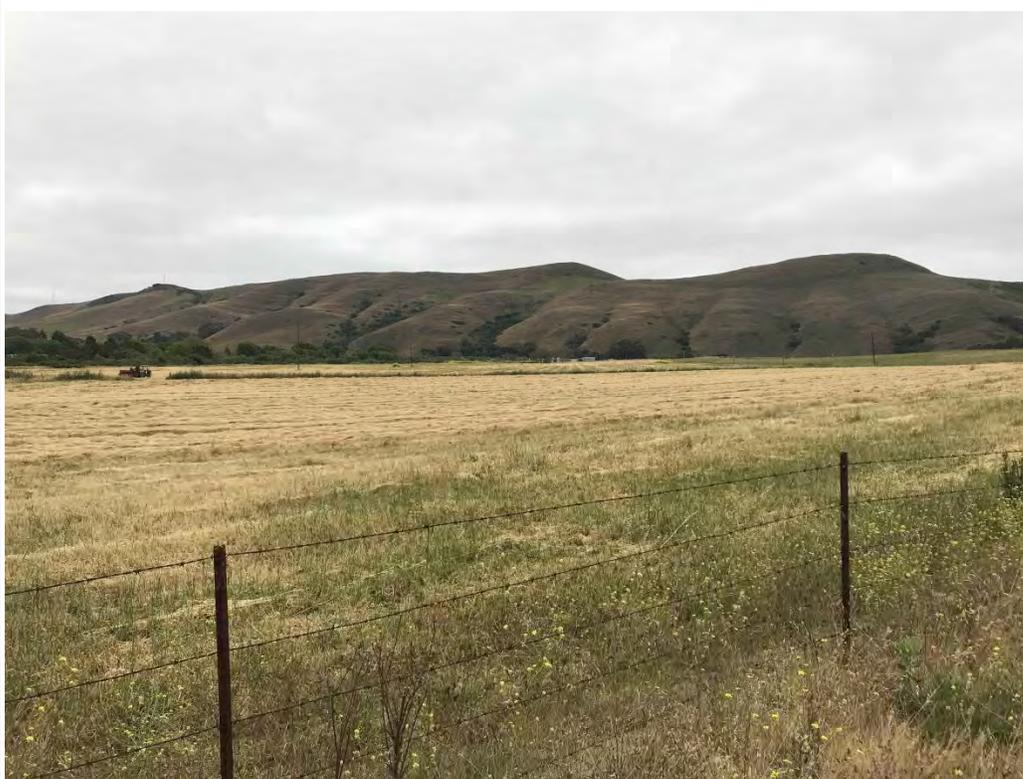
### Photograph No. 1

Former U.S. Army Airstrip.  
View to the Southwest

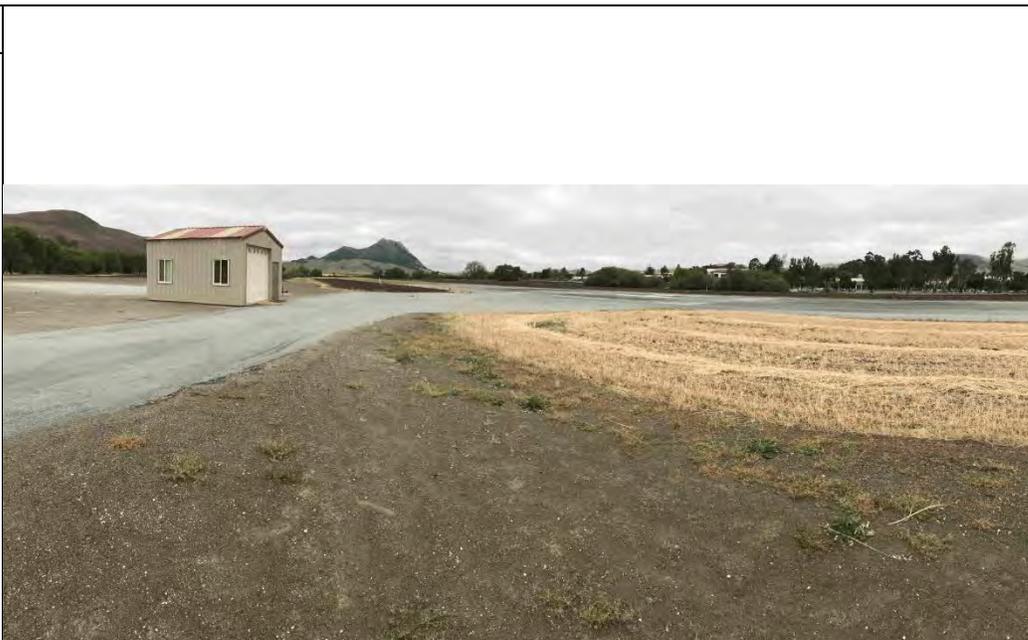
O'Sullivan Airfield. Shed  
situated in top left corner of  
photo is where containers  
containing AFFF were  
observed to be stored. View to  
the West.
