FINAL Preliminary Assessment Report High Altitude Aviation Training Site, Gypsum, Colorado

Perfluorooctanesulfonic Acid (PFOS) and Perfluorooctanoic
Acid (PFOA) Impacted Sites
ARNG Installations, Nationwide

October 2020

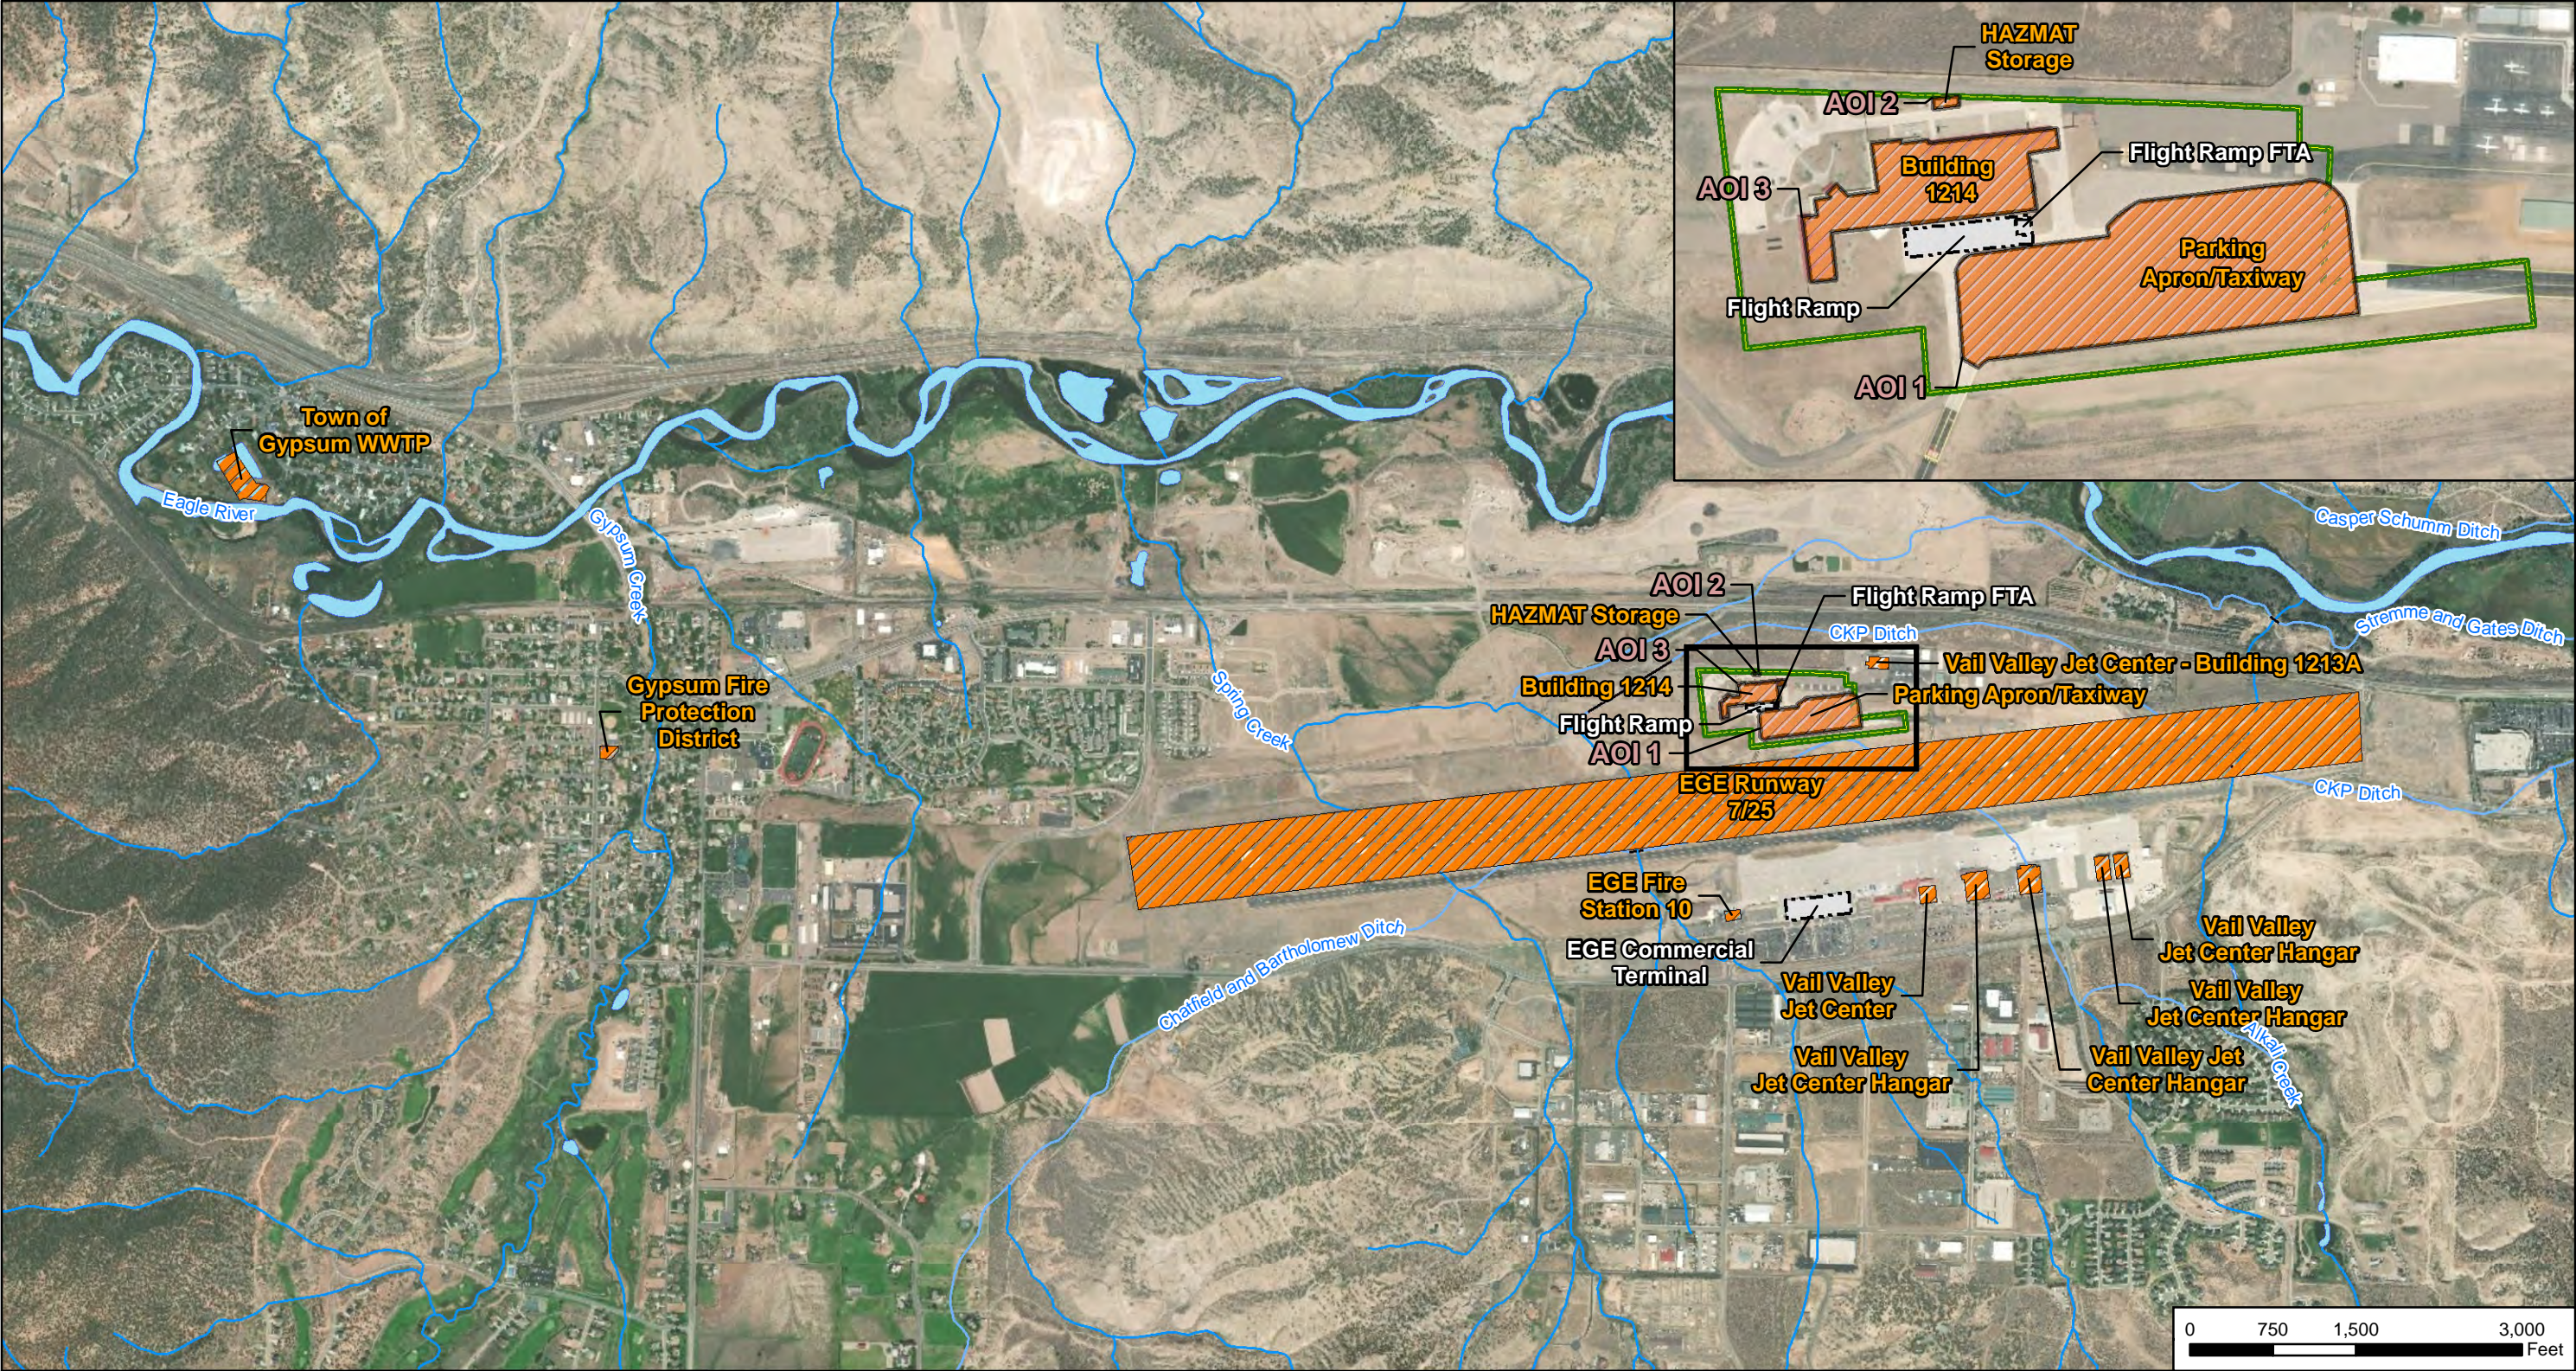
Figure ES-1

No documented releases of PFAS-containing materials were identified nor did interviewees recall any undocumented release AFFF at the facility; however, three AOIs related to potential PFAS release were identified at HAATS based on PA data (**Figure ES-1**) and are summarized in **Table ES-1** below:

Summary of Findings

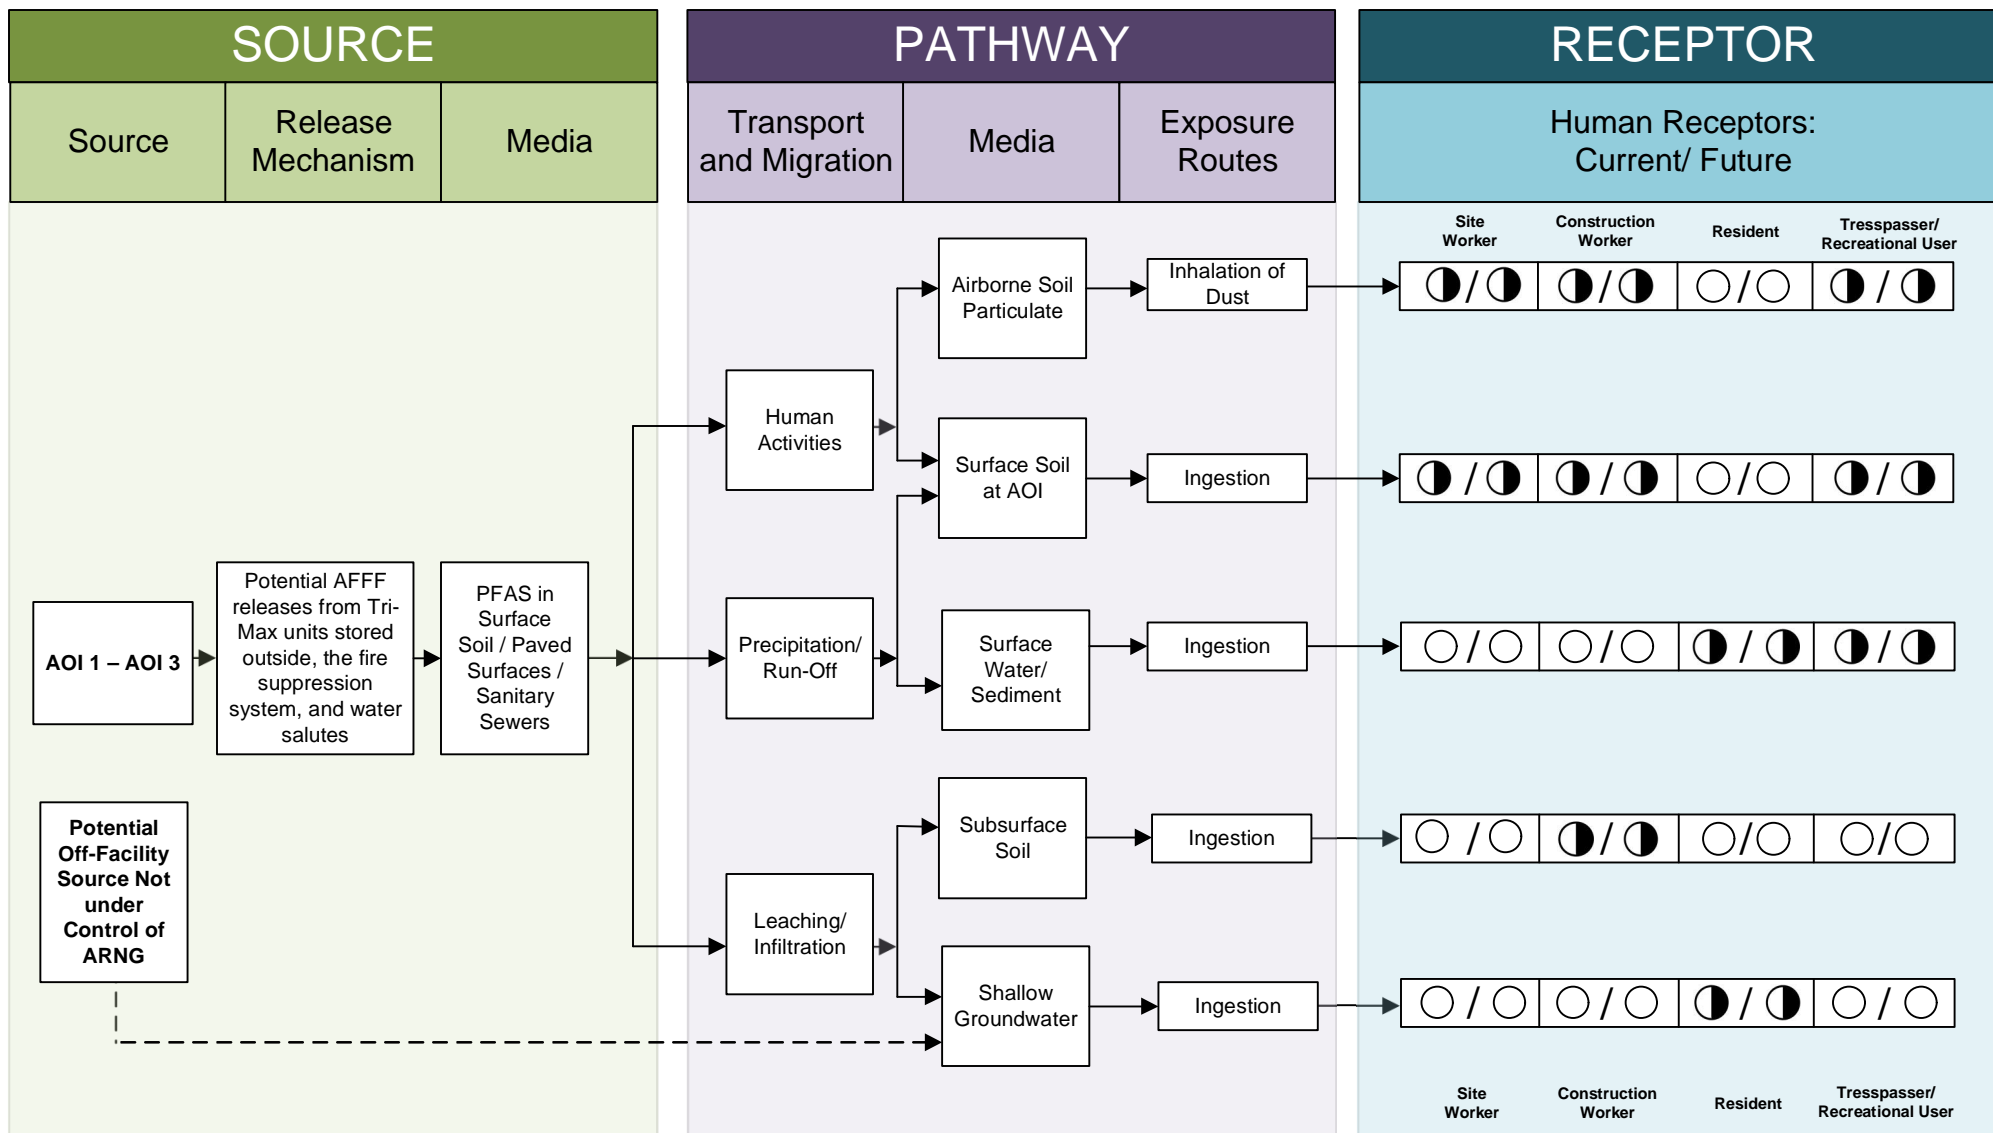
Figure ES-2
Preliminary Conceptual Site Model
HAATS, CO

Based on the possible PFAS releases at the AOIs, there is potential for exposure to PFAS contamination in surface soil to site and construction workers, and trespassers via ingestion and inhalation; in subsurface soil to construction workers via ingestion and inhalation; and in surface water and sediment to off-facility residents and recreational users via ingestion. Additionally, commercial and domestic wells located cross-gradient and downgradient of HAATS create a potentially complete pathway for PFAS exposure to off-facility residents via ingestion of groundwater. The preliminary CSM for HAATS, which presents the potential receptors and media impacted, is shown on **Figure ES-2**.

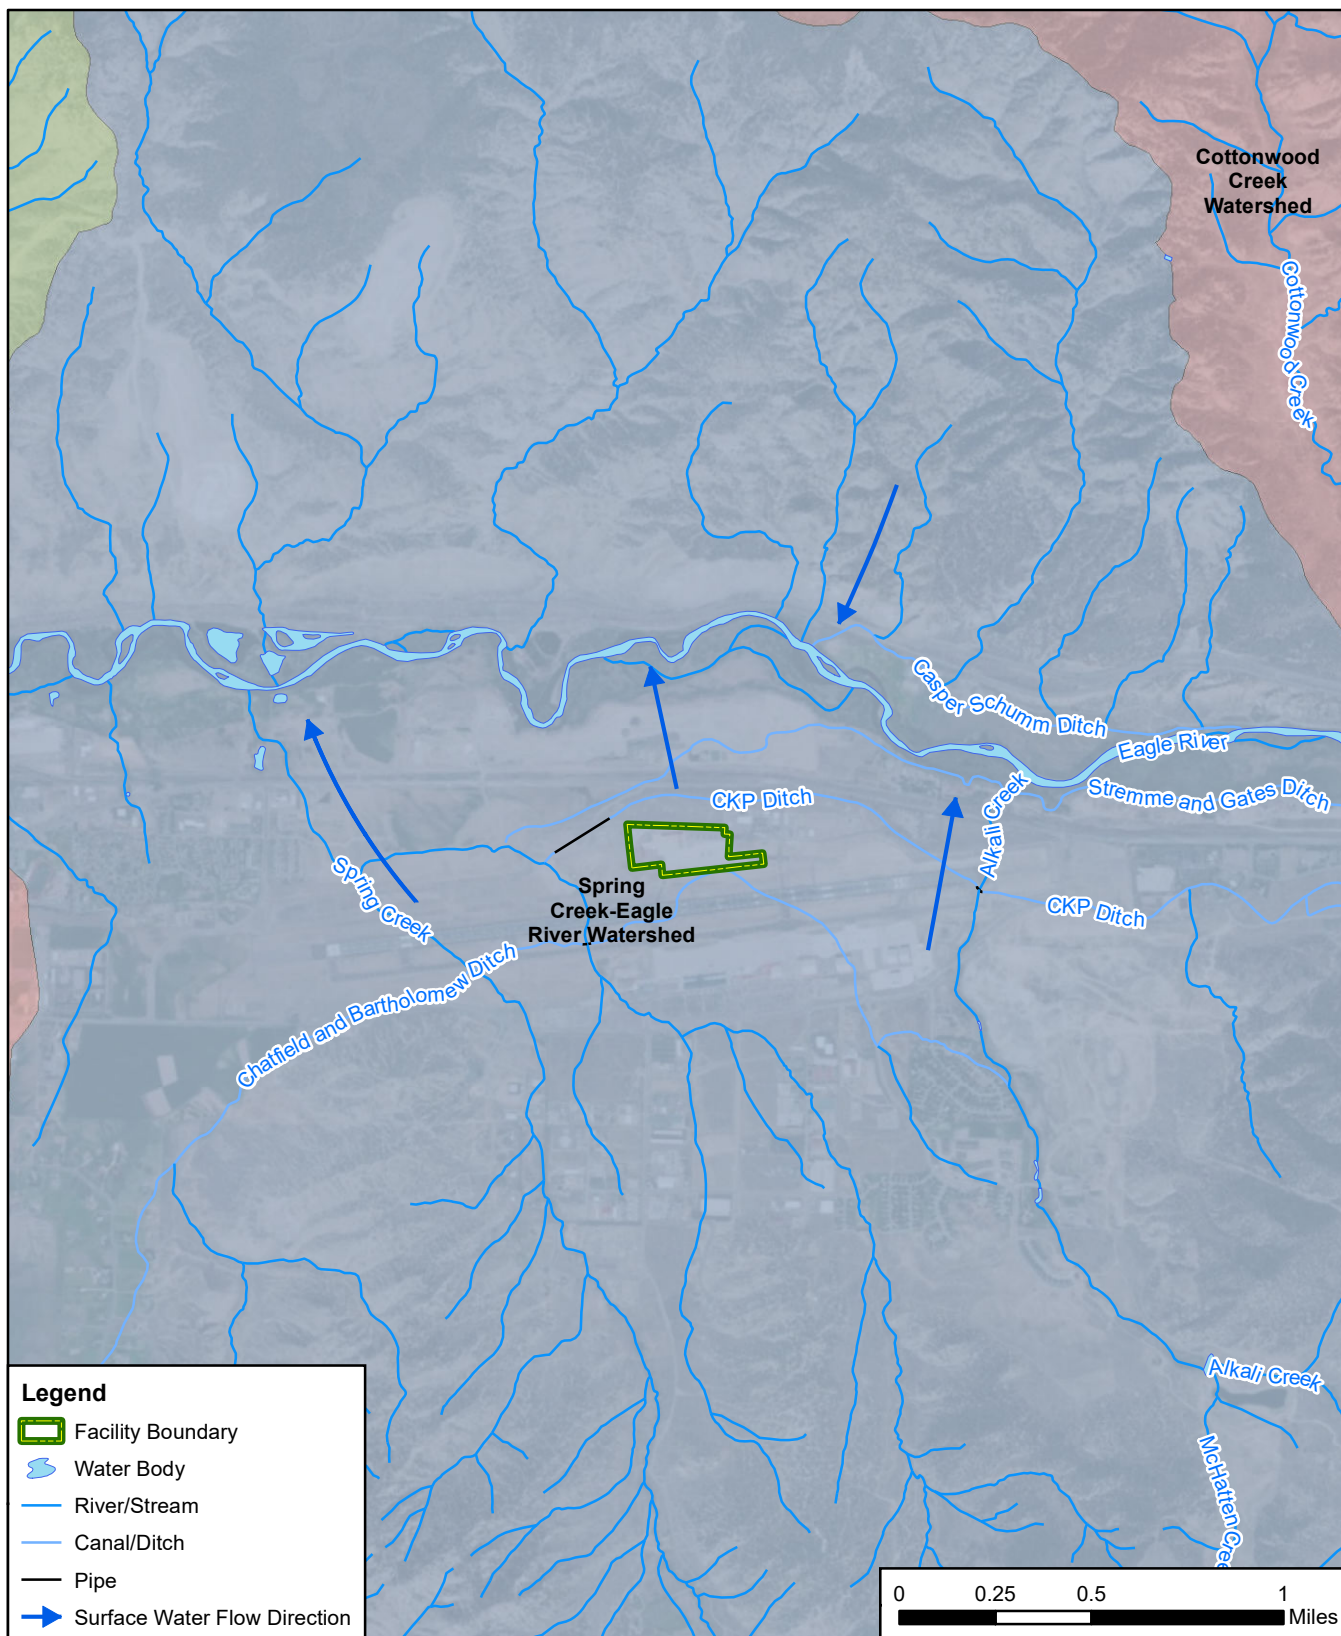
12420 Milestone Center Drive Germantown, MD 20876	Figure 1-3
SCALE	1:31,680	CHK BY	JW	3/10/2020			
Base Map: Source: Esri, DigitalGlobe, GeoEye, Earthstar Geographics, CNES/Airbus DS, USDA, USGS,		PM	RG	3/10/2020

National Wetlands Inventory (USFWS, 2019). The “Chattfield and Bartholomew Ditch” is designated as a freshwater emergent wetland or as riverine habitat, depending on location, and encroaches on the southern and western boundaries of the facility. The “CKP Ditch” is also designated as both freshwater emergent wetland and riverine habitat depending on location, and it encroaches on the northern and western boundaries of the facility as well (USFWS, 2019). Nearby surface water bodies are shown on **Figure 1-3**.

Surface Water Features	
NOTES		Preliminary Assessment for PFAS at HAATS, CO					
REVISED	3/10/2020	GIS BY	MS	3/10/2020

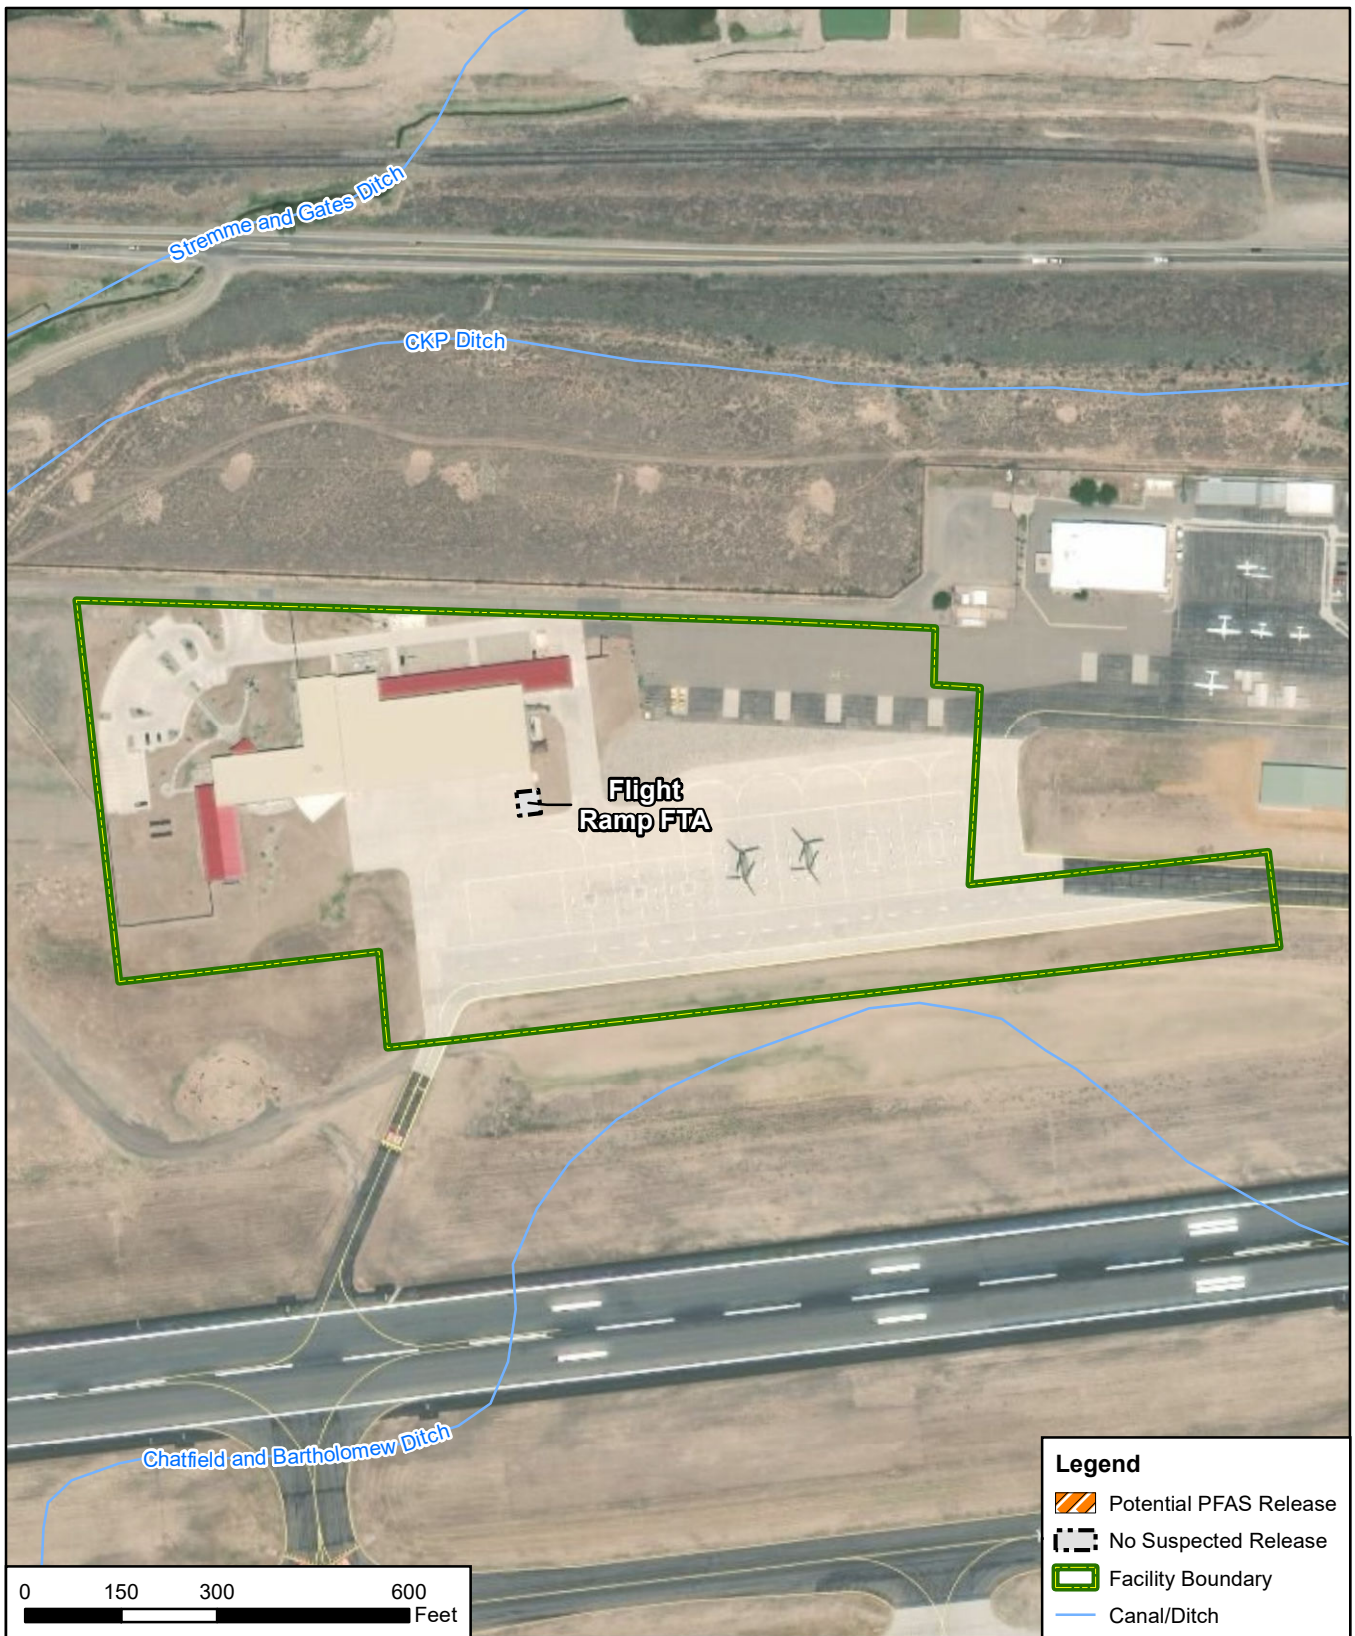
Fire Training Area	
AECOM 12420 Milestone Center Drive Germantown, MD 20876	Figure 2-1

HAATS facility personnel stated during interviews that annual fire training is performed near the southeastern corner of Building 1214 on the flight ramp. The fire training involves the lighting of diesel fuel in a drip pan and the subsequent extinguishing of the flames using ABC dry chemical handheld fire extinguishers. According to interviewees whose collective tenure span the entire history of the new HAATS facility (2013-present), no AFFF has ever been used during the annual fire training. Records are not kept to document the annual training. Mobile Tri-Max™ 30 Cold Compressed Air Foam (CAF) fire extinguishers that contain AFFF are stored at the HAATS facility, but they have never been used for fire training purposes. The extinguishers are capable of using Class A foams, which do not include PFAS, but facility personnel stated that the Tri-Max™ units contain AFFF. Photographs of the Tri-Max™ units, which were provided by COARNG, are included in **Appendix A**. The Flight Ramp FTA is not considered a potential PFAS release area.

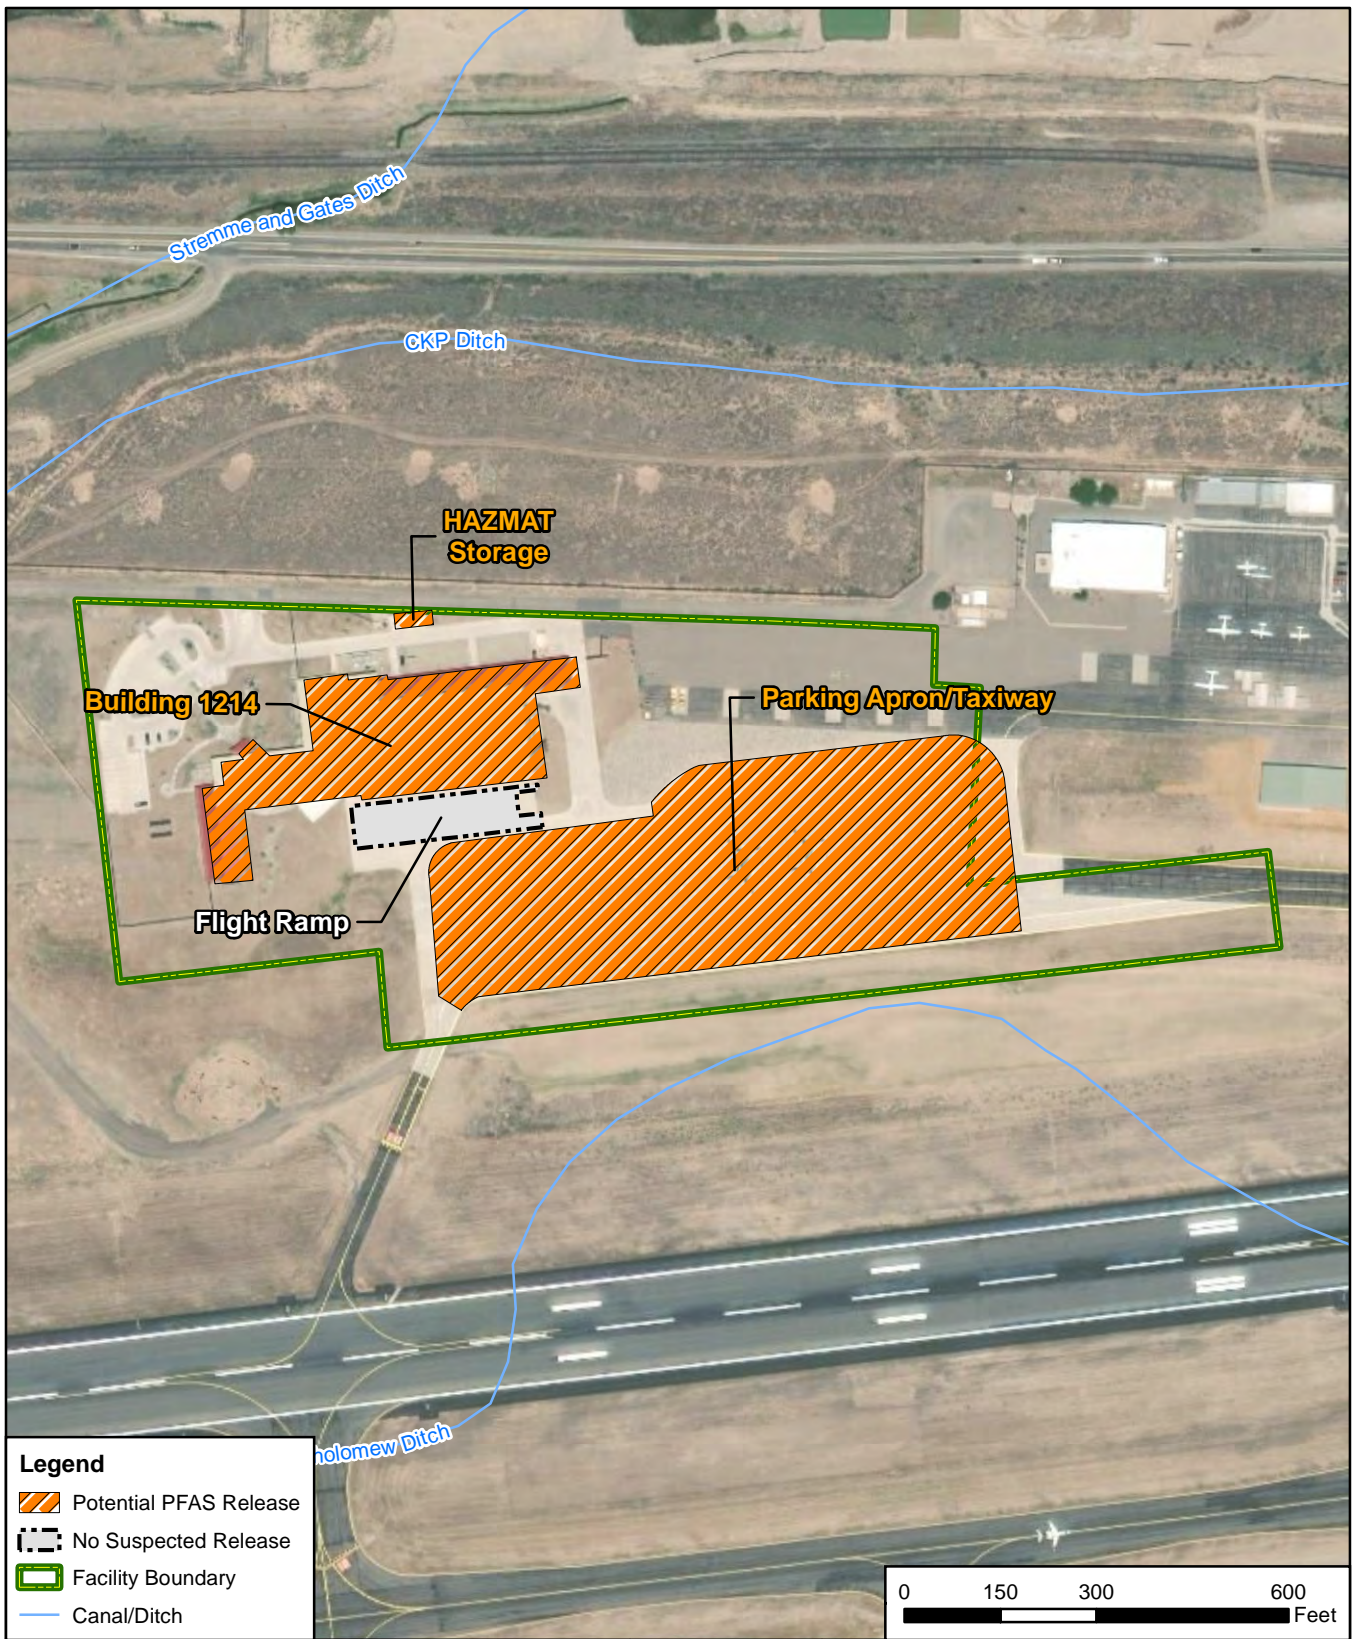
In addition to FTAs, the PA evaluated areas where PFAS-containing materials may have been broadly used, stored, or disposed. This may include buildings with fire suppression systems, paint booths, AFFF storage areas, and areas of compliance demonstrations. Information on these features obtained during the PA are included in **Appendices A and B**. Several non-FTAs where AFFF could have been stored and/or released at HAATS were identified during the PA. A description of each non-FTA is presented below, and the non-FTAs are shown on **Figure 3-1**.

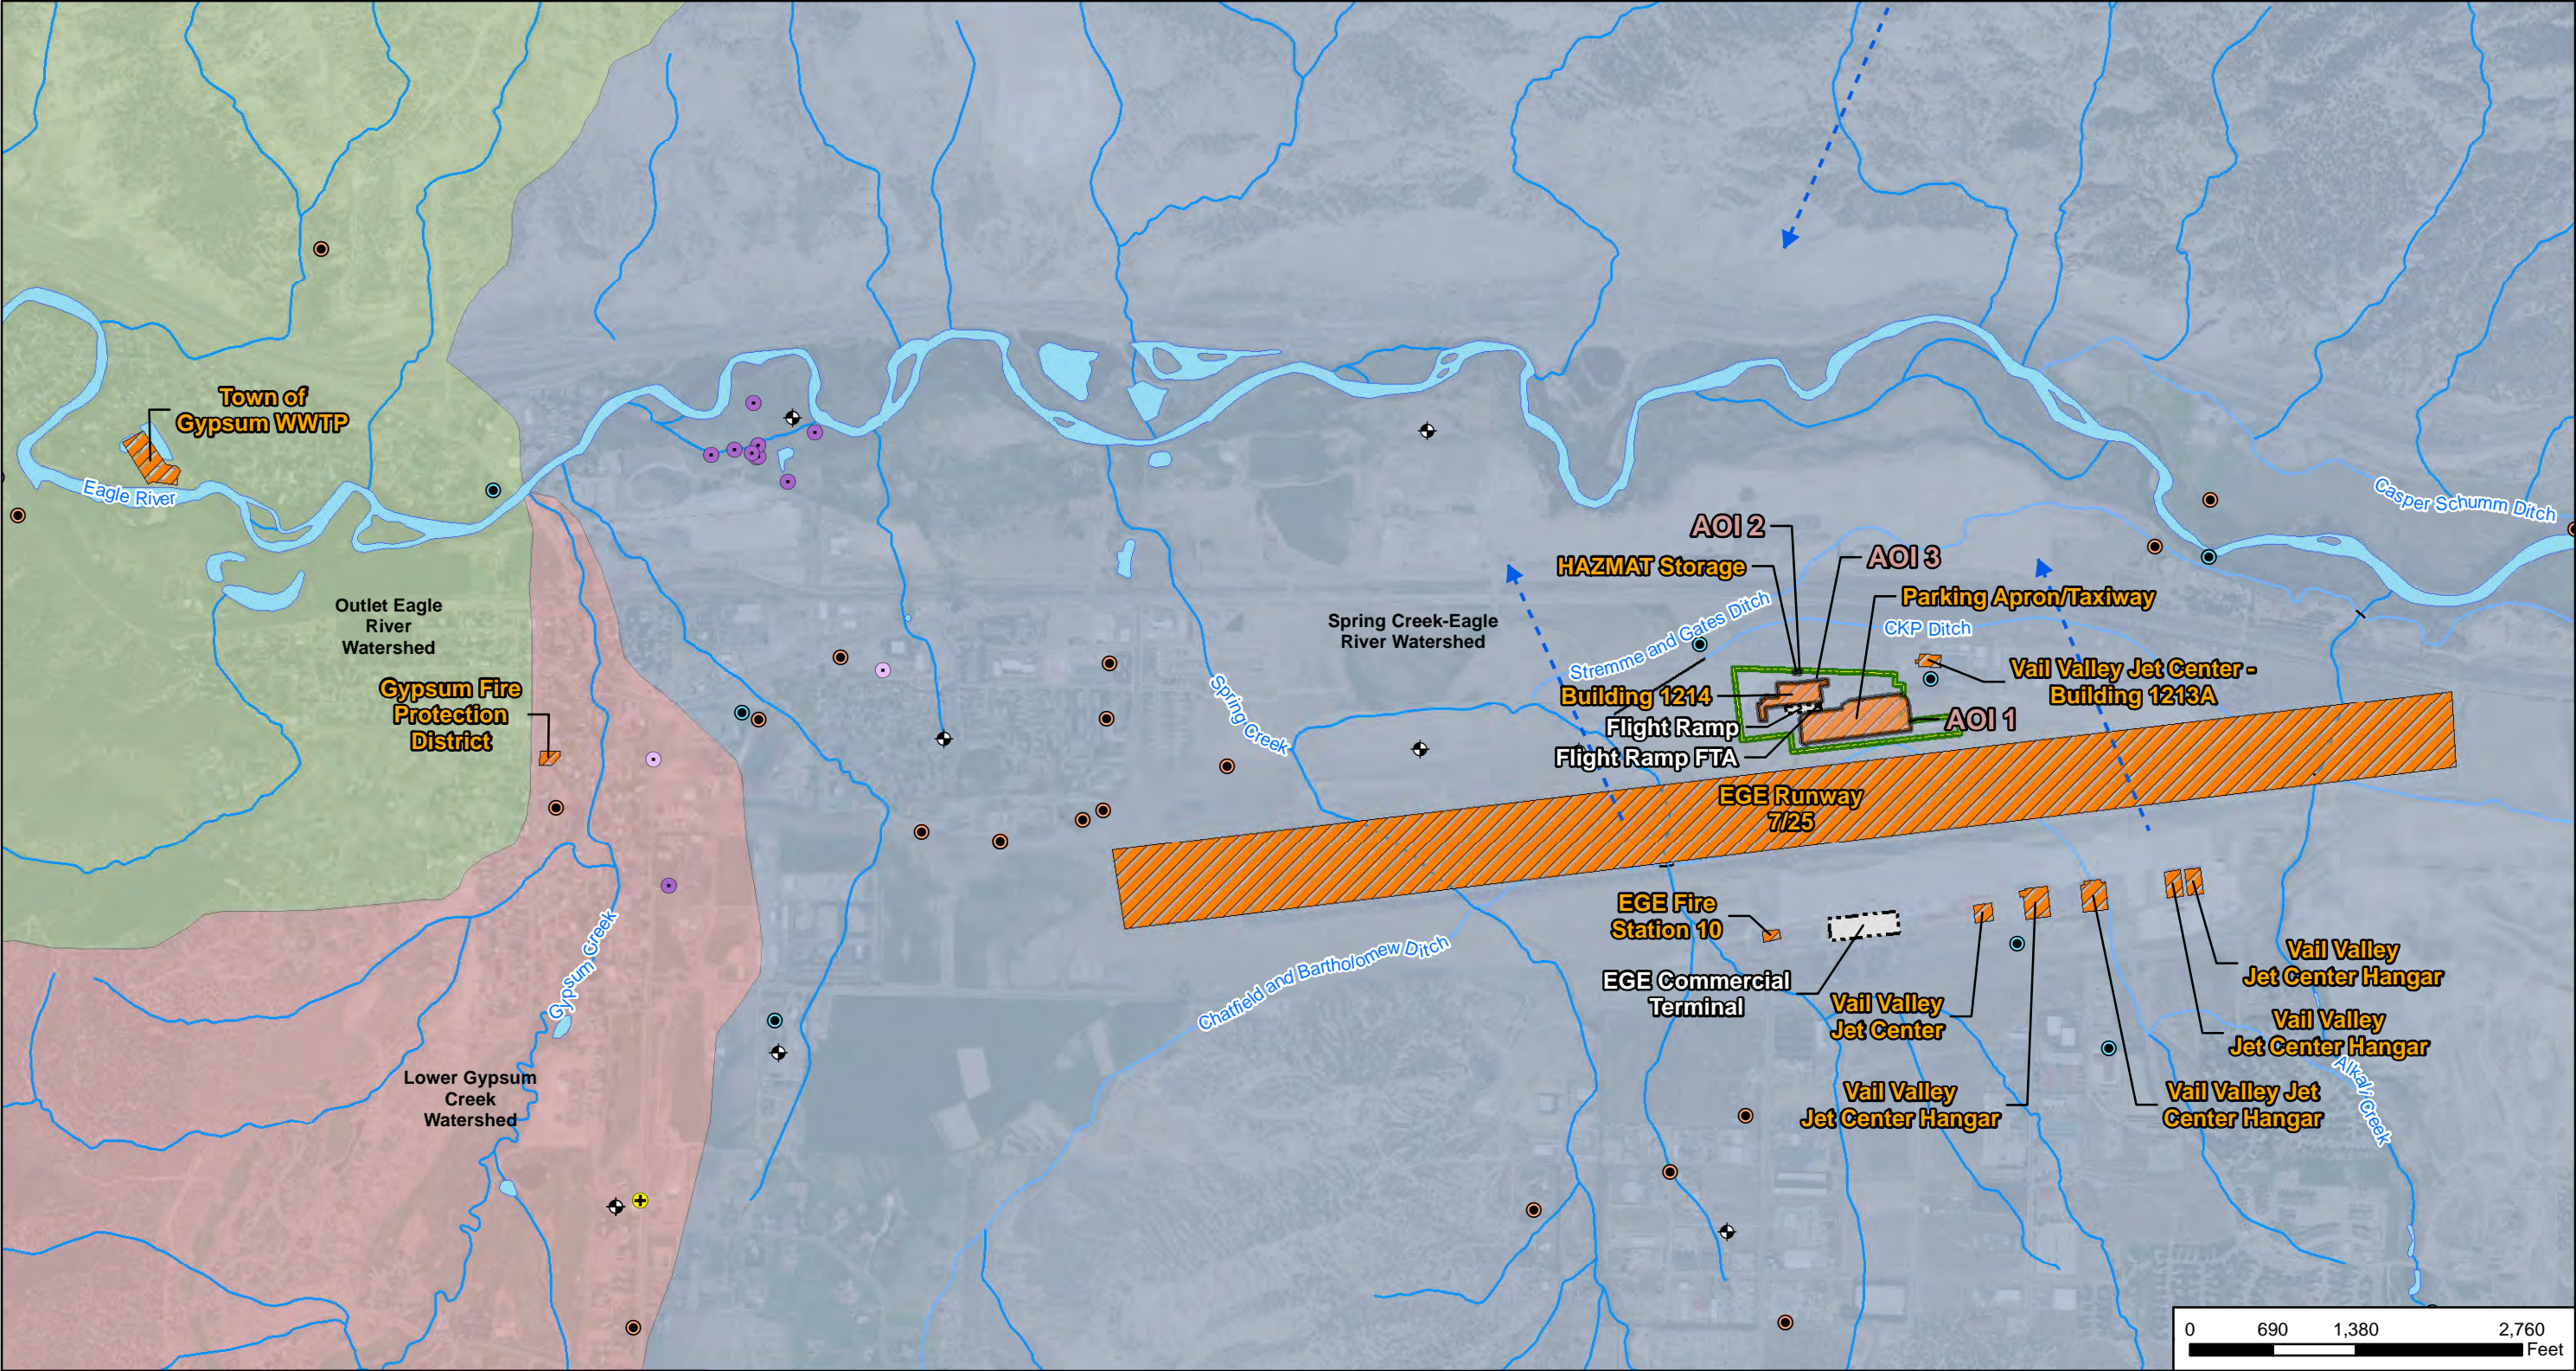
Based on the PA findings, two AOIs were identified at the COARNG HAATS facility: AOI 1 Parking Apron/Taxiway and AOI 2 HAZMAT Storage Area. The AOI locations are shown on **Figure 6-1**. The following sections describe the CSM components and the specific preliminary CSM developed for the AOIs. A CSM identifies three components necessary for an exposure pathway: (1) source, (2) pathway, (3) receptor. If any of these elements are missing, the pathway is considered incomplete.

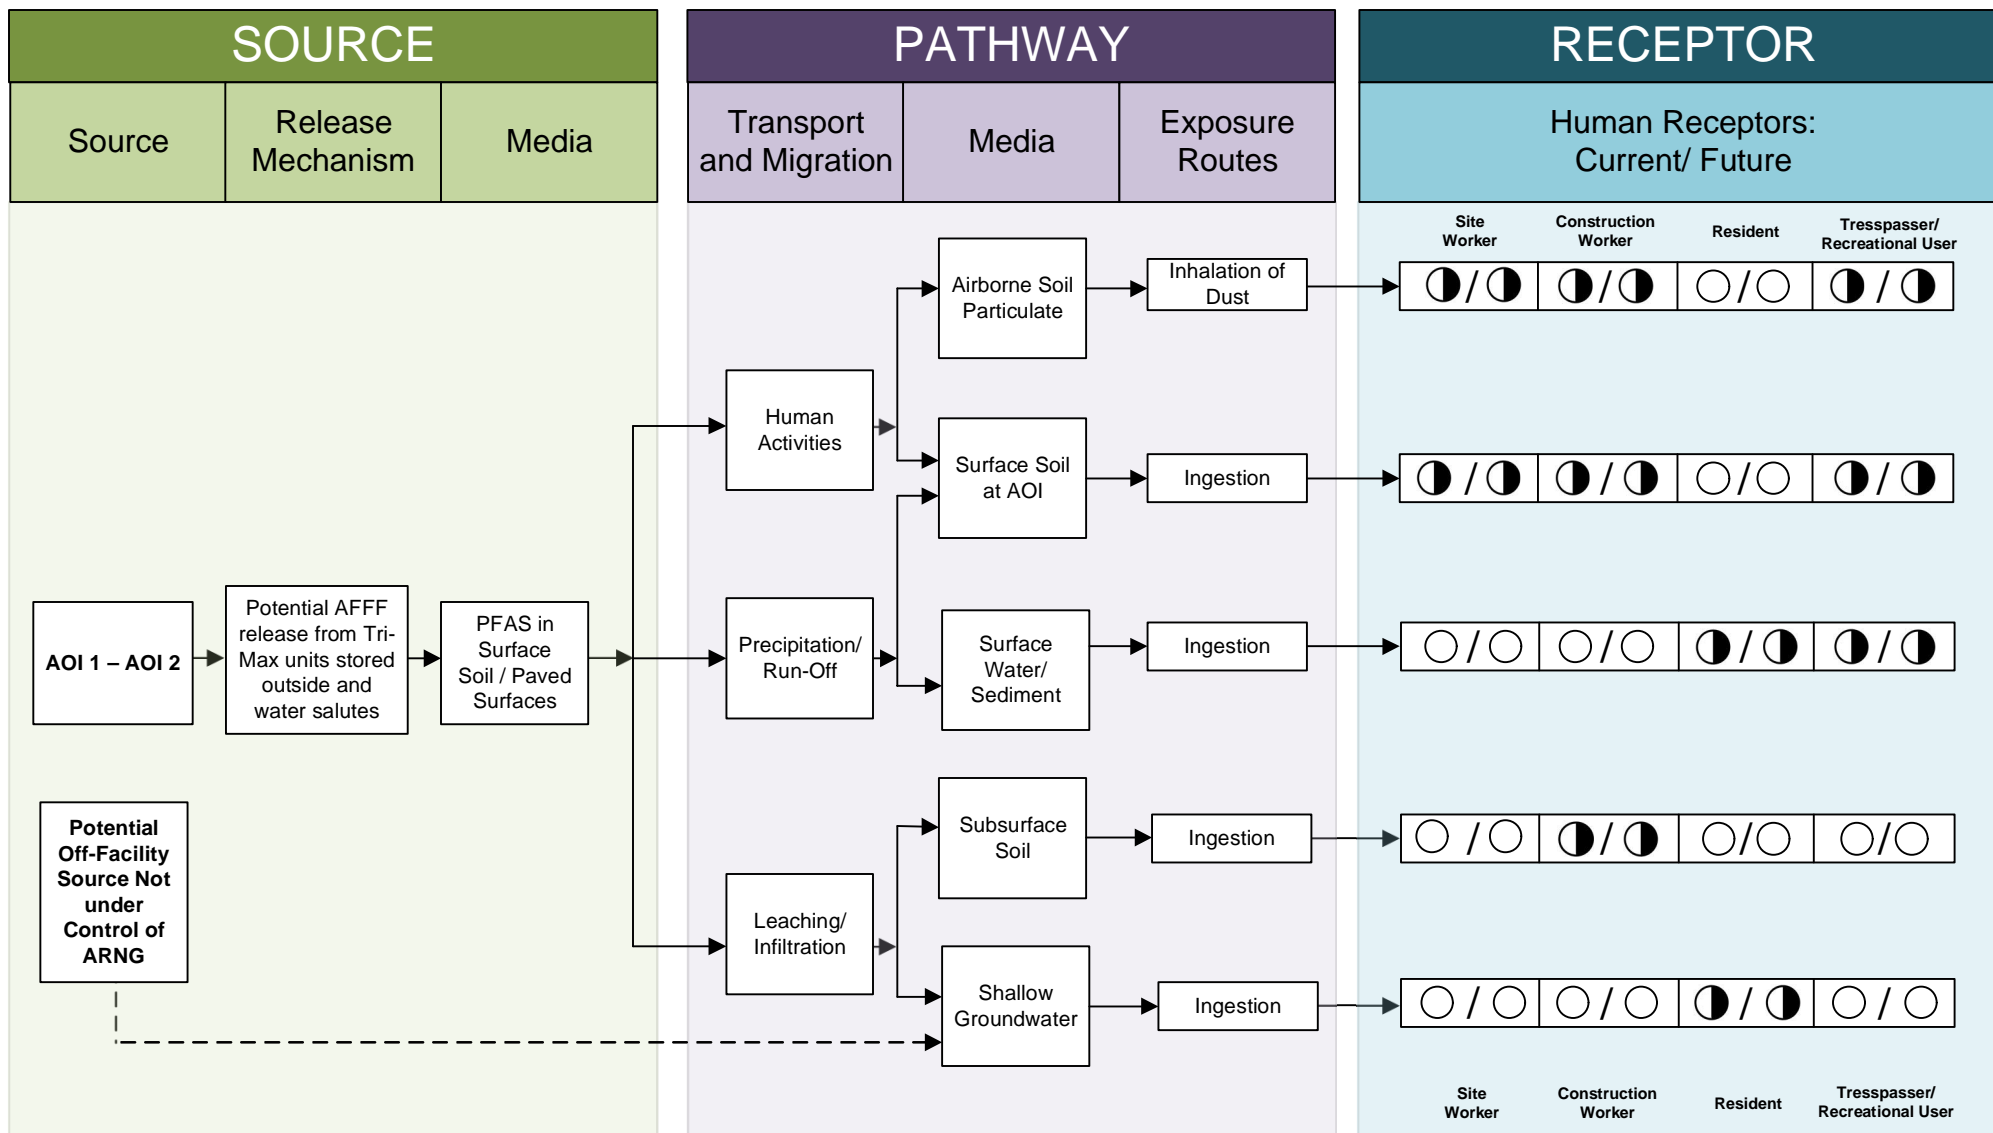
Figure 6-2
Preliminary Conceptual Site Model
AOI 1 (Parking Apron) and AOI 2 (HAZMAT Storage Area)

If any releases of AFFF occurred on the parking apron, they would have occurred on the paved apron surface and may have migrated to the unpaved or gravel surfaces surrounding the parking apron depending on the location of the release. As such, it is possible that PFAS infiltrated subsurface soil via cracks in pavement, joints between areas that are paved with different materials, and surface soil in the unpaved and gravel areas surrounding the apron. If AFFF released at the AOI infiltrated surface soil, then surface soil presents a potential pathway for PFAS exposure to site workers, construction workers, and trespassers via ingestion and inhalation if any PFAS has been released. If AFFF infiltrated subsurface soil, then ground-disturbing activities may result in PFAS exposure to construction workers via ingestion and inhalation. Accidental ingestion of groundwater during ground-disturbing activities is not considered a potential pathway for exposure to PFAS due to the depth to groundwater at the HAATS facility.

If any releases of AFFF occurred in the HAZMAT storage area, they may have occurred on paved, grassy or gravel surfaces depending on the location of the release. As such, it is possible that PFAS infiltrated subsurface soil via cracks in pavement, joints between areas that are paved with different materials, and surface soil in the unpaved and gravel areas. As such, surface soil presents a potentially exposure pathway for PFAS to site workers, construction workers, and trespassers via ingestion and inhalation. Ground-disturbing activities may result in PFAS exposure to construction workers via ingestion and inhalation of subsurface soil; however, they are unlikely to create a pathway for construction workers to PFAS via ingestion of groundwater due to the depth to groundwater at the HAATS facility.

1. The resident and recreational user receptors refer to an off-site resident and recreational user.
2. The site worker and construction worker receptors refer only to COARNG HAATS site and construction workers.
3. Dermal contact exposure pathway is incomplete for PFAS.

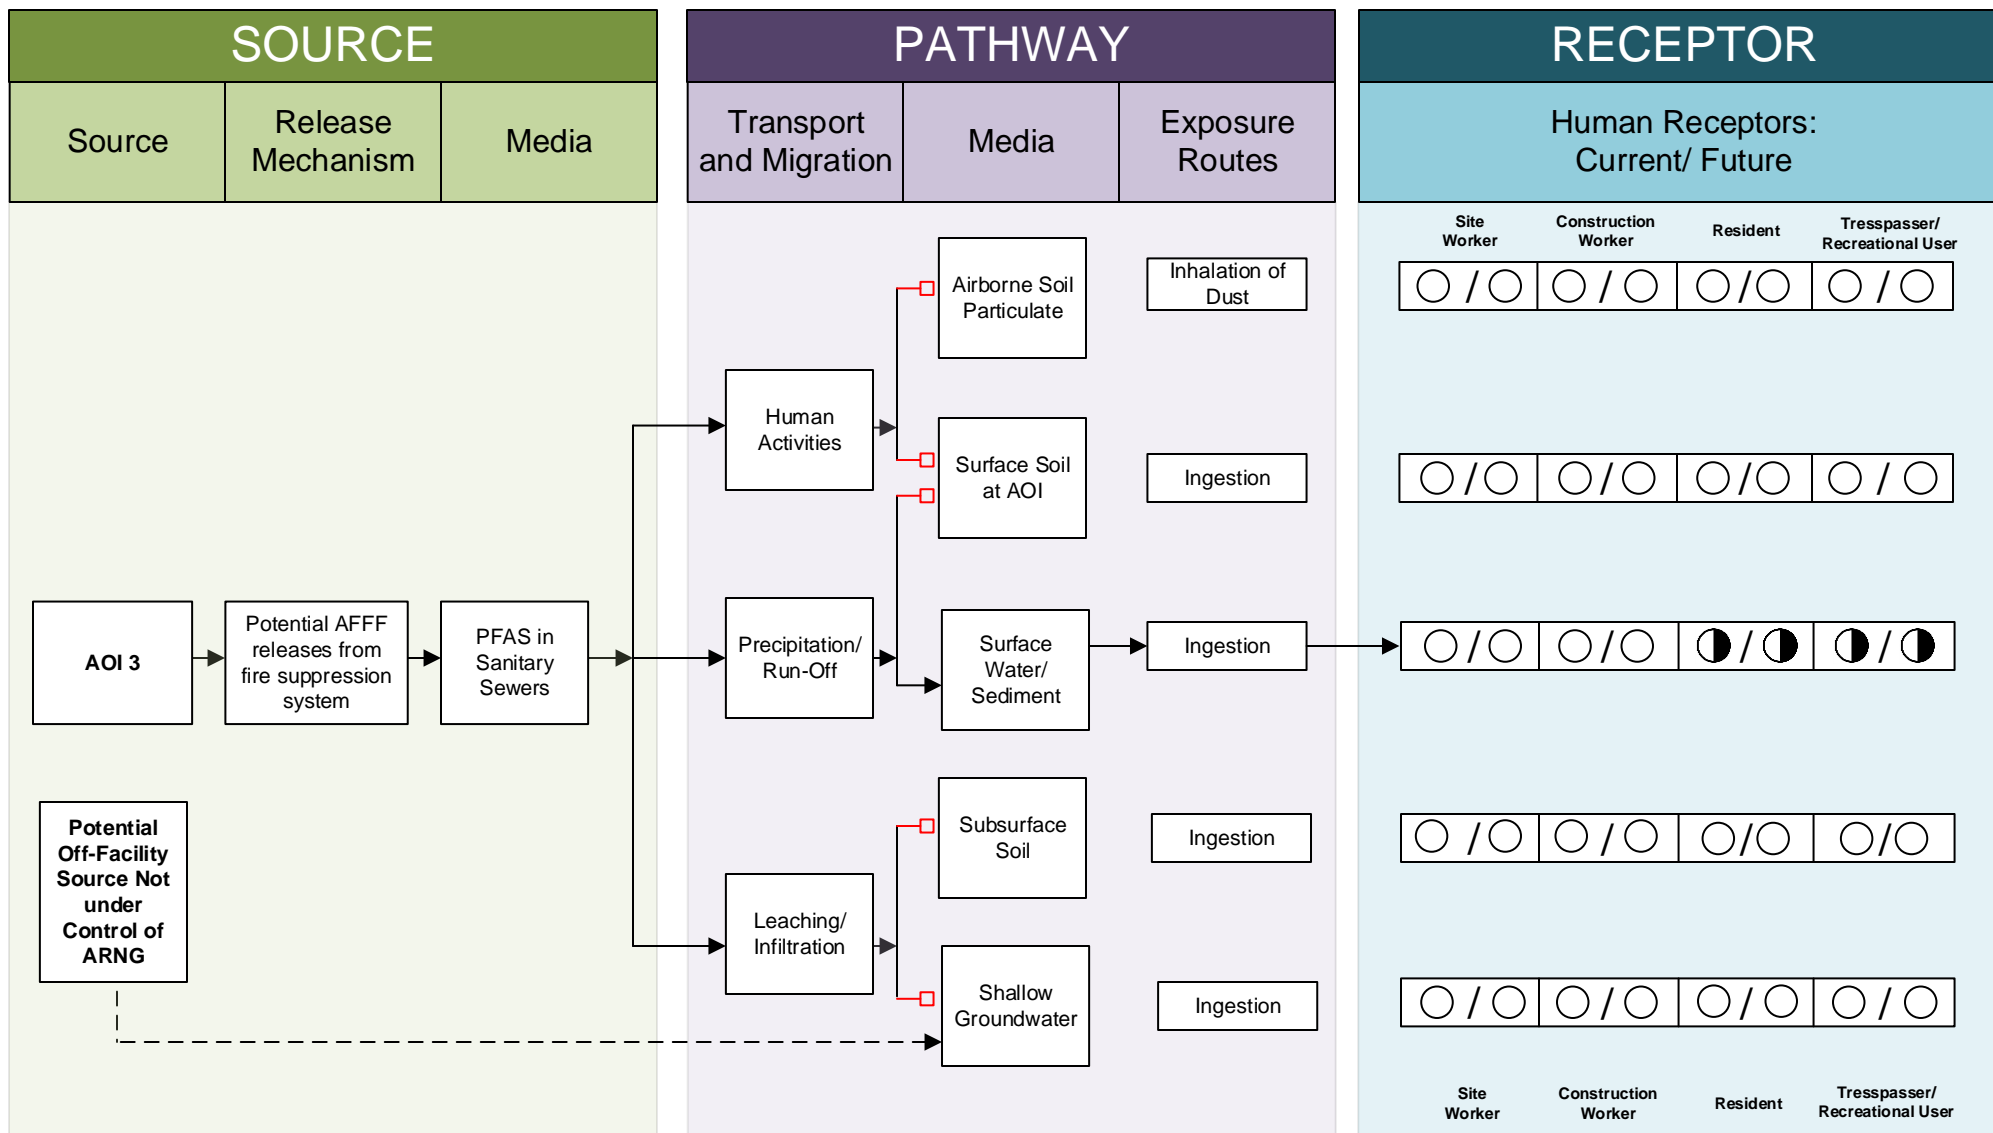
PFAS is not expected to have escaped the Building 1214 confines based on the lack of known AFFF system releases. Any AFFF releases are presumed to be of low volume and confined to the tank room. As such, AFFF is not expected to have migrated to surface or subsurface soil surrounding or beneath the building. PFAS is also not expected to have migrated to groundwater as a result of potential AFFF releases at AOI 3.

1. The resident and recreational user receptors refer to an off-site resident and recreational user.
2. The site worker and construction worker receptors refer only to COARNG HAATS site and construction workers.
3. Dermal contact exposure pathway is incomplete for PFAS.
