FINAL Preliminary Assessment Report High Altitude Aviation Training Site, Gypsum, Colorado

Perfluorooctanesulfonic Acid (PFOS) and Perfluorooctanoic
Acid (PFOA) Impacted Sites
ARNG Installations, Nationwide

October 2020

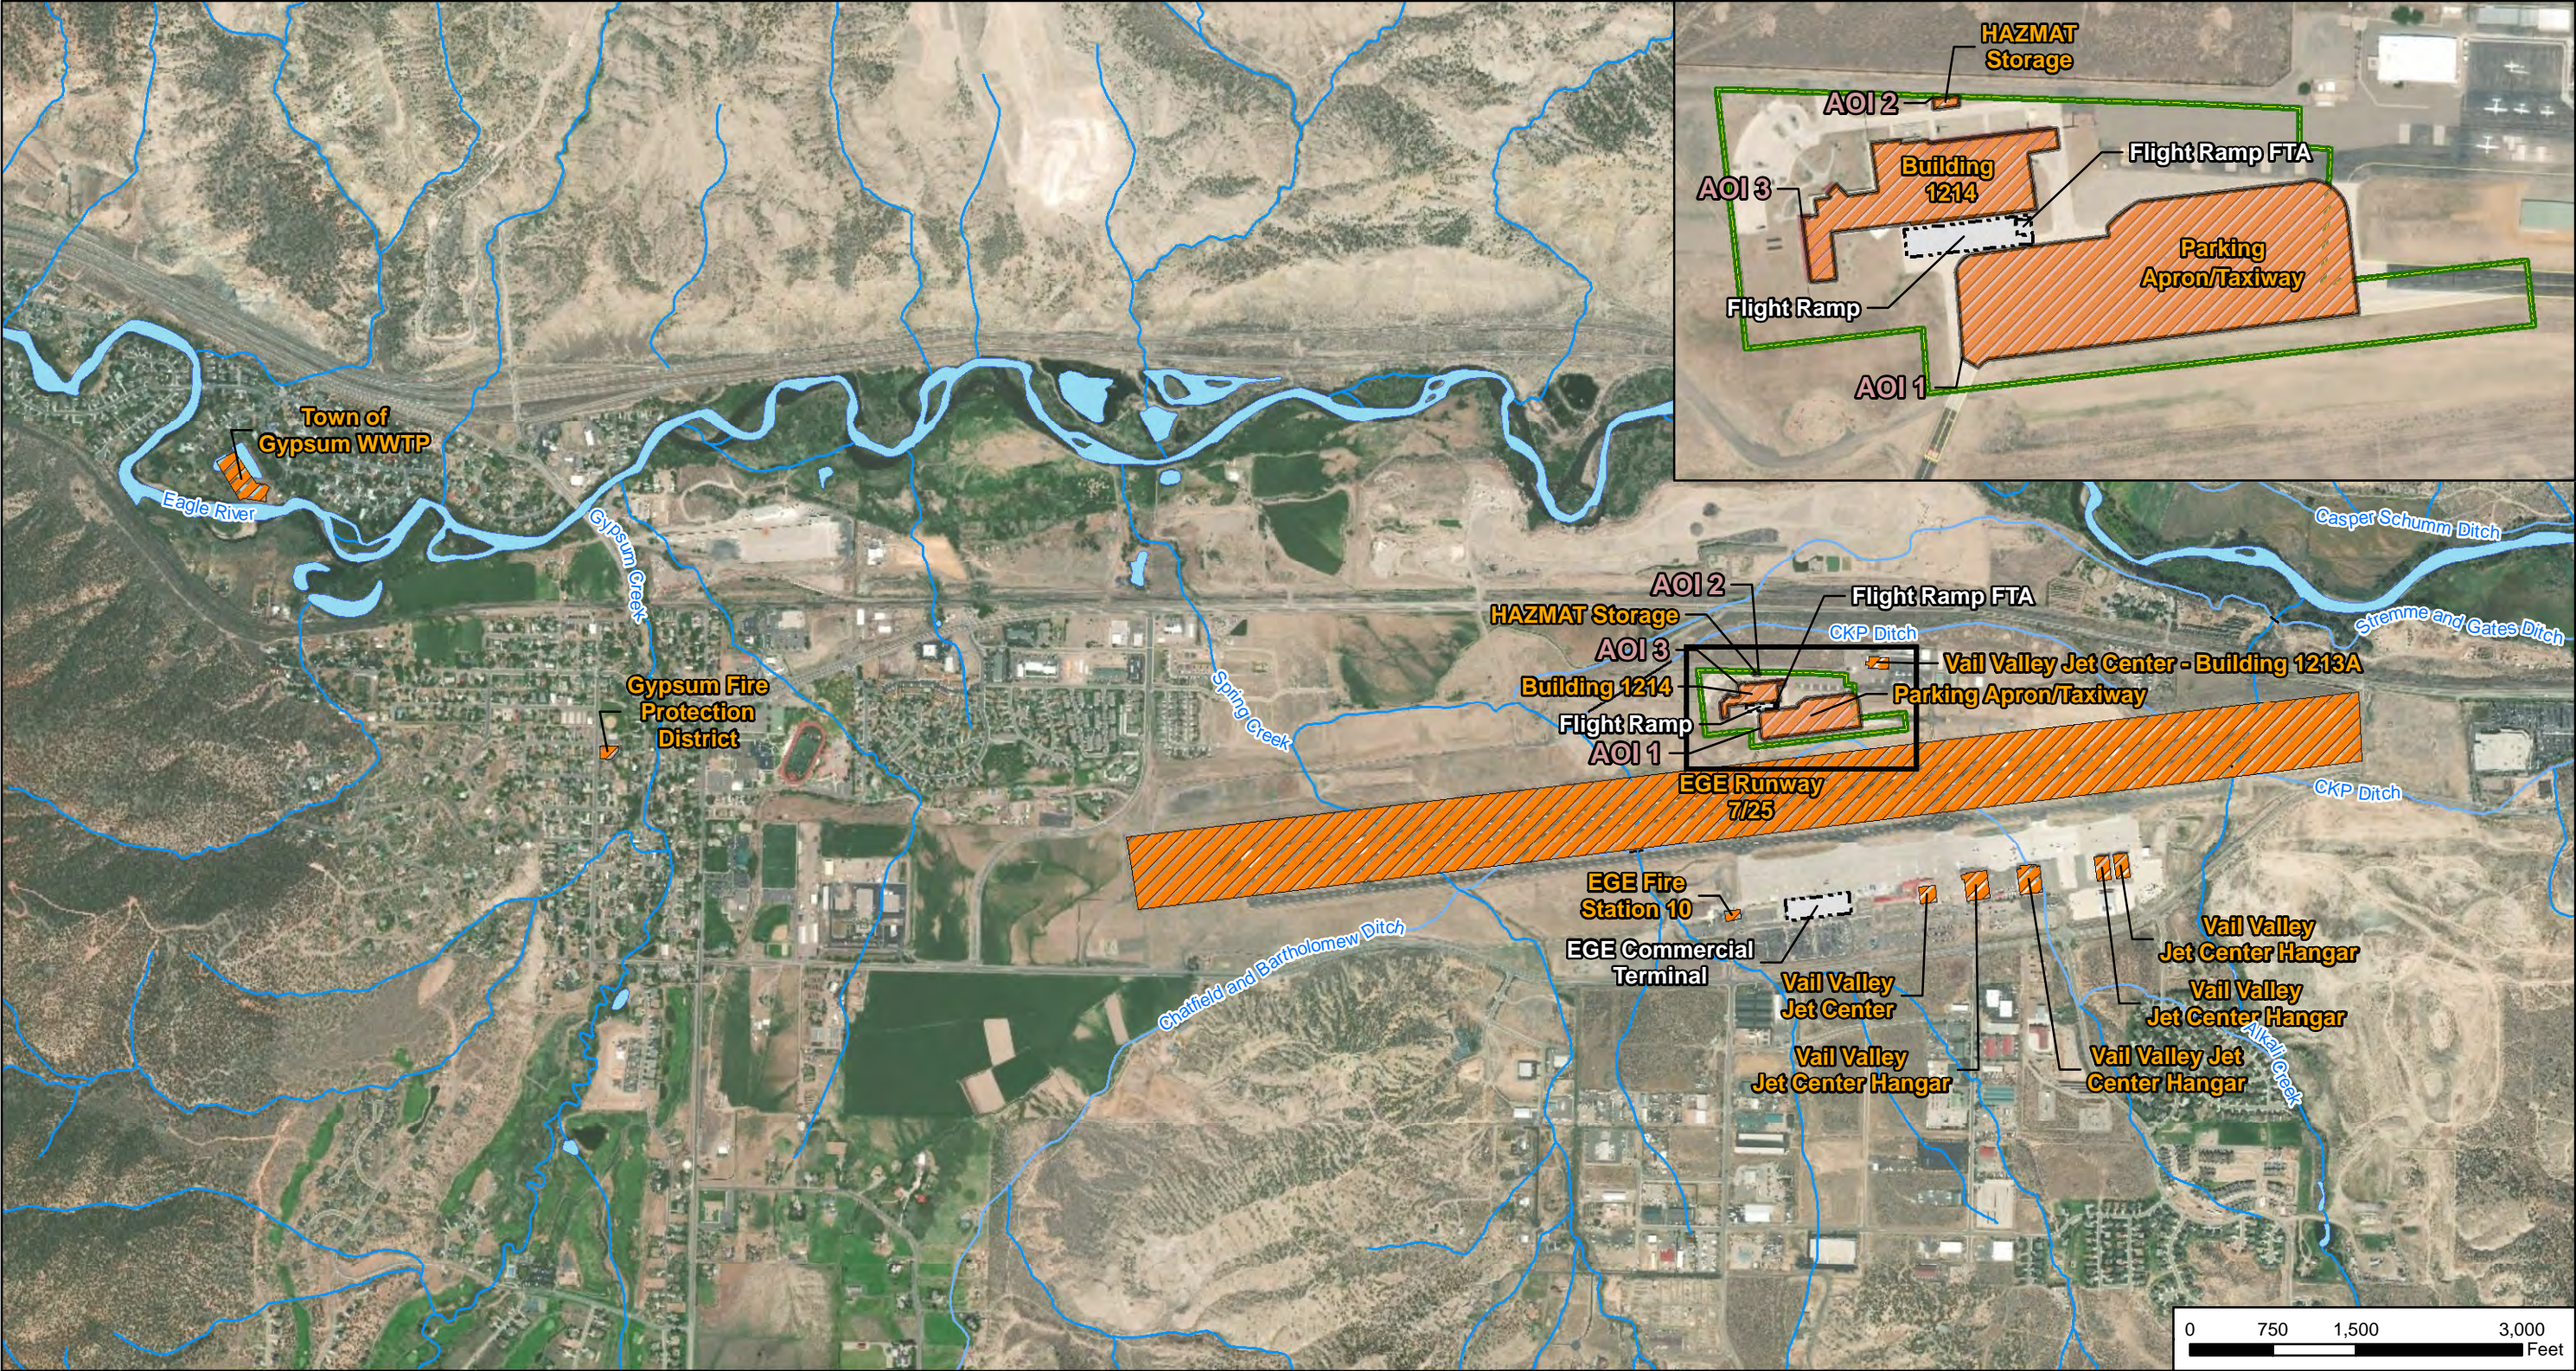
CLIENT		ARNG			
PROJECT		Preliminary Assessment for PFAS at HAATS, CO			
REVISED	4/8/2020	GIS BY	MS	4/8/2020	
SCALE	1:18,000	CHK BY	JW	4/8/2020	
Base Map: Source: Esri, DigitalGlobe, GeoEye, Earthstar Geographics, CNES/Airbus DS, USDA, USGS, AeroGRID, IGN, and the GIS User Community		PM	RG	4/8/2020

Area of Interest		AOI Location	Rationale	Potential Future Action
AOI 1	Parking Apron/Taxiway	39°38'41.54"N; 106°54'48.54"W	Potential AFFF releases from Tri-Max units stored outside.	Proceed to an SI, focus on soil and groundwater.
AOI 2	HAZMAT Storage Area	39°38'45.51"N; 106°54'55.54"W	Potential AFFF releases from Tri-Max units stored outside.	Proceed to an SI, focus on soil and groundwater.
AOI 3	Building 1214	39°38'43.50"N; 106°54'56.06"W	Potential AFFF releases from fire suppression system and drum.	Proceed to an SI, focus on surface water.
