Surface Metal Monitoring Survey Report

Kansas Army National Guard
Lawrence Armory
200 Iowa Street
Lawrence, Kansas

Survey Date: July 23, 2012

Department of the Army
National Guard Bureau
Region West Industrial Hygiene Office
NGB-AVN-S1

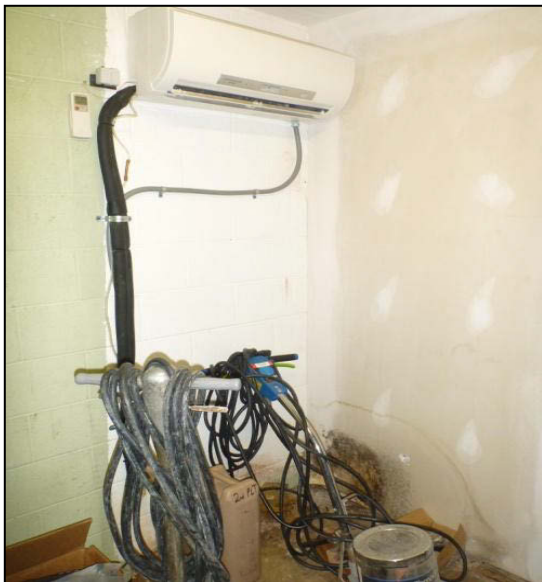
Figure 3 - Mold in the Server Room.

There is visible mold on the gypsum board walls and floor in the server room located in the maintenance bay area. The drain for the air conditioning wall unit appears to be leaking and should be repaired (RAC 2). Ensure all visible mold is removed and remediate water-damaged areas to prevent mold growth (RAC 2).

There is visible mold on the gypsum board walls and floor in the server room located in the maintenance bay area (Figure 3). The drain for the air conditioning wall unit appears to be leaking and should be repaired. All visible mold should be cleaned up. An airborne mold survey was conducted for this facility in April 2009; the indoor levels of mold were lower than the outdoor levels indicating there was no additional risk of exposure to those employees who worked inside the facility.

1. Repair all water leaks to prevent additional water damage and potential mold growth (RAC2).
2. Areas of water damage and visible mold growth should be remediated (RAC 2).

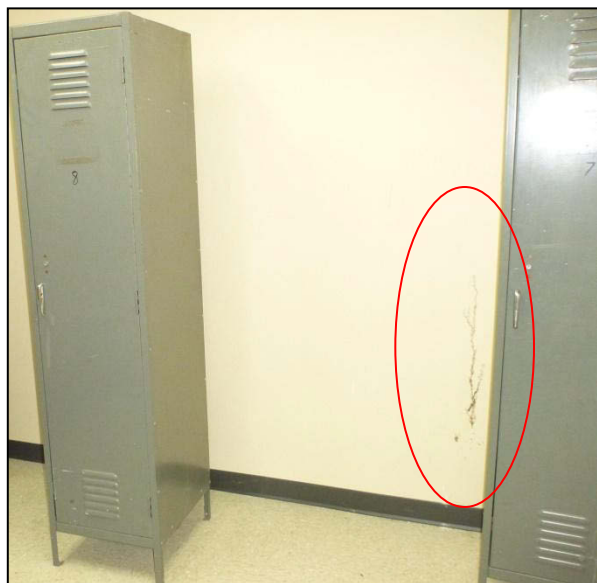
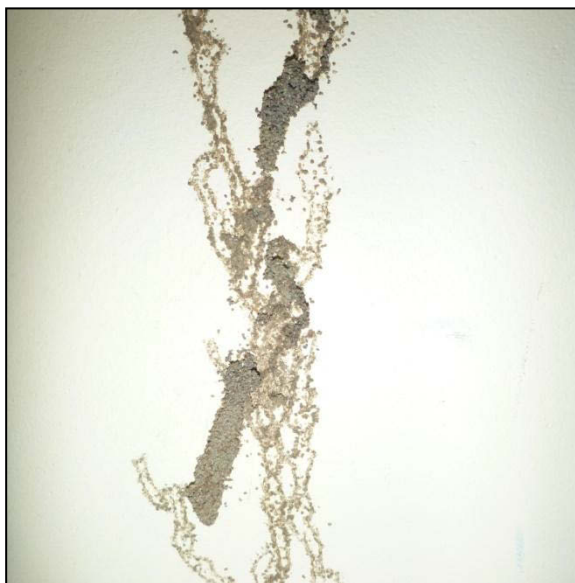
Figure 4 - Possible Termite Damage in the Platoon Office Area.

Possible termite damage was observed in the platoon office area. Based on the visual observations, the KSARNG environmental health personnel or a licensed exterminator should be consulted to identify and address any potential infestation issues (RAC2).

Possible termite damage was observed in the platoon office area (Figure 4). Based on the visual observations, the KSARNG environmental health personnel or a licensed exterminator should be consulted to identify and address any potential infestation issues.

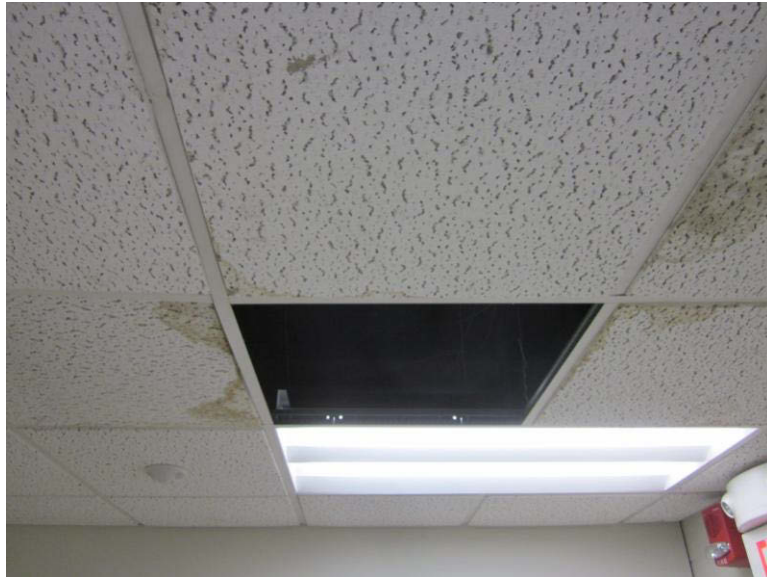
Figure C-1 Water Damage and Mold on Ceiling Tiles in the West End of the John W. Briedenthal Hall

1. Repair roofs and walls to prevent additional water leakage (RAC 2).
2. Repair the leaking cast iron waste pipe in the basement kitchen and dining area (RAC 2).
3. Perform mold abatement. Engage a licensed mold abatement contractor to perform the mold abatement. Mold damaged materials should be removed and discarded or cleaned up to remove mold (RAC 2).
4. Perform periodic inspections to identify sources of water damage. Conduct repairs of water damaged areas as soon as they are identified (RAC 2).

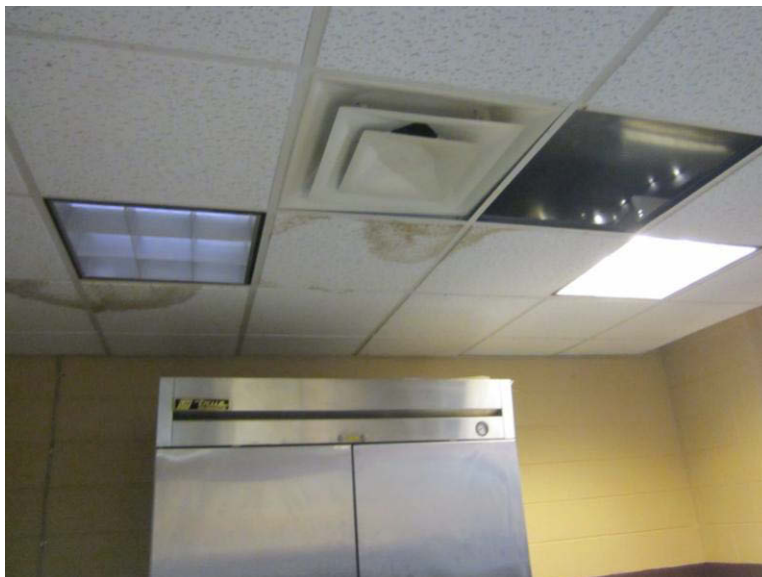
**Figure C-2 Water Damage and Mold on Ceiling Tiles
in First Floor Kitchen Area**

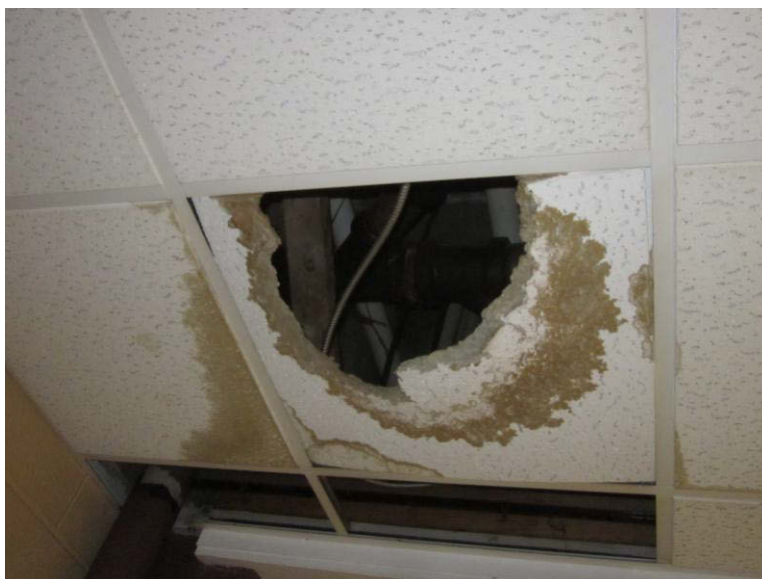
**Figure C-3 Water Damage and Mold on Ceiling Tiles in Basement Kitchen
and Dining Area - Beneath Leaking Cast Iron Waste Pipe**

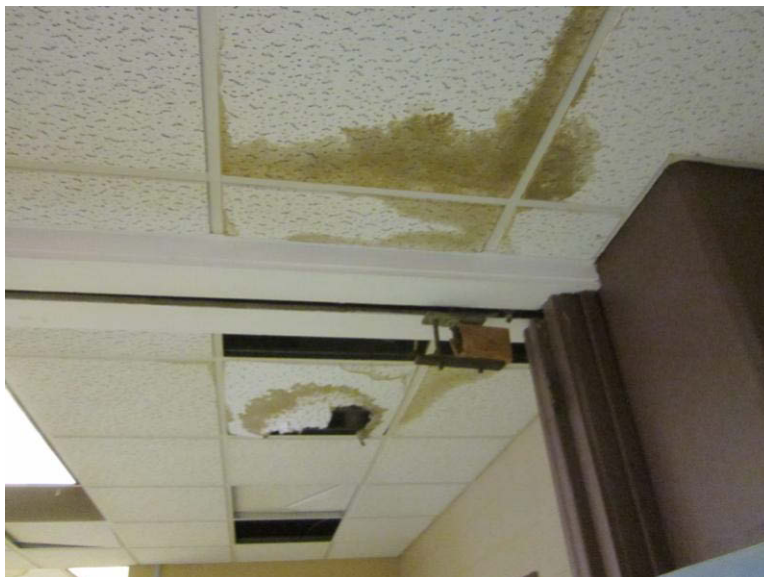
**Figure C-4 Water Damage and Mold on Ceiling Tiles
in Basement Kitchen and Dining Area**

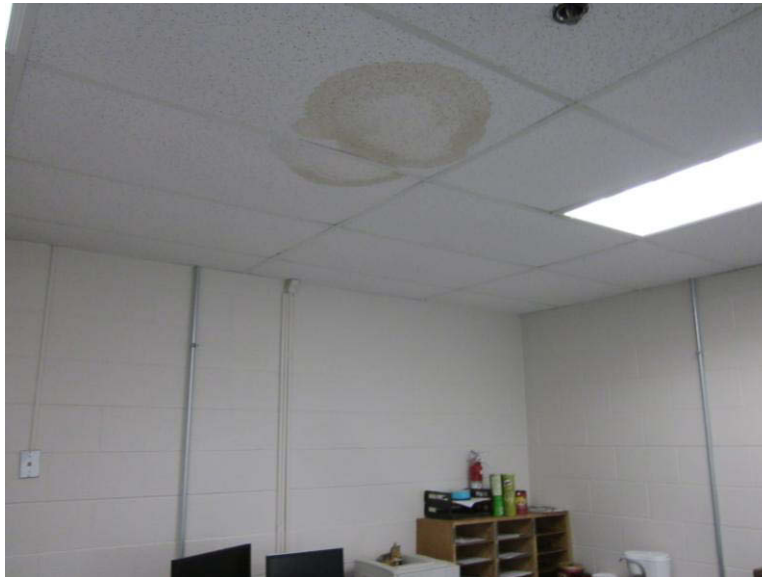
Figure C-1 – Water Damage and Mold on Ceiling Tile in 1-161 Orderly Room

1. Repair roofs and walls to prevent additional water leakage (RAC 2).
2. Perform mold abatement. Engage a licensed mold abatement contractor to perform the mold abatement. Mold damaged materials should be removed and discarded or cleaned up to remove mold (RAC 2).
3. Perform periodic inspections to identify sources of water damage. Conduct repairs of water damaged areas as soon as they are identified (RAC 2).

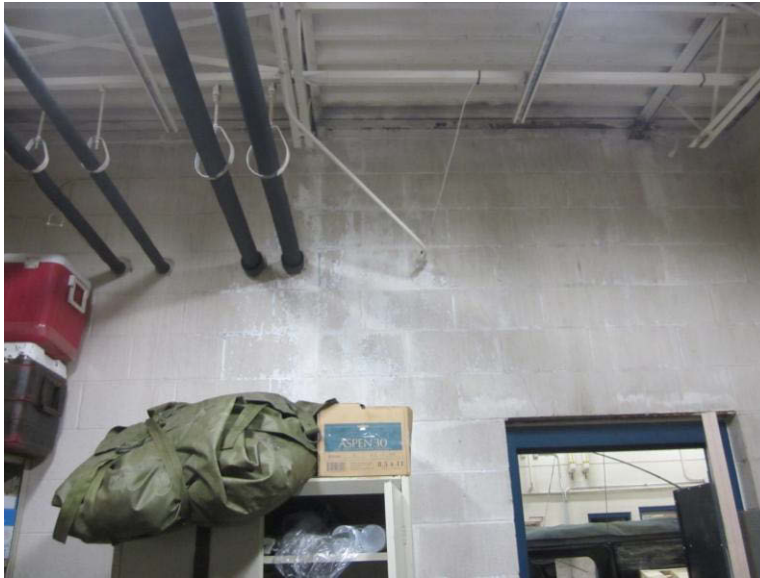
Figure C-2 – Water Damage and Efflorescence on Cement Block Wall in RSP Storage Room

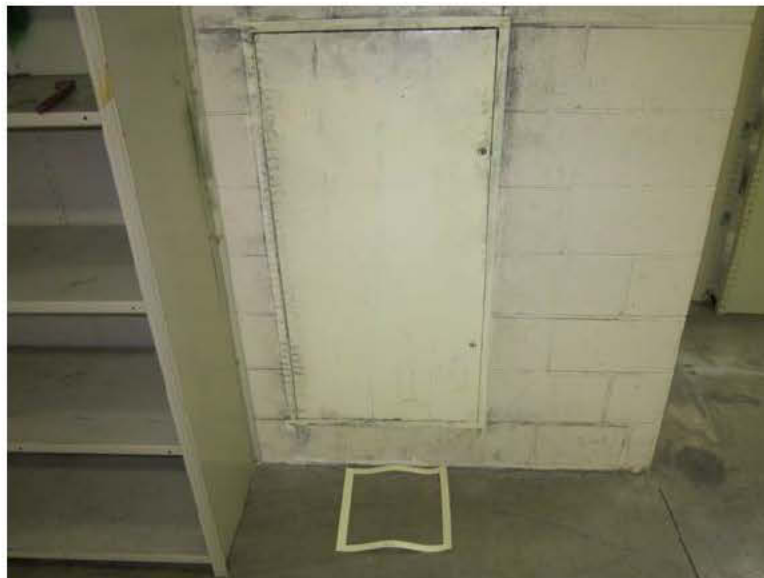
Figure 2 – Access door to bullet trap with visible silver/gray deposits that originate from the edge of the sealing area of the access door.

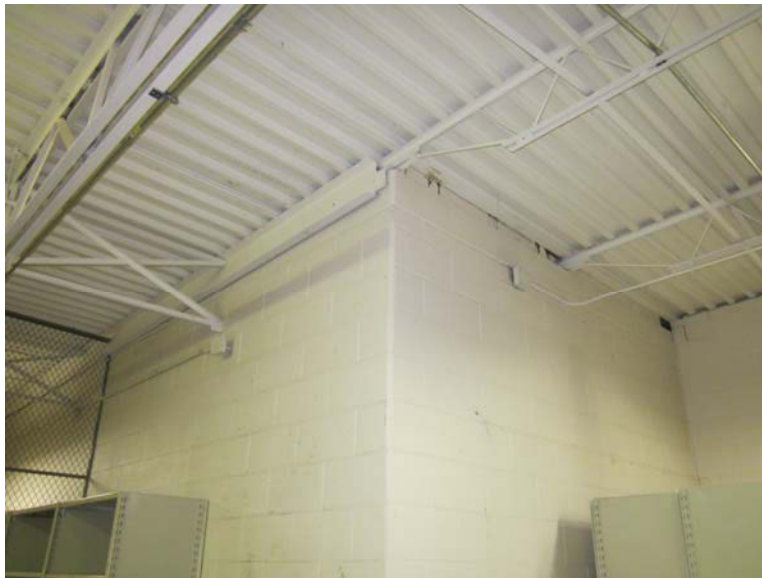
The partition wall between the firing range and the FA storage room has gaps (Figure 4). The unsealed areas (gaps) above the partition wall between the firing range and FA storage room should be sealed to prevent migration of metal contamination.

**Figure 4 -Unsealed areas above partition wall
between firing range and FA storage room**
