## EXECUTIVE SUMMARY

## 1.0 INTRODUCTION

## **CLOVIS ARMORY**

## INDUSTRIAL HYGIENE ASSISTANCE VISIT CLOVIS ARMORY CLOVIS, NEW MEXICO

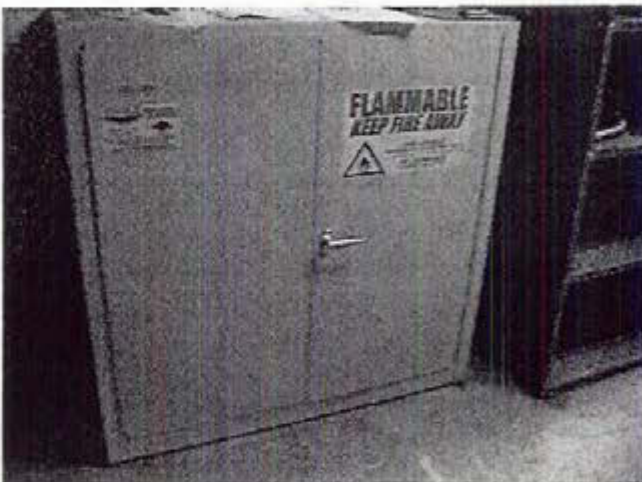
**Photograph 17**  
Flammable storage cabinet, closed

The flammable storage cabinet was inspected, and no storage incompatibilities or leaking materials were found. However, the chemicals on the inventory were found to be inconsistent with the contents of the flammable cabinet. This cabinet was in good condition and all doors closed properly.

See recommendation for Section 4.6.1 of this report.

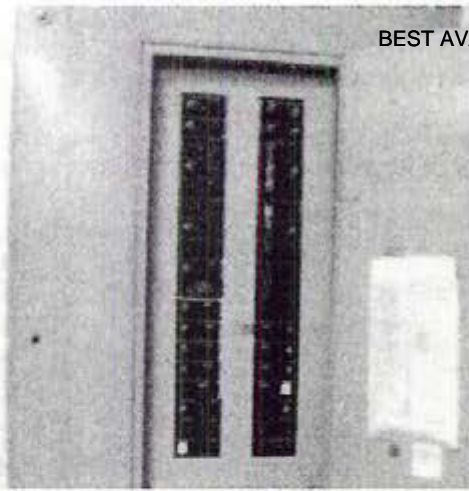
**Photograph 19**  
Safety, missing cover plate on electrical panel

electrical panel K missing plate

1. Ensure all fire extinguishers undergo an annual and monthly maintenance check.
2. Replace the cover plate on electrical panel box K in the kitchen so electrical wires cannot be contacted.
3. Install GFCI protection on any outlets within six feet of a water source.

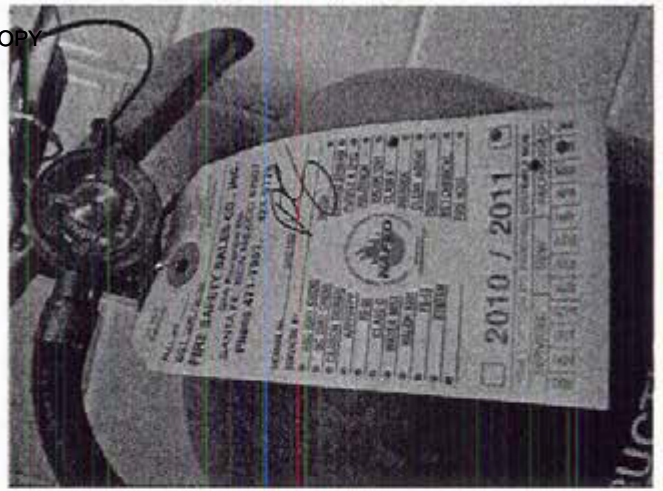
**Photograph 20**  
Safety, expired fire extinguishers

1. Housekeeping throughout the facility was good.
2. There are fire alarms present in this facility.
3. Fire extinguishers are strategically located throughout the armory. The annual and monthly inspections were out of date on several of the fire extinguishers, including the extinguishers in the kitchen and supply room.
4. Eyewash stations were not observed in this facility.
5. Fire evacuation routes and emergency exit signs are posted throughout this armory.
6. A cover plate on an electrical panel in the kitchen (Box "K") was missing and wires are accessible.
7. There was no ground fault circuit interrupter (GFCI) outlet located within six feet of the kitchen sink.

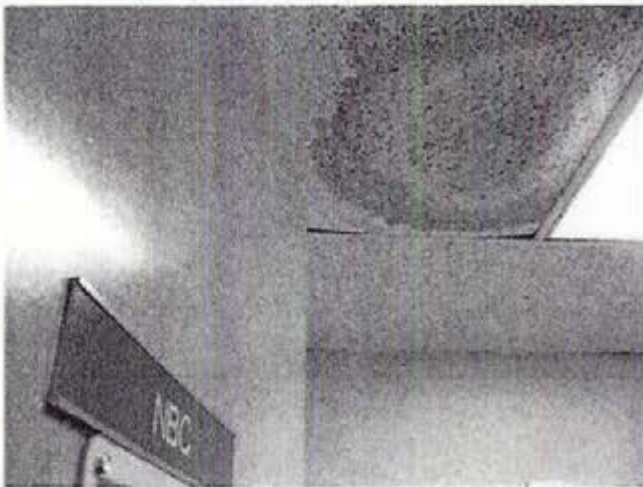
**Photograph 21**  
Water stained ceiling tile in NBC Room

Water-damaged ceiling tiles were noted in five rooms, as well as the central longitudinal corridor. Dark staining was found on the gypsum wallboard behind the peeling paint along the south wall of the southwest classroom. Surface or airborne spore samples were not collected on the day of the survey; however, fungal growth is suspected. There was no visible evidence of fungal growth in the remaining surveyed spaces. See Appendix C for photos of the stained materials and the drawing in Appendix E for locations of these ceiling tiles.

Conduct a comprehensive moisture intrusion and fungal growth assessment. Ensure that all water leaks are repaired before any mitigation efforts are undertaken.
