Industrial Hygiene Site Assistance Visit

Las Cruces Armory (IFR)
249 Armory Road
Las Cruces, NM 88007

SUBJECT: Executive Summary for Industrial Hygiene Site Assistance Visit (IHSAV) for the Las Cruces Armory, 249 N. Armory Rd, Las Cruces, NM conducted on 10 September 2012.

NEW MEXICO ARMY NATIONAL GUARD
LAS CRUCES CONVERTED INDOOR FIRING RANGE

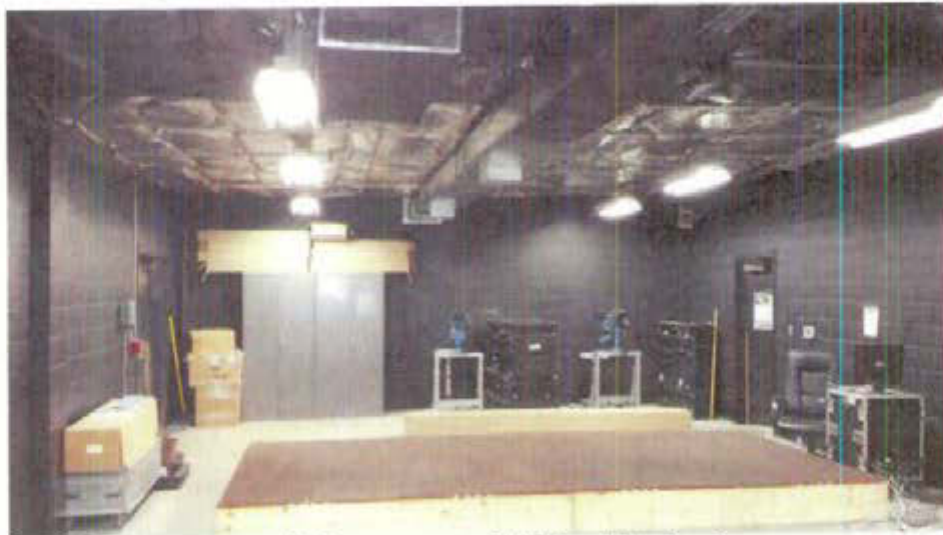
Photo 3: Interior of the converted IFR with the laser weapons training equipment and firing platform. Lead wipe sample 61214-32-I was collected from the back wall door header.

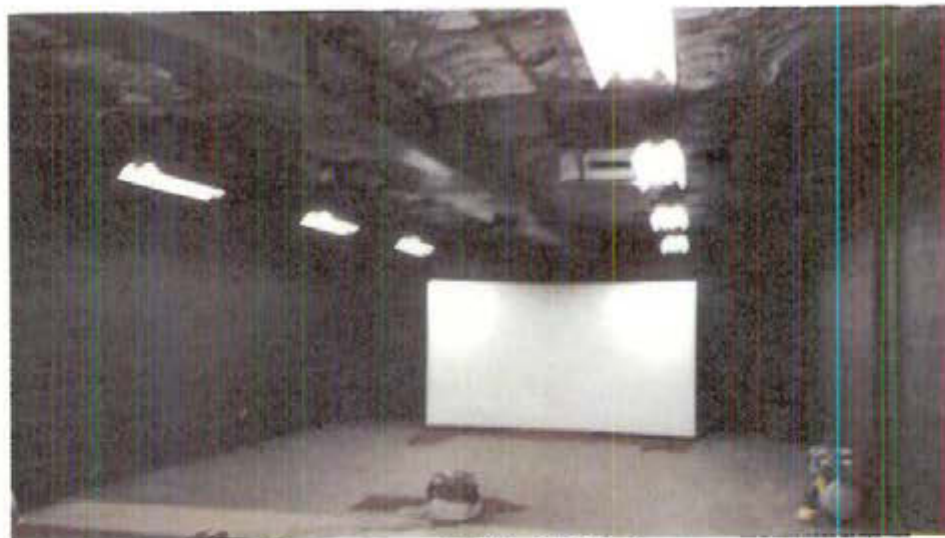
Photo 4: Interior of the converted IFR with the laser weapons system target screen. Lead wipe sample 61214-32-H was collected from the top of the HVAC ducting on the east end.

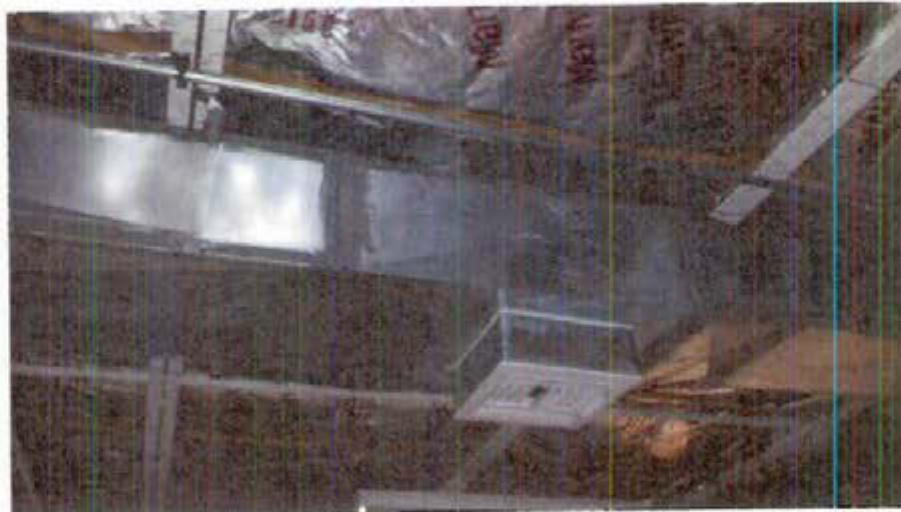
Photo 5: HVAC ducting in the converted IFR. Lead wipe sample 61214-32-G was collected from the top of the HVAC ducting on the west end.

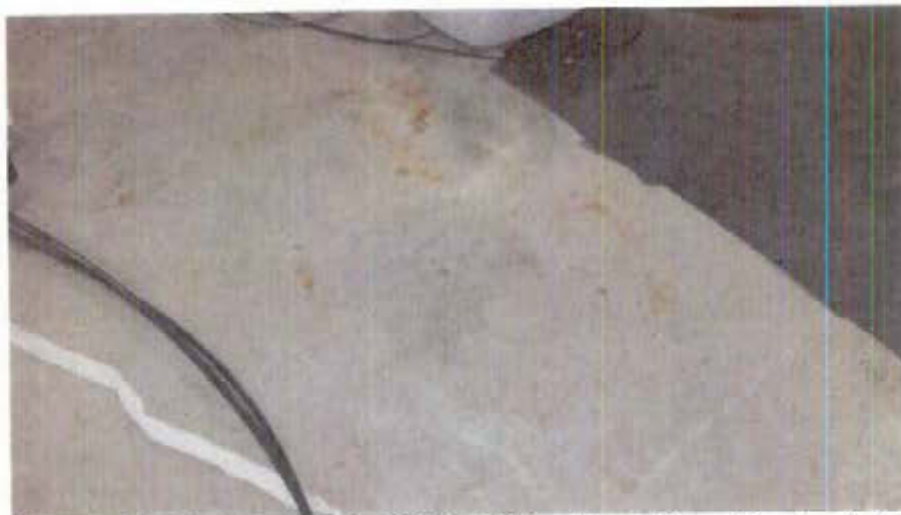
Photo 6: Lead wipe sample 61214-32-F collected from the unpainted concrete floor in the center of the converted IFR.

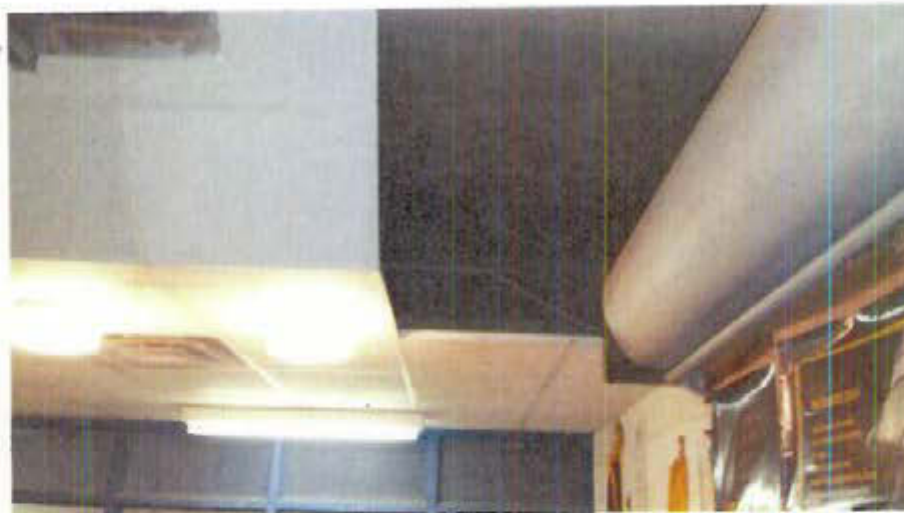
Photo 8: Drop ceiling in the State Guard Office covering the existing IFR concrete shell.

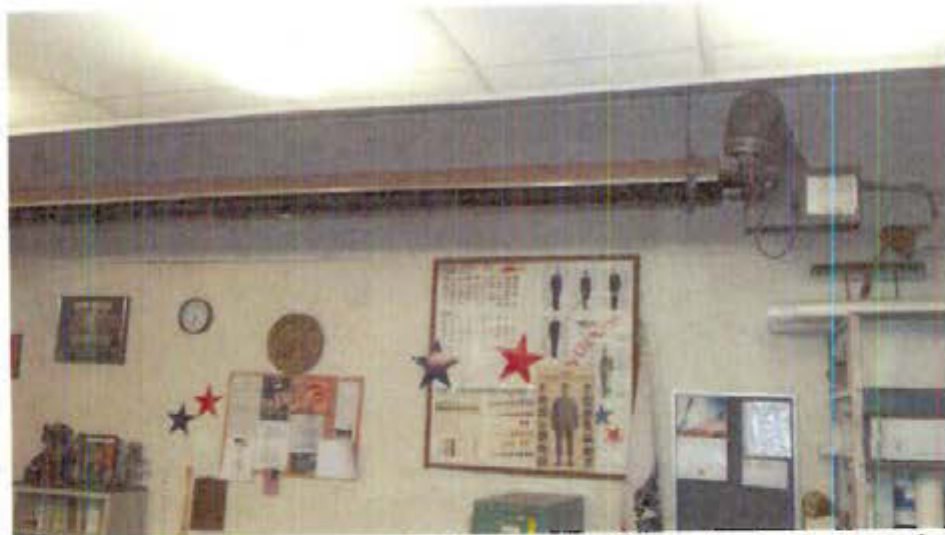
Photo 10: Radiant heater in the State Guard Office. Lead wipe samples 61214-32-J and K were collected from this location.

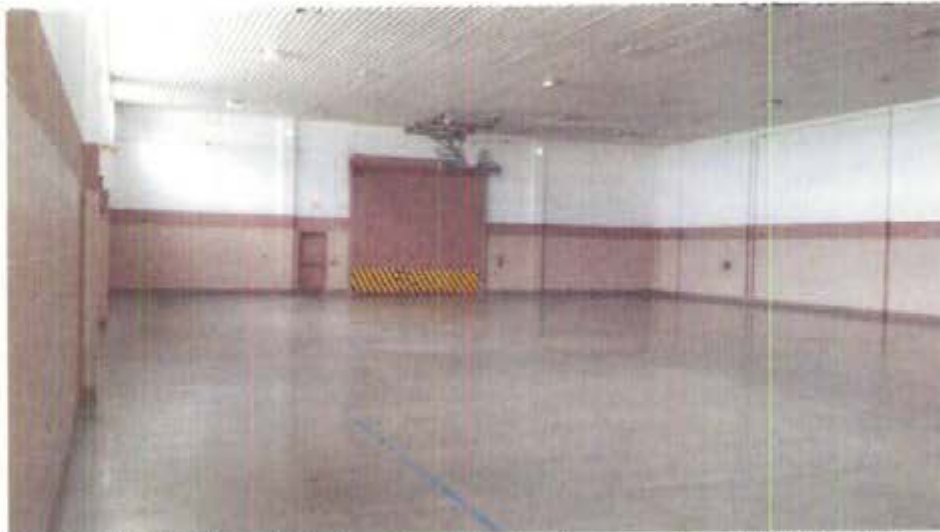
Photo 5: Drill Floor interior view. Lead wipe samples 61214-32-A to E were collected from the center and four corners of this area.

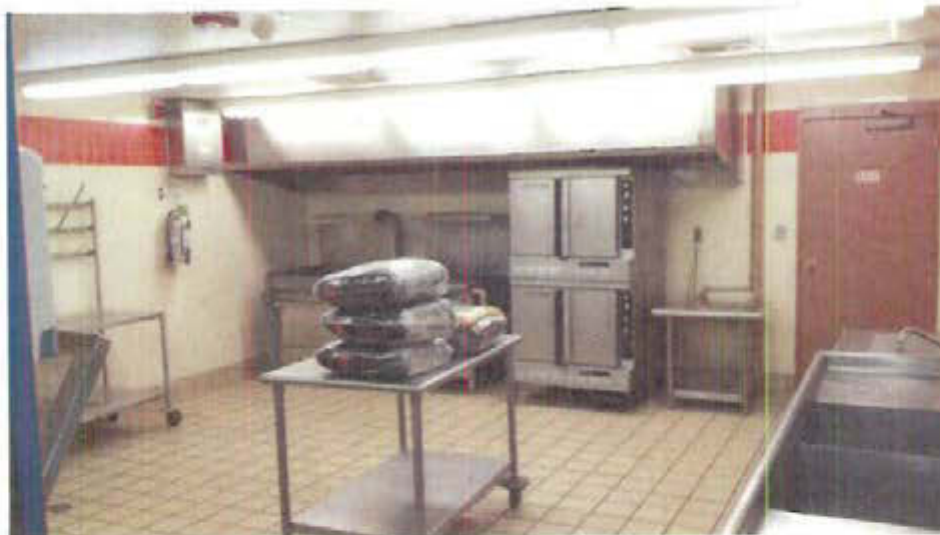
Photo 6: Kitchen with canopy hoods above range and ovens. Ventilation measurements were collected from the three (3) kitchen hoods.

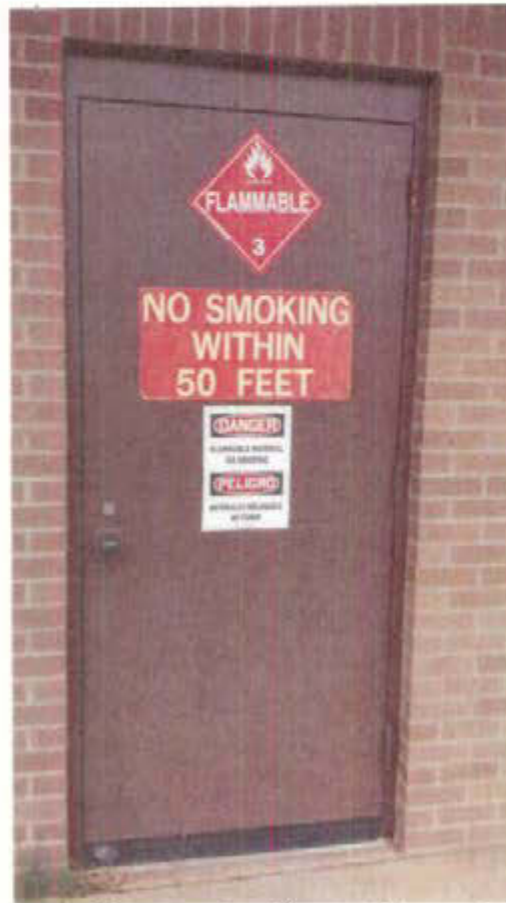
Photo 7: Entrance door to the flammable materials storage room, missing NFPA diamond placarding.
