Final
Preliminary Assessment Report
Fort Allen
Juana Diaz, Puerto Rico

Perfluorooctane-Sulfonic Acid (PFOS) and Perfluorooctanoic Acid (PFOA) Impacted Sites
ARNG Installations, Nationwide

March 2020

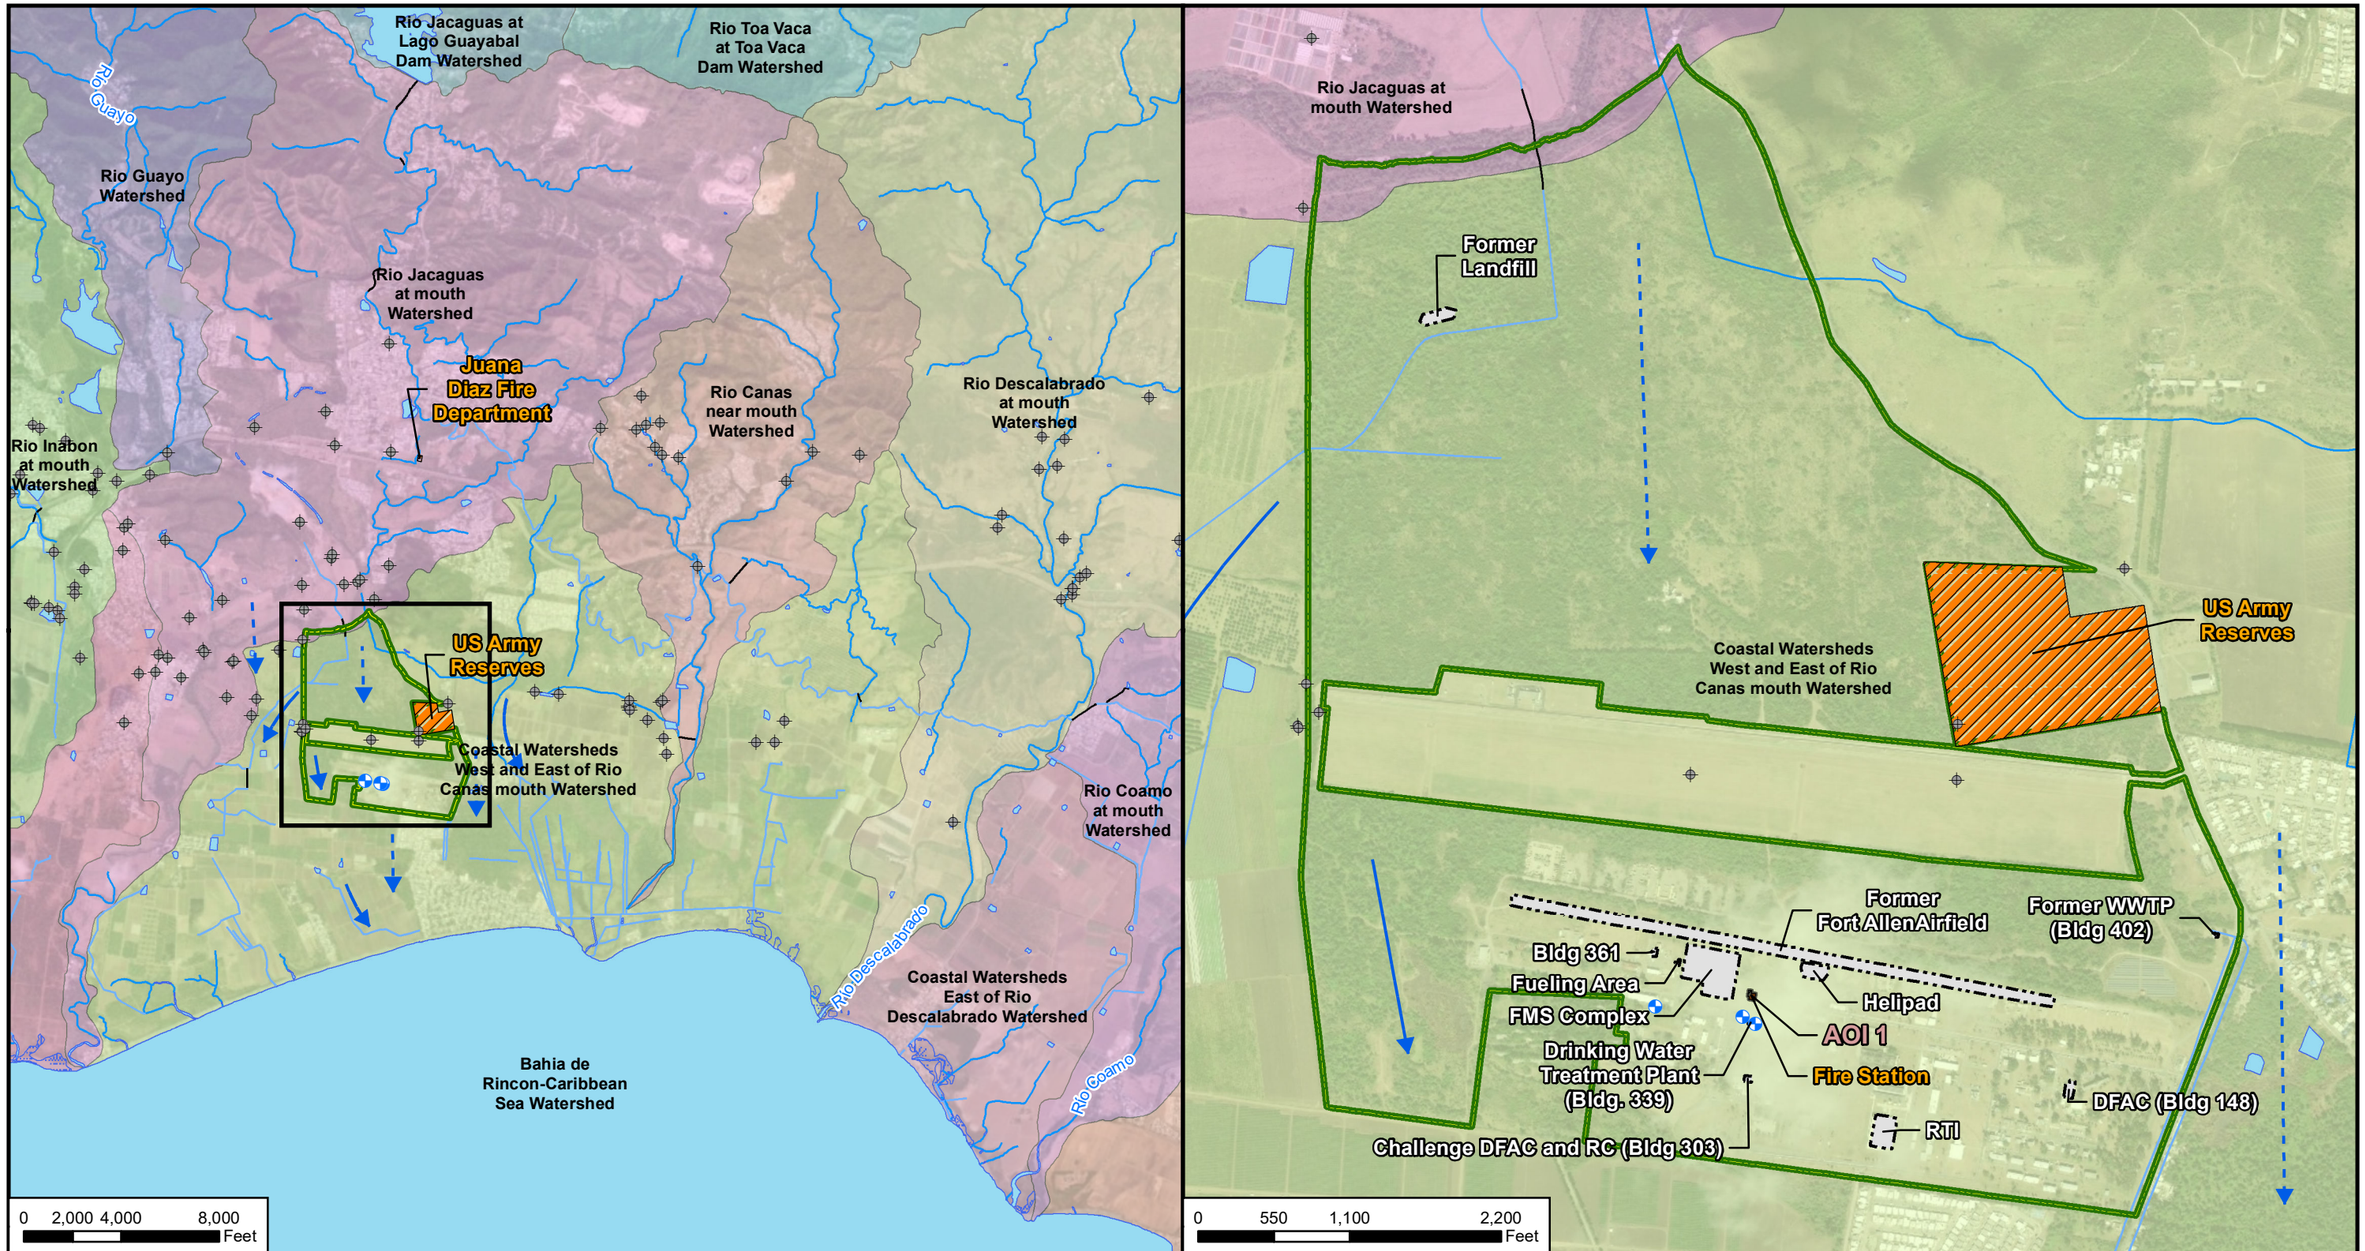
Based on the PA findings, one AOI was identified at Fort Allen: AOI 1 Fort Allen Fire Station. The AOI location is shown on **Figure 6-1**. The following sections describe the CSM components and the specific preliminary CSM developed for the AOI. The CSM identifies the three components necessary for a potentially complete exposure pathway: (1) source, (2) pathway, (3) receptor. If any of these elements are missing, the pathway is considered incomplete.

AOI 1 is the Fort Allen Fire Station located in the northwestern portion of the facility cantonment area (18°00’25.53"N; 66°30'15.77"W), near the former airfield. The fire station currently stores a Rosenbauer R-1 Airwolf Firetruck equipped with a 40-gallon AFFF tank. Although no evidence indicates that AFFF has ever been released at the Fire Station, the corrosive nature of AFFF may lead to unknown leaks of AFFF, or PFAS-tainted water.

Potential AFFF or PFAS-tainted water releases at AOI 1 may have occurred within the fire station, on paved surfaces outside the fire station, or on grassy surfaces surrounding the building. PFAS releases inside the fire station would have likely migrated via floor drains off-facility to municipal sanitary sewers. There is no WWTP at Fort Allen, and therefore, no suspected secondary release areas at the facility as a result of PFAS releases inside the building. If PFAS has been released outside the fire station, it may have infiltrated subsurface soil via cracks in pavement and joints between areas paved with different materials, or via the soil in the surrounding grassy areas. As a result, PFAS may be present in surface soil and subsurface soil at the AOI. The pathway for PFAS exposure to site workers, construction workers, and trespassers via inhalation and ingestion of surface soil is considered potentially complete. The pathway for PFAS exposure via ingestion of subsurface soil is also considered potentially complete for construction workers.

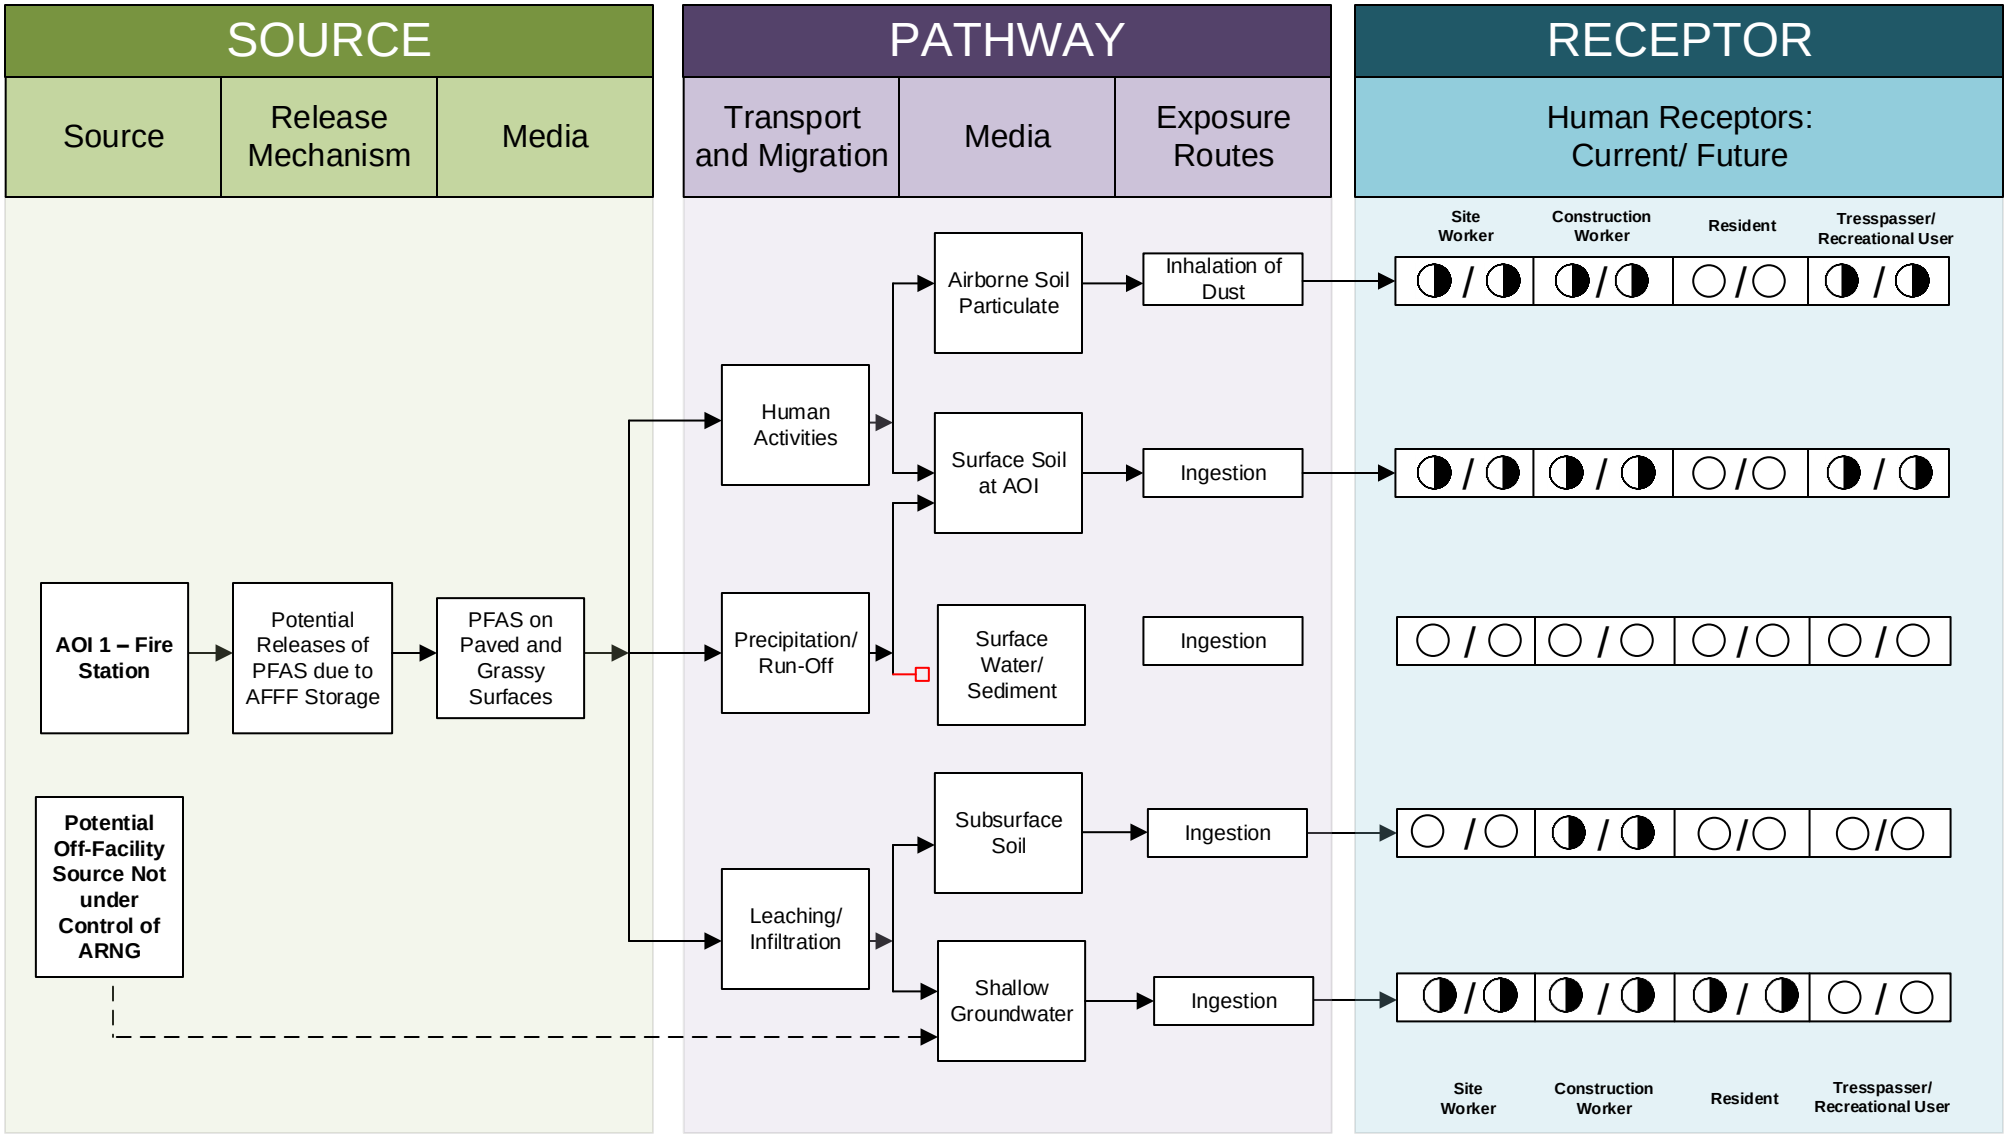
If PFAS releases at the AOI have migrated to subsurface soil, then PFAS may have also leached to groundwater. Two of the three facility drinking water wells are located downgradient of the fire station. As such, groundwater is considered a potentially complete pathway for PFAS exposure to site and construction workers via ingestion. Domestic wells may exist within the cross- and down-gradient adjacent residential areas. If AFFF releases at the AOI infiltrated the subsurface, the pathway for off-facility resident exposure to PFAS in groundwater is also considered potentially complete.

The preliminary CSM diagram for AOI 1 (**Figure 6-2**) indicates which specific receptors could potentially be exposed to PFAS.

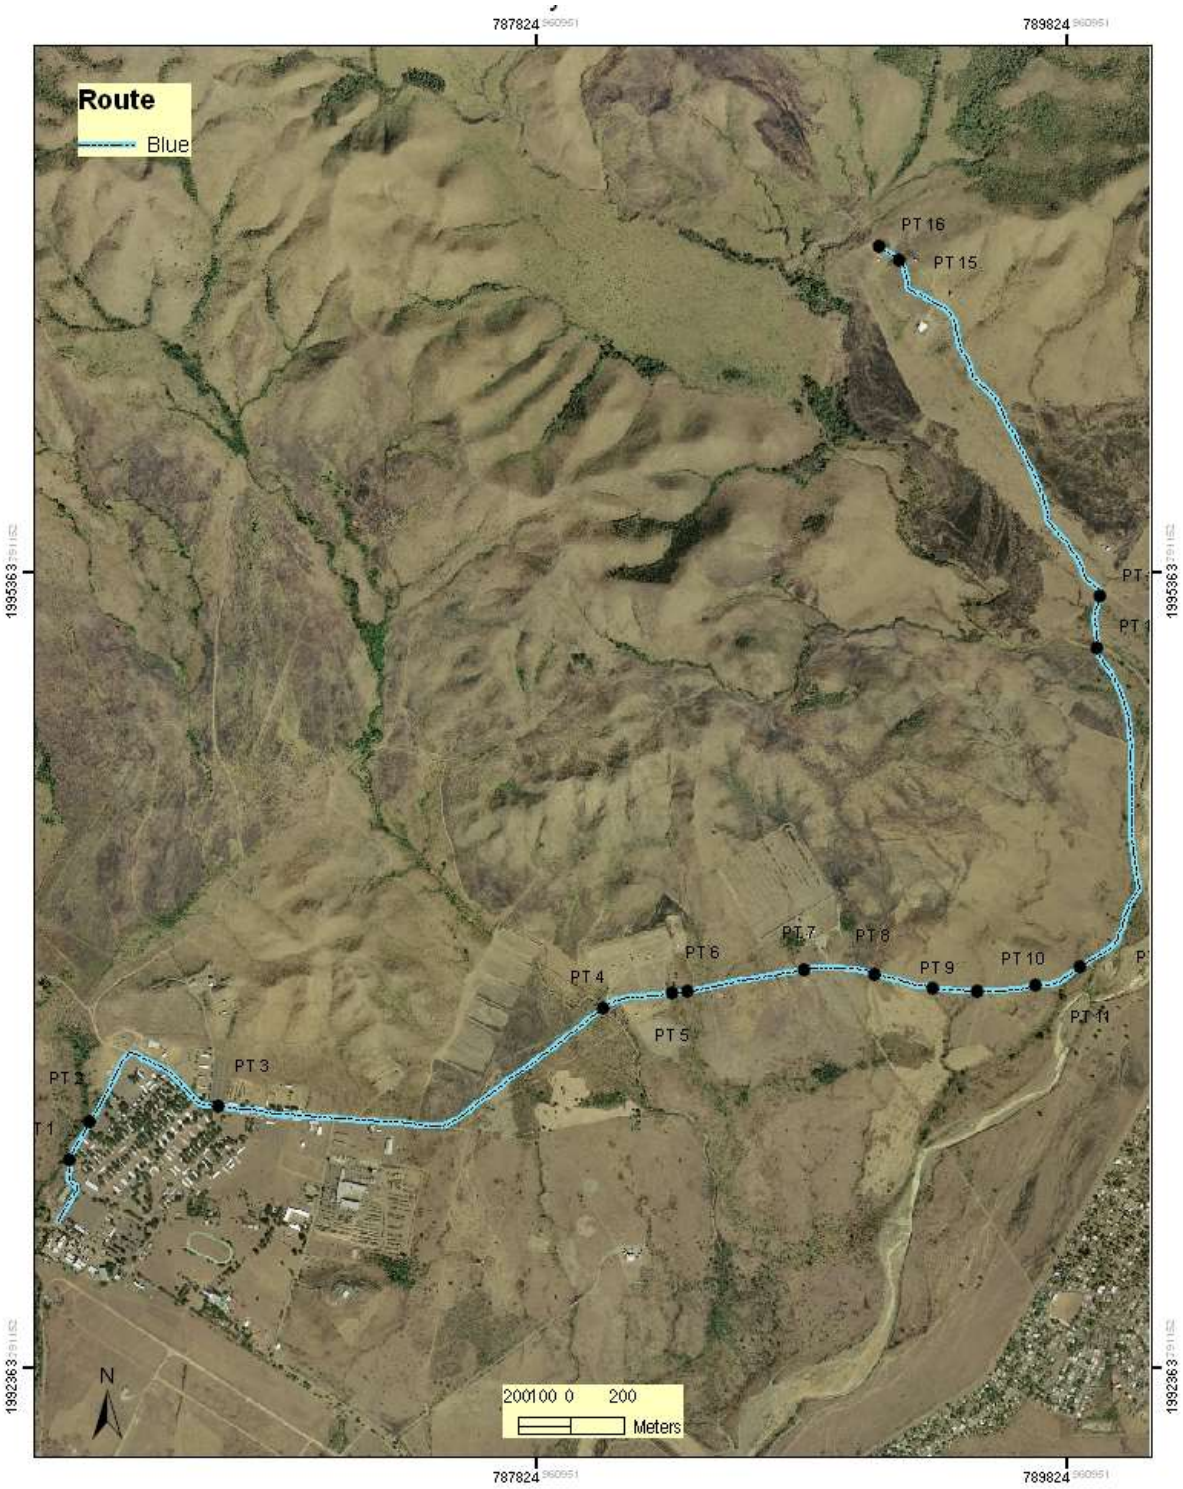
Figure 8.1. Blue Convoy Route

End of Route Blue

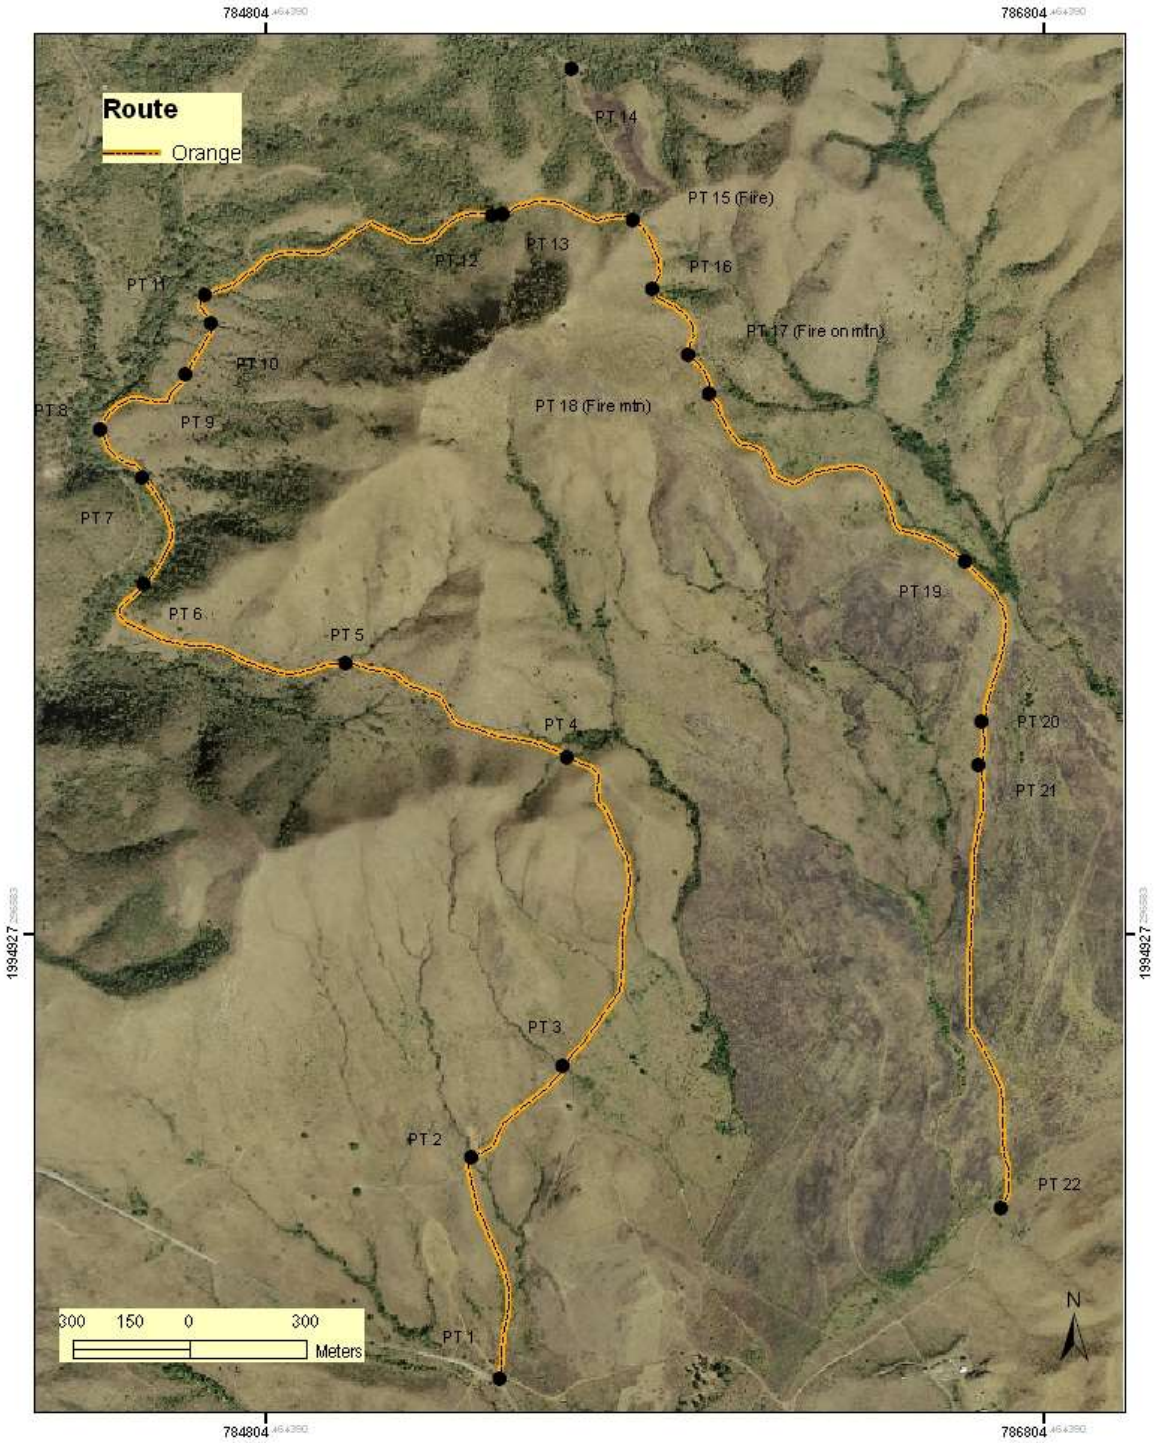
Figure 8.4. Orange Convoy Route

End of Orange Route, intersection with Brown Route.

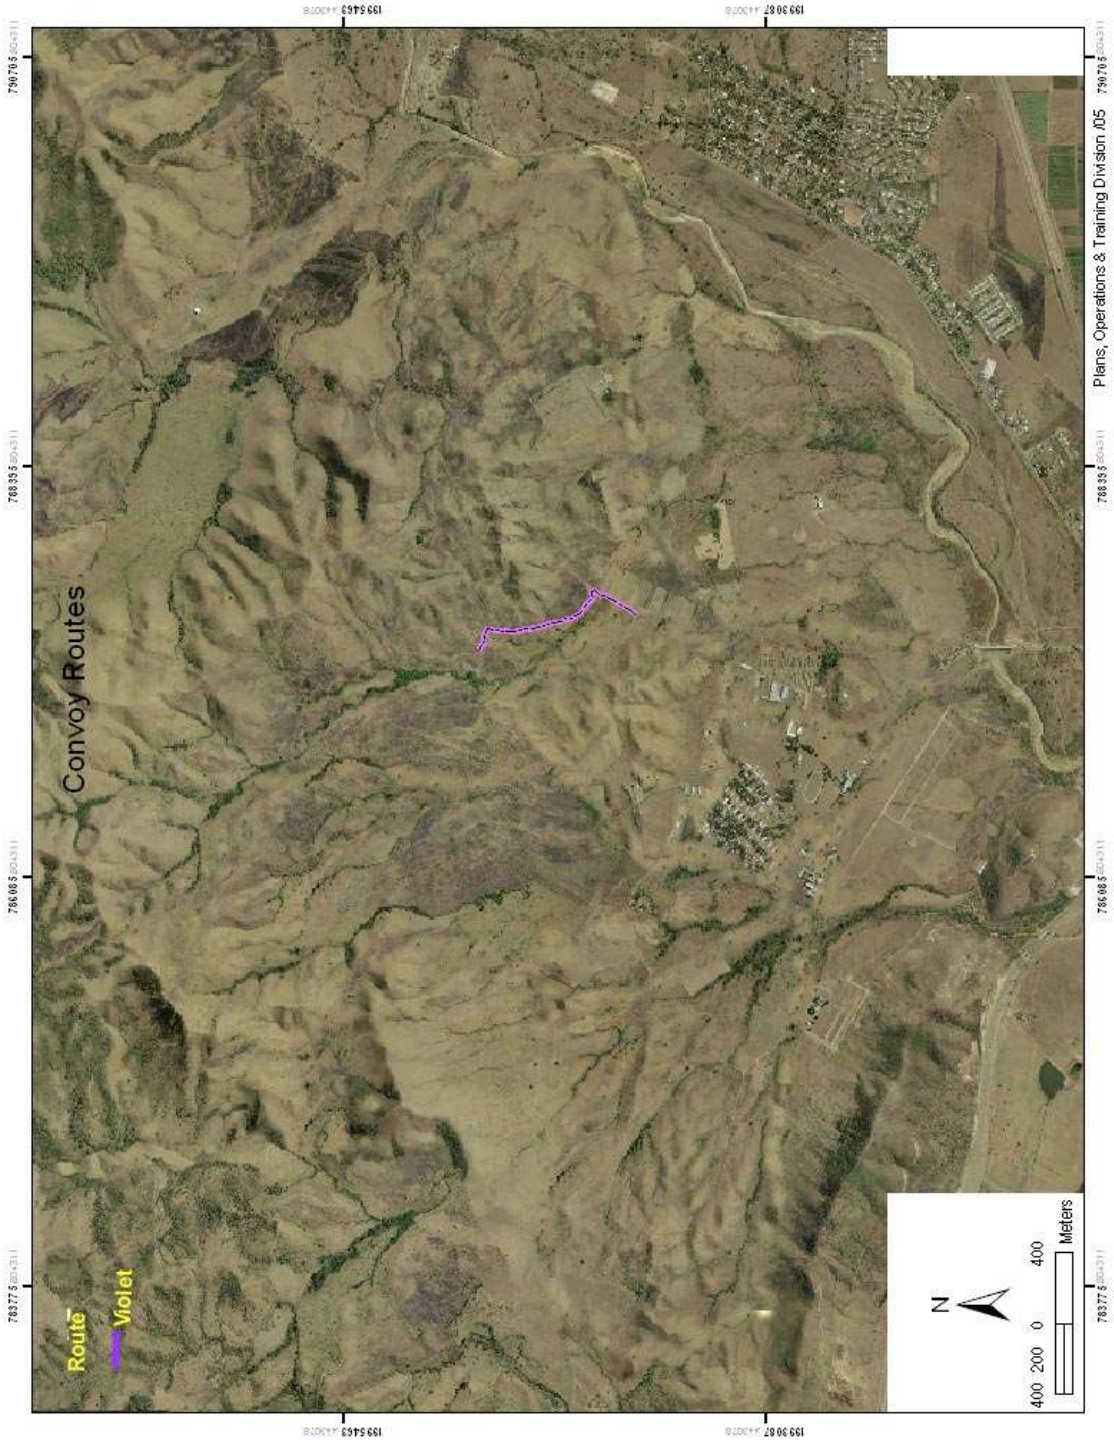
Figure 8.6. Violet Convoy Route

Outlet along Violet Convoy Route, Point 11.
