1. PURPOSE OF EVALUATION. To conduct surveys at Maryland Army National Guard (MDARNG) facilities to identify and measure the existence and extent of potentially hazardous operations or conditions.

2. PURPOSE. To conduct an industrial hygiene survey at the Maryland Army National Guard (MDARNG) MG Harry C. Ruhl Armory, Towson, MD, to identify and measure the existence and extent of potentially hazardous operations or conditions. This survey will serve as a baseline so that an occupational exposure history can be compiled for each civilian or military employee.

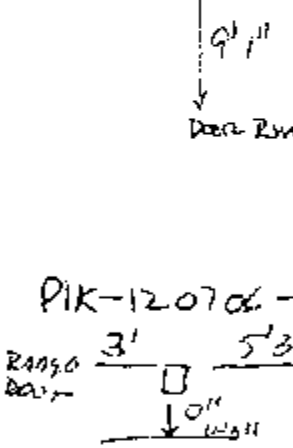
Pic # 843

PIK-120706-007 – Outside Right entry to range next to room 211

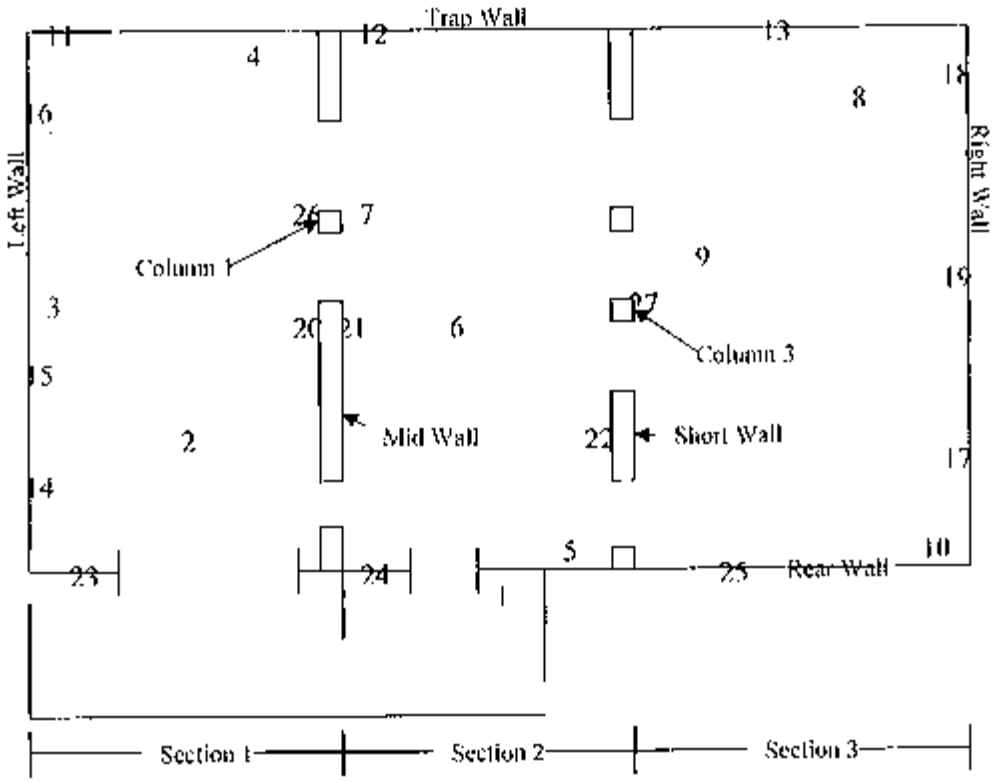
Sampling Diagram:

Lead Check sticks tested positive for lead.

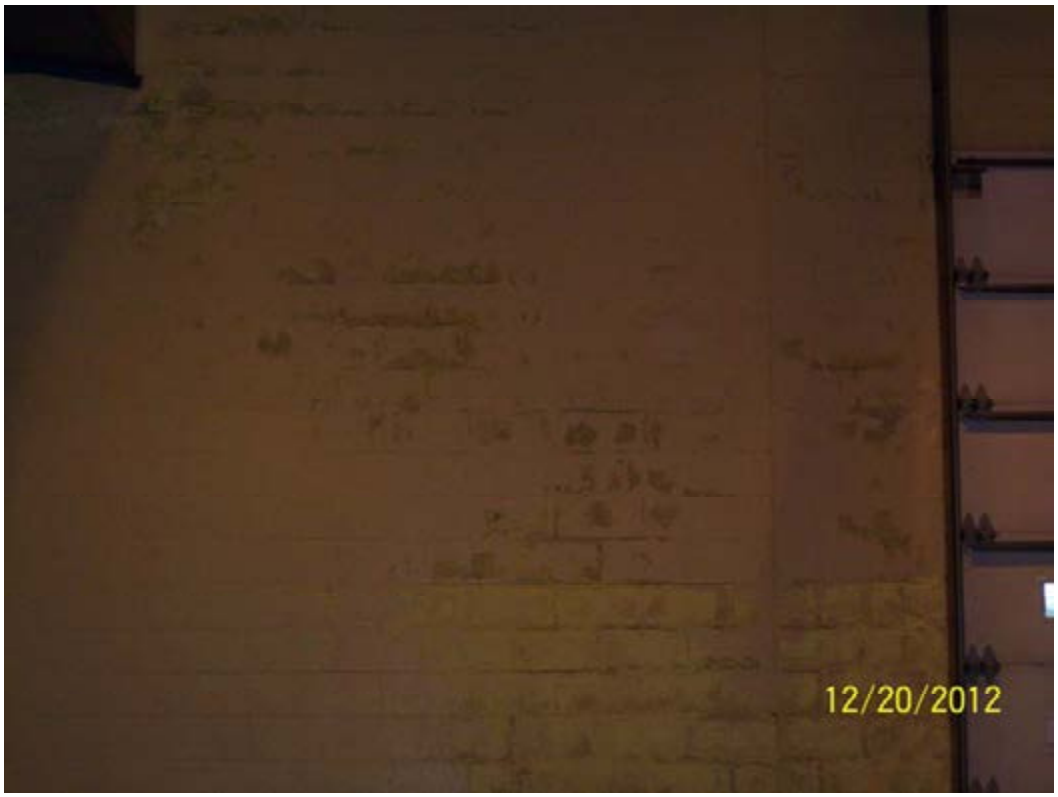
Drill Hall South Wall Water Damage

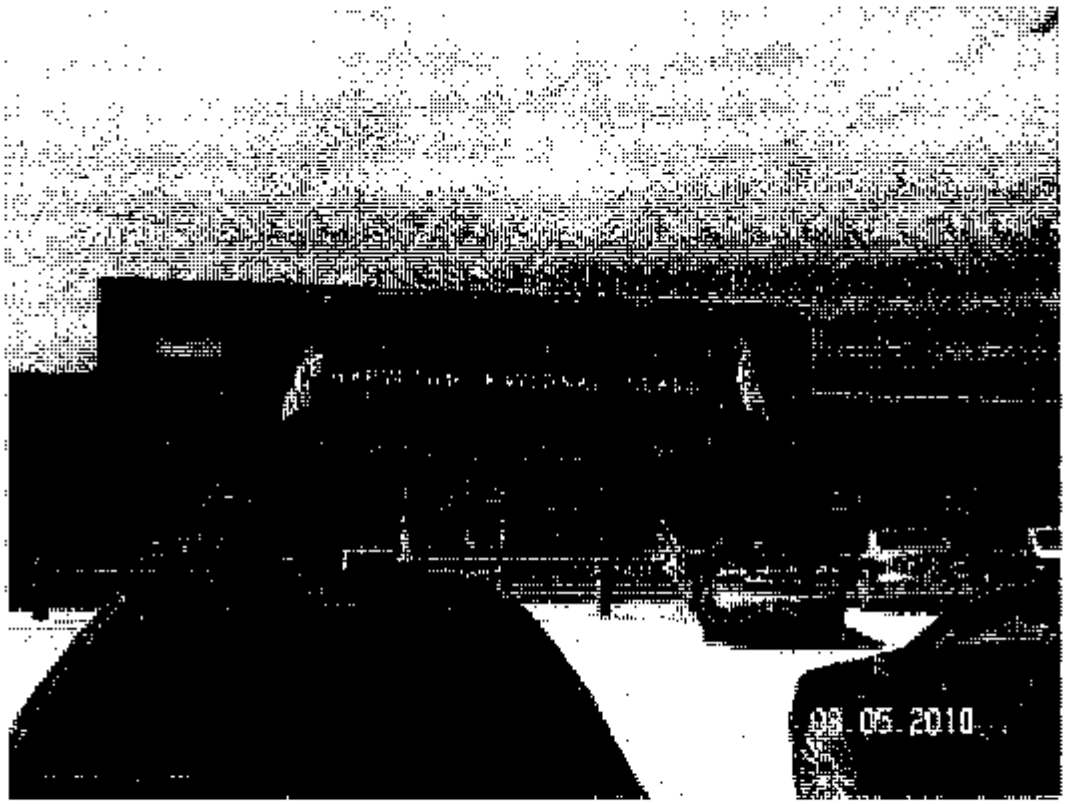
Photo 1: Exterior view, front.

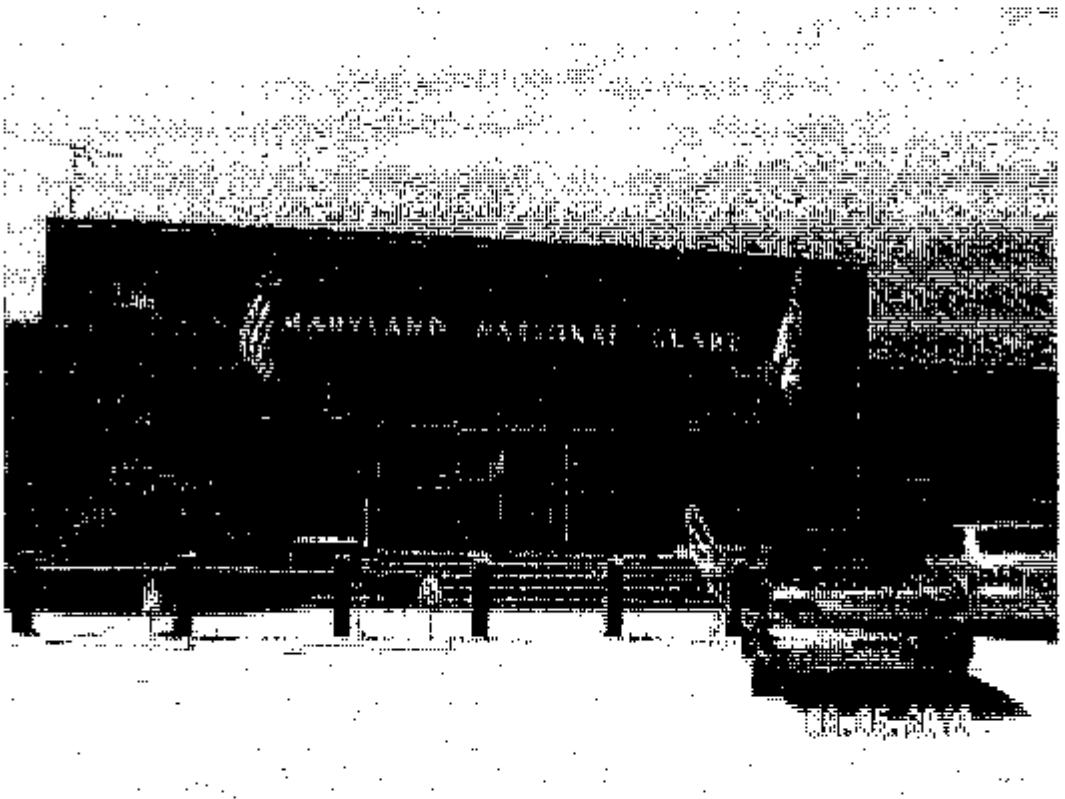
Photo 2: Exterior view, front.

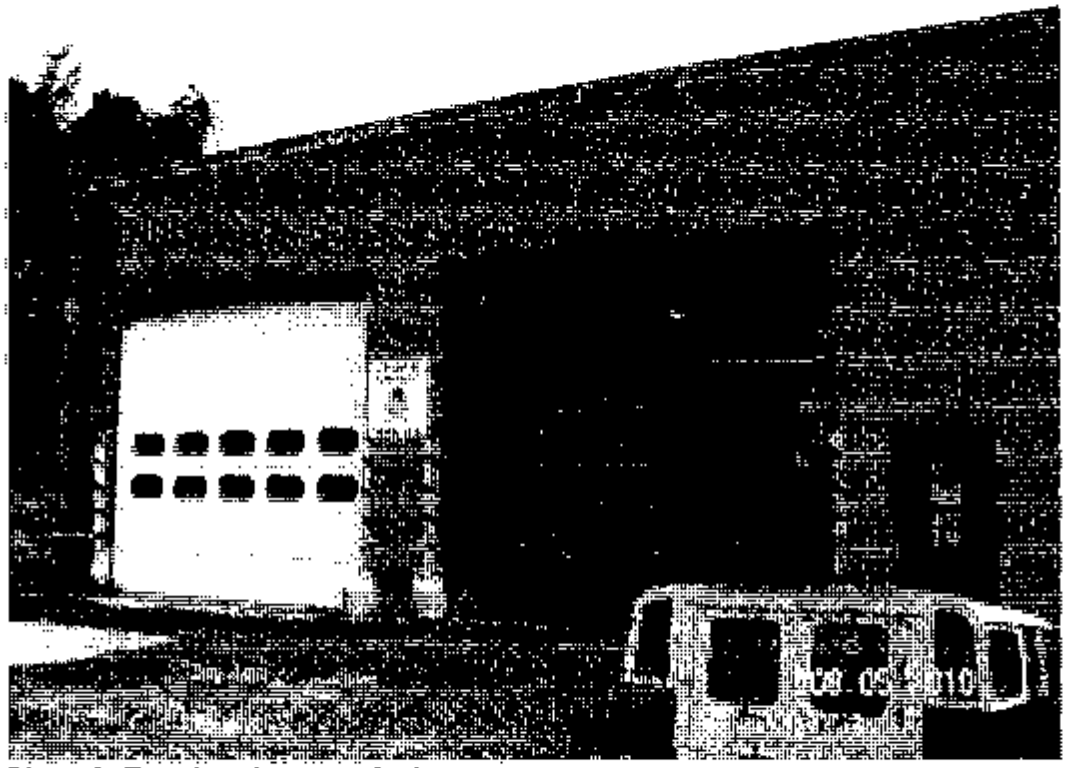
Photo 3: Exterior view, attached garage.

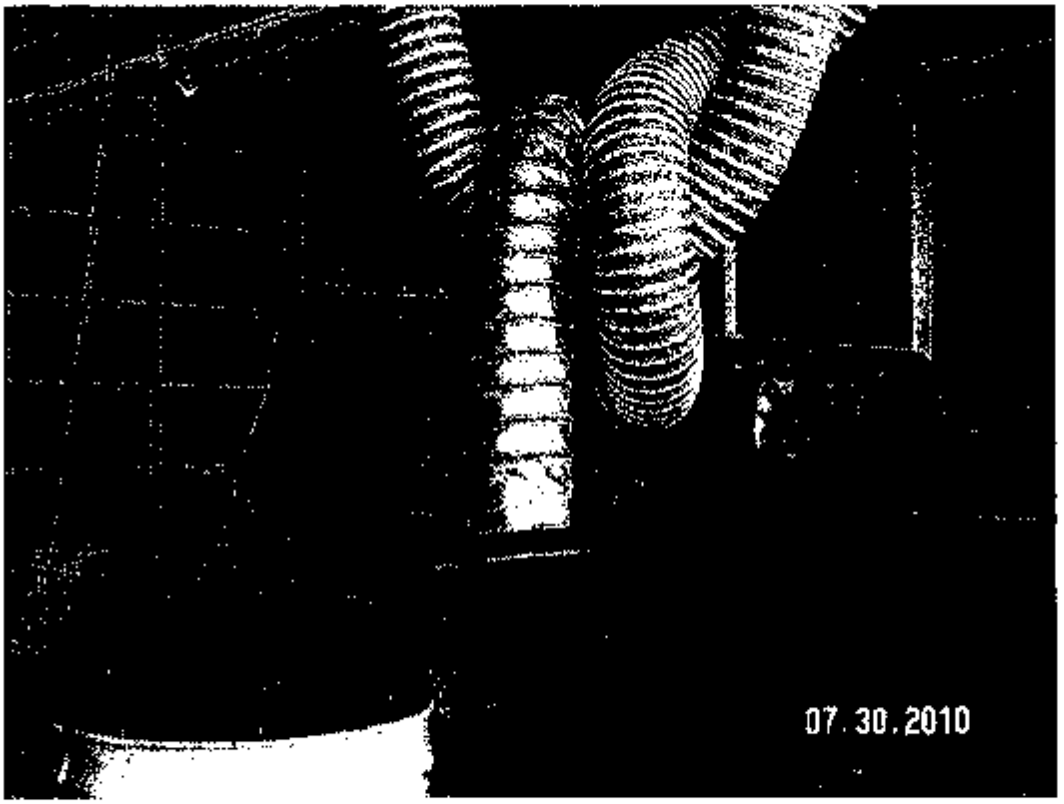
Photo 5: Exhaust ductwork in attached garage.

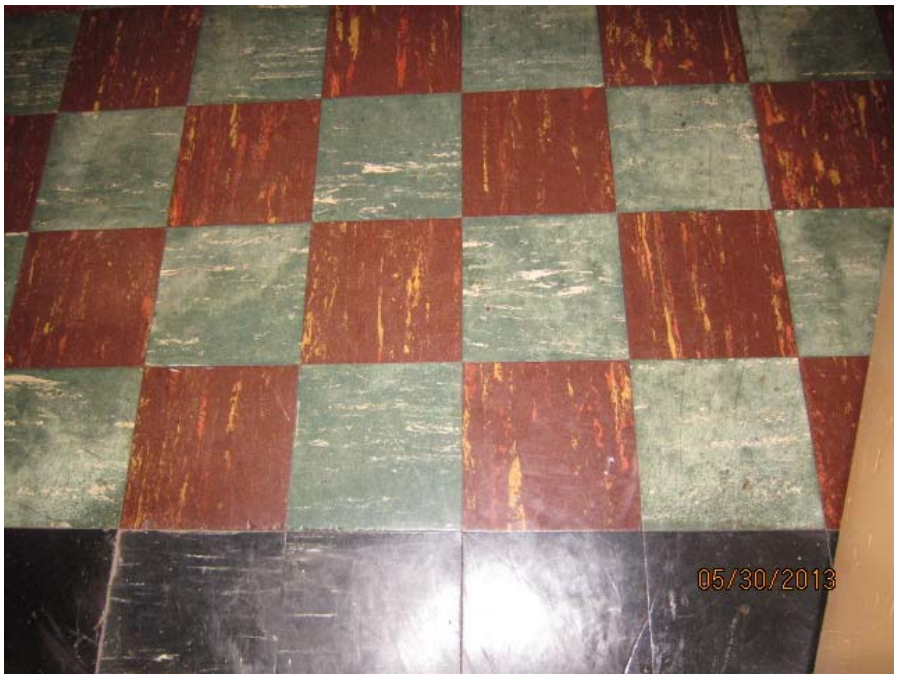
Green, black and red 9”X9” floor tile

Basement bathroom suspect asbestos damaged mudded joint fitting and pip insulation

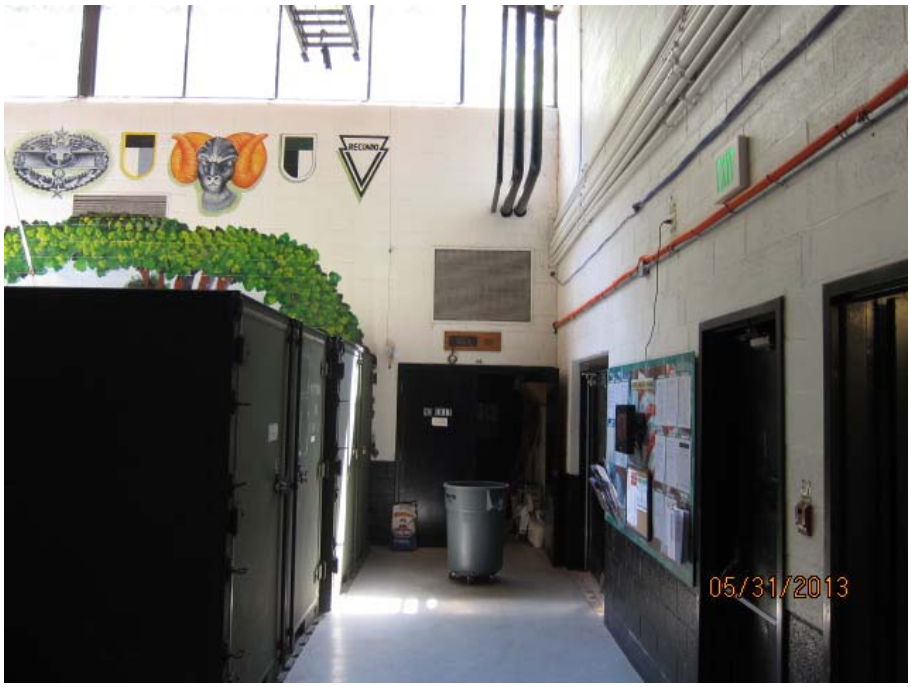
Drill Hall leaking pipe garbage can collecting water
