NATIONAL GUARD REGION SOUTH
INDUSTRIAL HYGIENE OFFICE
510 PLAZA DRIVE, SUITE 1530
COLLEGE PARK, GA 30349

SUBJECT: Waver for conversion of Indoor Firing Range, Aberdeen, MS.

ABERDEEN ARMY NATIONAL GUARD ARMORY
INDOOR FIRING RANGE
809 HIGHWAY 145 NORTH
ABERDEEN, MISSISSIPPI 39730

SUBJECT: Industrial Hygiene Consultation and Health Hazard Information Module (HHIM) Survey, Amory Army National Guard, Amory, Mississippi

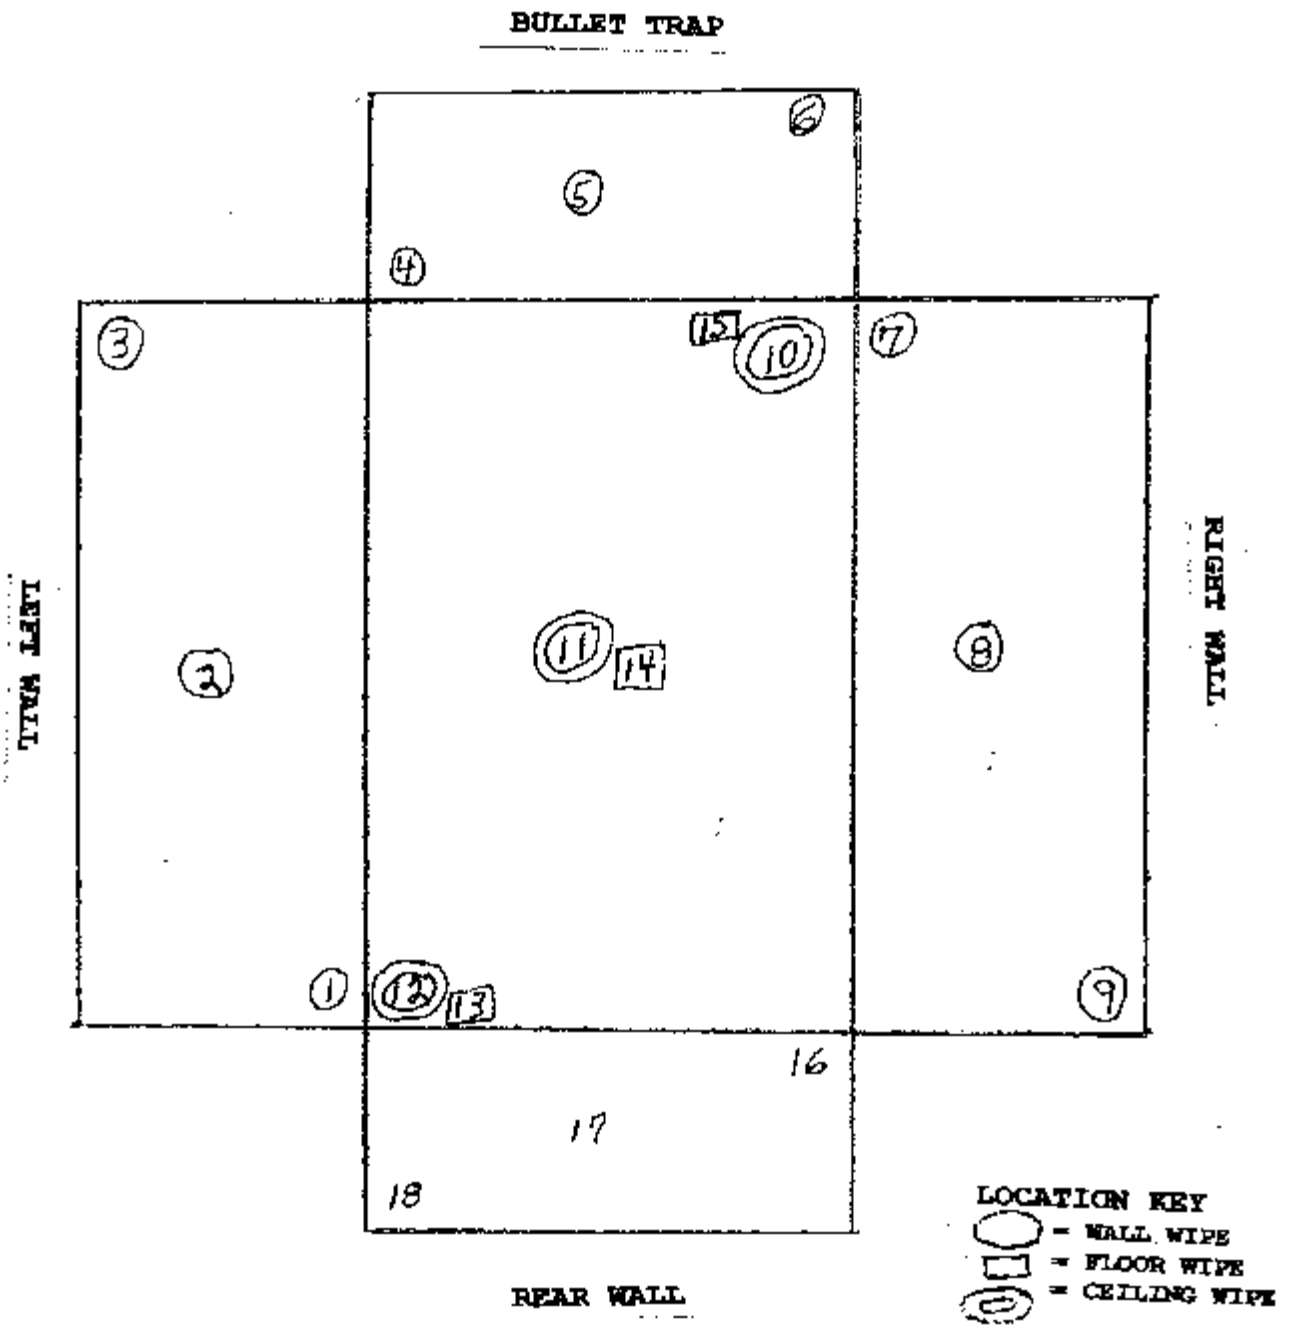
MS ARNG ABERDEEN
INDOOR FIRING RANGE
LEAD WIPE DIAGRAM

1. At the request of MS ARNG Occupational Health Office, Industrial Hygiene Lead Sampling was conducted at this Indoor Firing Range following application of sealant by contract vendor. Twenty sampled were collected and submitted for testing of Total Lead. Of those twenty samples, two blanks were included. All samples returned by the lab after analysis were bellow recordable levels (BRL), being the BRL 20 total.

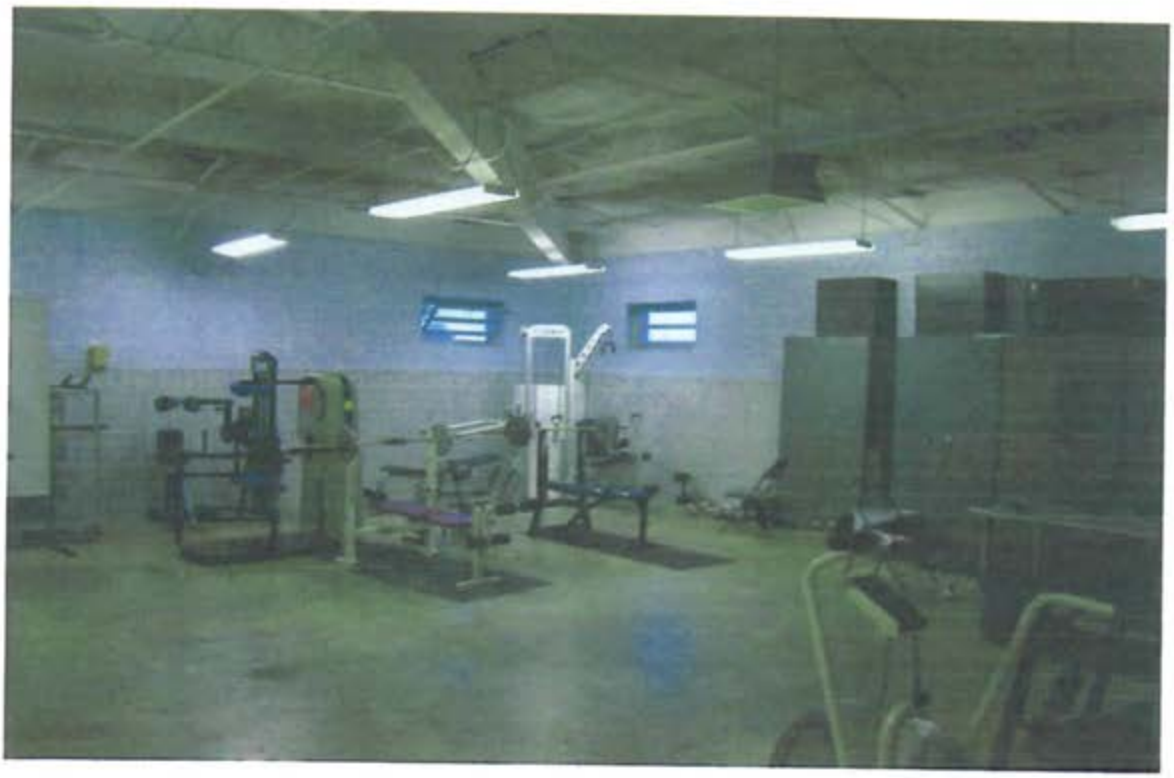
Photo #13: Exercise Room.

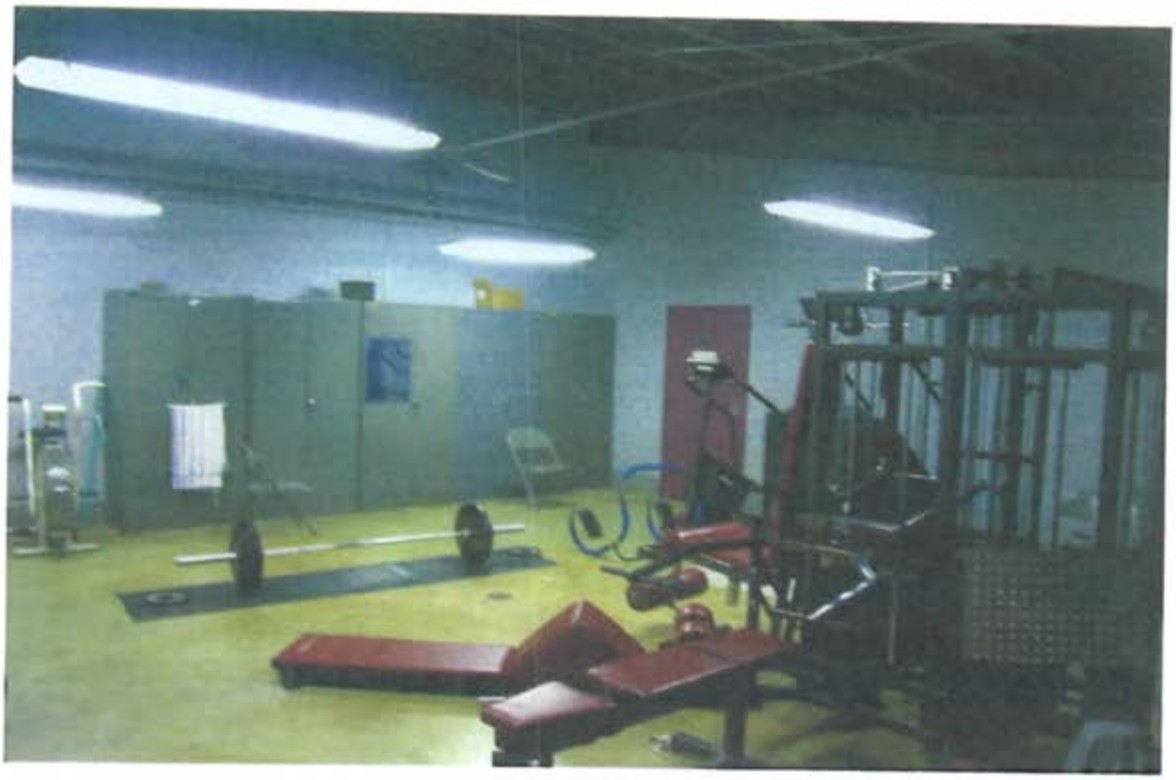
Photo #9: Exercise Room.

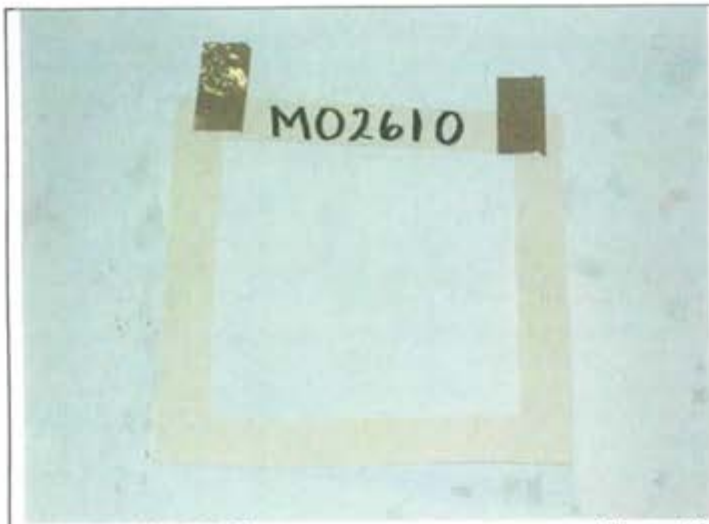
East Middle Wall Photo 13

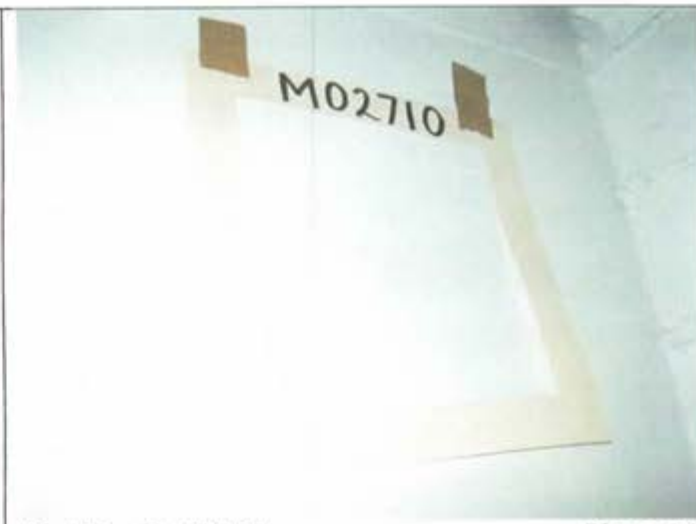
East Top End Wall Photo 14

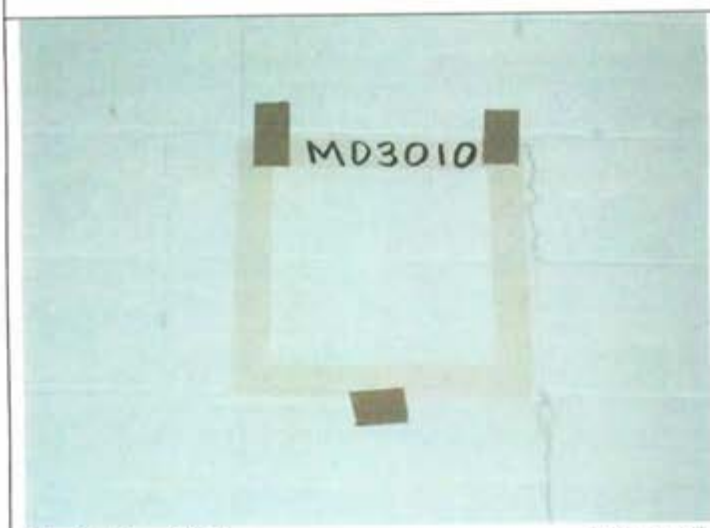
South Top Wall Photo 17

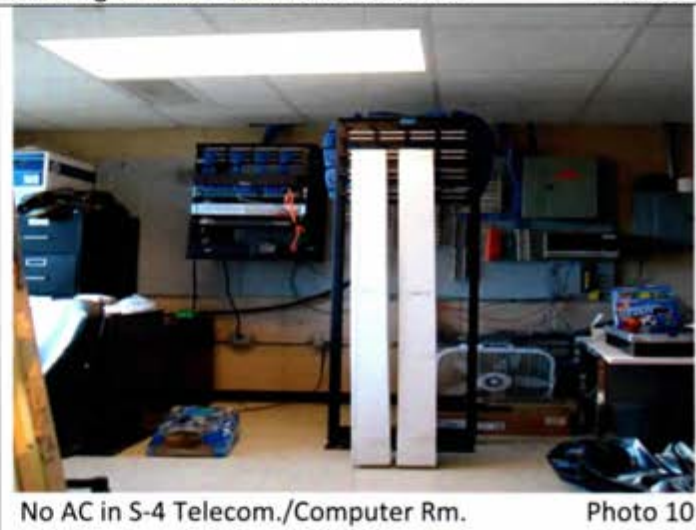
No AC in S-4 Telecom./Computer Rm. Photo 10

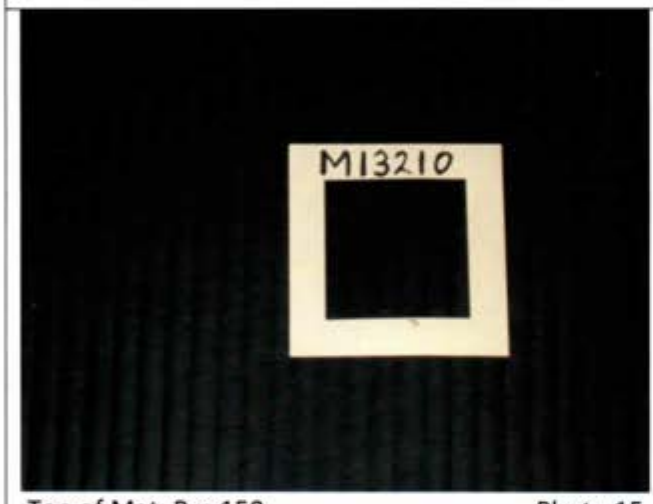
Top of Mat, Rm.150 Photo 15

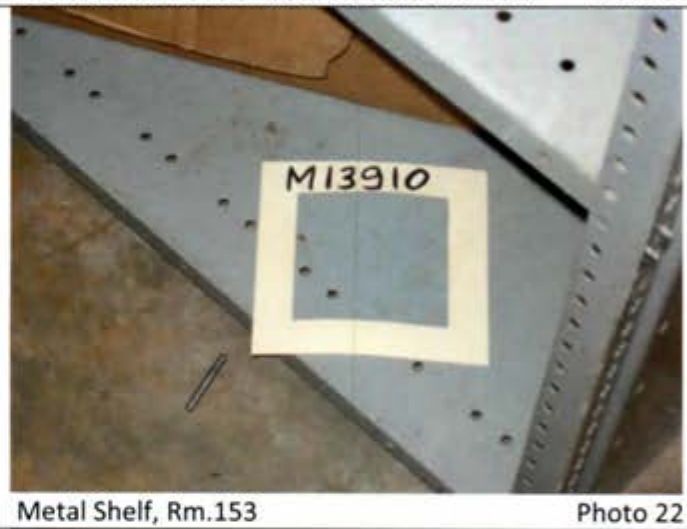
Metal Shelf, Rm.153 Photo 22

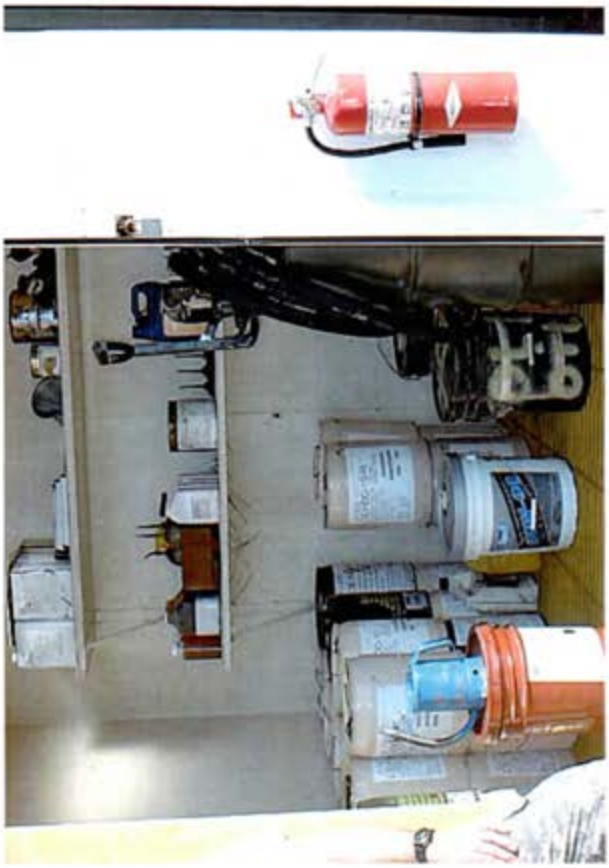
Photo 10: View of the interior of the hazardous materials storage building adjacent to the maintenance office building.

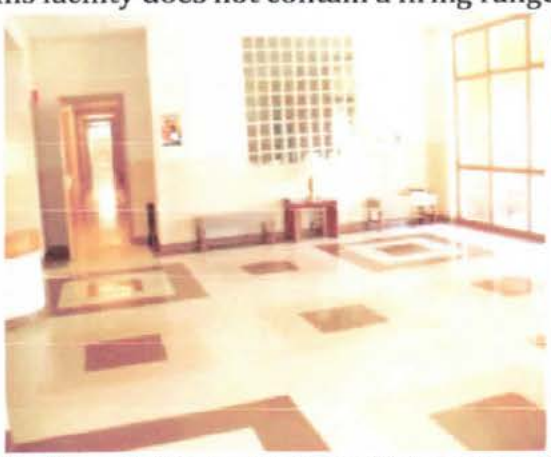
The foyer is tiled with beautiful designs and shades of tans and brown colored tile. It is decorated with military memorabilia and rich finished furniture also up the stairway.

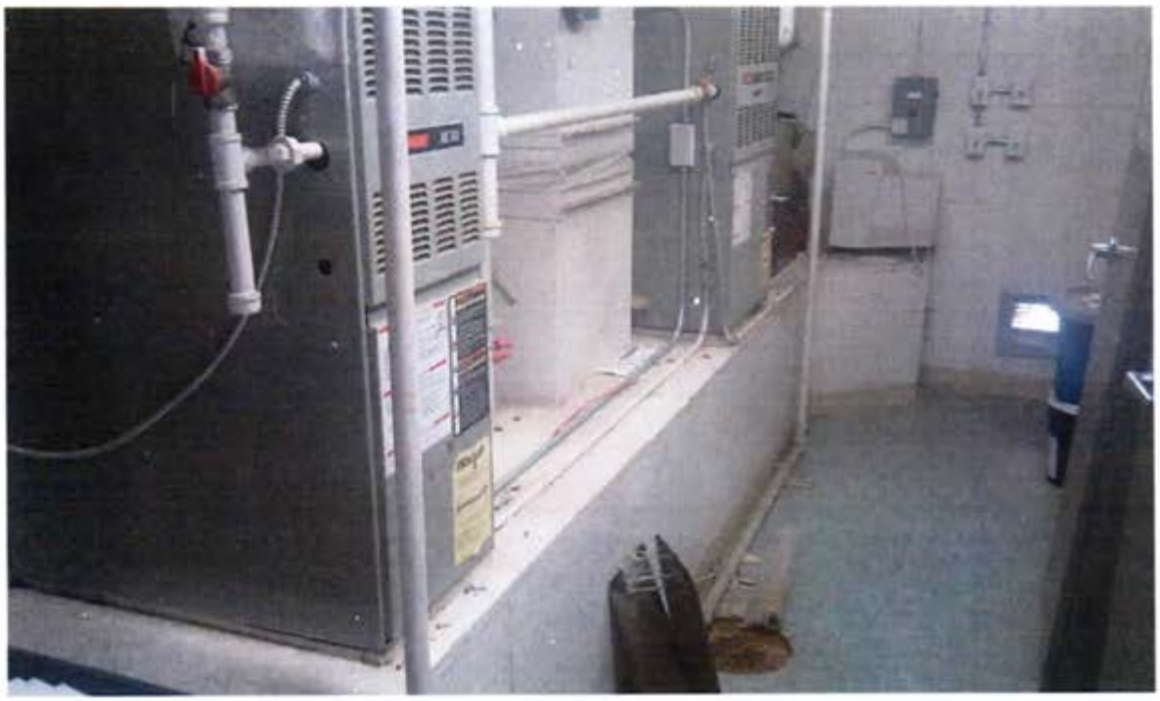
Photo #7: Two other furnace units showing the wood constructed common return air plenum.

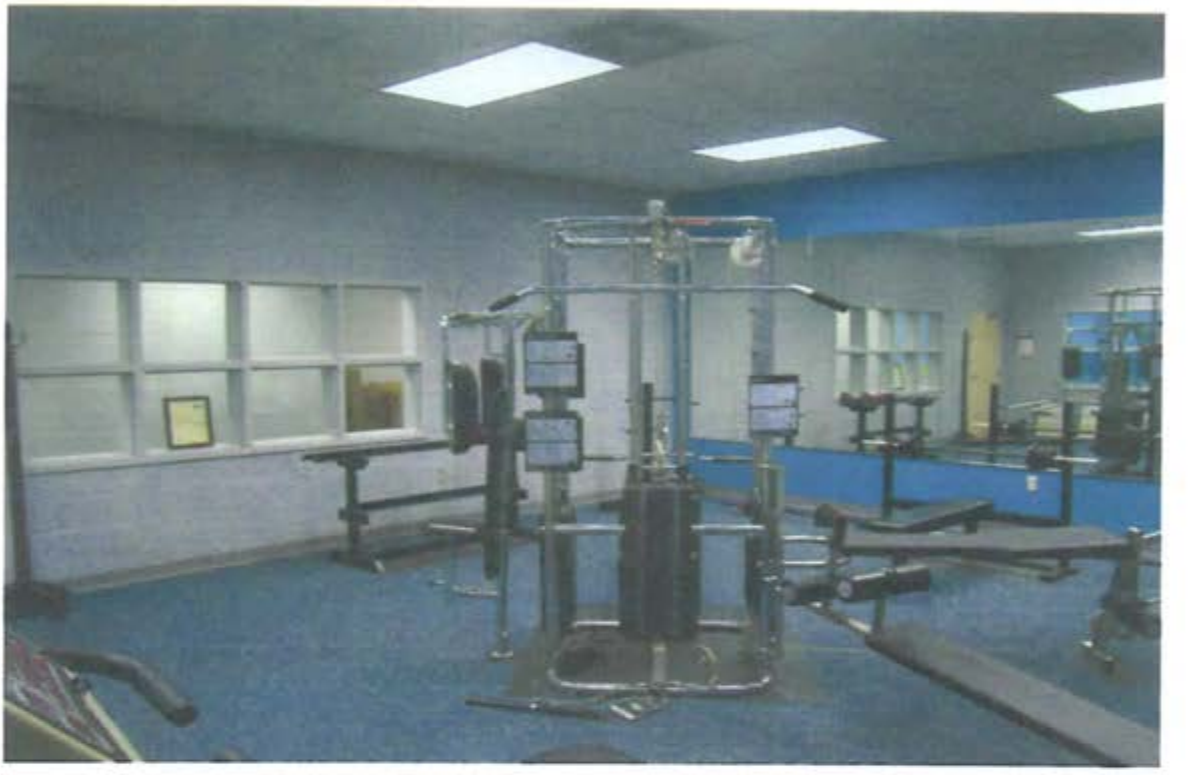
Photo #12: Classroom C.

Photo #13: Exercise or Physical Fitness Room.
