FINAL Preliminary Assessment Report AASF #3 Bates Field, Mobile, Alabama

Perfluorooctanesulfonic Acid (PFOS) and Perfluorooctanoic
Acid (PFOA) Impacted Sites
ARNG Installations, Nationwide

September 2020

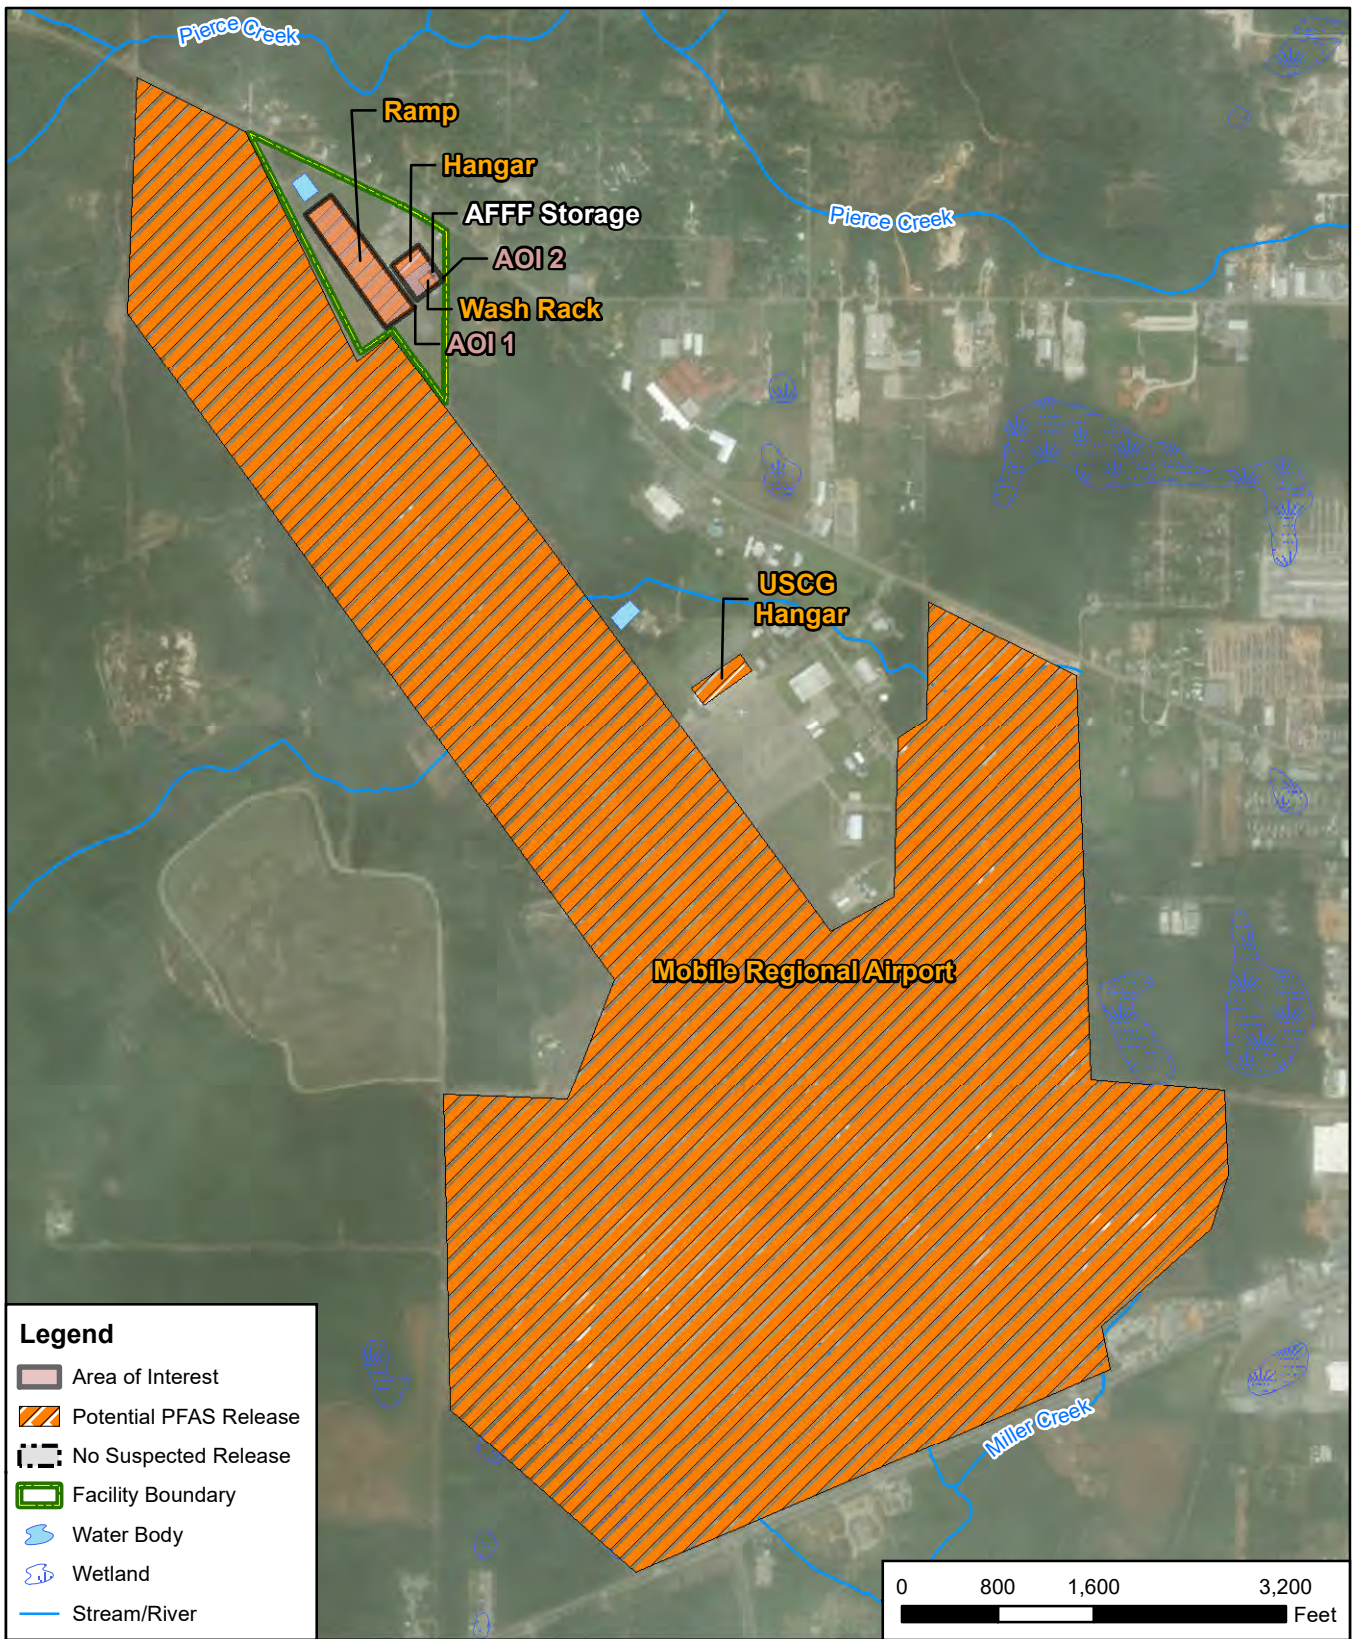
Summary of Findings	
AECOM 12420 Milestone Center Drive Germantown, MD 20876	Figure ES-1

Construction of the AASF #3 facility began in 1996 and was completed in 1999. The original hangar building was equipped with an AFFF dispensing system that was replaced with 3% AFFF from 2016 to 2018 as part of a statewide upgrade effort. Three areas were investigated during this PA: the hangar building & AFFF suppression system, the AFFF storage building, and the flight ramp.

Based on potential PFAS releases at these AOIs, there is potential for exposure to PFAS contamination in media at or near the facility. The preliminary CSM for the facility, which presents the potential receptors and media impacted, is shown on **Figure ES-2**. Based on the US Environmental Protection Agency (USEPA) Unregulated Contaminant Monitoring Rule 3 (UCMR3) data, it was indicated that no PFAS were detected in a public water system above the USEPA’s lifetime Health Advisories (HAs) within 20 miles of the facility. The HA is 70 parts per trillion for PFOS and PFOA, individually or combined. PFAS analyses performed in 2016 had method detection limits that were higher than currently achievable. Thus, it is possible that low concentrations of PFAS were not detected during the UCMR3 but might be detected if analyzed today.

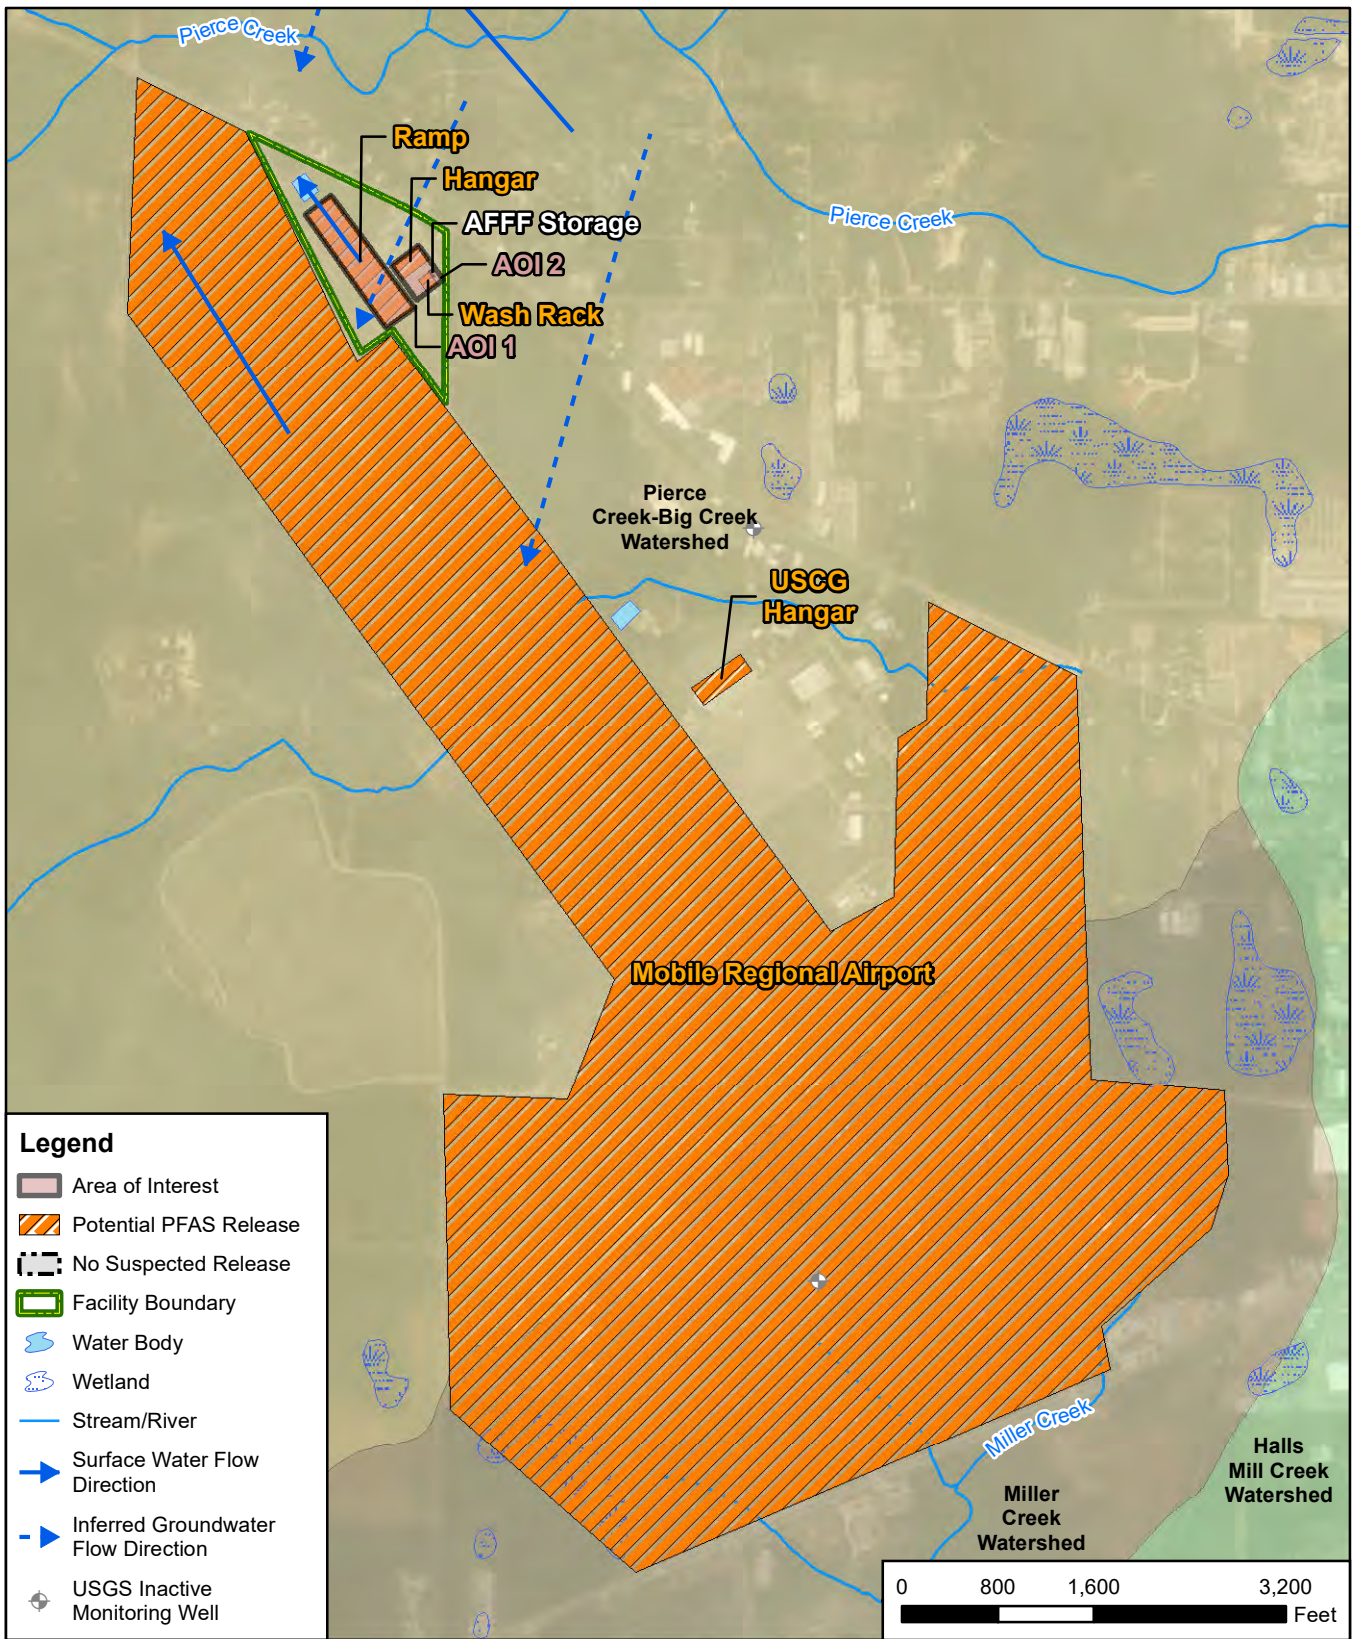
Area of Interest	
AECOM 12420 Milestone Center Drive Germantown, MD 20876	Figure 6-1

Based on the PA findings, two AOIs were identified at the AASF #3 facility. The locations of the AOIs are shown on **Figure 6-1**. The preliminary CSM for AOI 1 and AOI 2 is shown on **Figure 6-2**. The following sections describe the CSM components and the specific preliminary CSM developed for each AOI. The CSM identifies the three components necessary for a potentially complete exposure pathway: (1) source, (2) pathway, (3) receptor. If any of these elements are missing, the pathway is considered incomplete.

AOI 2 encompasses the fire suppression system within the hangar building and the wash rack, located southeast of the hangar building. Releases of AFFF may have occurred from the fire suppression system sometime between 1999 and 2018. According to ALARNG personnel, dispensing nozzles from the previous system were rusted, which indicates corrosion from AFFF concentrate. If a release of AFFF from the suppression system occurred, AFFF would have collected in the storm drains within the hangar building. Floor drains in the hangar building drain to the OWS and then discharge to the sanitary sewer system. It is possible AFFF could have traveled outside the hangar and onto the flight ramp and migrated to surrounding grass areas.

Releases of AFFF may have also occurred at the wash rack from around 2002 to 2008. According to ALARNG personnel, annual fire training was conducted with a burn barrel and Purple K units at the wash rack area. It is reasonable to assume that Tri-Max™ 30 units from the flight ramp may have been used for fire training as well. Similar to potential releases in the hangar building, AFFF

could have been collected by the storm drain located in the center of the wash rack and discharged to the sanitary sewer system.

AFFF releases at the hangar building and wash rack not captured by storm drains could migrate to the grass areas surrounding the flight ramp, the retention pond, or tributaries feeding Big Creek Lake. Additionally, due to the shallow water table beneath the facility, releases of AFFF to impervious surfaces around the flight ramp could impact groundwater via leaching. As such, the pathways for PFAS exposure in AOI 2 are considered potentially complete for the site worker, construction worker, off-facility resident, and off-facility recreational user. Potential PFAS exposure pathways resulting from releases at AOI 2 are described in **Table 6-1**.

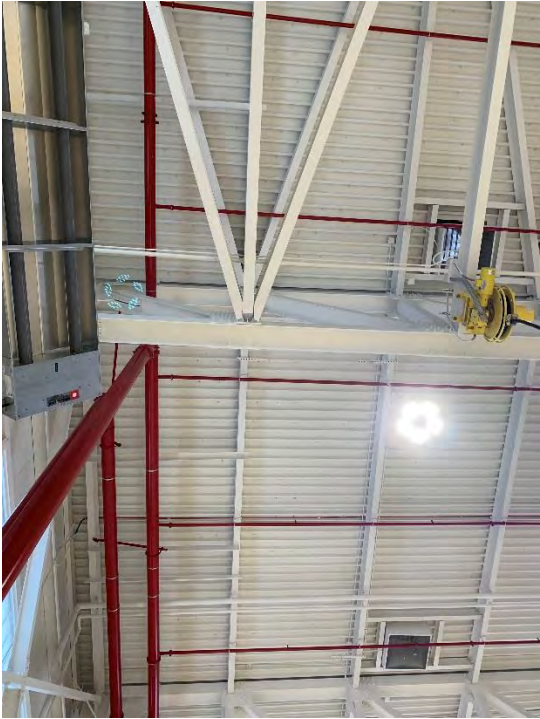
Army National Guard, Preliminary Assessment for PFAS	AASF #3 Bates Field	Mobile, Alabama
<p>Photograph No. 3</p> <p>Description:</p> <p>Unknown direction</p> <p>General view of overhead fire suppression system</p> <p>Photo Date: 4/9/19</p>

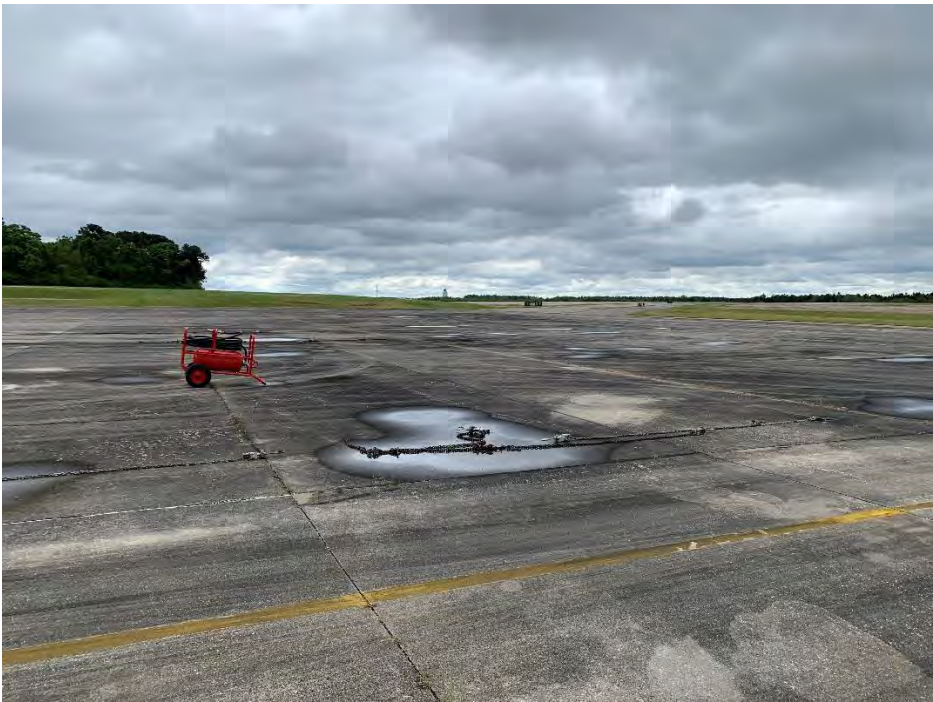
It was noted during the PA that the ramp is not constructed with storm drains. Surface water drainage appears to flow northwest to the retention pond located at the northwest corner of the facility property.

A photograph showing a large blue 55-gallon drum with a white label, sitting on a yellow plastic grating floor. The drum is in a storage area with various boxes and equipment in the background. A person's legs in camouflage pants and brown boots are visible on the right side of the frame.	
<p>Photograph No. 6</p> <p>Description:</p> <p>Looking Southeast</p> <p>General view of Ramp with mobile Purple K unit</p> <p>Photo Date: 4/9/19</p>

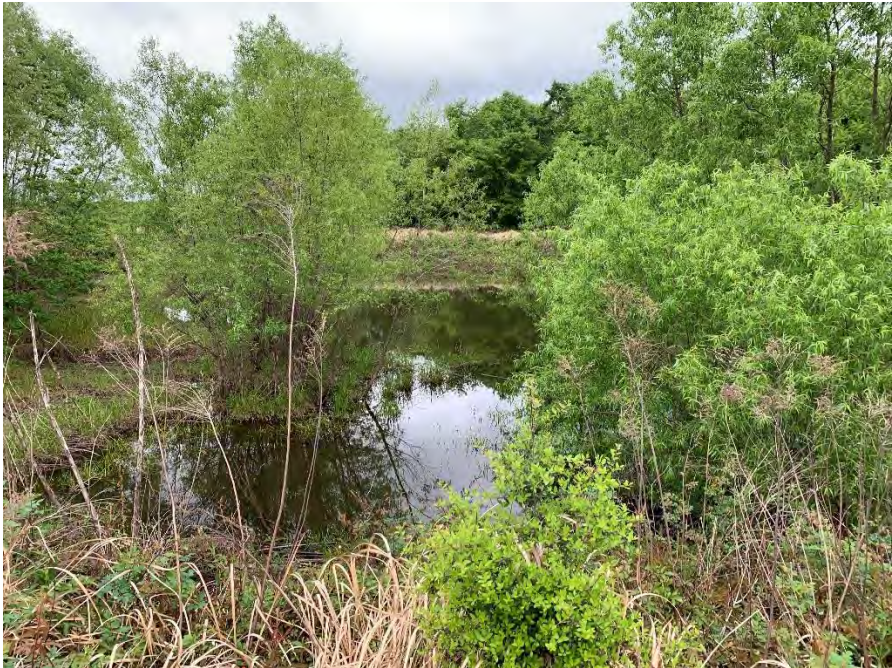
A gravel path leads from the foreground into a grassy field. The path is made of grey gravel and is flanked by green grass. In the background, there is a dense line of green trees under a cloudy sky.	
<p>Photograph No. 10</p> <p>Description:</p> <p>Looking Northwest</p> <p>General view of retention pond</p> <p>Photo Date: 4/9/19</p>
