FINAL Preliminary Assessment Report AASF #1 RW Shepherd, Montgomery, Alabama

Perfluorooctanesulfonic Acid (PFOS) and Perfluorooctanoic
Acid (PFOA) Impacted Sites
ARNG Installations, Nationwide

September 2020

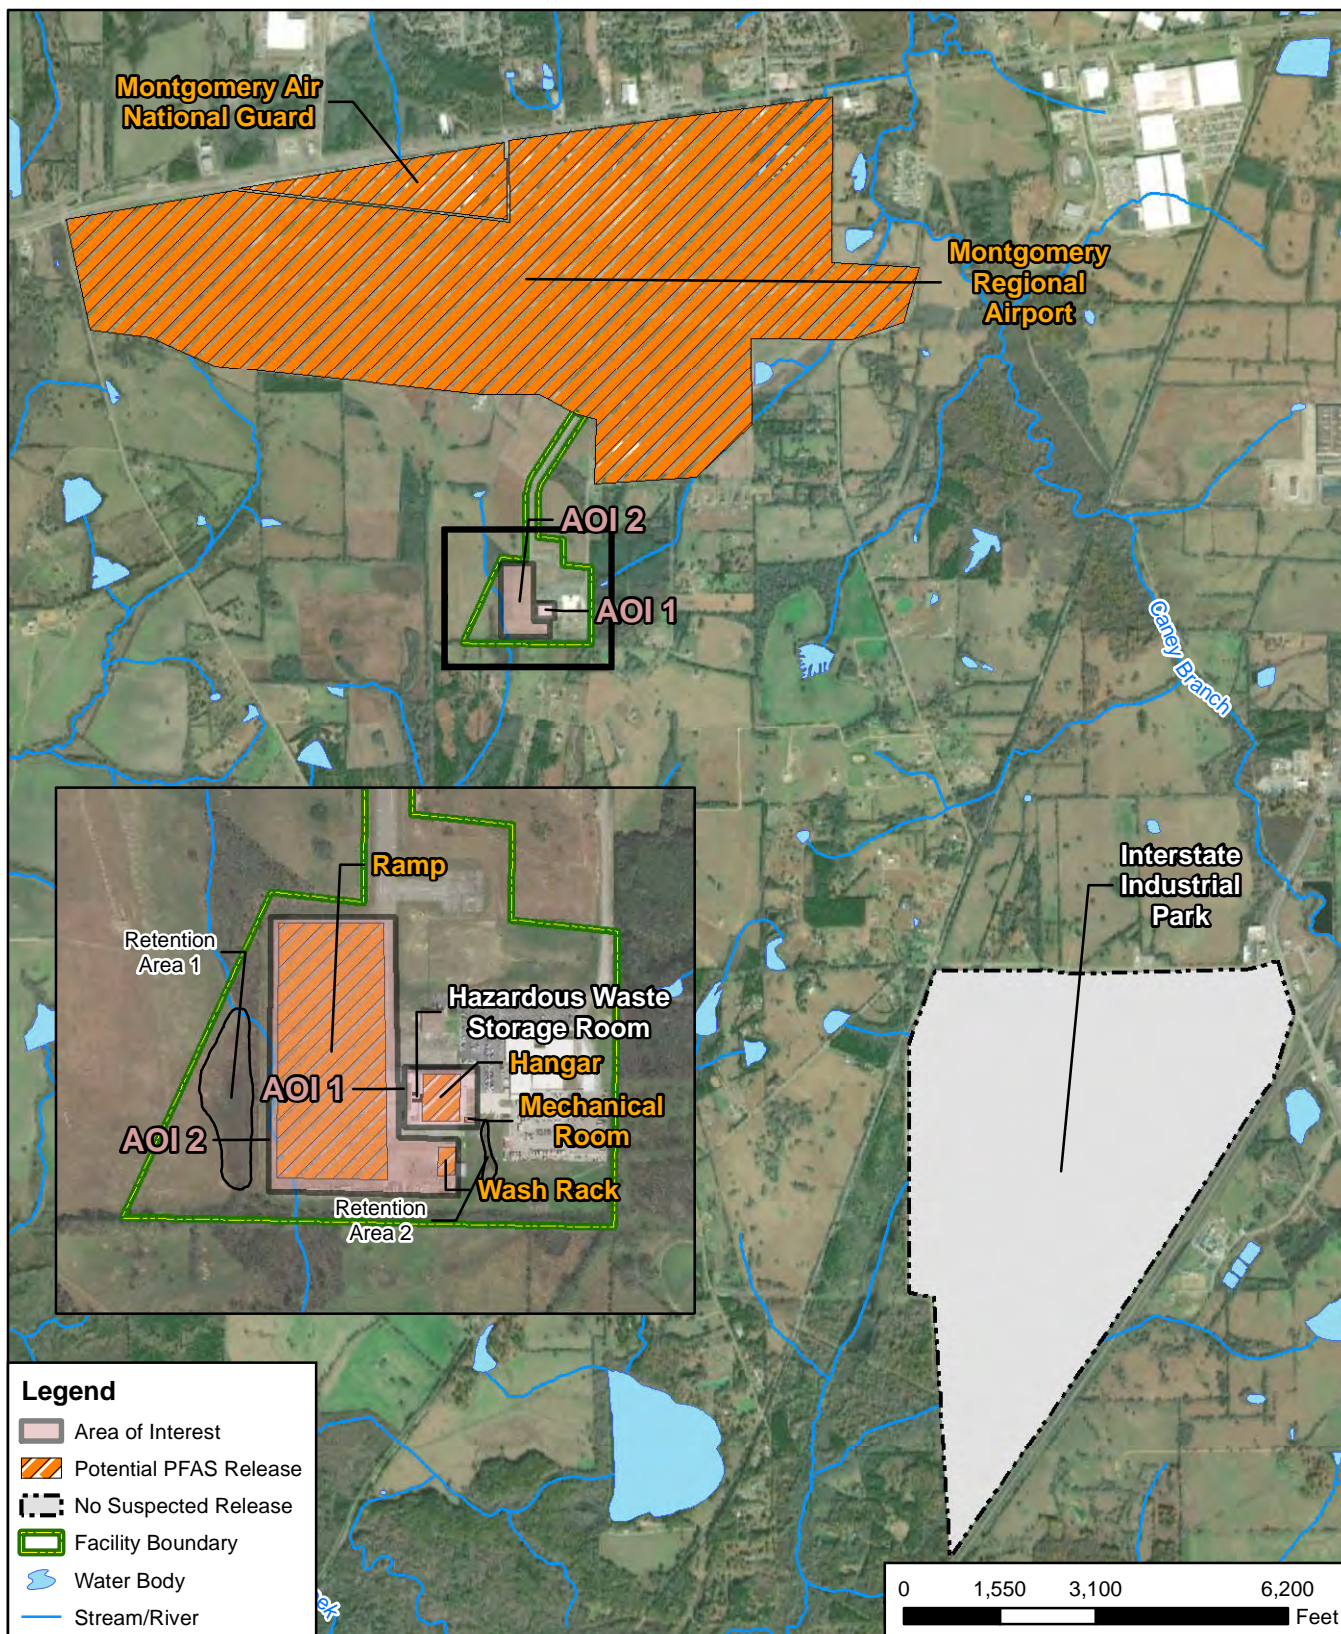
Based on potential PFAS releases at these AOIs, there is potential for receptor exposure to PFAS contamination in media at or near the facility. The preliminary CSM for the facility, which presents the potential receptors and media impacted, is shown on **Figure ES-2**. Based on the United States (US) Environmental Protection Agency (USEPA) Unregulated Contaminant Monitoring Rule 3 (UCMR3) data, it was indicated that no PFAS were detected in a public water system above the USEPA's lifetime Health Advisories (HAs) within 20 miles of the facility. The HA is 70 parts per trillion for PFOS and PFOA, individually or combined. PFAS analyses performed in 2016 had method detection limits that were higher than currently achievable. Thus, it is possible that low concentrations of PFAS were not detected during the UCMR3 but might be detected if analyzed today.

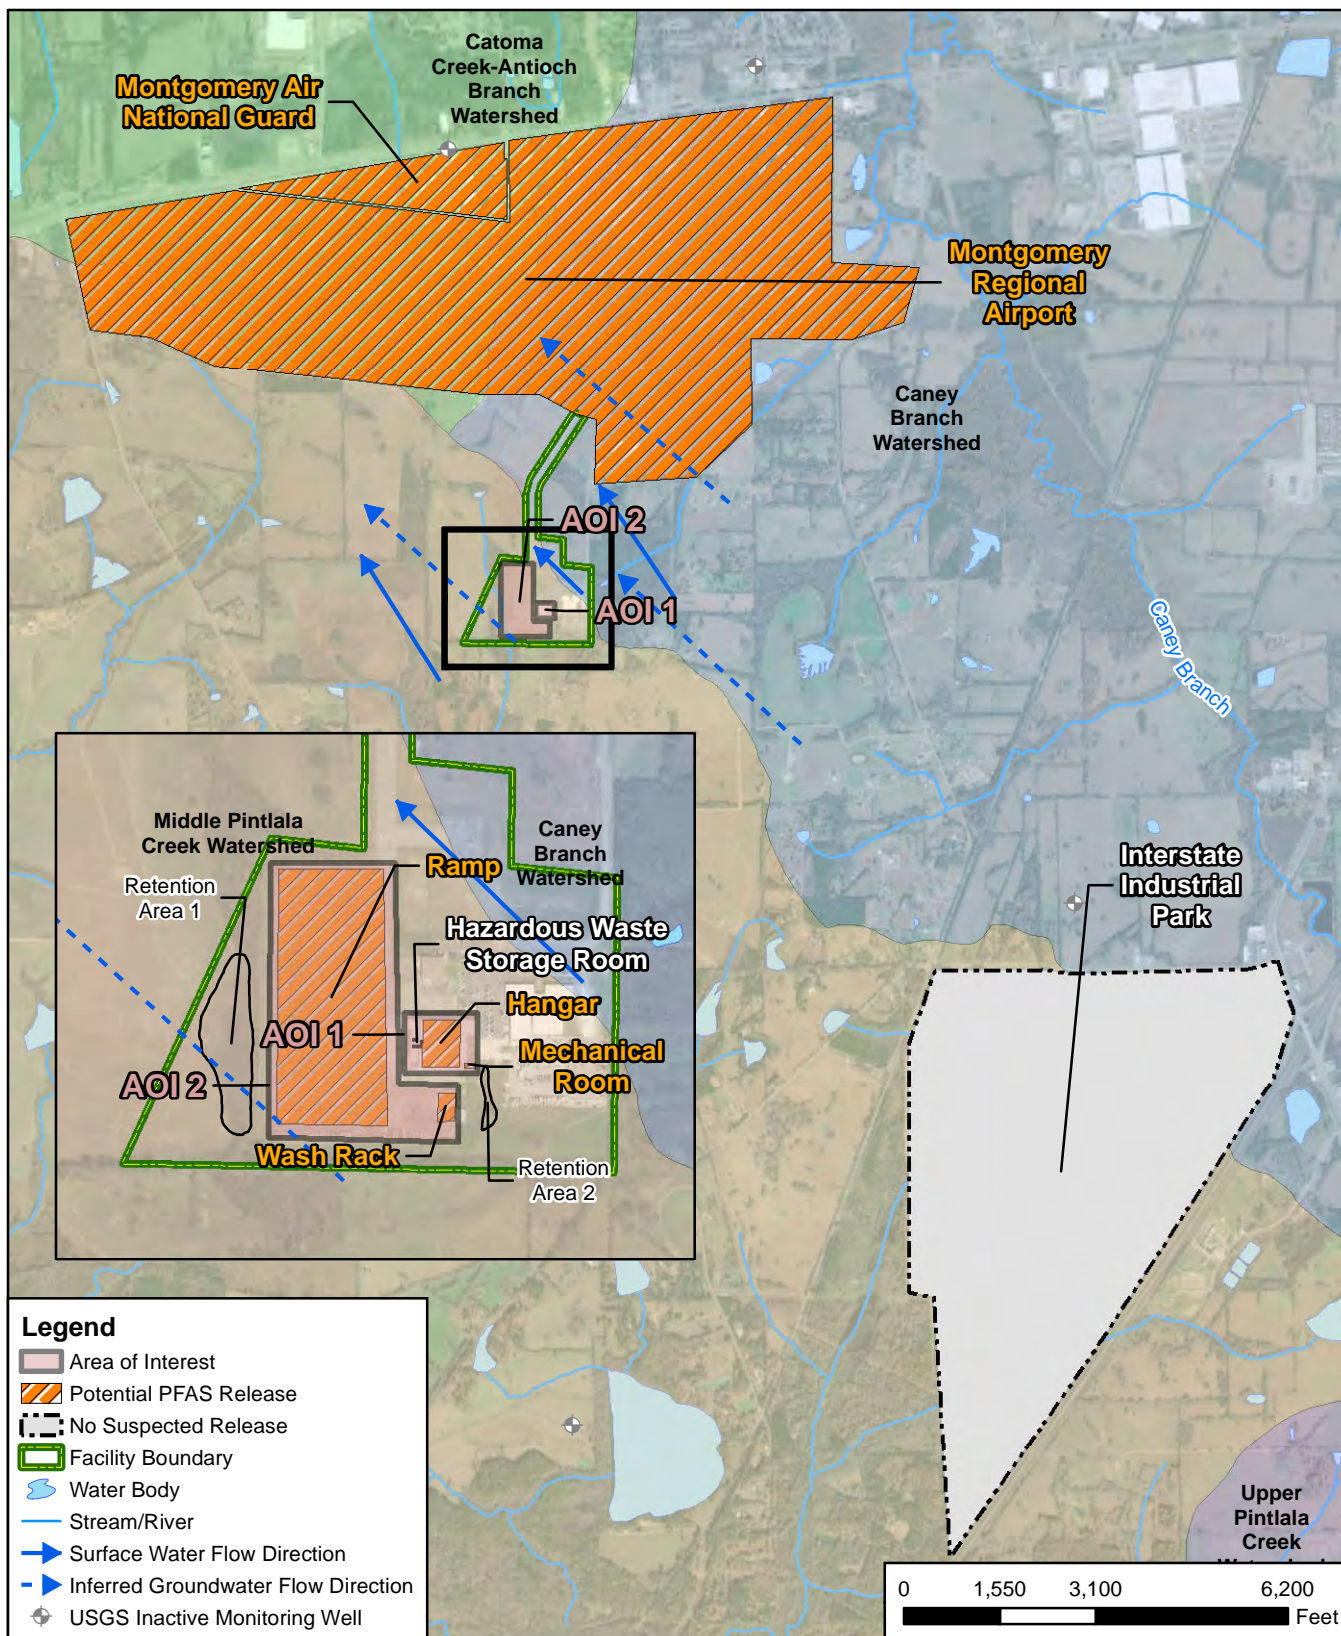
Based on the PA findings, two AOIs were identified at the AASF #1 facility. Locations of the AOIs are shown on **Figure 6-1**. The preliminary CSM for AOI 1 is shown on **Figure 6-2**, and the preliminary CSM for AOI 2 is shown on **Figure 6-3**. The following sections describe the CSM components and the specific preliminary CSMs developed for each AOI. The CSM identifies the three components necessary for a potentially complete exposure pathway: (1) source, (2) pathway, (3) receptor. If any of these elements are missing, the pathway is considered incomplete.

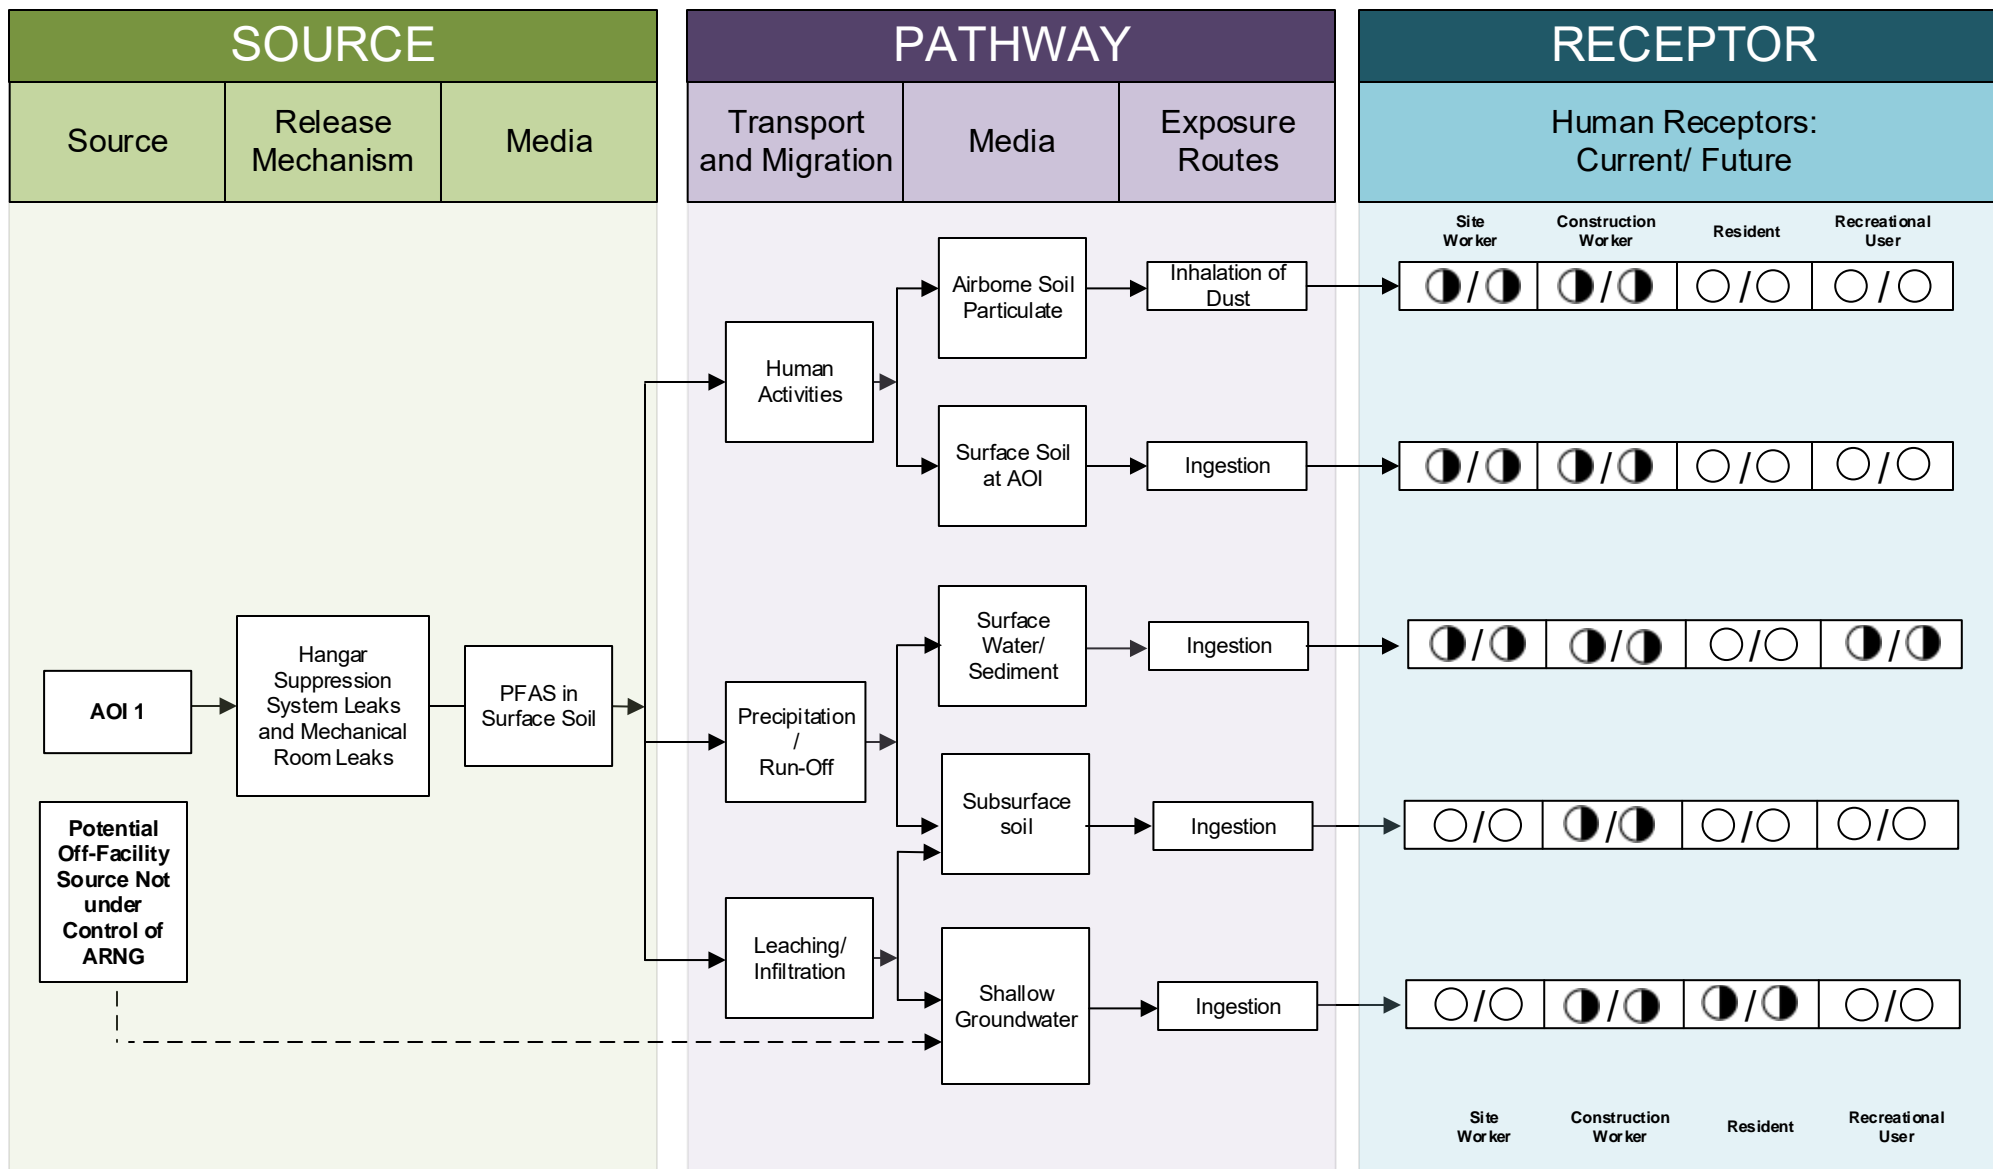
Hangar Suppression System and Mechanical Room

AOI 1 encompasses the AFFF fire suppression system within the hangar building and mechanical room. Seepage of AFFF is evident from corrosion identified at the floor tanks in the hangar building. ALARNG personnel use water and mops to clean the floor within the hangar building. Possible releases from the floor boxes within the hangar building could be transported via cleaning and captured by floor drains located on the north and south ends of the hangar building. These floor drains empty to the oil/water separator which then discharges to the sanitary sewer. However, it is possible for minor amounts of AFFF to travel beyond the hangar to the flight ramp on the north and south ends of the building.

Seepage of AFFF is also evident from corrosion identified at the two 800-gallon 3% AFFF concentrate tanks, located in the mechanical room. ALARNG personnel also noted that during the AFFF concentrate replacement between 2006 and 2009, an unknown quantity of concentrate was spilled on the south side of the mechanical room, which consequently killed the grass. Except for the wash rack area, surface water surrounding the hangar drains via sheet flow. The apparent surface water flow direction is toward the north and northwest. However, surface water may flow to the low-lying Retention Areas 1 and 2, located southeast of the flight ramp and southwest of the hangar building, respectively.
