FINAL Preliminary Assessment Report Camp Navajo Bellemont, Arizona

Perfluorooctanesulfonic Acid (PFOS) and Perfluorooctanoic
Acid (PFOA) Impacted Sites
ARNG Installations, Nationwide

September 2020

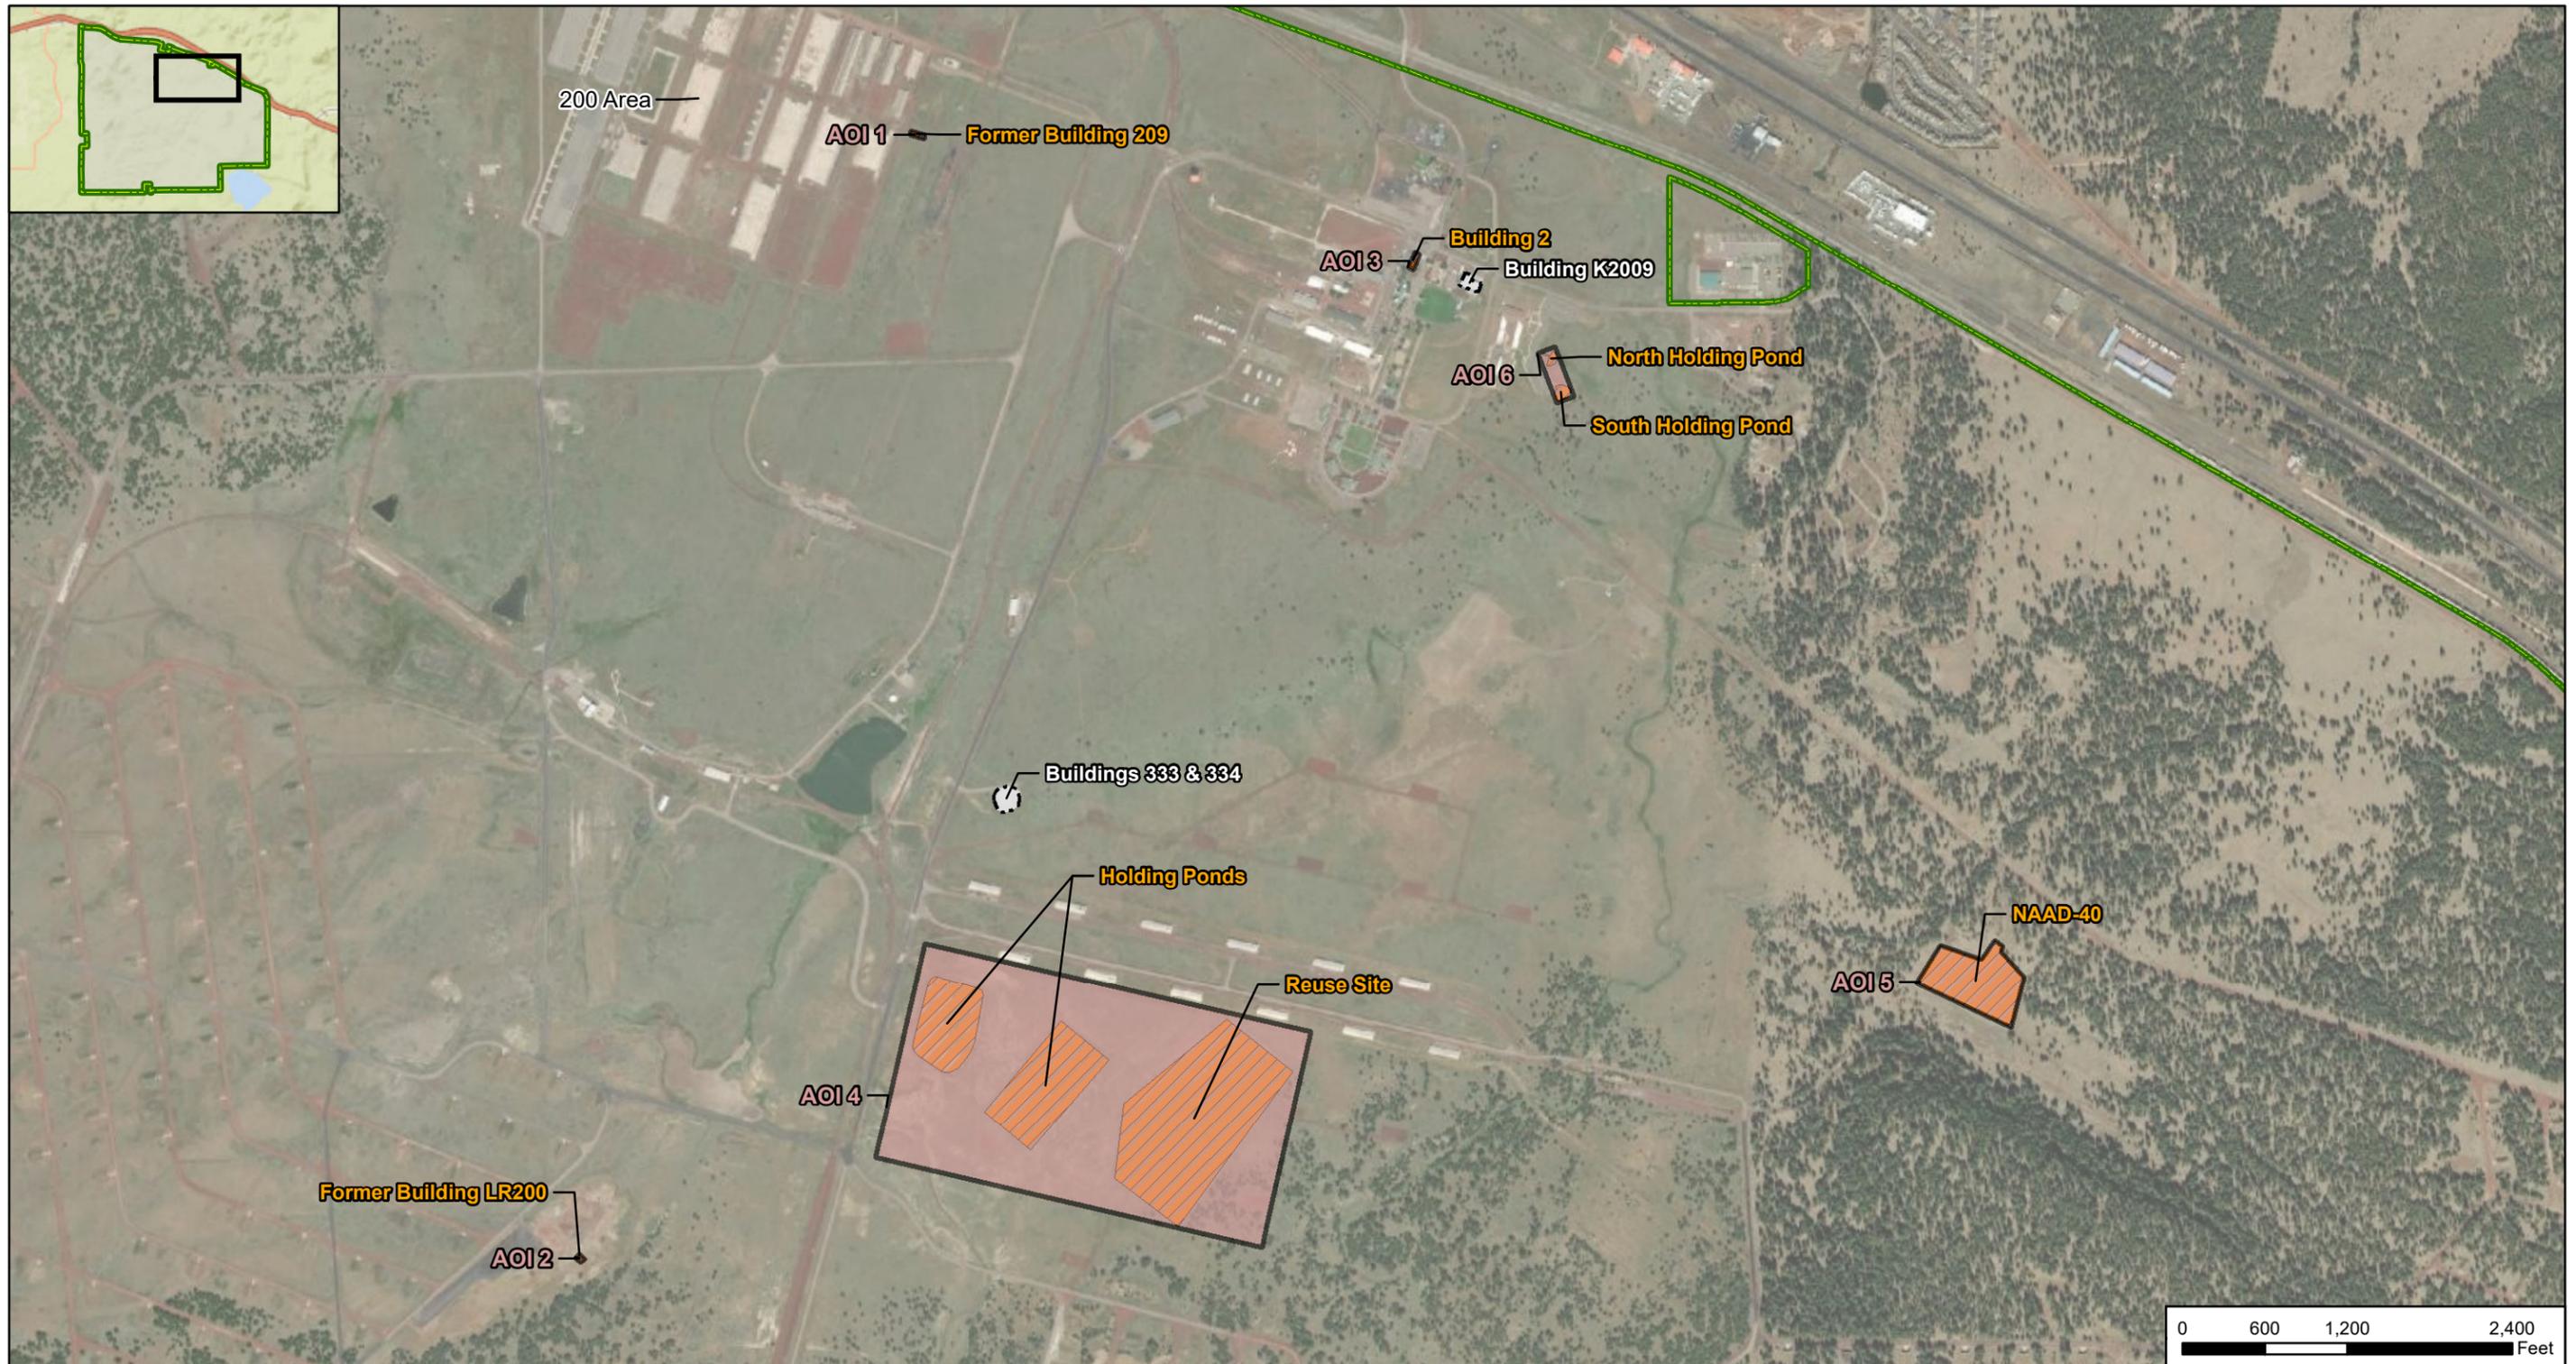
Figure ES-1

ARNG will evaluate the need for an SI at AOIs 1, 2, 3, 4, 5, and 6 at Camp Navajo based on the potential receptors and the potential migration of PFAS contamination off the installation. ARNG sites will be prioritized for SIs based on funding.

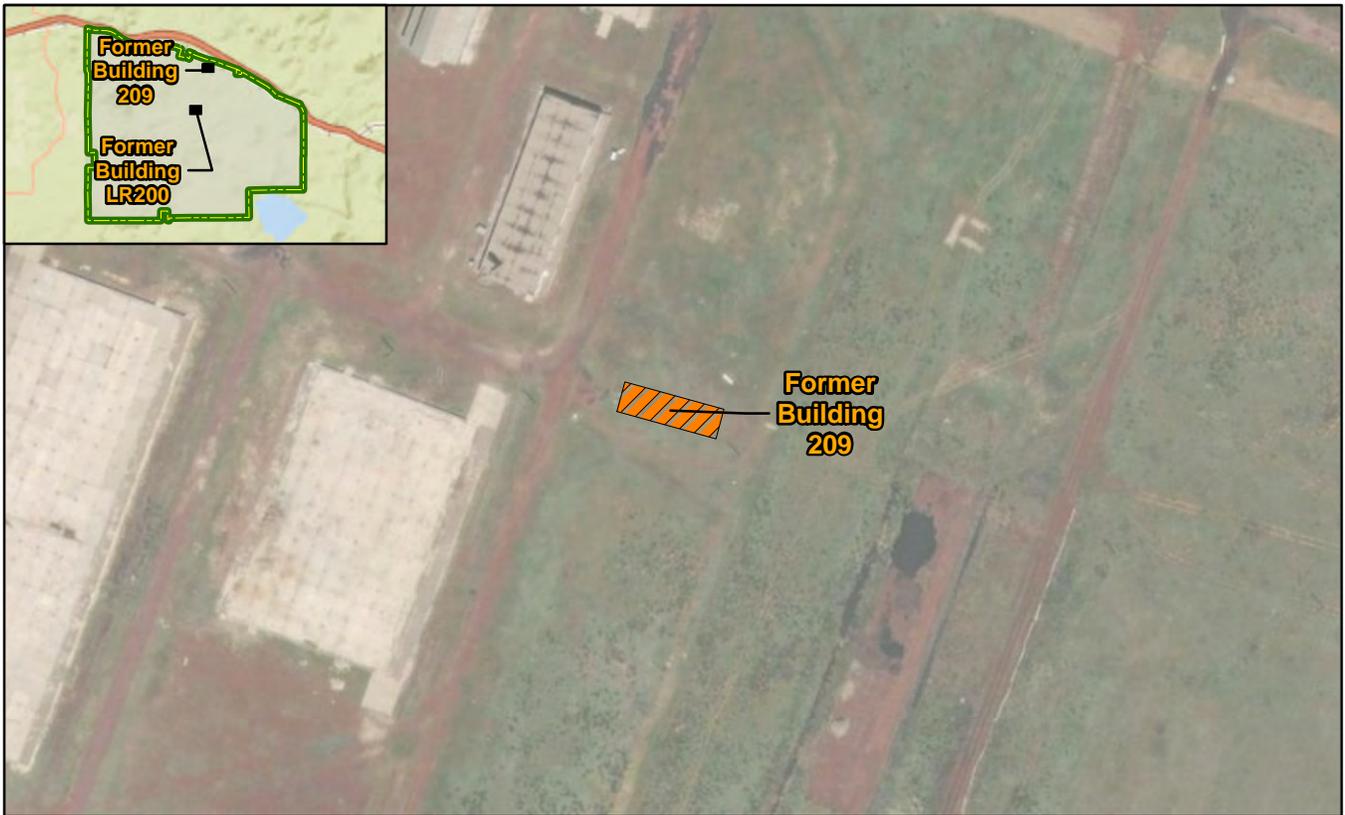
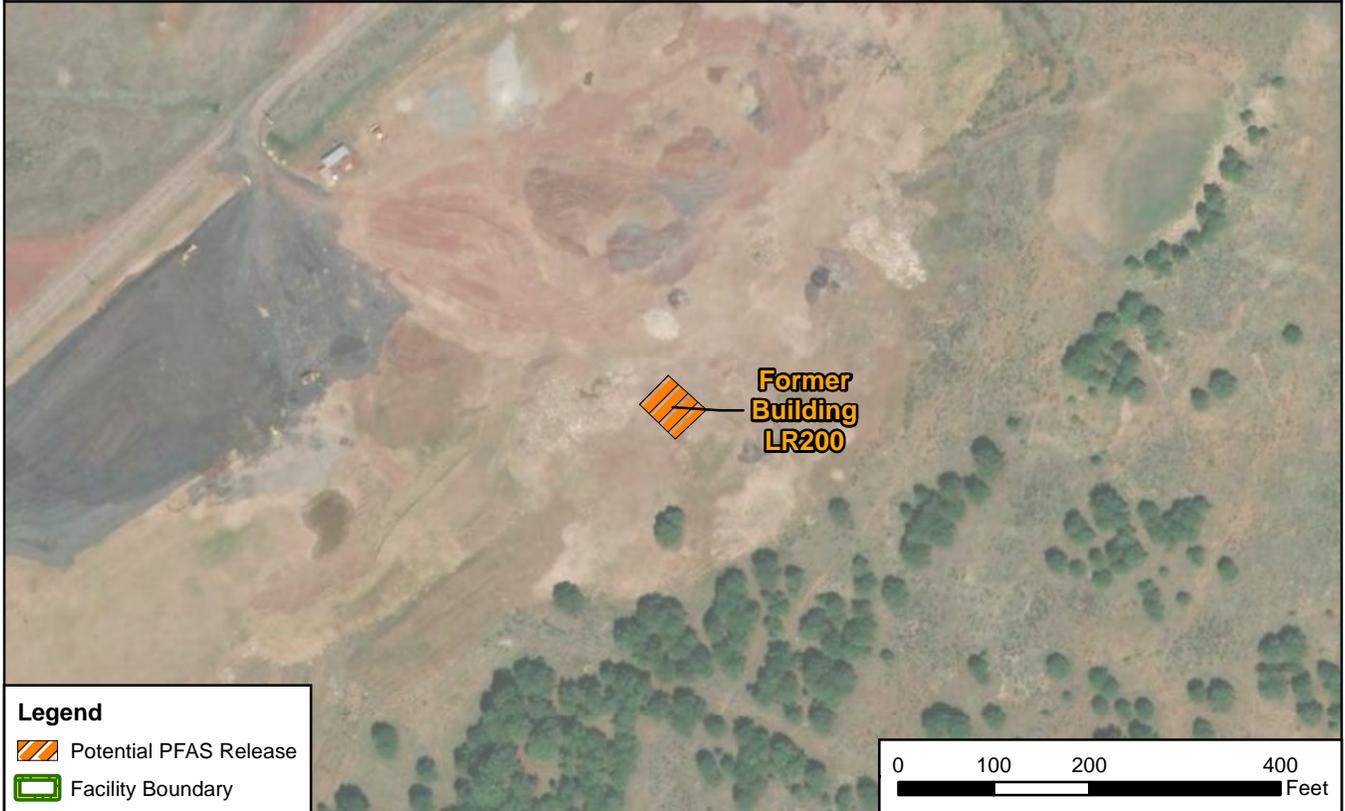
The area where Building LR200 stood is currently a patch of exposed earth. According to observations made during the PA site visit, a drainage ditch is located along the western side of the Former Building LR200 footprint. The drainage ditch runs north-south and likely flows towards

the south end of the installation, consistent with regional drainage patterns. There is a sinkhole on the eastern side of the Former Building LR200 area with an escarpment consistent with the north-south orientation of the Bellemont Fault. Water that enters this sinkhole is likely in communication with the regional aquifer. It is likely that AFFF was used during this training activity and it infiltrated to the subsurface. Water and AFFF infiltrating at the surface have the potential to eventually leach to the regional aquifer.

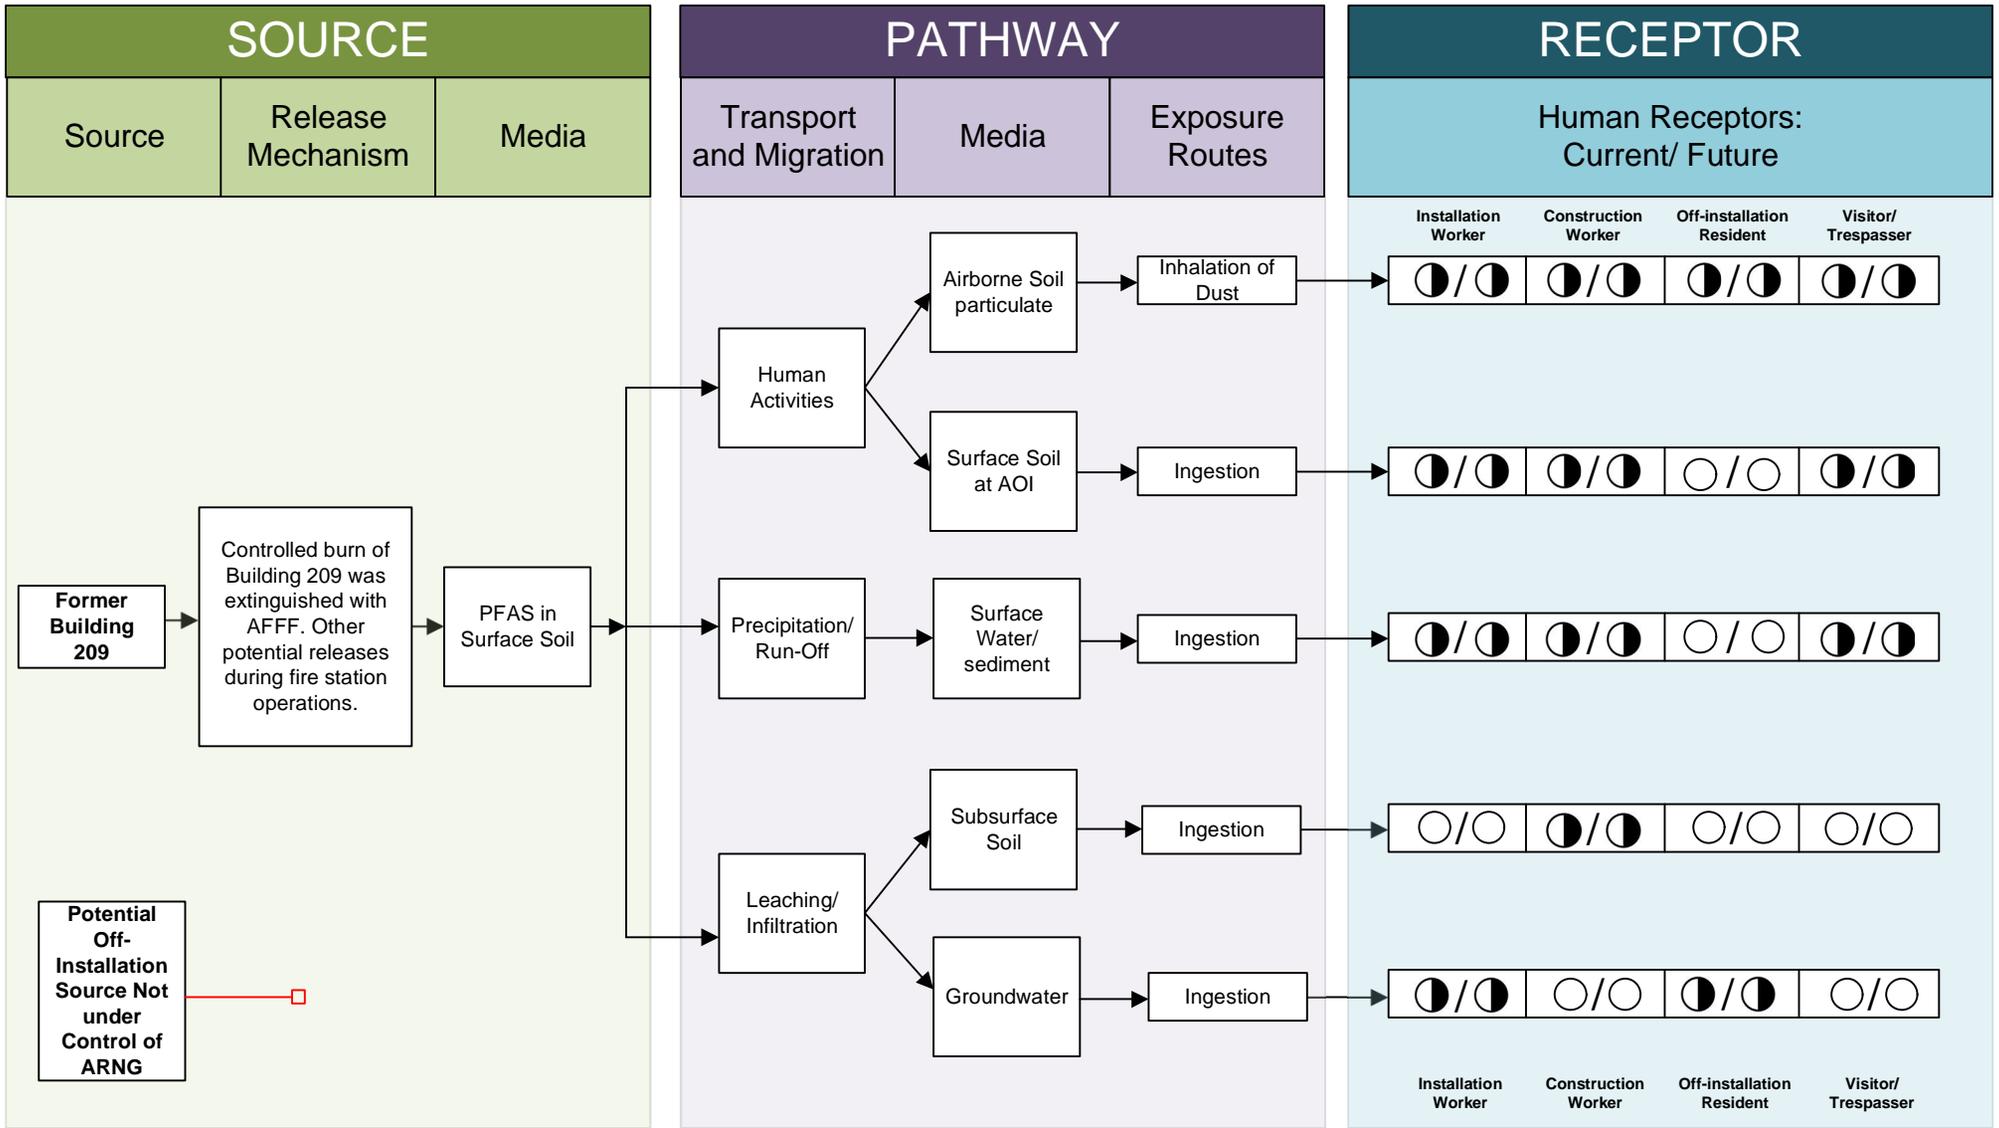
Figure 6-2
 Preliminary Conceptual Site Model – AOI 1 Former Building 209
 Camp Navajo

and sediment to site workers, construction workers, and visitors/trespassers. The CSM for AOI 1 is shown on **Figure 6-2**.

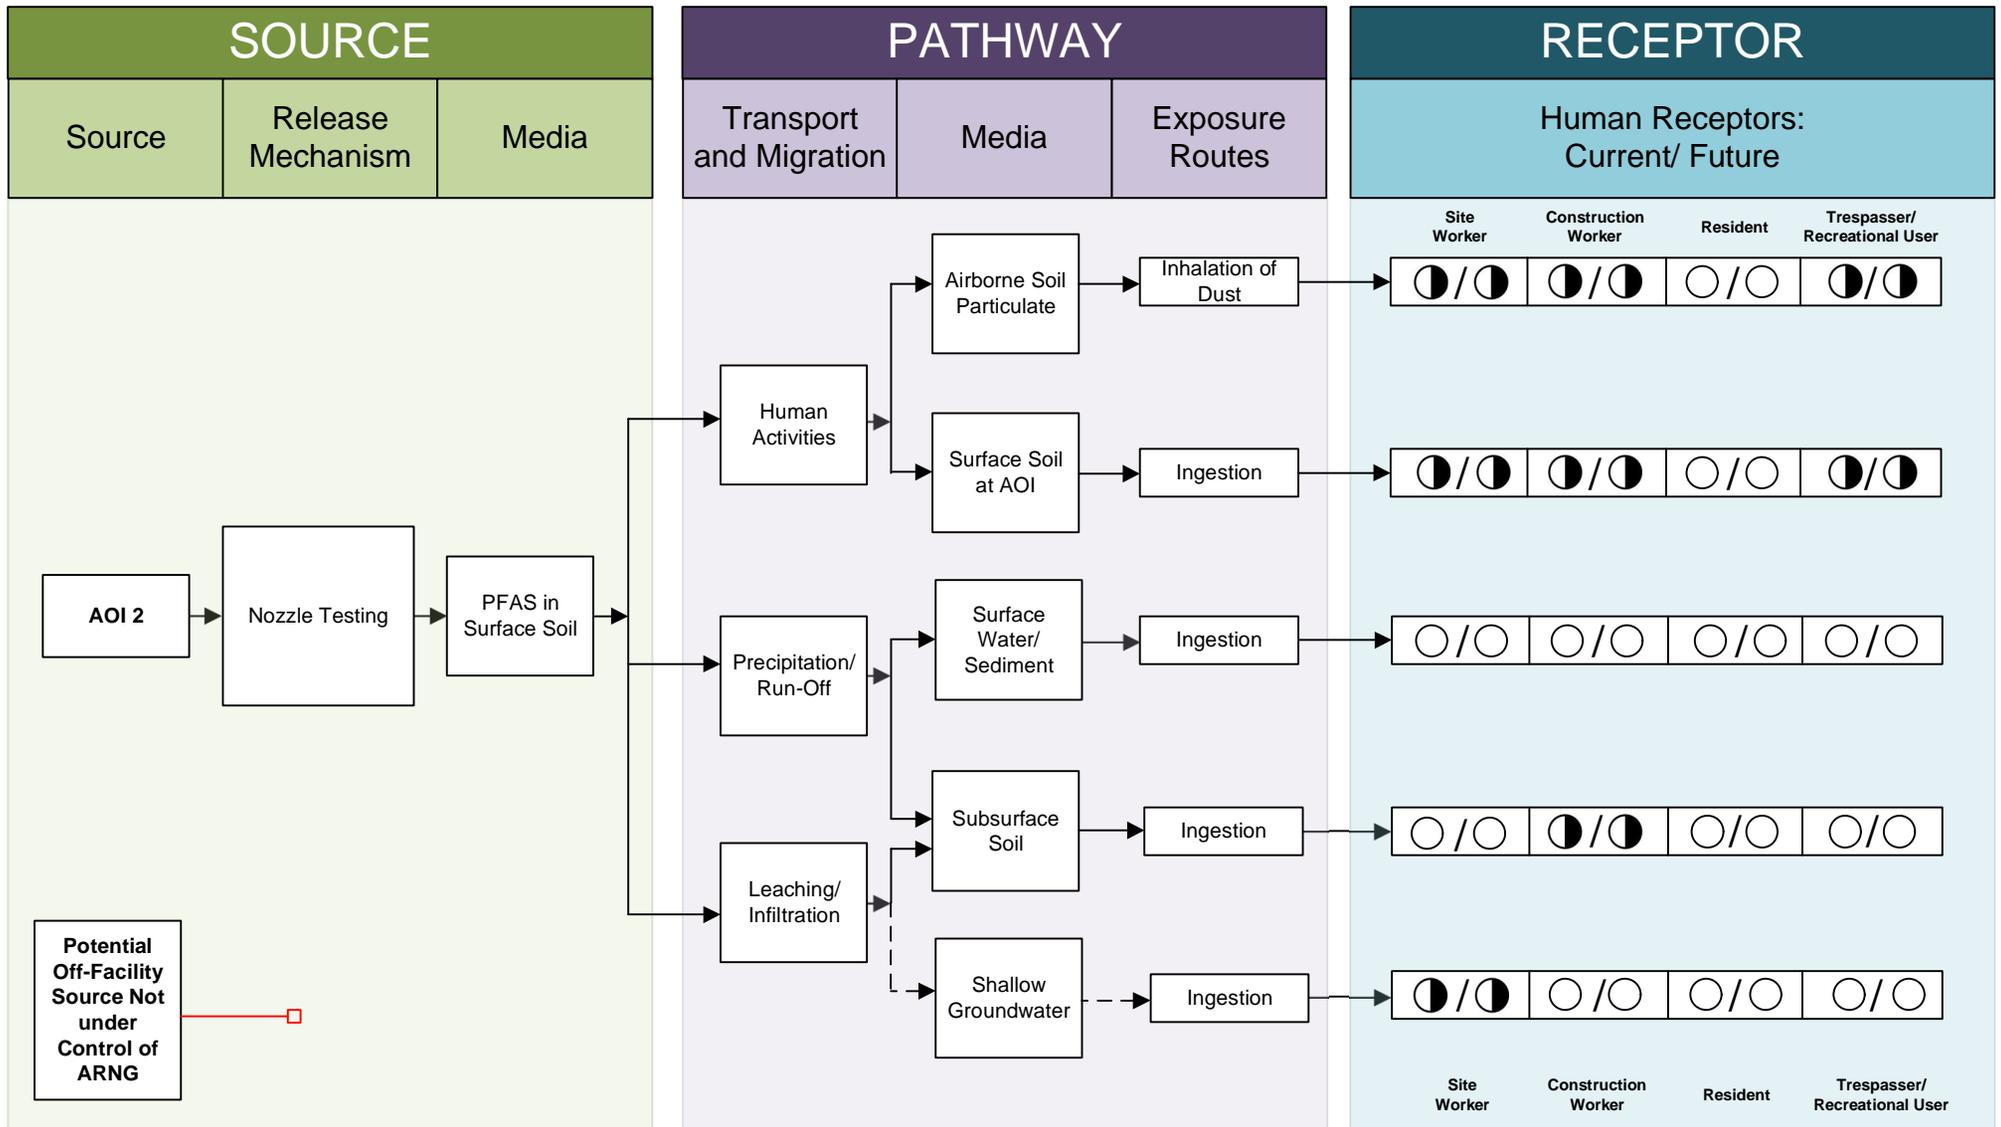
Figure 6-3
 Preliminary Conceptual Site Model
 AOI 2 – OCTC Fire Station

Ground-disturbing activities to surface soil at AOI 2 may result in installation worker, site worker, off-installation residents (about 2-miles away), and visitor/trespasser exposure to potential PFAS contamination via ingestion or inhalation of airborne particulates. Ground-disturbing activities to subsurface soil could result in construction worker exposure to PFAS contamination via ingestion or inhalation of airborne particulates. Surface water at AOI 2 enters drainageways which eventually flow to South Sink, which is believed to be a pathway to the regional aquifer (~1,500 ft bgs). Based on the location of well CN-2, which supplies the installation with potable water, downgradient of AOI 2 in the regional aquifer, there is a potentially complete exposure pathway from deep groundwater to installation workers. Based on the presence of deep public supply wells within 2-miles to the north of AOI 2, there is a potentially complete exposure pathway from deep groundwater to off-installation residents. Based on the presence of an ephemeral drainage ditch adjacent to AOI 2, there is a potentially complete exposure pathway from surface water and sediment to installation workers, construction workers, and visitors/trespassers. The CSM for AOI 2 is shown on **Figure 6-3**.

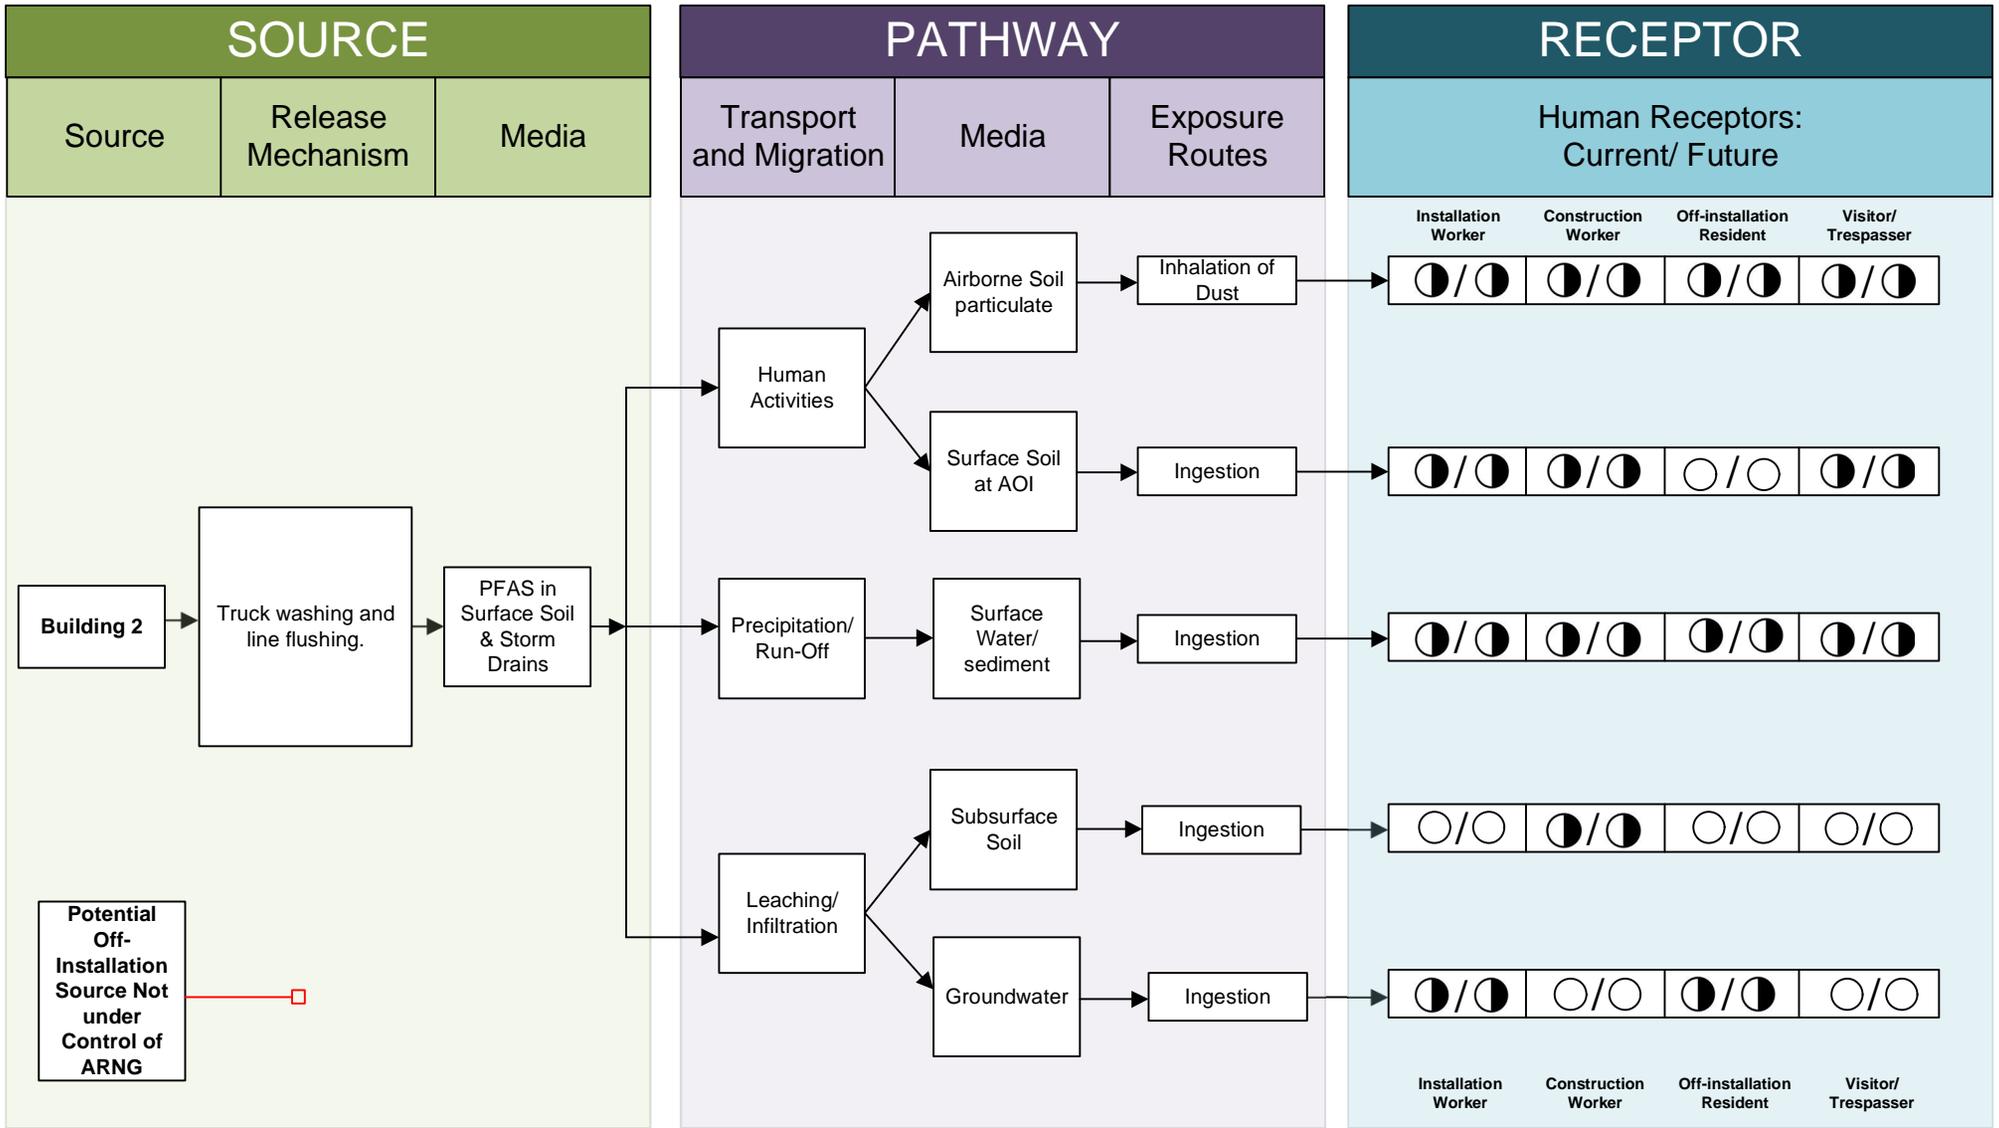
Figure 6-4
 Preliminary Conceptual Site Model – AOI 3 Building 2
 Camp Navajo
 30

contamination in the shallow perched aquifer, which is in communication with the potable springs and potentially shallow aquifers off-installation, via infiltration at Building 2, or at the Cantonment Area Holding Ponds. Therefore, there is a potentially complete exposure pathway from shallow groundwater to installation workers and off-installation residents. There is also the potential for the perched aquifer to be in communication with the regional aquifer. Based on the stormwater pathway to the Cantonment Area Holding Ponds, which occasionally overflow to Volunteer Wash, there is a potentially complete exposure pathway from surface water and sediment to installation workers, construction workers, off-installation residents, and visitors/trespassers. The CSM for AOI 3 is shown on **Figure 6-4**.

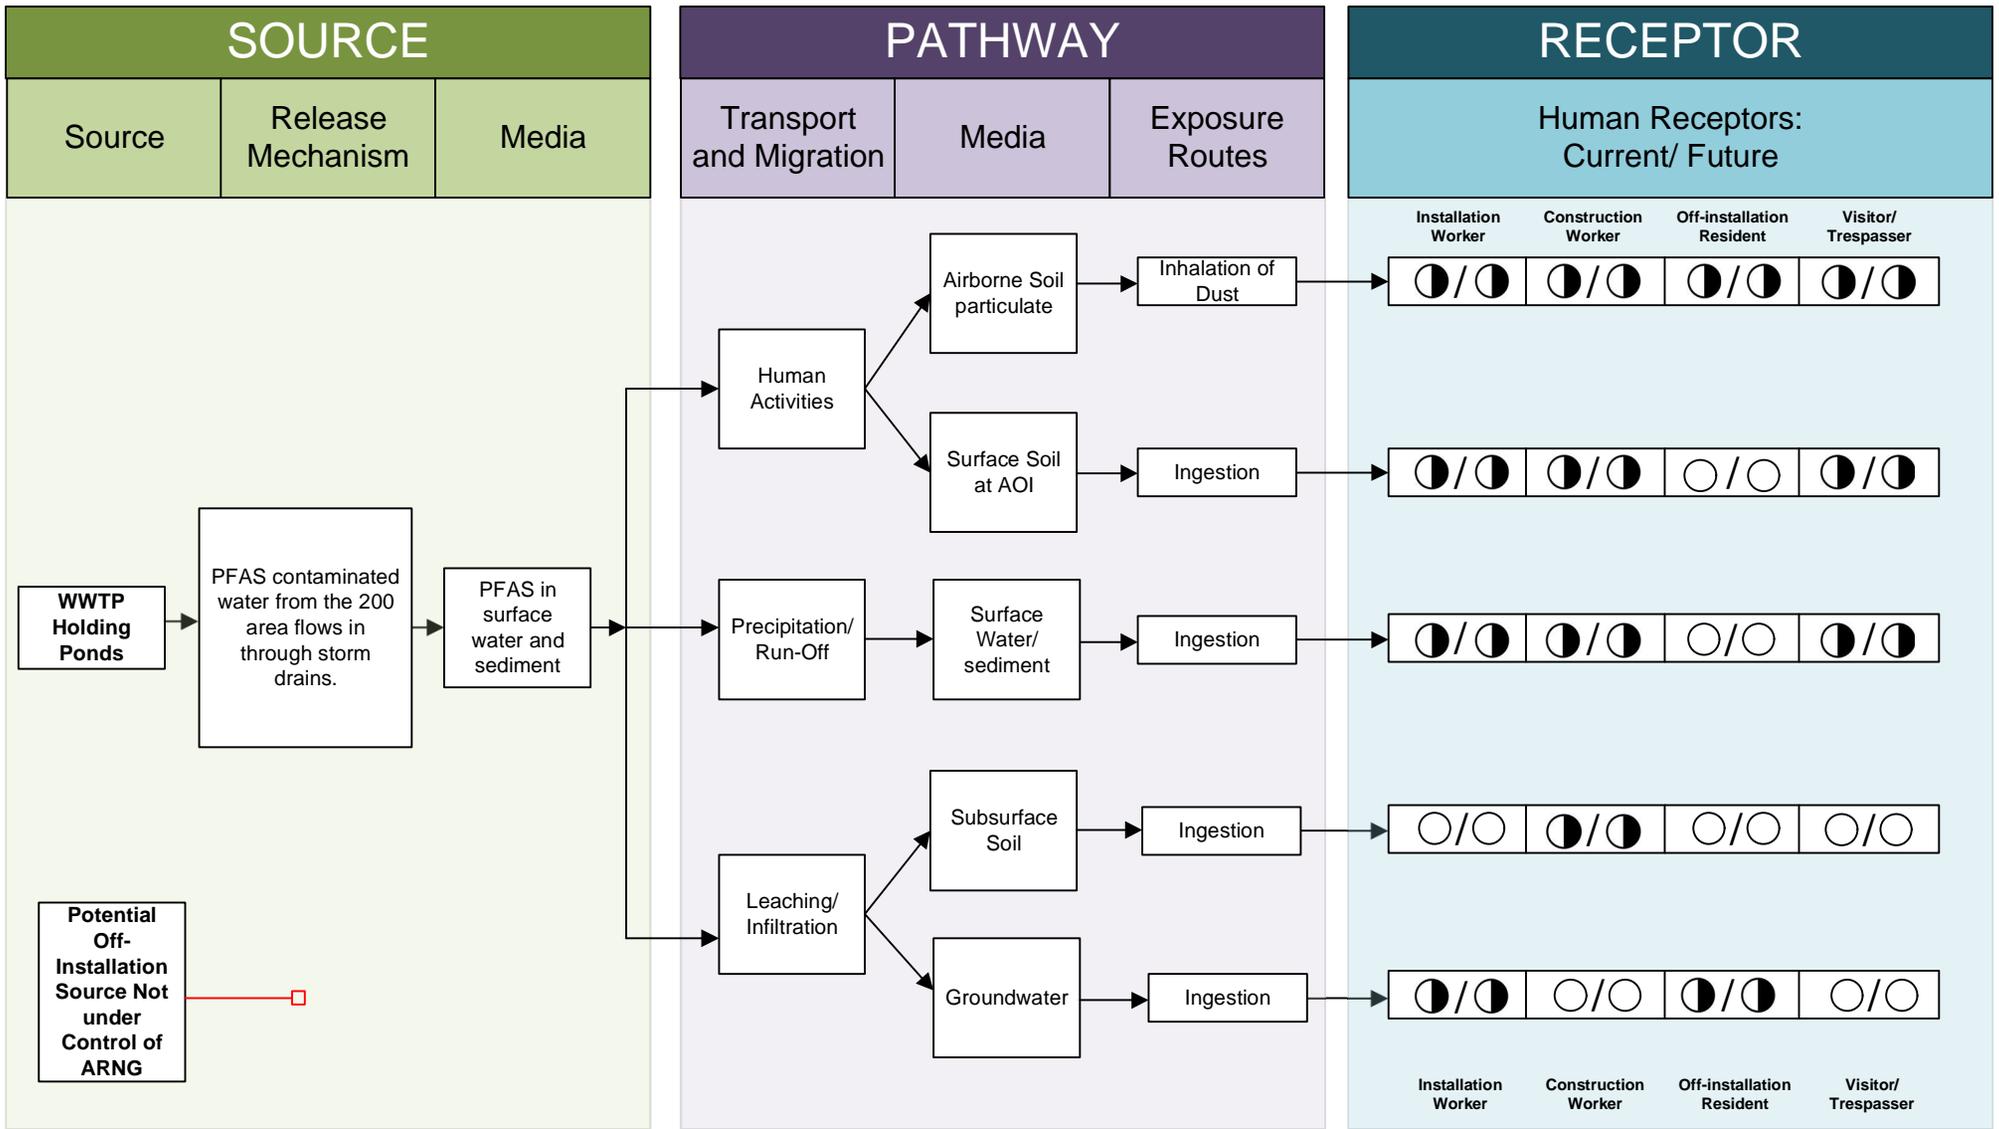
Figure 6-5
 Preliminary Conceptual Site Model – AOI 4 WWTP Holding Ponds
 Camp Navajo

Ground-disturbing activities to surface soil at AOI 4 may result in installation worker, construction worker, off-installation resident (1.65-miles to the north-northeast), and visitor/trespasser exposure to potential PFAS contamination via ingestion or inhalation of airborne soil particulates. Ground-disturbing activities to subsurface soil could result in construction worker exposure to potential PFAS contamination via ingestion or inhalation of airborne soil particulates. Based on the potential for water to infiltrate to the regional aquifer, and given the presence of potable well CN-2 downgradient, and deep public supply wells (1.5-miles to the north), there is a potentially complete exposure pathway for groundwater to installation workers and off-installation residential receptors. Based on the potential for PFAS to be present in the holding pond water, and for the holding pond water to be discharged to the effluent reuse area (**Figure 3-1**), there is a potentially complete exposure pathway for surface water and sediment to installation workers, construction workers, and trespassers. The CSM for AOI 4 is shown on **Figure 6-5**.

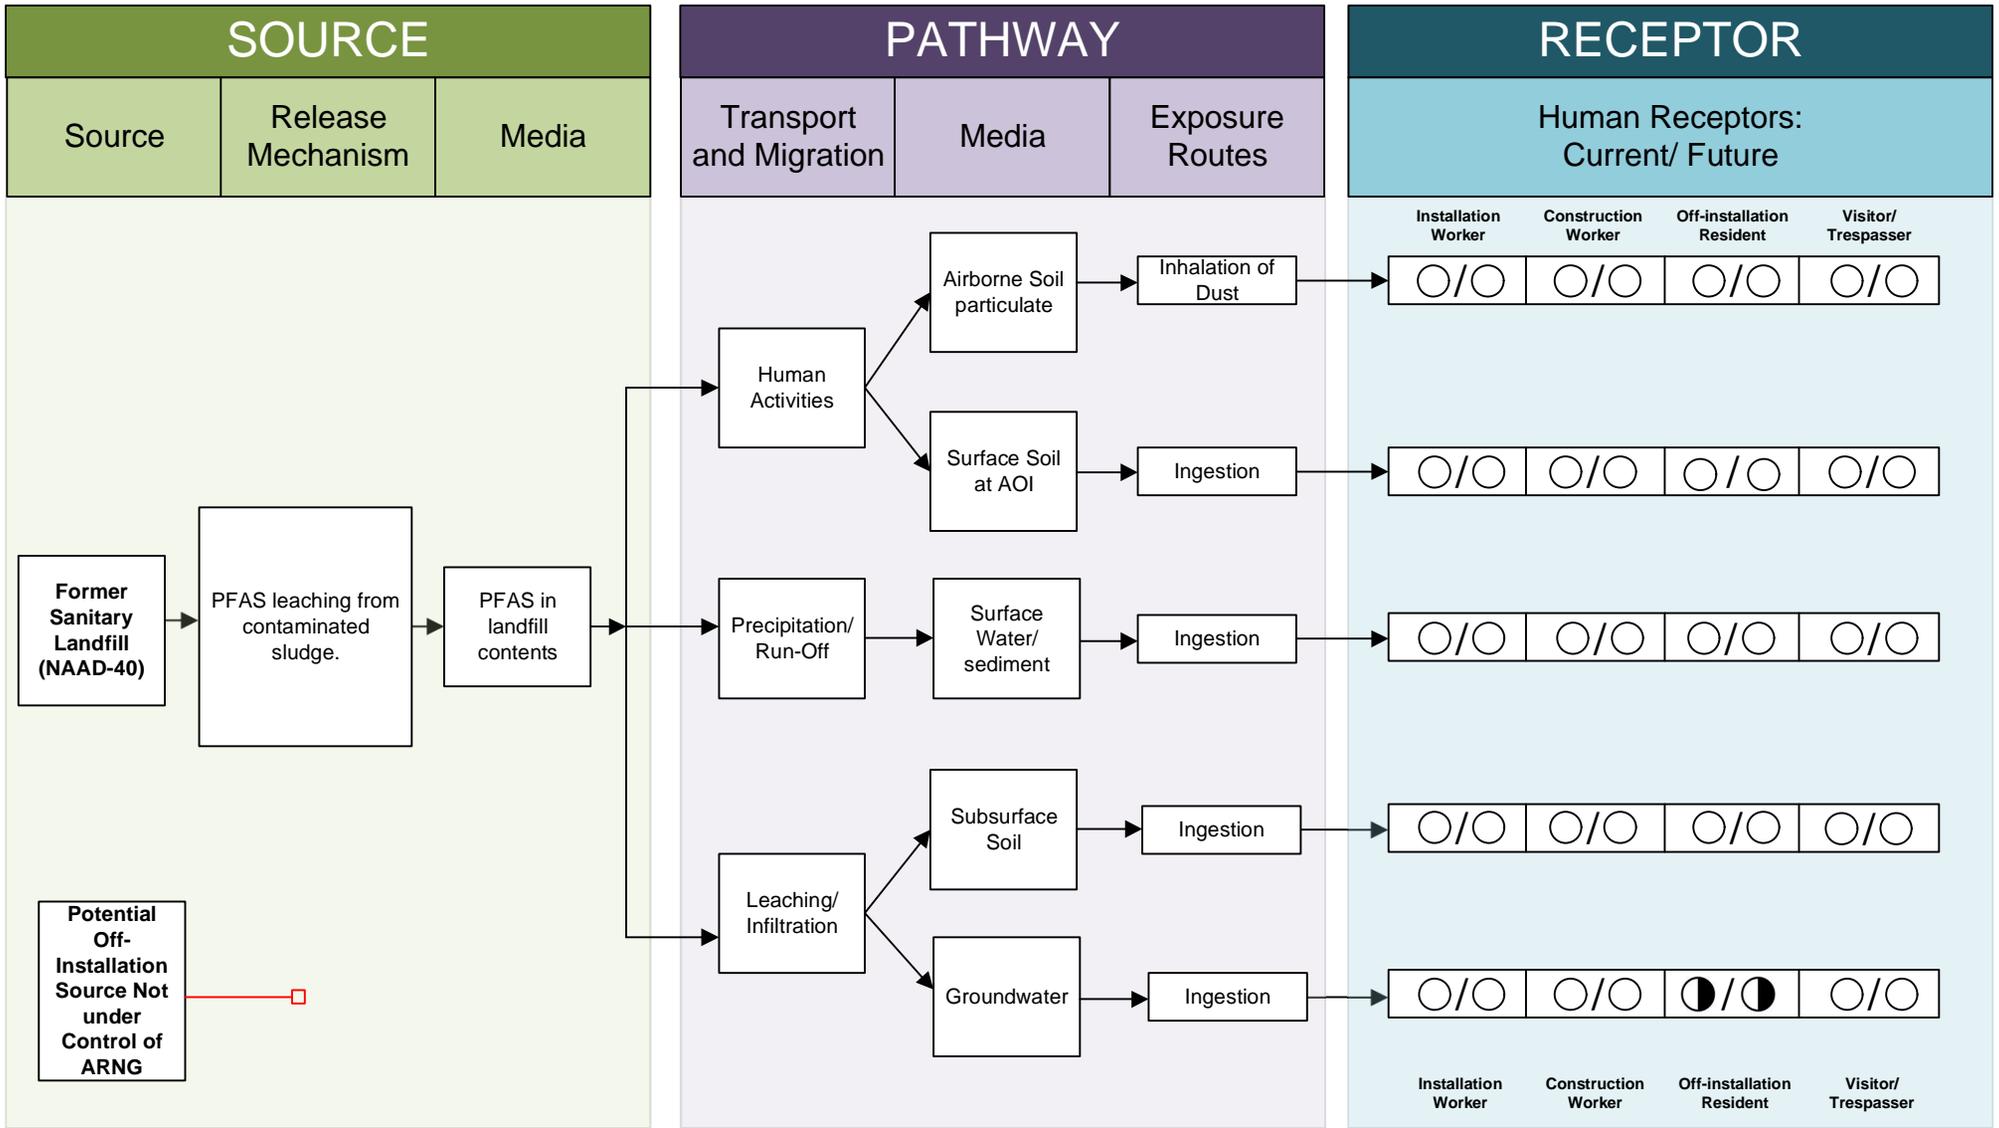
Figure 6-6
 Preliminary Conceptual Site Model – AOI 5 Former Sanitary Landfill (NAAD-40)
 Camp Navajo

to have leached to the perched water table or the regional aquifer, there is the potential for multiple residential wells off the installation which are screened in shallow and regional aquifers to be hydraulically connected to the aquifer at NAAD-40. Therefore, there is a potentially complete exposure pathway from groundwater to off-installation residential receptors. The landfill soil cap keeps surface water from coming into contact with potential PFAS-containing materials; therefore, there is no complete exposure pathway from surface water and sediment to any receptor. The CSM for AOI 5 is shown on **Figure 6-6**.

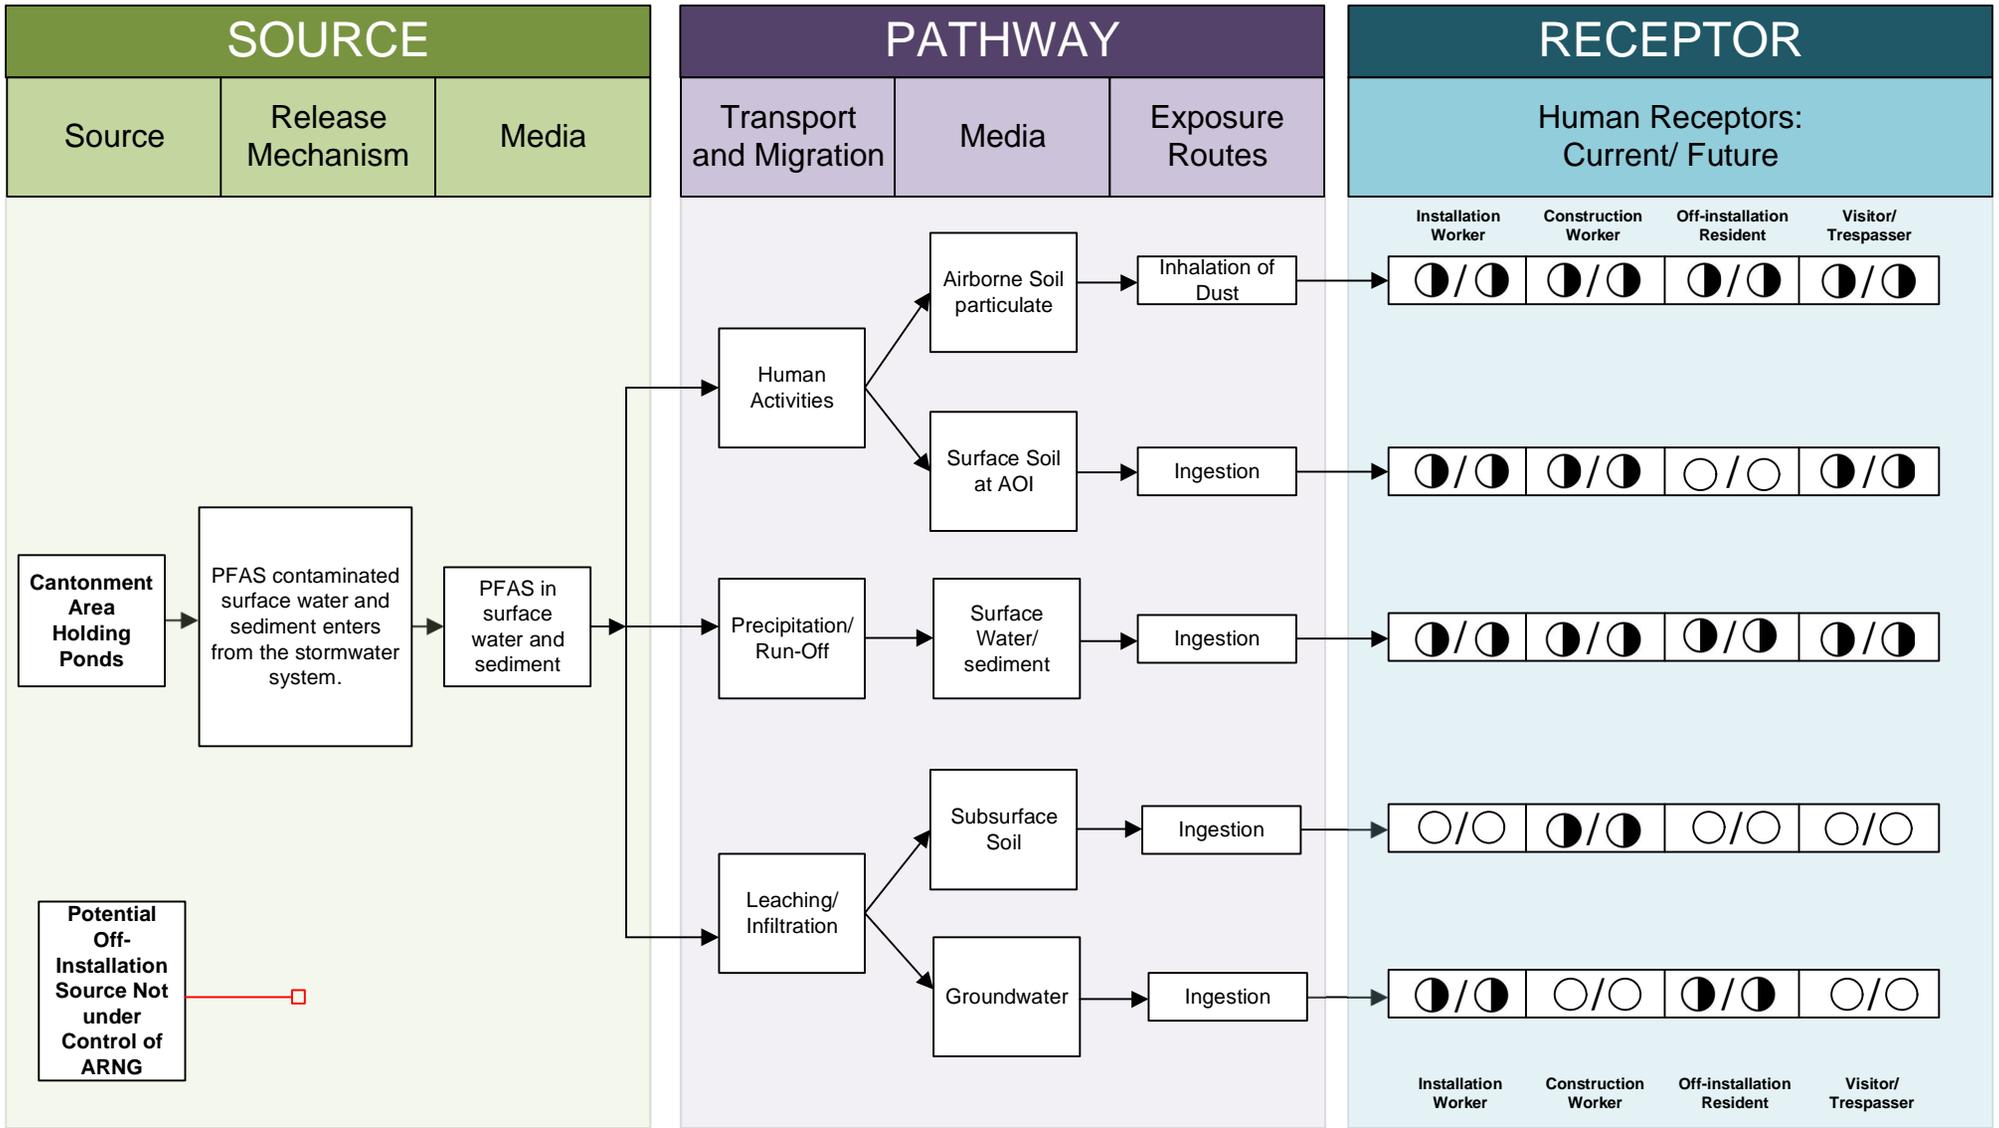
Ground-disturbing activities to surface soil and subsurface soil at AOI 6 may result in installation worker, construction worker, off-installation residents (0.55-miles to the north-northeast), and visitor/trespasser exposure to potential PFAS contamination via ingestion or inhalation of airborne soil particulates. Ground-disturbing activities to subsurface soil could result in construction worker exposure to potential PFAS contamination via ingestion or inhalation of airborne soil particulates. AOI 6 is located above the Camp Navajo Clay atop which sits a perched aquifer. There is the potential for PFAS to have leached to the shallow aquifer. The shallow residential wells within 0.6-miles to the north, and the natural springs at Camp Navajo use water from this perched aquifer for potable purposes. Therefore, there is a potentially complete exposure pathway from shallow groundwater to off-installation residents and installation workers. There is also the potential for the perched aquifer to be in communication with the regional aquifer. The Cantonment Area Holding Ponds may overflow into Volunteer Wash and eventually off-site during periods of abnormally high surface water discharge. Therefore, there is a potentially complete exposure pathway for surface water and sediment to all receptors. The CSM for AOI 6 is shown on **Figure 6-7**.

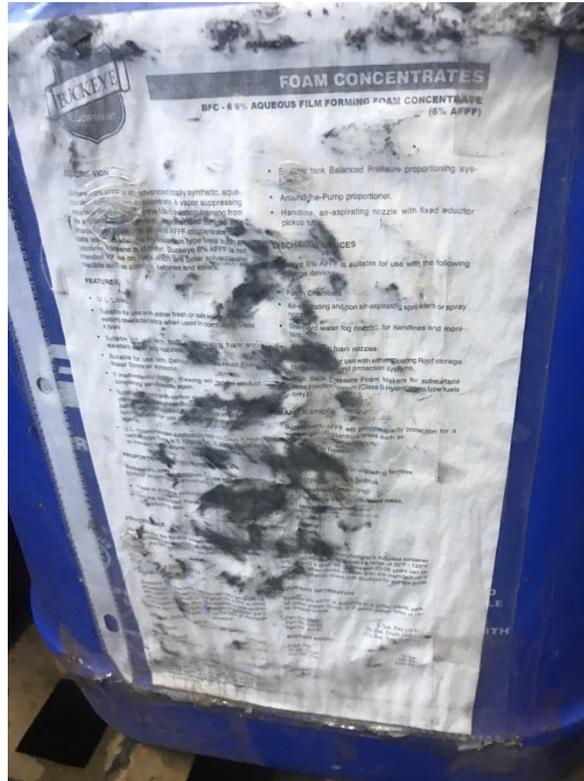
Photograph No. 6

Label for AFFF

(view to S)

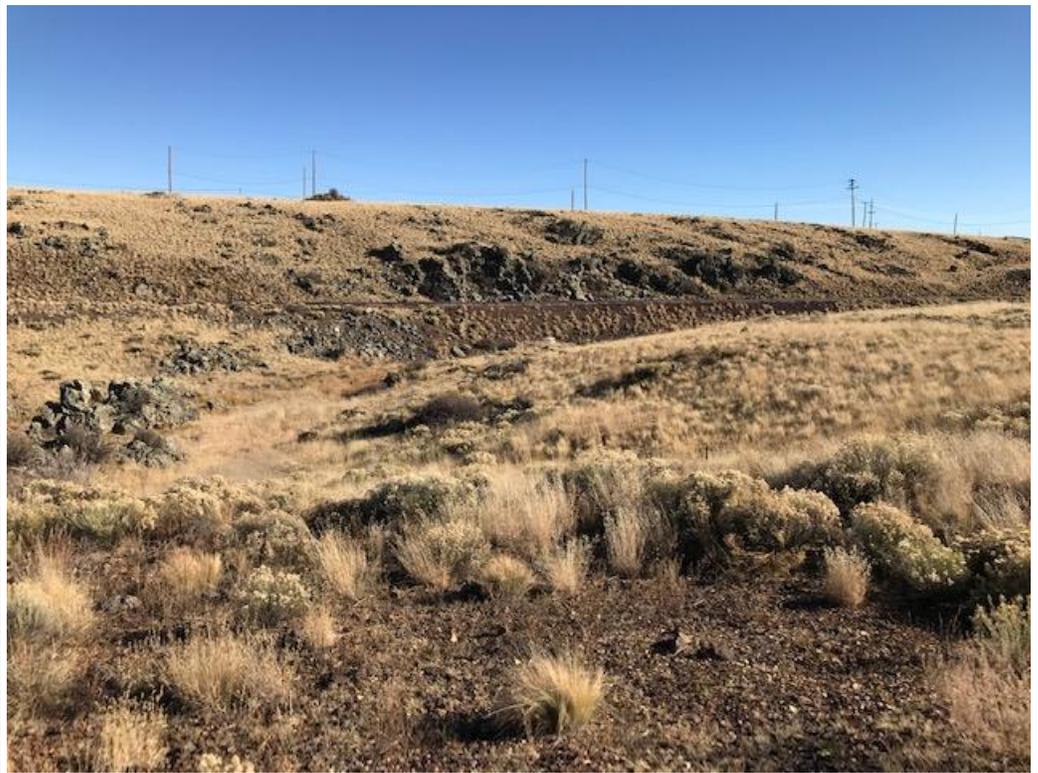
Area of Springs
