FINAL Preliminary Assessment Report Camp Navajo Bellemont, Arizona

Perfluorooctanesulfonic Acid (PFOS) and Perfluorooctanoic
Acid (PFOA) Impacted Sites
ARNG Installations, Nationwide

September 2020

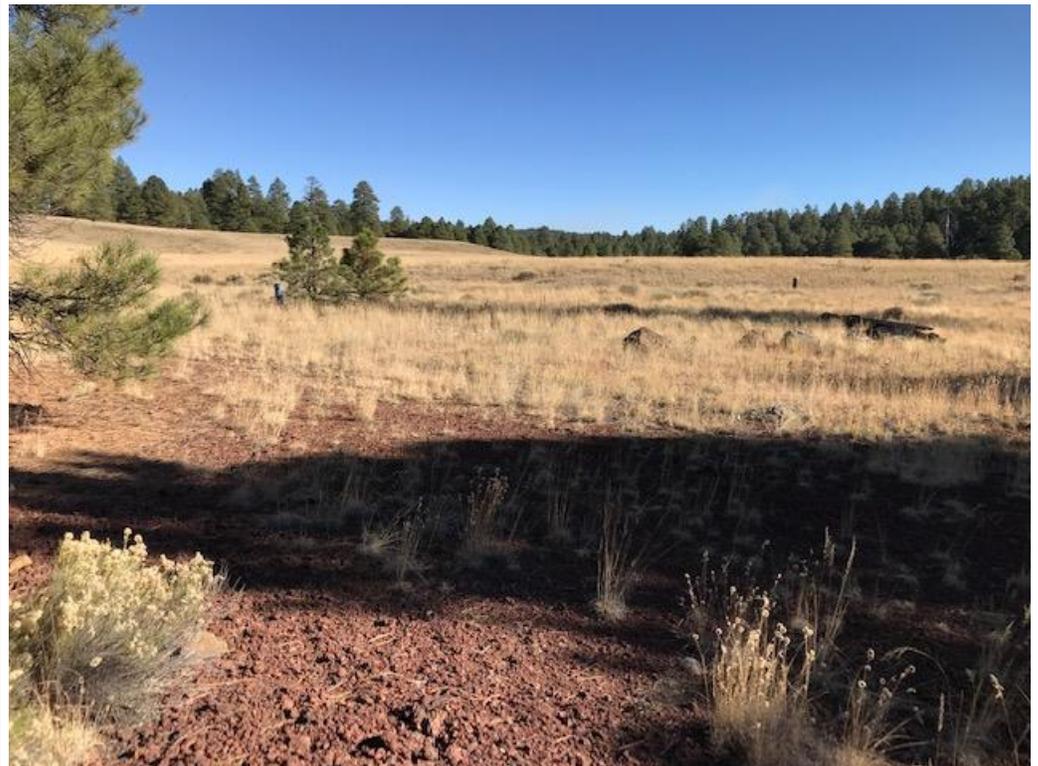
Photograph No. 10

Landfill

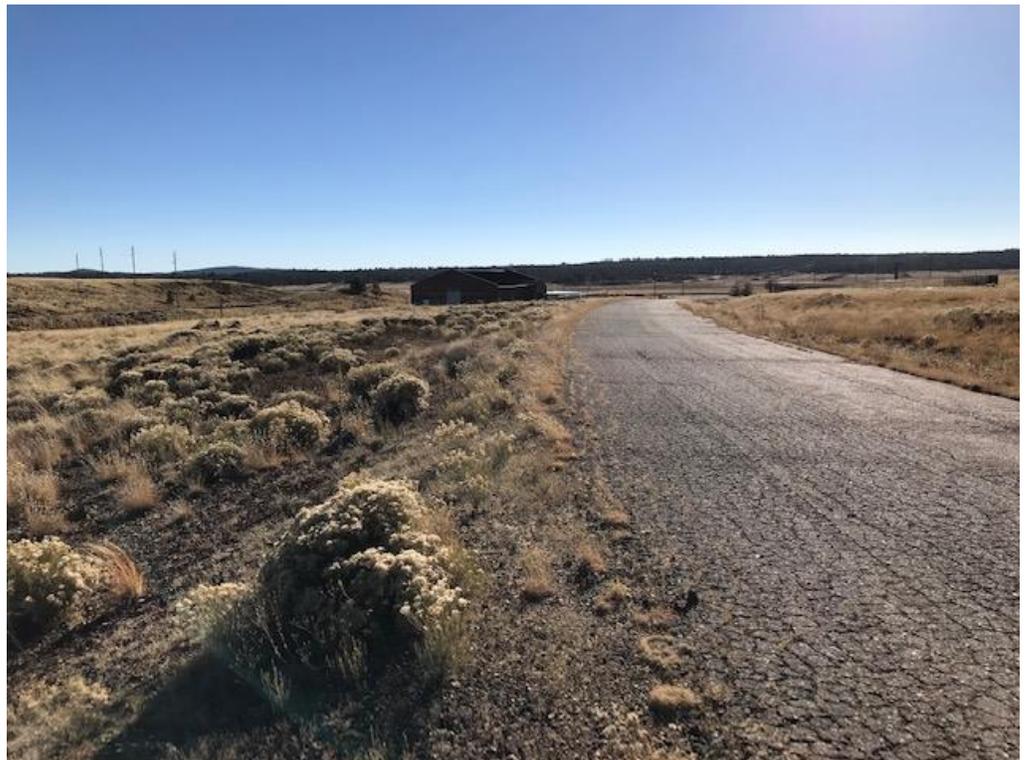
Road to 200 Area
