FINAL Preliminary Assessment Report Silver Bell Army Heliport Marana, Arizona

Perfluorooctanesulfonic Acid (PFOS) and Perfluorooctanoic
Acid (PFOA) Impacted Sites
ARNG Installations, Nationwide

September 2020

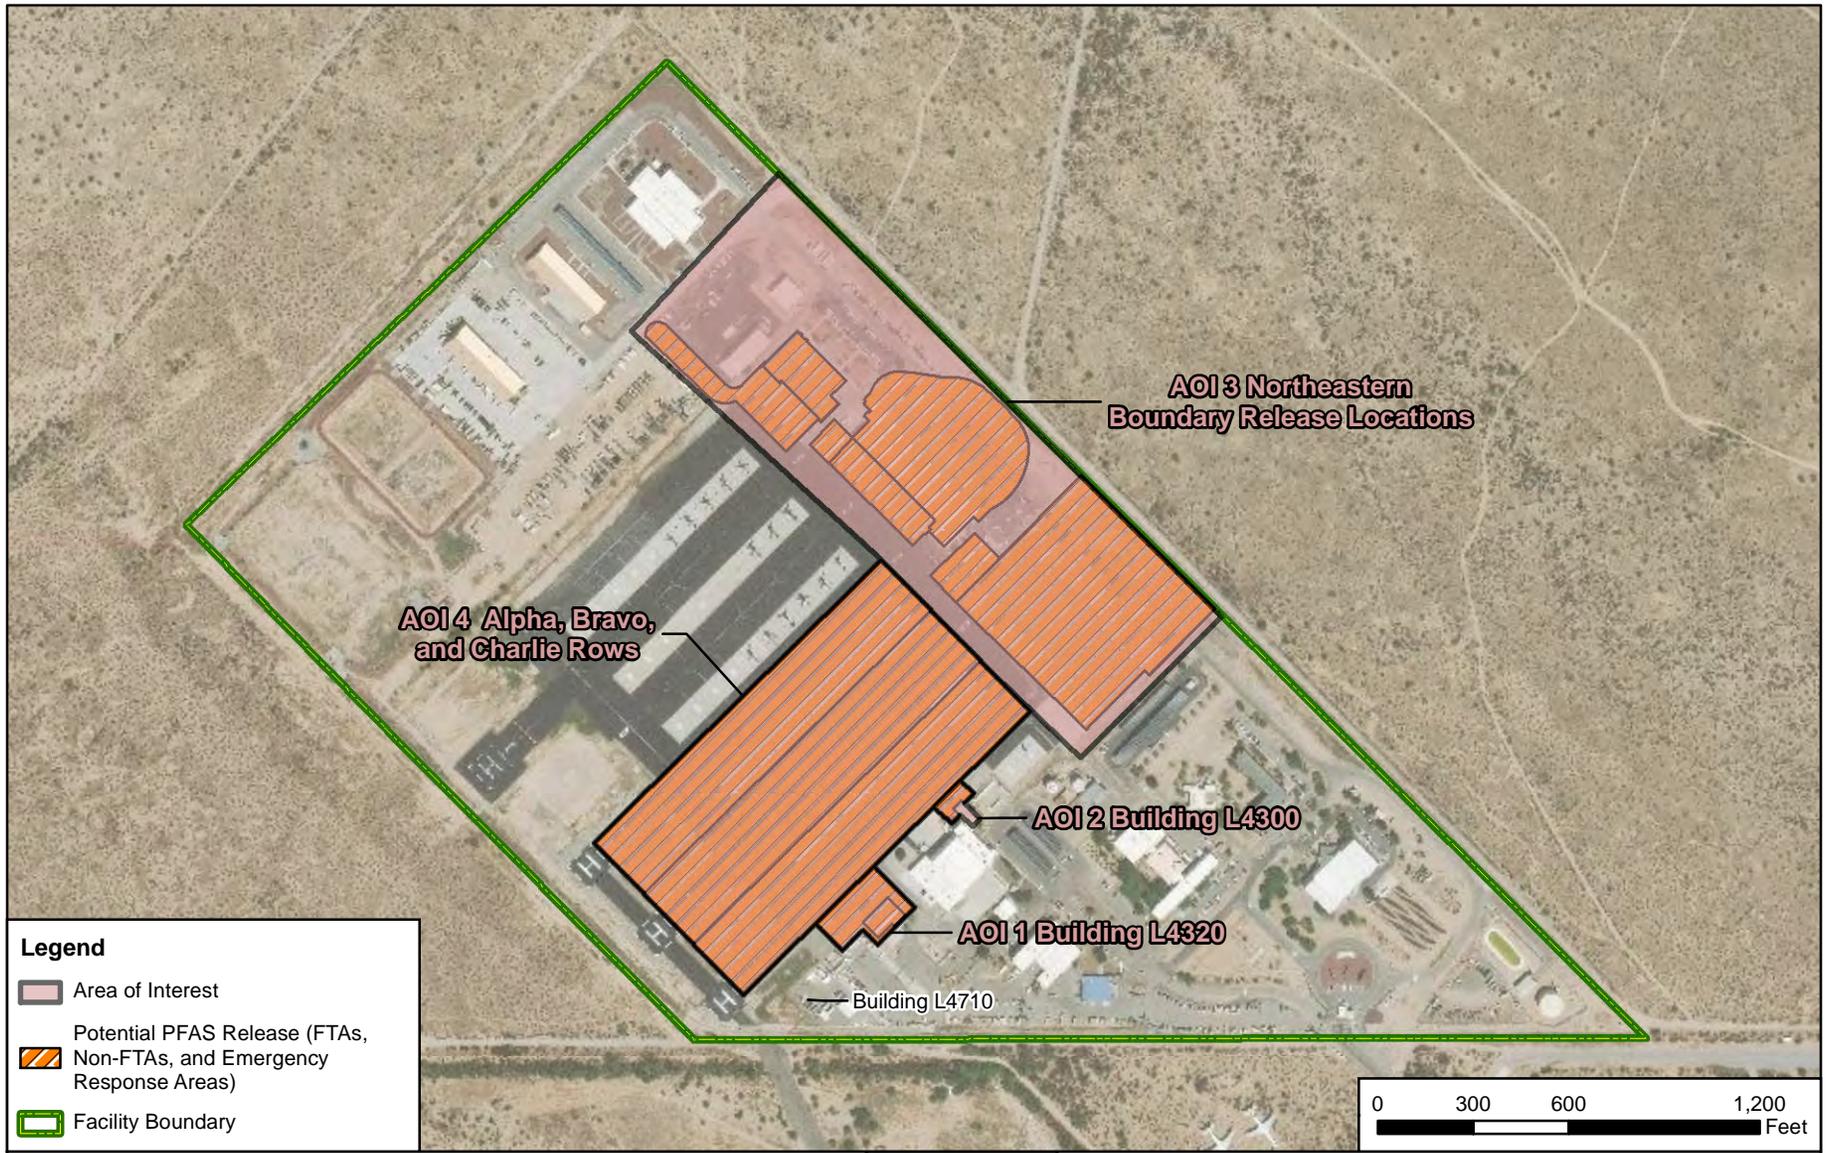
TITLE	Summary of Findings	
	12420 Milestone Center Drive Germantown, MD 20876	Figure ES-1

Interviews with SBAH staff whose first-hand knowledge of the facility span 1994 to present indicate that AZARNG activities at SBAH have contributed PFAS contamination to the environment through means of fire-training, fire suppression system releases, maintenance activities, equipment storage, and responses to fuel spills. Based on known AFFF releases at the AOIs listed above, there is potential for exposure to PFAS contamination in media at or near the facility. A summary of PA findings is shown on **Figure ES-1**. The summary preliminary CSM diagram for SBAH is shown on **Figure ES-2**.

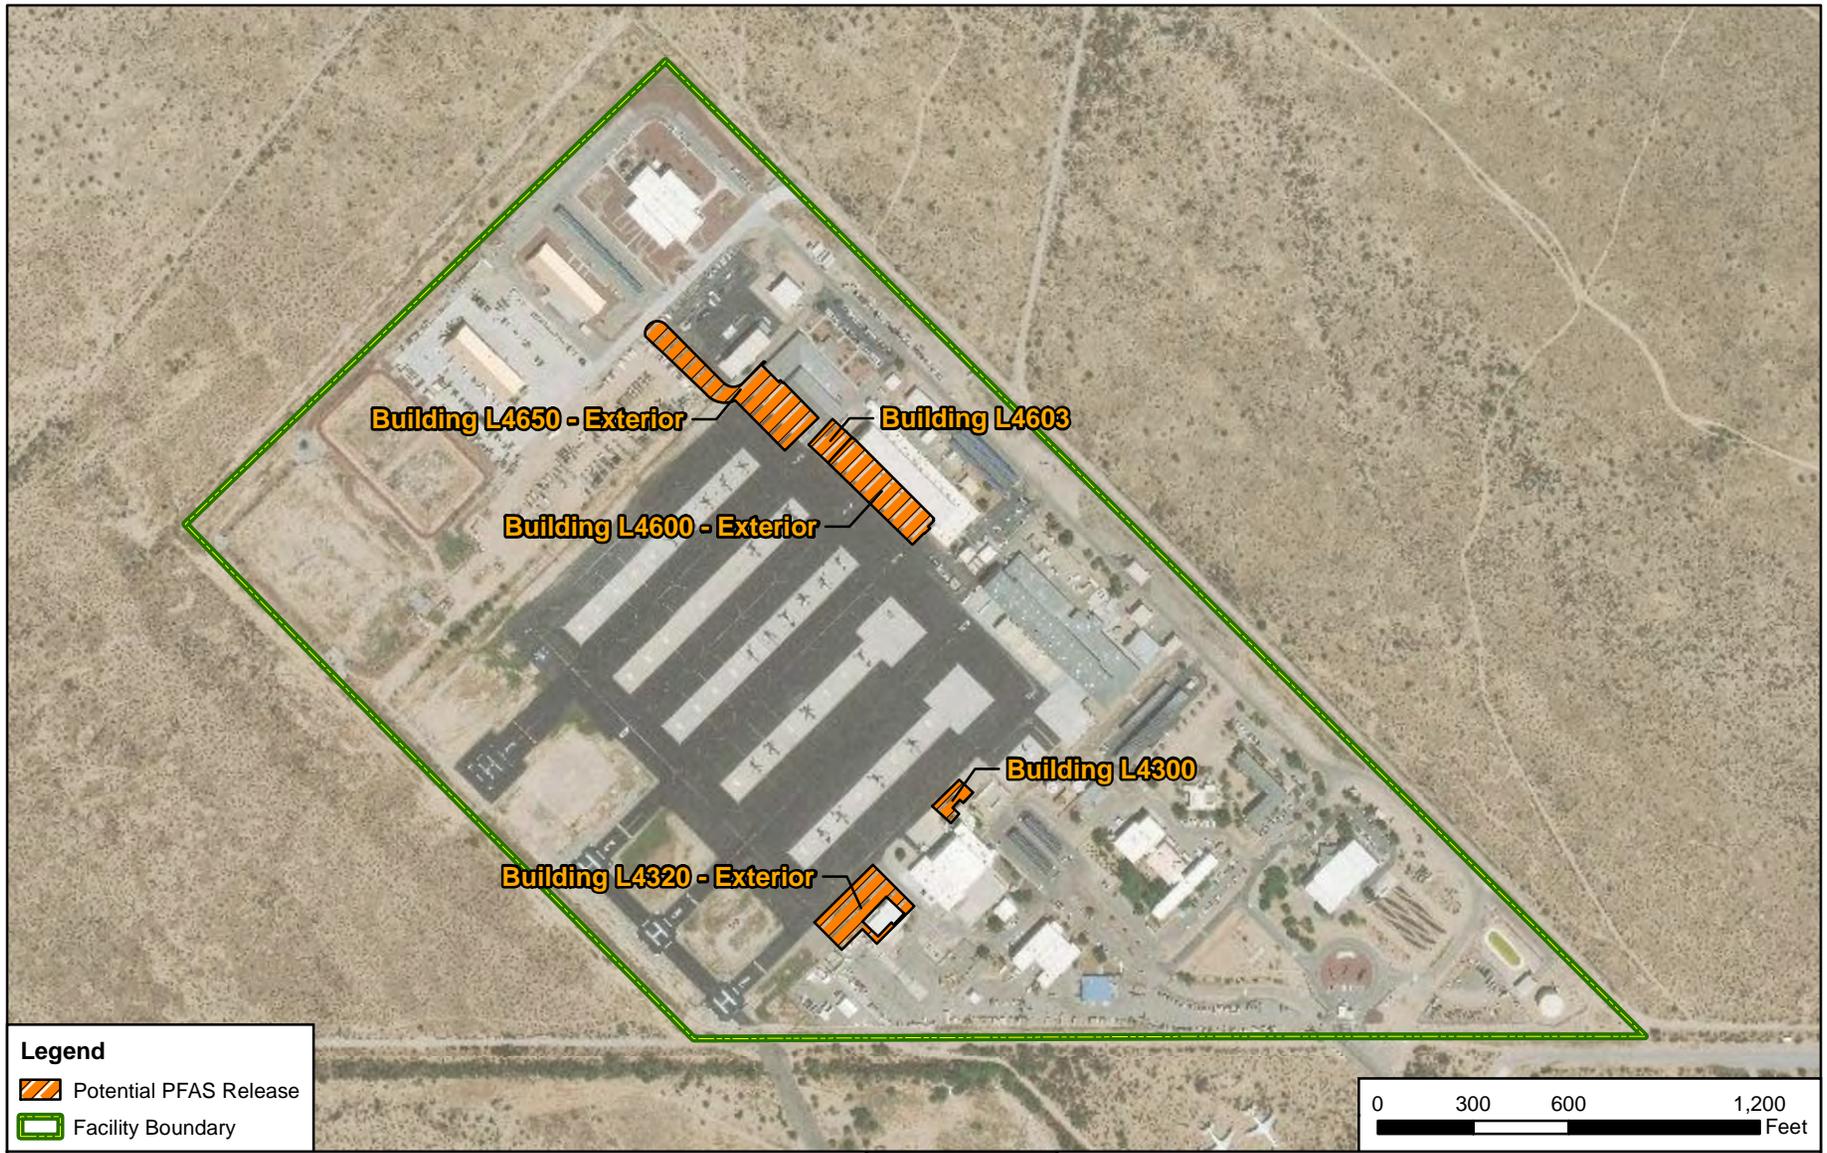
Based on visual inspection and descriptions of the fire training and maintenance activities, PFAS releases to the environment at the former fire station driveway, AC Maintenance hangar, and surrounding area (L4300) have occurred within the asphalt driveway and surrounding landscaping gravel. It is possible that sufficient rainfall may cause ponding in the area, allowing PFAS overflow from the landscaping gravel to the stormwater feature to the east. Additionally, inspection of aerial photos of this area suggests that water from the gravel areas routinely overflows to the northeast drainage ditch. There is an observable flow channel through the gravel and a linear stain feature on the asphalt to the drainage channel.

Based on historical fire training, the current fire station (L4320) driveway and surrounding area FTA includes the entire length of the asphalt and gravel driveway, the immediate areas of landscaping gravel on either side of the driveway, and in front of the current fire station (L4320) building where the fire training activities occurred. PFAS releases to the environment in this area occurred within the asphalt and gravel driveway and surrounding landscaping gravel. PFAS released on the driveway and the landscape gravel may have infiltrated the subsurface via the stormwater drainage feature located within the stormwater collection basin to the west of the fire station.

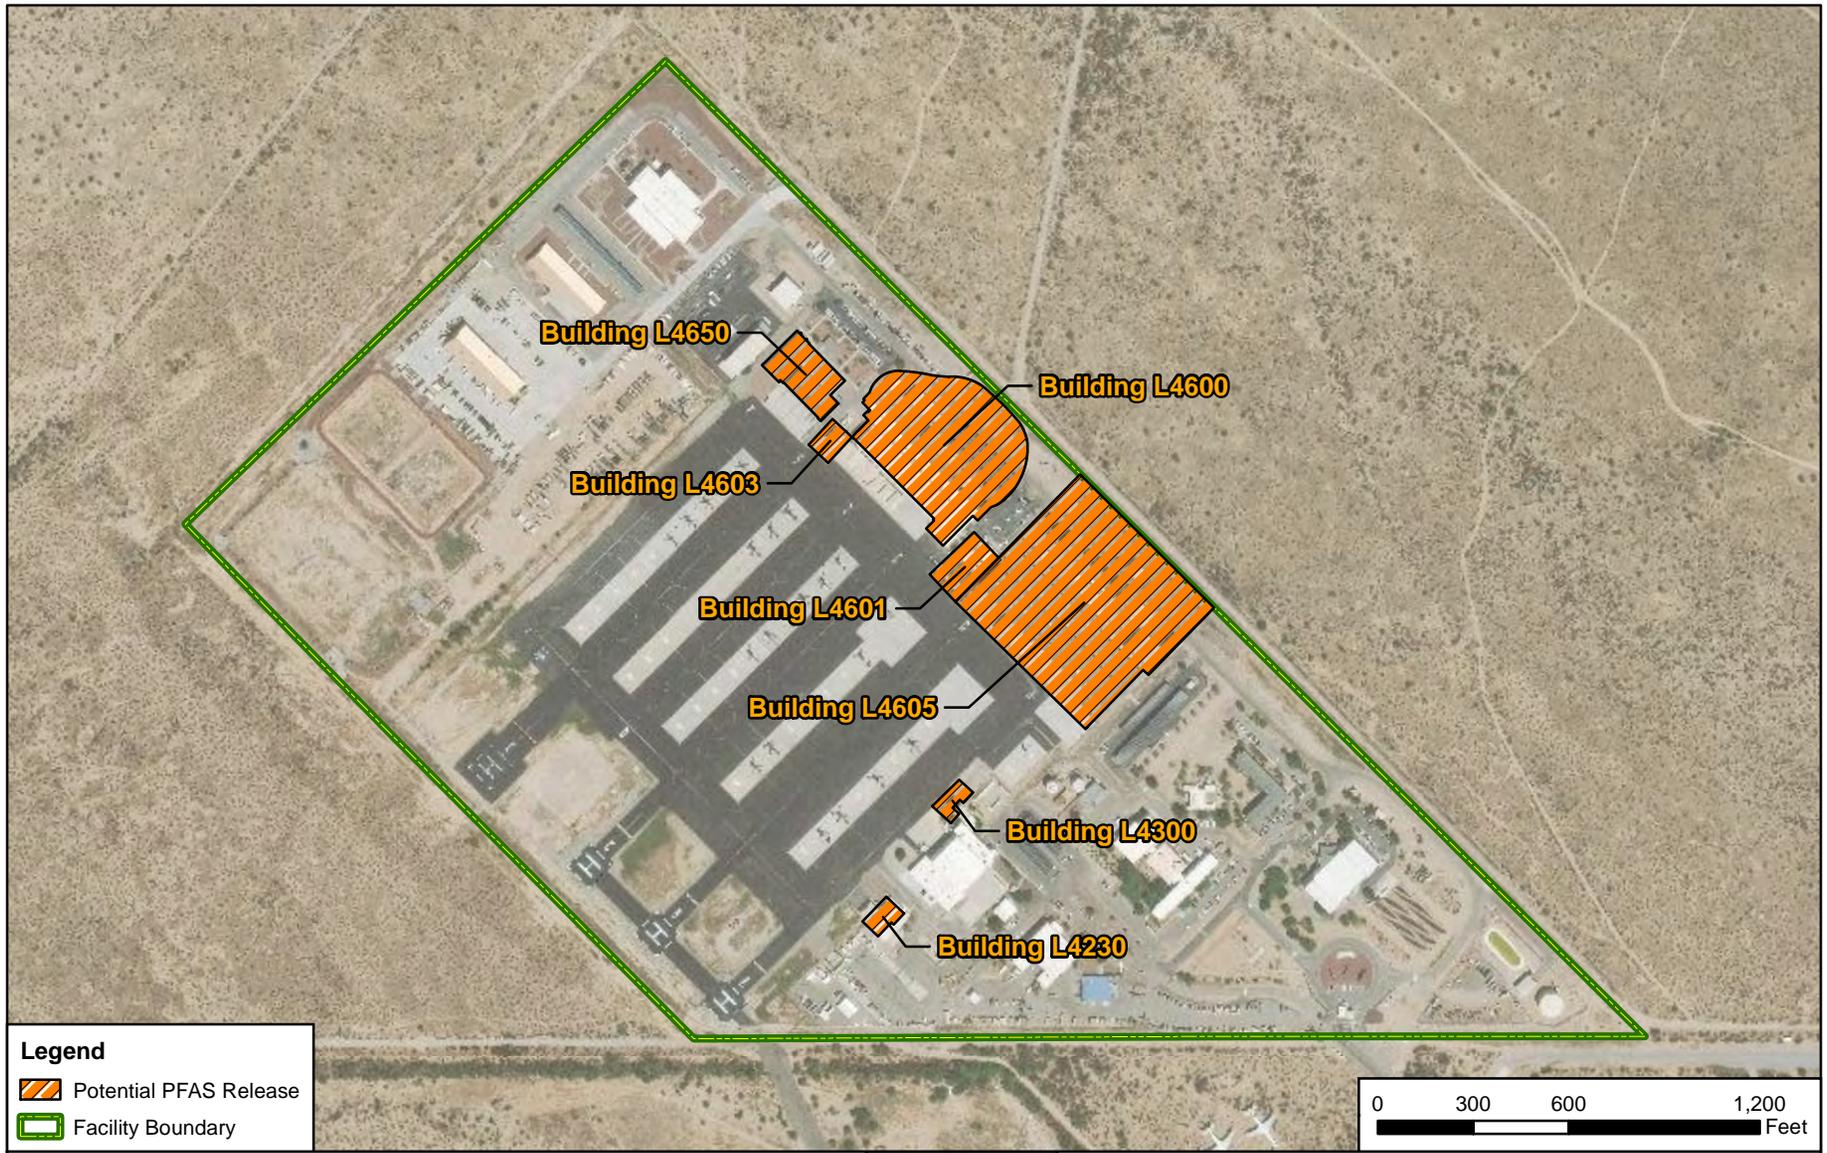
Although the Wash Rack and Drain (L4603) has a drain directing fluids to the WWTP (L4710), it is possible that environmental releases of PFAS have occurred at the Wash Rack (L4603) due to cracks and/or leaks in the surface concrete or drainage piping to the WWTP (L4710). The location of the Wash Rack and Drain is depicted on **Figure 3-1**.

Based on visual inspection and descriptions of the maintenance activities, PFAS releases to the environment at the former fire station, AC Maintenance hangar, and surrounding area (L4300) have occurred within the asphalt driveway and surrounding landscaping gravel. It is possible that sufficient rainfall may cause ponding in the area, allowing PFAS overflow from the landscaping gravel to the stormwater feature to the east. The location of the former fire station driveway, AC maintenance hangar, and surrounding area (L4300) is depicted on **Figure 3-1**.

Based on historical maintenance and equipment storage activities at the current fire station (L4320), PFAS releases to the environment in this area occurred within the asphalt and gravel driveway and surrounding landscaping gravel and fire station. PFAS released on the driveway and the landscape gravel may have infiltrated the subsurface via the stormwater drainage feature located within the stormwater collection basin to the west of the fire station, where it would then travel to the stormwater retention basin, and then infiltrate groundwater. Any PFAS released within the fire station were likely removed via the bay drains that direct fluids to the on-site WWTP (L4710) and ultimately the WWTP (L4710) retention ponds.

It is presumed that PFAS entered the environment in the unpaved areas to the northeast of the WAATS Hangar (L4605) as a result of these AFFF releases. Depending on the magnitude of the releases and rainfall following the events, PFAS may have also migrated to the stormwater feature to the northeast and to the stormwater retention basin. Possible staining was identified during the site visit in the bare earth area to the northeast.

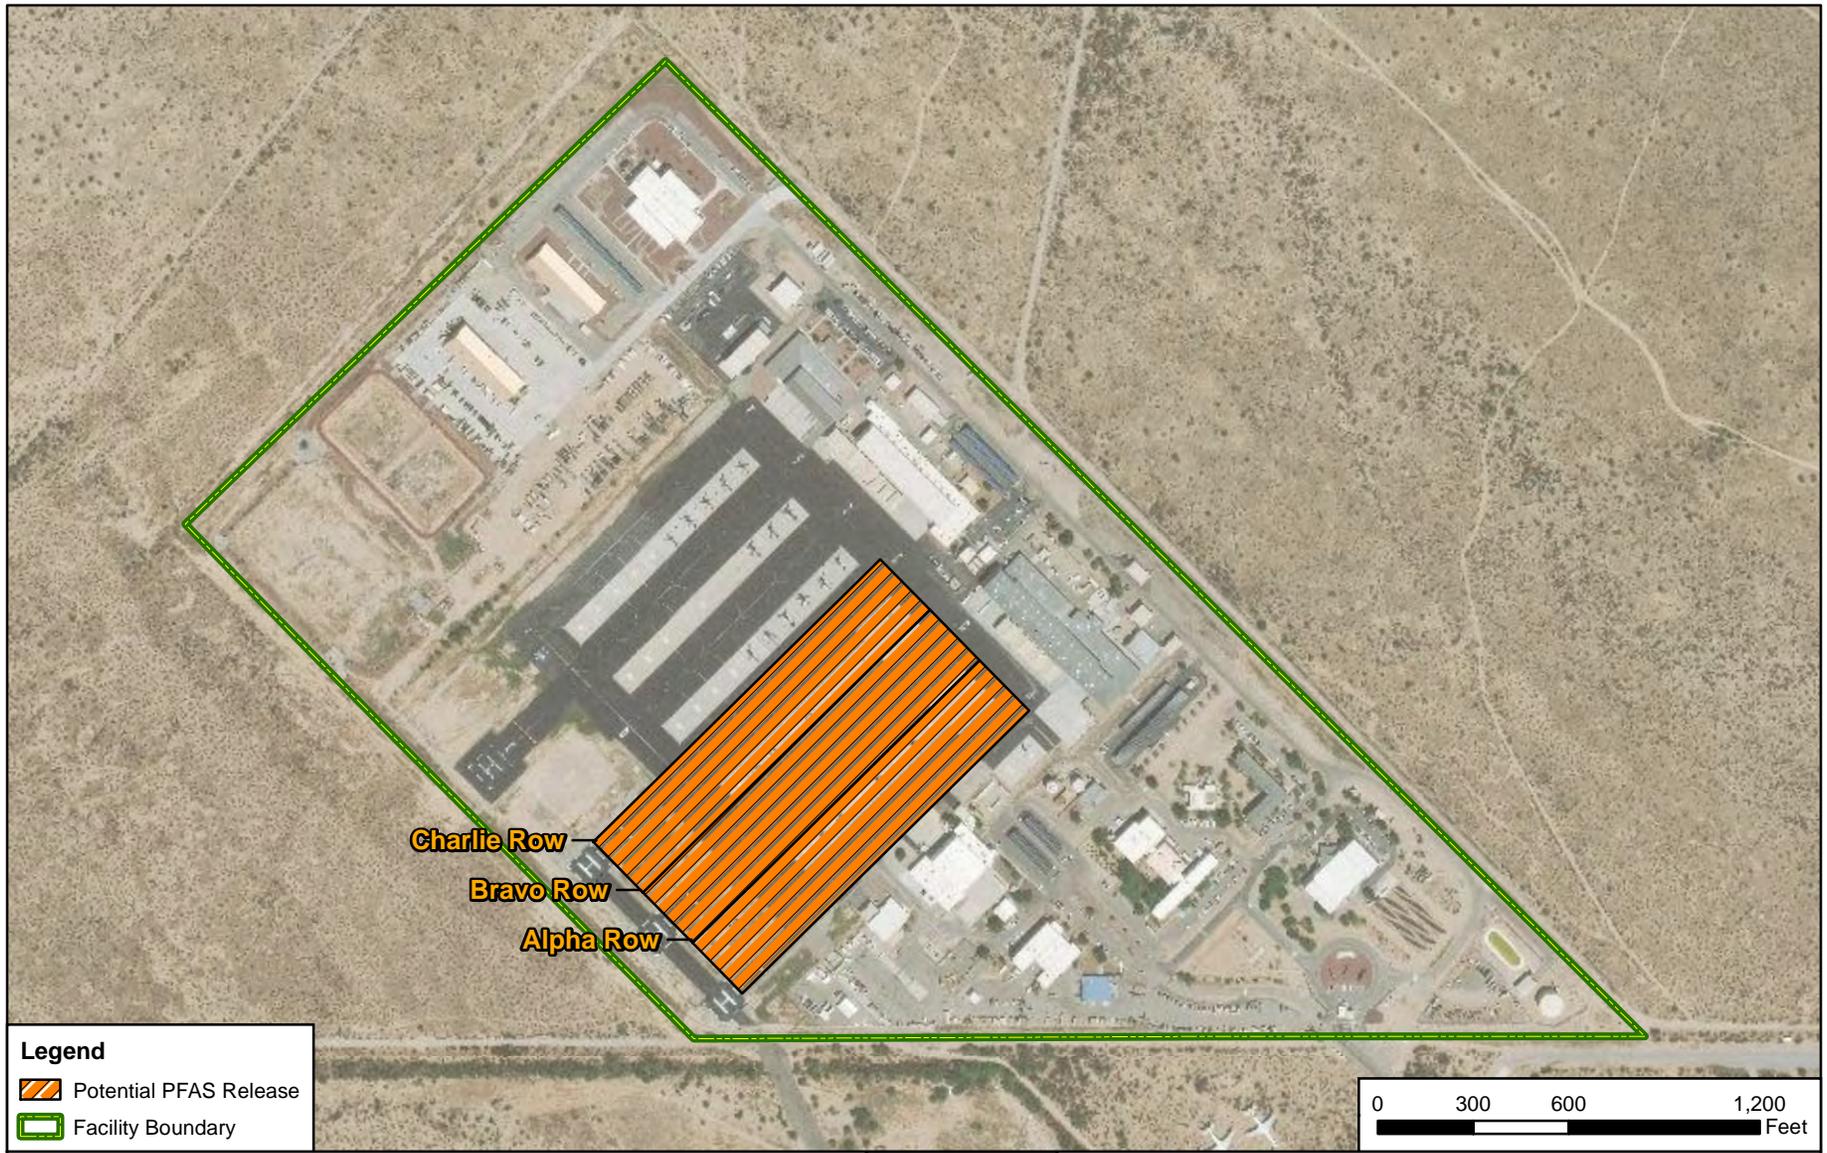
AFFF is commonly used to extinguish aviation fuel-related fires. Several fuel spills have occurred on the tarmac at SBAH. AFFF was used to control a fire or fire-potential at spills in the Alpha, Bravo, Charlie rows of the tarmac southwest of the AASF #2/WAATS Hangar. The Charlie row spill was speculated by staff to have occurred in 2003 or 2004. The timeframe of the Alpha/Bravo row spill is unknown, though SBAH personnel stated that the asphalt had to be replaced due to the extent of the spill. The volume of AFFF used in response to both events is unknown, and spill records were unavailable during the site visit. Emergency release areas are shown on **Figure 4-1**.

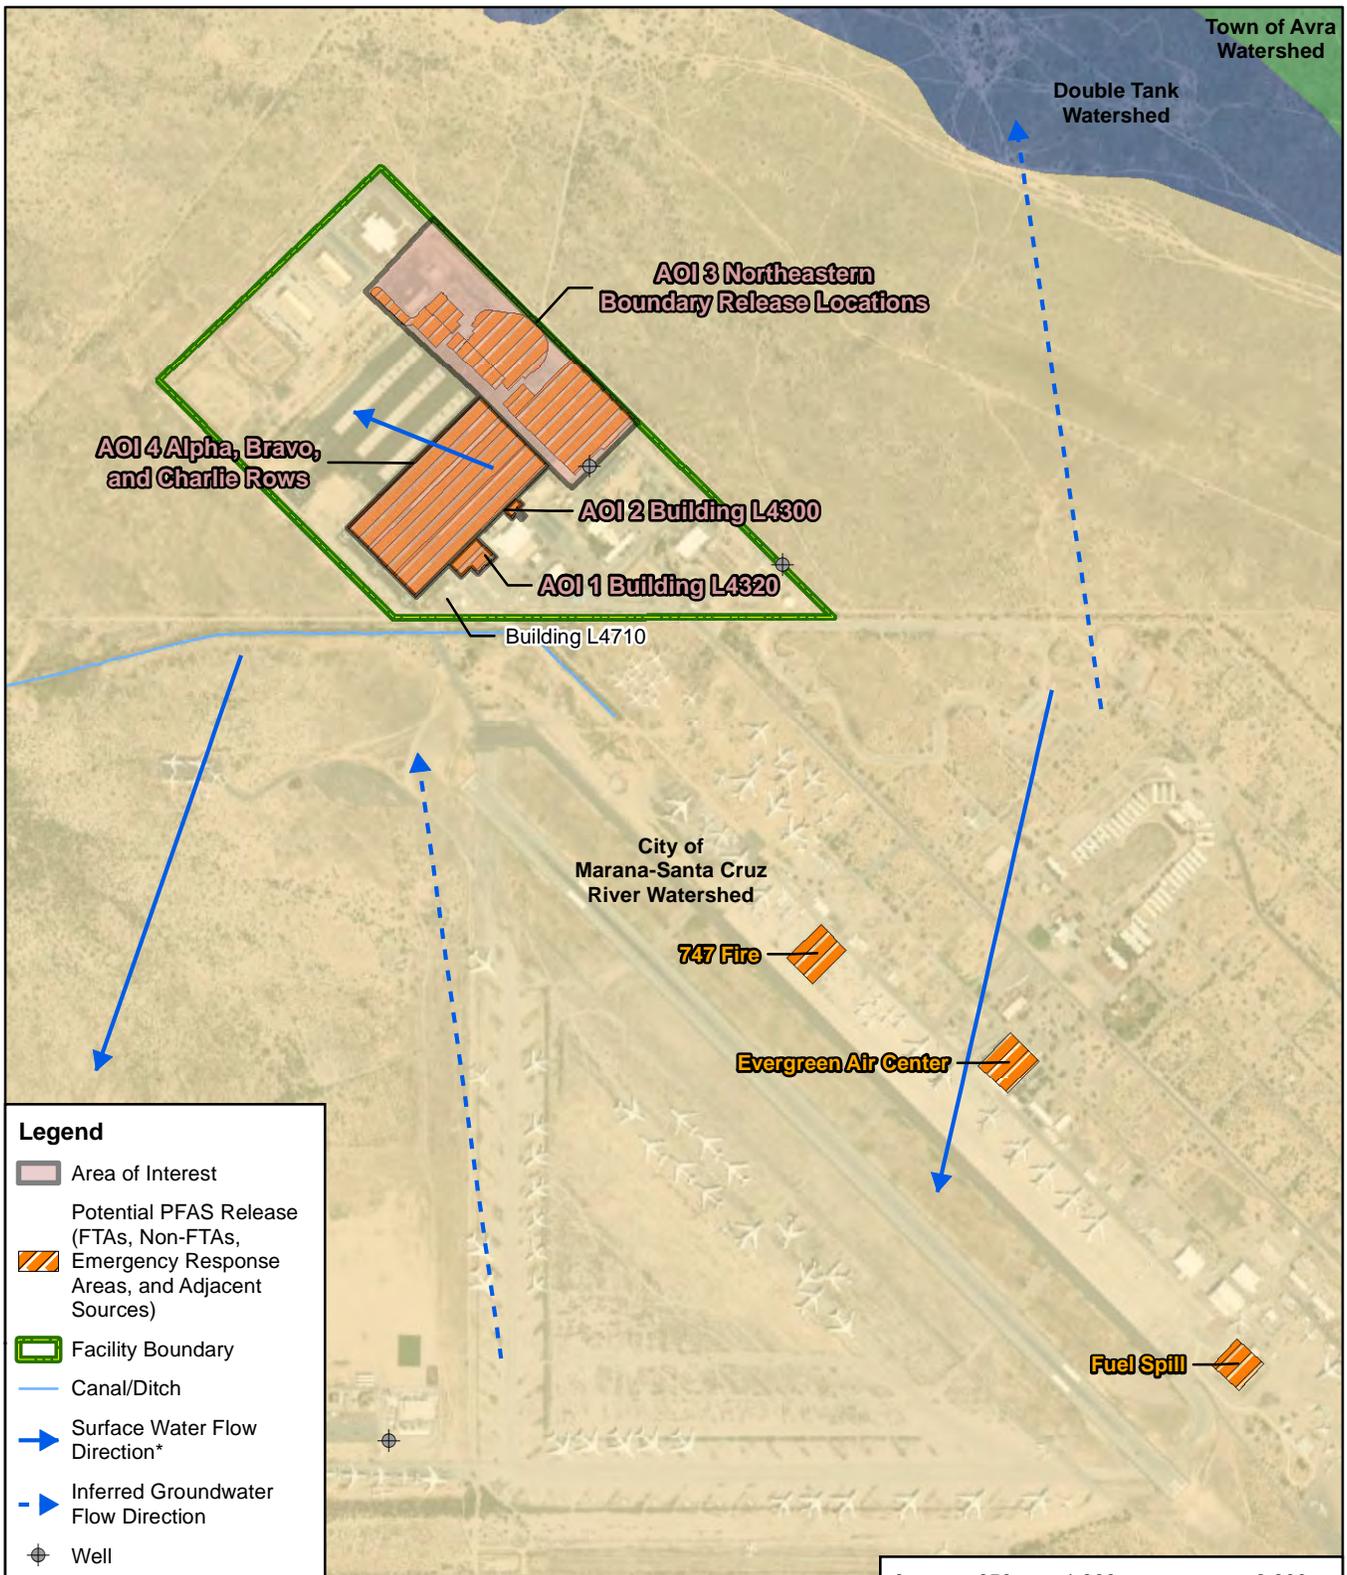
Figure 6-1

Based on the findings of this PA, four AOIs have been identified at SBAH: AOI 1 Current Fire Station (L4320), AOI 2 Former Fire Station Driveway, AC Maintenance Hangar, and Surrounding Area (L4300), AOI 3 Northeastern Boundary Release Locations (which encompasses the Singapore Hangar [L4650], Wash Rack and Drain [L4603], AASF #2 [L4600], Former Fire Station [L4601], and WAATS Hangar [L4605]), and AOI 4 Alpha, Bravo, and Charlie rows. An AOI can be the location of a single known or suspected PFAS release or a group of closely related releases on a facility. Off-facility releases are not categorized as AOIs but are noted in the preliminary CSM if there is a potential to impact receptors on the facility. A preliminary CSM is provided for each AOI with a unique set of sources/pathways/receptors. If the preliminary CSM is identical for multiple AOIs, then they are shown on one diagram. The AOI locations are shown on **Figure 6-1**. The following sections describe the CSM components for each AOI identified. Each preliminary CSM identifies the three components necessary for a potentially complete exposure pathway: (1) source, (2) pathway, and (3) receptor. If any of these elements are missing, the pathway is considered incomplete.

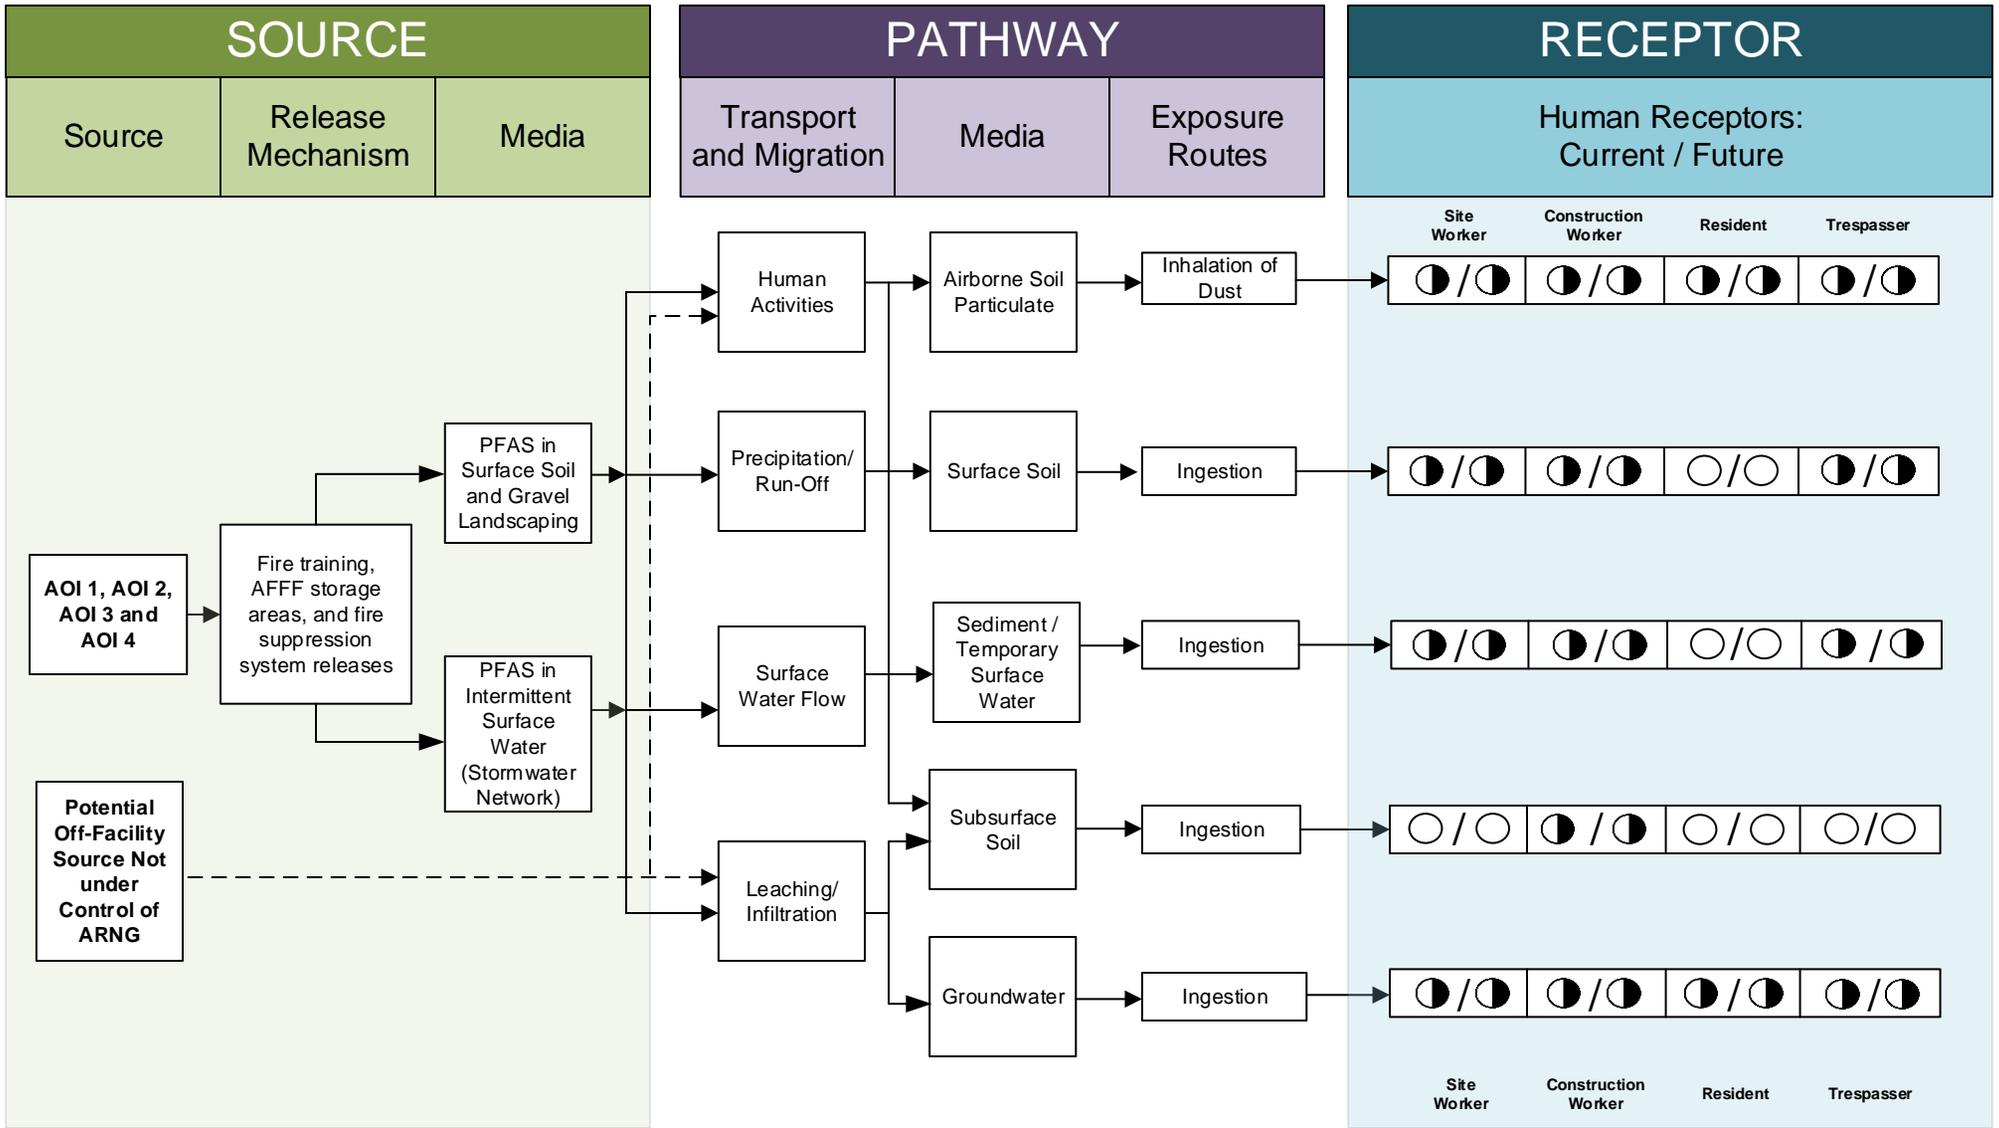
PFAS may have also been transported to subsurface soil and groundwater via dry wells in the SBAH stormwater network. Because drinking supply wells exist at the facility, the pathway for PFAS in groundwater to facility staff, construction workers, and trespassers is potentially complete. Additionally, private wells exist off-facility and downgradient to the north. Therefore, the pathway for PFAS exposure in drinking water to off-facility receptors is potentially complete.

Ground-disturbing activities to subsurface soil at AOI 4 could result in construction worker exposure to potential PFAS contamination via inhalation of dust particles or ingestion of subsurface soil in the unpaved areas within and surrounding the Alpha, Bravo, and Charlie Rows. Therefore, the exposure pathways for these receptors are potentially complete. The preliminary CSM diagram for AOI 4 is shown on **Figure 6-2**.
