# FINAL Preliminary Assessment Report Camp Roberts, California

Perfluorooctane-Sulfonic Acid (PFOS) and Perfluorooctanoic  
Acid (PFOA) Impacted Sites  
ARNG Installations, Nationwide

November 2019

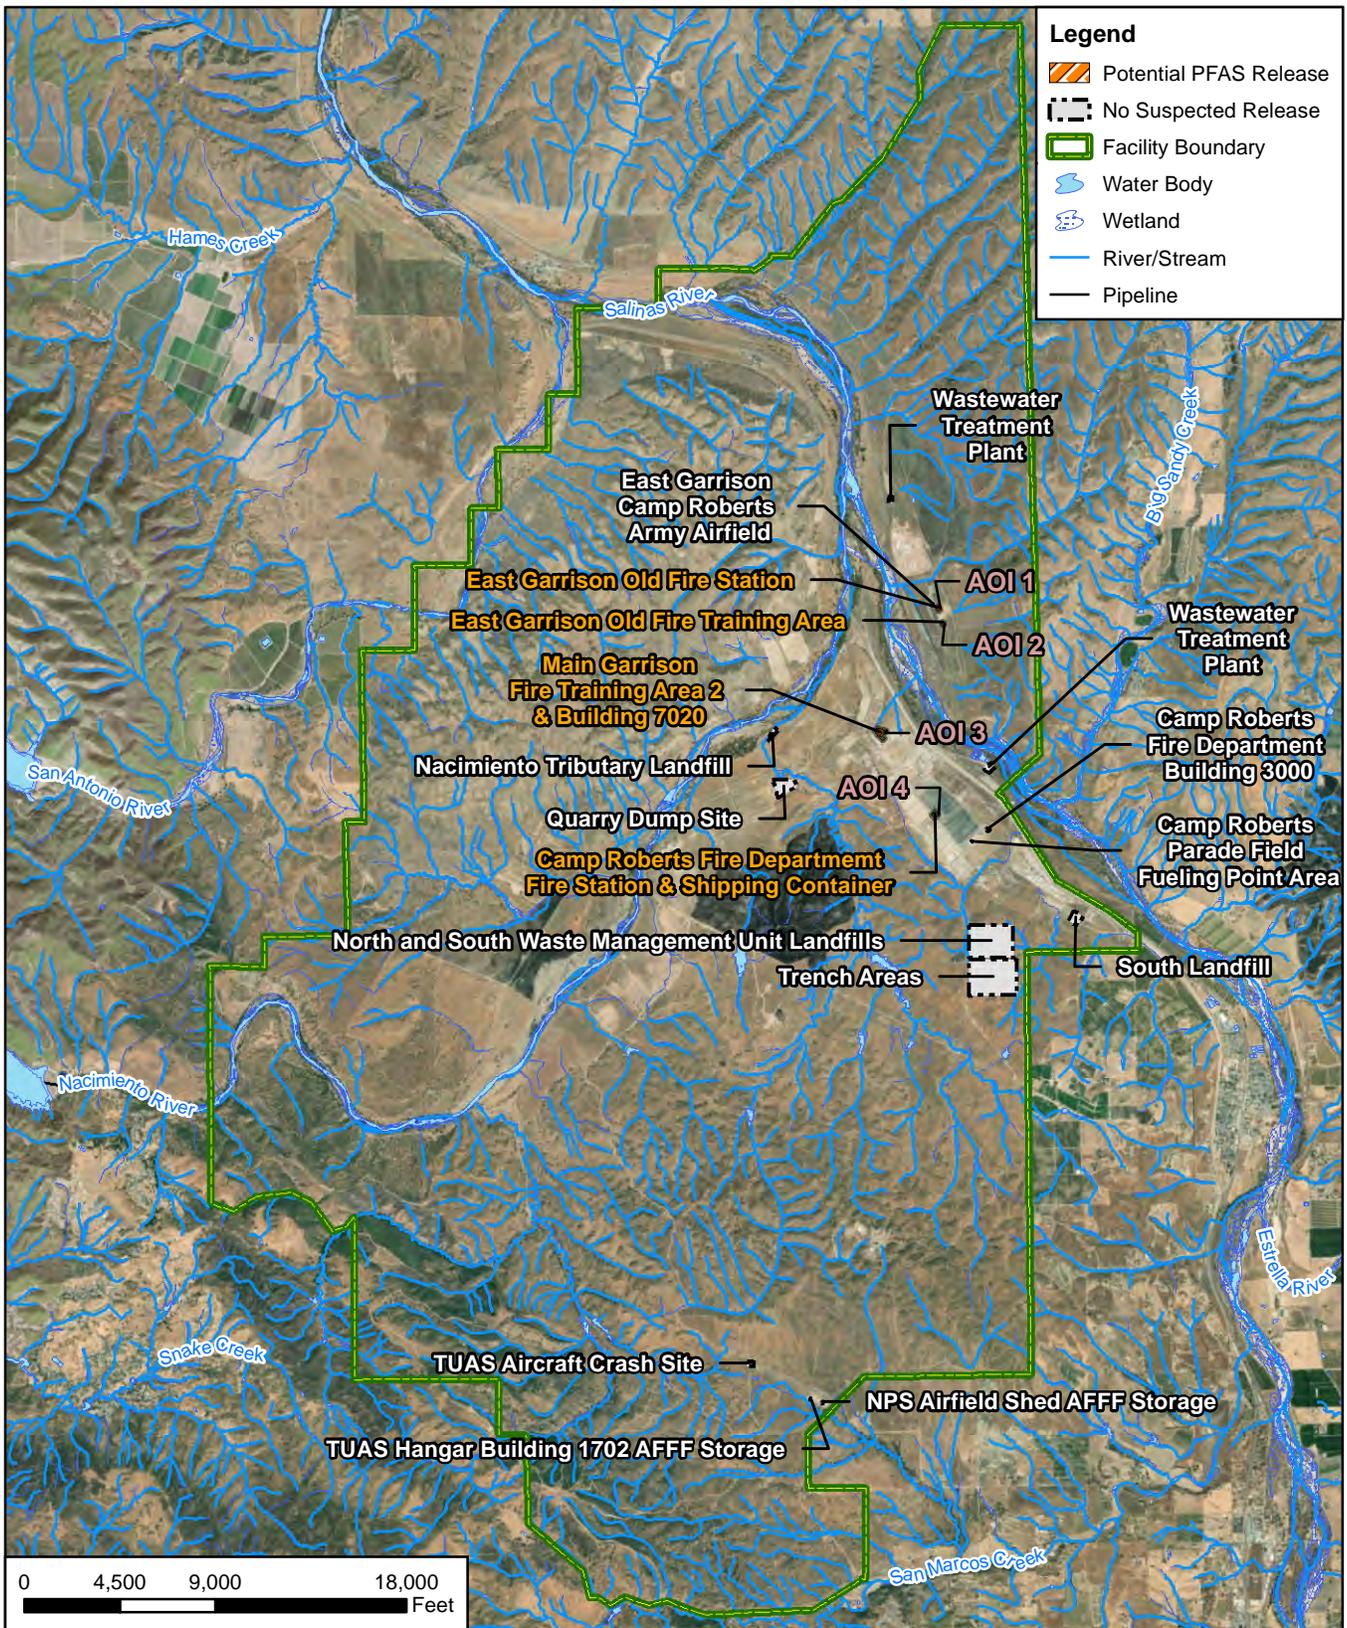
<b>Summary of Findings</b>	
<b>AECOM</b> 12420 Milestone Center Drive Germantown, MD 20876	<b>Figure ES-1</b>

Based on information obtained during the PA at these AOIs, there is potential for exposure to PFAS contamination in surface soil and intermittent surface water and sediments to site workers, construction workers, residents, recreational users, and trespassers via ingestion and inhalation;

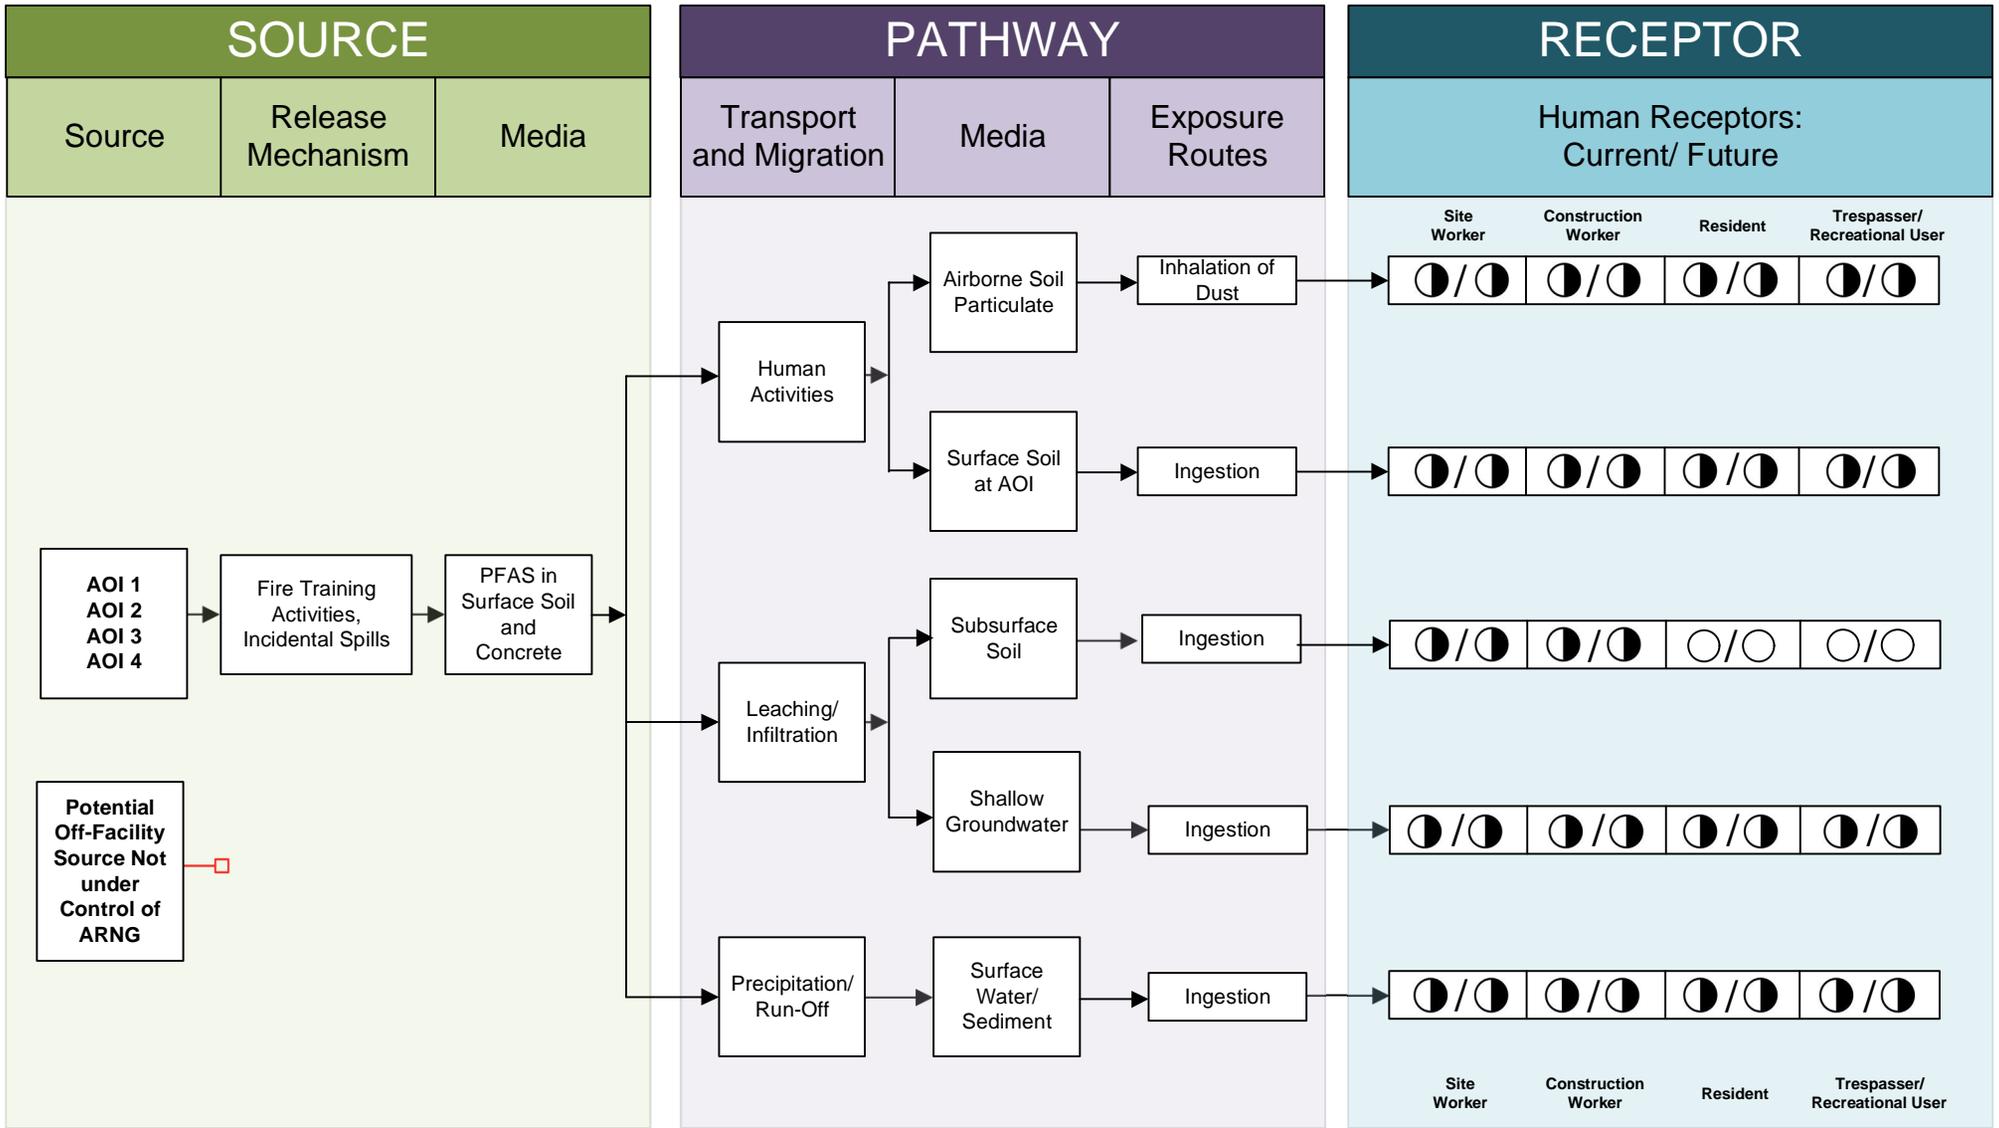
subsurface soil to site and construction workers via inhalation; and groundwater to all receptors via ingestion. The CSM for Camp Roberts is shown on **Figure ES-2**.

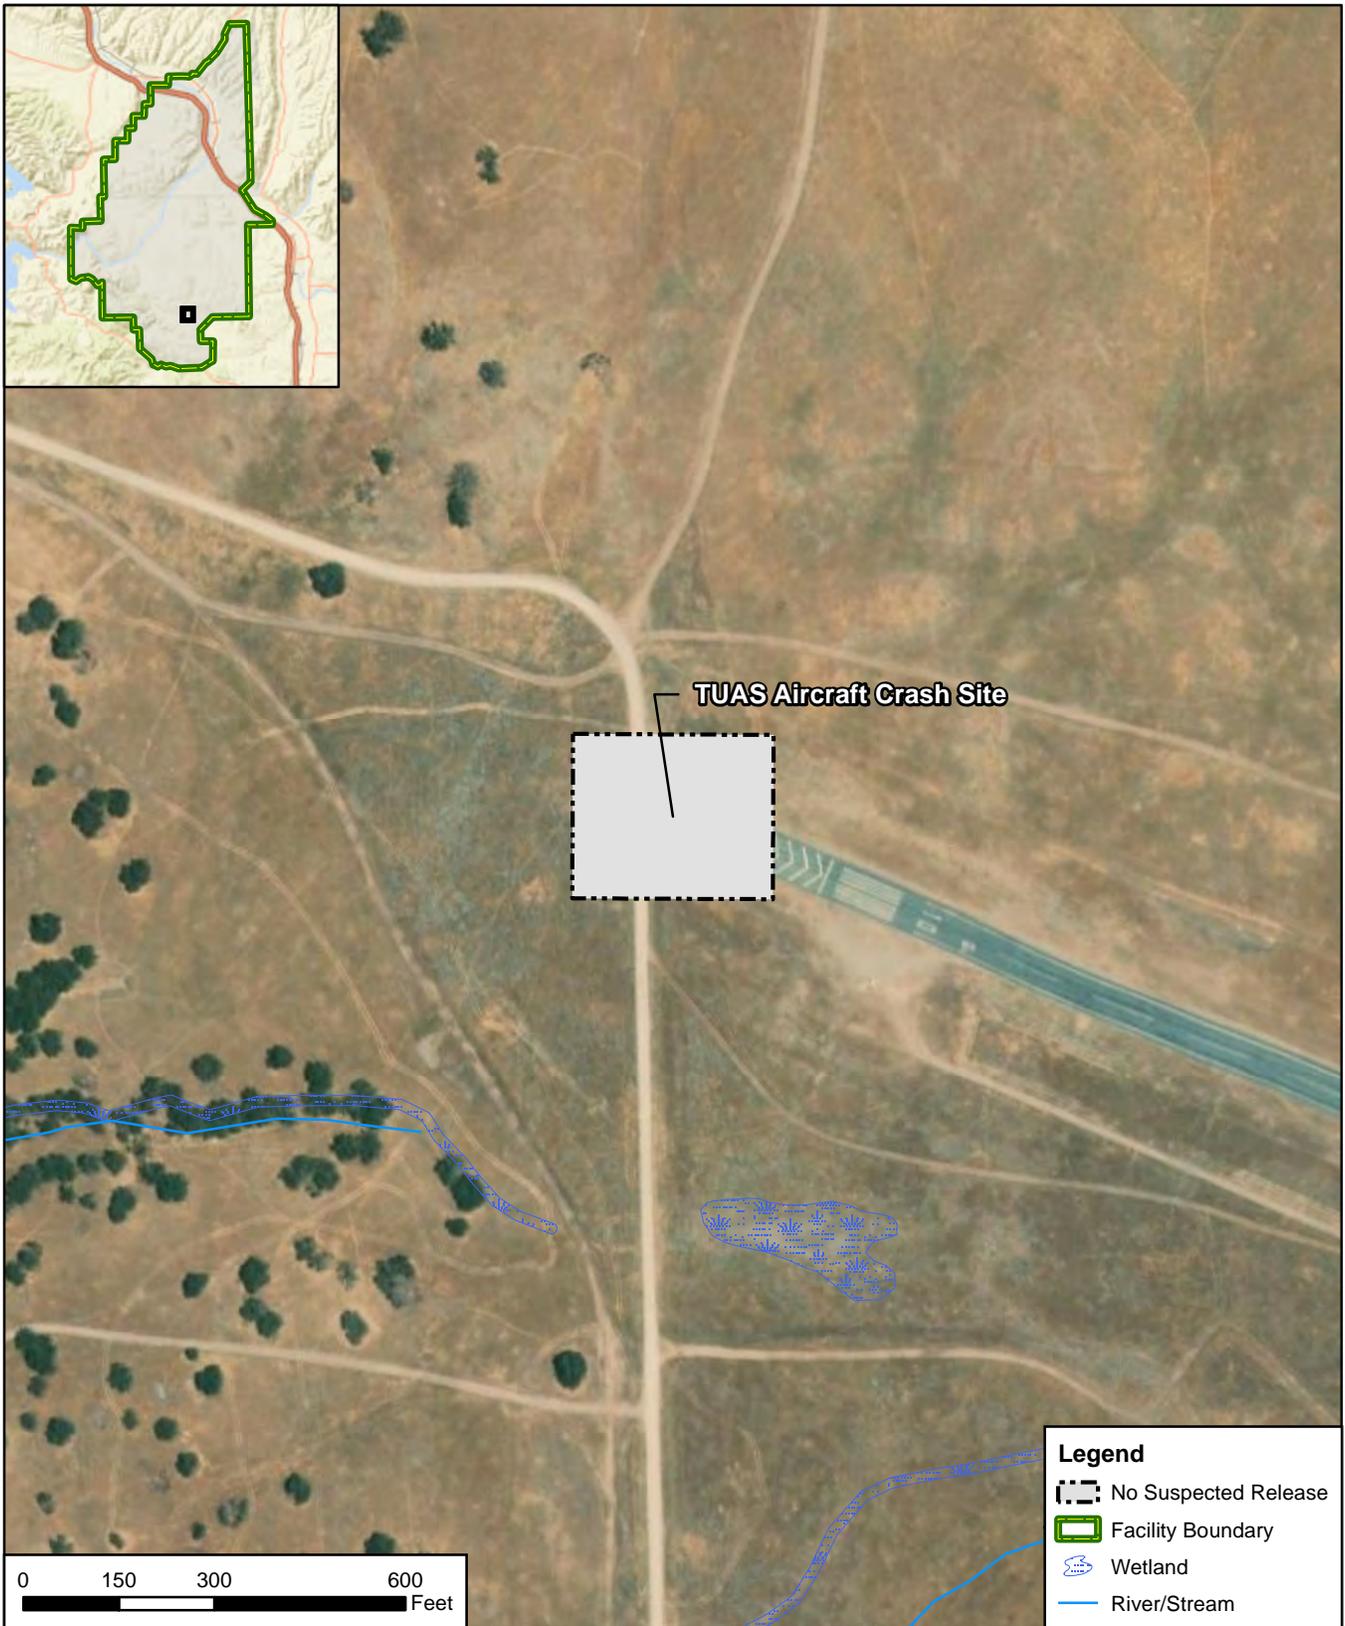
TUAS Aircraft Crash Site

In the late 1990s or early 2000s, a TUAS aircraft crashed near the end of the McMillan Airfield runway. TUAS aircraft at McMillan airfield are operated by the TUAS division of the CA ARNG. During the crash, the lithium ion battery was damaged and caused a fire that spread to about three acres in size. According to the NPS and CR FD staff interviewed, the fire was extinguished with water by the CR FD.

A second crash incident occurred that also involved a TUAS aircraft. The aircraft was reported to have crashed in a high ridge area near Camp Roberts. Other information related to the crash was not recalled by those interviewed.

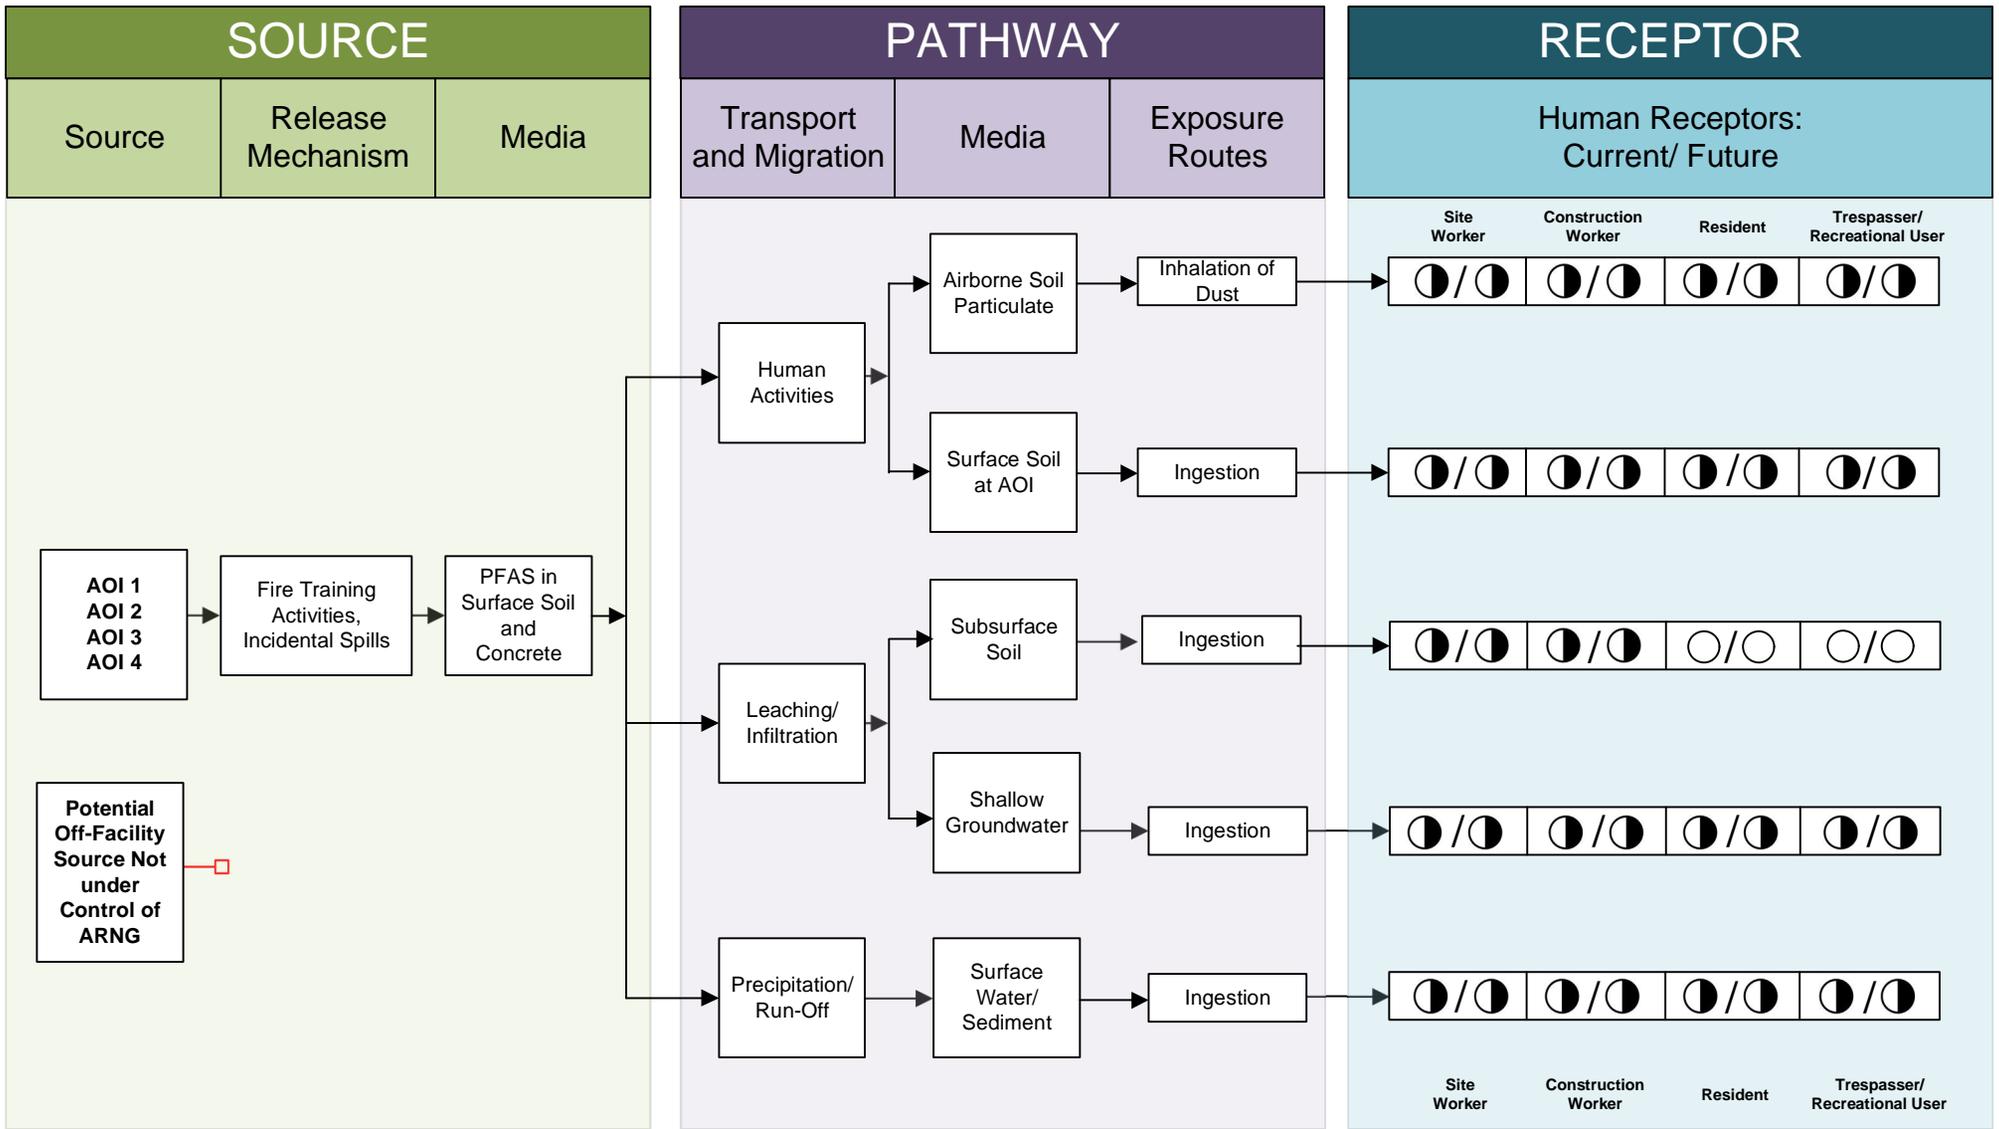
Figure 6-2  
Conceptual Site Model  
Camp Roberts AOIs

exposure via ingestion of subsurface soil. Therefore, the inhalation and ingestion pathways for these receptors are considered potentially complete. Based on an assumed northwestern groundwater flow direction, the AOIs are upgradient of potable wells. Because the drinking water supply wells may be impacted by potential PFAS releases at the AOIs, the exposure pathway for groundwater to all receptors is potentially complete. Site workers, construction workers, and trespassers at the facility may be exposed to PFAS via ingestion of surface water and sediment in the Salinas River and its tributaries. Similarly, farmers, residents, and recreational users may be exposed to PFAS in surface water and sediment off-facility. The CSM for AOI 1 and AOI 2 is shown on **Figure 6-2**.

Surface water at AOI 3 flows to the southeast, towards a small drainage ditch which captures and carries water towards the Salinas River. The river is located approximately 0.5 miles to the east of AOI 3. If PFAS were released to surface soil at AOI 3, they had potential to migrate from surface soil to surface water via run-off and to groundwater via leaching. The nearest groundwater wells to AOI 3 are to the west of the AOI. With groundwater flow to the northwest, the supply wells are potentially downgradient of the AOI. The pathways and receptors for AOI 3 are the same as described in **Section 6.1**. The CSM for AOI 3 is shown on **Figure 6-2**.

Incidental spills of AFFF could migrate through gravel covered areas into surface soil and subsurface soil to groundwater via leaching. Nearby tributaries may have been impacted by surface water run-off from AOI 4. Surface and groundwater flow is to the north/northeast, towards the Salinas River. The pathways and receptors for AOI 4 are the same as described in **Section 6.1**. The CSM for AOI 4 is shown on **Figure 6-2**.
