FINAL Preliminary Assessment Report Brooksville Readiness Center / AASF #2 Spring Hill, Florida

Perfluorooctanesulfonic Acid (PFOS) and Perfluorooctanoic
Acid (PFOA) Impacted Sites
ARNG Installations, Nationwide

August 2020

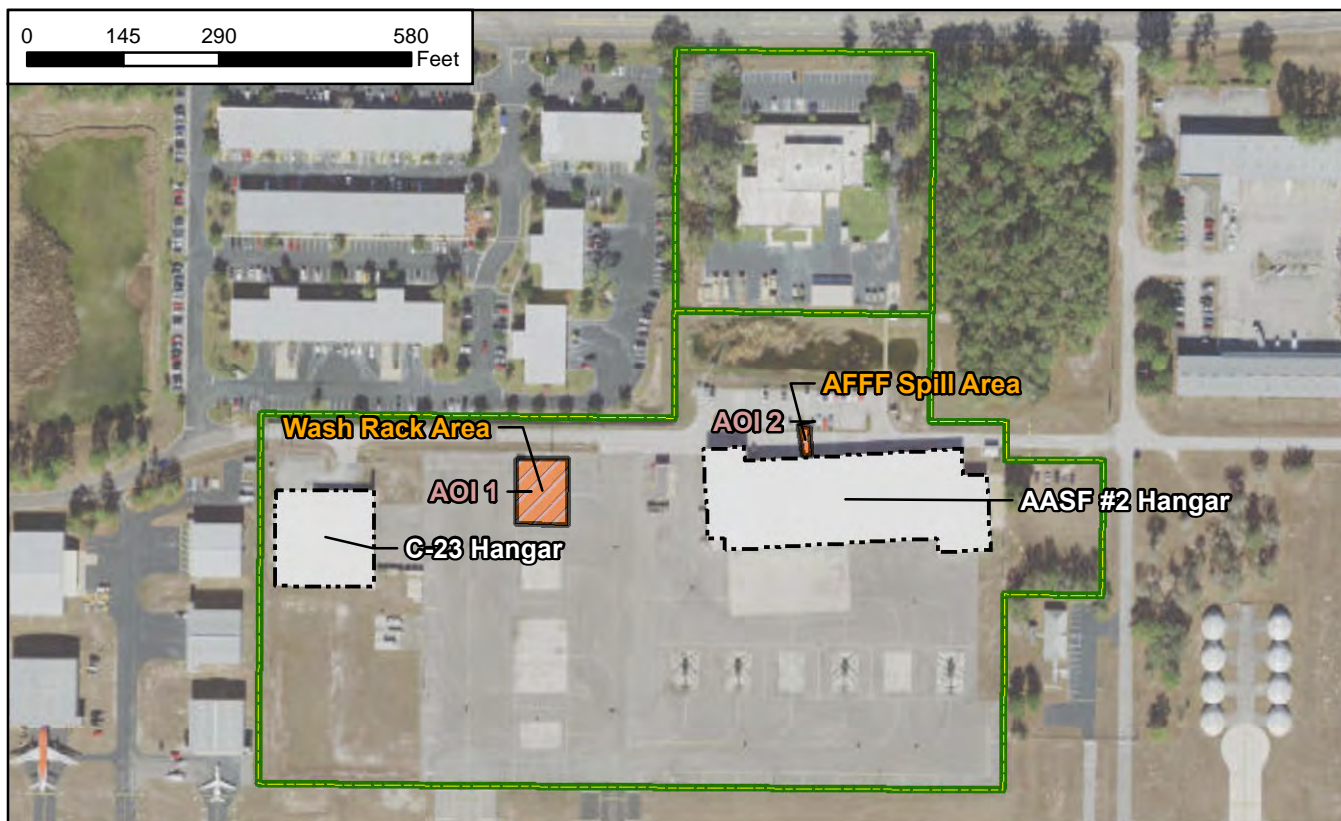
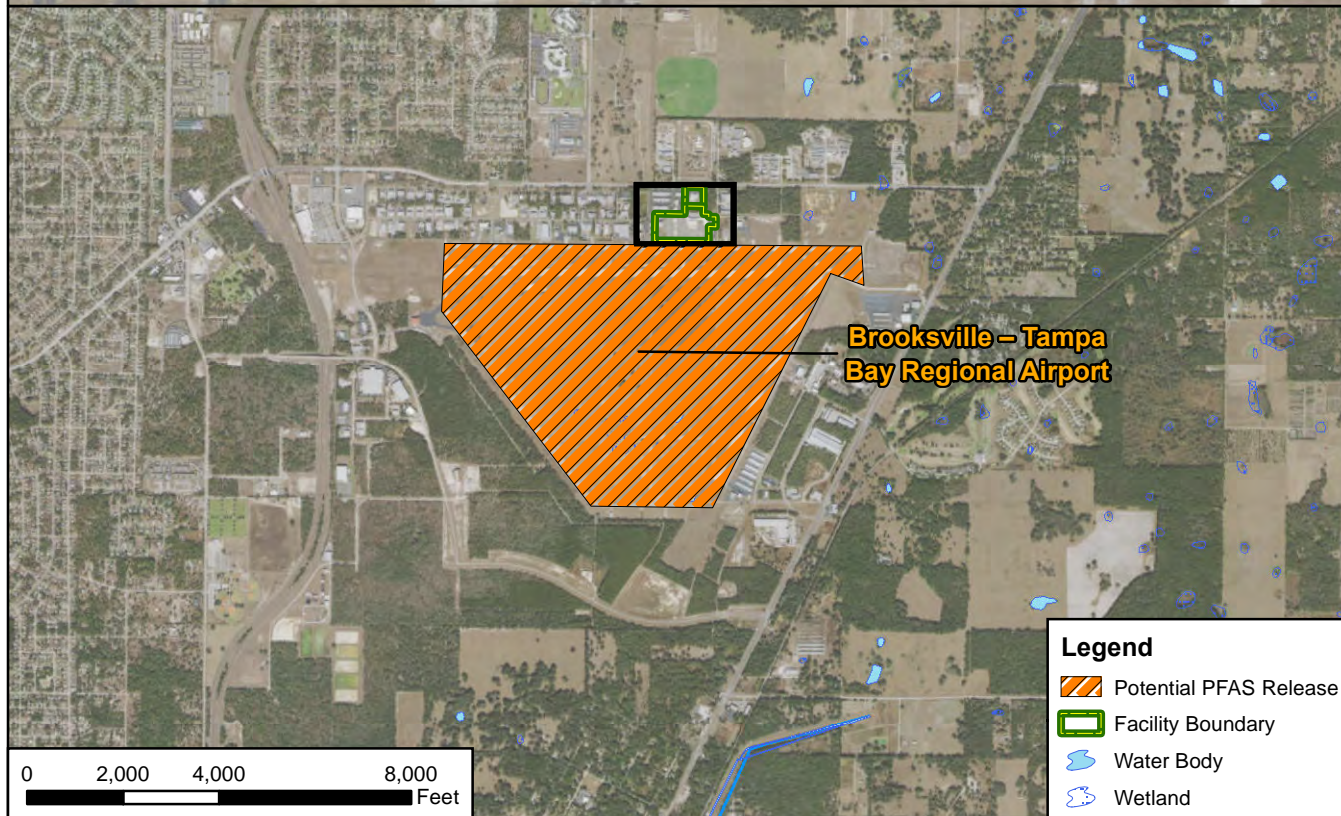
Area of Interest	Name	Used by	Potential Release Dates
AOI 1	Wash Rack Area	FLARNG	2007 - 2008
AOI 2	AFFF Spill Area	FLARNG	2002 - 2003

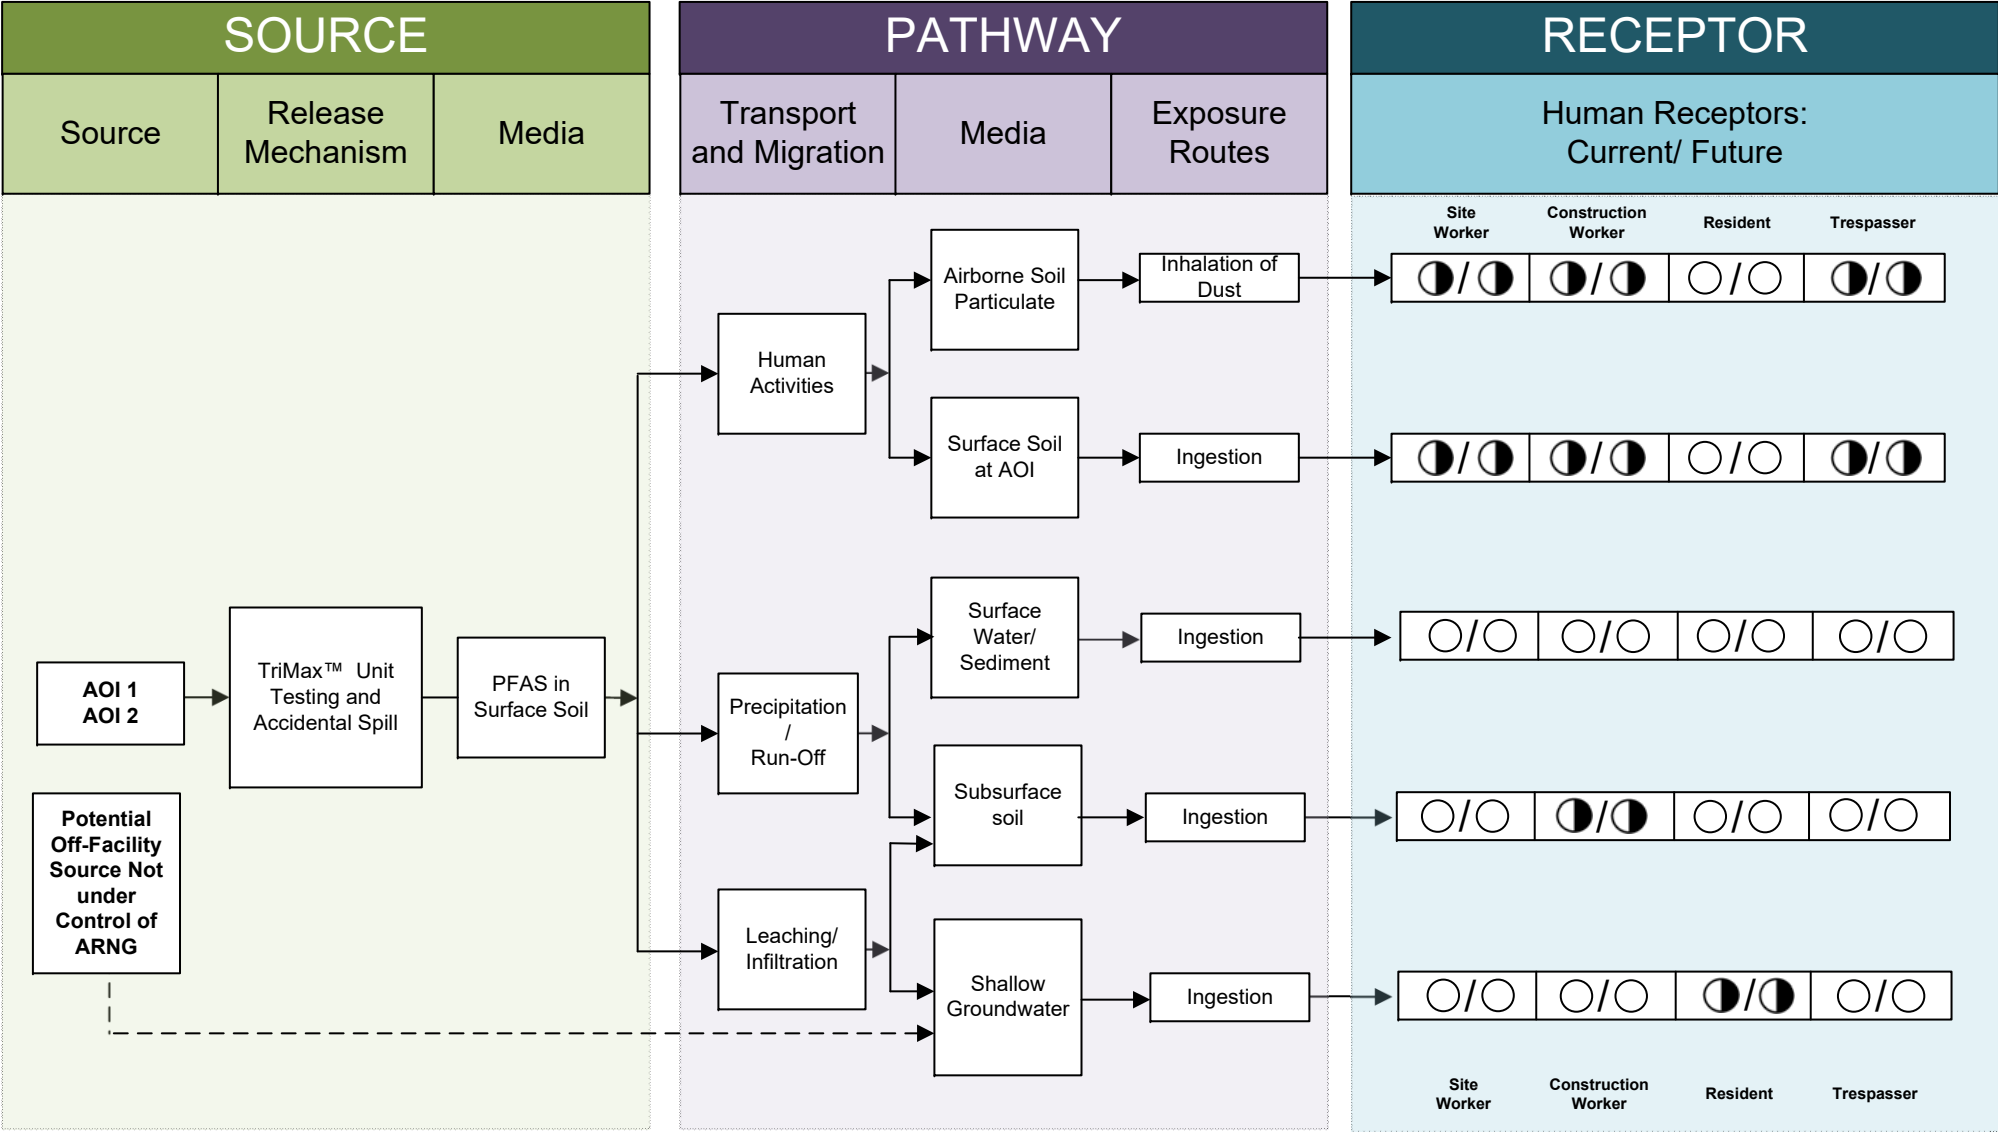
Figure ES-2

Based on documented potential PFAS releases at these AOIs, there is potential for exposure to PFAS contamination in media at or near the facility. The CSM for Brooksville RC, which presents the potential receptors and media impacted, is shown on **Figure ES-2**. Based on the third Unregulated Contaminant Monitoring Rule (UCMR3) data, it was indicated that there were no detections above USEPA Health Advisory levels in public water systems within 20 miles of the facility.

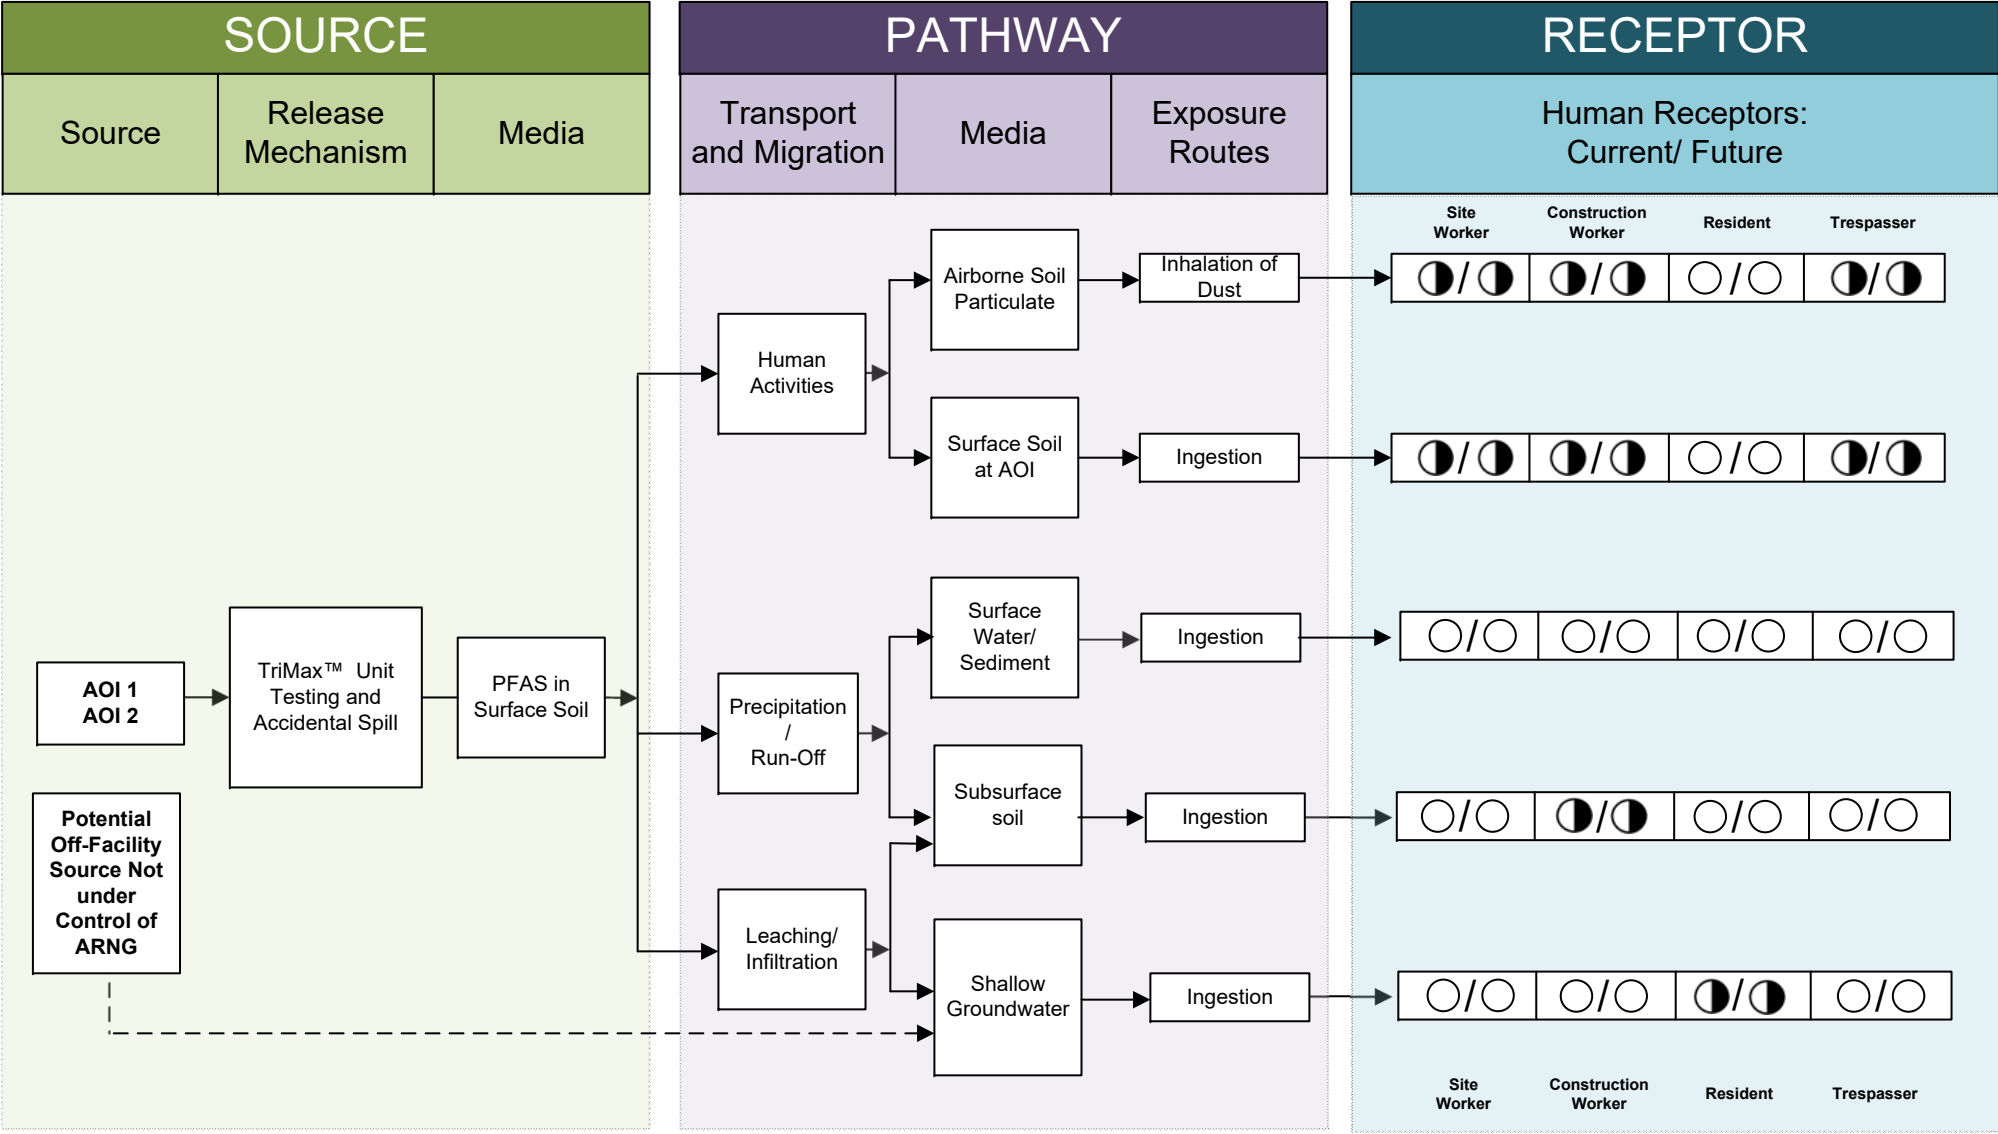
Area of Interest	AOI Location	Rationale	Potential Future Action
AOI 1 Wash Rack Area	28°28'44.33"N and 82°27'20.62"W	Annual TriMax™ unit testing completed at wash rack from 2007 to 2008.	Proceed to an SI, focus on soil and groundwater
AOI 2 AFFF Spill Area	28°28'44.98"N and 82°27'16.07"W	Approximately 5 gallons of 3% AFFF spilled some time in 2002-2003.	Proceed to an SI, focus on soil and groundwater
