# FINAL Preliminary Assessment Report Army Aviation Support Facility #1, Hammond, Louisiana

Perfluorooctanesulfonic Acid (PFOS) and Perfluorooctanoic  
Acid (PFOA) Impacted Sites  
ARNG Installations, Nationwide

July 2020

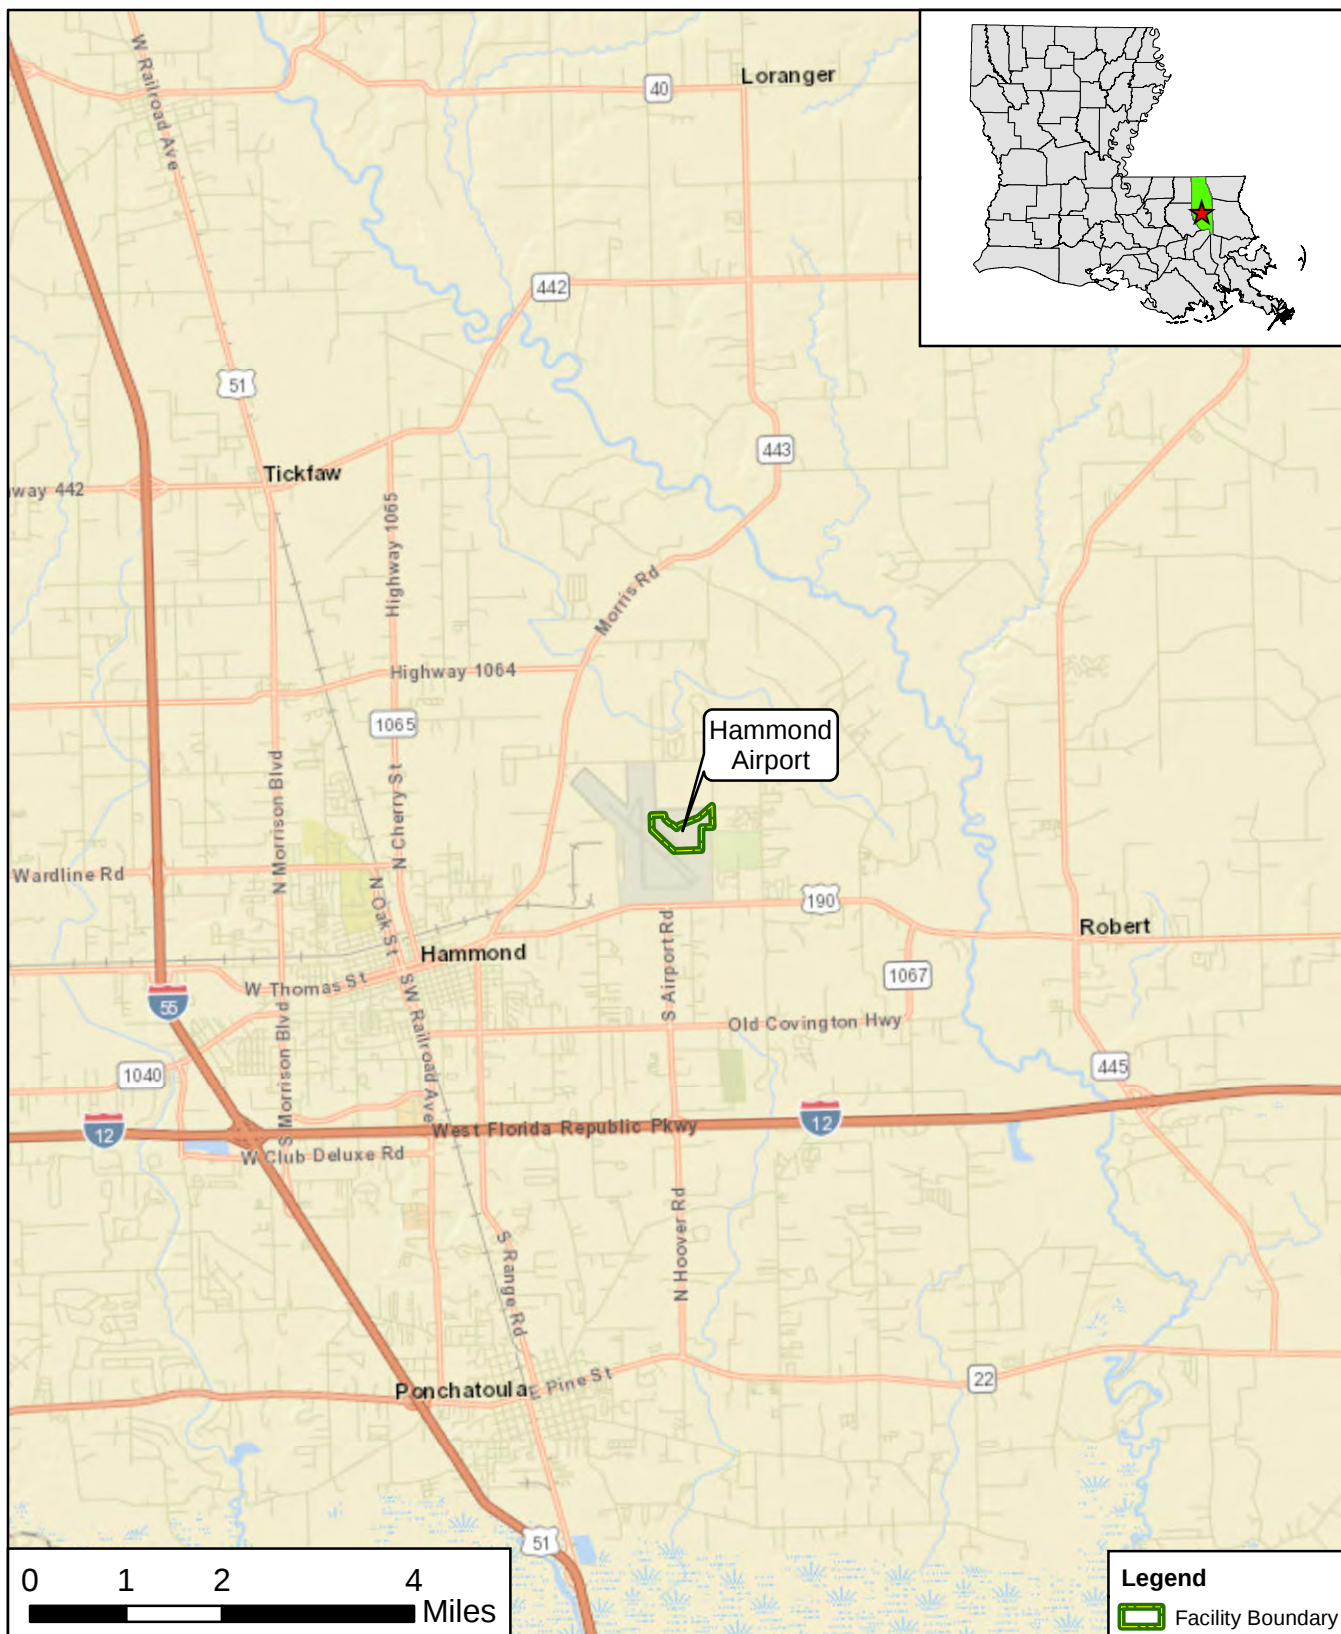
**Figure 1-1**

Hammond AASF #1 is co-located with Hammond Northshore Regional Airport and an Air National Guard (ANG) facility. The AASF #1 is just north of Highway 190 at 1399 Industrial Park Road Hammond, LA 70701, in Tangipahoa Parish (**Figure 1-1**).

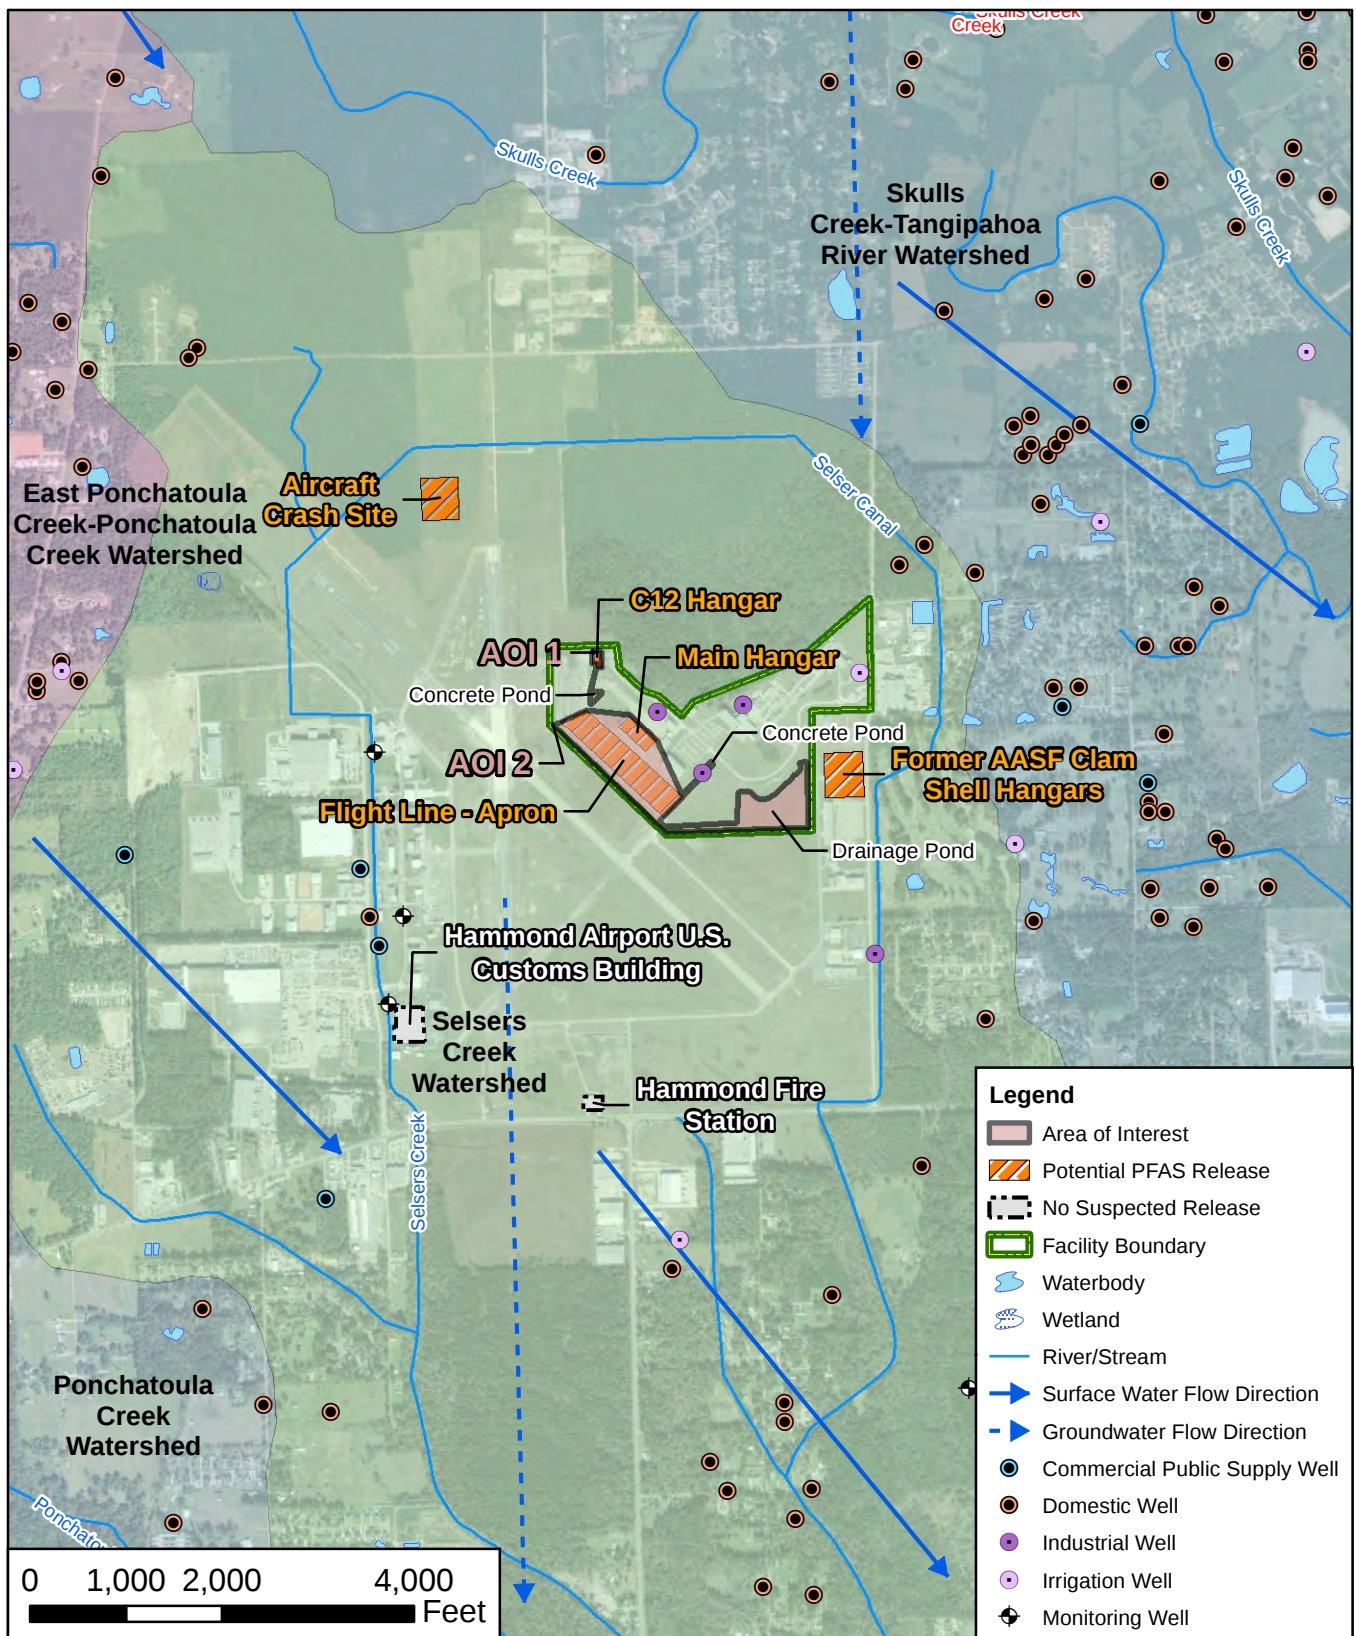
Based on the PA findings, two non-FTAs were identified as AOIs where PFAS may have been incidentally spilled or discharged to the ground surface. As such, these AOIs may be potential PFAS source areas. The AOIs are shown on **Figure 6-1** and summarized below.

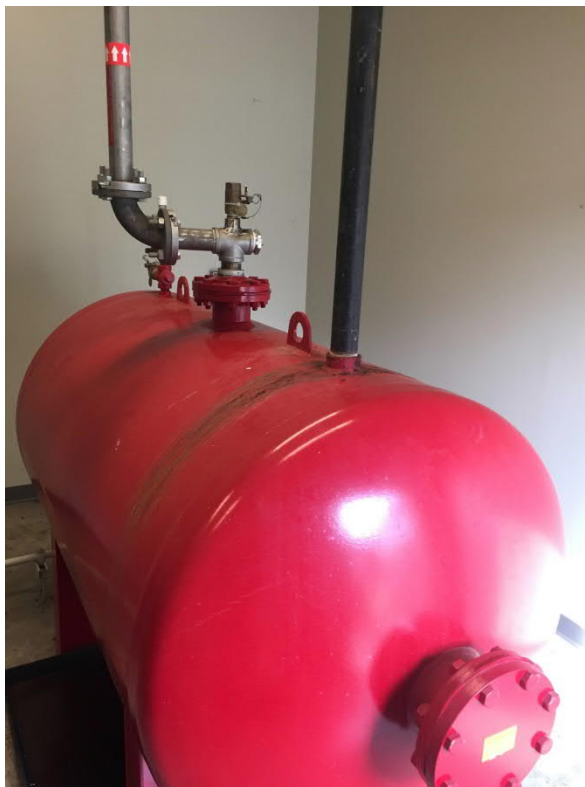
### Photograph No. 10

Fire Suppression System,  
C12 Hangar.

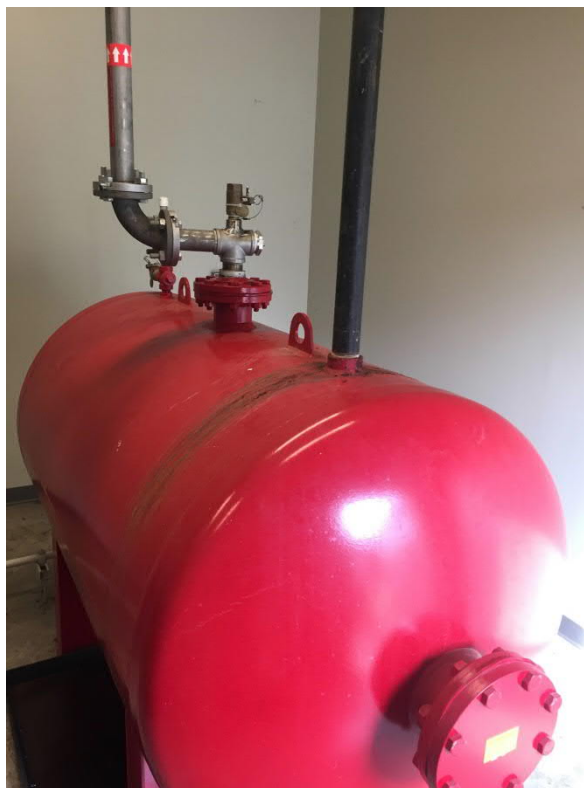
### Photograph No. 12

Fire Suppression System,  
C12 Hangar.

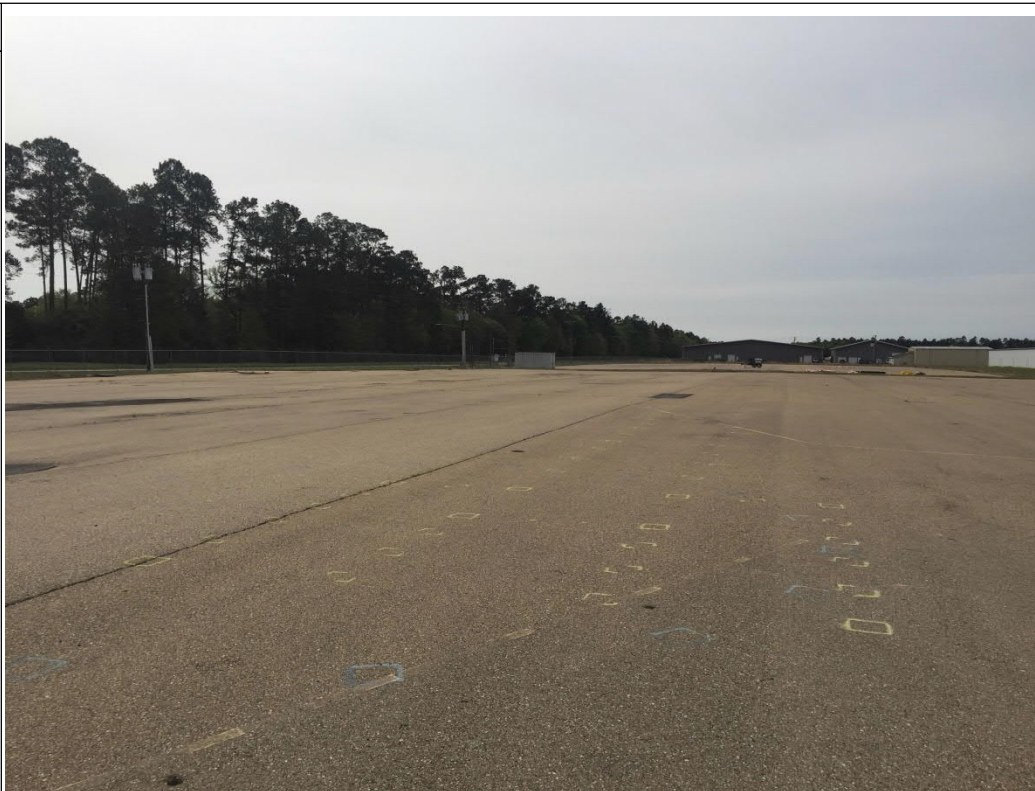
### Photograph No. 16

Location of former AASF.  
Formerly contained  
temporary “Clam Shell”  
hangars. No Fire  
Suppression Systems  
present.
