FINAL Preliminary Assessment Report Esler Field Army Aviation Support Facility, Louisiana

Perfluorooctanesulfonic Acid (PFOS) and Perfluorooctanoic
Acid (PFOA) Impacted Sites
ARNG Installations, Nationwide

July 2020

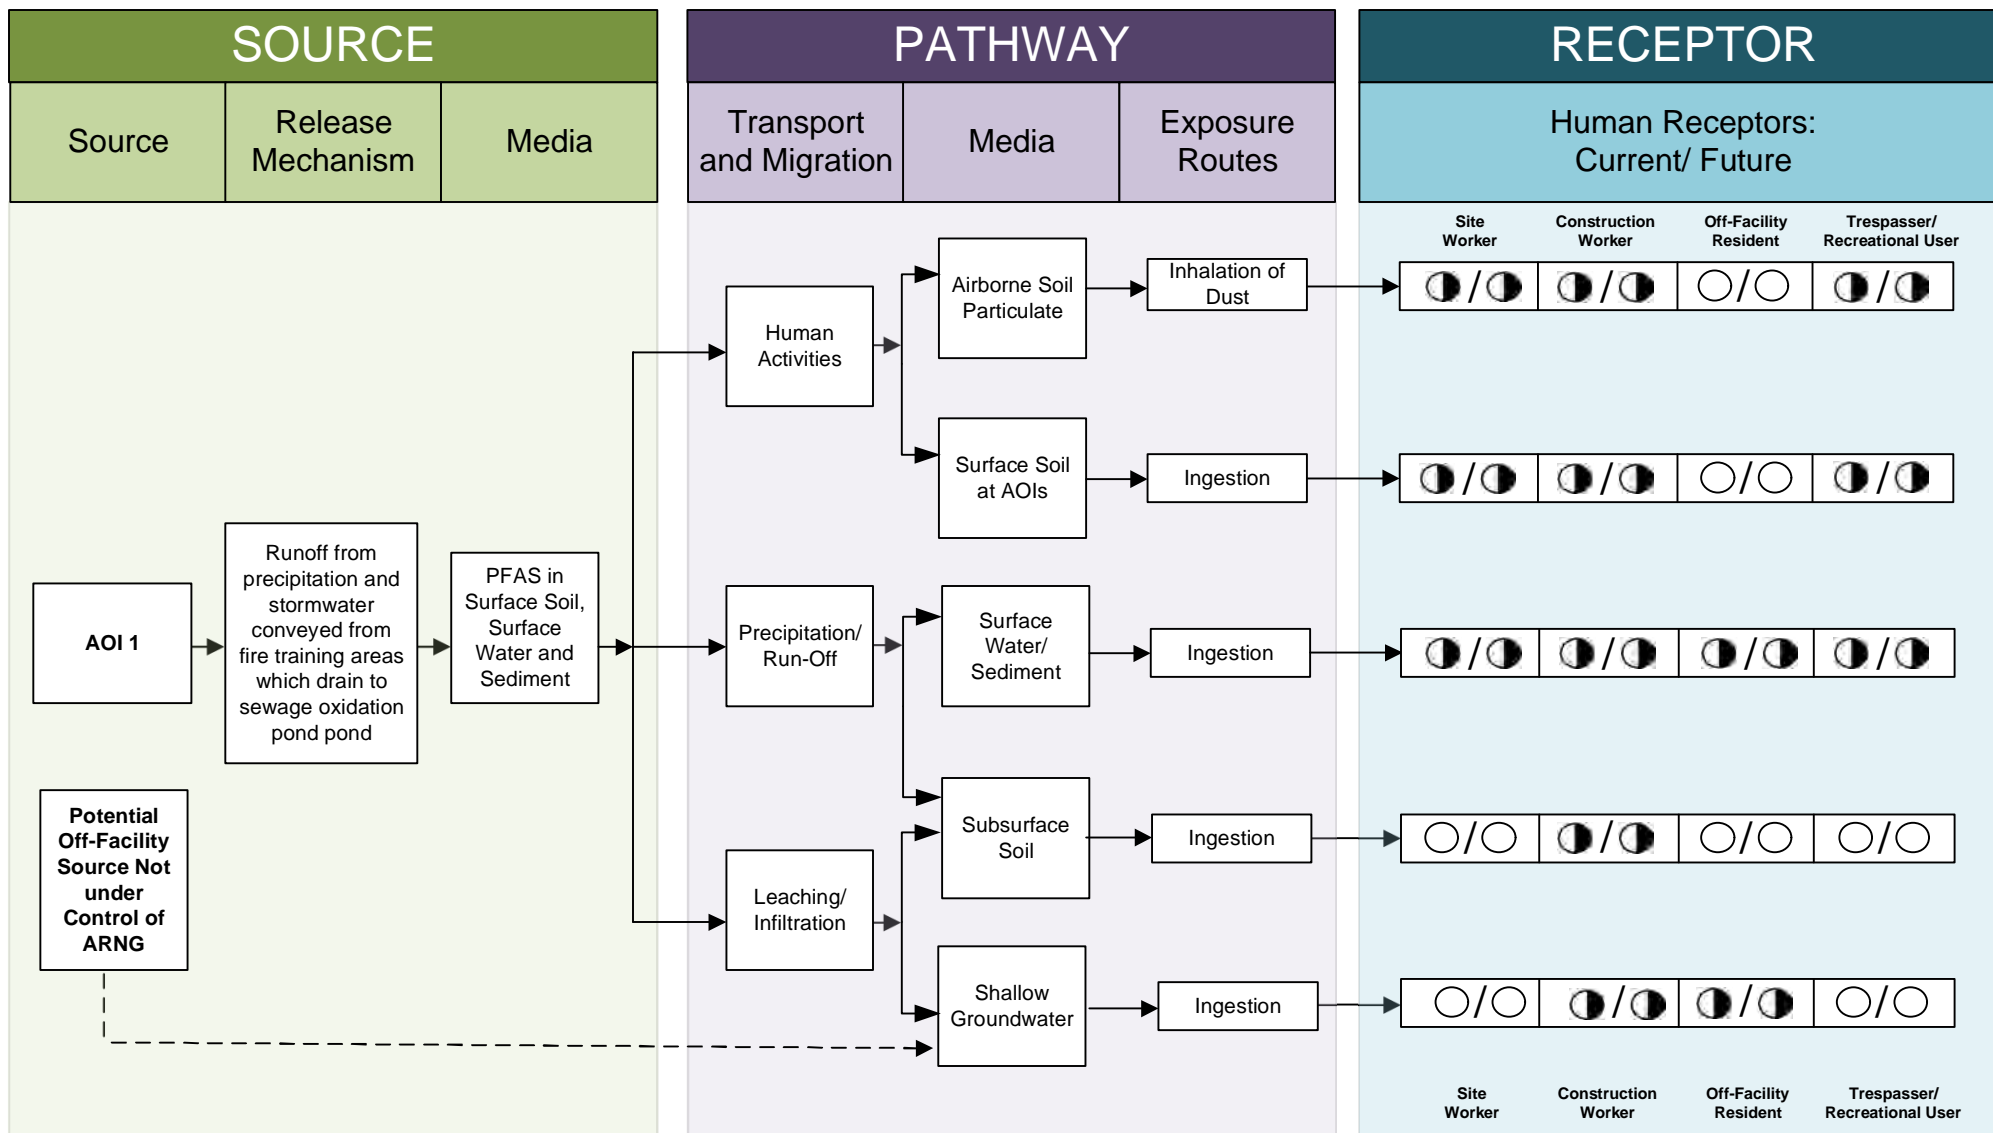
Figure 6-2
Preliminary Conceptual Site Model
AOI 1 Sewage Oxidation Pond Pond at Esler Field AASF, LA 24

The preliminary CSM for AOI 1 is presented on **Figure 6-2**. Potential PFAS exposure pathways resulting from releases at AOI 1 are described in **Table 6-1**:

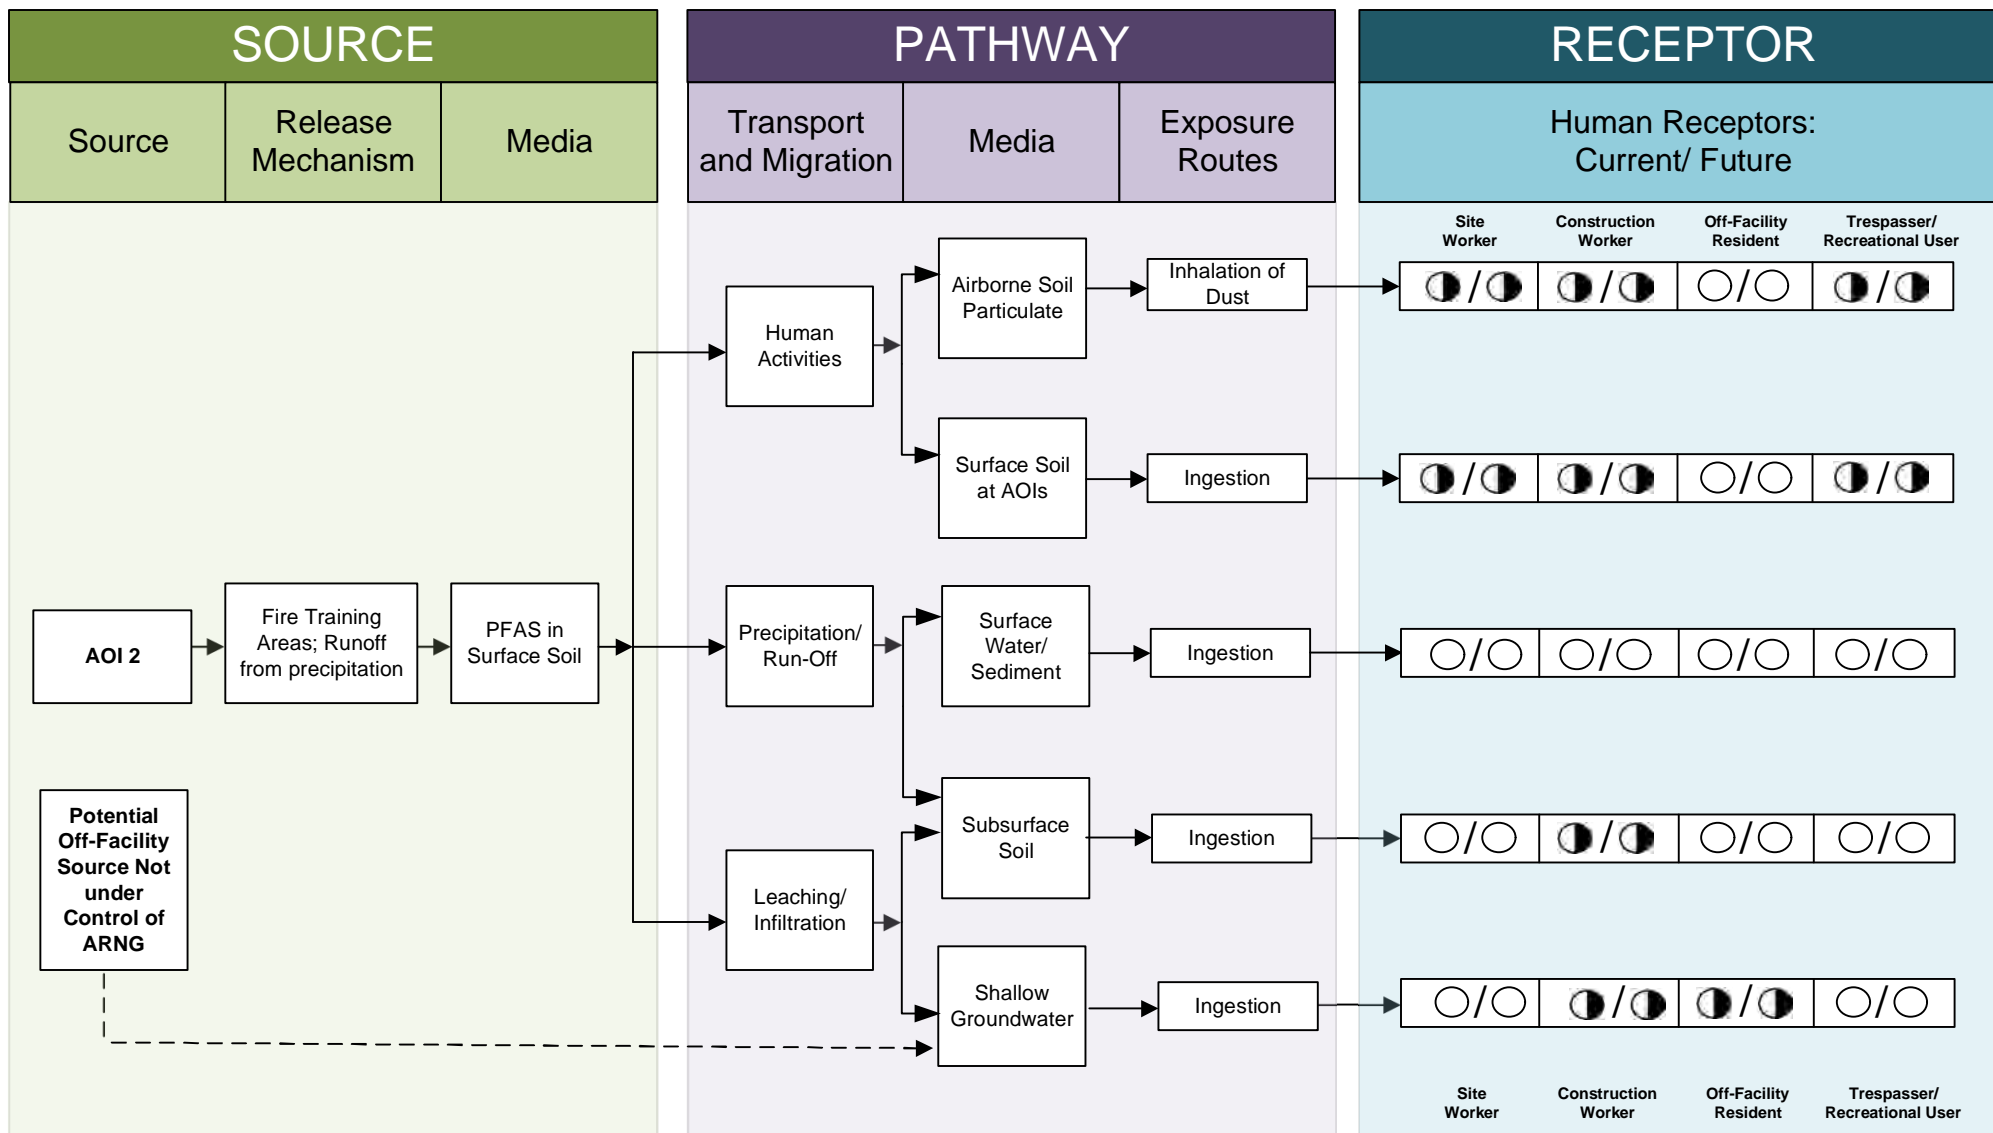
Figure 6-3
Preliminary Conceptual Site Model
AOI 2 North Ramp/Wash Rack at Esler Field AASF, LA

The preliminary CSM for AOI 2 is presented on **Figure 6-3**. Potential PFAS exposure pathways resulting from releases at AOI 2 are described in **Table 6-2**:

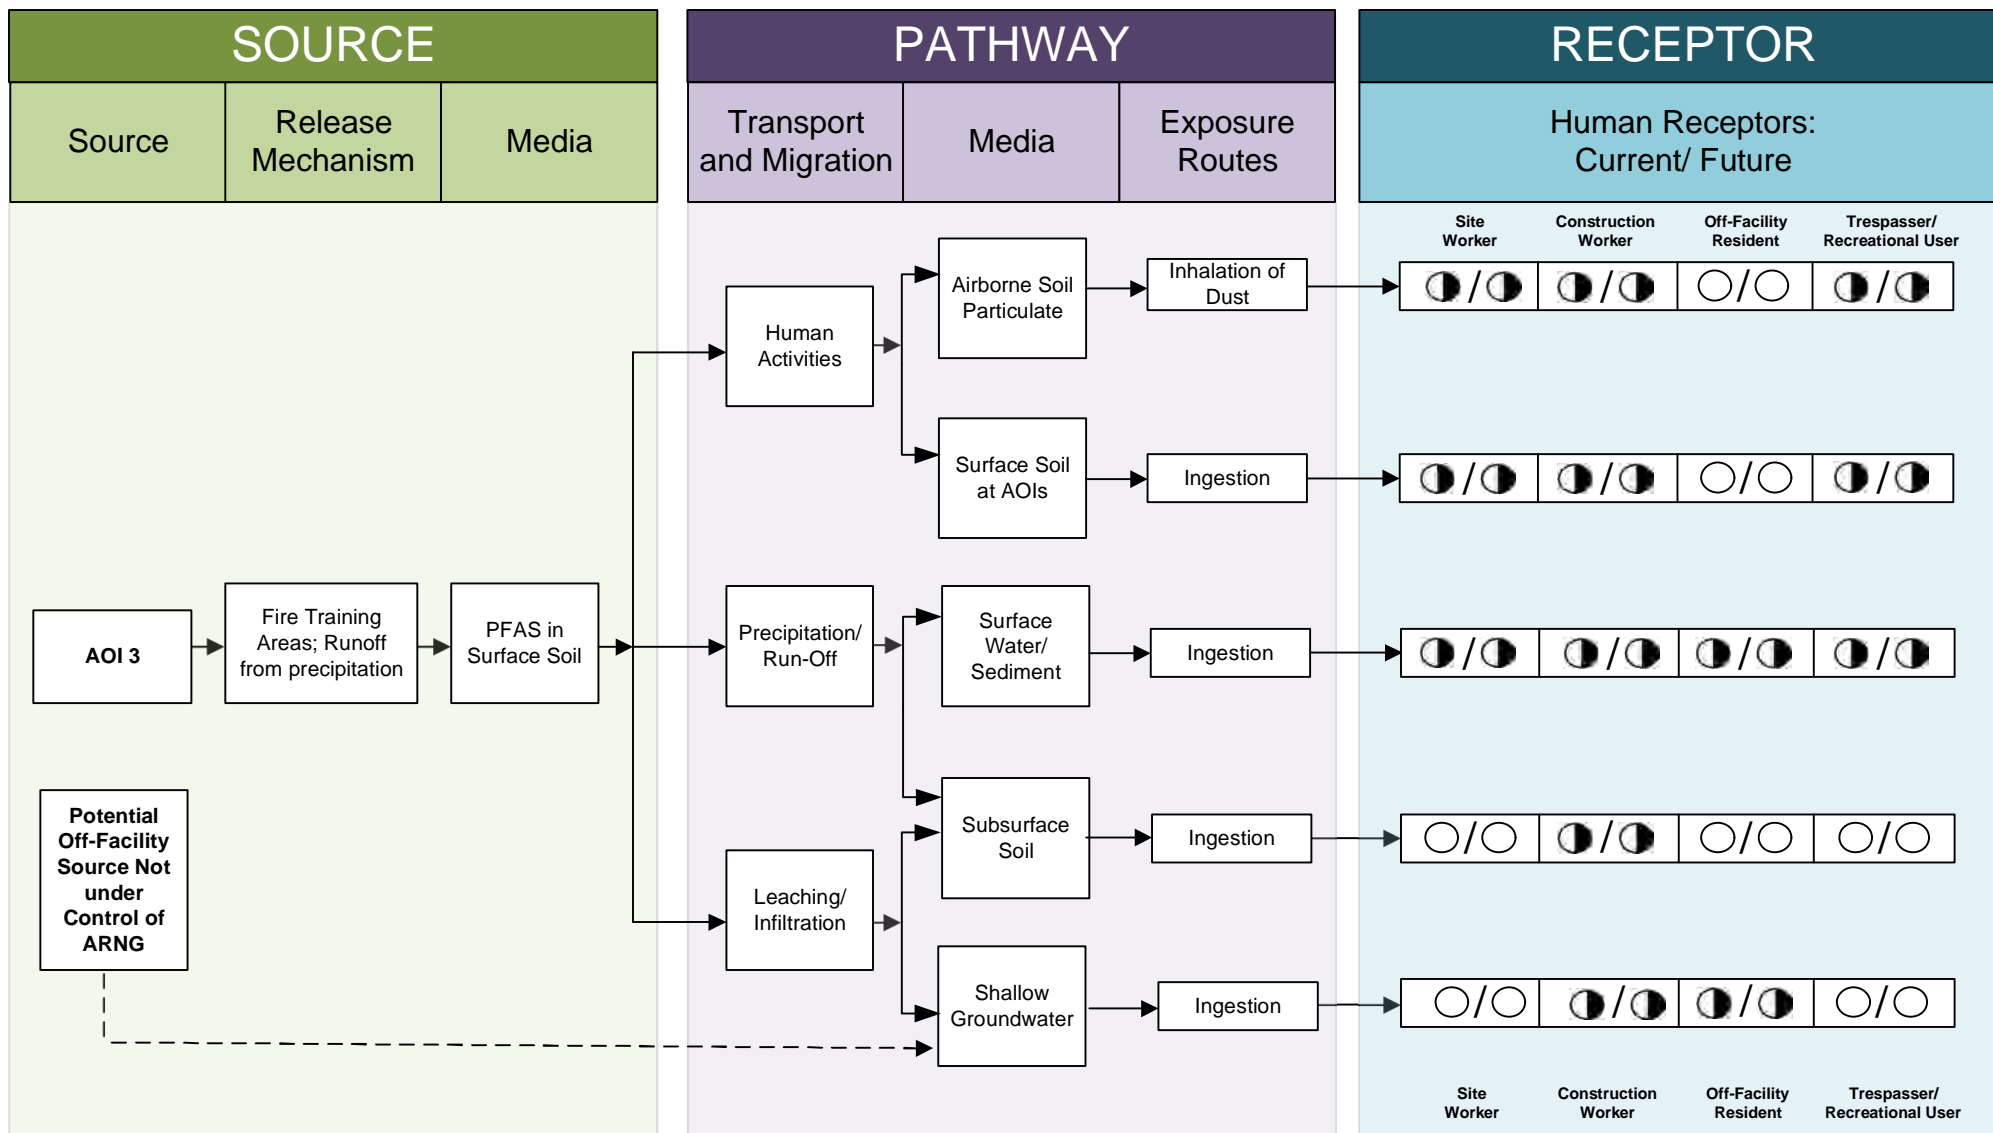
Figure 6-4
Preliminary Conceptual Site Model
AOI 3 South Ramp at Esler Field AASF, LA

The preliminary CSM for AOI 3 is presented on **Figure 6-4**. Potential PFAS exposure pathways resulting from releases at AOI 3 are described in **Table 6-3**:
