FINAL Preliminary Assessment Report Weide Army Aviation Support Facility Aberdeen Proving Ground, Maryland

Perfluorooctanesulfonic Acid (PFOS) and
Perfluorooctanoic Acid (PFOA) Impacted Sites
ARNG Installations, Nationwide

September 2020

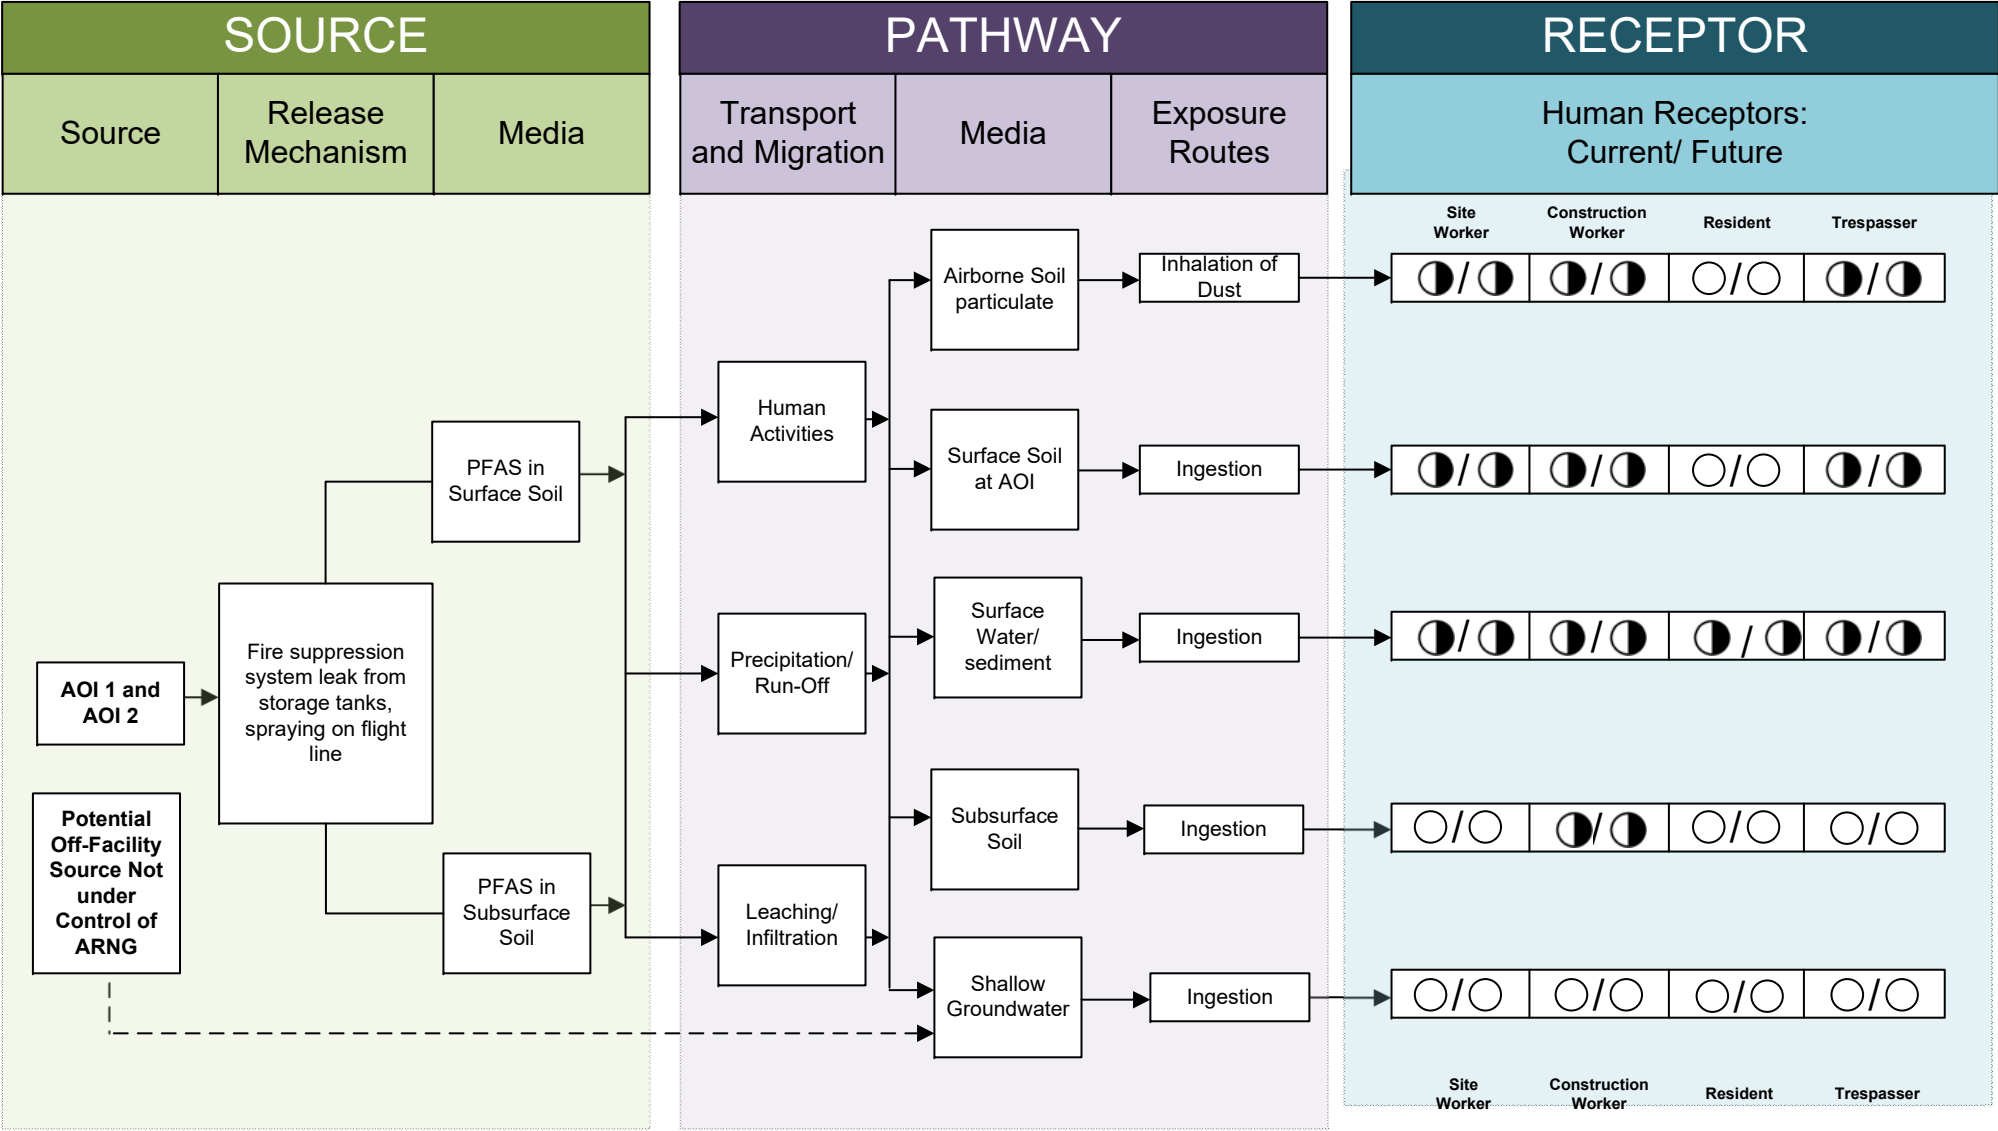
The preliminary CSM for Weide AASF is shown on **Figure ES-2**.

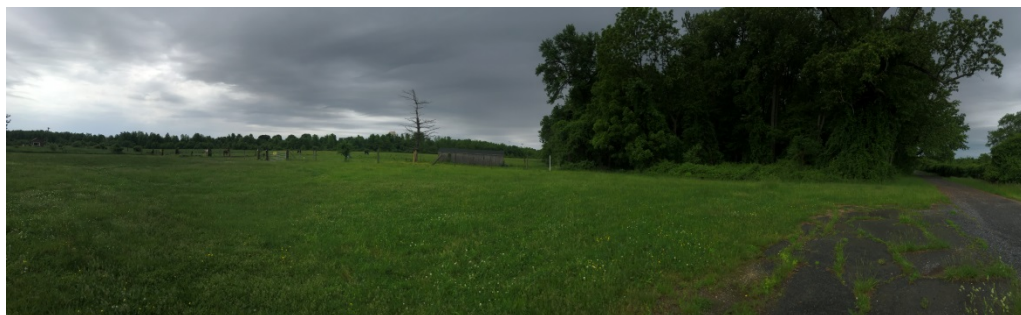
Looking south at location of prior Fire Training Area where two buildings were used at least once a week for fire training when the weather was good. Both buildings and their foundations were removed. Buildings are seen on 2006 aerial photographs; however, they are not seen on the 2013 aerial. Therefore, exact date of removal is unknown.
