Preliminary Assessment Report

1108th Theatre Aviation Sustainment Maintenance Group (TASMG), Gulfport, Mississippi

Perfluorooctanesulfonic Acid (PFOS) and Perfluorooctanoic Acid
(PFOA) Impacted Sites
ARNG Installations, Nationwide

September 2020

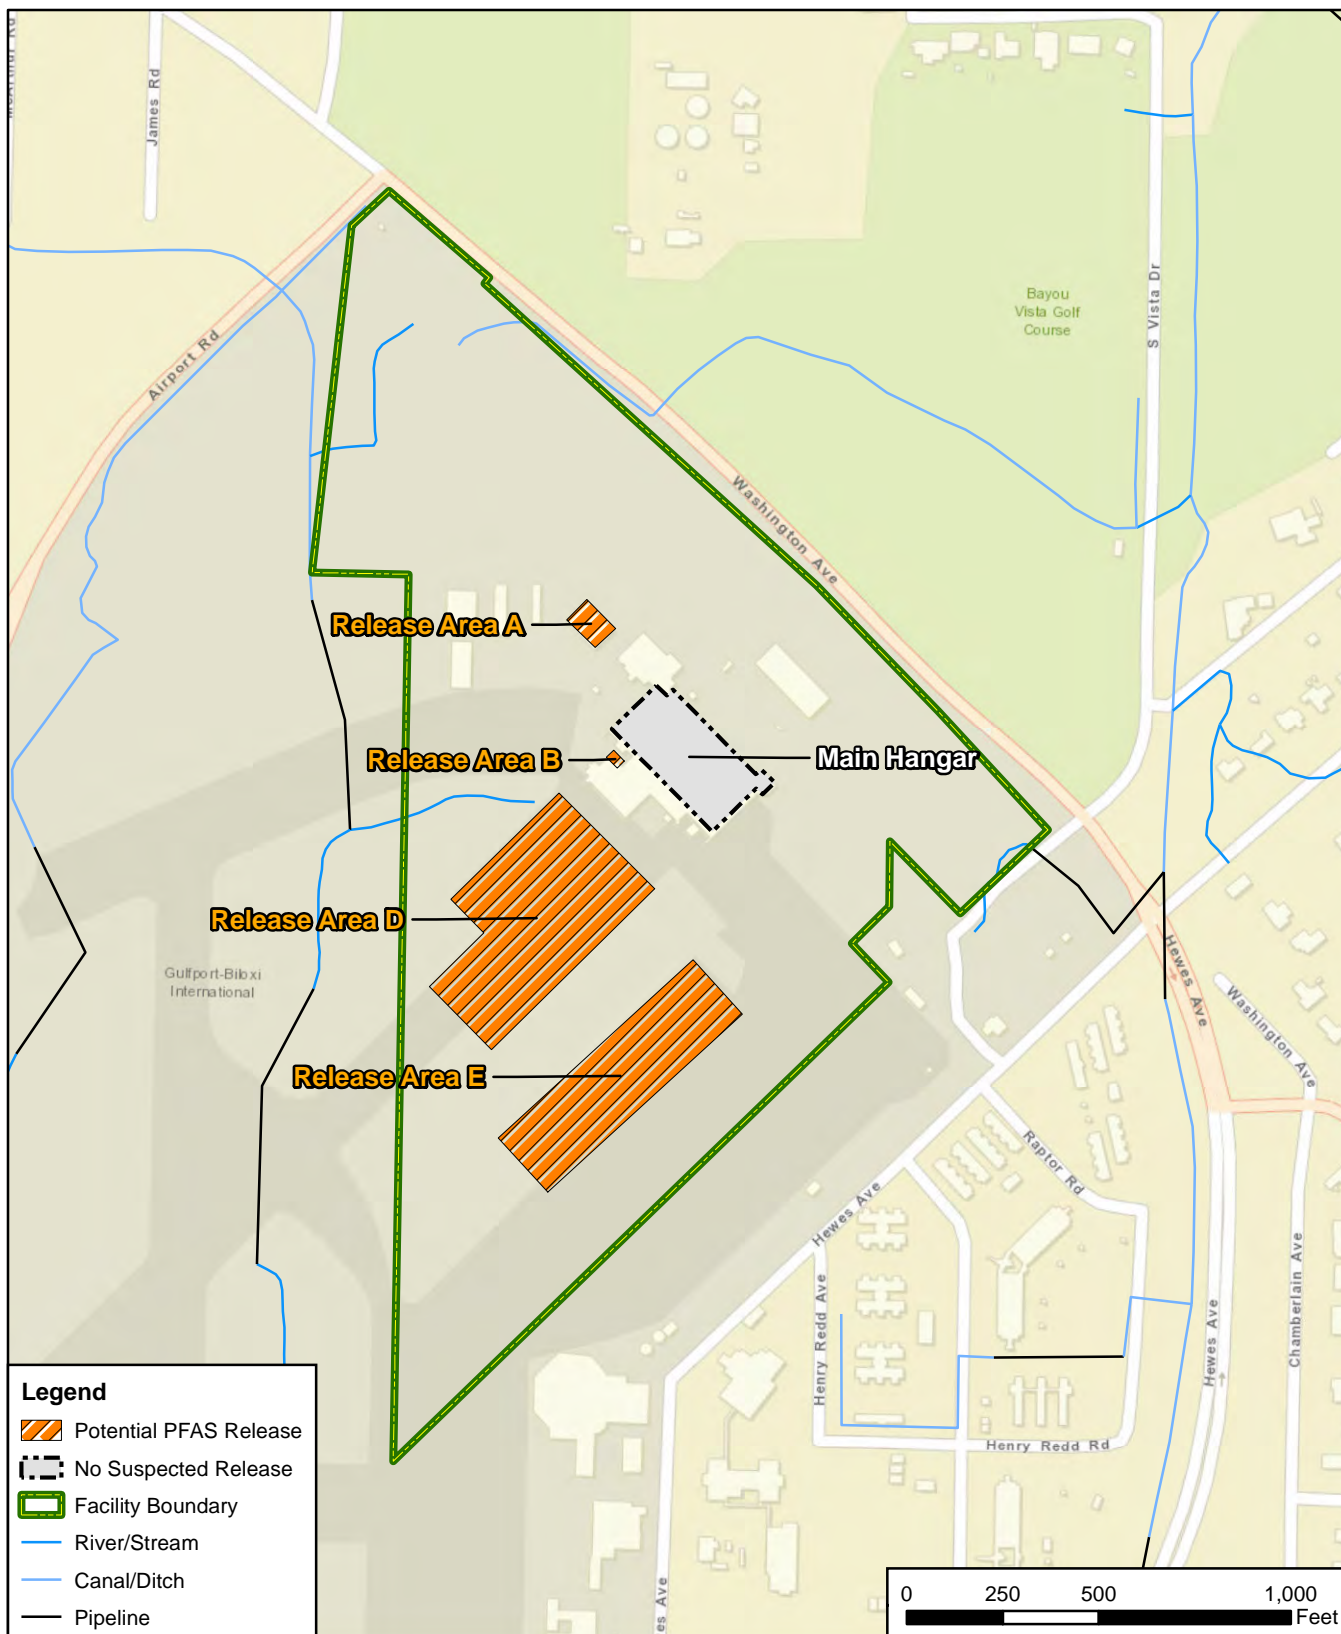
Figure 3-1

The New Paint Hangar is located on the northern half of the facility. Construction of the building began in 2017 and was completed in September 2018. Release Area A is shown on **Figure 3-1**.

According to multiple interviews with site personnel, in October 2018, a full test of the New Paint Hangar suppression system was conducted using Jet-X. The hangar doors were shut, and the walls were covered in plastic in order to prevent foam from exiting the hangar. During the test, the tank was completely expended, and it was reported that the foam reached heights of 4-6 feet within the hangar. After the test, the foam was cleaned with mops and guided into hangar floor drains. These drains lead to an oil-water separator (OWS) located behind the hangar that drains to the city sanitary sewer, and ultimately to the city of Gulfport Waste Water Treatment Plant (WWTP) located just north of the facility boundary (**Figure 3-1**). Sludge that collects inside the OWS is vacuumed out and sent to a Subtitle D landfill.

The Old Aircraft Staging Ramp includes two paved areas located adjacent to the Main Hangar on its southwest side. Release Areas D & E are shown on **Figure 3-1**. The ramp was used for aircraft staging until about 2016. At the time of the PA site visit, the northern part of the Old Aircraft Staging Ramp (Release Area D) was being used as a staging area for active construction. A new hangar was being built adjacent to the Main Hangar, which is the second stage of the project that completed the New Paint Hangar in 2018.

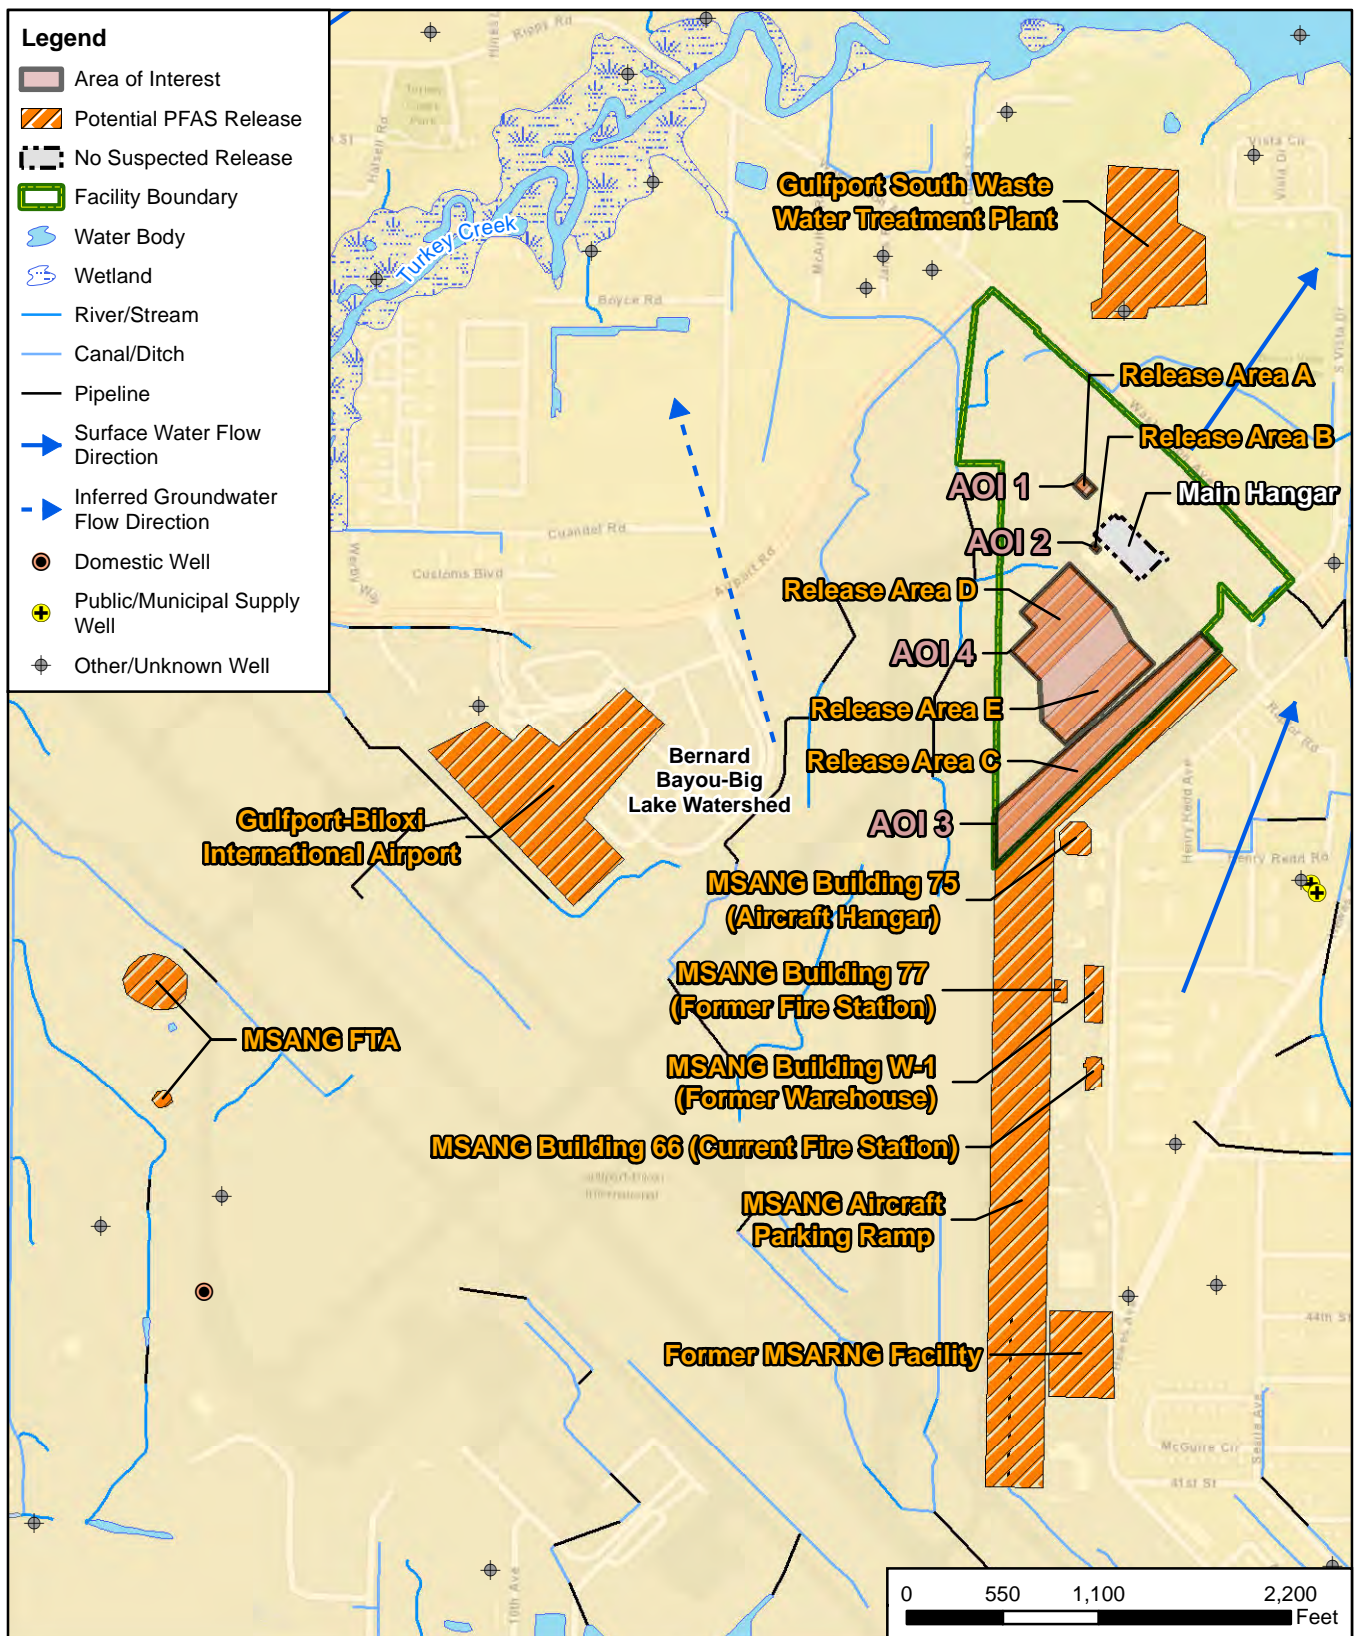
12420 Milestone Center Drive Germantown, MD 20876	Figure 6-1
REVISED	7/9/2020	GIS BY	MS	7/9/2020			
SCALE	1:13,200	CHK BY	PD	7/9/2020			
Base Map: Sources: Esri, HERE, Garmin, USGS, Intermap, INCREMENT P, NRCan, Esri Japan, METI,		PM	RG	7/9/2020

Based on the PA findings, four AOIs were identified at 1108th TASM: AOI 1 Release Area A, AOI 2 Release Area B, AOI 3 Release Area C, and AOI 4 Release Area D & E. The AOI locations are shown on **Figure 6-1**. The following section describes the CSM components and the specific preliminary CSM developed for this AOI. The CSM identifies the three components necessary for a potentially complete exposure pathway: (1) source, (2) pathway, (3) receptor. If any of these elements are missing, the pathway is considered incomplete.

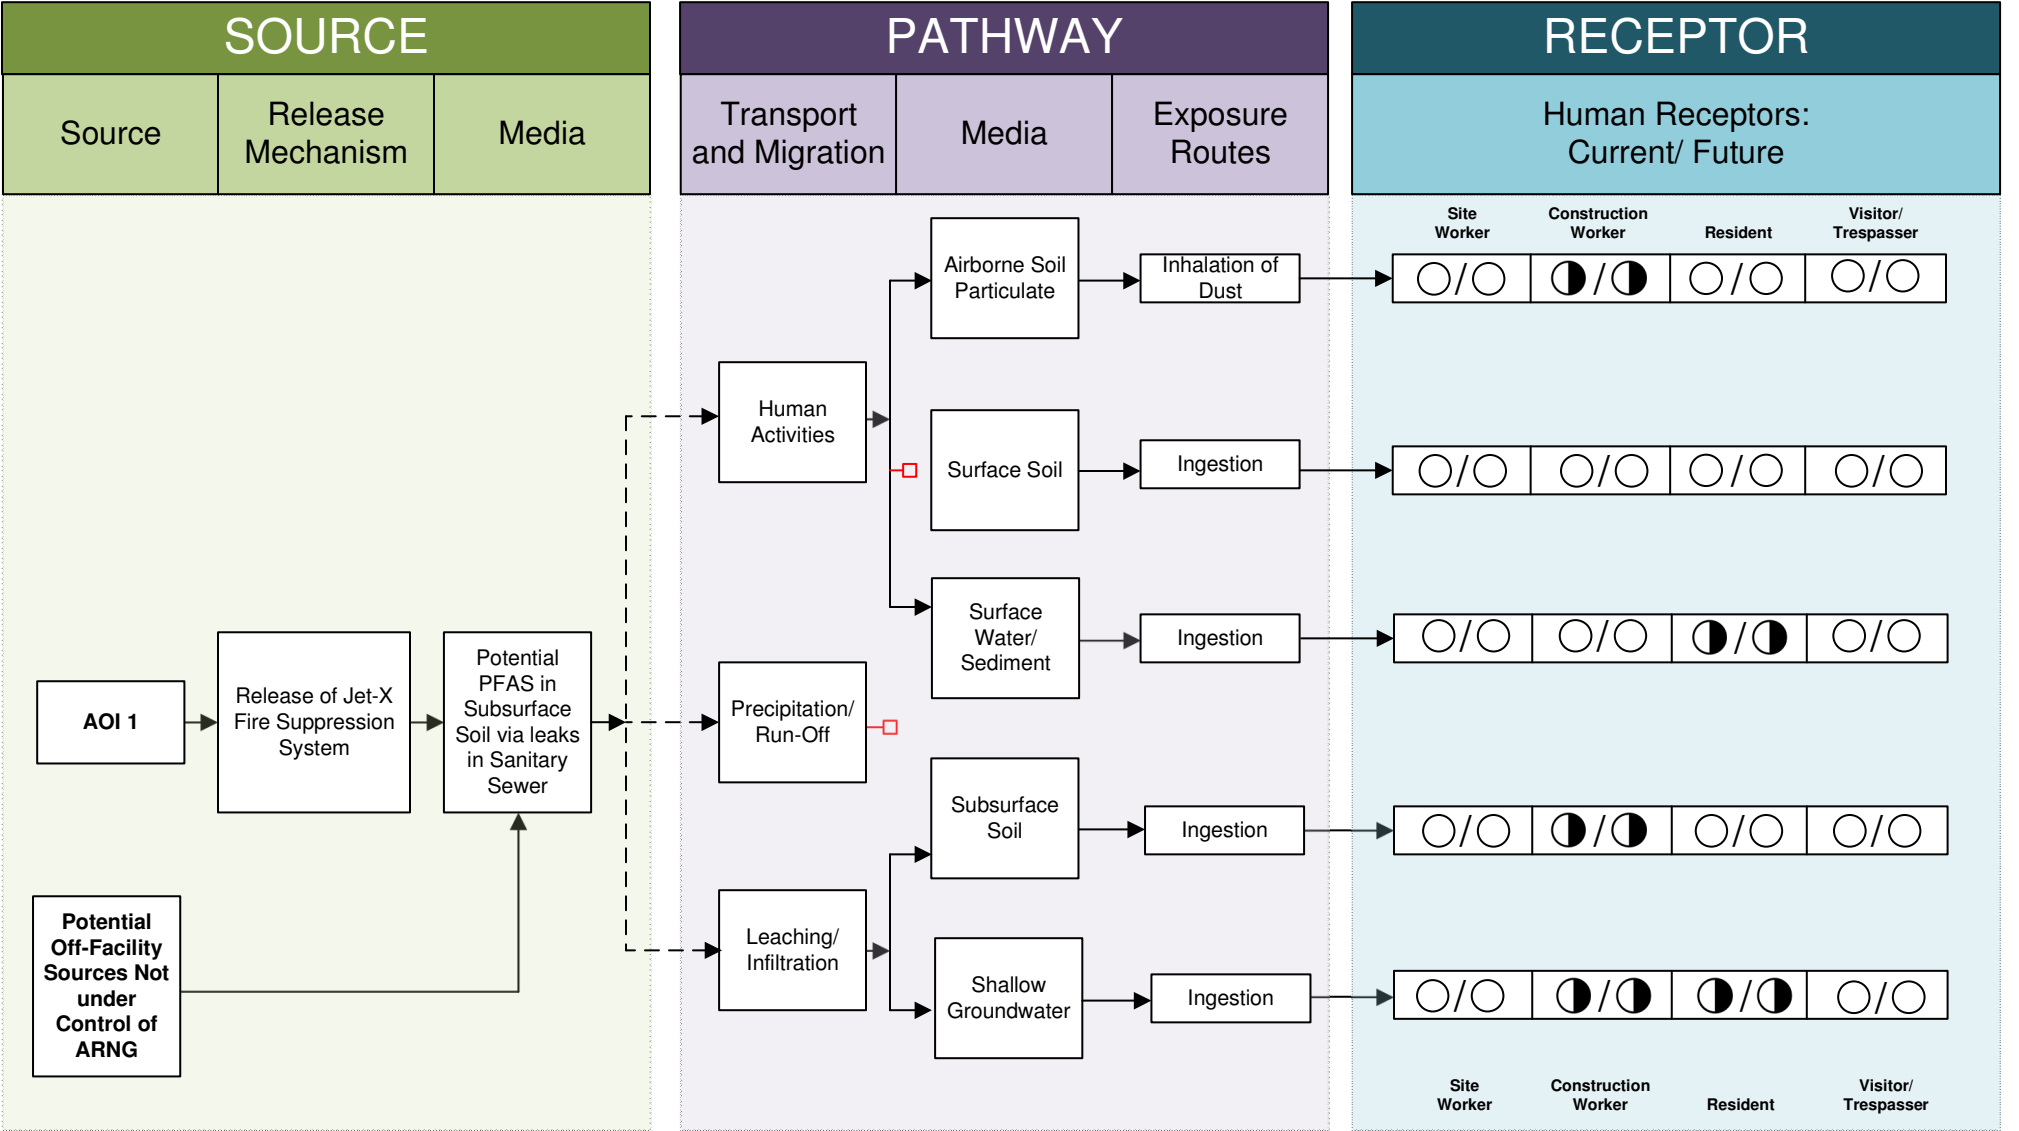
Figure 6-2
Preliminary Conceptual Site Model
AOI 1 – Release Area A

AOI 1 encompasses Release Area A (**Figure 6-1**). A large release of Jet-X by the MSARNG inside the hangar occurred in 2018 during a full test of the fire suppression system. No remediation activities have occurred at AOI 1.

The Gulfport WWTP discharges effluent to local streams. Therefore, the PFAS contamination exposure pathways for surface water and sediment to off-facility residents are potentially complete. The preliminary CSM for AOI 1 is shown on **Figure 6-2**.

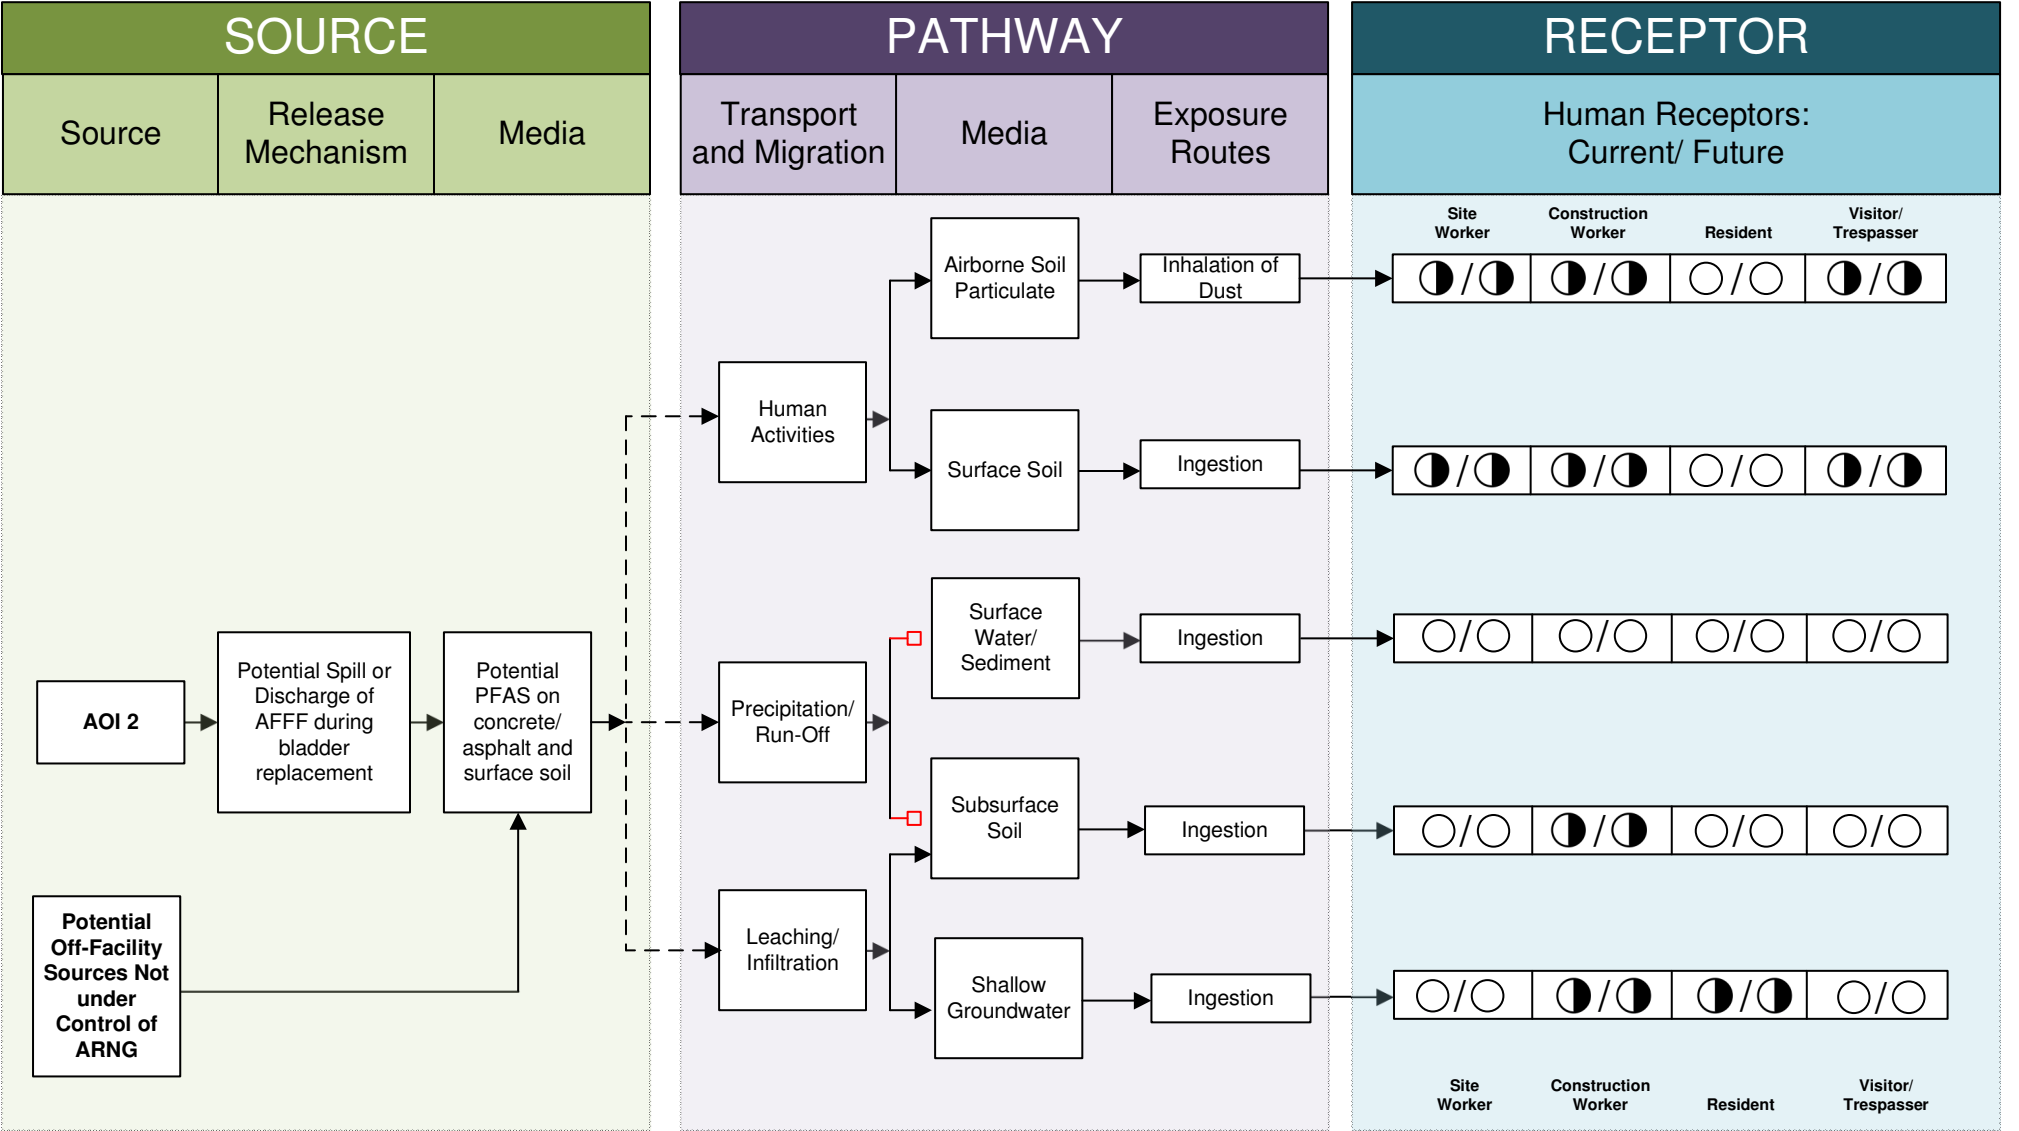
Figure 6-3
Preliminary Conceptual Site Model
AOI 2 – Release Area B

AOI 2 encompasses Release Area B (**Figure 6-1**). Due to uncertainties regarding the management of AFFF during a bladder change of the AFFF tank during 2018, PFAS may have been released into the environment. No remediation activities have occurred at AOI 2.

AFFF released outside of the tank room would have contacted concrete and/or surface soil and infiltrated in the area immediately surrounding the tank room. Ground disturbing activities to surface soil could result in facility worker, construction worker, and visitor/trespasser exposure to potential PFAS contamination via ingestion and inhalation of airborne particulates. Ground disturbing activities to subsurface soil could result in construction worker exposure to potential PFAS contamination via ingestion and inhalation of airborne particulates, and ingestion of contaminated shallow groundwater. Therefore, these pathways are potentially complete. Multiple municipal wells are located downgradient of 1108th TASMG, therefore, the PFAS exposure pathway for groundwater to off-facility residents is potentially complete. There are no surface water features in this area; therefore, the surface water and sediment pathways for PFAS are incomplete for all receptors. The preliminary CSM for AOI 2 is shown on **Figure 6-3**.

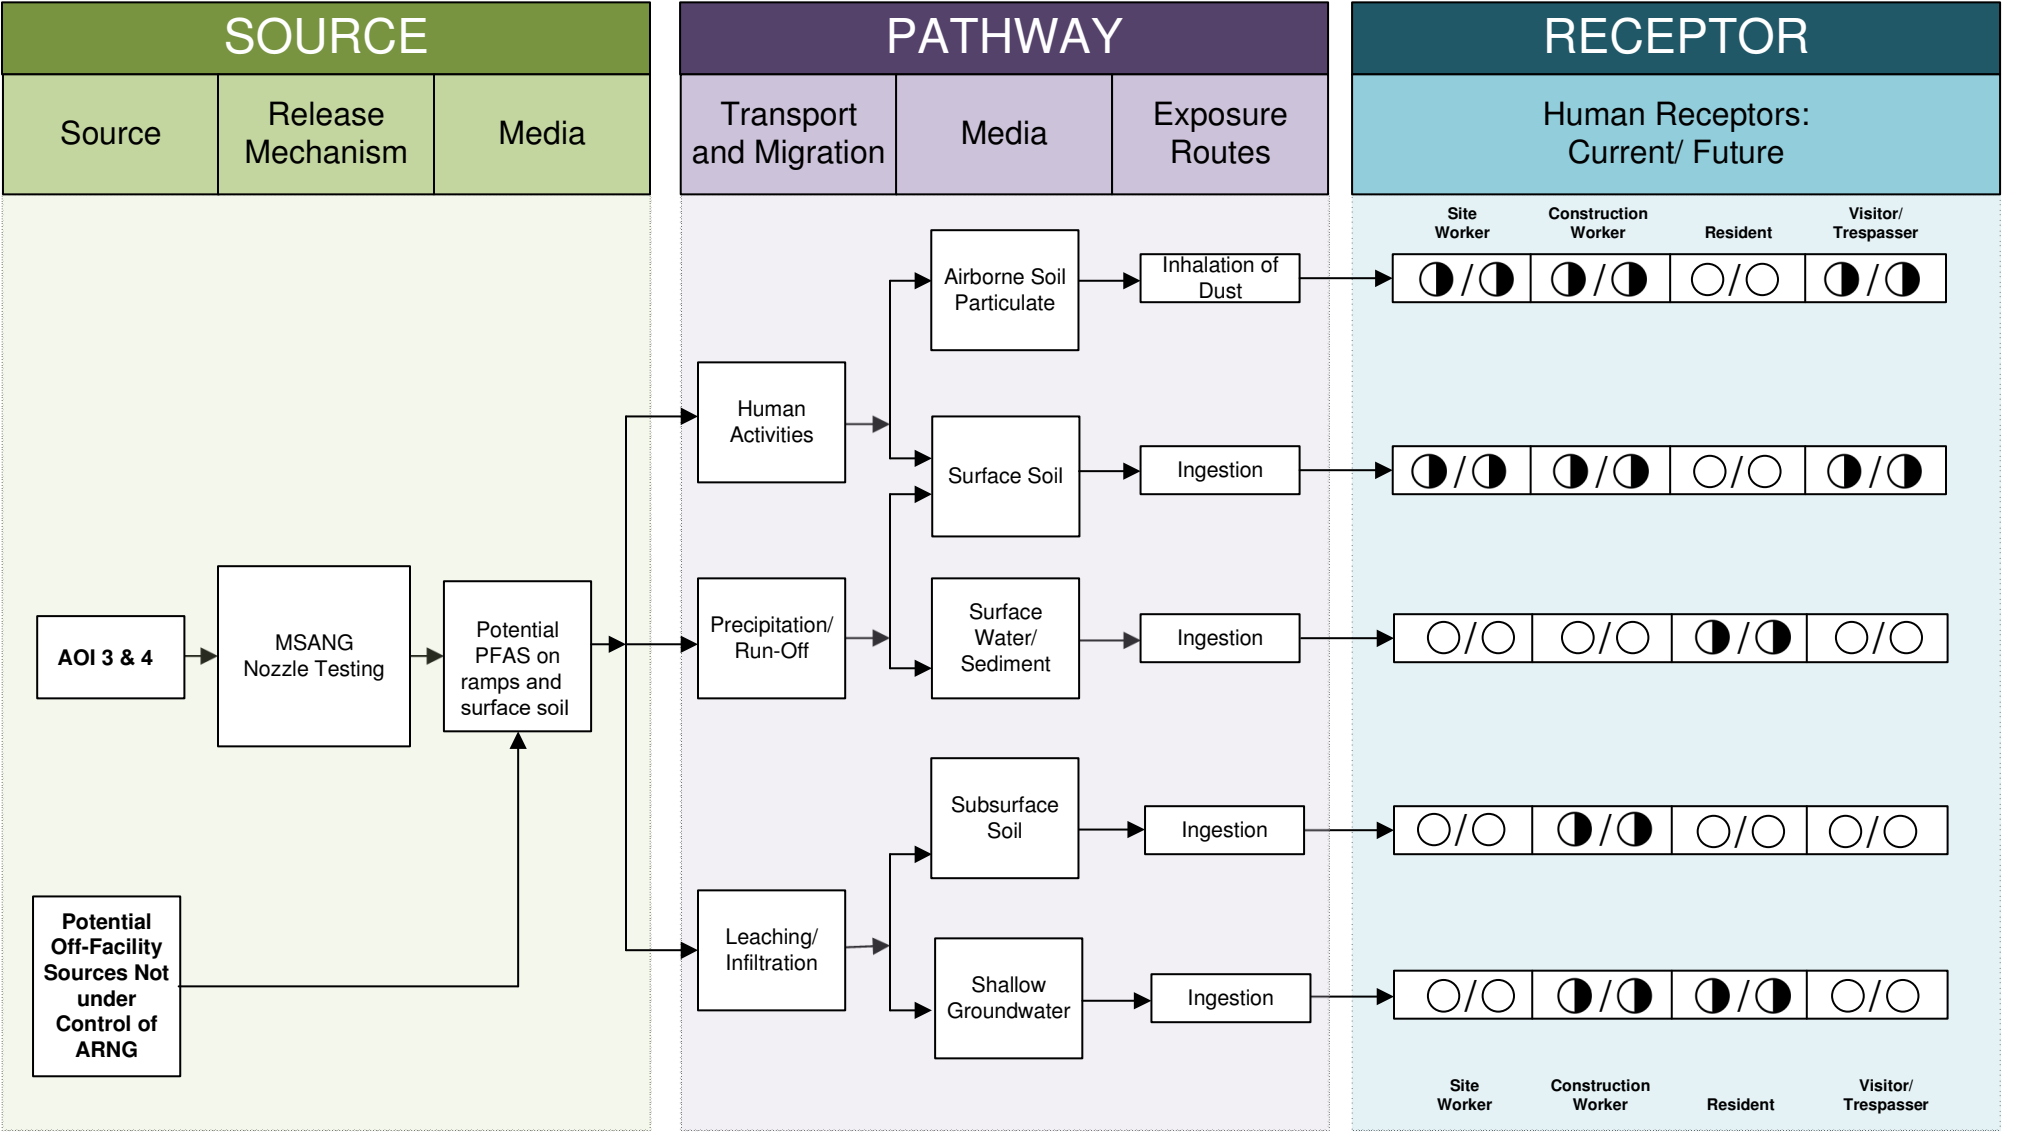
Figure 6-4
Preliminary Conceptual Site Model
AOIs 3 & 4 – Release Areas C, D & E

AOI 3 encompasses Release Area C which is a part of the MSANG Parking Ramp discussed in Section 5.1 (**Figure 6-1**). The northern portion of the ramp is divided between the MSANG and the MSARNG by a trench drain that runs northeast to southwest down the middle of the ramp. In the 1990s, nozzle testing with AFFF was conducted by MSANG personnel and is known to have occurred on both sides of the Aircraft Parking Ramp (Leidos, 2019). No remediation activities have occurred at AOI 3 to date.

Ground-disturbing activities to surface soil at AOI 3 may result in facility worker, construction worker, and visitor/trespasser exposure to potential PFAS contamination via ingestion or inhalation of airborne particulates. Ground-disturbing activities to subsurface soil could result in construction worker exposure to potential PFAS contamination via ingestion of soil, ingestion of shallow groundwater, or inhalation of airborne particulates. Given the detections of PFAS in the surface water and sediment at the off-facility outfall, the exposure pathways for these media to off-facility residents are potentially complete. The preliminary CSM for AOI 3 is shown on **Figure 6-4**.

AOI 4 encompasses Release Areas D and E (**Figure 6-1**). Tri-Max™ units were historically staged in this area. Given a lack of information prior to 1991 and uncertainty regarding the maintenance of these units, there is the potential for PFAS to have been released into the environment. No remediation activities have occurred at AOI 4.

Potential releases of AFFF on the Old Aircraft Staging Ramp (Release Areas D & E) would have directly contacted the concrete, soil, or entered the surface water drainage ditch located immediately to the north of the area. Due to their proximity to each other, the potential migration and exposure pathways to receptors at AOI 4 are the same as those discussed in **Section 6.3** for AOI 3. The preliminary CSM for AOI 4 is shown on **Figure 6-4**.
