Preliminary Assessment Report

Joint Base McGuire-Dix-Lakehurst

Lakehurst, New Jersey

Perfluorooctane-Sulfonic Acid (PFOS) and Perfluorooctanoic Acid (PFOA) Impacted Sites
ARNG Installations, Nationwide

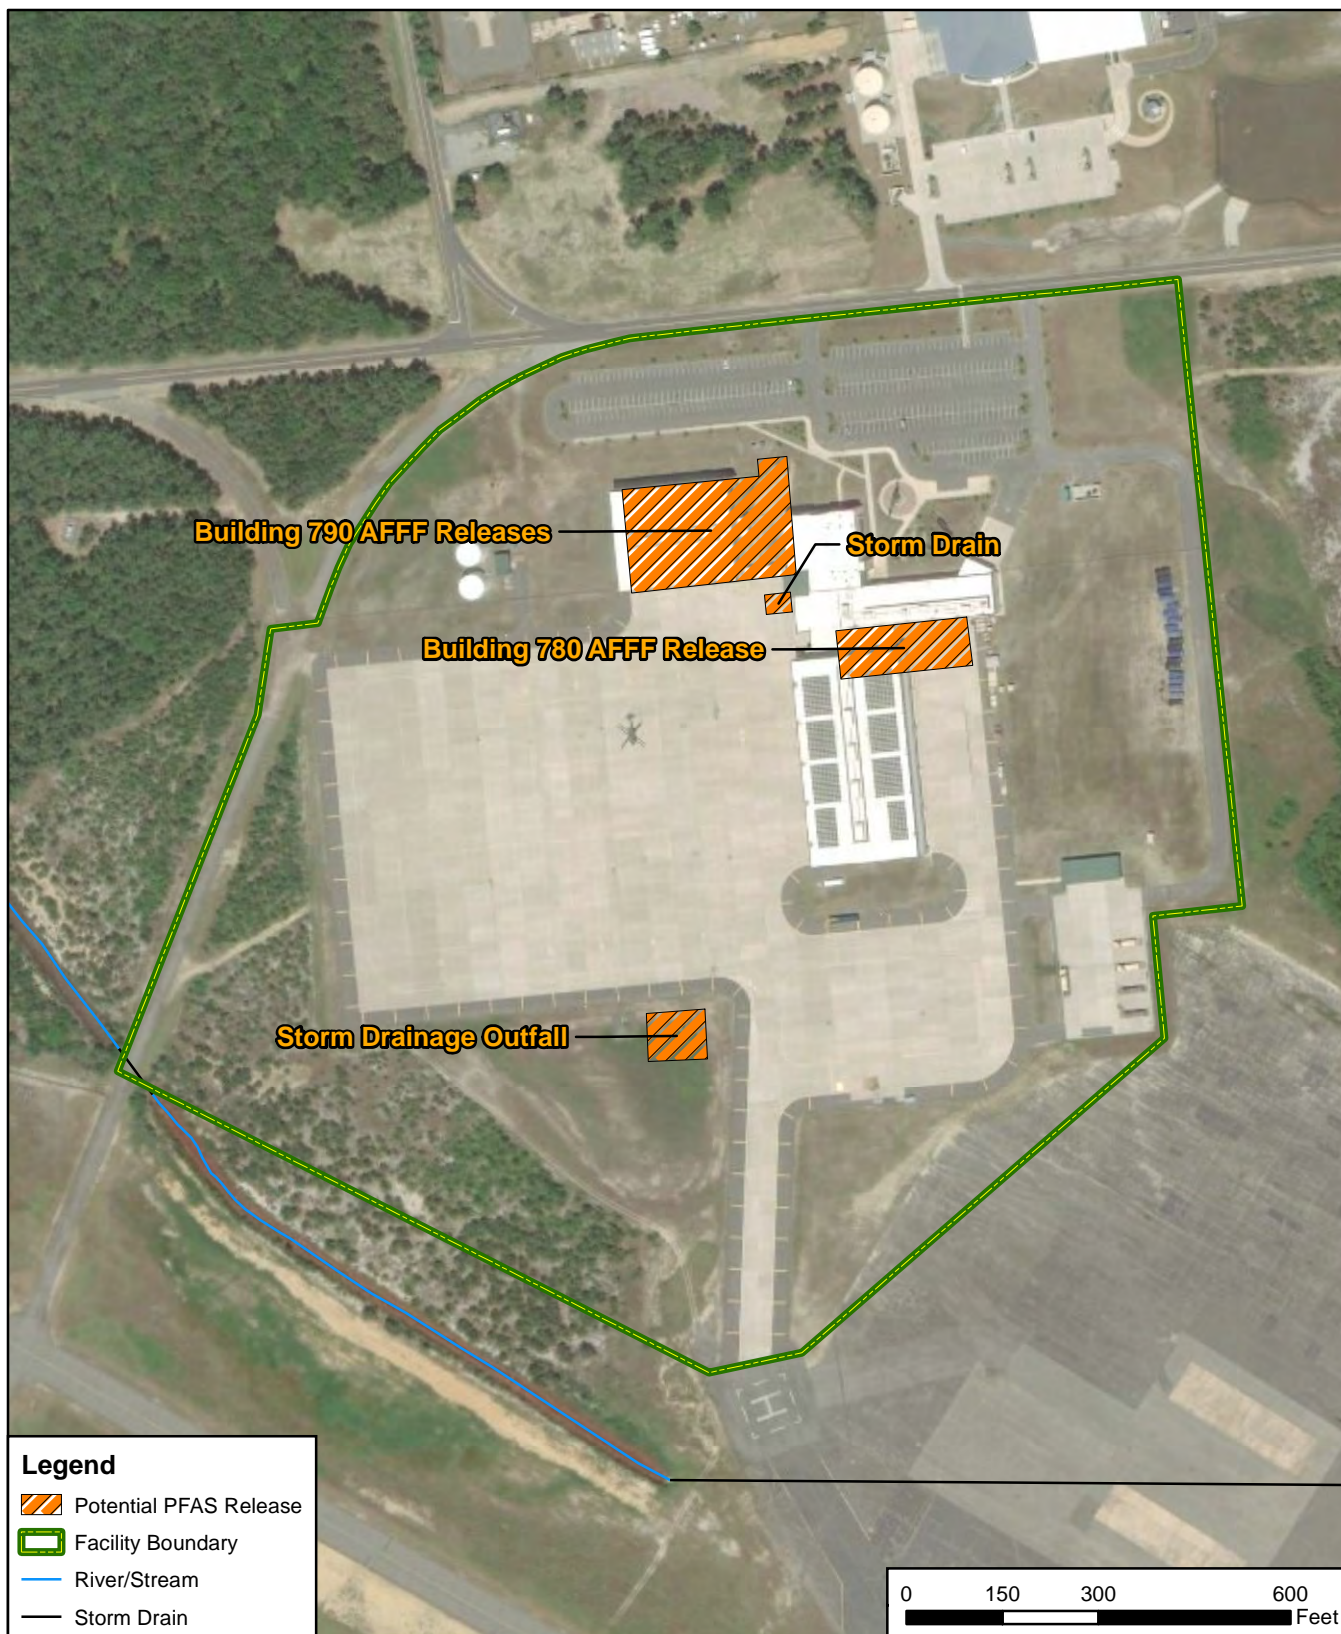
| NOTES | | Preliminary Assessment for PFAS at Lakehurst AASF, NJ | | | | 12420 Milestone Center Drive Germantown, MD 20876 | Figure 3-1 | |

On 12 June 2017, approximately 1,000 gallons of C8 3% AFFF were released in the maintenance room on the eastern side of the Building 790. The spill was caused by an incorrectly installed cap on the tank manifold system. Pressure built up within the tank and blew the cap off, releasing the C8 3% AFFF. The pressure of the AFFF filling the maintenance room cracked the sheetrock wall separating the maintenance room and the hangar bay, causing AFFF to spill west onto the concrete floor in the hangar bay of Building 790. The pressure also pushed open the doors on the east side of the maintenance room and spilled out into the grassy area between Buildings 790 and the Warm Storage Hangar (Building 780) (**Figure 3-1; Appendix C**).

A large amount of the AFFF spilled in the grassy area and entered a storm drain located between Buildings 790 and 780. The AFFF exited the storm drain from the outfall located approximately 100 feet south of the southern end of the helipad and a drain located on the west side of Building 780 (**Figure 3-1; Appendix C**). The drain on the west side of Building 780 runs approximately the entire length of the hangar bay from north to south and leads to the sanitary sewer system. During the spill, the drain acted as a conduit transporting a large amount of the AFFF inside the hangar bay. The AFFF that flowed west into the Building 790 hangar bay was pushed into the floor drain with brooms. Water containing AFFF was pulled from the lift station and put into a frac tank before containerization. In total, approximately 10,000 square feet of area were contaminated.

room was done incorrectly. A pressure build-up caused less than 25 gallons of residual C8 3% AFFF to leak into a pipe that leads to a down spout valve outside the building (**Figure 3-1**). This pipe releases rinse water from the tank. A bucket has since been staged in this area and catches very small amounts of residual leakage (**Appendix C**). The AFFF spill extended into the maintenance room and outside Building 790 in an unpaved, grassy area (approximately 100 square feet area) between Buildings 790 and 780, within the bounds of the first spill event from June 2017 (**Figure 3-1; Appendix C**). A 5-inch rubber drain plug was put into place in Building 790's maintenance room after this spill event.

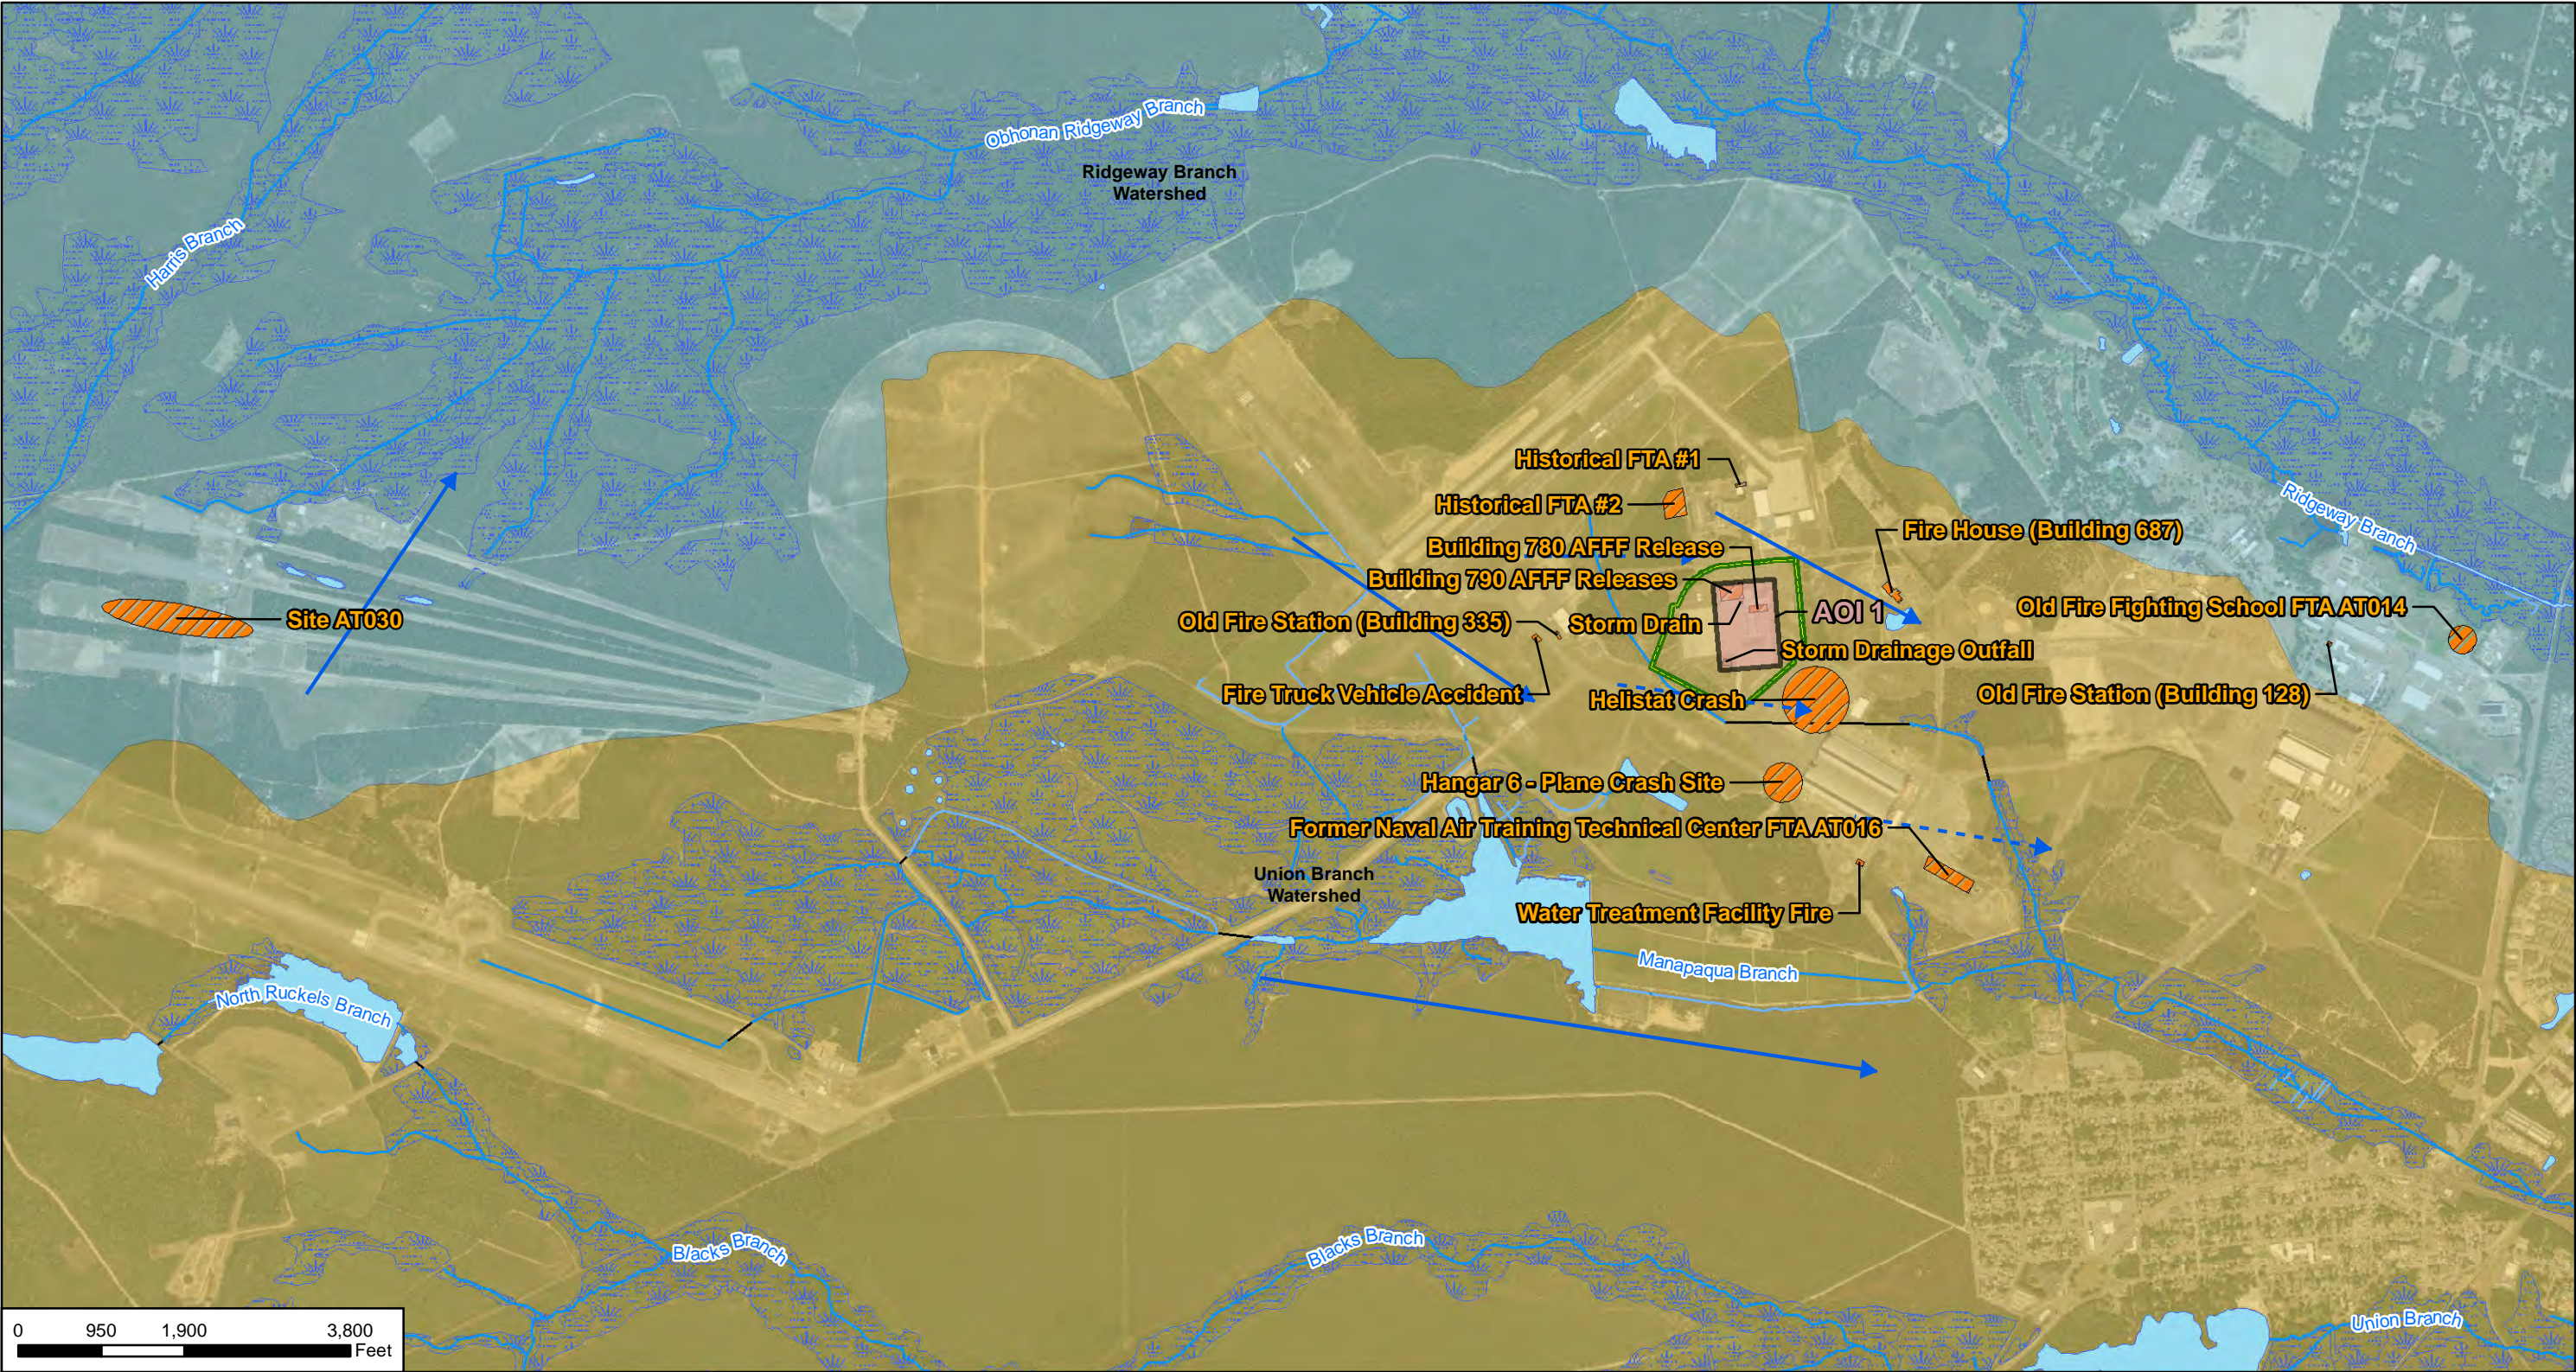
Based on the PA findings, AOI 1 was identified at the Lakehurst AASF as shown in **Figure 6-1**. The following section describes the CSM components and the specific preliminary CSM developed for AOI 1. The CSM identifies the three components necessary for a potentially complete exposure pathway: (1) source, (2) pathway, (3) receptor. If any of these elements are missing, the pathway is considered incomplete. Receptors at the Lakehurst AASF include site workers, construction workers, and trespassers. Potential offsite receptors include nearby residents in the surrounding communities.

| Area of Interest | AOI Location | Rationale | Potential Future Action |
|---|---|--|--|
| AOI 1 | 40°1'59.45"N; 74°20'23.98"W | Several documented releases of AFFF from the fire suppression system at the Lakehurst AASF. AFFF was directly in contact with surface soil and entered a storm drain transporting it under the apron and into a retention basin. | Proceed to an SI, focus on subsurface soil and groundwater |

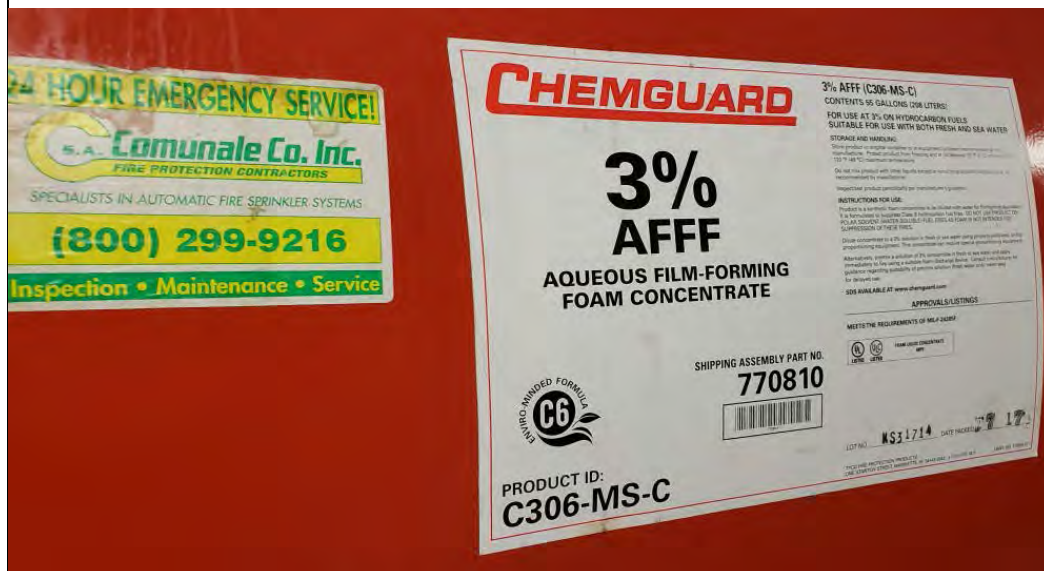
Inside Building 780 (Warm Storage Hangar). AFFF stains are visible due to a valve leak during the replacement of the bladder.

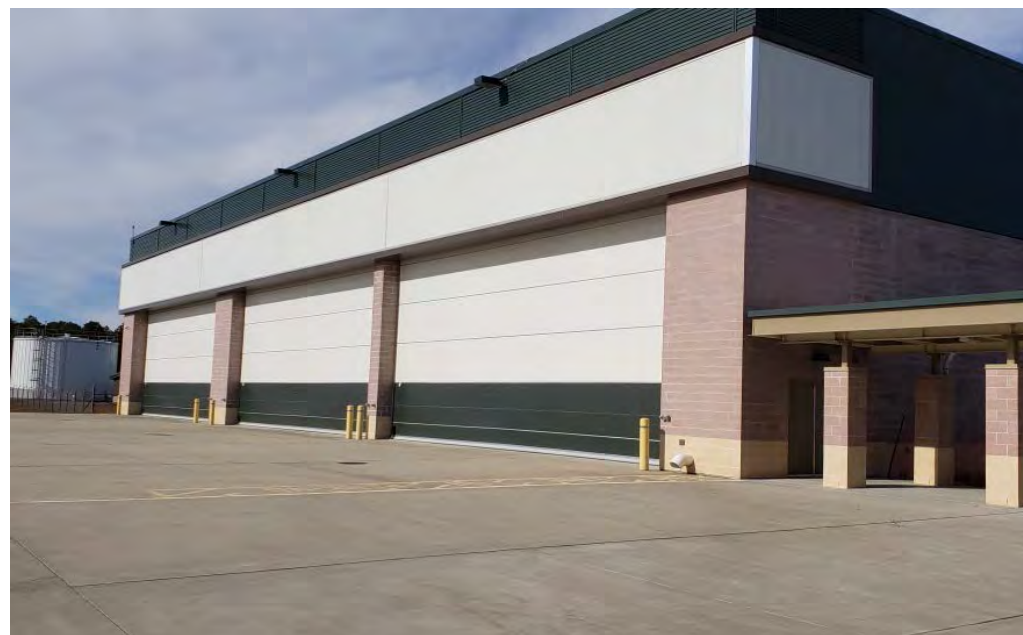
Outside south entrance of Building 790 (Cold Storage Hangar) where the AFFF spill originated from.

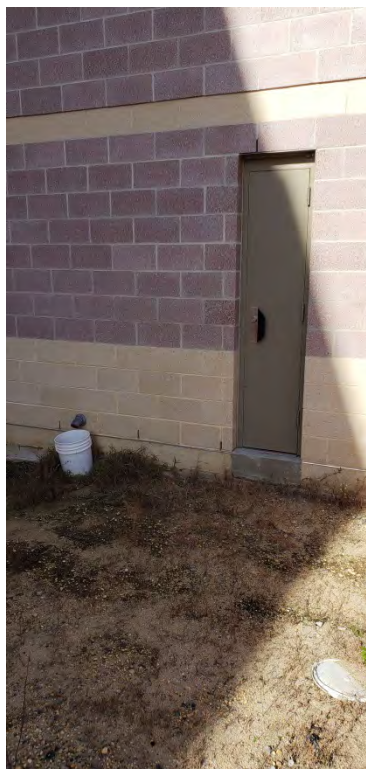
Location of second spill directly east of Building 790 (Cold Storage Hangar). AFFF leaked out of valve (indicated by white bucket underneath).

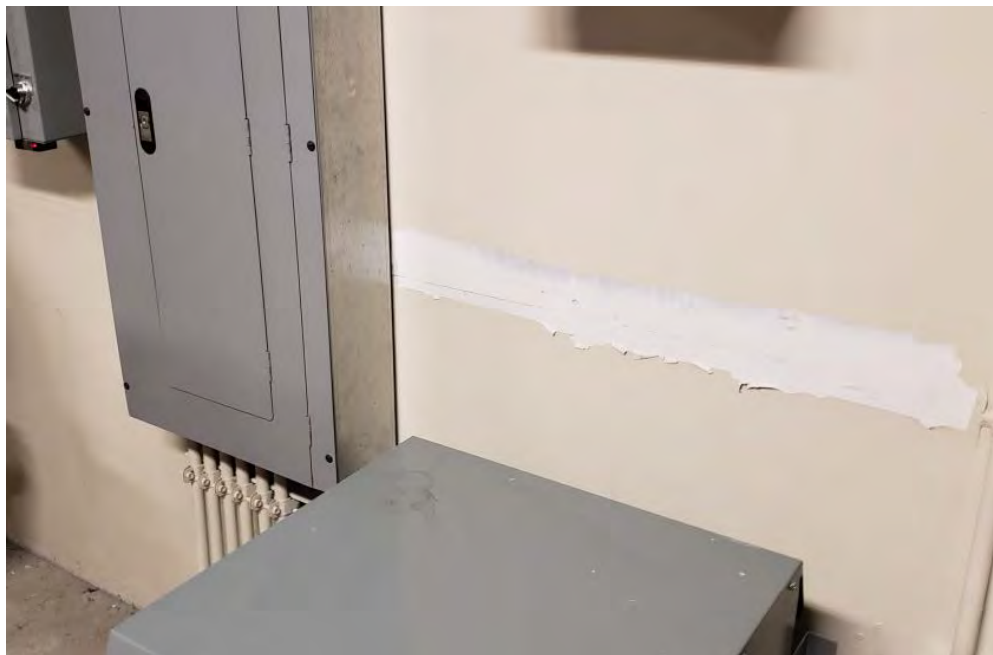
Inside Building 790 (Cold Storage Hangar) maintenance room that holds AFFF tank. Cap featured is what malfunctioned causing the discharge. New sheetrock pictured after spill damaged original wall.

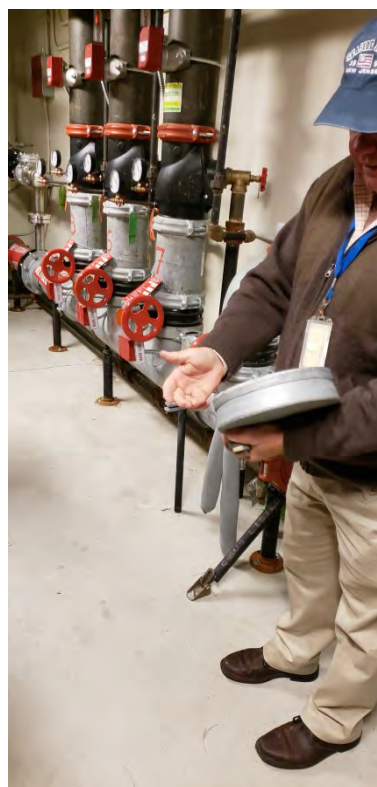
Photograph No. 16

NJARNG Lakehurst Environmental Manager [REDACTED] with new cap in Building 790 (Cold Storage Hangar) maintenance room.

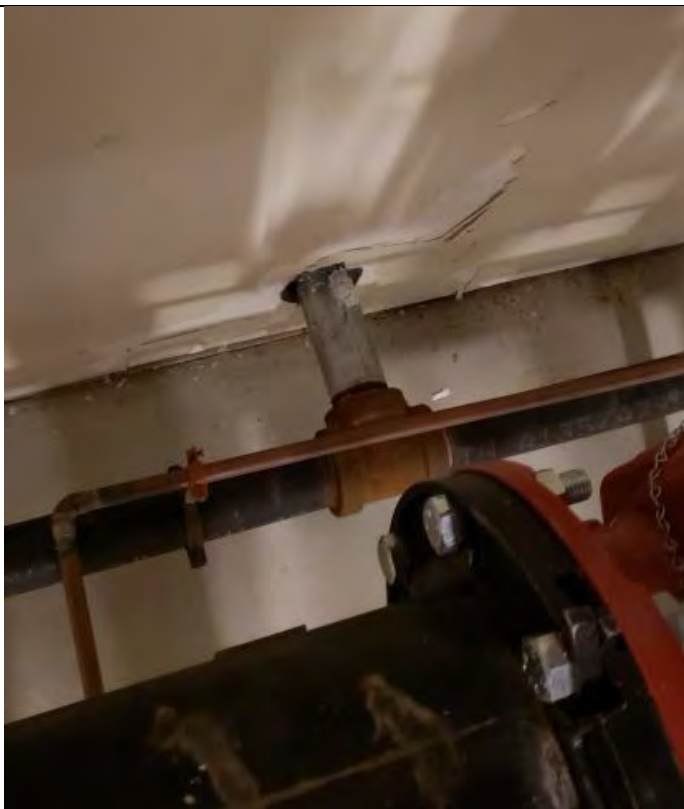
Building 790 (Cold Storage Hangar) maintenance room. The pipe that leaked AFFF during second spill event is pictured.

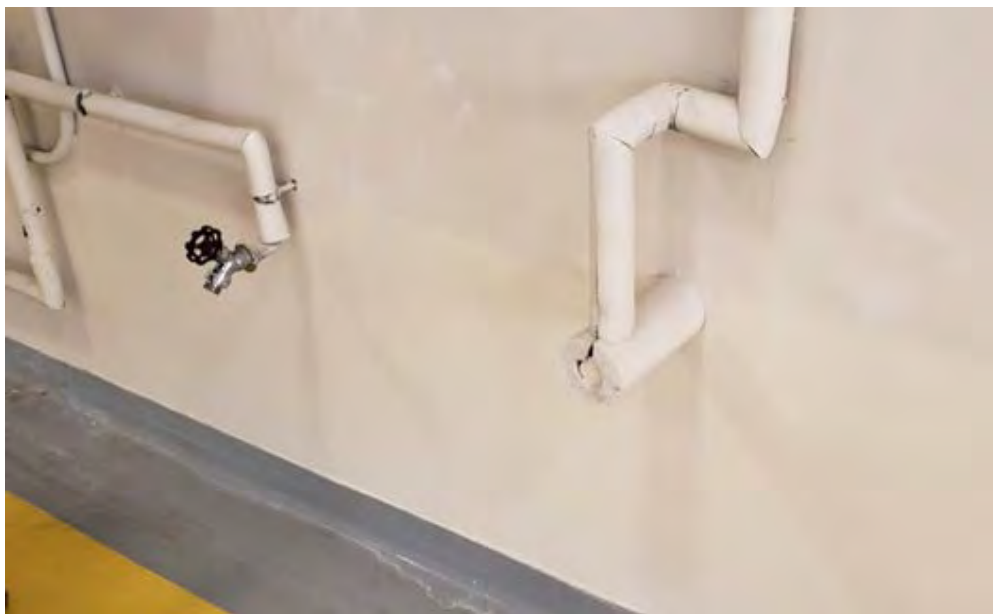
Building 790 (Cold Storage Hangar) inside Hangar adjacent to AFFF maintenance room. During discharge event AFFF knocked the dry wall out and leaked onto the hangar floor. New sheetrock is indicated by different coloring from the floor up.

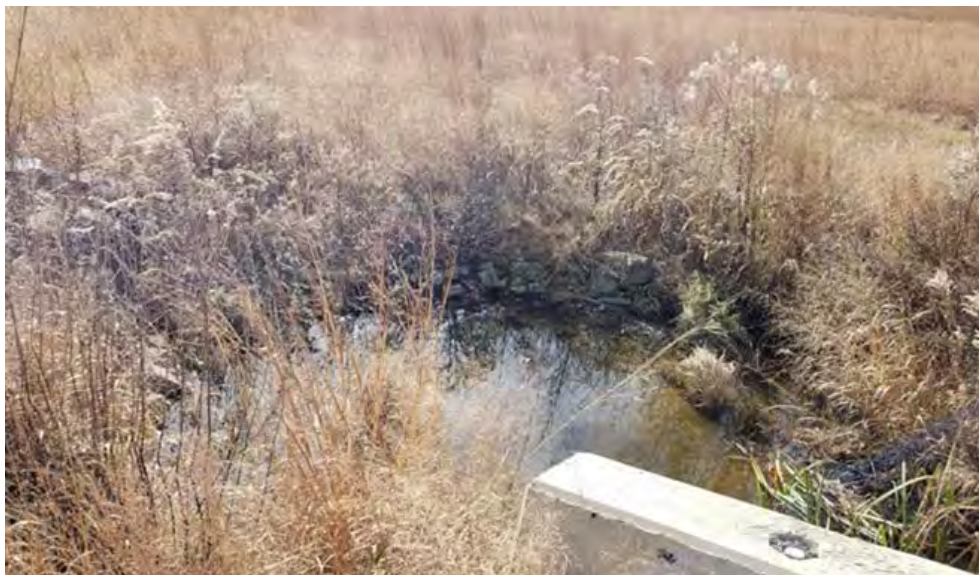
Outfall located south of Building 790 (Cold Storage Hangar). AFFF discharged from the Outfall during the first spill event and was later excavated.
