# Final Preliminary Assessment Report Salisbury Army Aviation Support Facility #2, North Carolina

Perfluorooctane-Sulfonic Acid (PFOS) and Perfluorooctanoic  
Acid (PFOA) Impacted Sites  
ARNG Installations, Nationwide

August 2020

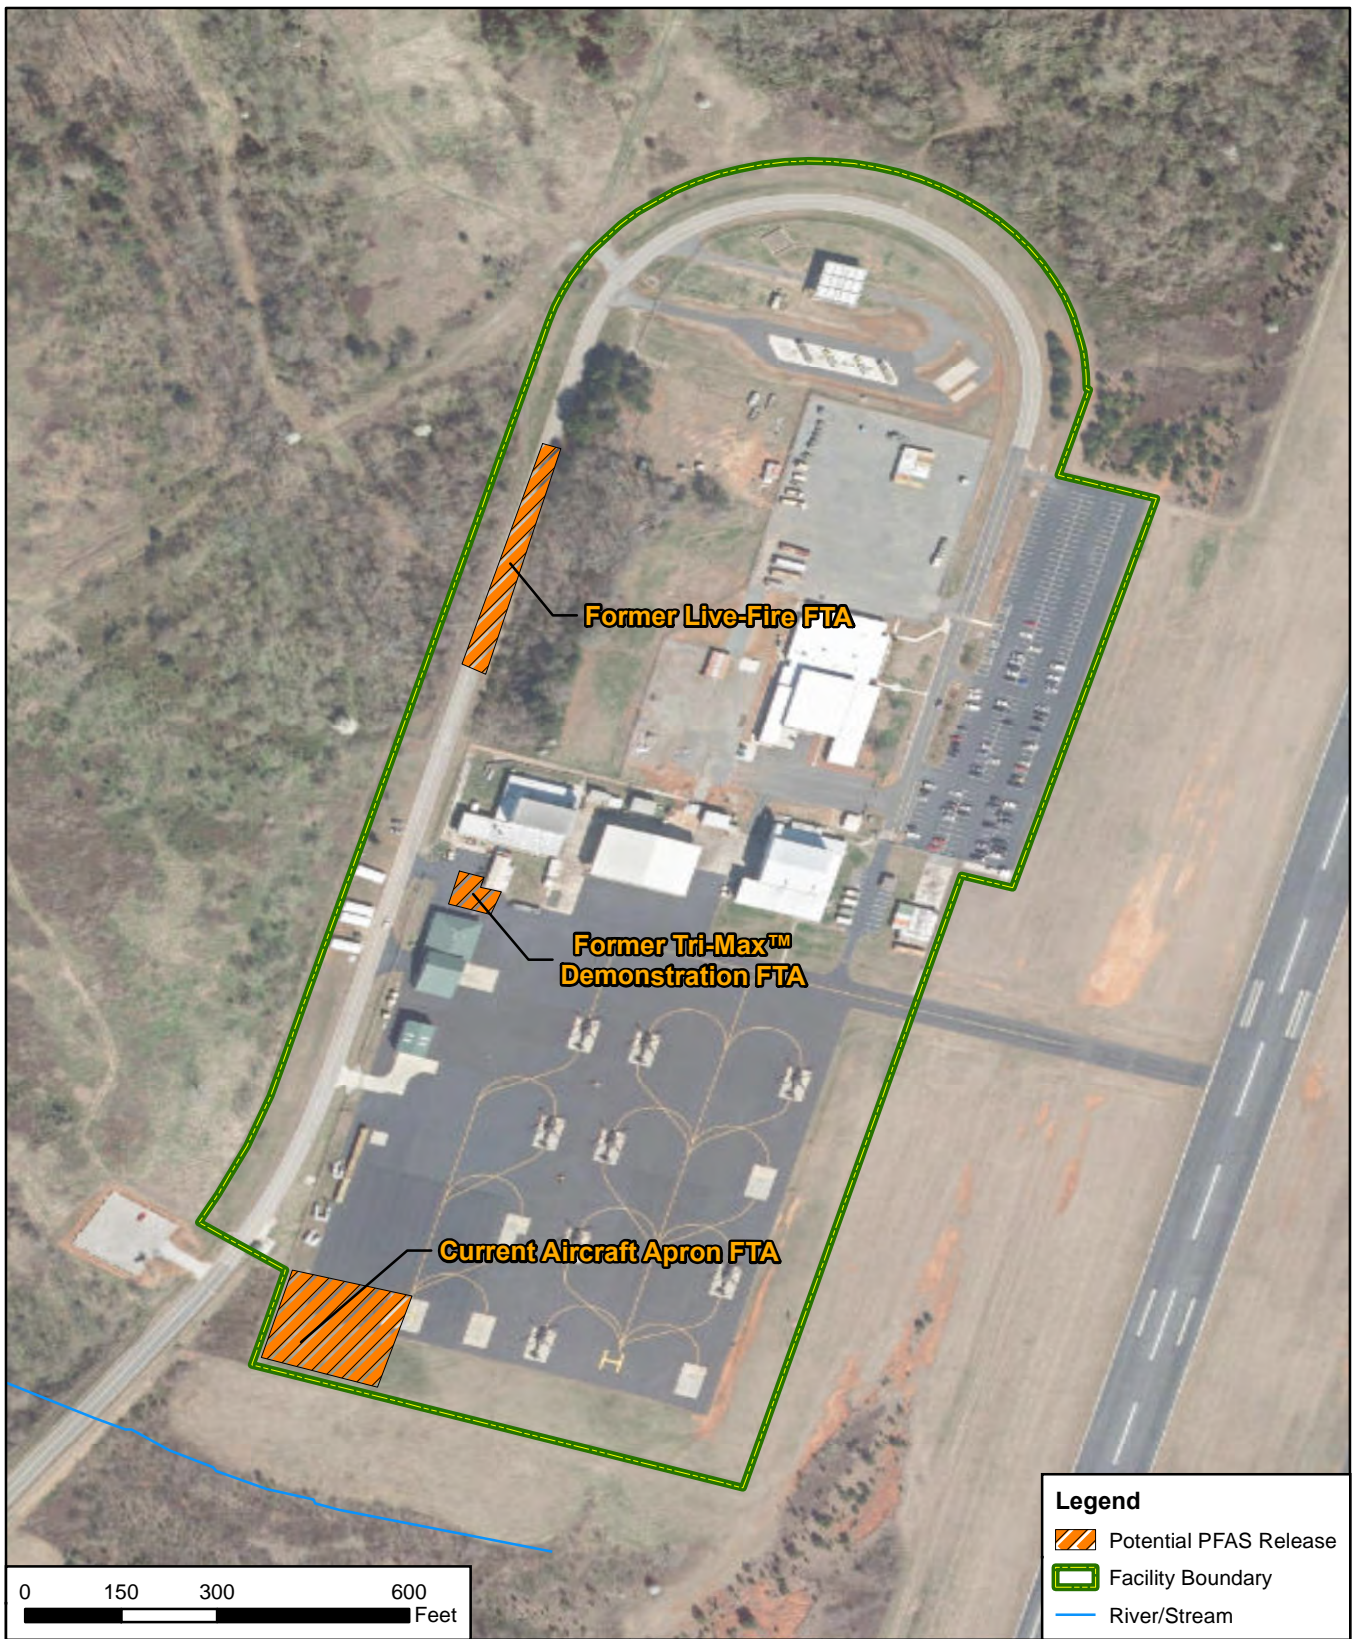
Based on PA interviews, the southwestern corner of the aircraft apron is used as an FTA. The training in this area involves using a firetruck to spray water from the southwestern corner of the apron toward the south, into the grassy vegetated area. It is unknown whether the same firetruck is used for each training event. Although the 430th Engineer Firefighting Team trains with only water in this location, both firetrucks used by the 430th Engineer Firefighting Team also store AFFF. It is possible that AFFF contained within the truck has migrated into other lines due to the corrosive nature of PFAS. As such, it is possible that water sprayed may contain PFAS. Water sprayed during training is aimed towards a drainage swale off-facility that flows downslope to the west towards Grants Creek. This FTA is considered a potential PFAS release area.

Based on PA interviews, an area near the northwestern boundary of the facility was also used as an FTA in the 1990s. Fire training was performed on a gravel area located where National Guard Road is currently paved. During training, a fuel pan was burned so that the former fire unit could train with various materials to extinguish the flames. On most occasions, water, Purple K and other dry chemical agents were used to extinguish the fire. On one occasion, a Tri-Max™ 30 wheeled fire extinguisher containing AFFF was used, however, the type and concentration of AFFF used is unknown and undocumented. The volume of AFFF sprayed is also unknown. A concrete drainage structure near the FTA conveys surface runoff to the north, into the wooded

area northwest of the facility. Based on the known release of AFFF during a training event at the Former Live-Fire FTA, the area is considered a potential PFAS release area.

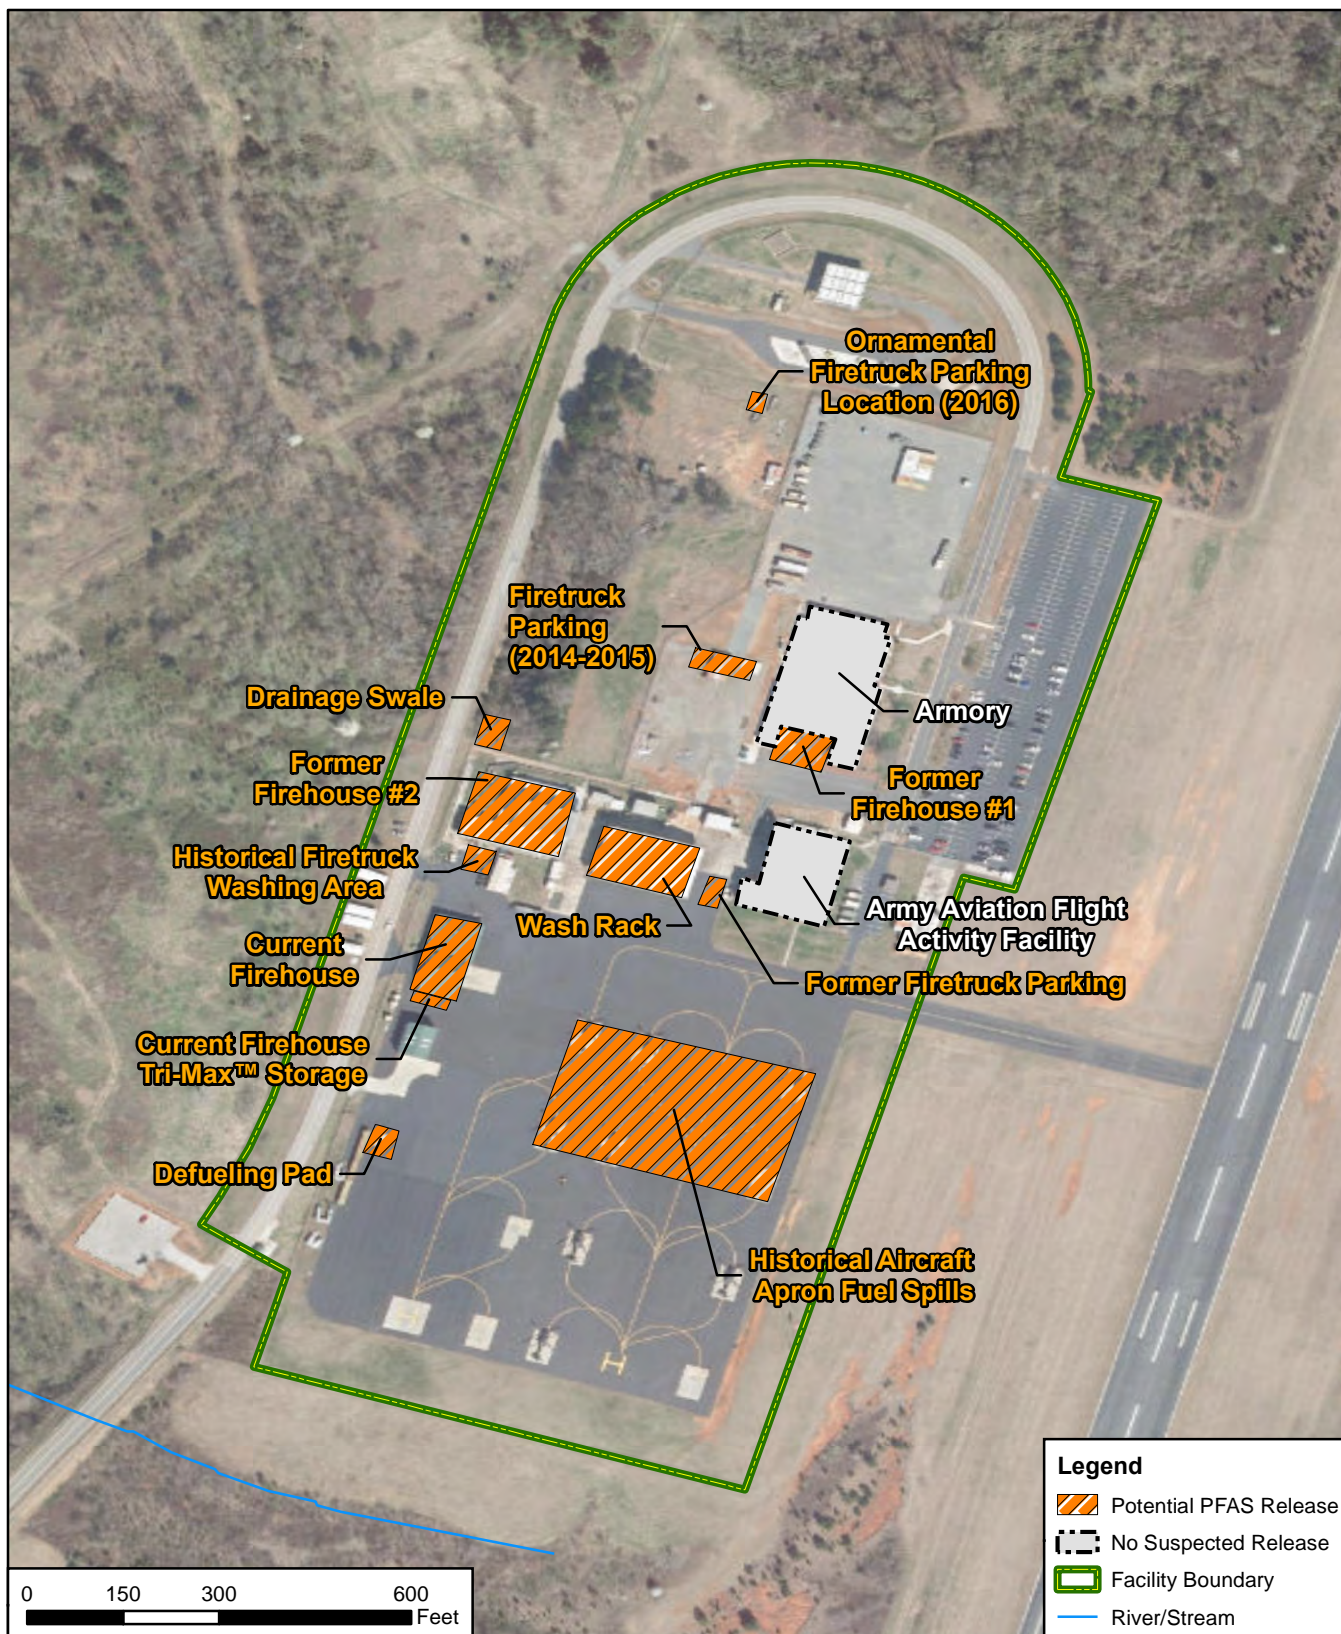
Based on PA interviews, the Current Firehouse was constructed circa 2005, which is corroborated by historical aerial imagery. The firehouse is located towards the northwestern end of the paved aircraft parking apron along National Guard Road. The 430th Engineer Firefighting Team was stationed at the Salisbury AASF #2 with the construction of the Current Firehouse. This team replaced the previous firefighting unit and is not a continuation of the previous unit.

Based on the storage of AFFF concentrate at the current firehouse, the potential leak of AFFF from the TFFT, the washing of firetrucks, the unknown disposal of previously stored AFFF concentrate from the firehouse, and the storage of Tri-Max™ 30 units at the firehouse, the area is considered a potential PFAS release area.

The Drainage Swale is a depressed, wooded area at the corner of two concrete drainage structures running south to north and east to west, adjacent to the Former Firehouse #2. The concrete ditch that runs south to north has received firetruck wash water from the Former Firehouse #2 and discharged AFFF from the Former Tri-Max™ 30 Demonstration FTA; this drainage then flowed north before overflowing into the Drainage Swale area. The as-built drawings appear to indicate the presence of a catch basin south of the Former Firehouse #2 that also drains into the concrete ditch via a 15-inch reinforced concrete pipe. In addition, a “brush barrier” is labeled at the approximate location of the Drainage Swale. The drainage pattern from the Drainage Swale is unknown but is presumed to flow north along National Guard Road before infiltrating into the ground or draining into a tributary of Grants Creek. The Drainage Swale is considered a potential PFAS release area, because the area has received drainage from other potential PFAS release areas.

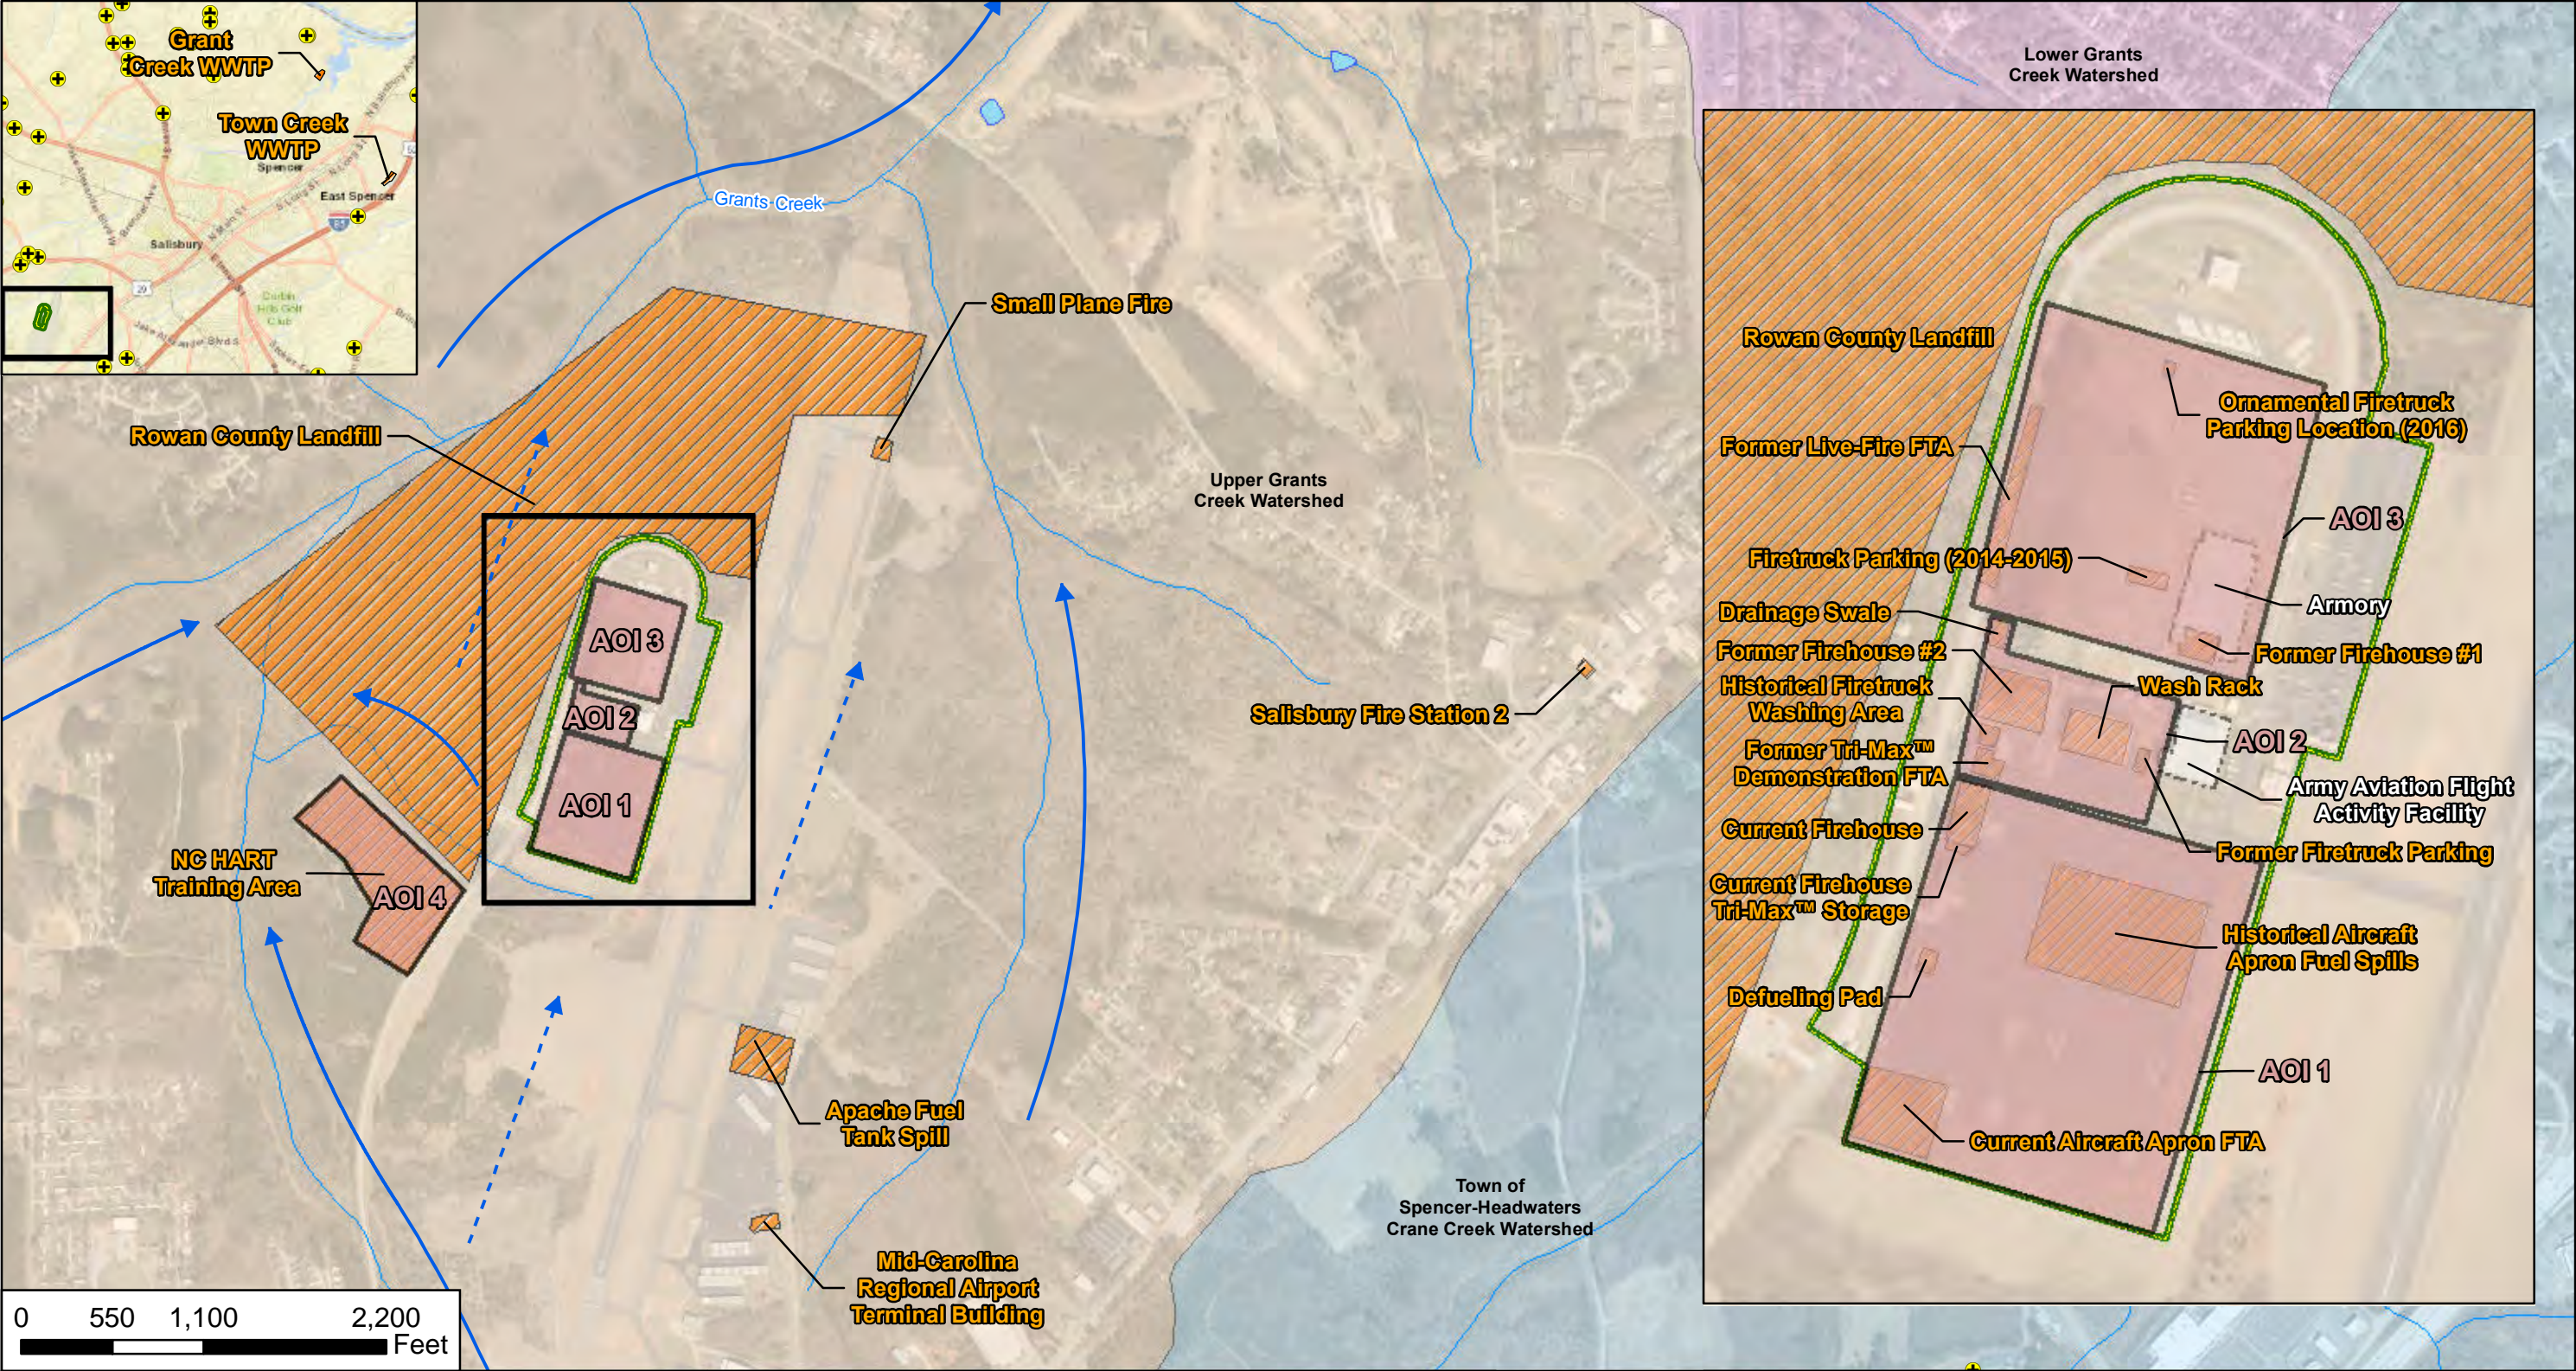
Locations of the AOIs are shown on **Figure 6-1**. Except for AOI 4, all AOIs were located on land licensed to NCARNG. AOI 4 is located on off-facility, adjacent property but is solely used by NCARNG for fire training purposes. The following sections describe the CSM components and the specific preliminary CSMs developed for each AOI. The CSM identifies the three components necessary for a potentially complete exposure pathway: (1) source, (2) pathway, (3) receptor. If any of these elements are missing, the pathway is considered incomplete.

AOI 4 encompasses the open field located off-facility and adjacent to the southwestern portion of the facility where the 430<sup>th</sup> Engineer Firefighting Team performs fire training exercises. Although this training uses only water, the firetruck used also stores AFFF. It is possible that AFFF contained within the truck has migrated via backflow into other lines due to the corrosive nature of PFAS. As such, it is possible that this water is contaminated with PFAS.

Runoff from the training exercises likely flows into the small stream/drainage swale, bordering the FTA to the north, that drains west into Grants Creek. Potential PFAS exposure pathways resulting from releases at AOI 4 are described in **Table 6-1**.

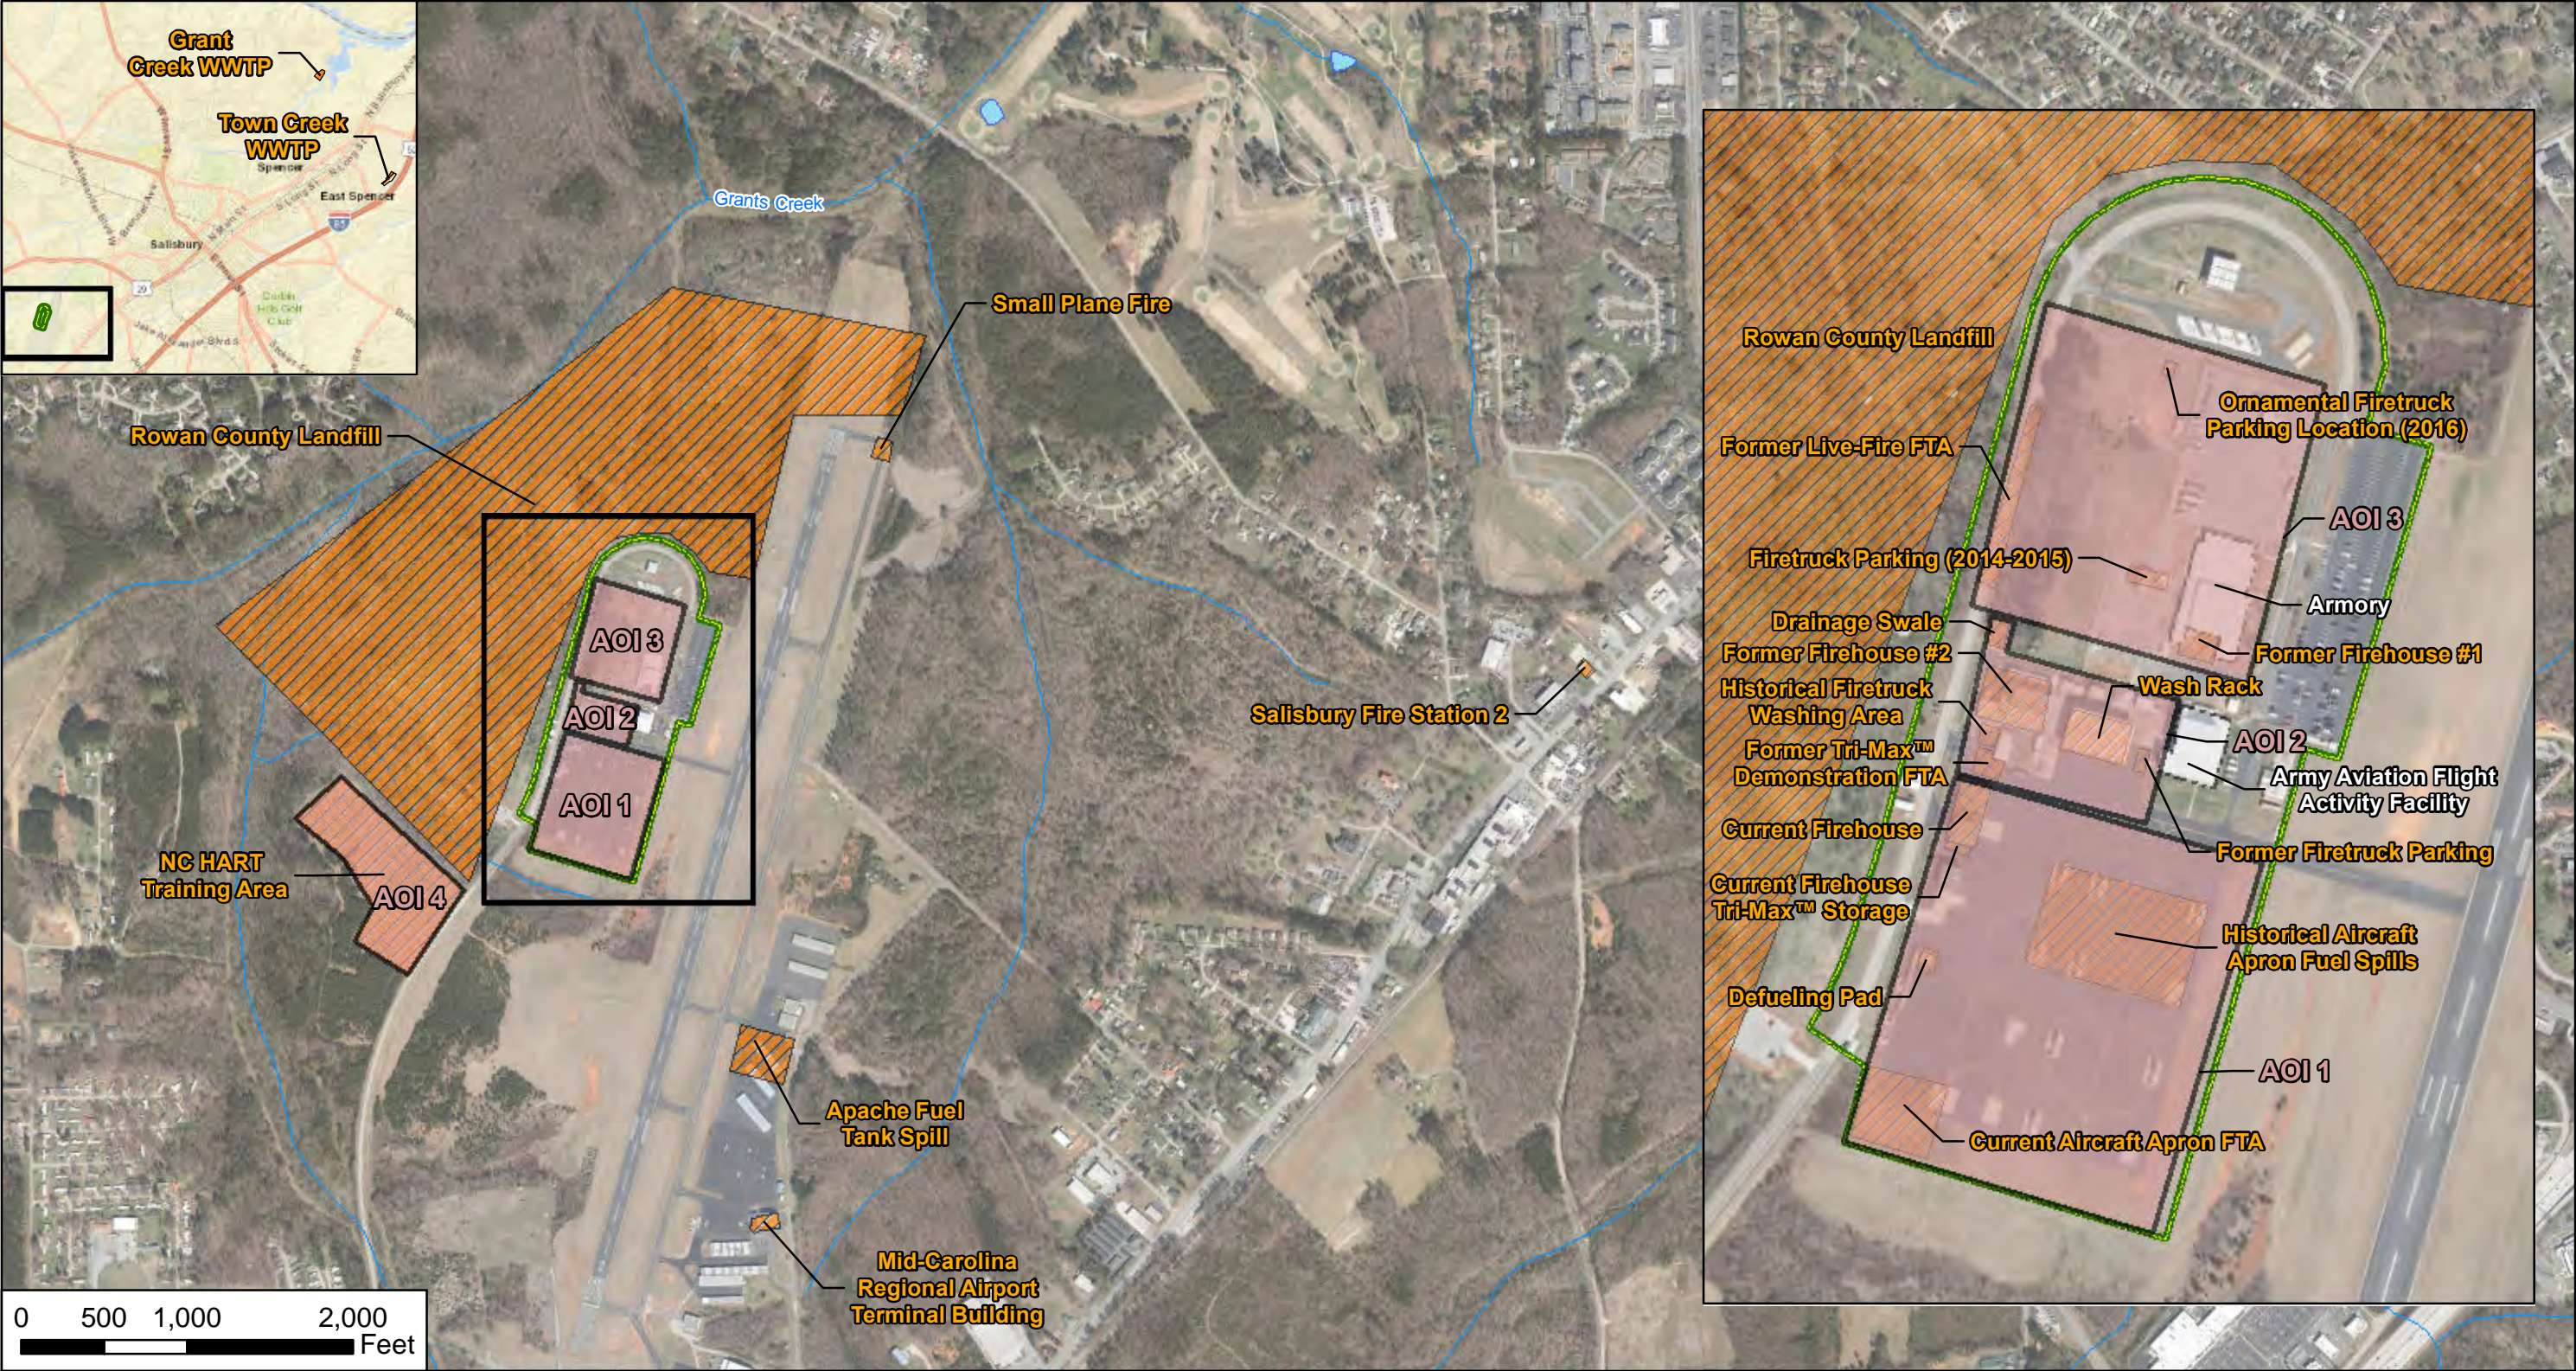
Area of Interest	AOI Location	Rationale	Potential Future Action
AOI 1 Southern Portion of Salisbury AASF #2	35°38'48.89"N; 80°31'21.72"W	AOI 1 includes known AFFF storage and release locations.	Proceed to an SI, focus on soil, sediment, groundwater, and surface water
AOI 2 Central Portion of Salisbury AASF #2	35°38'53.74"N; 80°31'21.08"W	AOI 2 includes known AFFF storage and release locations.	Proceed to an SI, focus on soil, sediment, groundwater, and surface water
AOI 3 Northern Portion of Salisbury AASF #2	35°38'58.18"N; 80°31'18.18"W	AOI 3 includes known AFFF storage and release locations.	Proceed to an SI, focus on soil, sediment, groundwater, and surface water
AOI 4 NC HART FTA	35°38'44.78"N; 80°31'37.51"W	AOI 4 was used by NCARNG as an FTA involving AFFF-containing firetrucks.	Proceed to an SI, focus on soil, sediment, groundwater, and surface water
