# Final Preliminary Assessment Report Morrisville Army Aviation Support Facility #1, North Carolina

Perfluorooctanesulfonic Acid (PFOS) and Perfluorooctanoic  
Acid (PFOA) Impacted Sites  
ARNG Installations, Nationwide

August 2020

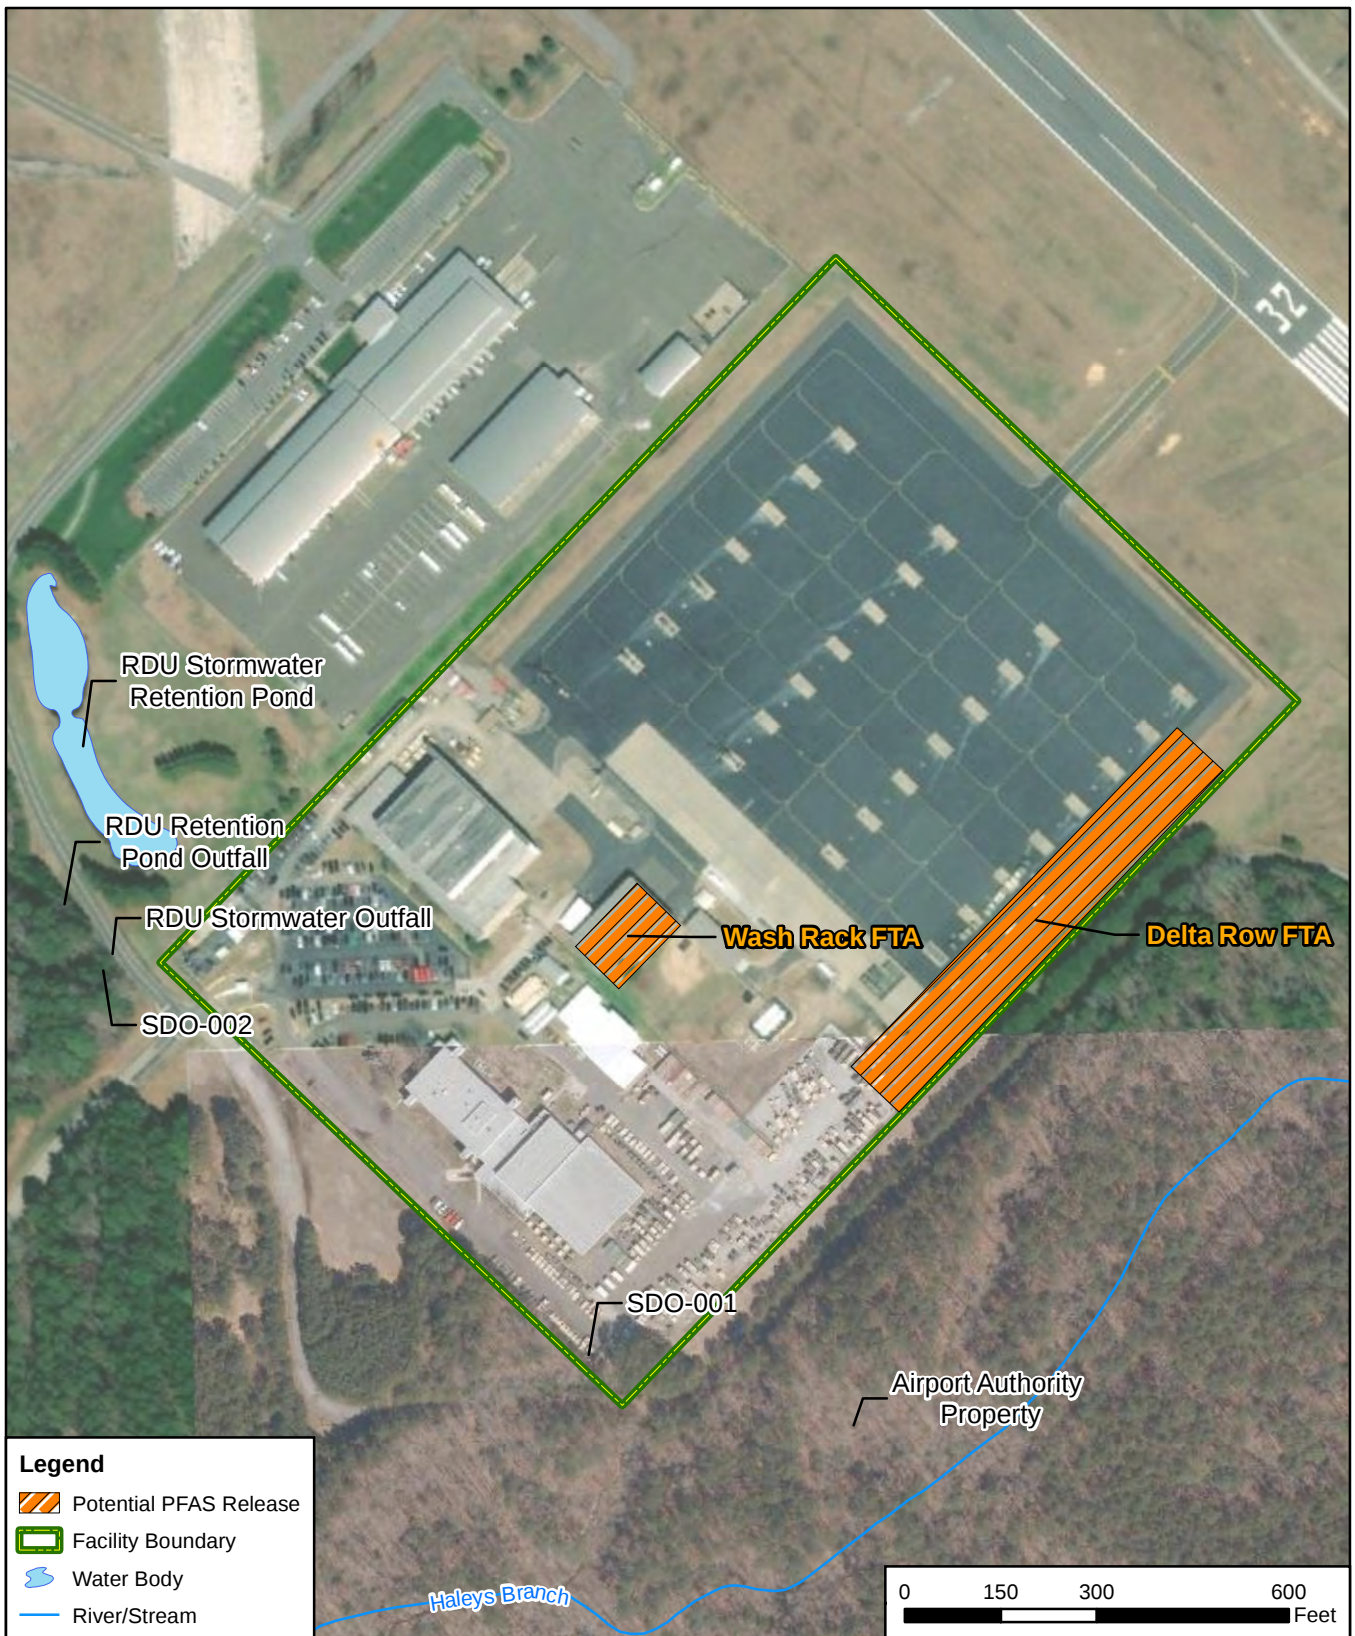
| Preliminary Assessment for PFAS at Morrisville AASF #1, NC | | | | | | <br>12420 Milestone Center Drive<br>Germantown, MD 20876 | Figure 2-1 |

Two FTAs were identified at Morrisville AASF #1 during the PA. Descriptions of the FTAs are presented below, and their locations are shown on **Figure 2-1**. Interview records and photographs are included in **Appendix B** and **Appendix C**; respectively.

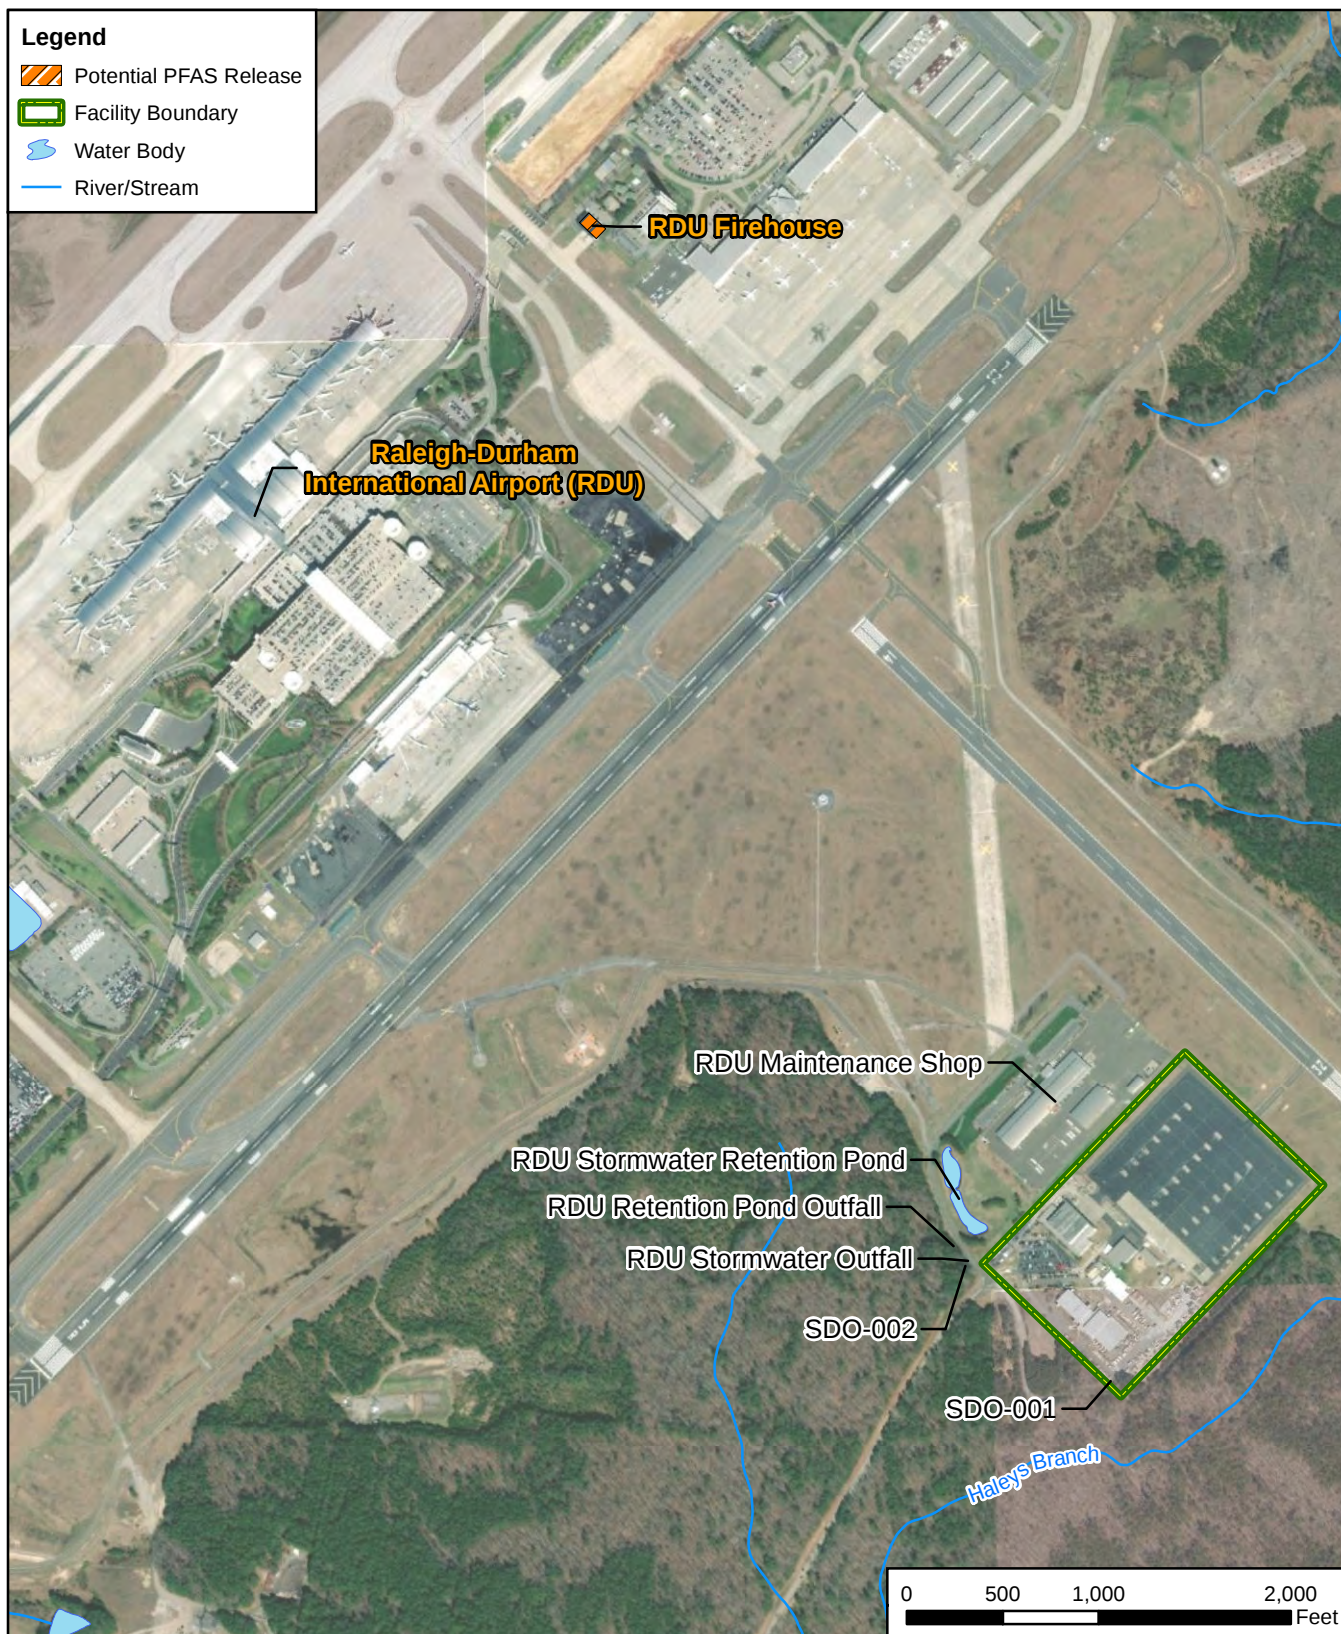
| Preliminary Assessment for PFAS at Morrisville AASF #1, NC | | | | | | <br>12420 Milestone Center Drive<br>Germantown, MD 20876 | Figure 5-1 |

One potential off-facility PFAS source was identified adjacent to Morrisville AASF #1 during the PA. The location of potential off-facility source areas are shown on **Figure 5-1**.

The RDU Maintenance Shop shares its eastern boundary with Morrisville AASF #1. The geographical coordinates of the building are 35°52'4.03"N; 78°46'47.77"W. The maintenance shop was built in 2003 and is used to provide maintenance services on RDU vehicles. It is unknown if the RDU Maintenance Shop has conducted maintenance on emergency vehicles.

The RDU retention pond outfall is located approximately 100 feet north of the AASF #1 stormwater outfall, SDO-002. Both the RDU retention pond outfall and SDO-002 outfall release to Haleys Branch via the same route but do not combine stormwater prior to the release. However, the facility also receives minimal overland flow from the RDU Airport property that does not directly release into the stormwater outfalls (NCDEQ, 2017).

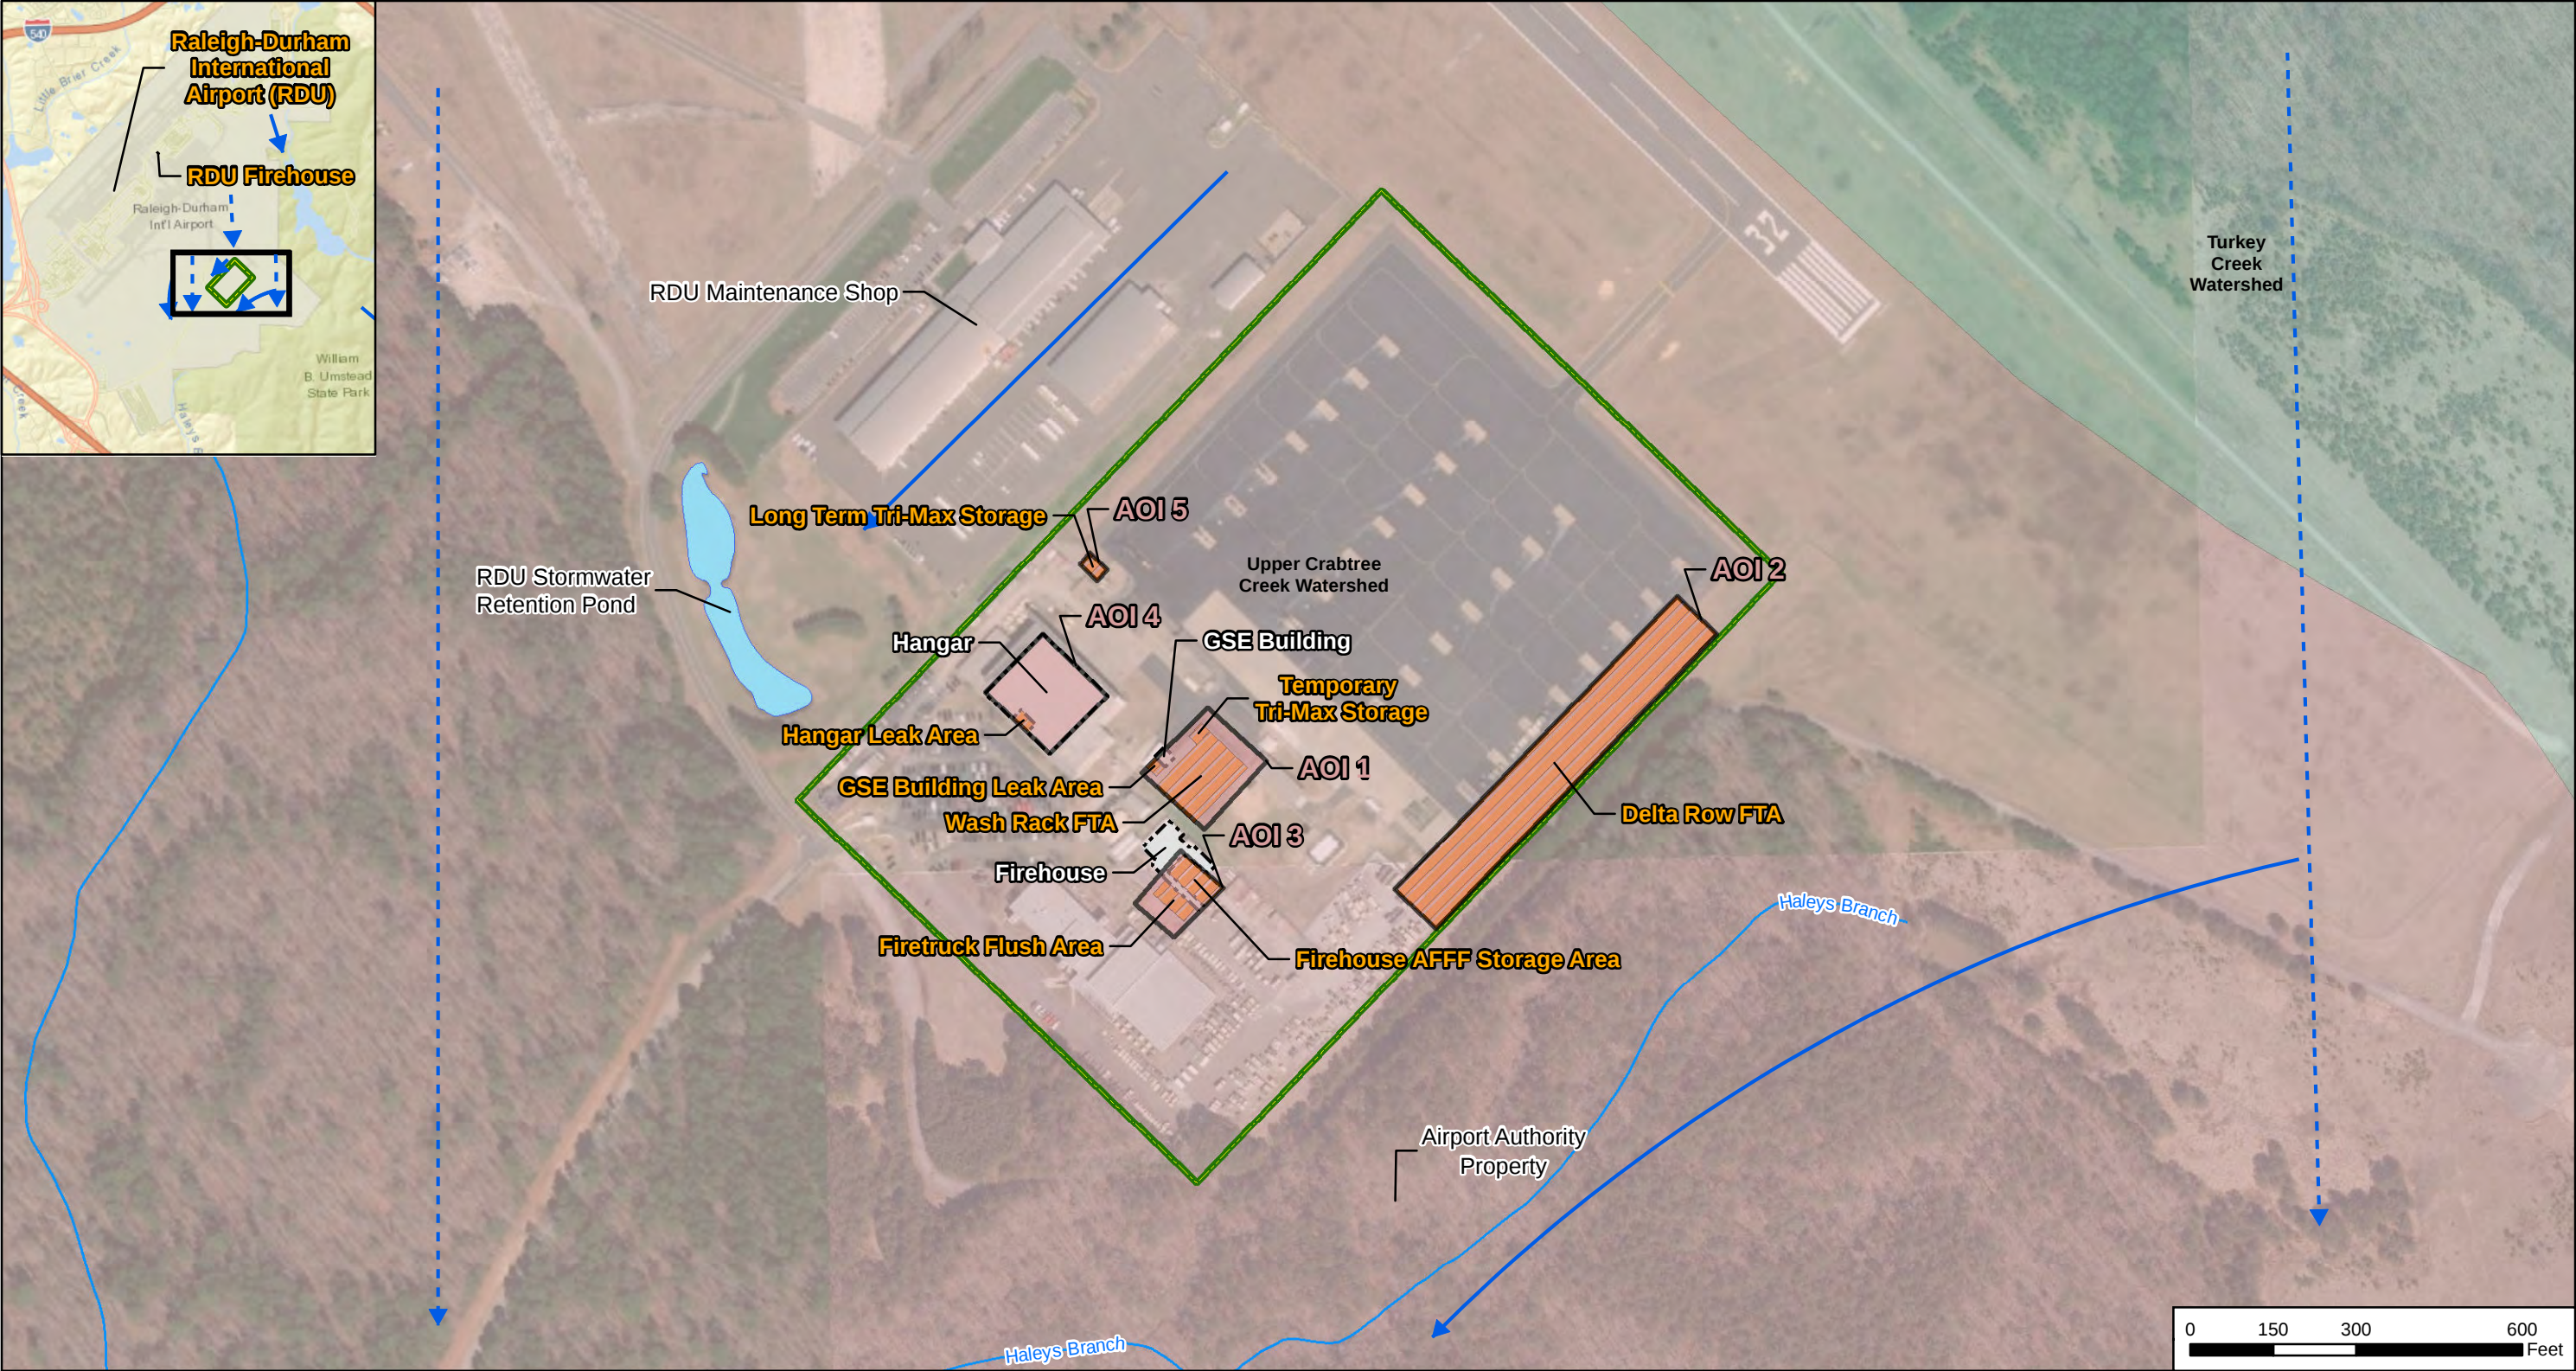
Based on the PA findings, five AOIs were identified at Morrisville AASF #1. Locations of the AOIs are shown on **Figure 6-1**. The preliminary CSMs for the AOIs at Morrisville AASF #1 are shown on **Figure 6-2** and **Figure 6-3**. The following sections describe the CSM components and the specific preliminary CSMs developed for each AOI. The CSM identifies the three components necessary for a potentially complete exposure pathway: (1) source, (2) pathway, (3) receptor. If any of these elements are missing, the pathway is considered incomplete.

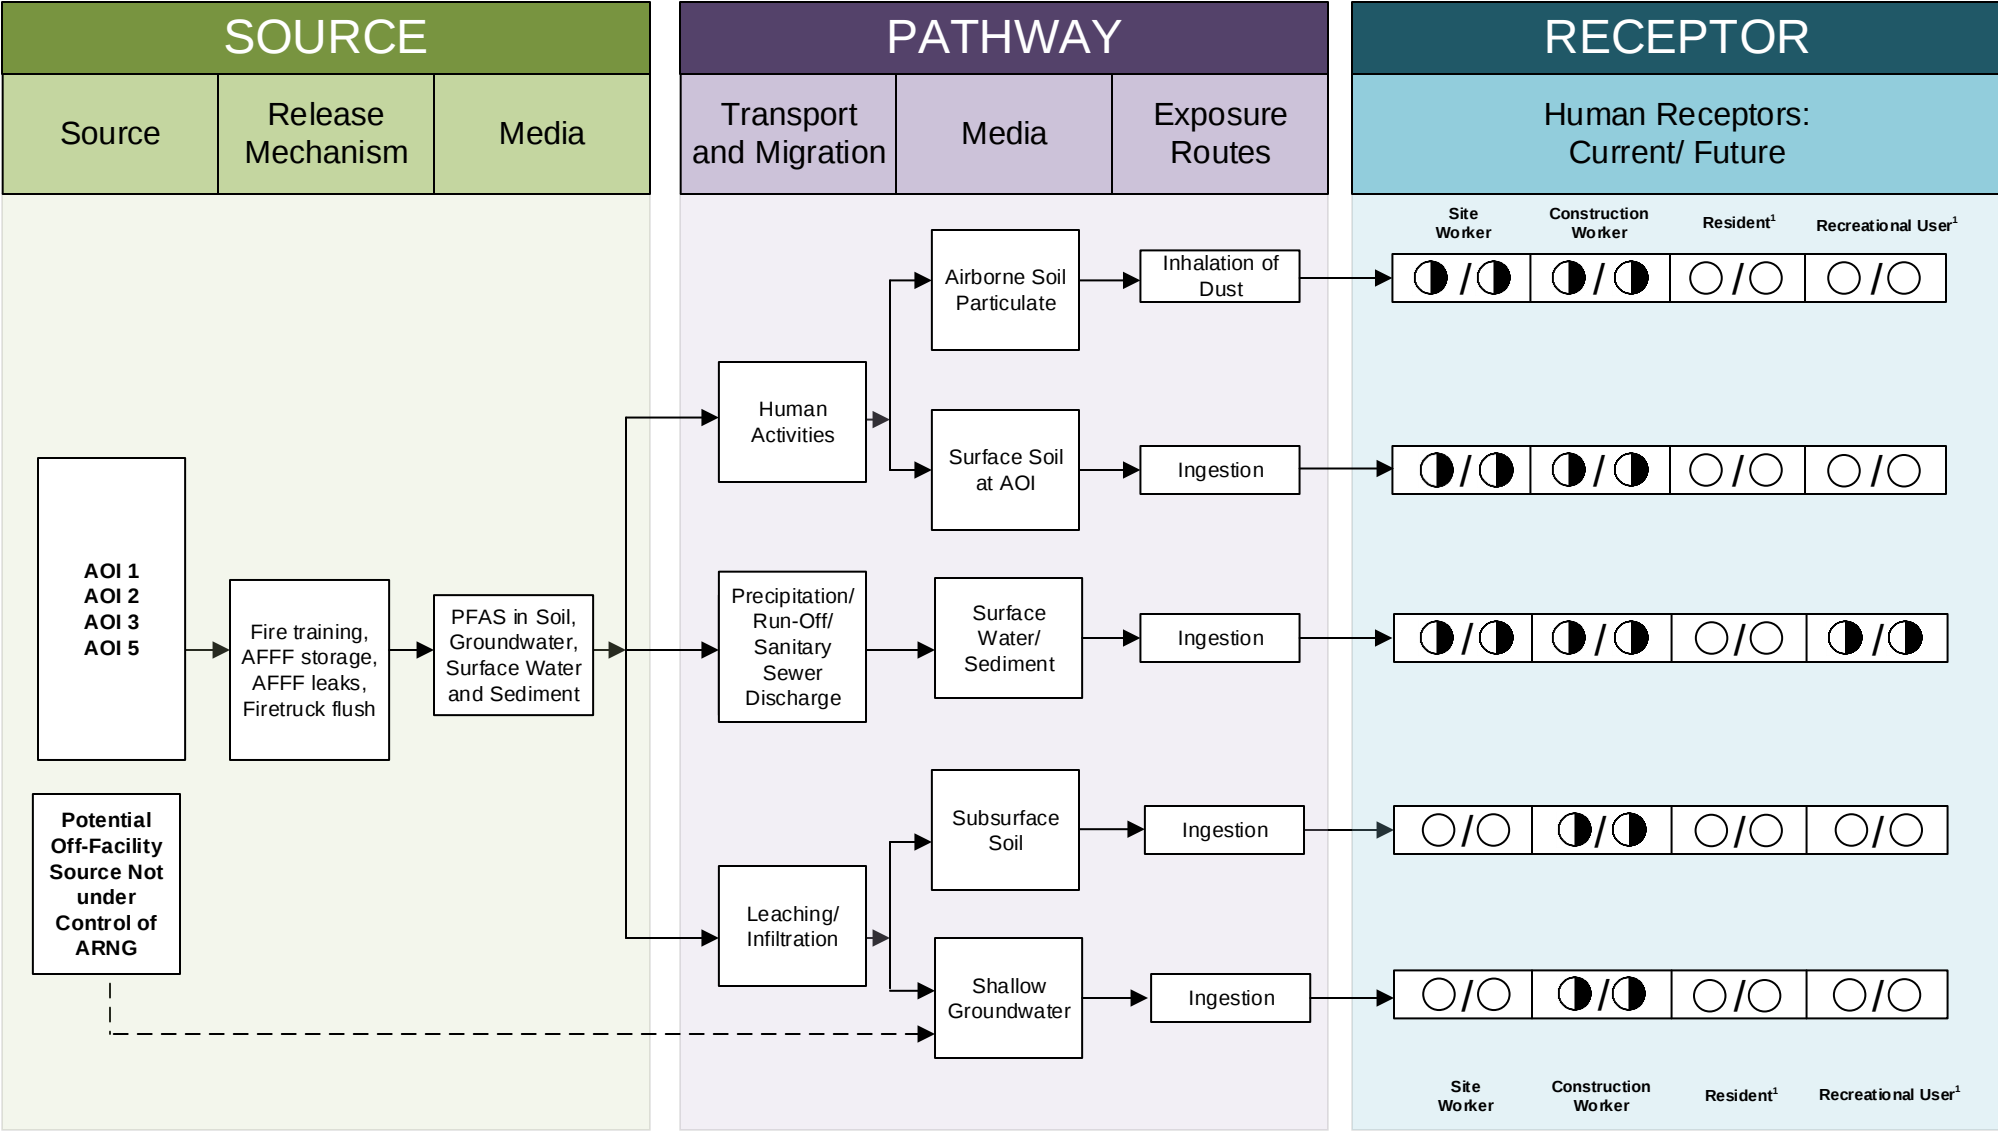
**Figure 6-2**  
Preliminary Conceptual Site Model  
AOI 1, AOI 2, AOI 3, and AOI 5

- Construction workers are considered workers who represent a utility worker or other worker who would be exposed to surface and/or subsurface conditions through ground-disturbing activities.
- Off-facility recreational users typically identify a person who may recreationally use an off-facility area that may be affected by a PFAS release from the facility. Off-facility recreational users could be exposed to sediment and surface water during recreational use.
- The preliminary CSM for Morrisville AASF #1 indicates which specific receptors could potentially be exposed to PFAS. The preliminary CSM for AOIs 1, 2, 3, and 5 is shown on **Figure 6-2**.

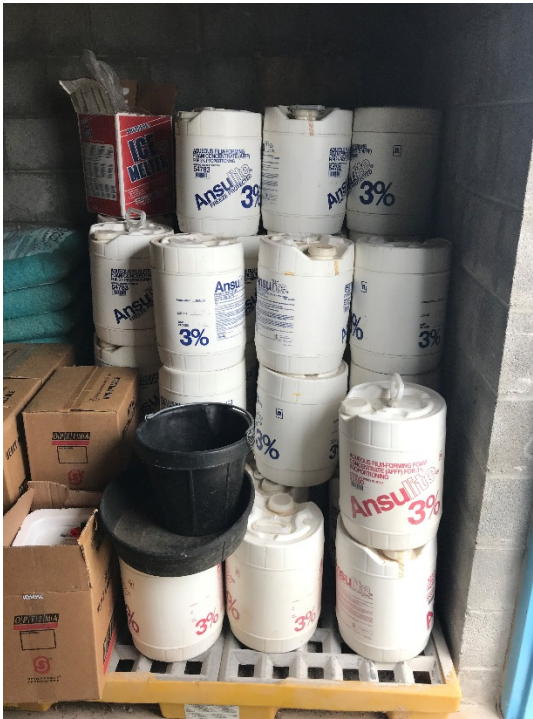
| Army National Guard, Preliminary Assessment for PFAS | Morrisville AASF | Morrisville, North Carolina |
|---|---|---|
| <p><b>Photograph No. 9</b></p> <p><b>Description:</b></p> <p>The GSE storage room, containing 20 five-gallon buckets of 3% AFFF (Ansulite).</p> <p>Date Taken:<br/>22 October 2019</p> | | |

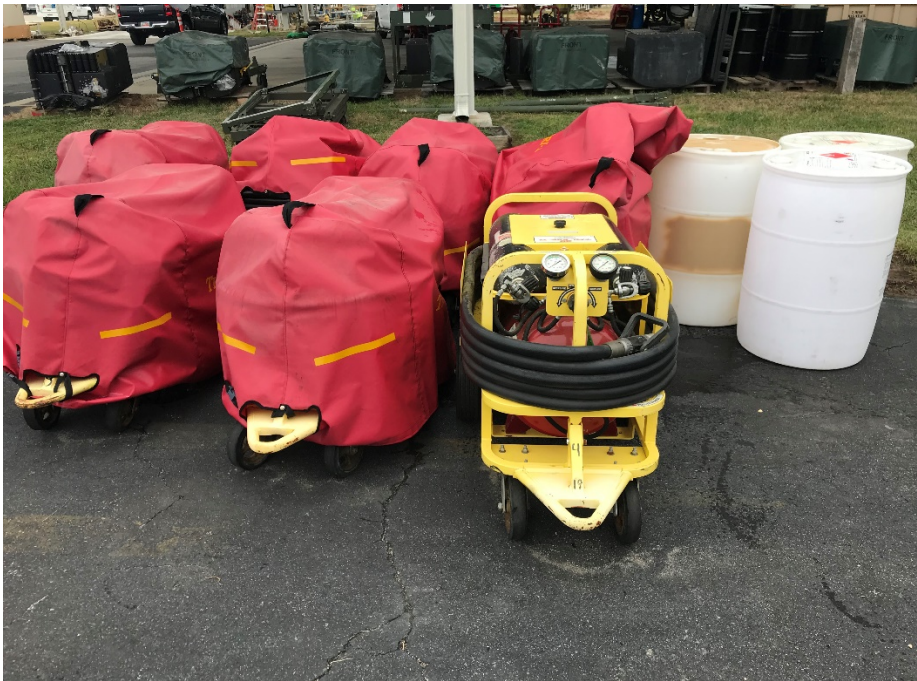
A temporary storage area for Tri-Max 30<sup>TM</sup> carts is just outside the western edge of the wash rack. The approximate geographic coordinates of the storage area are 35°51'57.87"N; 78°46'41.95"W; eight Tri-Max 30<sup>TM</sup> carts are currently located there. The carts were full at the time of the VSI and were scheduled to be emptied into the 55-gallon drums that were staged in the storage area. The planned AFFF transfer will take place in the wash rack. The empty Tri-Max 30<sup>TM</sup> carts will then likely be moved to the long-term gravel storage area near the aircraft apron. All Tri-Max 30<sup>TM</sup> carts will eventually be turned in to the NCARNG Construction Facilities Management Office (CFMO).

| Army National Guard, Preliminary Assessment for PFAS | Morrisville AASF | Morrisville, North Carolina |
|---|---|---|
| <p><b>Photograph No. 10</b></p> <p><b>Description:</b></p> <p>TriMax30™ carts stored outside the wash rack. Seven carts visible in the foreground, with one additional cart in the background under the wash rack pavilion.</p> <p>Date Taken:<br/>22 October 2019</p> | | |

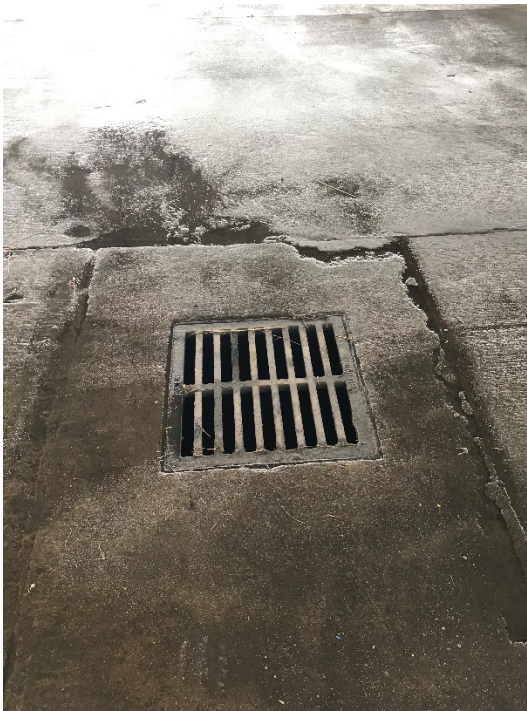
| Army National Guard, Preliminary Assessment for PFAS | Morrisville AASF | Morrisville, North Carolina |
|---|---|---|
| <p><b>Photograph No. 11</b></p> <p><b>Description:</b></p> <p>Drain located in the center, and lowest point, of the wash rack</p> <p>Date Taken:<br/>22 October 2019</p> | | |

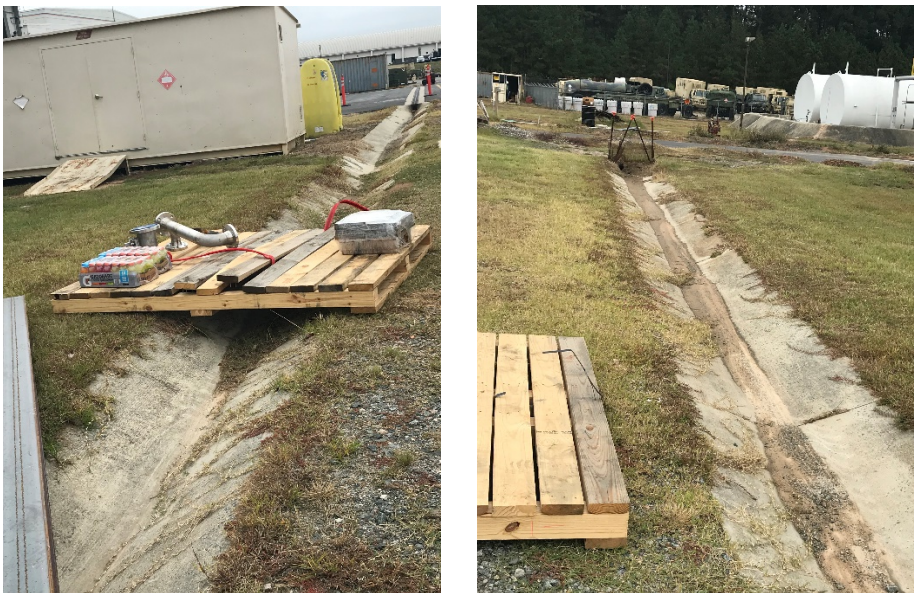
| Army National Guard, Preliminary Assessment for PFAS | Morrisville AASF | Morrisville, North Carolina |
|---|---|---|
| <p><b>Photograph No. 12</b></p> <p><b>Description:</b></p> <p>Pictured on left: nearest storm drain to the wash rack, visible in upper righthand corner with concrete conveyance toward the southeast.</p> <p>Pictured on right: the southeasternmost end of the same stormwater drainage structure</p> <p>Date Taken:<br/>22 October 2019</p> | | |

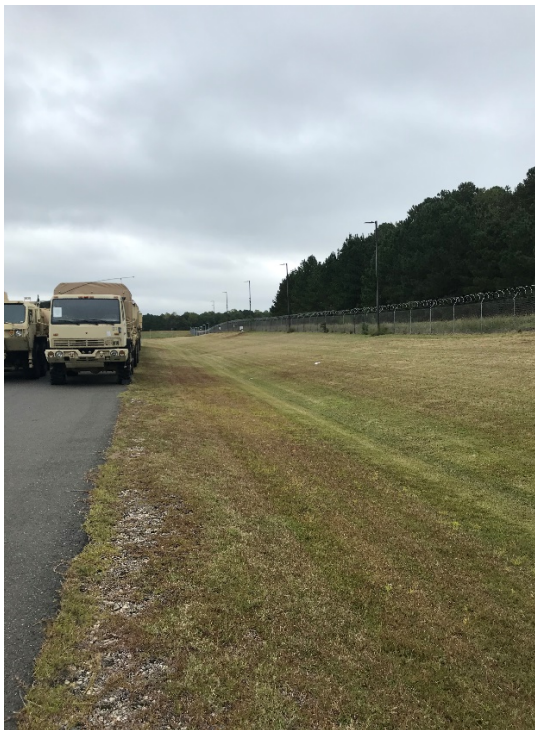
Based on PA interviews, the grassy area along the easternmost row of helicopter parking pads on the apron, known as Delta Row, was the second FTA at the facility, and it was used approximately once every two years from 1988 until sometime before 2010. It is unknown specifically how many times the FTA was used, as both FTAs were used on an as-available basis. During each training event, one Tri-Max 30™ was completely emptied by allowing each trainee to perform a brief AFFF discharge from the extinguisher. Discharges at the FTA were allowed to drain through one of the stormwater inlets along the grassy ditch, which runs parallel to the edge of Delta Row. According to the as-built drawings, a series of four stormwater inlets are located throughout the length of the ditch. As identified during the VSI, the southernmost stormwater inlet in the ditch is anticipated to have been the most impacted by fire training activities. All stormwater inlets draining the Delta Row FTA are connected and divert flow in a southwestern direction. The stormwater is discharged from Outfall SDO-001 to Haleys Branch which then flows to Lake Crabtree, Crabtree Creek, and the Neuse River. The approximate geographic coordinates of the FTA are 35°51'56.32"N; 78°46'35.48"W.

| APPENDIX C – Photographic Log | | |
|---|---|---|
| <b>Photograph No. 13</b><br><b>Description:</b><br>Looking Northeast from the southern end of the Delta Row Fire Training Area<br><br>Date Taken:<br>22 October 2019 | | |
