# FINAL Preliminary Assessment Report Tulsa Army Aviation Support Facility #2 Oklahoma

Perfluorooctanesulfonic Acid (PFOS) and Perfluorooctanoic  
Acid (PFOA) Impacted Sites  
ARNG Installations, Nationwide

October 2020

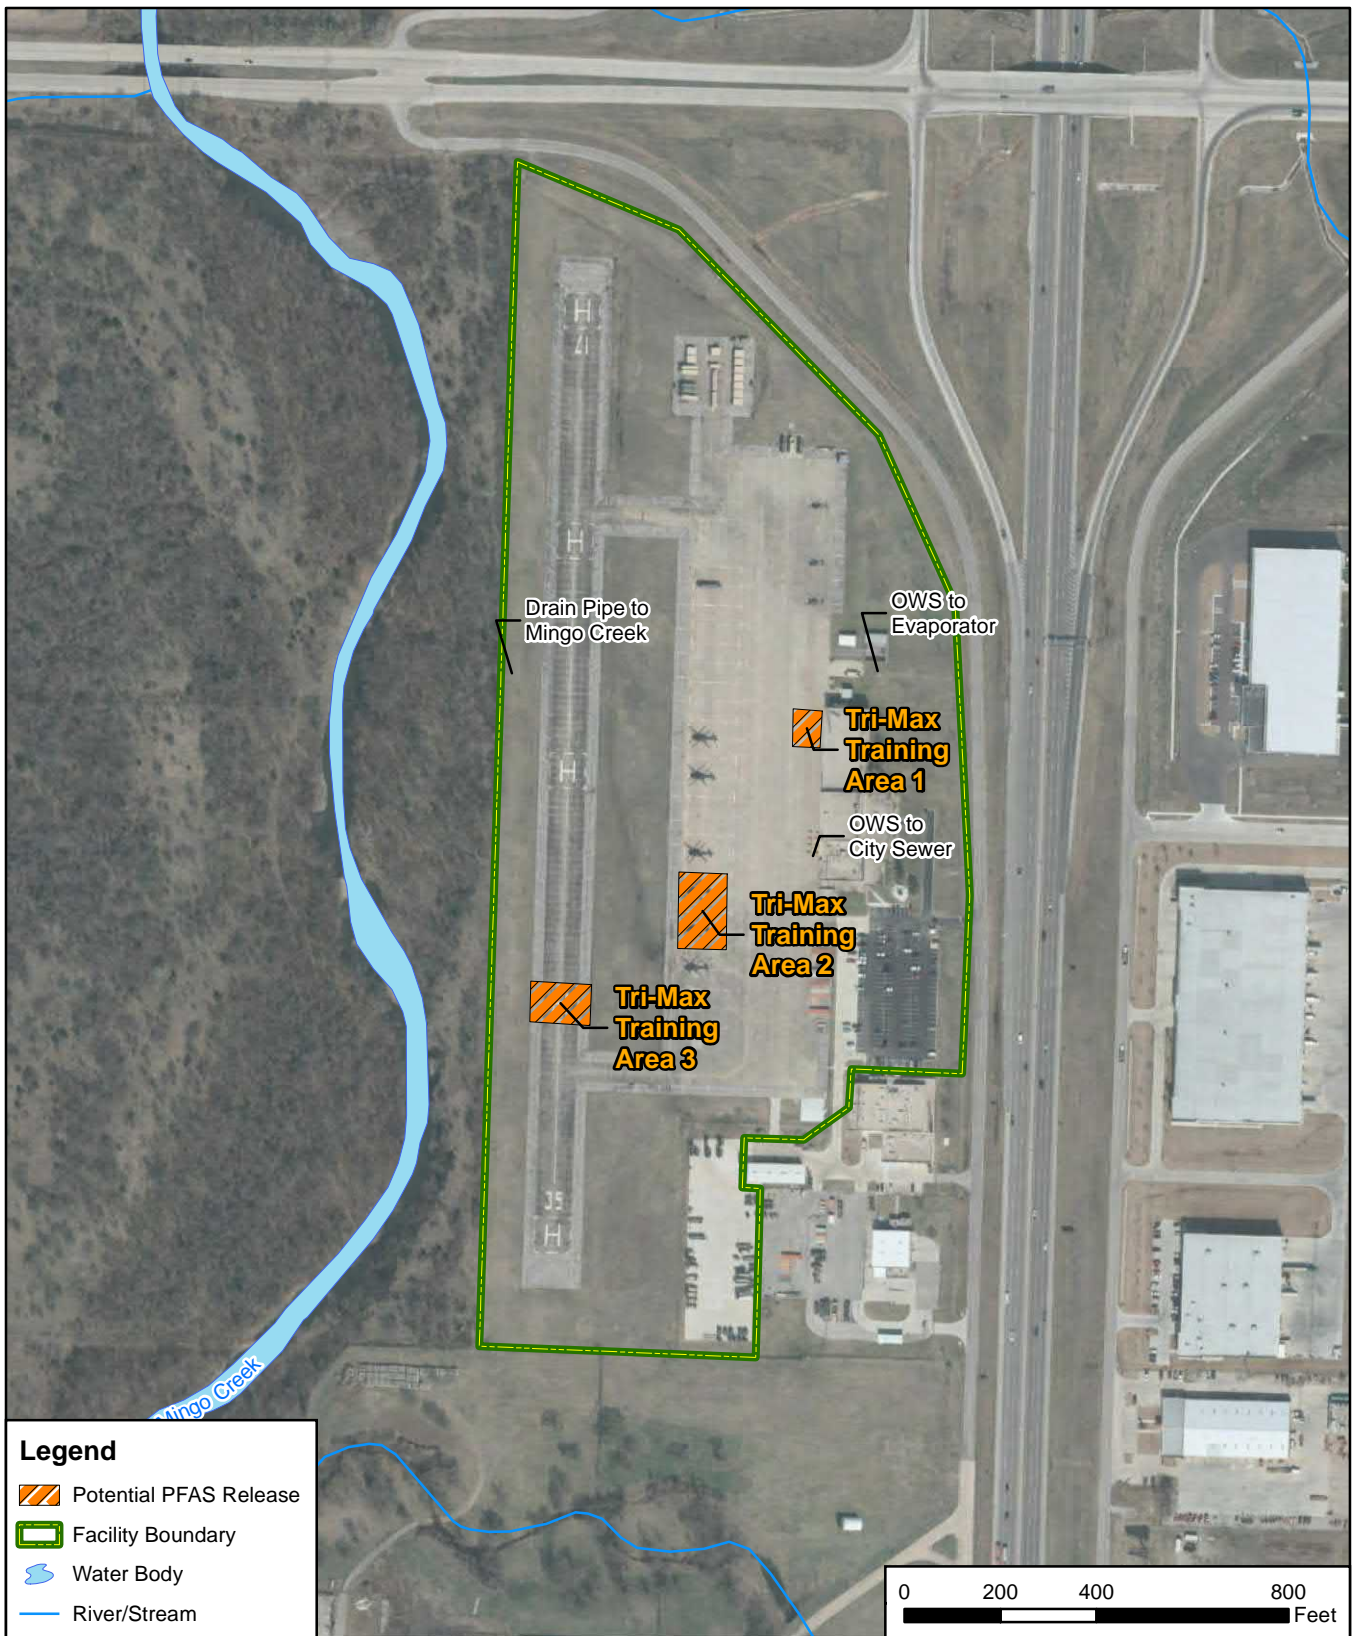
The facility obtained eight Tri-Max™ extinguishers in the 1990s and trained with the units on three occasions. One extinguisher was completely discharged during each training event. The training events occurred in three different locations, designated as Tri-Max Training Area 1, 2, and 3. The geographic coordinates of Tri-Max Training Areas 1, 2, and 3 are 36°13'00.8"N, 95°51'12.6"W; 36°12'57.0"N, 95°51'14.7"W; and 36°12'55.1"N, 95°51'18.2"W; respectively. A few extinguishers were located at the HEMTT Storage but the locations of the remaining units are unknown. No information was provided regarding the dates of the training events. The Tri-Max™ extinguishers were subsequently removed from use in the early 2000s. In 2011 the Tri-Max™ extinguishers were shipped to the US Property and Fiscal Office for Oklahoma.

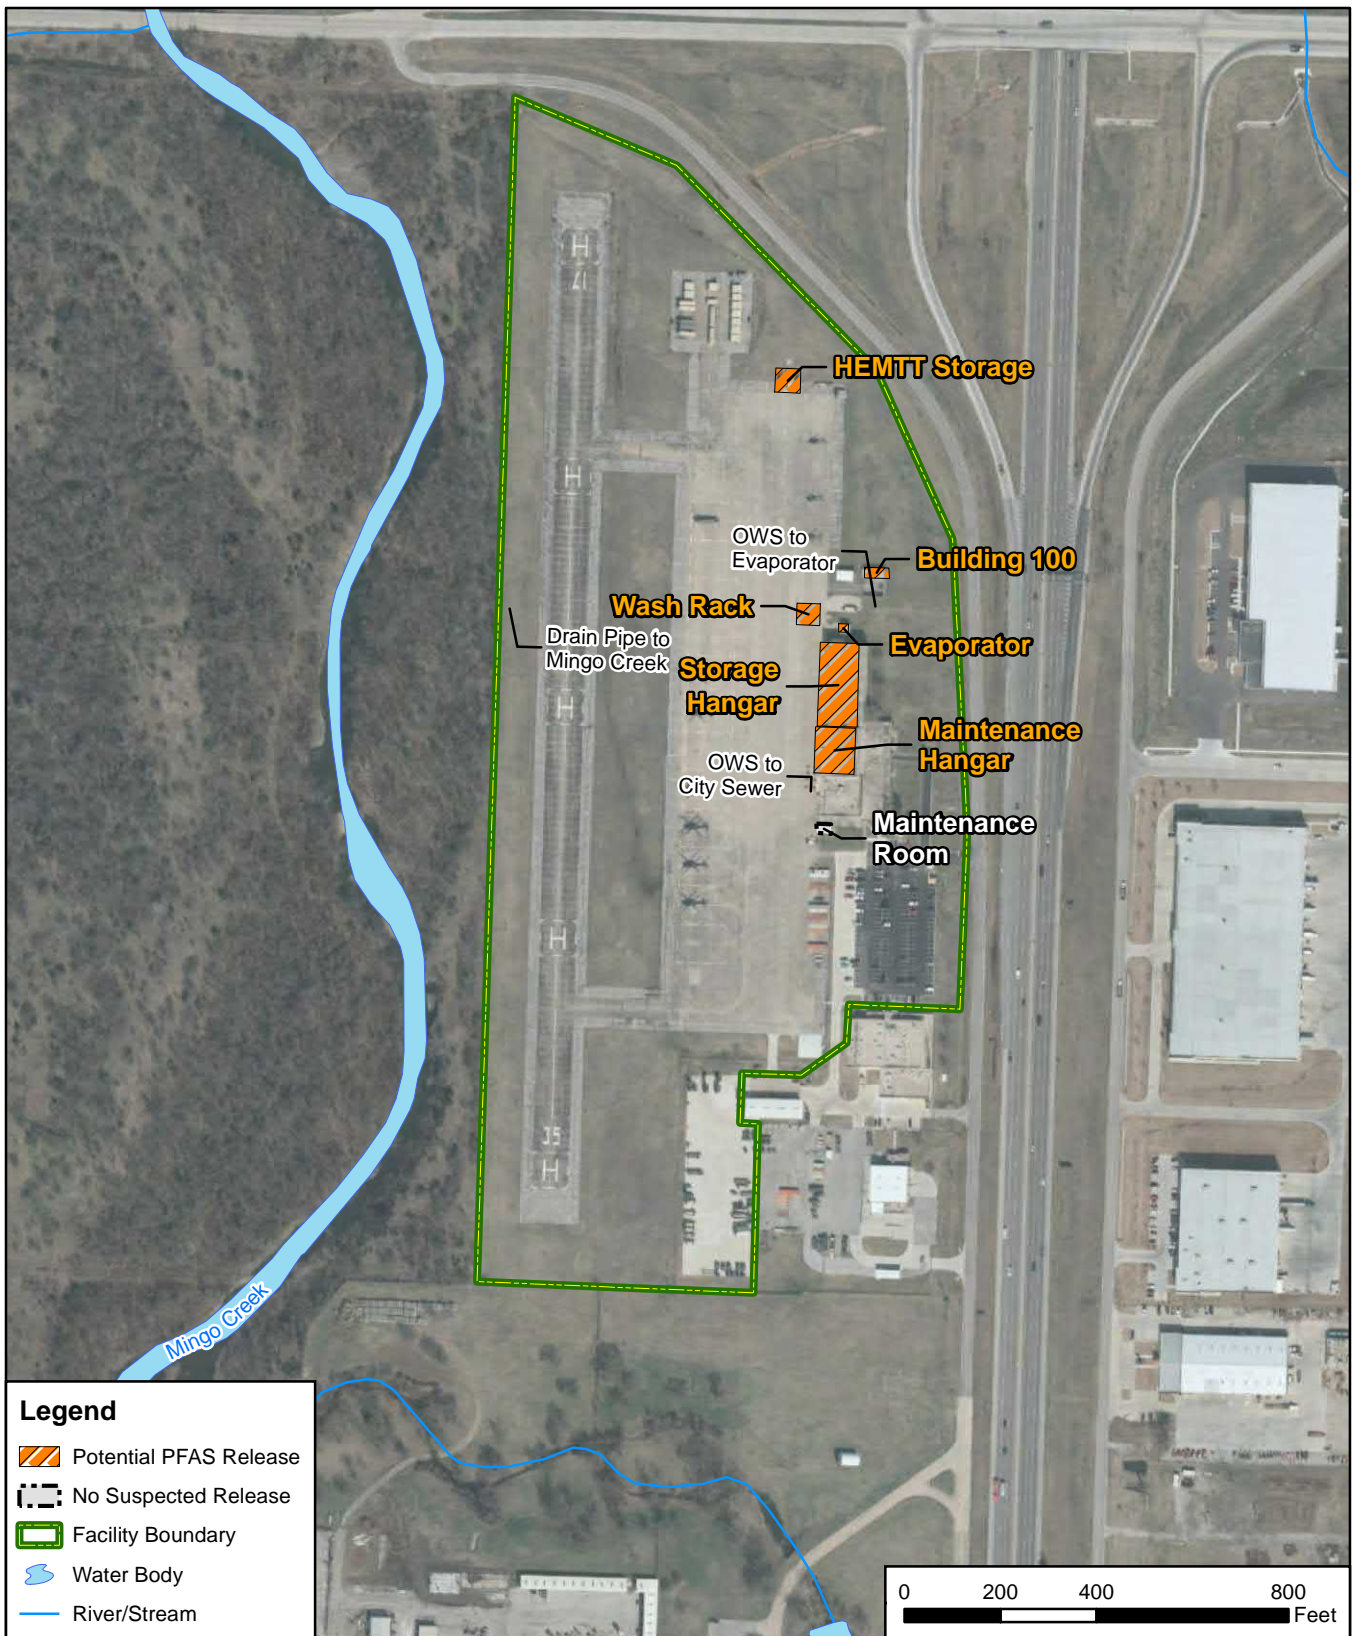
The Storage Hangar is located between the Maintenance Hangar and the Evaporator. The geographic coordinates are 36°13'00.4"N; 95°51'11.3"W. The Storage Hangar houses two 300-gallon foam tanks, located along the northern wall, and three 36-gallon manual AFFF tanks, located along the north, east, and south walls, that were obtained in 2013. The 300-gallon foam tanks are filled with 2.2% Buckeye Hi-Ex foam. Foam is replaced by contractors based in Houston, Texas. No information was provided on the disposal of AFFF and Buckeye Hi-Ex after it leaves the facility or when this occurred.

In 2014, a fire suppression system was installed, which conveys Buckeye Hi-Ex foam to three overhead sprayers in the Storage Hangar and two overhead sprayers in the Maintenance Hangar. The system was tested twice after installation. During both tests, plastic was placed around both the Storage Hangar and the Maintenance Hangar to prevent foam from leaving the hangars. The first test failed because not enough foam was produced by the system and only a small area of hangars was filled with foam. No information was provided on the type of foam used in the first test. Consequently, 2.2% Buckeye Hi-Ex foam was acquired, and a second test was conducted. The second test was meant to test whether both hangars would be adequately covered by the fire suppression system. The hangars were taped up in order to seal them so foam would not leak out of the hangars. The second test was successful, and the hangars filled up with 8 or 9 feet of foam. Only an estimated 5-10 gallons of Buckeye Hi-Ex foam were released during the second test. After both tests, the facility personnel let the foam settle and pushed it down to the trench drain, which transports wastewater to an oil/water separator (OWS), then to the City of Tulsa sanitary sewer, and, eventually, to the Northside Wastewater Treatment Plant (WWTP).

The Wash Rack is located 50 feet northwest of the Storage Hangar and west of the Evaporator. The geographic coordinates of the Wash Rack are 36°13'01.9"N; 95°51'12.1"W. The Wash Rack was used to wash the Buckeye Hi-Ex foam off the helicopters after the accidental fire suppression release event. The Wash Rack effluent drains to an OWS and is then conveyed to a holding tank. Water in the holding tank is reused by the facility to wash aircraft. The excess water is burned off at the evaporator.

The Evaporator is located just north of the Storage Hangar. The geographic coordinates are 36°13'01.6"N; 95°51'11.2"W. The Wash Rack effluent drains to an OWS and then to a holding tank. Any excess water is burned off at the Water Maze® Evaporator, which was installed in 2010. AFFF or Buckeye Hi-Ex foam discharged at the Wash Rack could be conveyed to the Evaporator. Solids from the wash water evaporation process are removed and disposed of by a contractor on routine basis. No information was available regarding the offsite disposal of the solid waste.

Building 100 is located east of the ramp and approximately 100 feet northeast of the evaporator. The geographic coordinates are 36°13'02.8"N; 95°51'10.4"W. Historically, 25 five-gallon buckets of AFFF were stored at this location. The buckets were donated to a local fire station at an unknown date. No information was available on the concentration or type of AFFF stored in the buckets. No leaks or spills were reported. No AFFF is currently stored in Building 100.

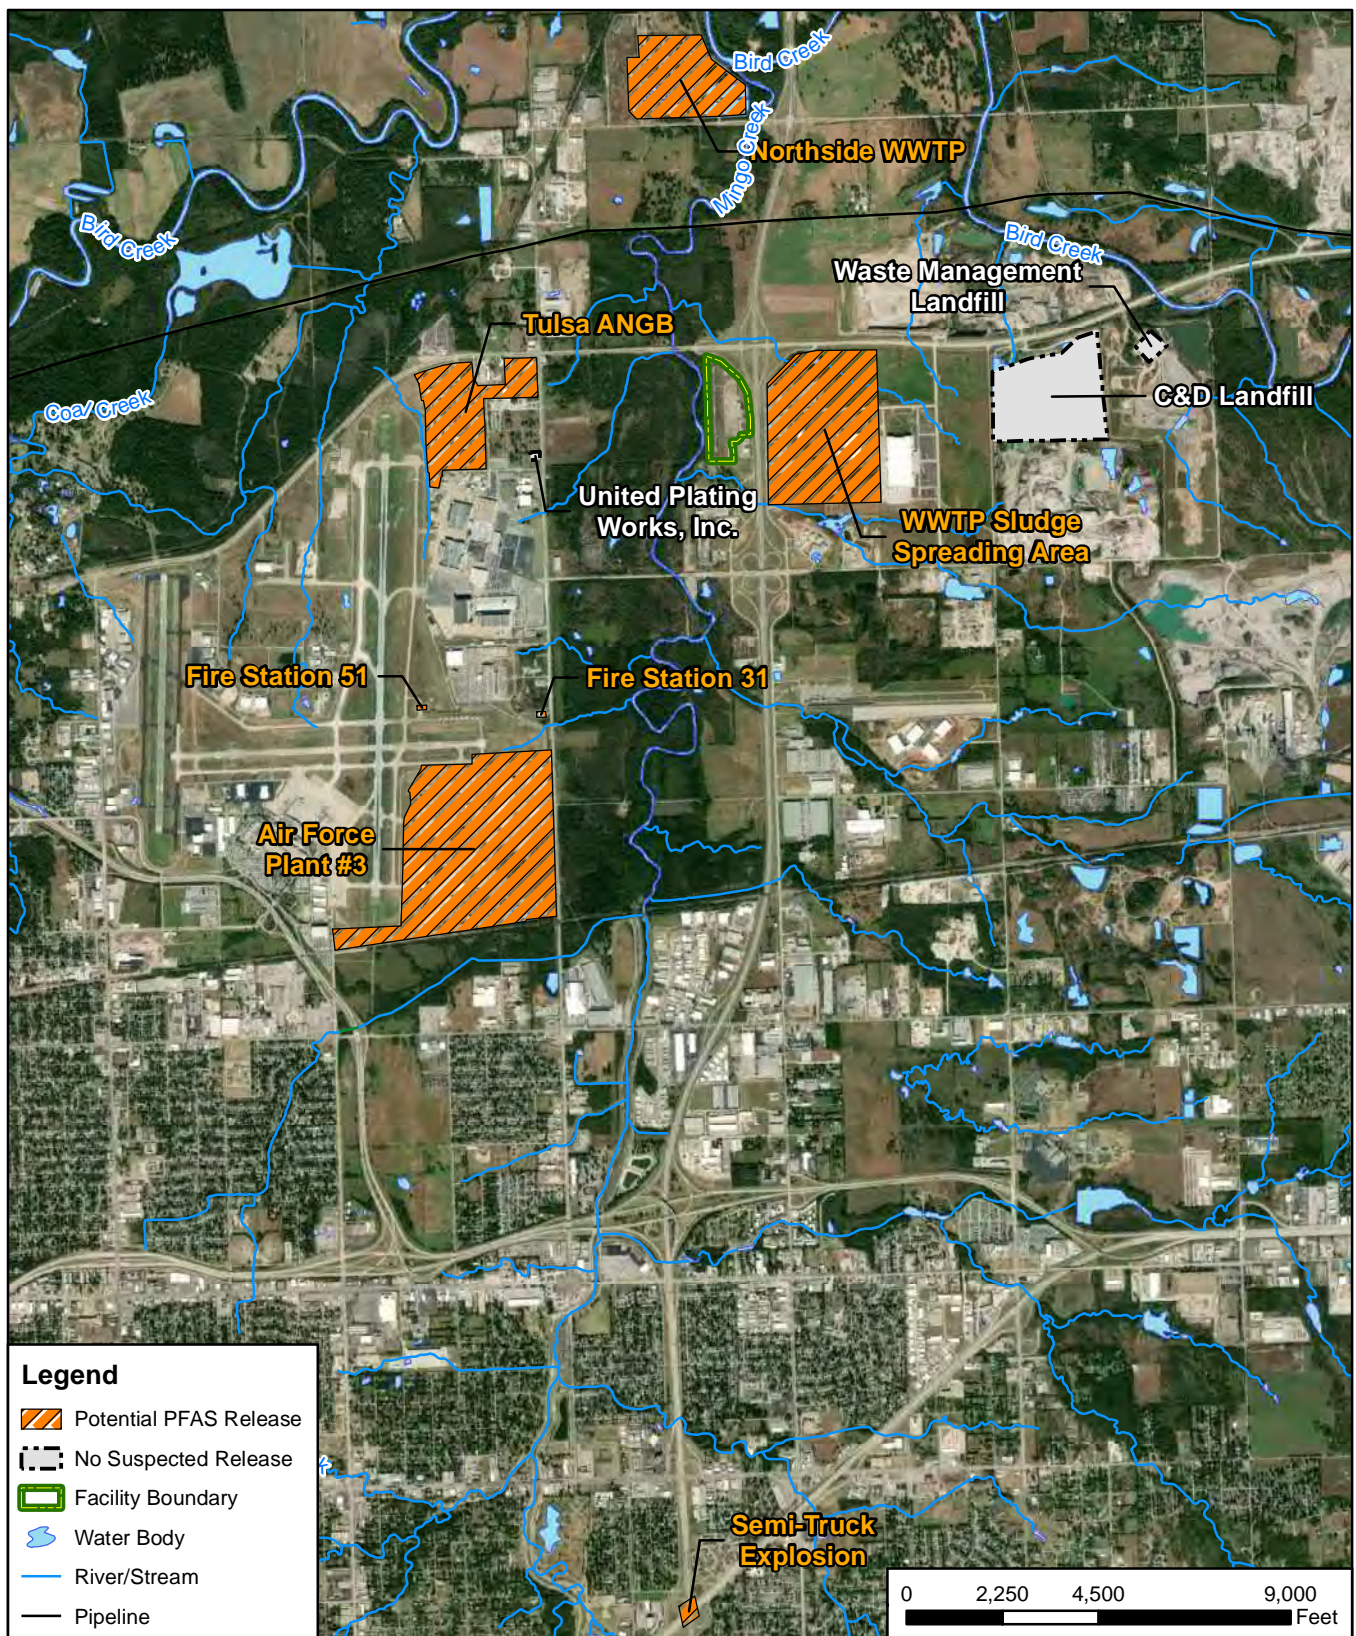
In June 2019, a semi-truck collision resulted in an explosion. The explosion occurred approximately 4.5 miles south of the facility at the junction of I-44 and Highway 169. The Tulsa Fire Department responded to the emergency and discharged firefighting foam in unknown quantities to put out the fire (Fox 23 News, 2019).

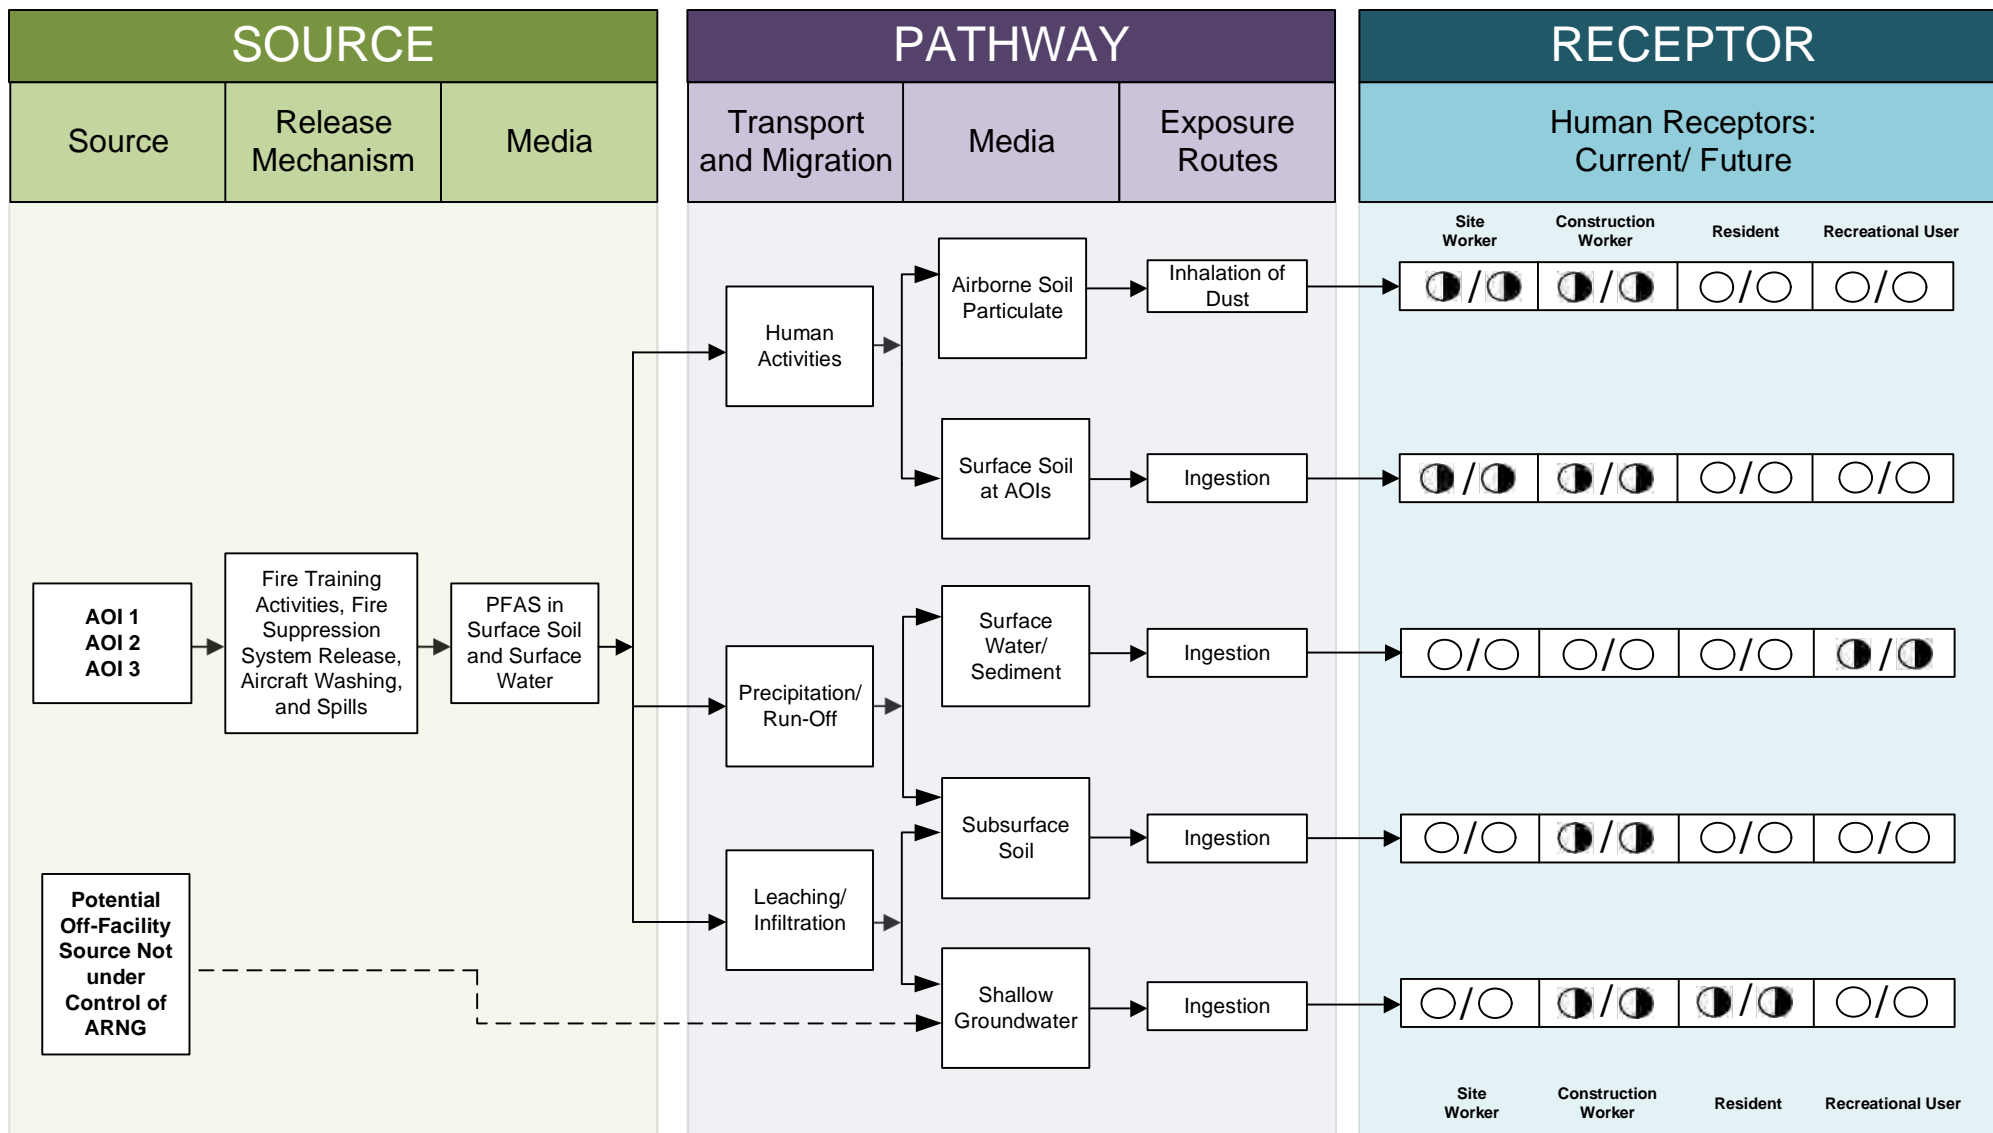
12420 Milestone Center Drive Germantown, MD 20876	Figure 6-1	
REVISED		6/24/2020		GIS BY		SK				6/24/2020
SCALE		1:4,800		CHK BY		JH				6/24/2020
Base Map: Source: Esri, Maxar, GeoEye, Earthstar Geographics, CNES/Airbus DS, USDA, USGS,				PM		RG				6/24/2020

Based on the PA findings, three AOIs were identified at the Tulsa AASF #2: AOI 1 Eastern Release Areas, AOI 2 Western FTAs, and AOI 3 HEMTT Storage. Locations of the AOIs are shown on **Figure 6-1**. The preliminary CSM for AOIs 1, 2, and 3 is shown on **Figure 6-2**. The following sections describe the CSM components and the specific preliminary CSMs developed for each AOI. The CSM identifies the three components necessary for a potentially complete exposure pathway: (1) source, (2) pathway, (3) receptor. If any of these elements are missing, the pathway is considered incomplete.

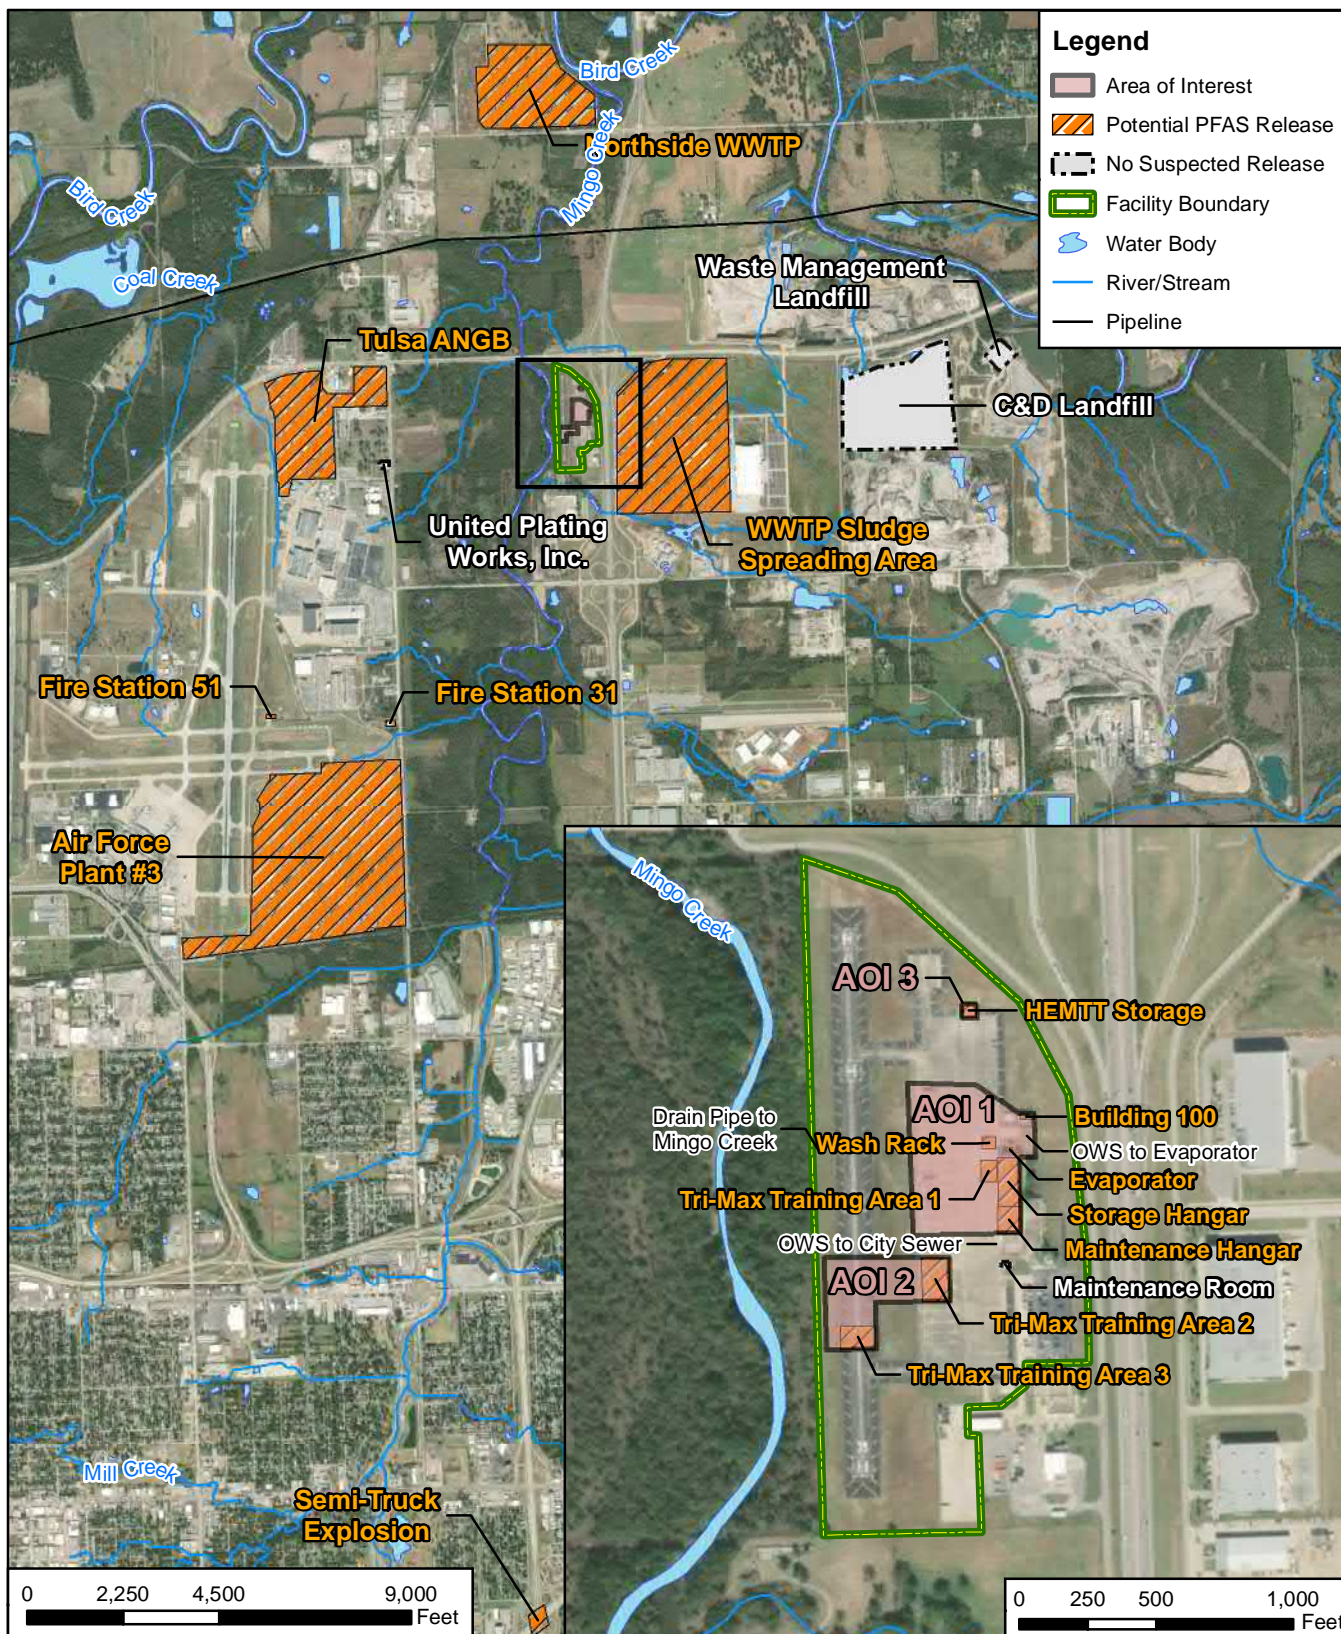
Area of Interest	AOI Location	Rationale	Potential Future Action
AOI 1: Eastern Release Areas	36°13'00.3"N; 95°51'11.2"W	Releases of AFFF to concrete during fire training activities from the 1990s to the early 2000s. Buckeye Hi-Ex foam released to concrete and surface soil during accidental triggering of the fire suppression system in 2014.	Proceed to an SI, focus on soil and shallow groundwater
AOI 2: Western FTAs	36°12'56.4"N; 95°51'17.5"W	Releases of AFFF to concrete and surface soil during fire training activities from the 1990s to the early 2000s.	Proceed to an SI, focus on soil and shallow groundwater
AOI 3: HEMTT Storage	36°13'06.7"N; 95°51'12.8"W	AFFF was historically stored at AOI 3 from the 1990s to the early 2000s.	Proceed to an SI, focus on soil and shallow groundwater
