# Final Preliminary Assessment Report Vega Baja Readiness Center, Vega Baja, Puerto Rico

Perfluorooctane-Sulfonic Acid (PFOS) and Perfluorooctanoic  
Acid (PFOA) Impacted Sites  
ARNG Installations, Nationwide

March 2020

AECOM  
12420 Milestone Center Drive, Suite 150  
Germantown, MD 20876  
aecom.com

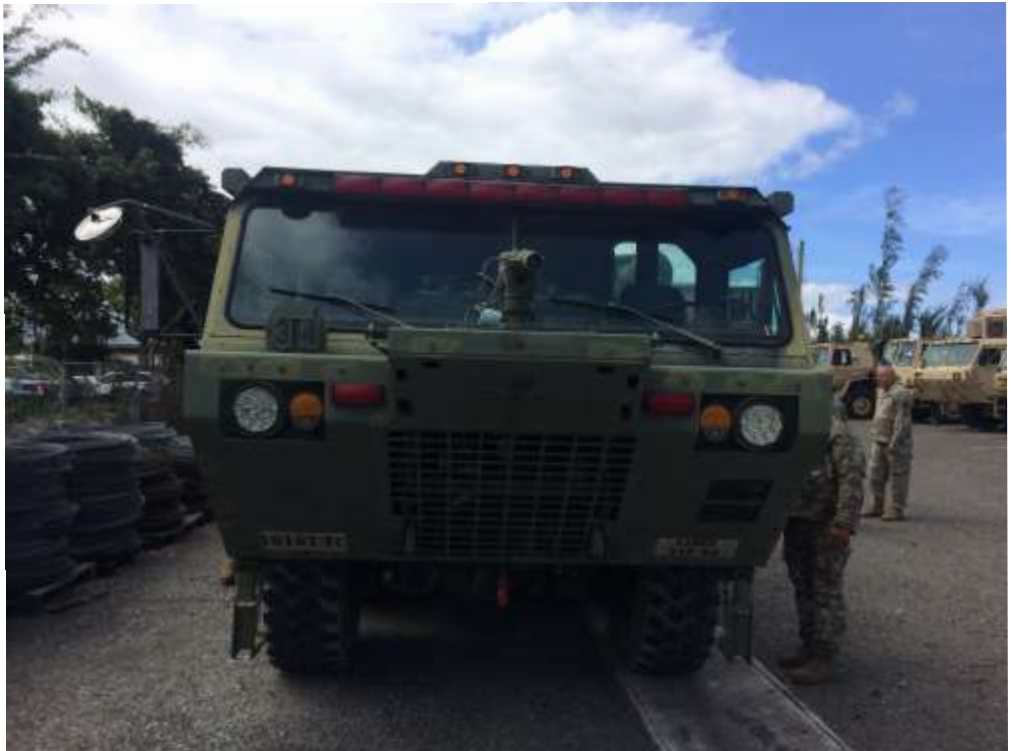
| Army National Guard, Preliminary Assessment for PFAS | | Vega Baja - FMS #7 | Vega Baja, Puerto Rico |
|---|---|---|---|
| <b>Photograph No. 2</b> | | | |

| Army National Guard, Preliminary Assessment for PFAS | | Vega Baja - FMS #7 | Vega Baja, Puerto Rico |
|---|---|---|---|
| <b>Description:</b><br>AFFF tank cap on the 1984 Osh Kosh Water Tanker Truck | | | |

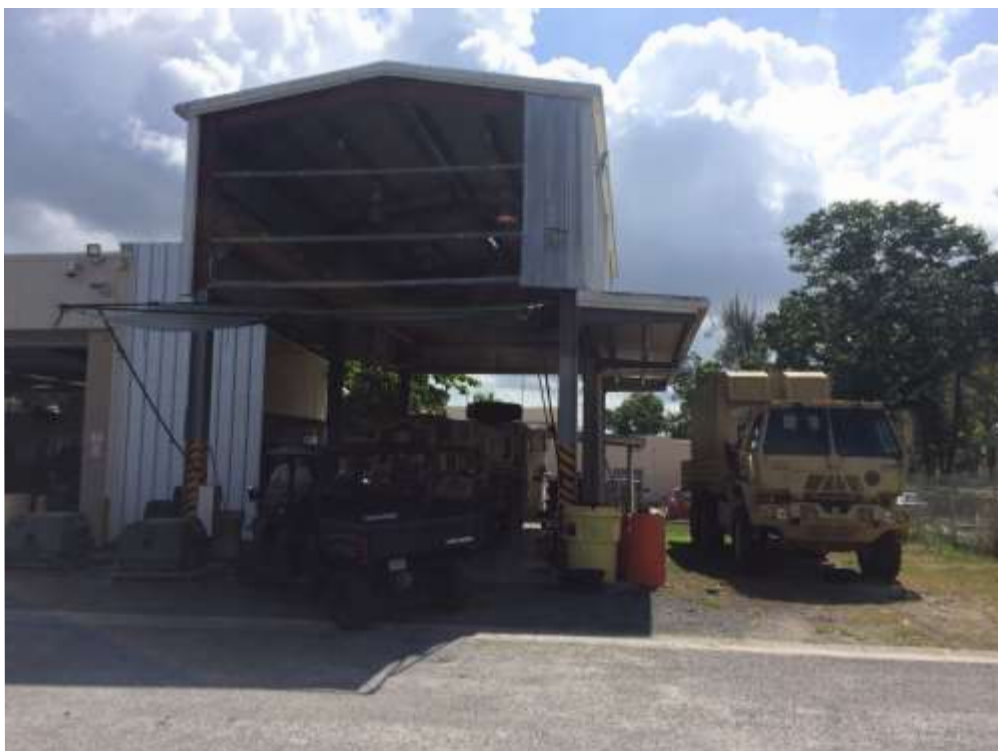
| Army National Guard, Preliminary Assessment for PFAS | | Vega Baja - FMS #7 | Vega Baja, Puerto Rico |
|---|---|---|---|
| <b>Photograph No. 6</b> | | | |

| Army National Guard, Preliminary Assessment for PFAS | | Vega Baja - FMS #7 | Vega Baja, Puerto Rico |
|---|---|---|---|
| <b>Description:</b><br>Former firetruck parking area at the Vega Baja ARNG facility | | | |
