Preliminary Assessment Report

Army Aviation Support Facility #2, Louisville, Tennessee

Perfluorooctanesulfonic Acid (PFOS) and Perfluorooctanoic
Acid (PFOA) Impacted Sites
ARNG Installations, Nationwide

October 2020

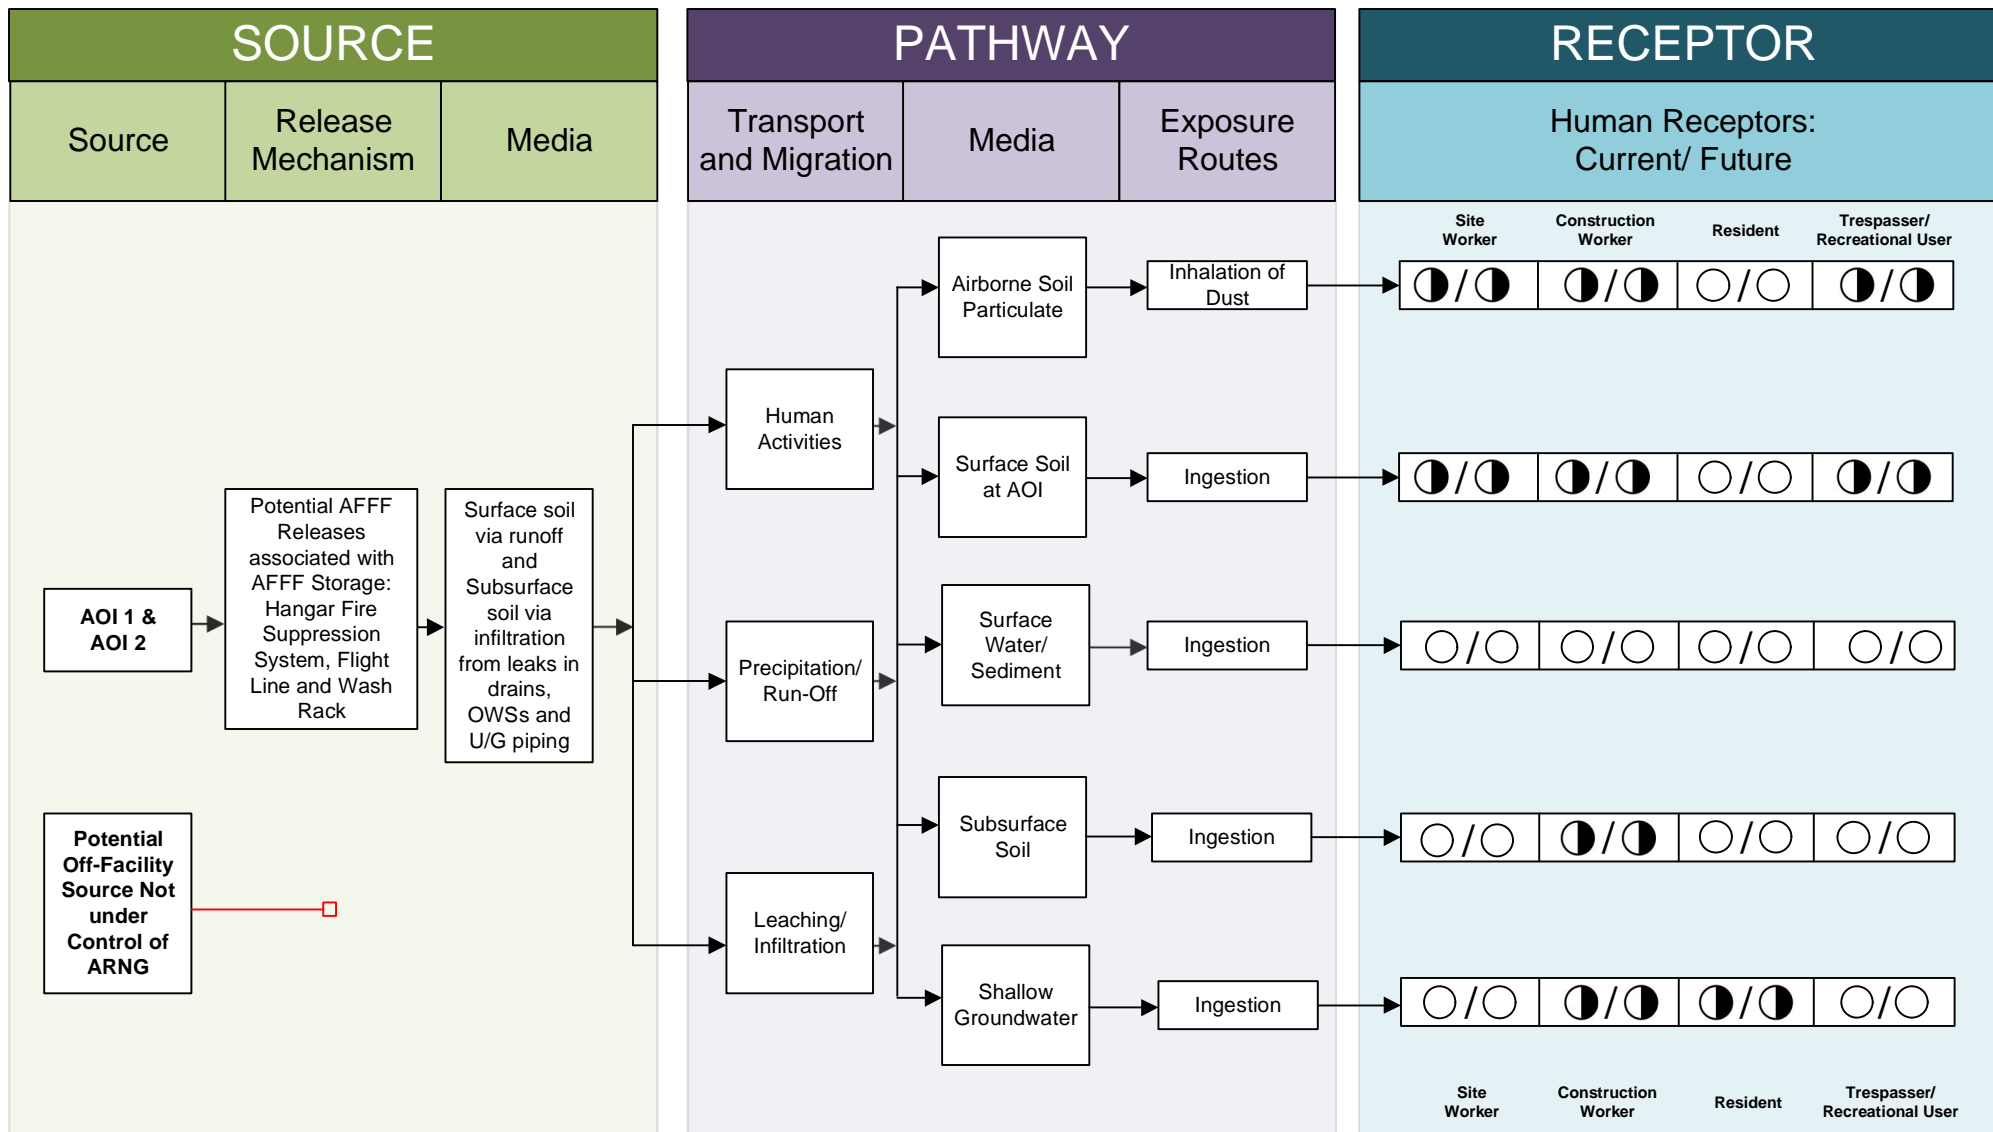
Figure ES-2
 Conceptual Site Model
 AOI 1 & AOI 2 Potential AFFF Releases from AFFF Storage, TNARNG
 AASF #2, Louisville TN

Based on the potential PFAS releases at AOI 1 and 2, there is potential for exposure to PFAS contamination in media at AASF #2. The preliminary CSM is shown on **Figure ES-2**. ARNG will evaluate the need for an SI based on the potential receptors, the potential migration of PFAS contamination off the facility, and the availability of resources. The Tennessee Air National Guard is investigating documented PFAS releases at their adjacent property (Leidos, 2019).

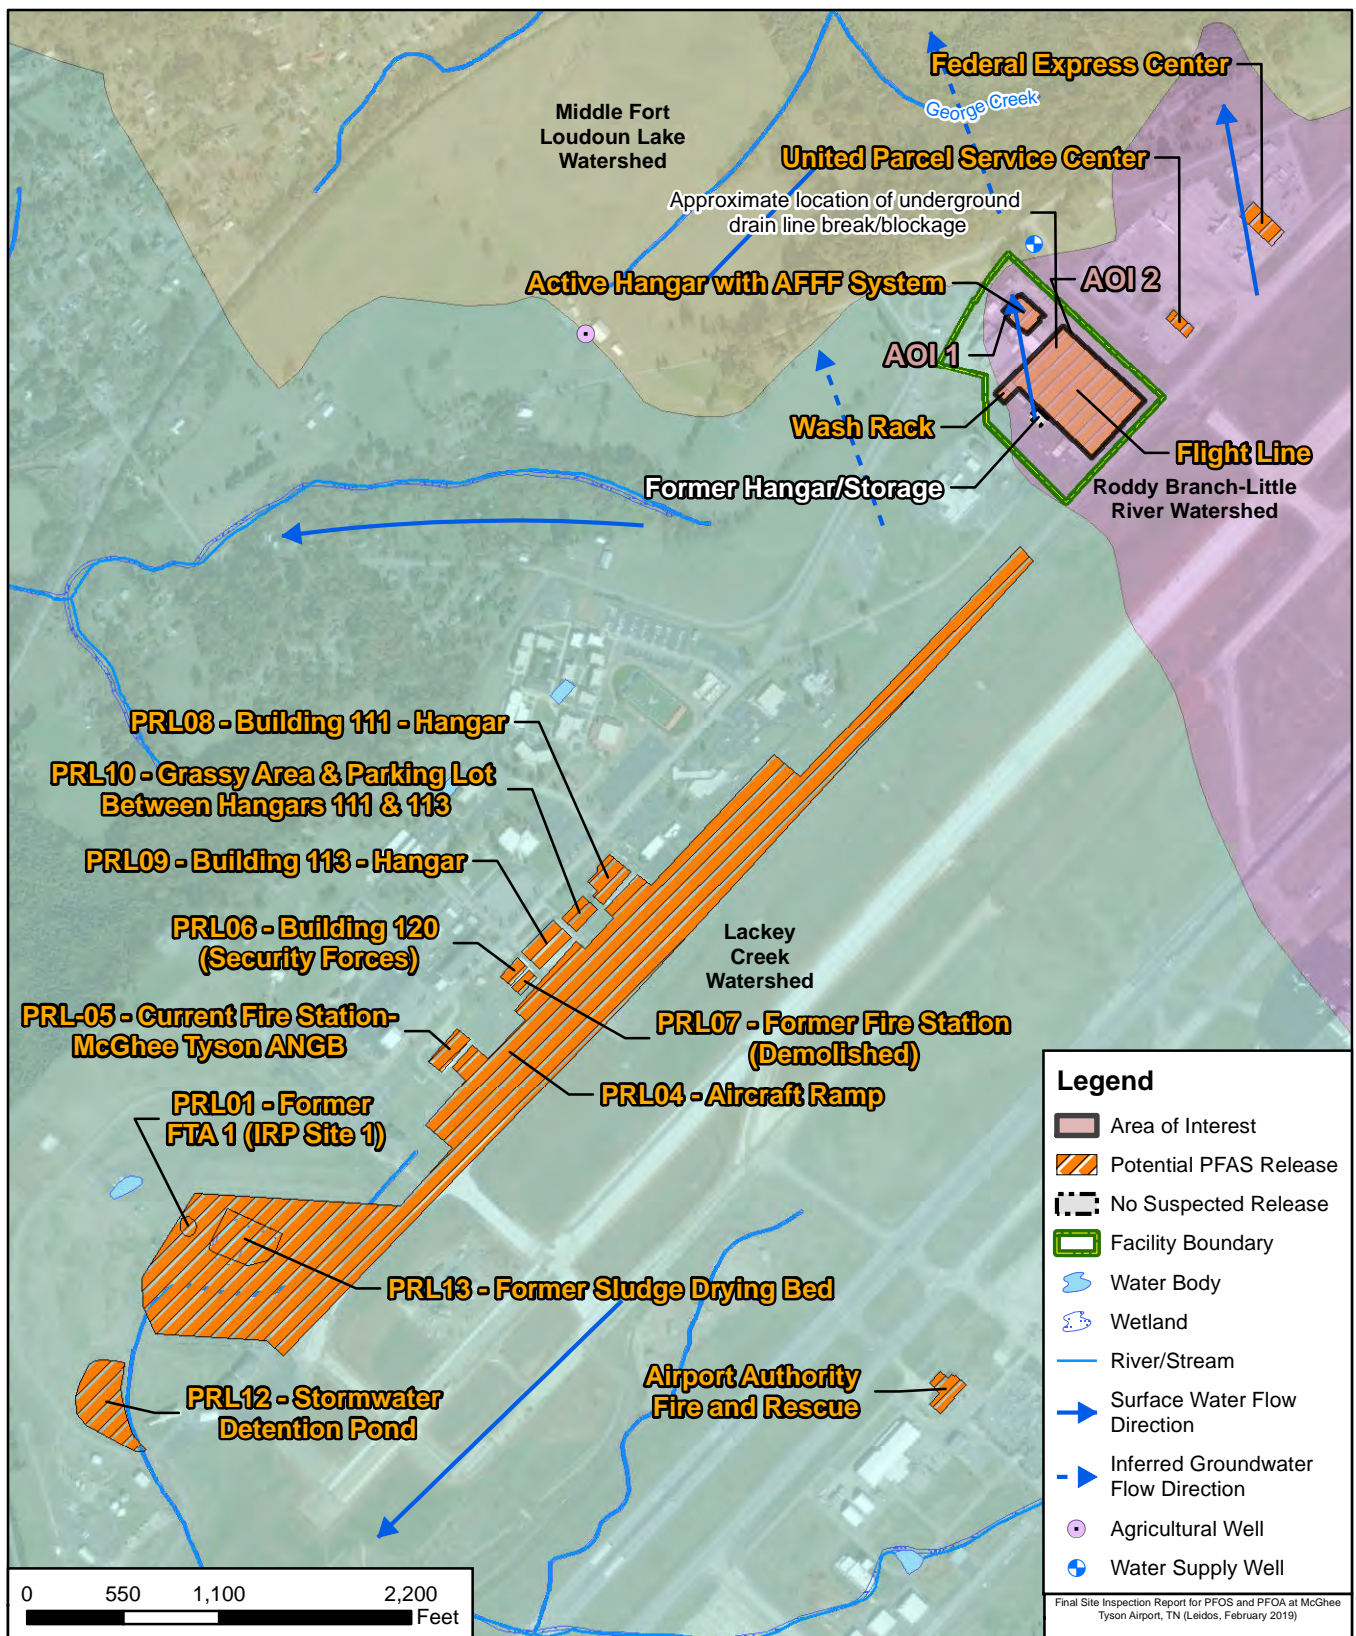
12420 Milestone Center Drive Germantown, MD 20876	Figure 6-1
REVISED		3/20/2020	GIS BY	MS	3/20/2020				
SCALE		1:13,200	CHK BY	SS	3/20/2020				
Base Map: Source: Esri, DigitalGlobe, GeoEye, Earthstar Geographics, CNES/Airbus DS, USDA, USGS,			PM	RG	3/20/2020

Based on the PA findings, two AOIs were identified at AASF #2: AOI 1 Active Hangar and AOI 2 Flight Line and Wash Rack. The AOIs are shown on **Figure 6-1**. The following sections describes the CSM components and the specific preliminary CSMs developed for AOIs 1 and 2. The CSM identifies the three components necessary for a potentially complete exposure pathway: (1) source, (2) pathway, (3) receptor. If any of these elements are missing, the pathway is considered incomplete.

Area of Interest	AOI Location	Rationale	Potential Future Action
AOI 1 Active Hangar	Hangar with AFFF fire suppression system and storage	While no PFAS releases have been documented at AASF #2, storage of AFFF represents a potential for PFAS release.	Proceed to an SI, focus on soil and groundwater.
AOI 2 Flight Line and Wash Rack	Cart storage on the flight line and wash rack	While no PFAS releases have been documented at AASF #2, storage of AFFF represents a potential for PFAS release.	Proceed to an SI, focus on soil and groundwater.

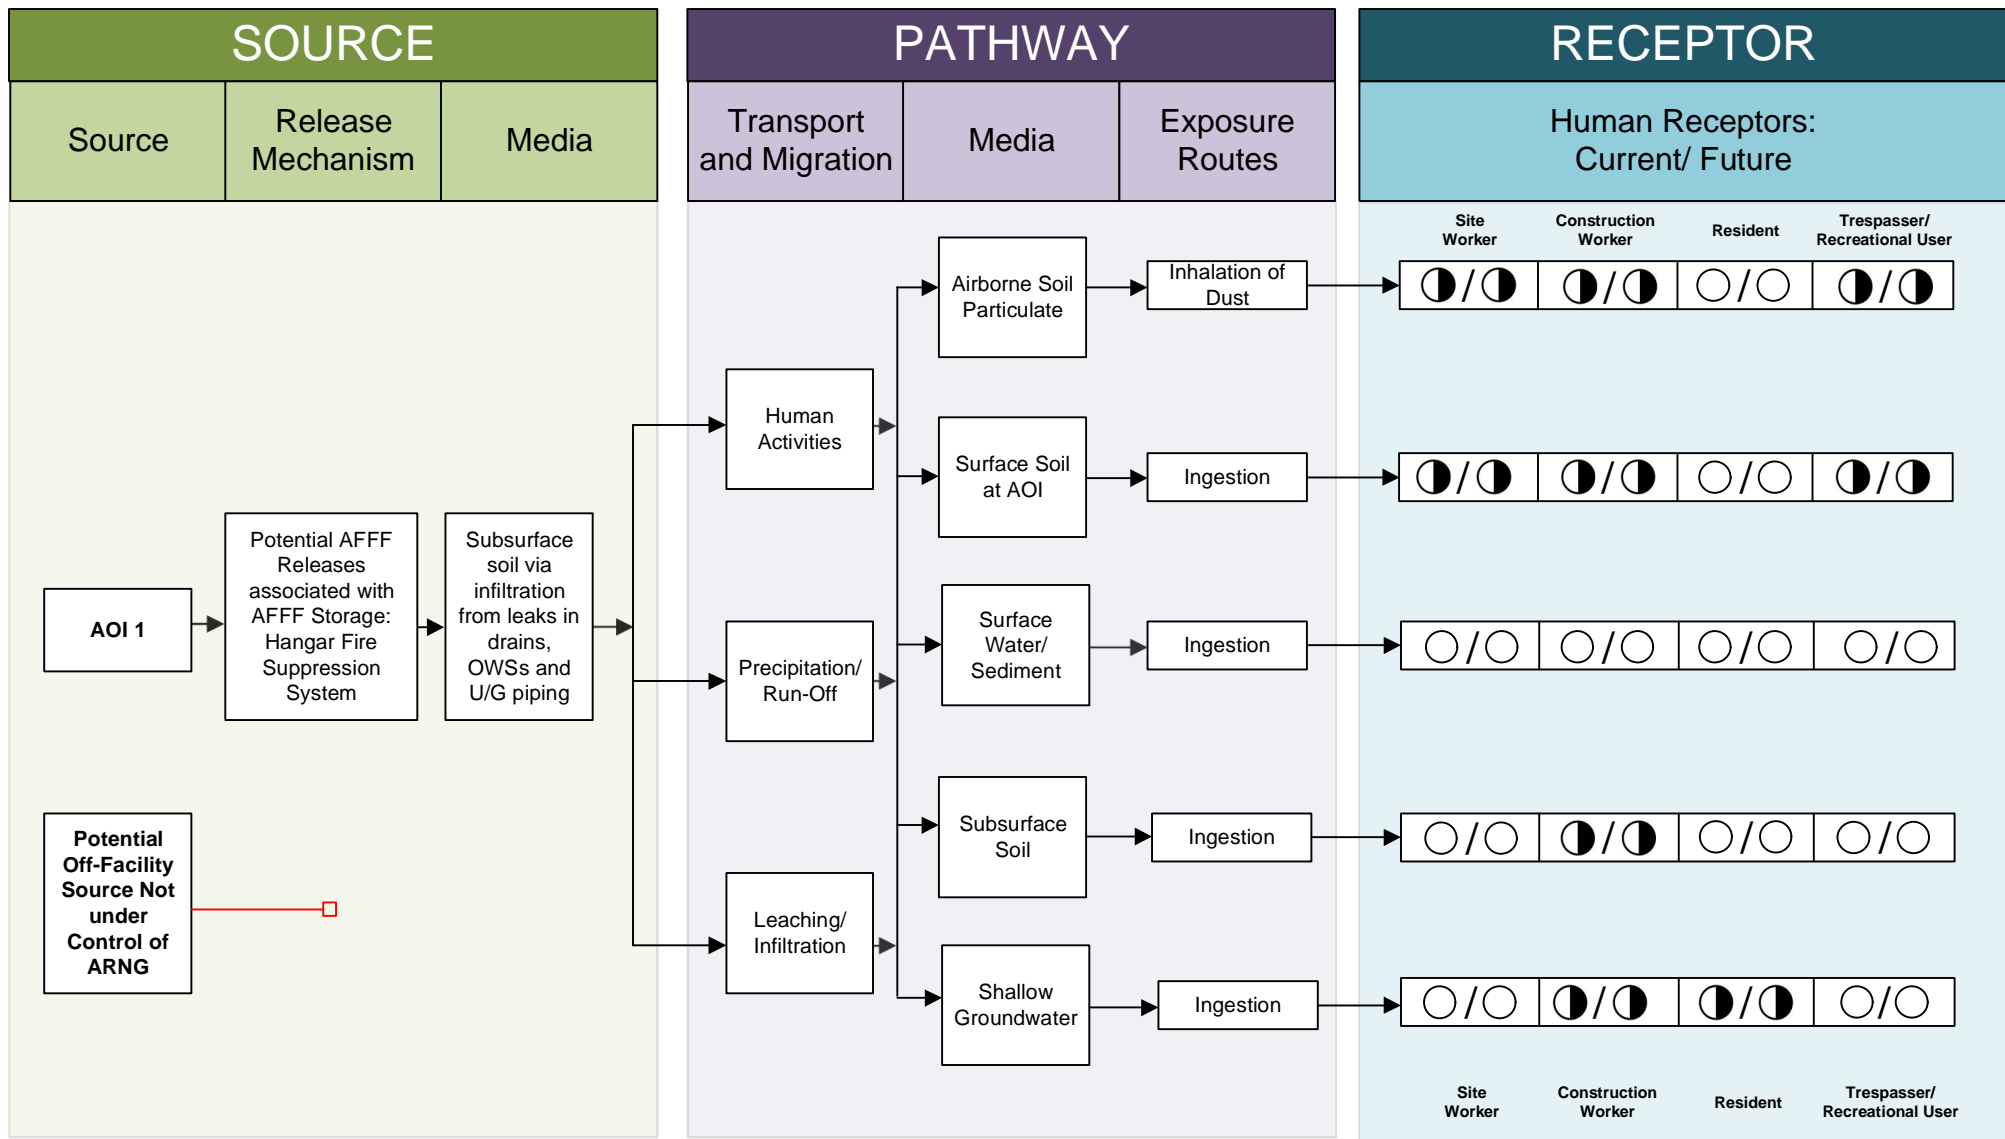
Figure 6-2
Conceptual Site Model
AOI 1 Potential AFFF Releases from AFFF Storage: Hangar Fire
Suppression System, TNARNG AASF #2, Louisville TN

If AFFF were to be released in the hangar: flow could migrate outside the building and drain to adjacent grassy areas; and, infiltrate downward to the subsurface from surface soil outside the building or through floor cracks/drains inside the building. PFAS are water soluble and can migrate readily from soil to groundwater via leaching. Groundwater is anticipated to flow northwest. It is possible that PFAS could have migrated to water wells identified within 1 mile of the facility boundaries. Reported well depths range from approximately 125 to 570 feet bgs. Wells located downgradient of the facility are classified as residential, agricultural, and other/unknown based on information in the EDR™ report (**Appendix A**).

The preliminary CSM for AOI 1 is shown on **Figure 6-2**. Potential PFAS exposure pathways resulting from releases at AOI 1 are described in **Table 6-1**:
