FINAL Preliminary Assessment Report Grand Prairie Army Aviation Support Facility Texas

Perfluorooctanesulfonic Acid (PFOS) and Perfluorooctanoic
Acid (PFOA) Impacted Sites
ARNG Installations, Nationwide

July 2020

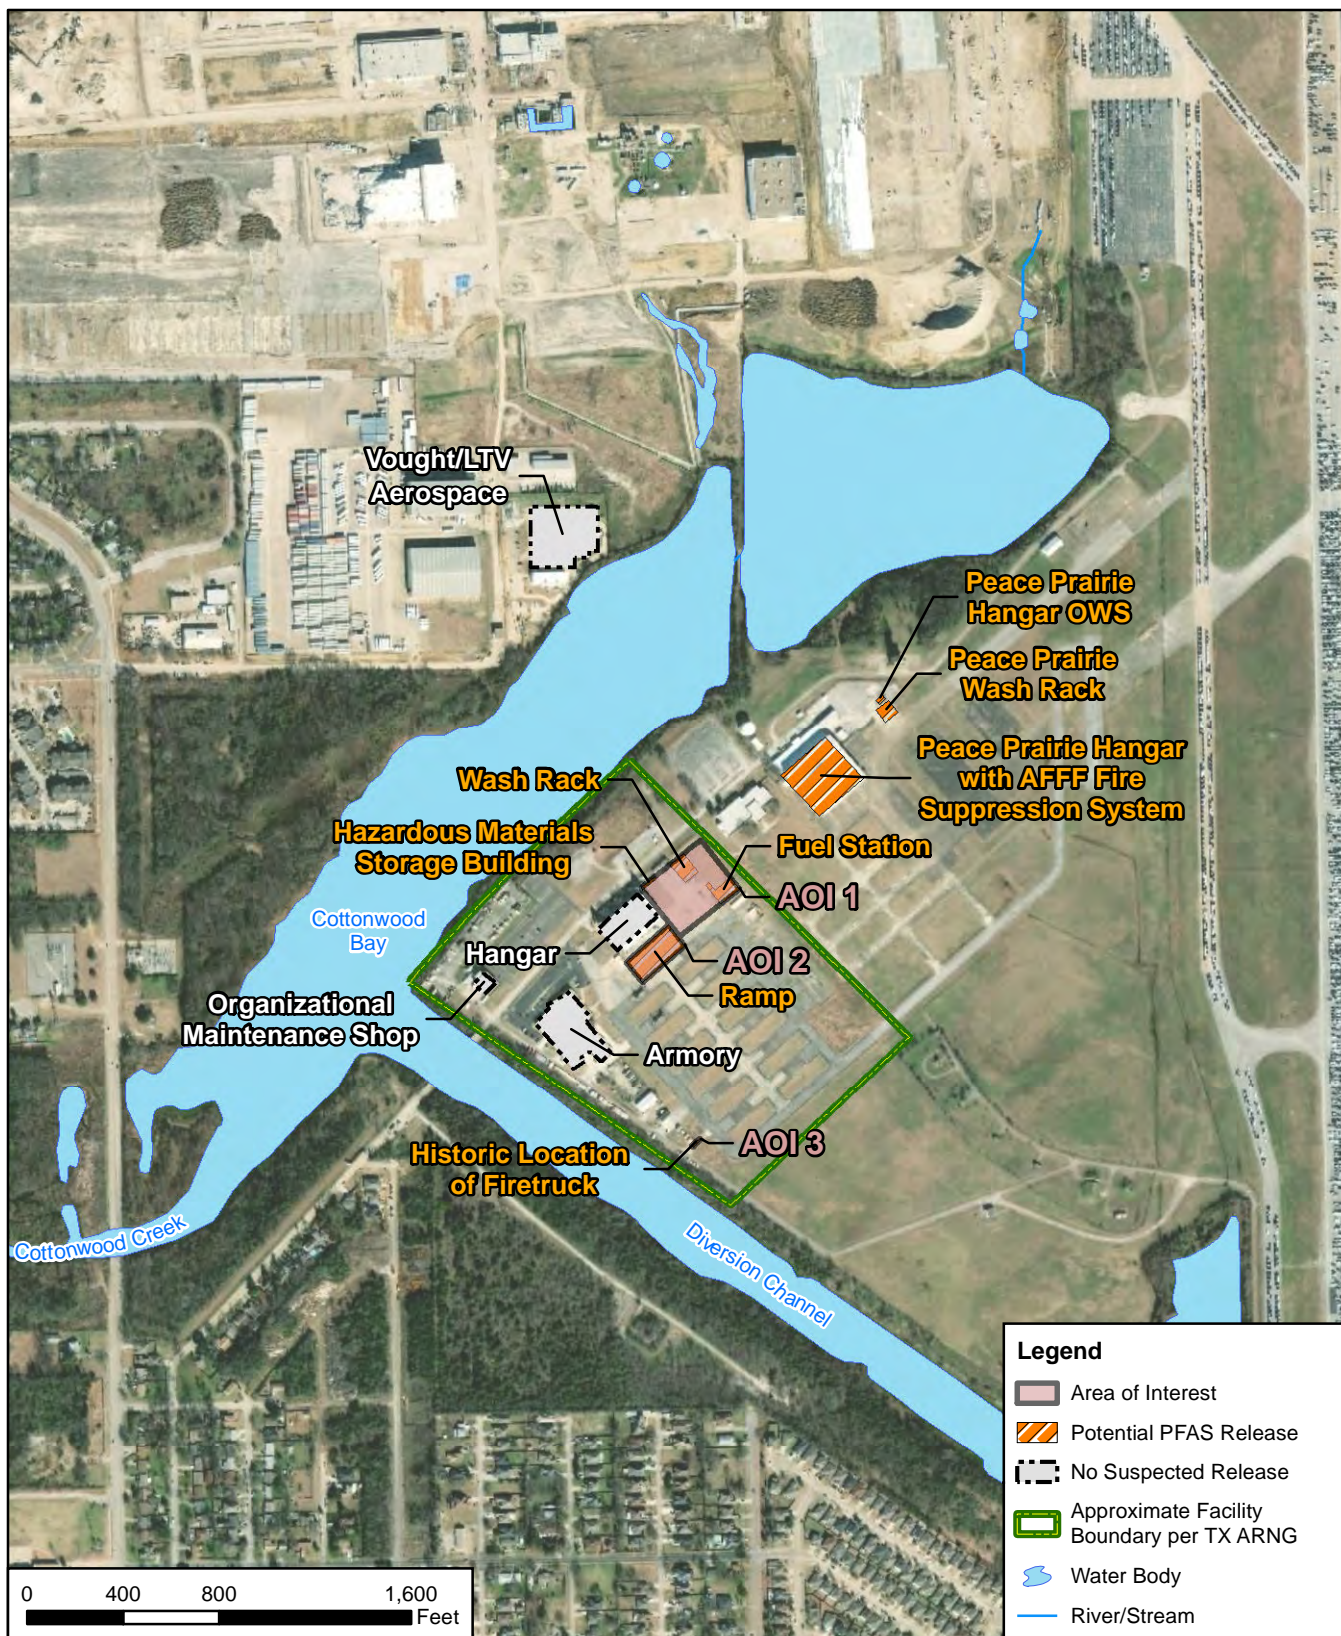
12420 Milestone Center Drive Germantown, MD 20876	Figure ES-1
SCALE	1:9,600	CHK BY	MC	4/28/2020			
Base Map: Sources: Esri, HERE, Garmin, USGS, Intermap, INCREMENT P, NRCan, Esri Japan, METI,		PM	RG	4/28/2020

AOI 3	AFFF was stored in the firetruck historically located in the southern part of the facility. Although there are no recorded uses of AFFF in the area, there is the possibility of leaking in the area.	TXARNG	Unknown
-------	---	--------	---------

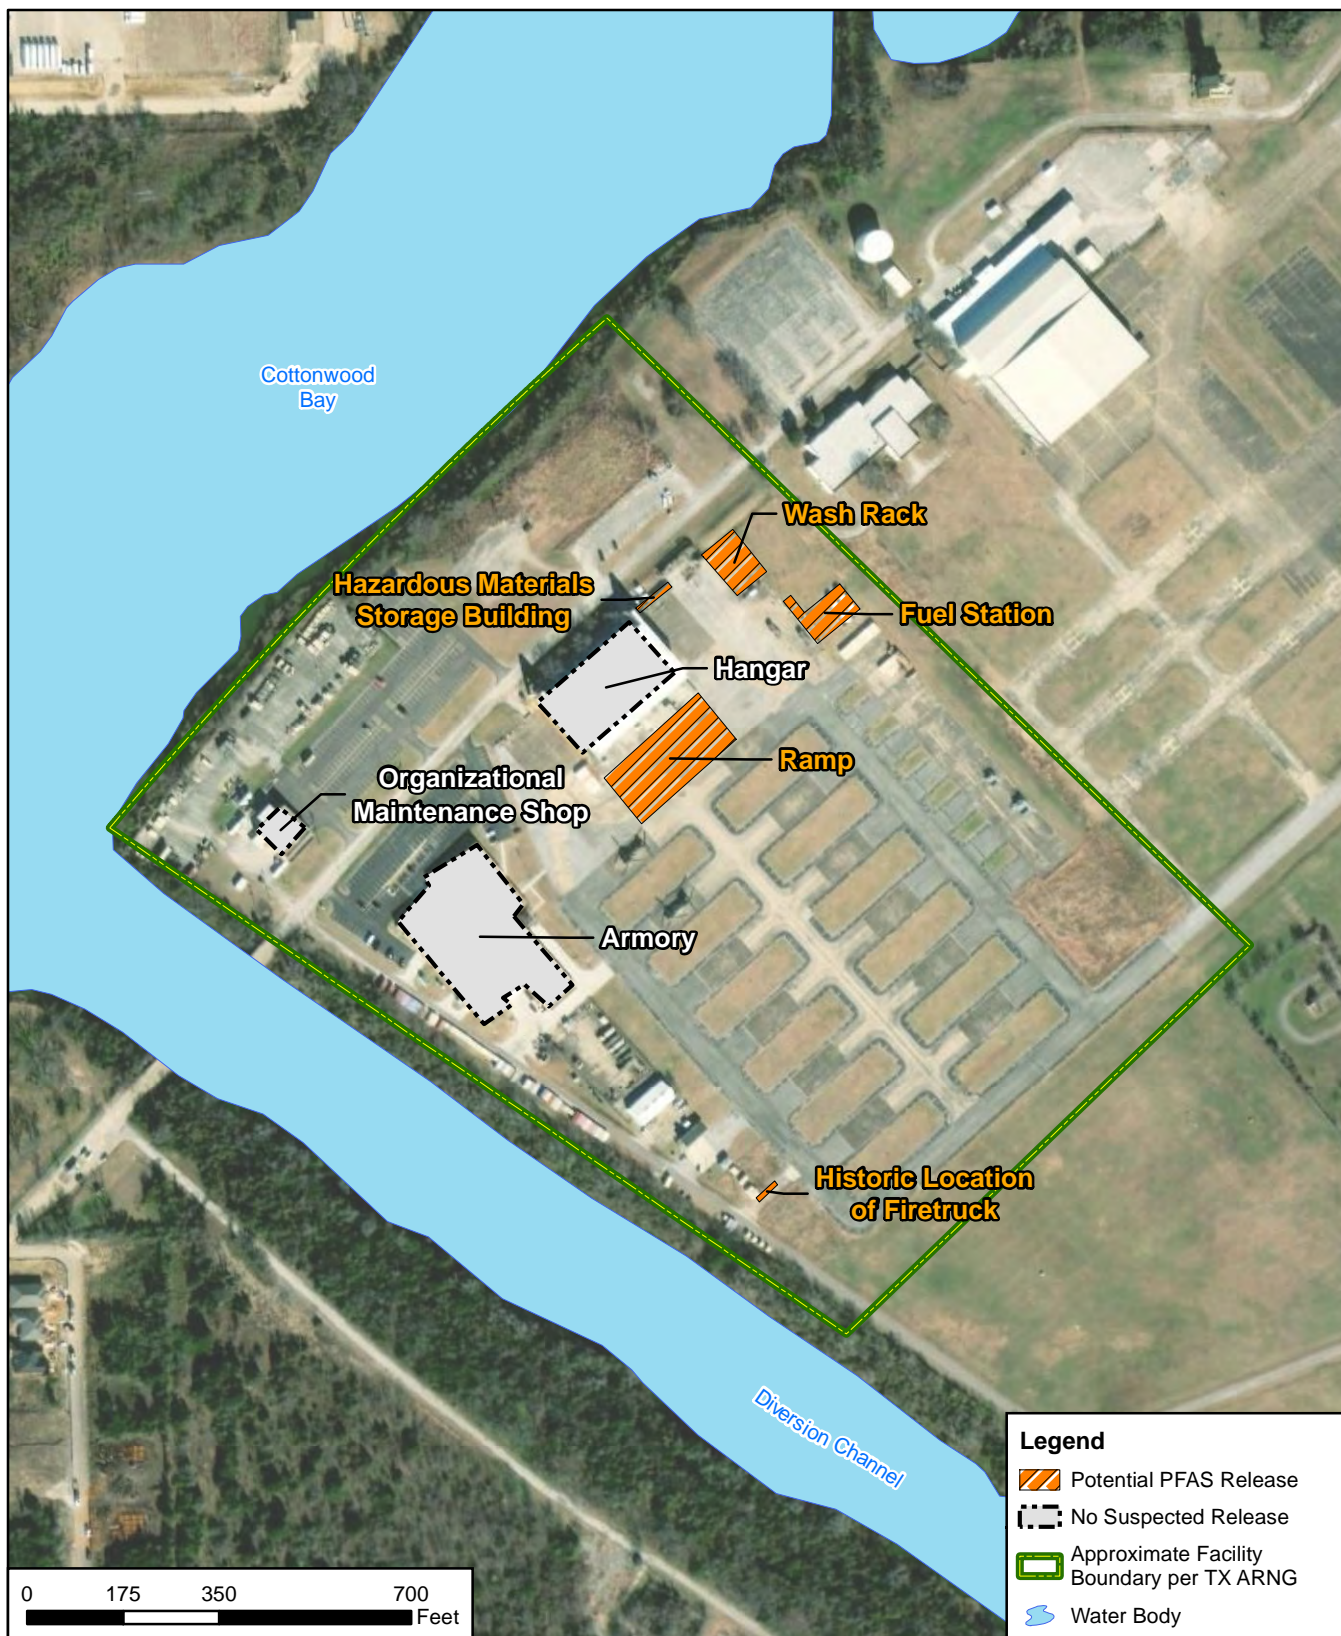
The wash rack area is located to the northeast of the hangar and hazardous materials storage building. From 2000 to 2012, mobile firefighting carts containing AFFF solution (Tri-Max™ units) were serviced at the wash rack, approximately once every two years. The AFFF solution stored in the Tri-Max™ units was poured down the drain in the wash rack. There were approximately six Tri-Max™ units at the facility that were serviced in this way. Additionally, training took place with the Tri-Max™ units at the wash rack approximately every two years from 2000 to 2012. Training on the wash rack area typically occurred with two or three Tri-Max™ units. While the majority of fluids drained to an OWS, it is possible that AFFF produced during fire training activities reached areas surrounding the wash rack and subsequently infiltrated into the soil. Depending on the positioning of a manual diverter valve, fluids entering the wash rack flowed either to the sanitary sewer system or were discharged to the street northeast of the OWS. The troops had to manually change the system from discharge to the sanitary sewer to discharge to surface water depending on the work they were performing. Interviews indicated that the valve may not have been diverted to the sanitary sewer for some events where the TriMax™ units were emptied or used.

The OWS was constructed in 1984-1985, and the Resource Conservation and Recovery Act (RCRA) Facility Investigation conducted in 2001 revealed leaking joints in the sewer system, so PFAS contamination may have infiltrated to subsurface soil via leaks in drains, OWS or underground wastewater conveyance piping beneath the wash rack, or leaks along piping from the facility to the municipal WWTP. To the best of their knowledge, TXARNG staff who had been working at the facility since 1989 reported no other releases in this area. Geographic coordinates for the wash rack are 32°43'57.0"N; 96°58'40.7"W.

The hazardous materials storage building is located northeast of the hangar. Various hazardous materials are stored inside the building. Historically, 30 5-gallon sealed buckets of 3 percent (%) AFFF were stored inside the building. The 5-gallon buckets were added to helicopter buckets for firefighting offsite. Around 2012, the 5-gallon buckets of AFFF were removed from the facility and sent to the Camp Mabry United States Property & Fiscal Office (USPFO) in Austin, Texas. To the best of their knowledge, TXARNG staff who had been working at the facility since 1989 reported no releases of any materials in this area. No floor drain was observed in the hazardous materials storage building. Geographic coordinates for the hazardous materials storage building are 32°43'56.3"N; 96°58'42.7"W.

Historically, AFFF containing Tri-Max™ units were stationed near the Fuel Station at the facility. TXARNG staff who had been working at the facility since 1989 reported no releases of any materials in this area. Precipitation and wastewater flow in this area would most likely infiltrate into the soil. Geographic coordinates for the fuel station are 32°43'56.0"N; 96°58'39.5"W.

A large green Osh Kosh™ firetruck was historically located in the southern corner of the facility. The firetruck was equipped with AFFF, but the foam was never deployed. Eventually, the firetruck was turned in, and it no longer is located at the facility. A small containment was located beneath the firetruck in case of spills. TXARNG staff who had been working at the facility since 1989 reported no releases of any materials in this area. Precipitation and wastewater flow in this area would most likely infiltrate into the surrounding grassland. Geographic coordinates for the fuel station are: 32°43'45.7"N; 96°58'40.5"W.

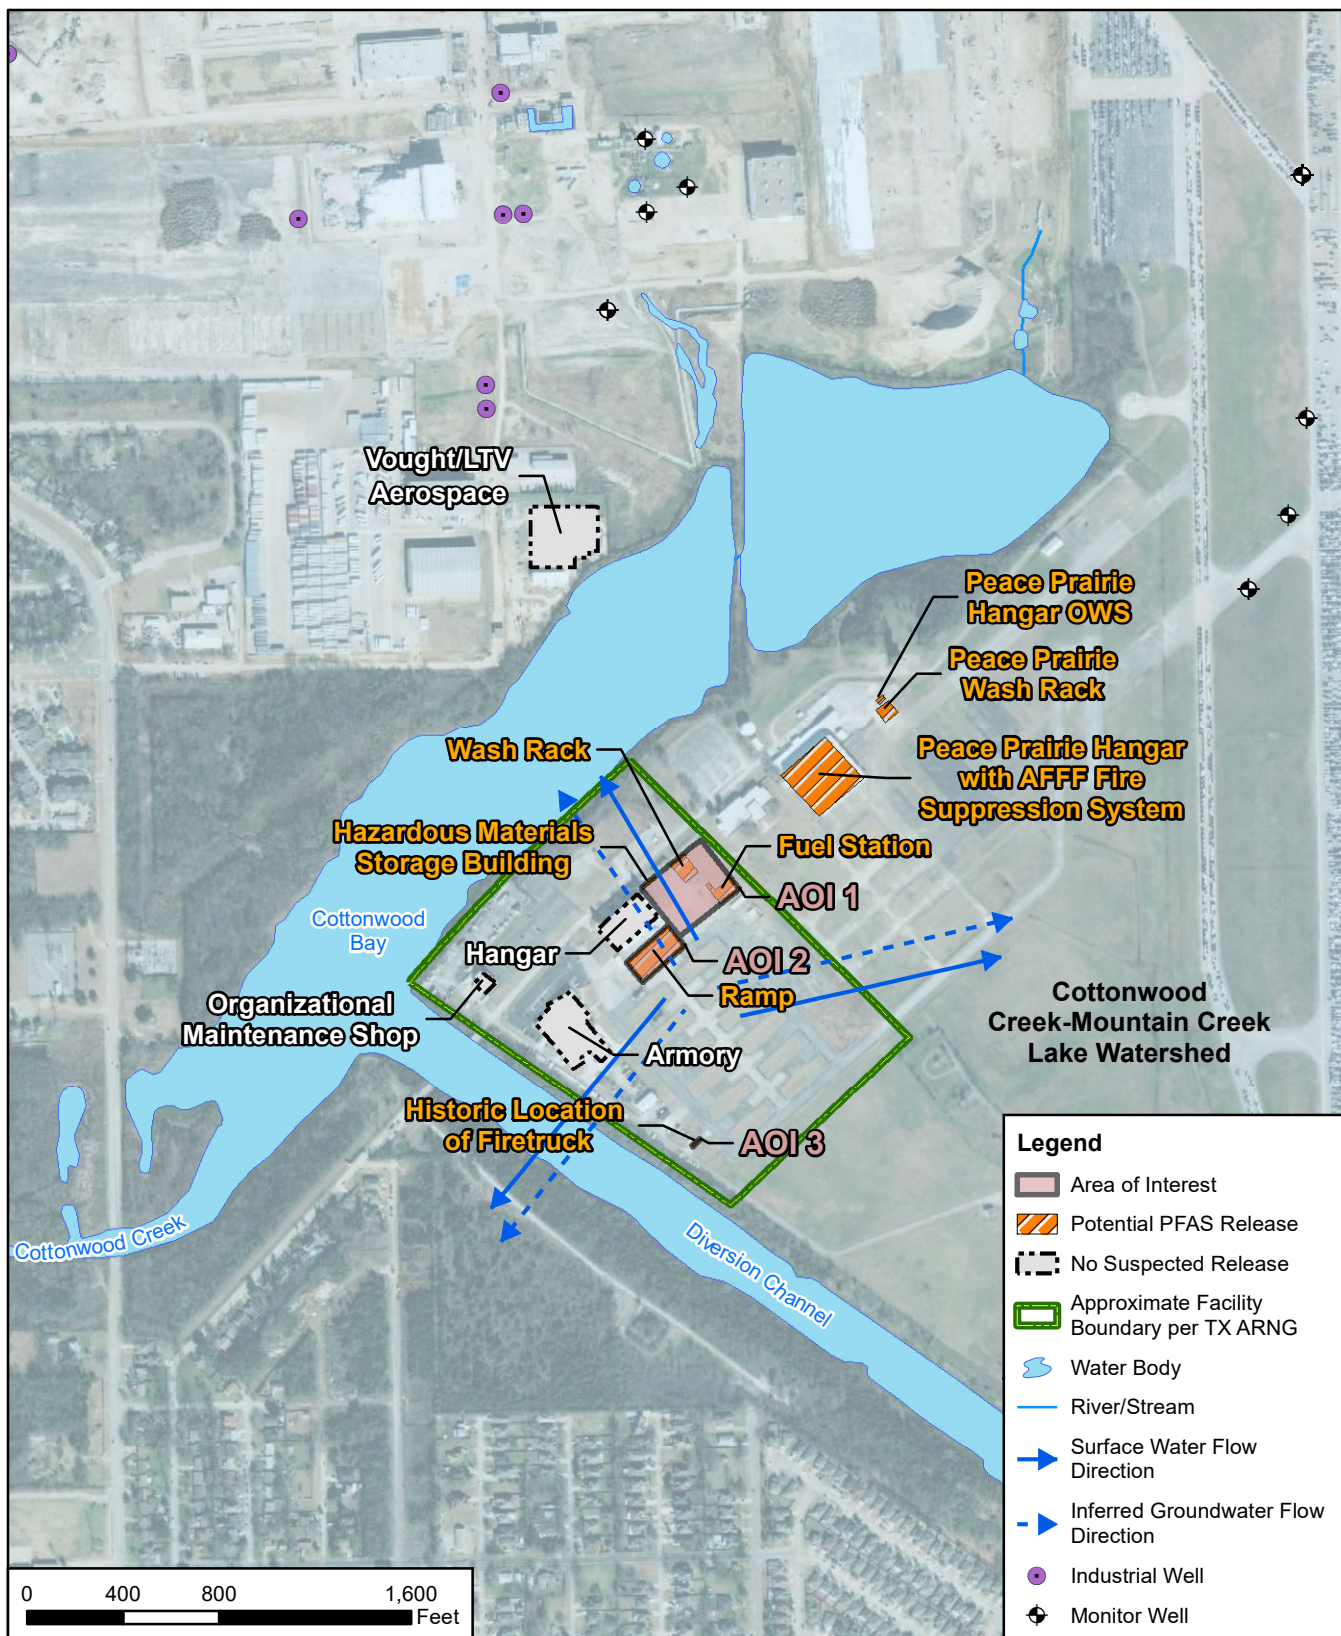
Based on the PA findings, the AFFF release area and storage areas associated with the Grand Prairie AASF wash rack, hazardous materials storage building, and fuel station were identified as AOI 1. The flight line ramp was identified AOI 2, and the historic location of the firetruck is identified as AOI 3. This section describes the preliminary CSM components developed for these three AOIs. The CSM identifies the three components necessary for a potentially complete exposure pathway: (1) source, (2) pathway, and (3) receptor. If any of these elements are missing, the pathway is considered incomplete. The AOIs are shown on **Figure 6-1**, and the preliminary CSM for AOI 1, 2, and 3 is presented on **Figure 6-2**.

Based on the nature of the release (during maintenance/routine testing/training) it appears unlikely AFFF would have been discharged to the ground surface outside of the wash rack, except potentially via runoff to the grassy areas surrounding the wash rack (**Figure 6-1**). PFAS contamination may have infiltrated to subsurface soil via leaks in drains, OWS or underground wastewater conveyance piping beneath the wash rack, or leaks along piping from the facility to the municipal WWTP. Under such scenarios ground disturbing activities in these areas could result in site or construction worker exposure to PFAS via inhalation of dust or ingestion of exposed surface soil, or construction worker exposure to PFAS via inhalation of dust or ingestion of exposed subsurface soil.

Based on the nature of the possible release, PFAS contamination may have further infiltrated to subsurface soil through precipitation from rain events. Under such scenarios, ground disturbing activities in this area could result in site or construction worker exposure to PFAS via inhalation of dust or ingestion of exposed surface soil, or construction worker exposure to PFAS via inhalation of dust or ingestion of exposed subsurface soil.

Potential PFAS contamination may have further infiltrated to shallow groundwater, which is anticipated to follow topography and flow radially toward Mountain Creek Lake, Cottonwood Bay, and the Diversion Channel.
