# FINAL Preliminary Assessment Report Austin Bergstrom Army Aviation Support Facility Austin, Texas

Perfluorooctanesulfonic Acid (PFOS) and Perfluorooctanoic  
Acid (PFOA) Impacted Sites  
ARNG Installations, Nationwide

July 2020

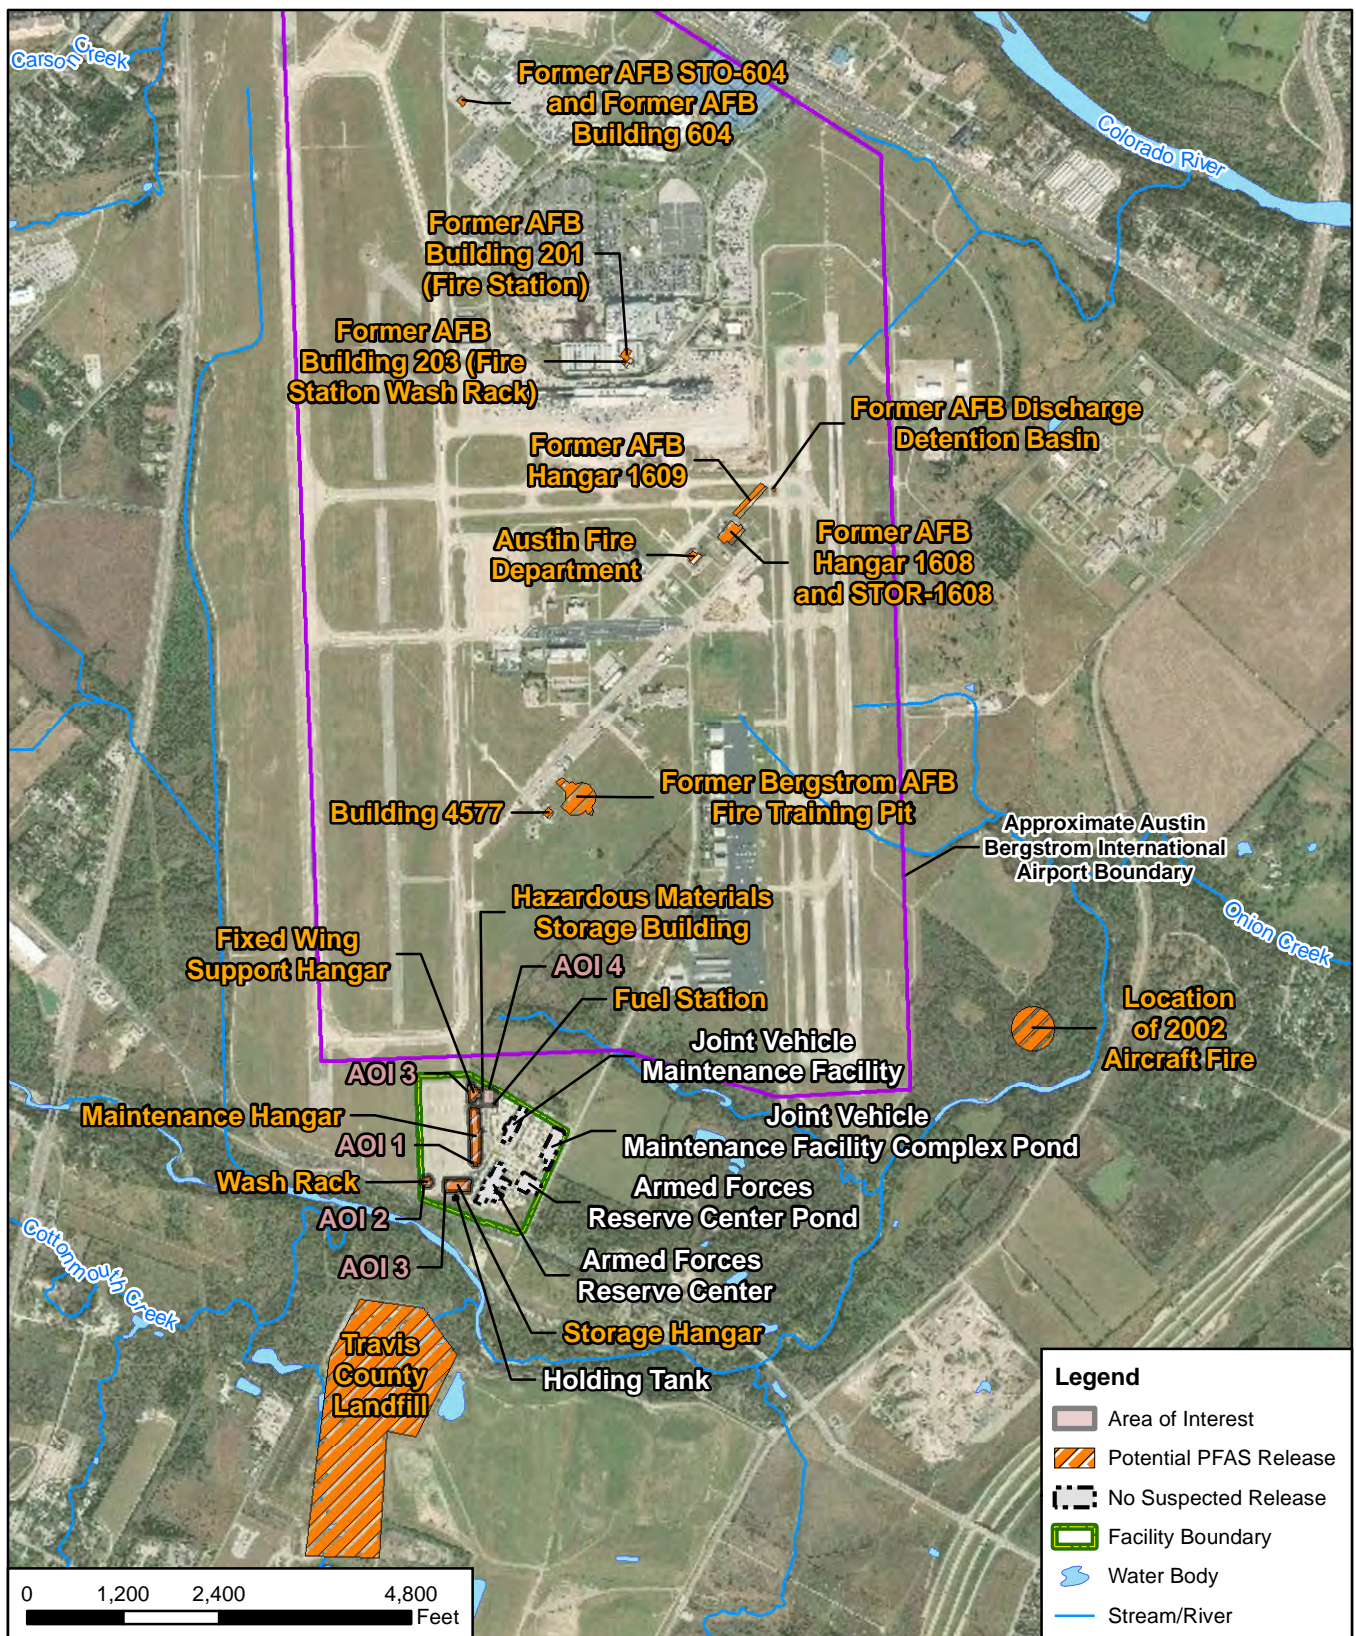
**Figure ES-1**

Area of Interest	Name	Used by	Release Dates
	the storm water drainage system travelled to the retention ponds.		
AOI 3	The Fixed Wing Support Hangar and the Storage Hangar are both equipped with AFFF fire suppression systems. It is likely that both systems were tested in 2005, when the hangars were being commissioned, leading to a release of AFFF. The flow path for AFFF foam would have been from the hangar to the trench drain, then to the holding tank, then to the OWS, and finally to the storm water drainage system, which discharges to the retention ponds.	TXARNG	2005
AOI 4	The Hazardous Materials Storage Building and the Fuel Station both historically contained AFFF in 5-gallon containers and in Tri-Max™ units (respectively). These areas will be investigated for potential PFAS release.	TXARNG	2005-2014

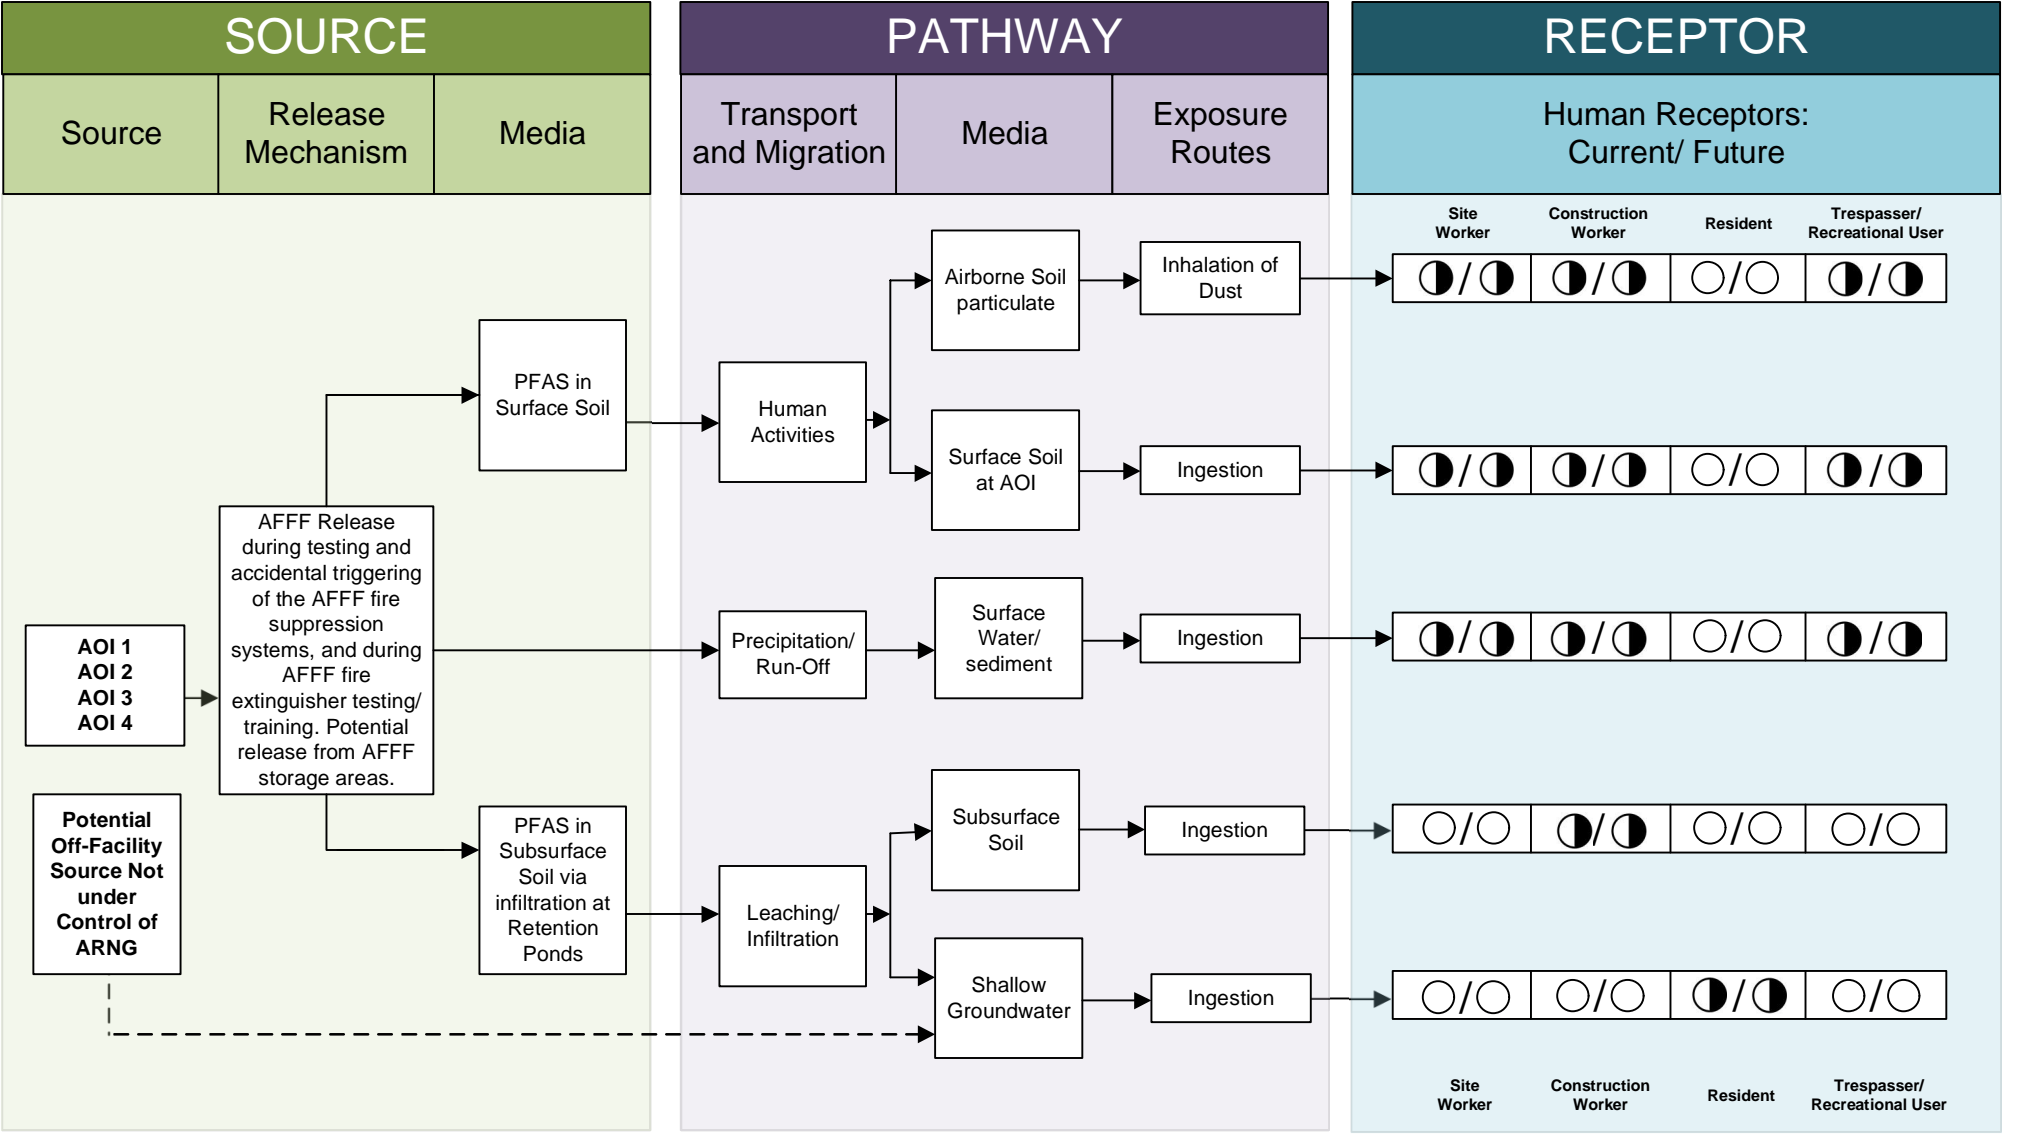
Based on the reported AFFF releases at these AOIs, there is potential for exposure to PFAS contamination in media at or near the facility. The preliminary CSM for the Austin Bergstrom AASF is shown on **Figure ES-2**. Based on the United States Environmental Protection Agency (USEPA) Unregulated Contaminant Monitoring Rule 3 (UCMR3) data, it was indicated that no PFAS were detected in a public water system above the USEPA Health Advisory (HA) within 20 miles of the facility. PFAS analyses performed in 2016 had method detection limits that were higher than currently achievable. Thus, it is possible that low concentrations of PFAS were not detected during the UCMR3 but might be detected if analyzed today.

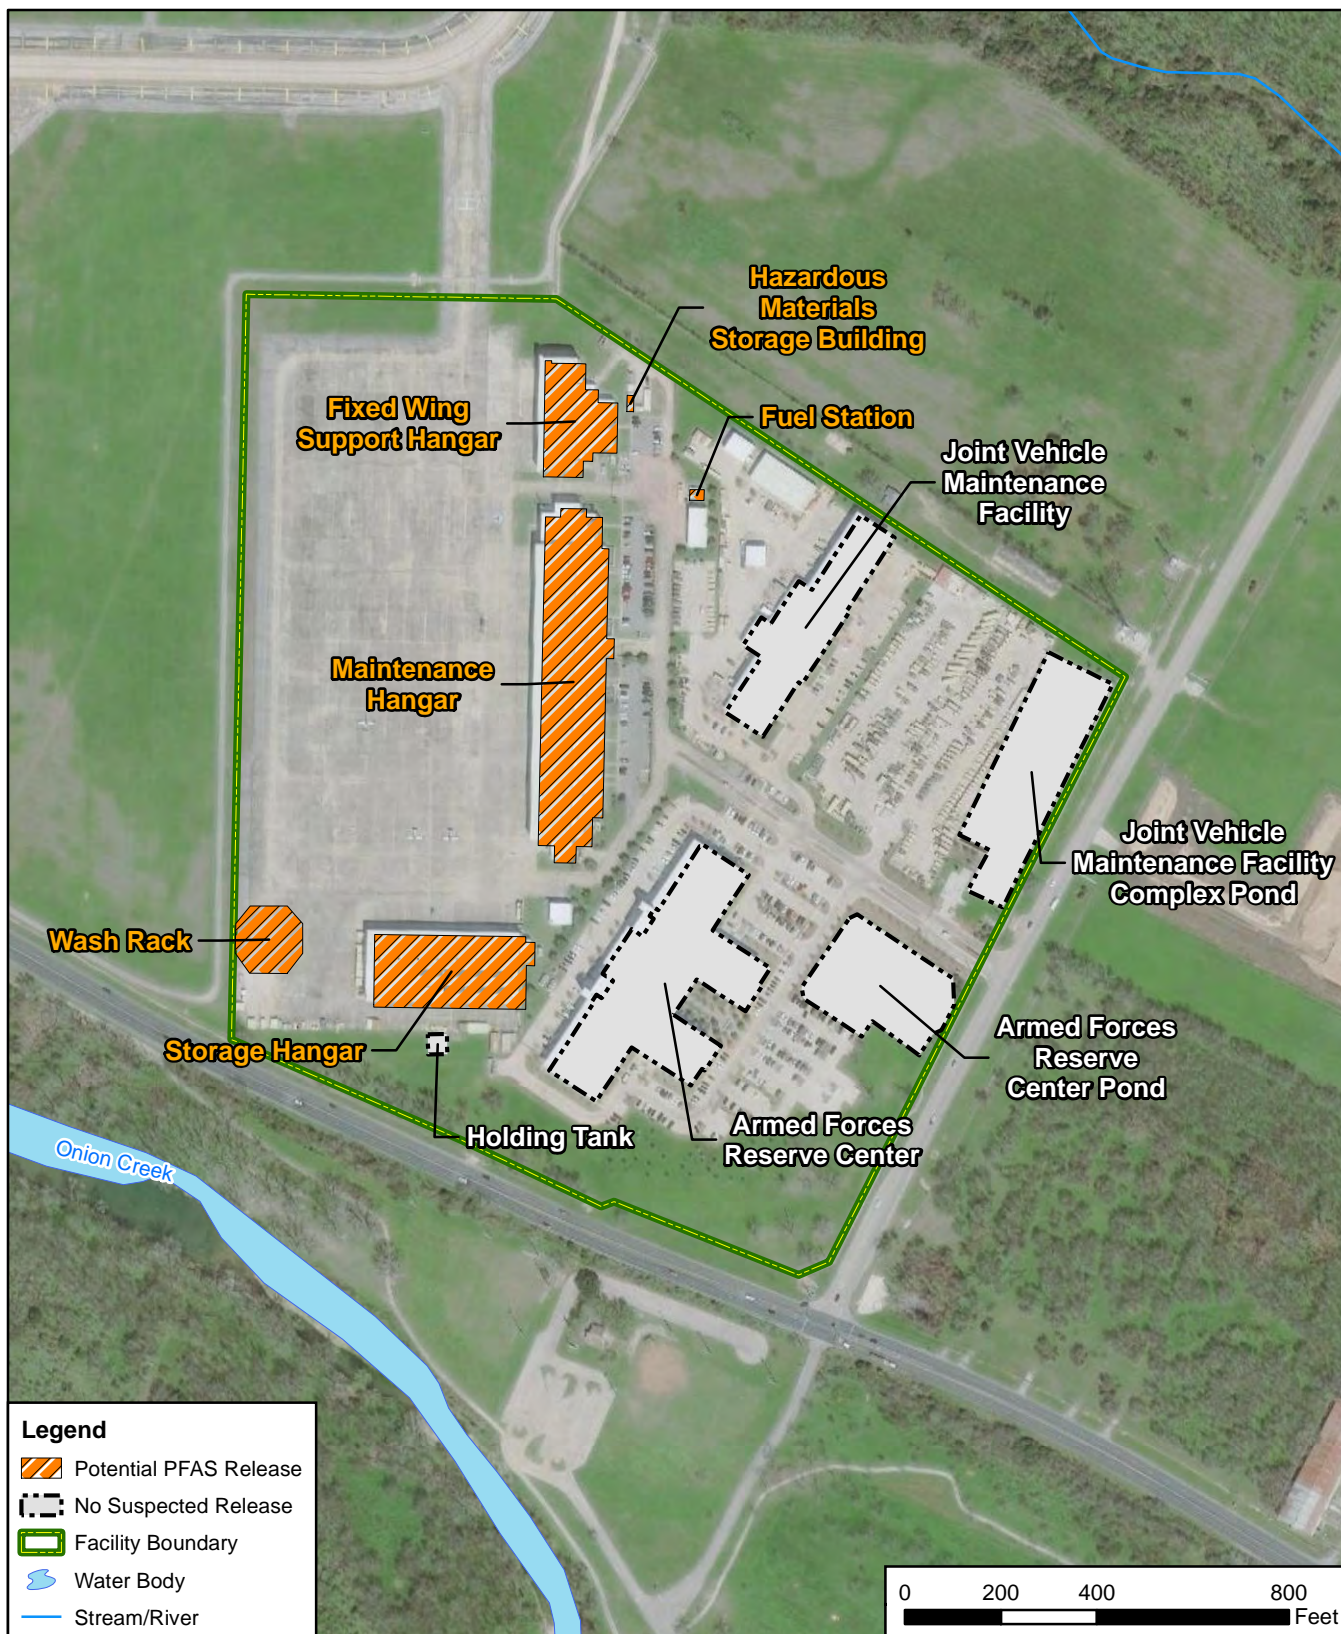
The hazardous materials storage building is located to the east of the Fixed Wing Support Hangar. Various hazardous materials are stored inside the building. Historically, 105 5-gallon sealed containers of AFFF were stored inside the building. The 5-gallon buckets were added to helicopter buckets for firefighting brushfires offsite. Around 2014, the 5-gallon buckets of AFFF were removed from the facility and sent to the Camp Mabry US Property & Fiscal Office (USPFO) in Austin, Texas. To the best of their knowledge, TXARNG staff who had been working on site since 2001 reported no releases of any materials in this area. No floor drain was observed in the hazardous materials storage building. Geographic coordinates for the hazardous materials storage building are 30°10'42.2"N; 97°40'19.5"W.

Historically, AFFF-containing Tri-Max™ units were stationed at the Fuel Station on site. TXARNG staff who had been working on site since 2001 reported no releases of any materials in this area. Precipitation and wastewater in this area flows to the OWS. Geographic coordinates for the fuel station are 30°10'40.4"N; 97°40'17.8"W.

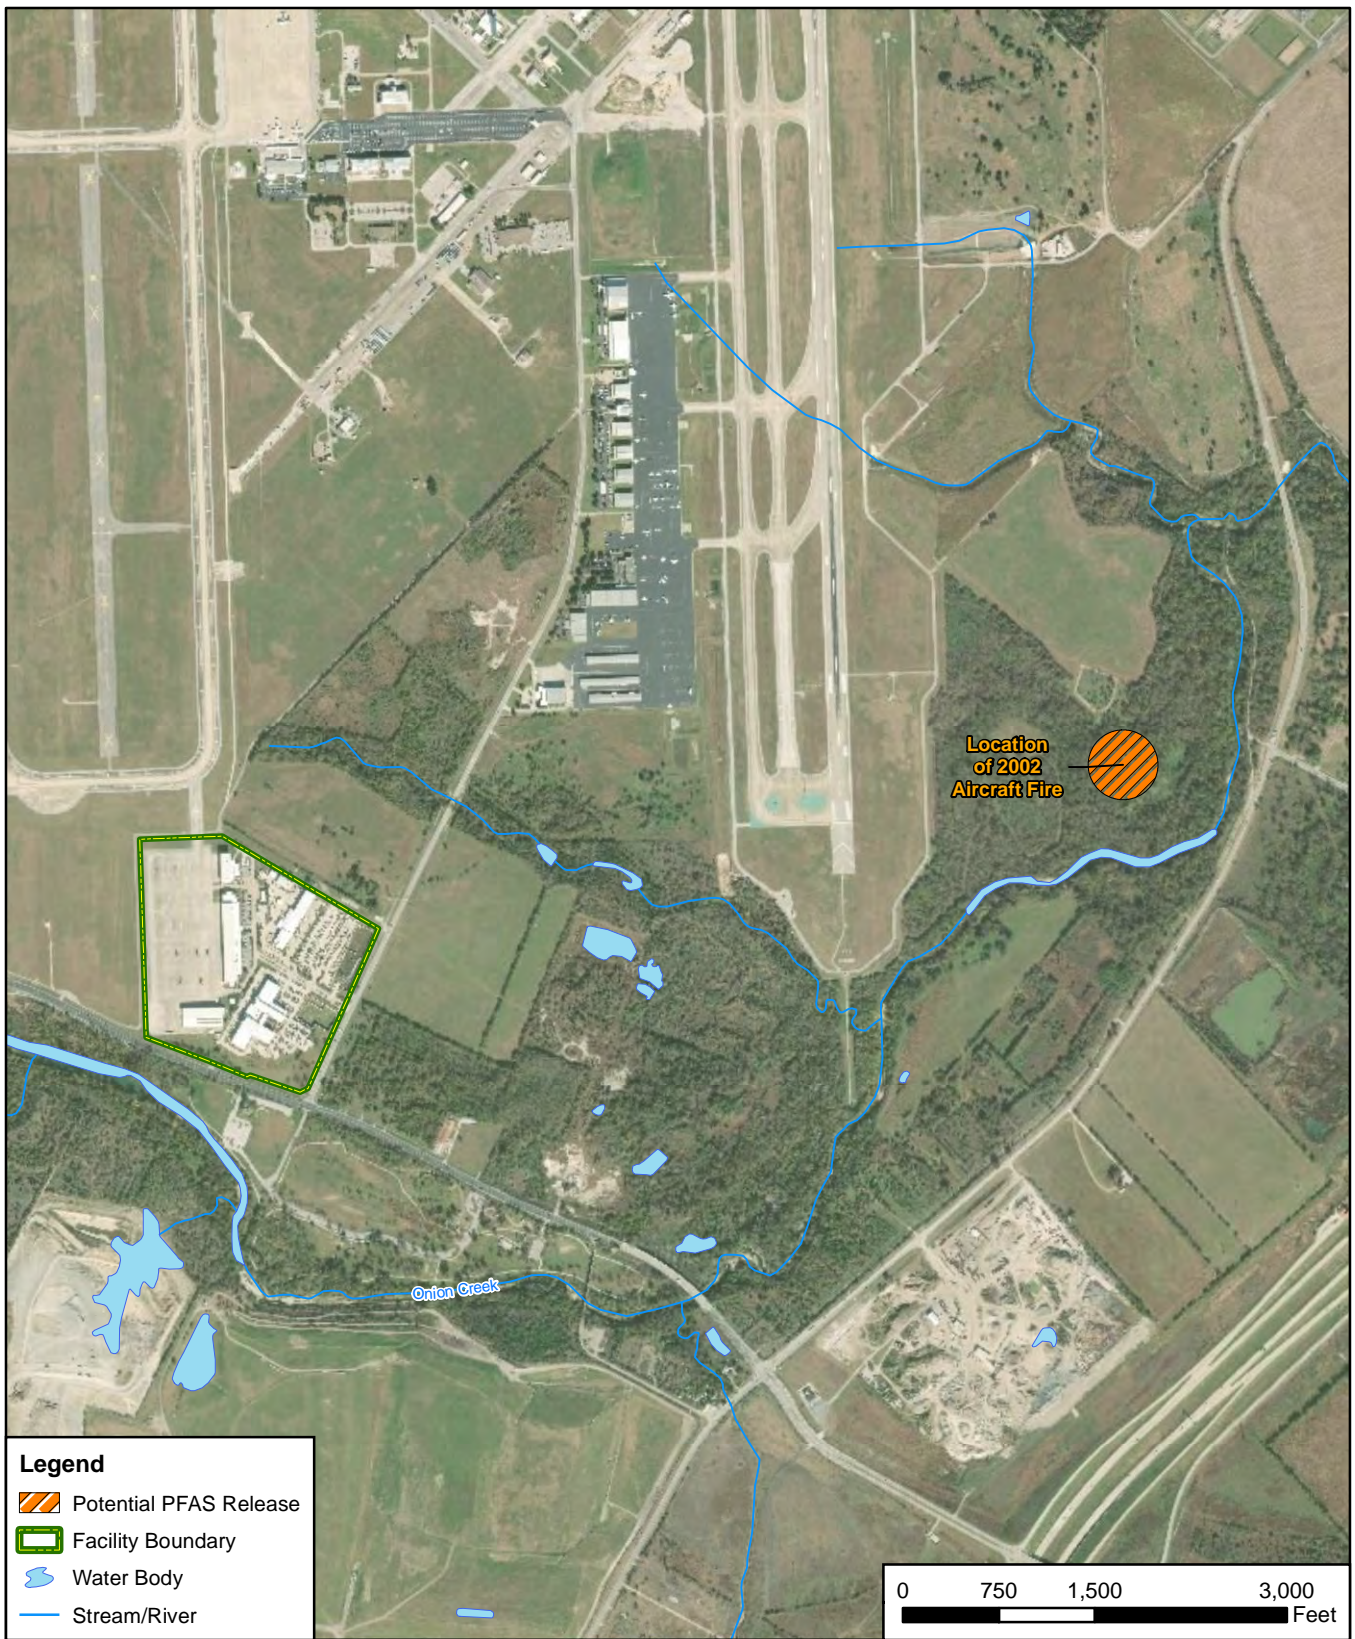
To the best of their knowledge, TXARNG personnel who have been working on site since 2001 reported no past emergency responses. However, the Airport Fire Department conducted an emergency response southeast of the east runway at the ABIA, when an aircraft crashed in the fog. The crash occurred in 2002, and AFFF was used at the crash site to put out the aircraft fire. The National Transportation Safety Board Aviation Accident Data Summary can be found in **Appendix A**, and the location of crash can be found on **Figure 4-1**.

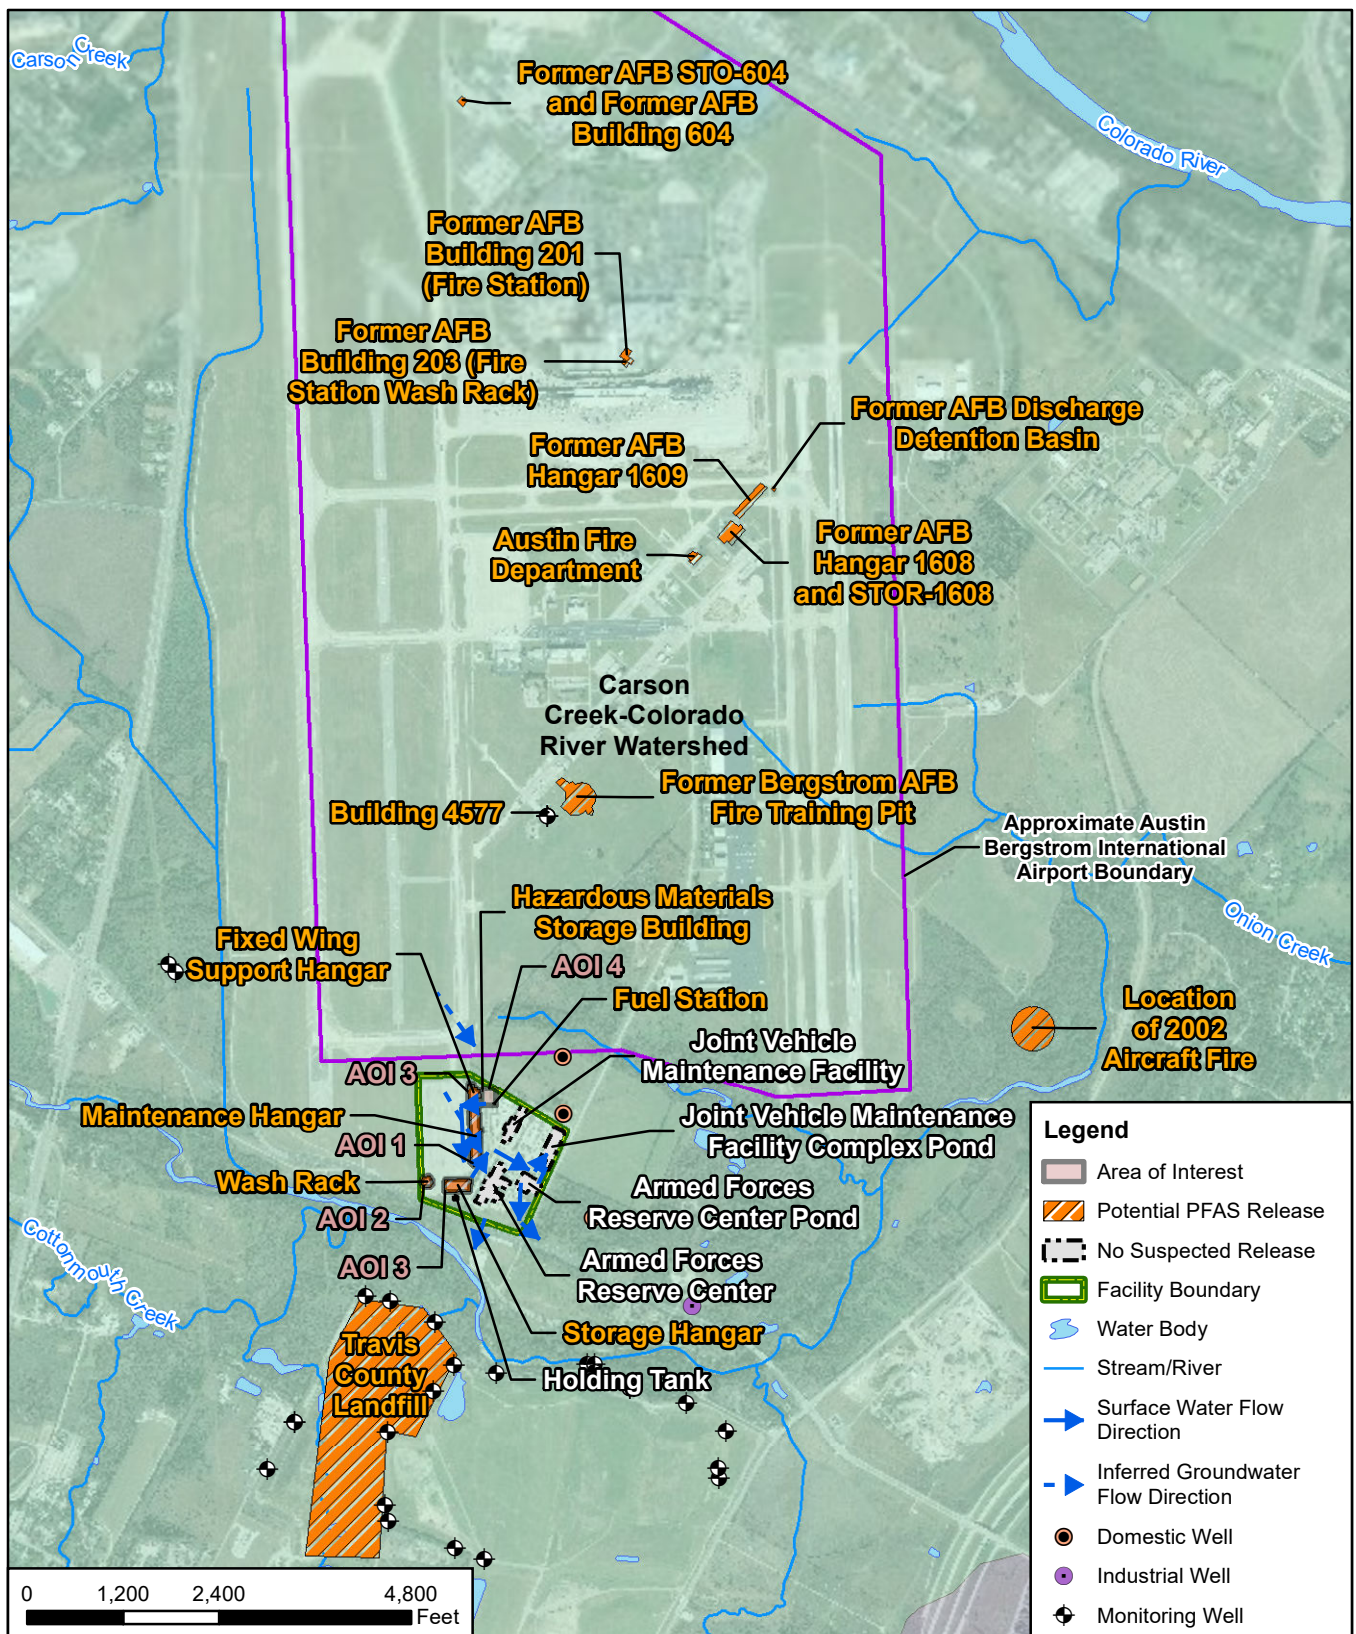
The Hazardous Materials Storage Building historically contained 105 5-gallon sealed containers of AFFF and the Fuel Station historically had AFFF-containing Tri-Max™ units stationed around the area. Although TXARNG reported no known releases of any PFAS-containing materials in either area, these areas should be investigated for potential release. Surface water in the vicinity of the Hazardous Materials Storage Building could potentially allow AFFF to infiltrate into nearby grassy areas, and surface water in the vicinity of the Fuel Station flows to the OWS.

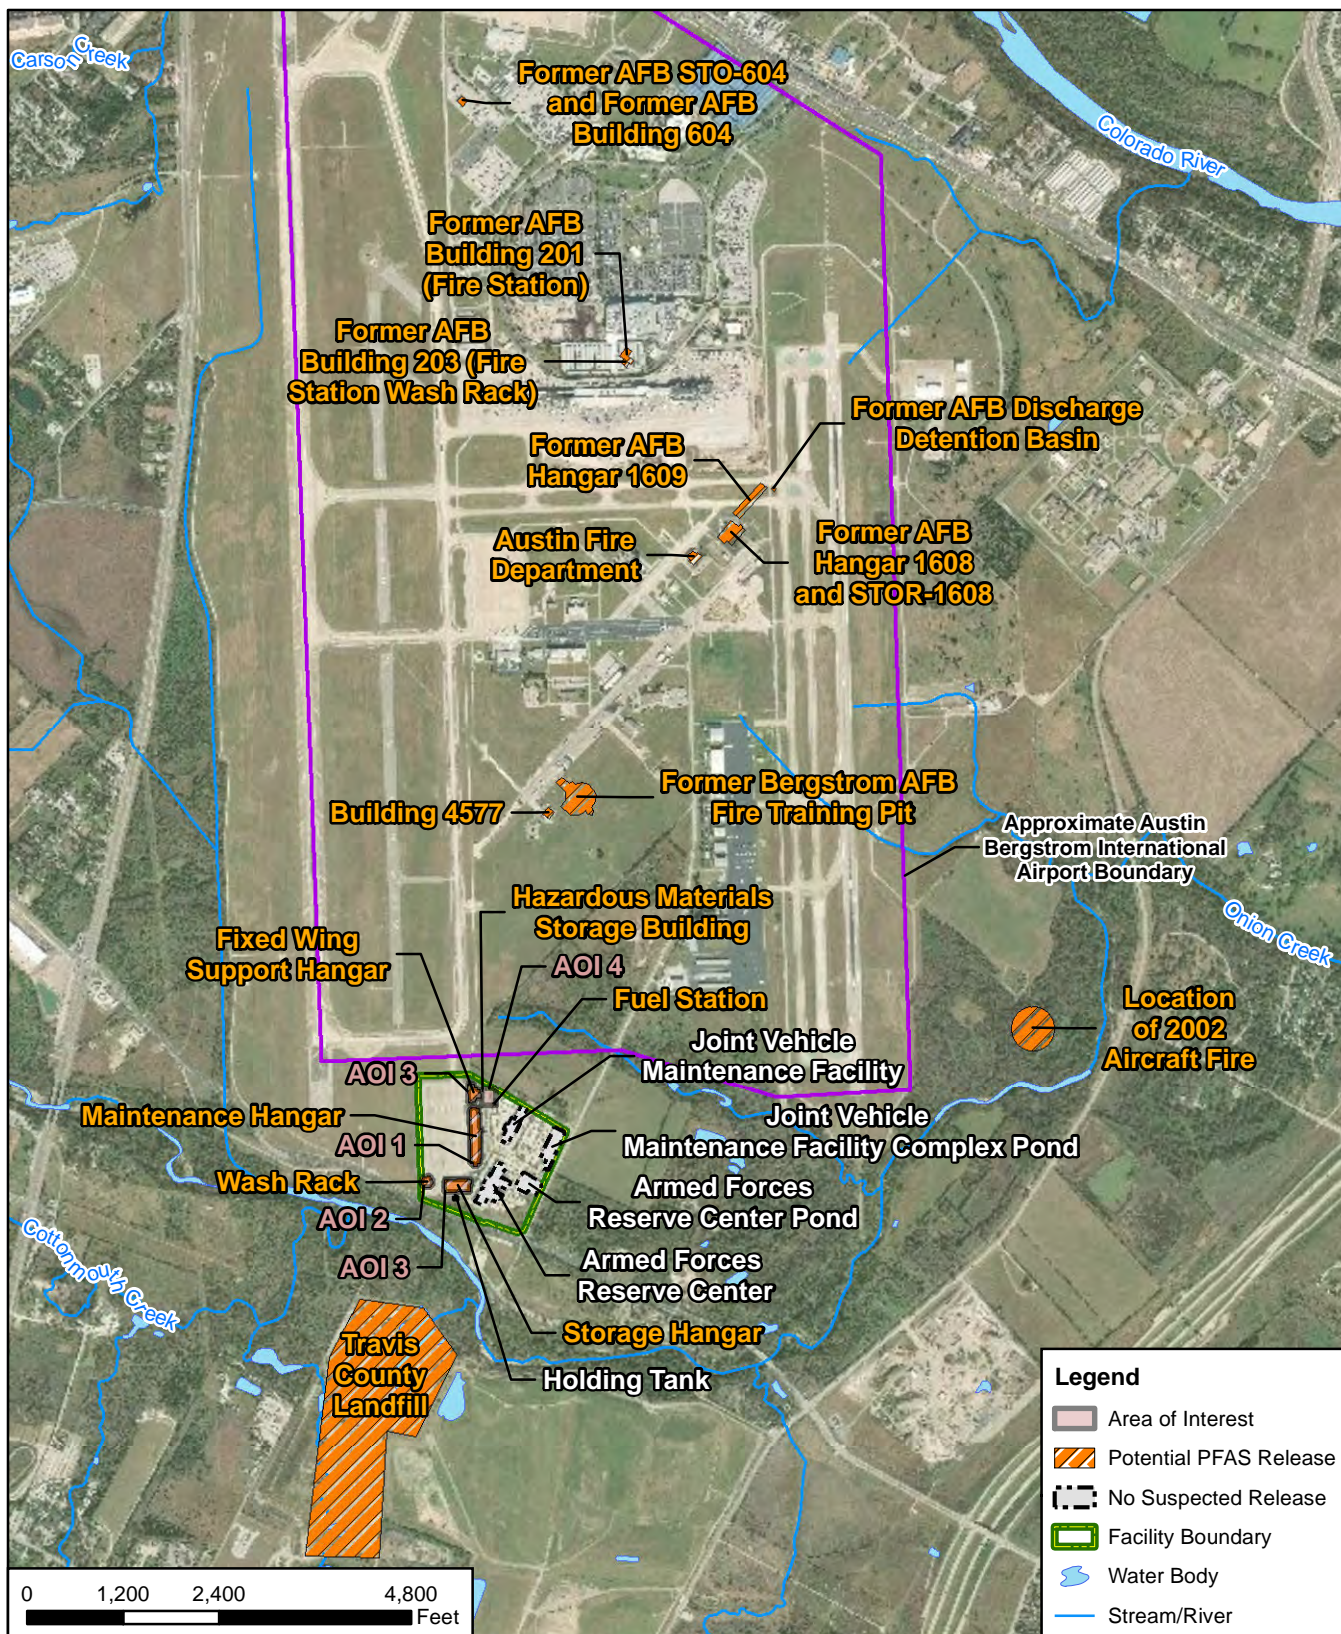
AOI 4	The Hazardous Materials Storage Building and the Fuel Station both historically contained AFFF in 5-gallon containers and in Tri-Max™ units (respectively). These areas will be investigated for potential PFAS release.	TXARNG	2005-2014
-------	--	--------	-----------

AOI 4: Hazardous Materials Storage Building and Fuel Station	30°10'42.2"N; 97°40'19.5"W and 30°10'40.4"N; 97°40'17.8"W	AFFF was stored at the Hazardous Materials Storage Building and at the Fuel Station. Although there are no documented releases at either location, they should be investigated to determine if PFAS releases occurred.	Proceed to an SI, focus on soil and groundwater.
---	---	---	--

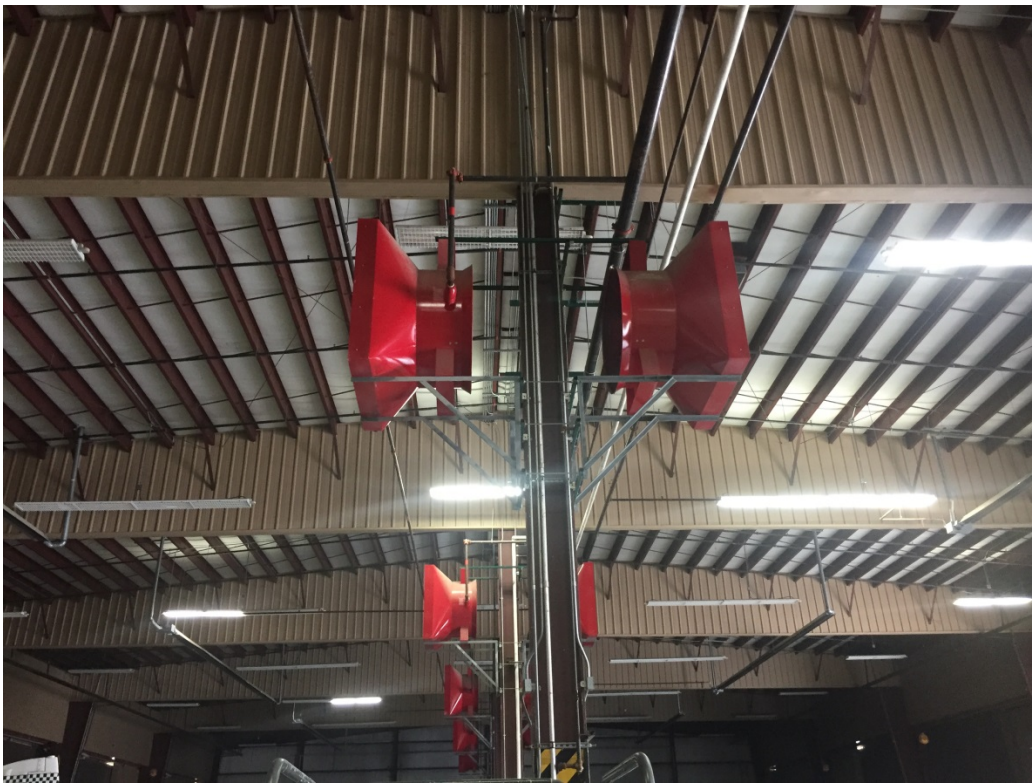
<p>This photograph shows industrial fire suppression equipment inside a maintenance hangar. In the foreground, there are two large, vertical, white foam tanks mounted on red bases. They are connected to a network of black pipes and valves. Red labels with the text 'FIRE PROTECTION' are visible on the pipes. The background shows more of the hangar's interior, including structural beams and other equipment.</p>	
<p><b>Photograph No. 6</b></p> <p><b>Description:</b></p> <p>Fire suppression nozzles in Storage Hangar.</p>
