Preliminary Assessment Report Sustained Airborne Training Facility Salt Lake City, Utah

Perfluorooctanesulfonic Acid (PFOS) and
Perfluorooctanoic Acid (PFOA) Impacted Sites
ARNG Installations, Nationwide

September 2020

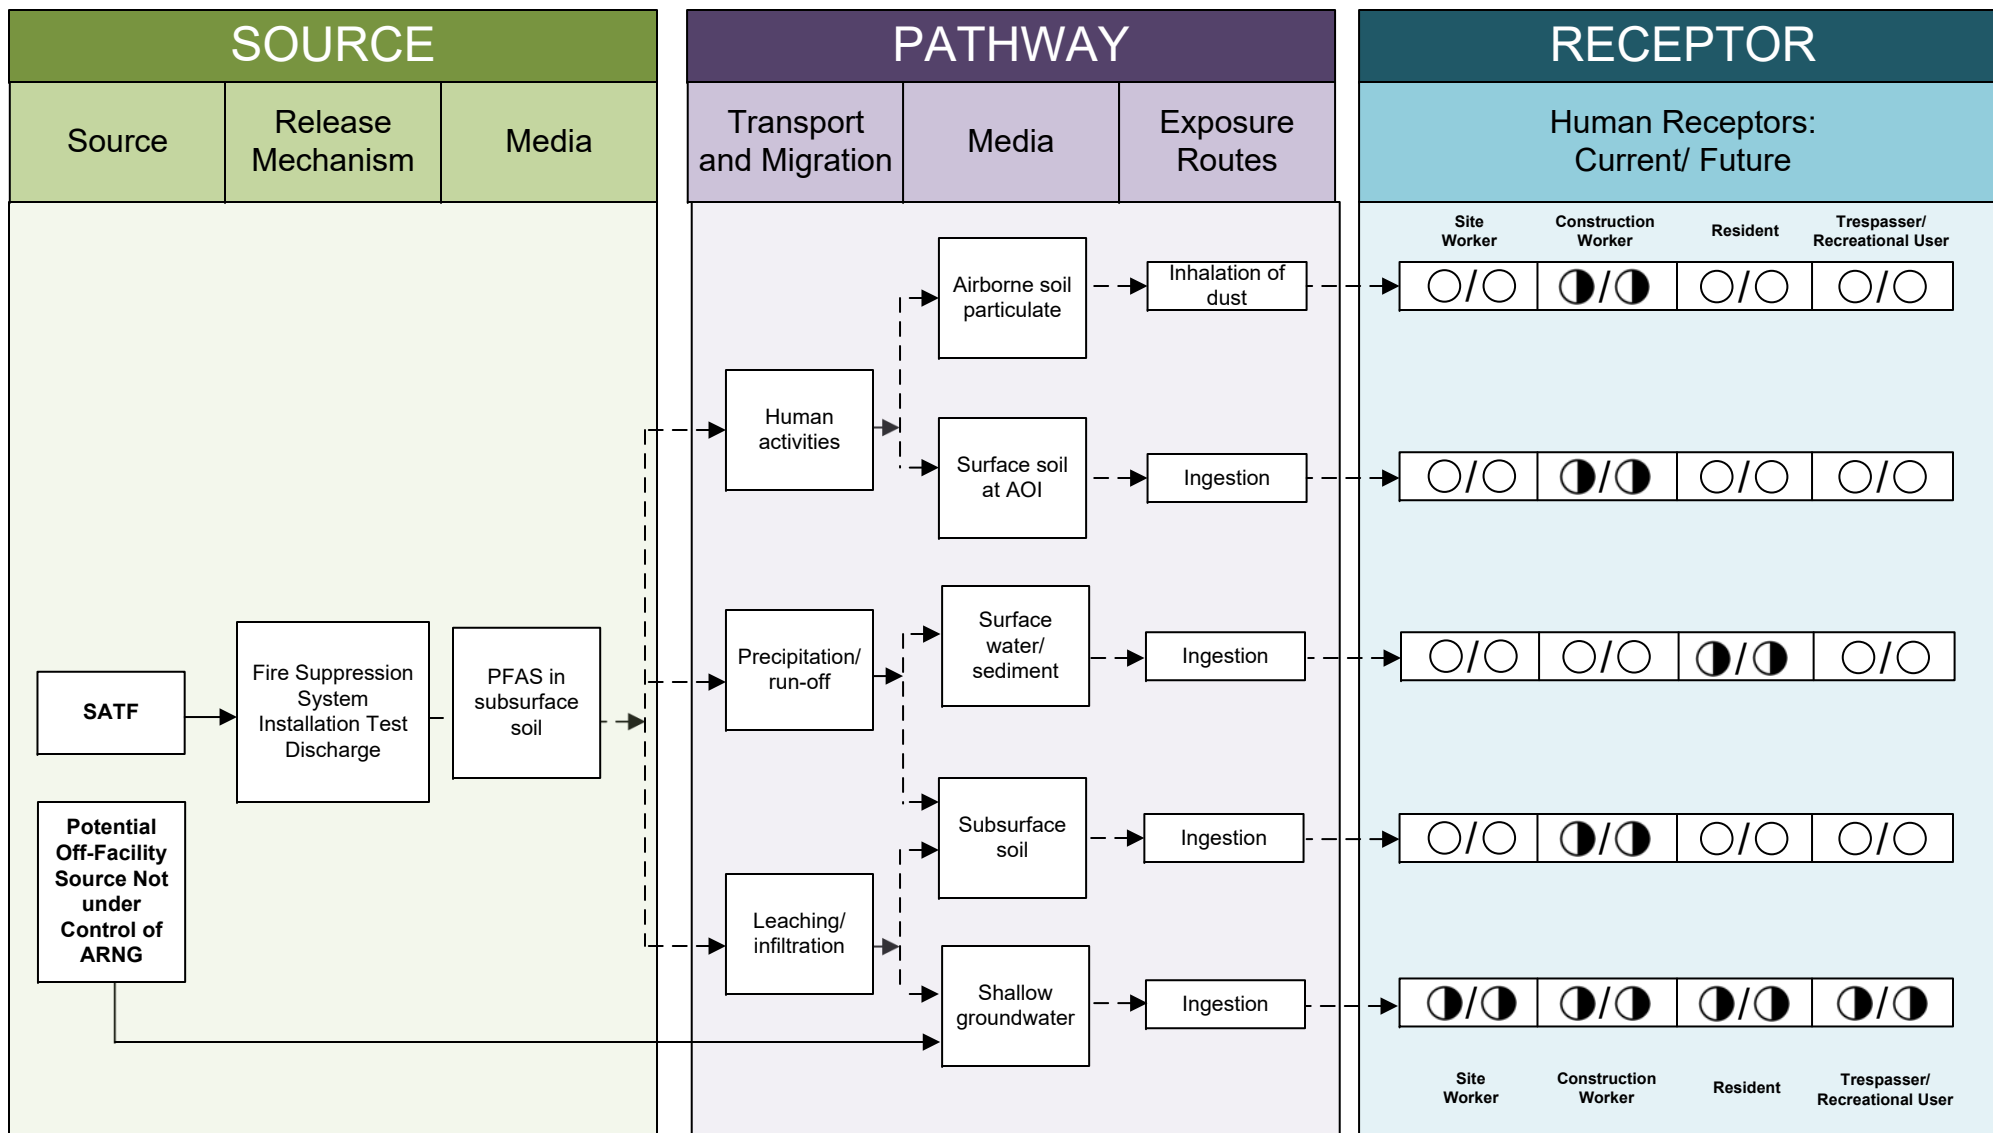
Figure ES-2
Preliminary Conceptual Site Model
SATF, UT

- The resident receptor refers to an off-site resident.
- Current risk practice suggests the exposure pathway for dermal contact is insignificant compared to ingestion, but supporting data is sparse and continues to be studied.
- Based on the topography and water bodies in the vicinity of the SATF, it is assumed groundwater moves from west to east or northeast, towards the Jordan River. The Jordan River is the main source of irrigation water for farms in the Jordan Valley; therefore, the exposure pathway for surface water to the off-facility resident receptor via ingestion is potentially complete.

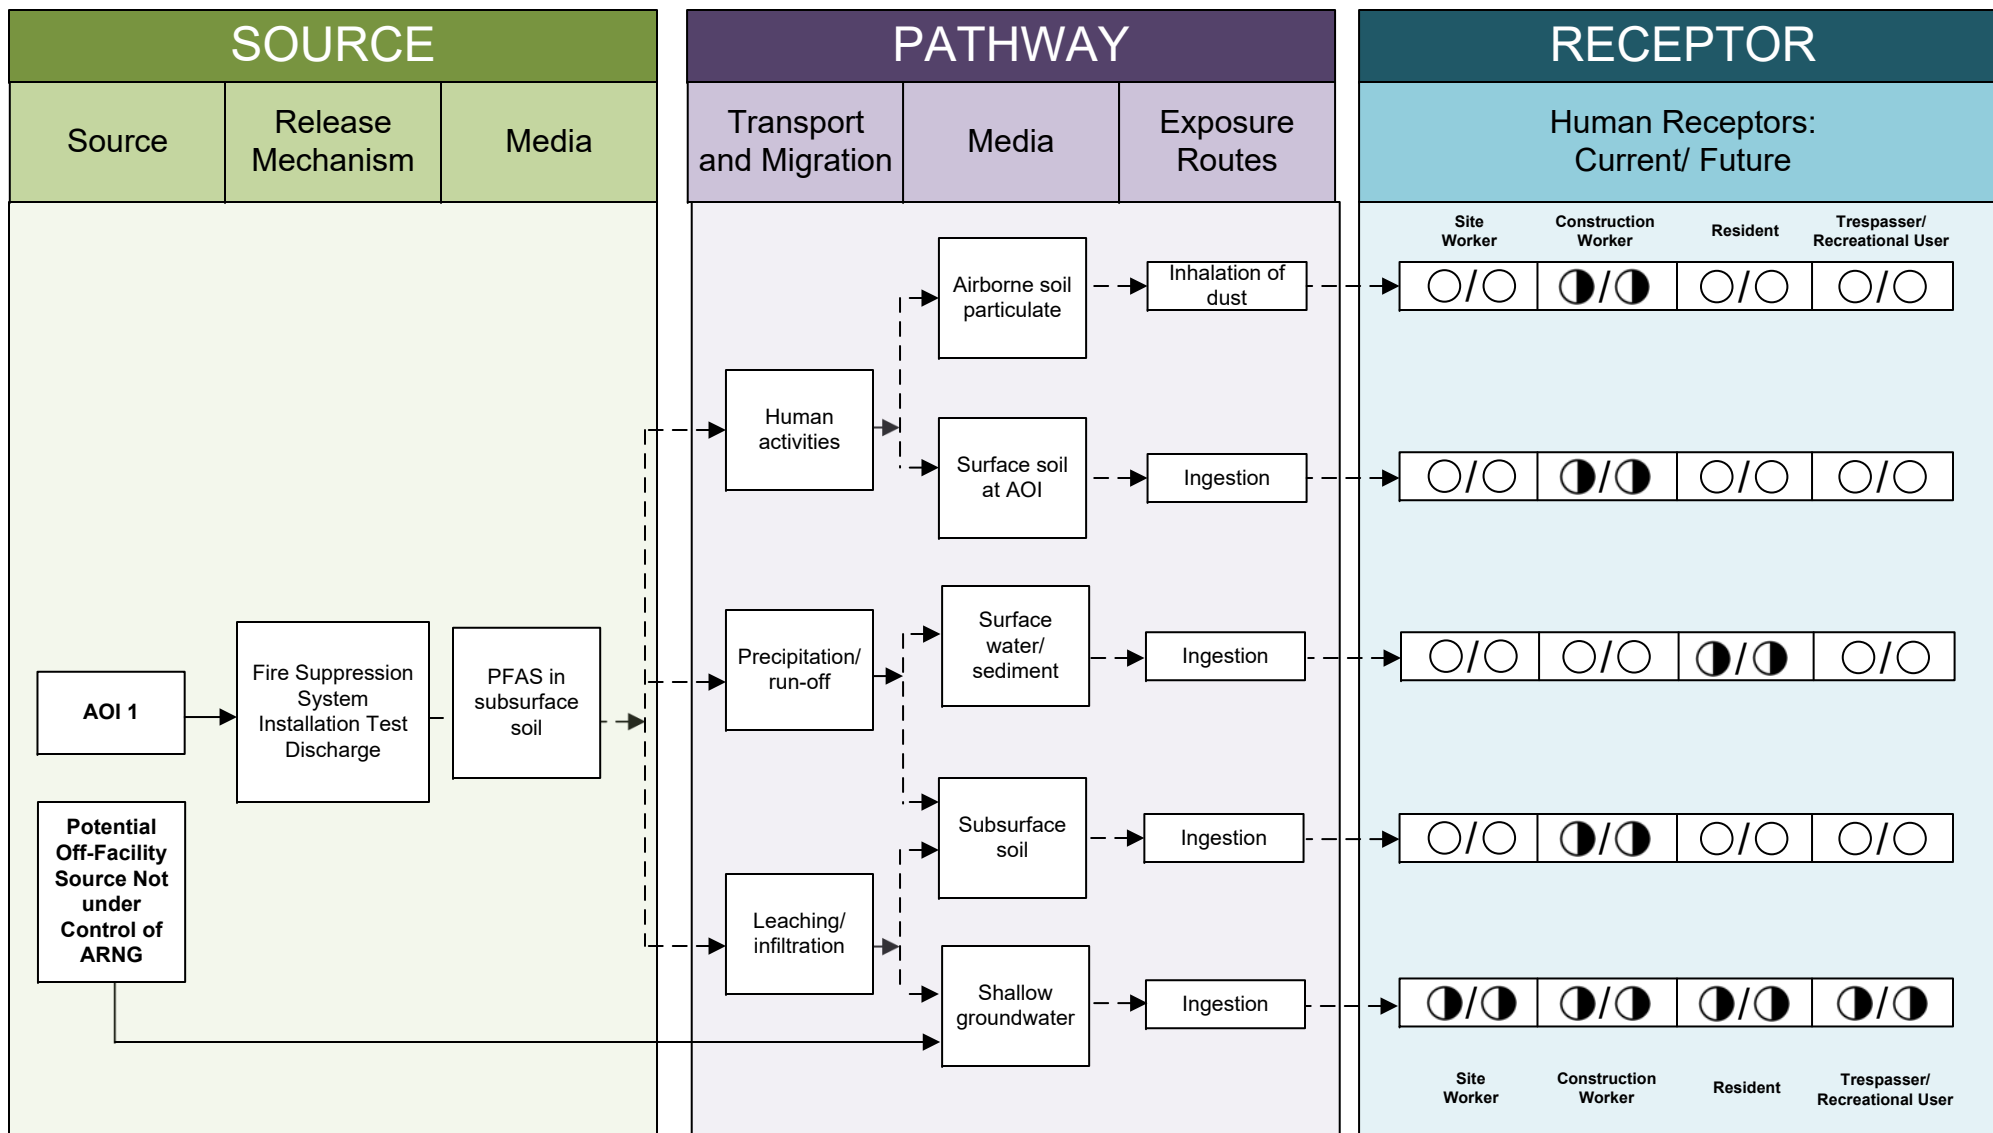
Since the UTARNG has occupied the building, there has been one known discharge of AFFF. The discharge of AFFF in the hangar area during the fire suppression system test in 2014 may have resulted in a release to a potentially broken pipe and subsequently, directly into the subsurface.

PFAS are water soluble and can migrate readily from soil to groundwater or surface water via leaching and run-off. If PFAS releases to the subsurface soil occurred, it is possible that PFAS have migrated from subsurface soil at AOI 1 to groundwater and waters in the Jordan River, and therefore, the exposure pathway for groundwater to the off-facility resident receptor is potentially complete. Based on the topography and water bodies in the vicinity of the SATF, it is assumed groundwater moves from west to east or northeast, towards the Jordan River. The Jordan River is the main source of irrigation water for farms in the Jordan Valley; therefore, the exposure pathway for surface water to the off-facility resident receptor via ingestion is potentially complete. Ground-disturbing activities to subsurface soil could present another potentially complete exposure pathway to construction workers via ingestion of subsurface soil. There is no exposed surface soil present at the facility. The preliminary CSM for AOI 1 is shown on **Figure 6-2**.

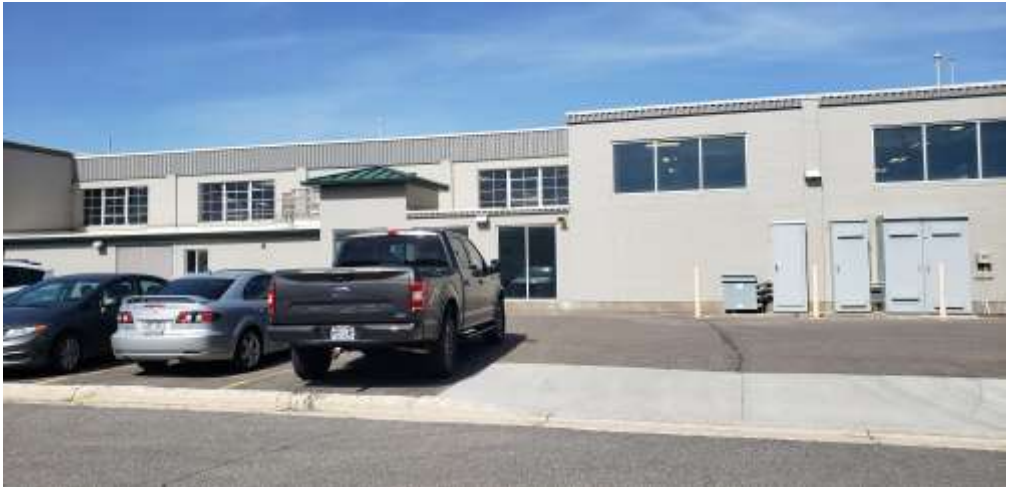
Appendix C - Photographic Log		
Army National Guard, Preliminary Assessment for PFAS	Sustained Airborne Training Facility	Salt Lake City International Airport, UT
Photograph No. 1 Date 7/18/2019 Time 10:28 Description: Photograph depicts the exterior of the SATF. Orientation: West

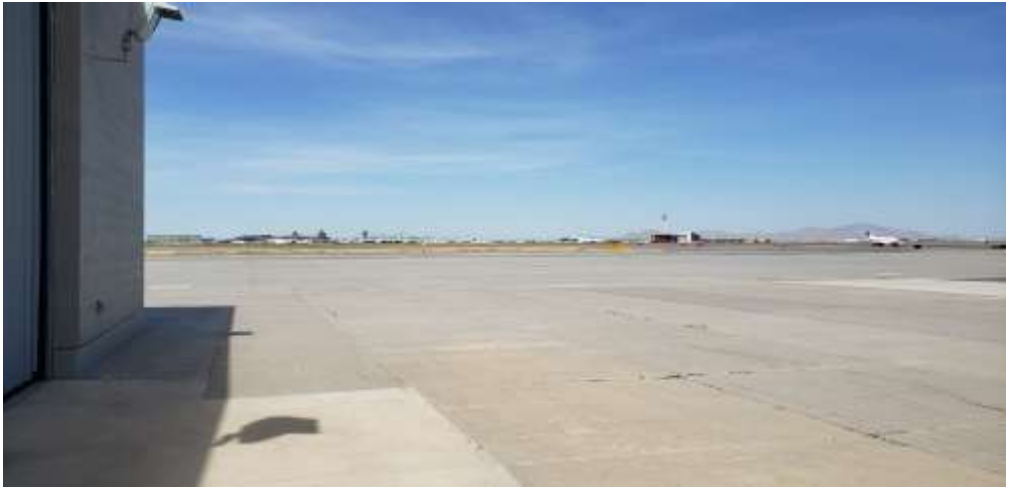
Photograph No. 2 Date 7/18/2019 Time 10:22 Description: Photograph depicts the airground directly outside the facility, with the Salt Lake City International Airport in the background. Orientation: West
