FINAL Preliminary Assessment Report Gary Army Aviation Support Facility, Indiana

Perfluorooctane-Sulfonic Acid (PFOS) and Perfluorooctanoic
Acid (PFOA) Impacted Sites
ARNG Installations, Nationwide

March 2020

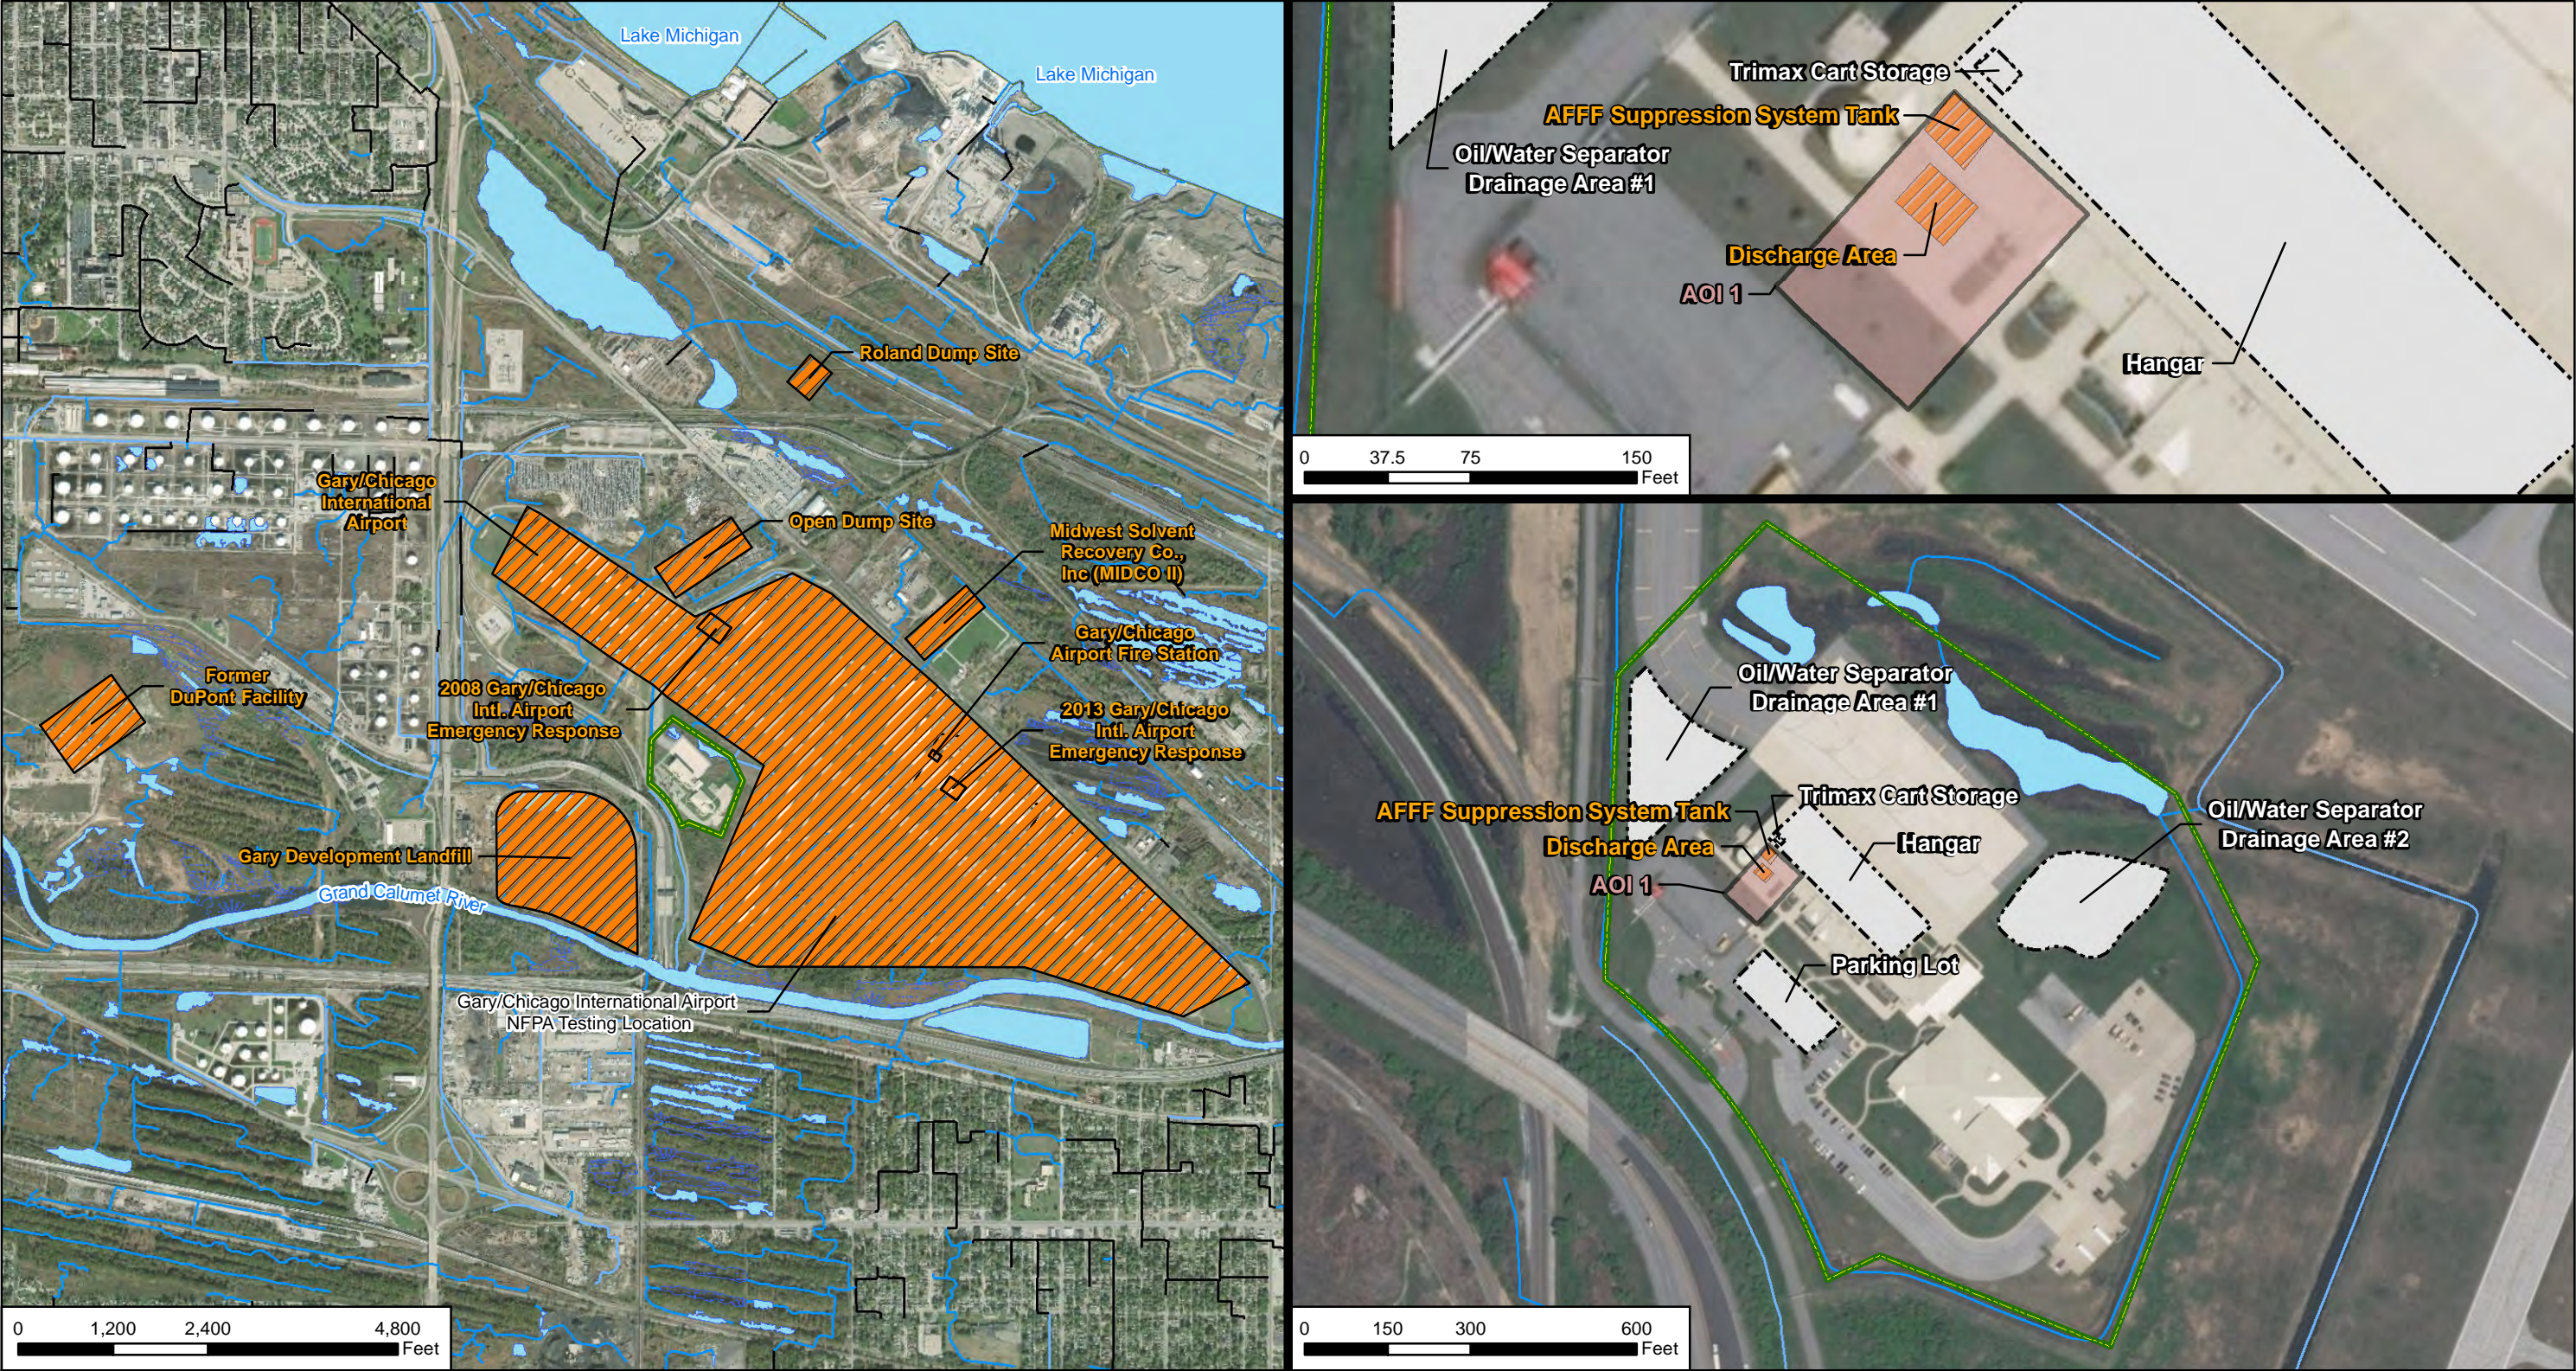
| 12420 Milestone Center Drive Germantown, MD 20876 | Figure ES-1 |

| Area of Interest | Name | Used by | Release Date |
|---|---|---|---|
| AOI 1 | AFFF Suppression System Leak Area | Gary AASF - Indiana ARNG | 6 February 2018 |

Based on the potential AFFF release at this AOI, there is potential for exposure to PFAS contamination in surface soil and subsurface soil to site and construction workers via ingestion and inhalation, and surface water and sediments to site workers, construction workers, and residents via ingestion. The CSM for the Gary AASF is shown on **Figure ES-2**.

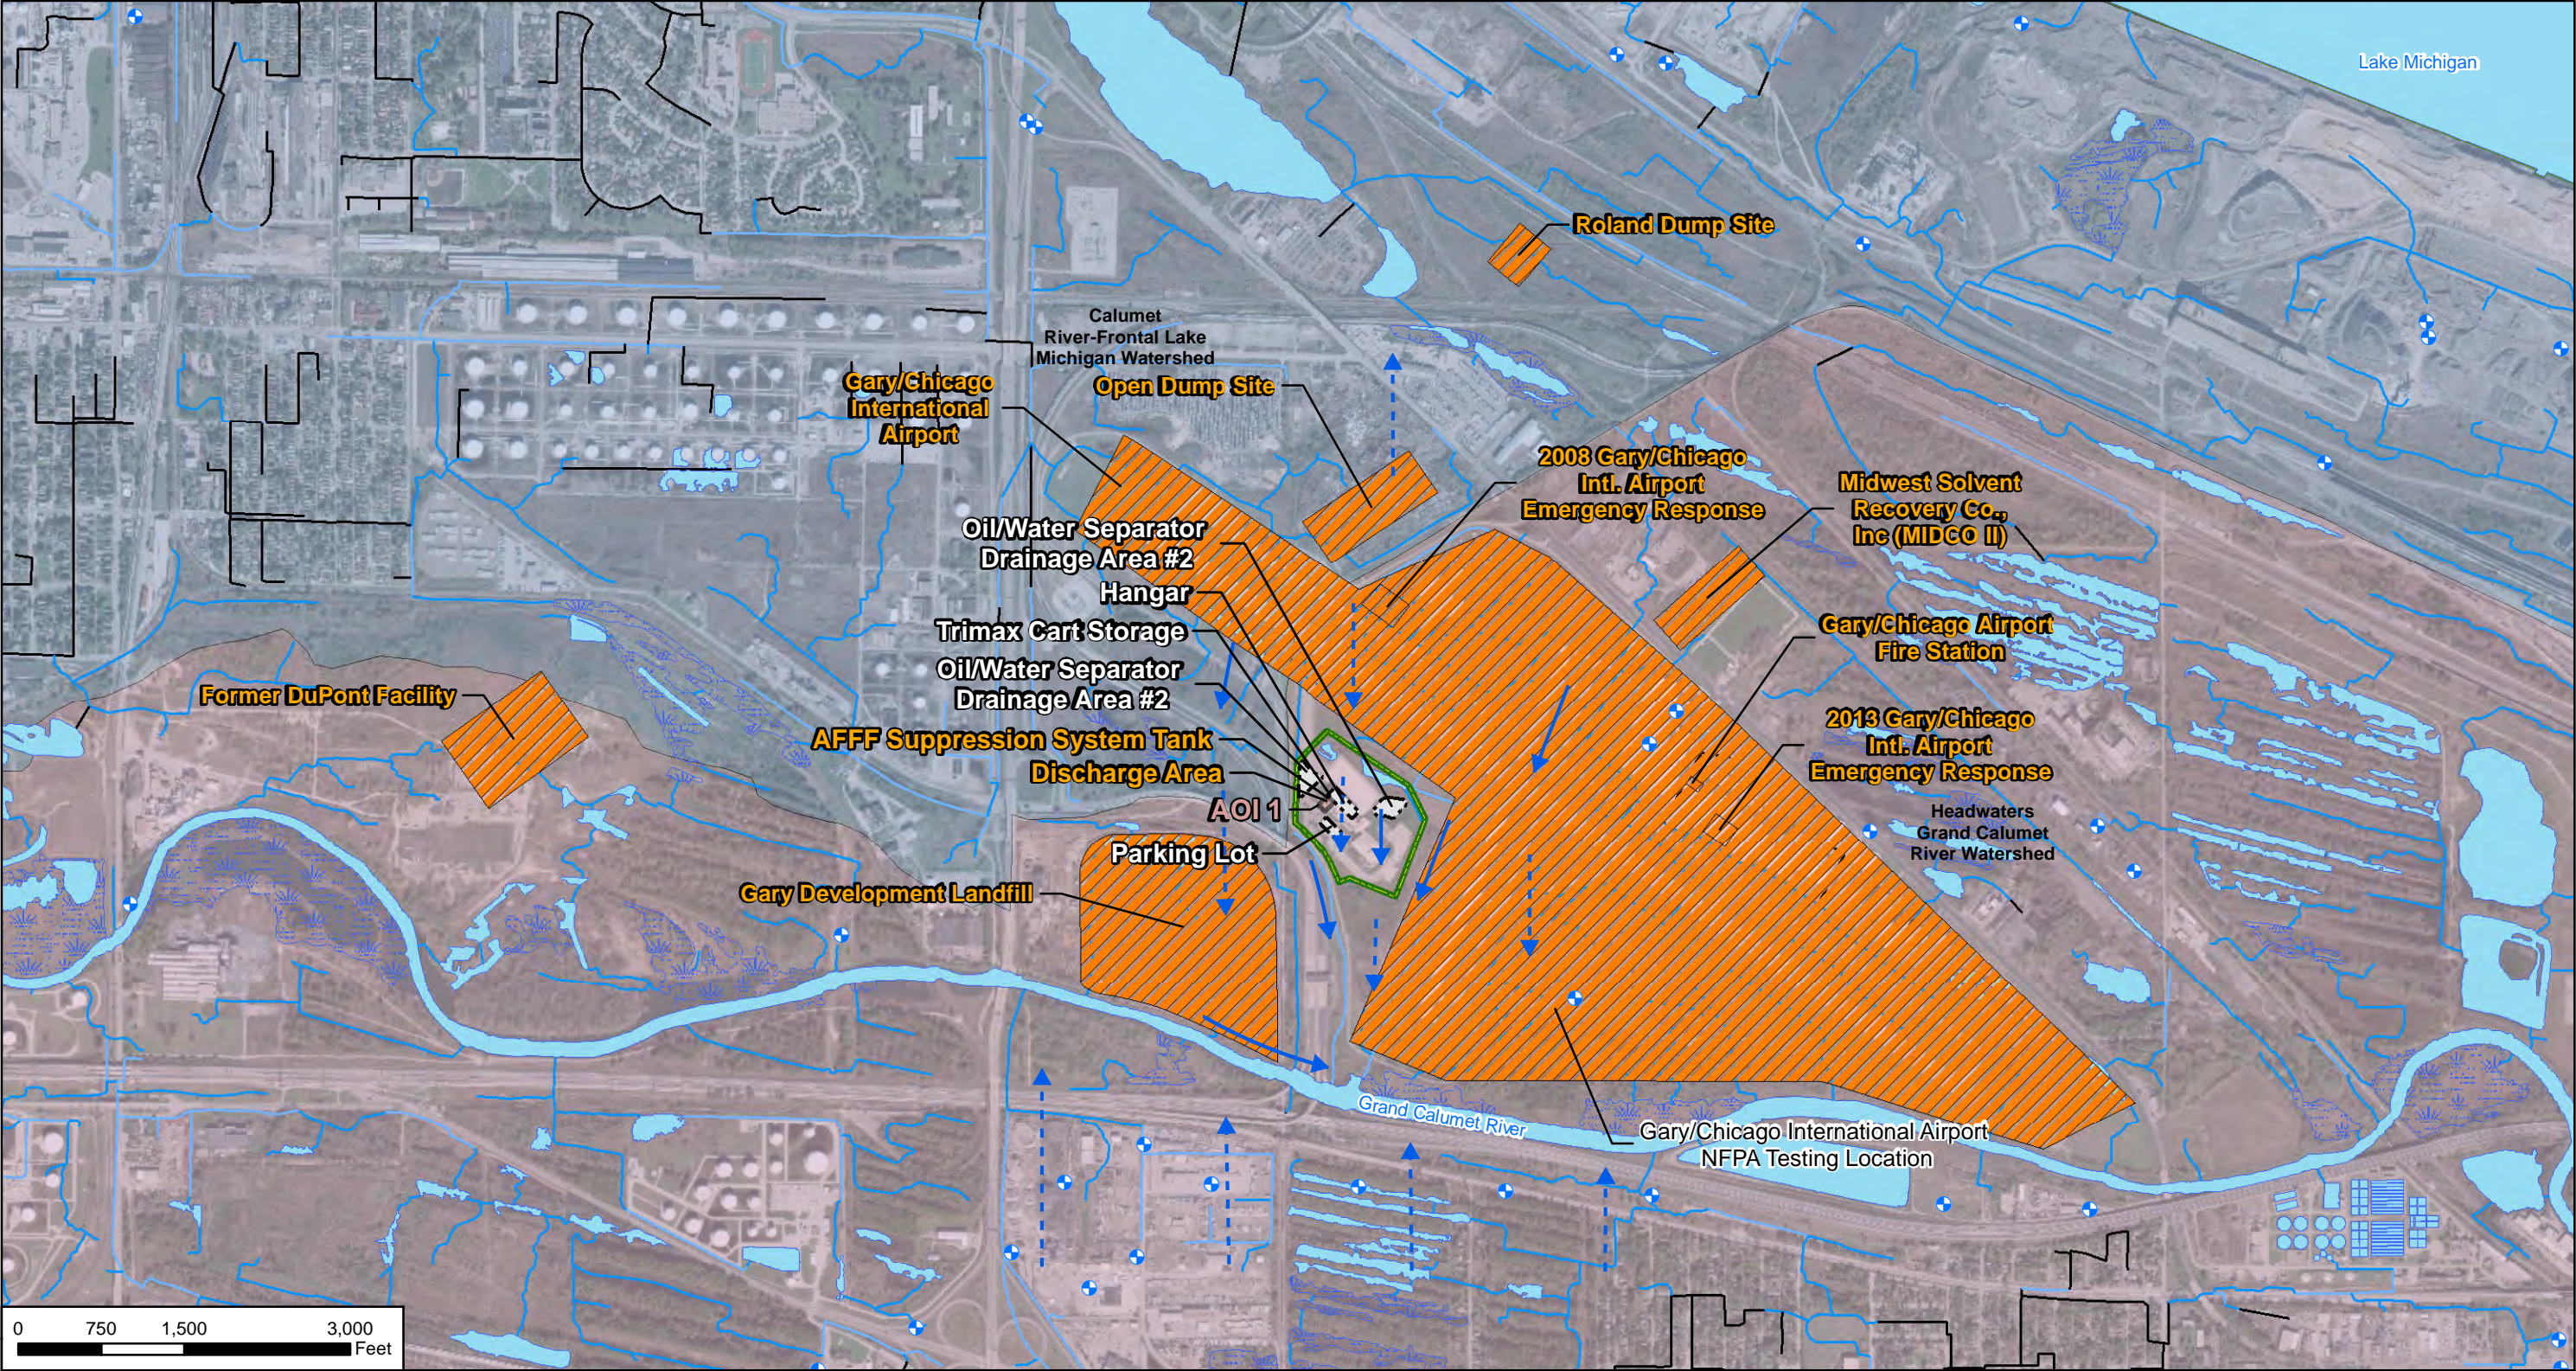
Figure 6-1

Based on the PA findings, one AOI was identified at the Gary AASF: AOI 1 – AFFF Suppression System Leak Area. The AOI location is shown on **Figure 6-1**. The following section describes the CSM components and the specific CSMs developed for each AOI. The CSM identifies the three components necessary for a potentially complete exposure pathway: (1) source, (2) pathway, (3) receptor. If any of these elements are missing, the pathway is considered incomplete.

AOI 1 is the location where a small quantity (precise amount is unknown) of dilute AFFF mixture leaked onto a concrete sidewalk outside of the boiler room in early February 2018. Due to a malfunction in the suppression system that supports the Rotary Aircraft Hangar, 3% AFFF concentrate leaked into the “cold storage lines” located in the Boiler Room. These lines contained water at the time, and the dilute AFFF mixture flowed from a discharge pipe, spilling onto the outside concrete. Interviewees estimated that the puddle volume was about 30 gallons that spread out across but remained confined to the concrete area. Remaining AFFF mixture within the “cold storage lines” and the puddle on the concrete was contained and cleaned up by a contractor. The waste was removed by the contractor and treated off-site with solidification at a treatment facility in Portage, Indiana.

The release of AFFF was reported by interviewees as a stationary puddle. Although this puddle was cleaned up and removed by a contractor, it is possible that AFFF incidentally migrated across the concrete and into the surrounding grassy areas prior to clean up or infiltrated to the soil beneath the concrete through pores, cracks, and seams. According to the engineering as-built drawings of the AASF, there are no storm drains servicing that portion of the facility. Drainages have been diverted around the current AASF that ultimately drain to the Grand Calumet River. Drinking water at the AASF is supplied by Indiana-American Water. No domestic wells are located downgradient of AOI 1. Groundwater under the facility, which flows toward the Grand Calumet River, is not anticipated to impact the groundwater south of the Grand Calumet River, since the hydraulic gradient south of the Grand Calumet River opposes the hydraulic gradient encompassing the facility.

| Area of Interest | AOI Location | Rationale | Potential Future Action |
|---|---|---|--|
| AOI 1 AFFF Suppression System Leak Area | 41°37'3.59"N and 87°25'17.90"W | Approximately 30 gallons of leaked AFFF mixture discharged, contained, and cleaned up in early February 2018. | Proceed to an SI, focus on soil, sediment, and surface water |

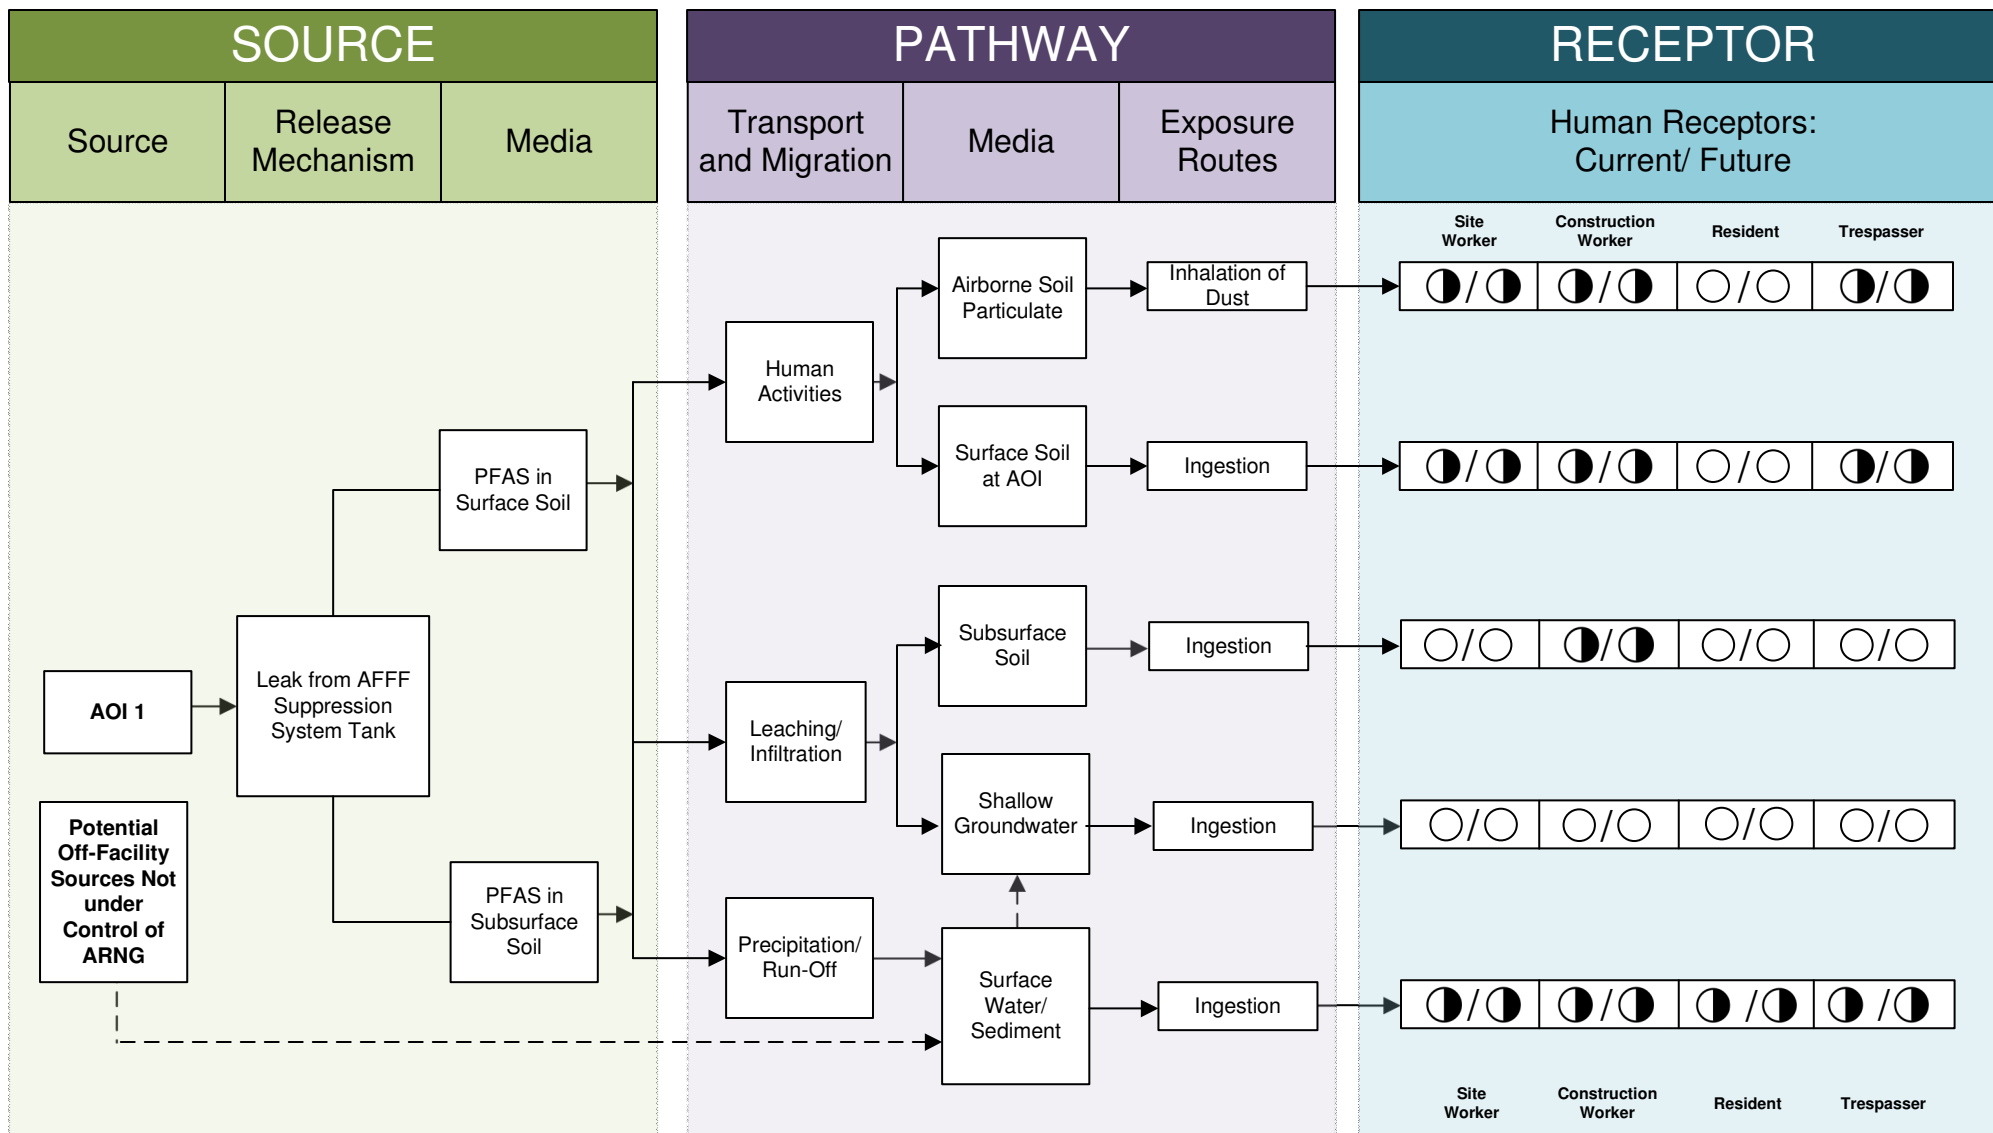
complete. Groundwater at the AASF flows predominantly to the south, towards the Grand Calumet River. Because drinking water at the Gary AASF is supplied by Indiana-American Water, and no domestic water supply wells are present downgradient of the AASF, the groundwater pathway is considered incomplete. The CSM for the Gary AASF is shown on **Figure 6-2**.

1. The resident receptor refers to an off-site resident.
2. Dermal contact exposure pathway is incomplete for PFAS.
