Final Preliminary Assessment Report Bangor Training Site Bangor, Maine

Perfluorooctane-Sulfonic Acid (PFOS) and Perfluorooctanoic Acid
(PFOA) Impacted Sites
ARNG Installations, Nationwide

January 2020

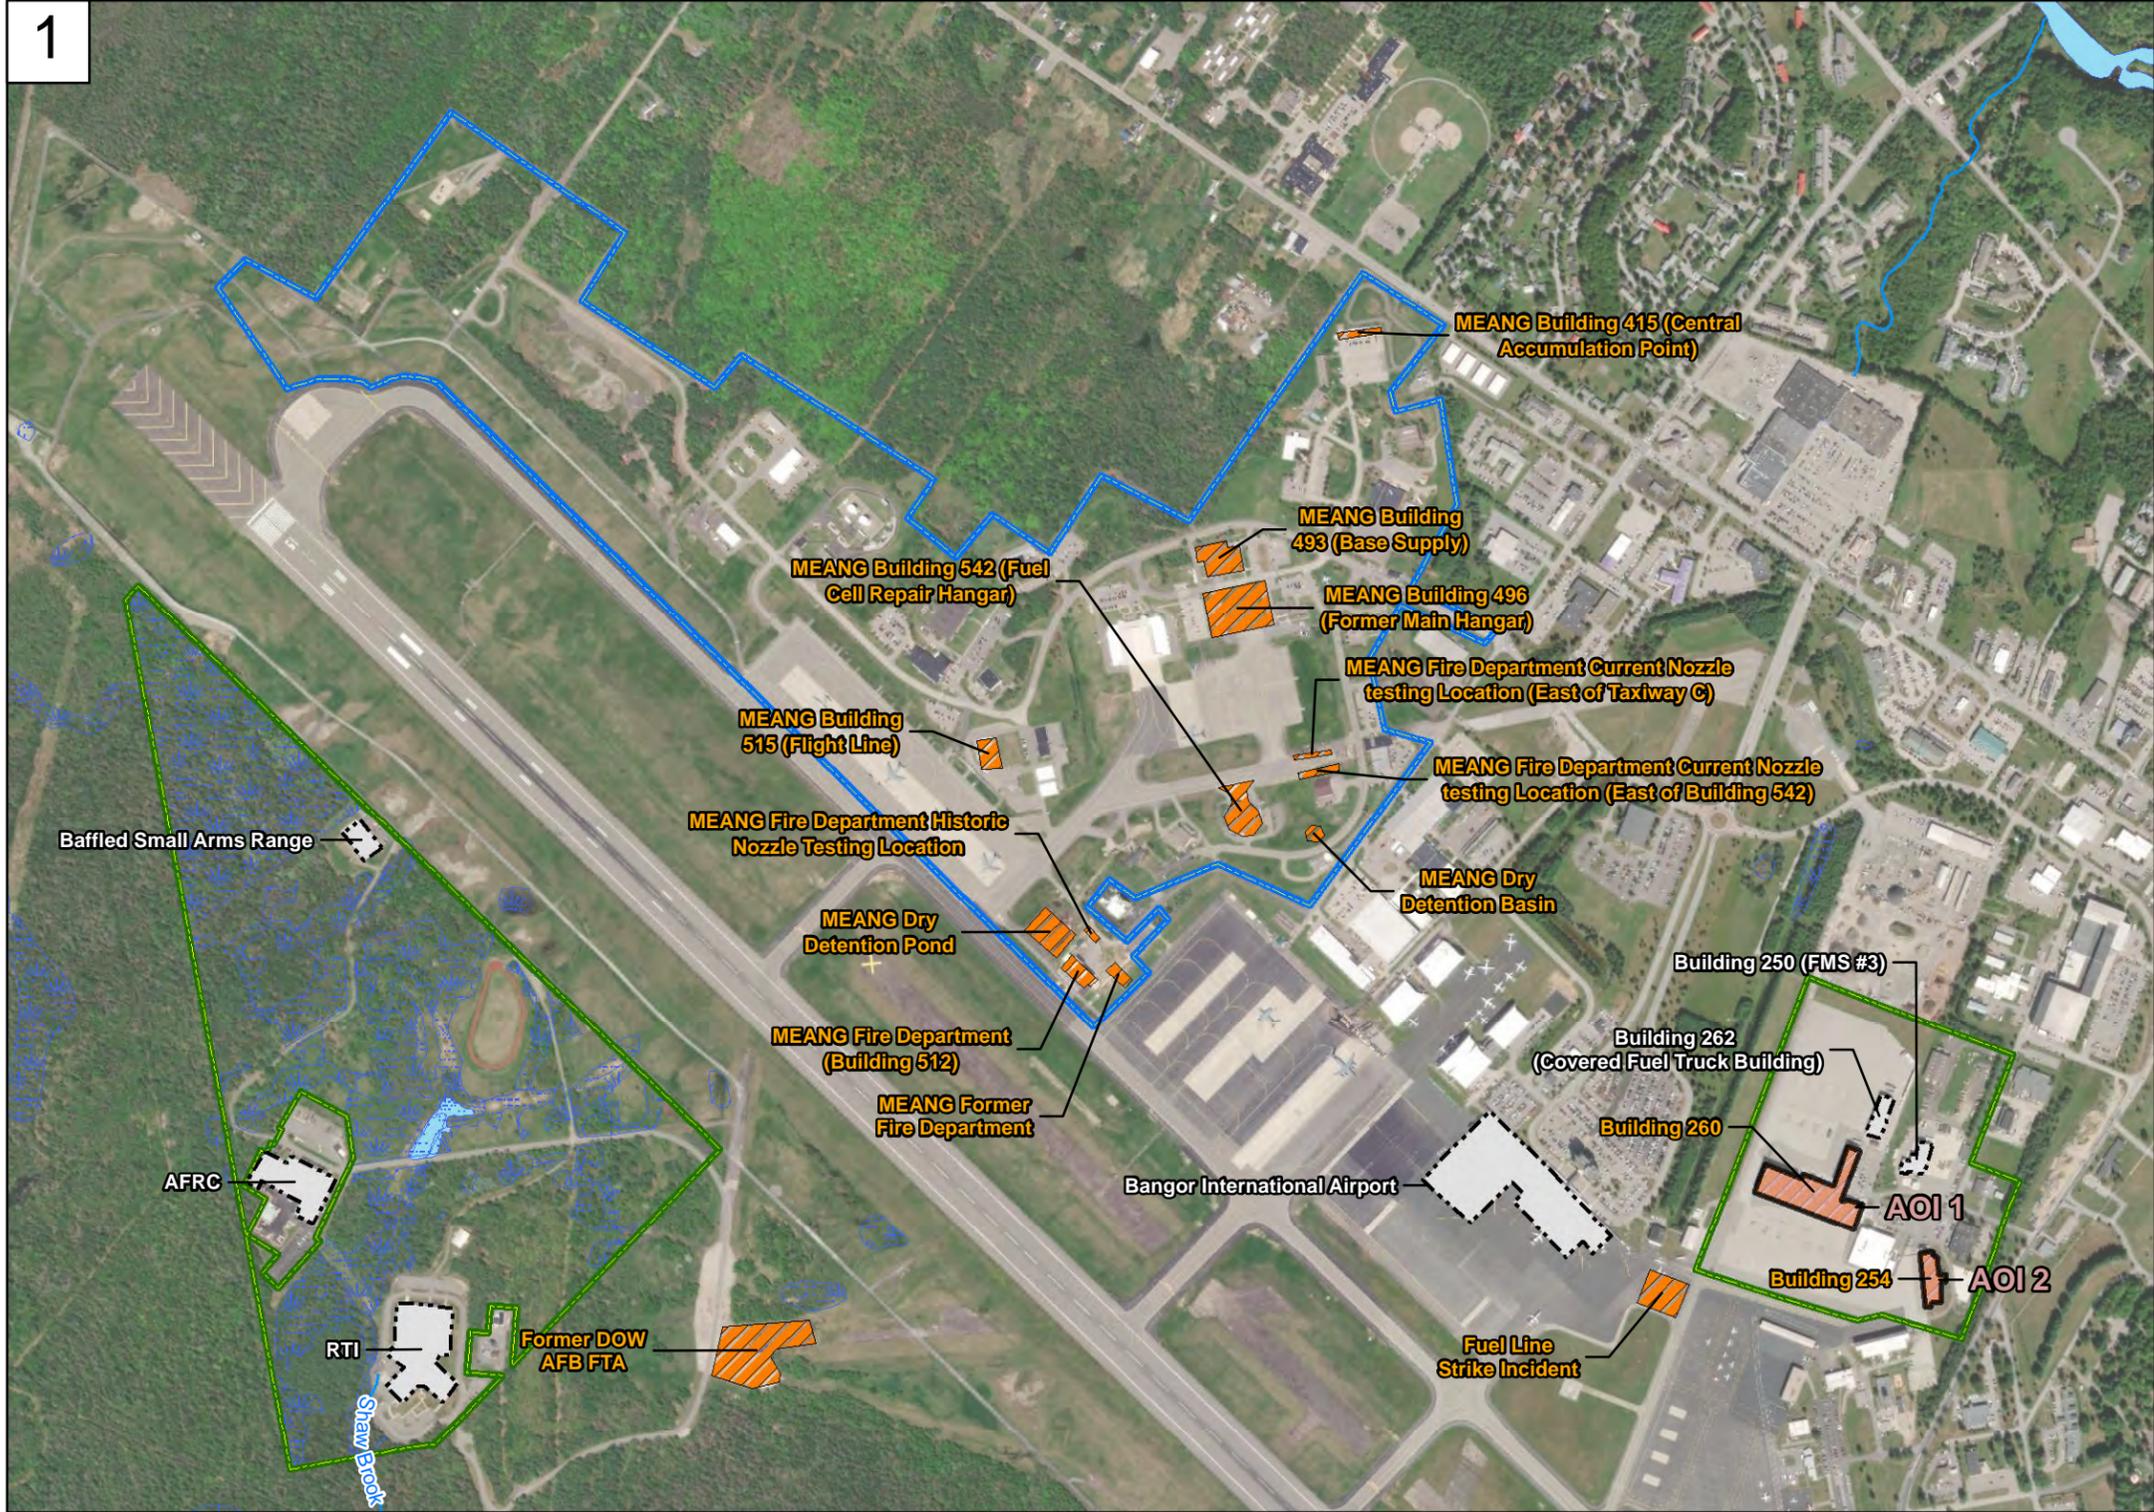
Figure ES-1

Several adjacent sources of PFAS release to the environment were identified in the area surrounding MEARNG Bangor Training Site through interviews or review of previous environmental investigations. The preliminary conceptual site model (CSM) for the MEARNG Bangor Training Site is shown on **Figure ES-2**.

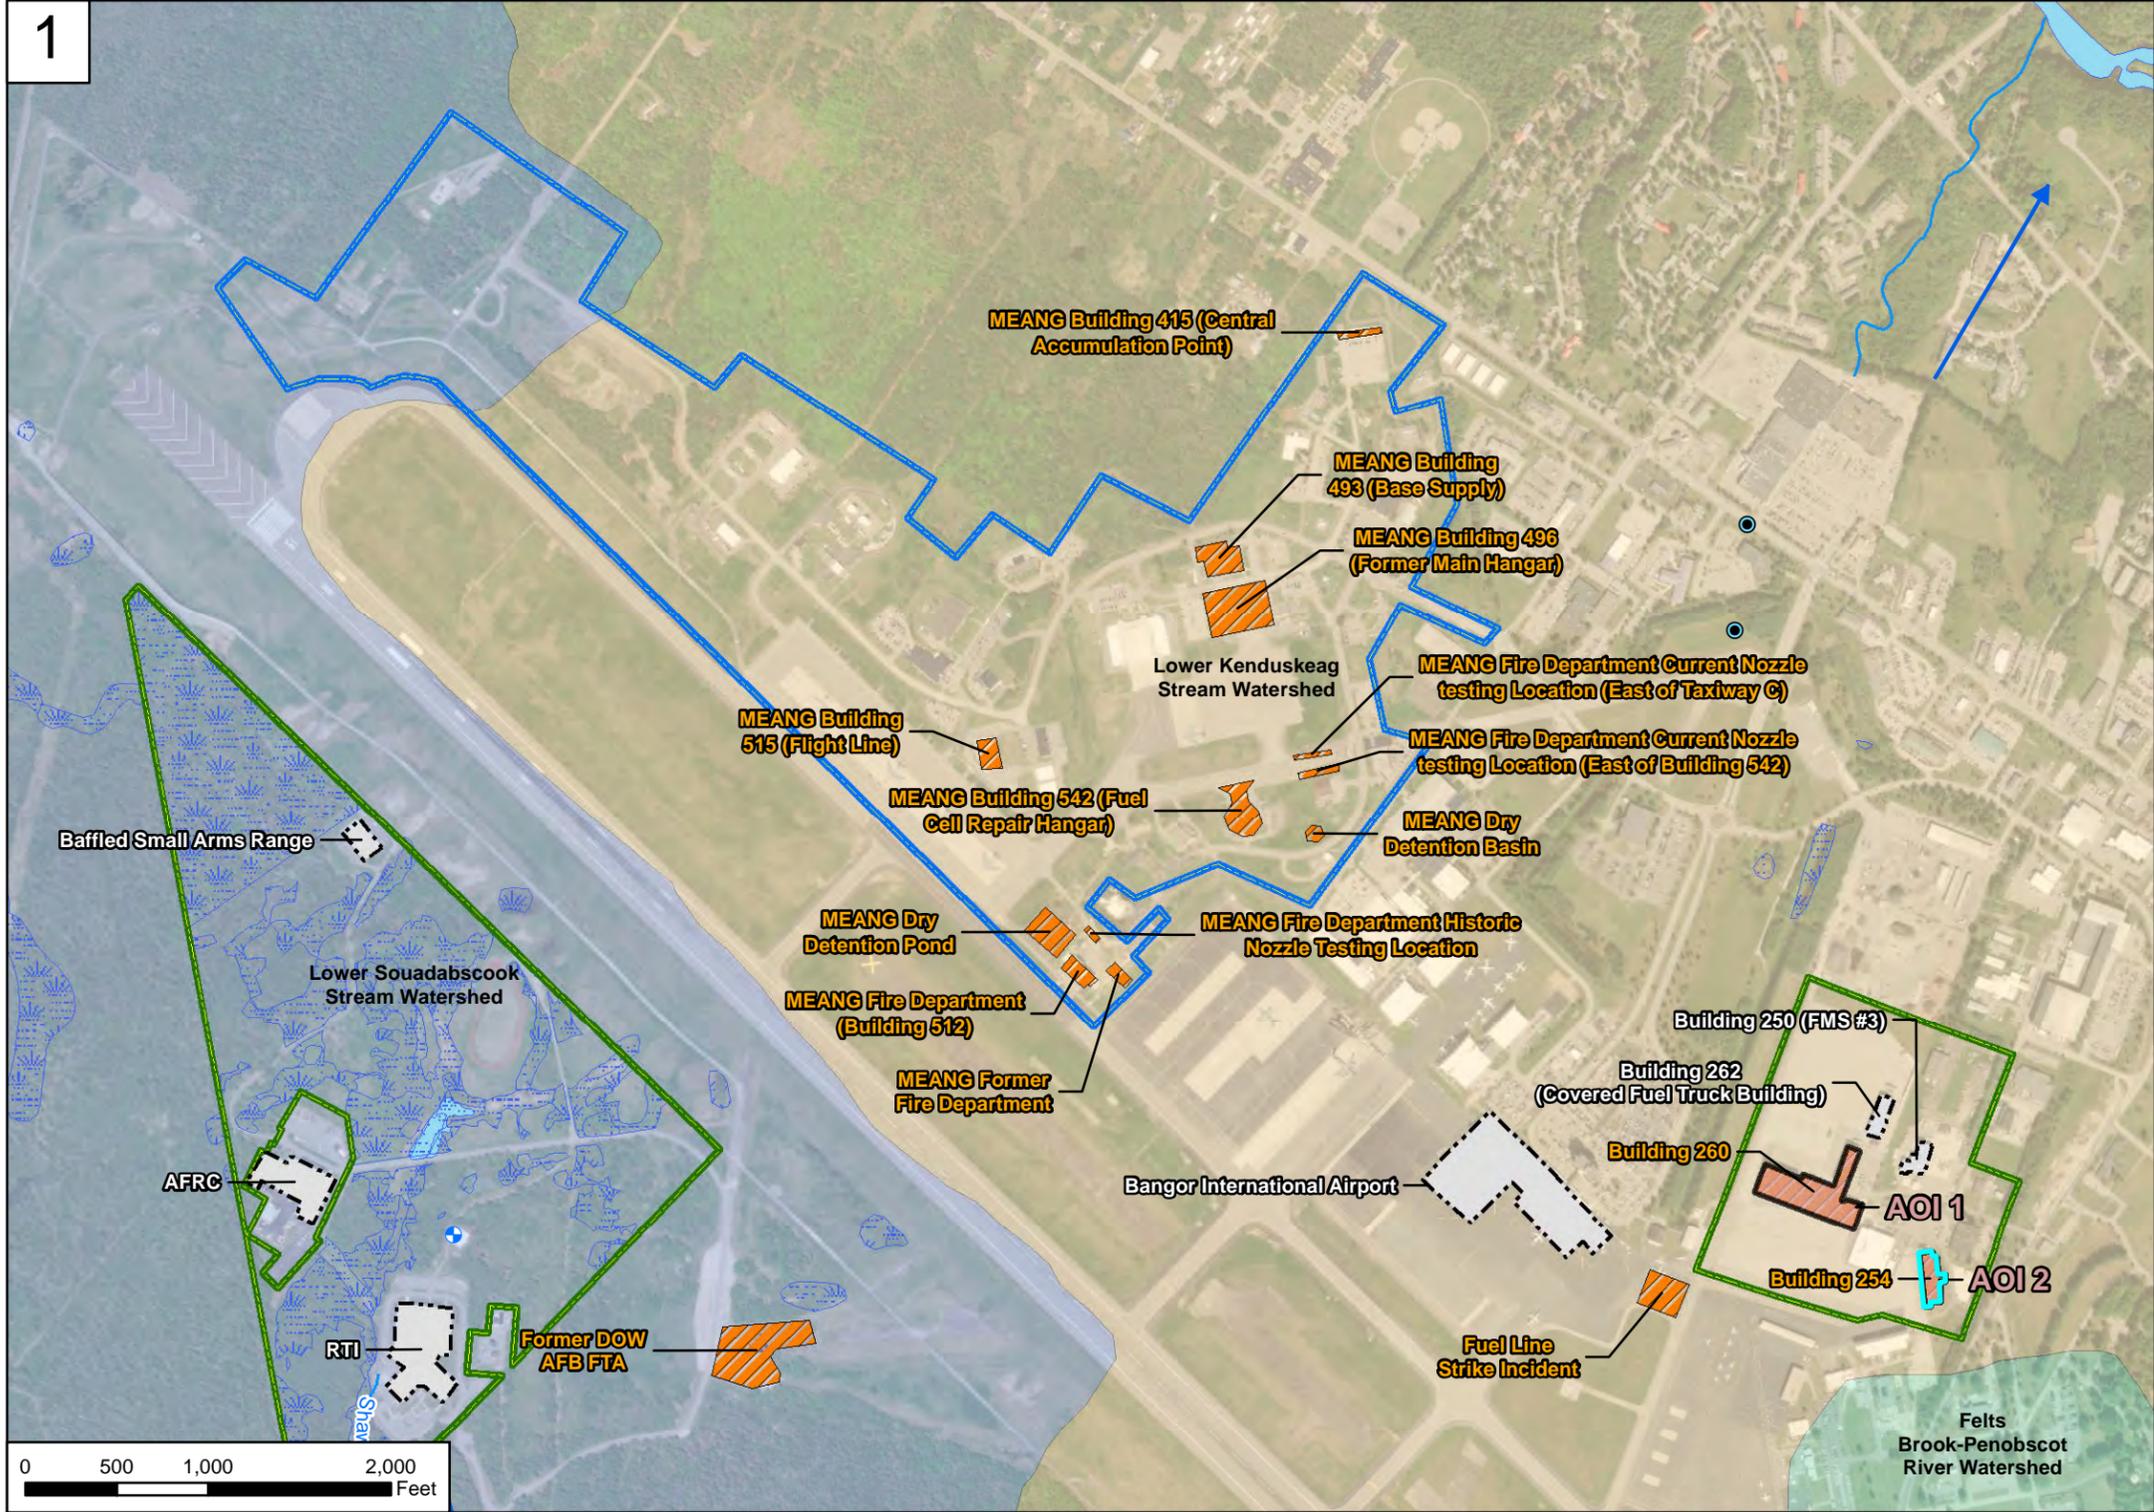
Figure 6-1

Based on the PA findings, two potential PFAS release areas were identified within the MEARNG facility: AOI 1 - Building 260 (AASF) and AOI 2 - Building 254 (Cold Storage Hangar). The AOI locations are shown on **Figure 6-1**. The following sections describe the CSM components and the specific CSM developed for the AOIs. The CSM identifies the three components necessary for a potentially complete exposure pathway: (1) source, (2) pathway, (3) receptor. If any of these elements are missing, the pathway is considered incomplete.

Area of Interest	AOI Location	Rationale	Potential Future Action
AOI 1 Building 260 (AASF)	44°48'28.84"N; 68°48'39.94"W	Multiple AFFF releases from fire suppression system to floor drains and sumps	Proceed to an SI, focus on soil, surface water, sediment, and groundwater
AOI 2 Building 254 (Cold Storage Hangar)	44°48'24.60"N; 68°48'31.46"W	Potential PFAS release during fire suppression system release	Proceed to an SI, focus on soil, surface water, sediment, and groundwater

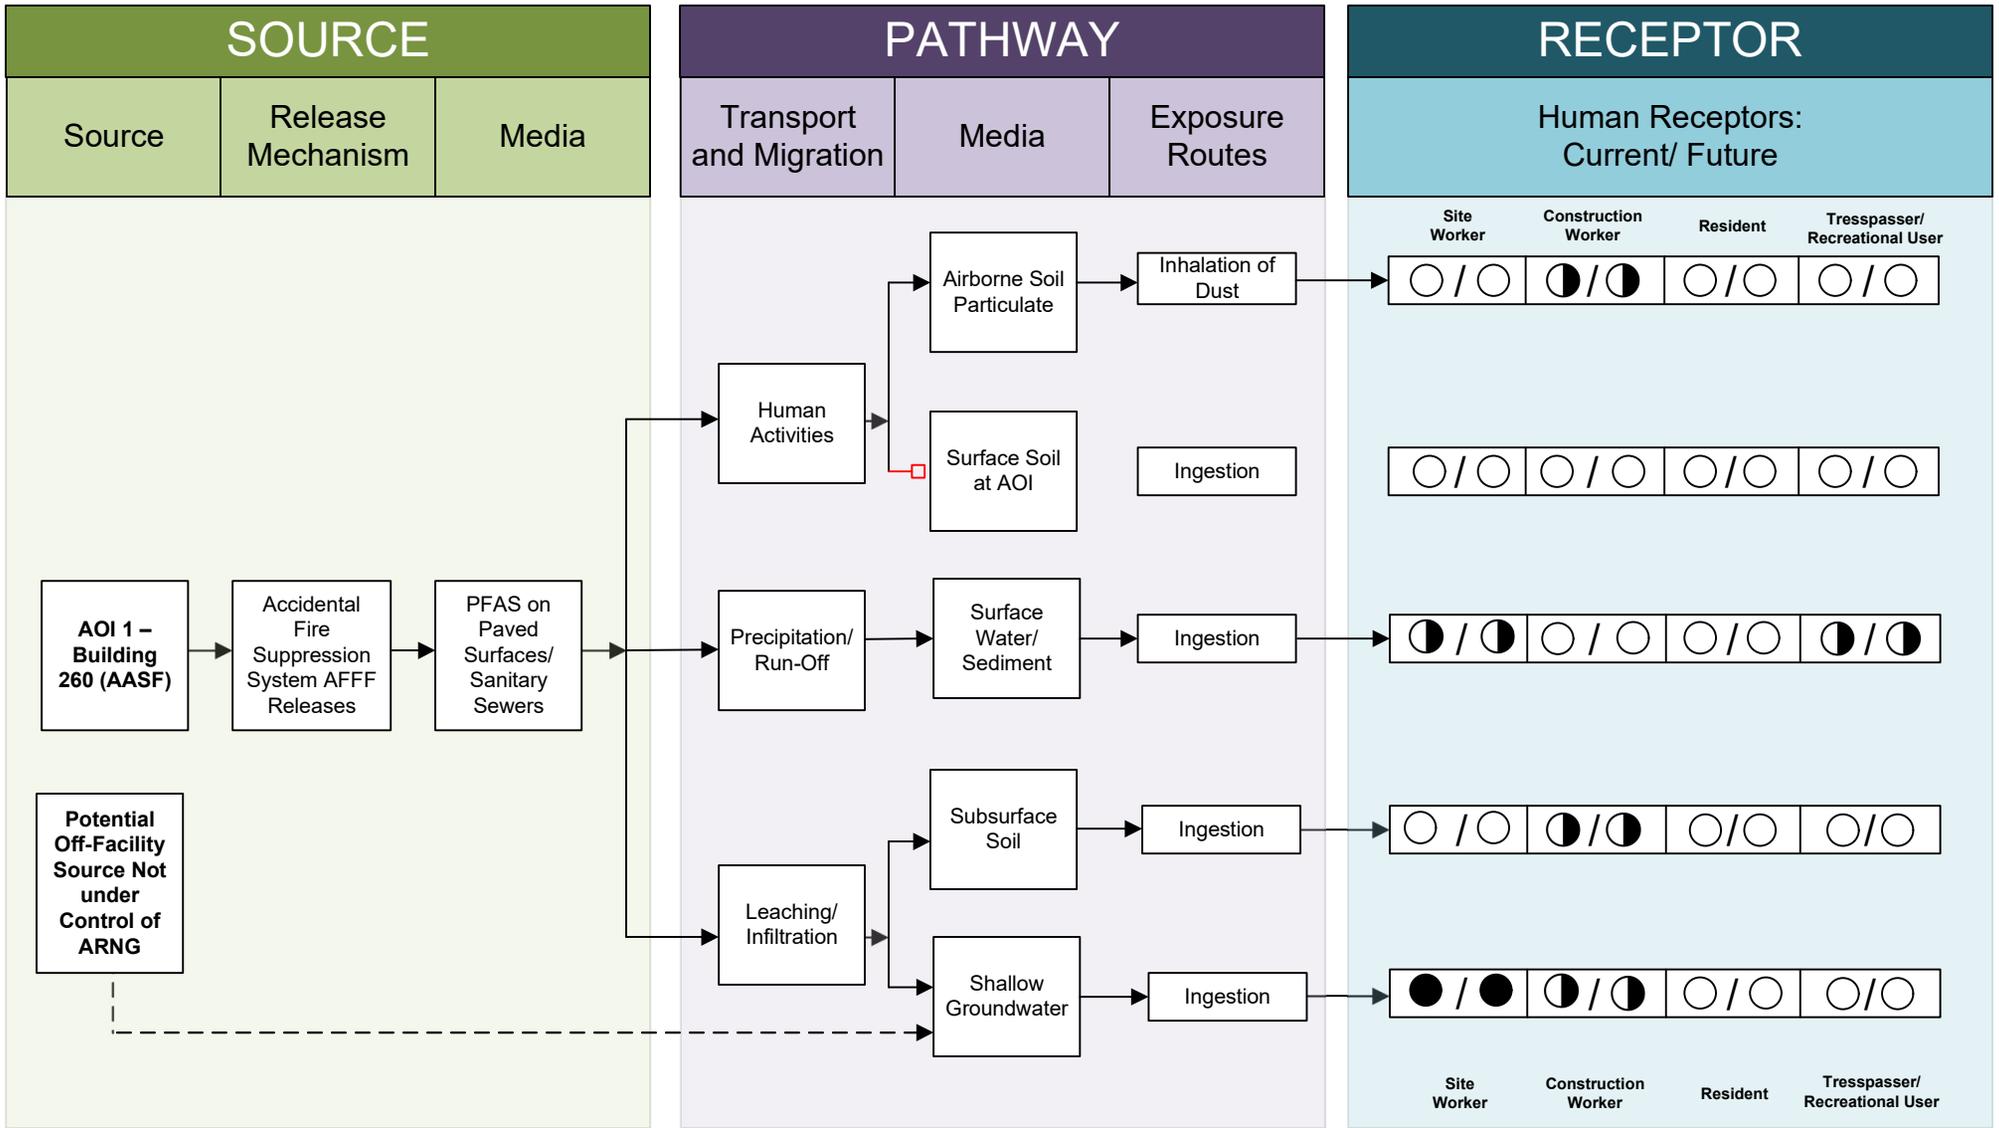
Figure 6-2
Preliminary Conceptual Site Model
Building 260 (AASF)

AOI 1 is the Building 260 (AASF) complex. This complex includes the hangars and flight operations office space within the complex. AFFF releases at the AOI include a 2003 fire suppression system AFFF release contained to building pipes that have since been replaced, a 2011 fire suppression system AFFF release to the fire suppression pump room and city sanitary sewer lines, and a 2016 fire suppression system AFFF release to the fire suppression pump room, ramp area outside the pump room, and runoff sump.

The majority of stormwater runoff at AOI 1 is collected in catch basins and a storm drain southwest of the AASF, which discharges to the Domestic Channel/Birch Stream. If any AFFF was not contained during the known releases, it is possible that PFAS migrated to into surface waters of the Domestic Channel/Birch Stream, and eventually the Kenduskeag Stream. As such, the pathway for PFAS exposure to site workers and trespassers/recreational users via ingestion of surface water is considered potentially complete. The preliminary CSM for AOI 1 is shown on **Figure 6-2**.

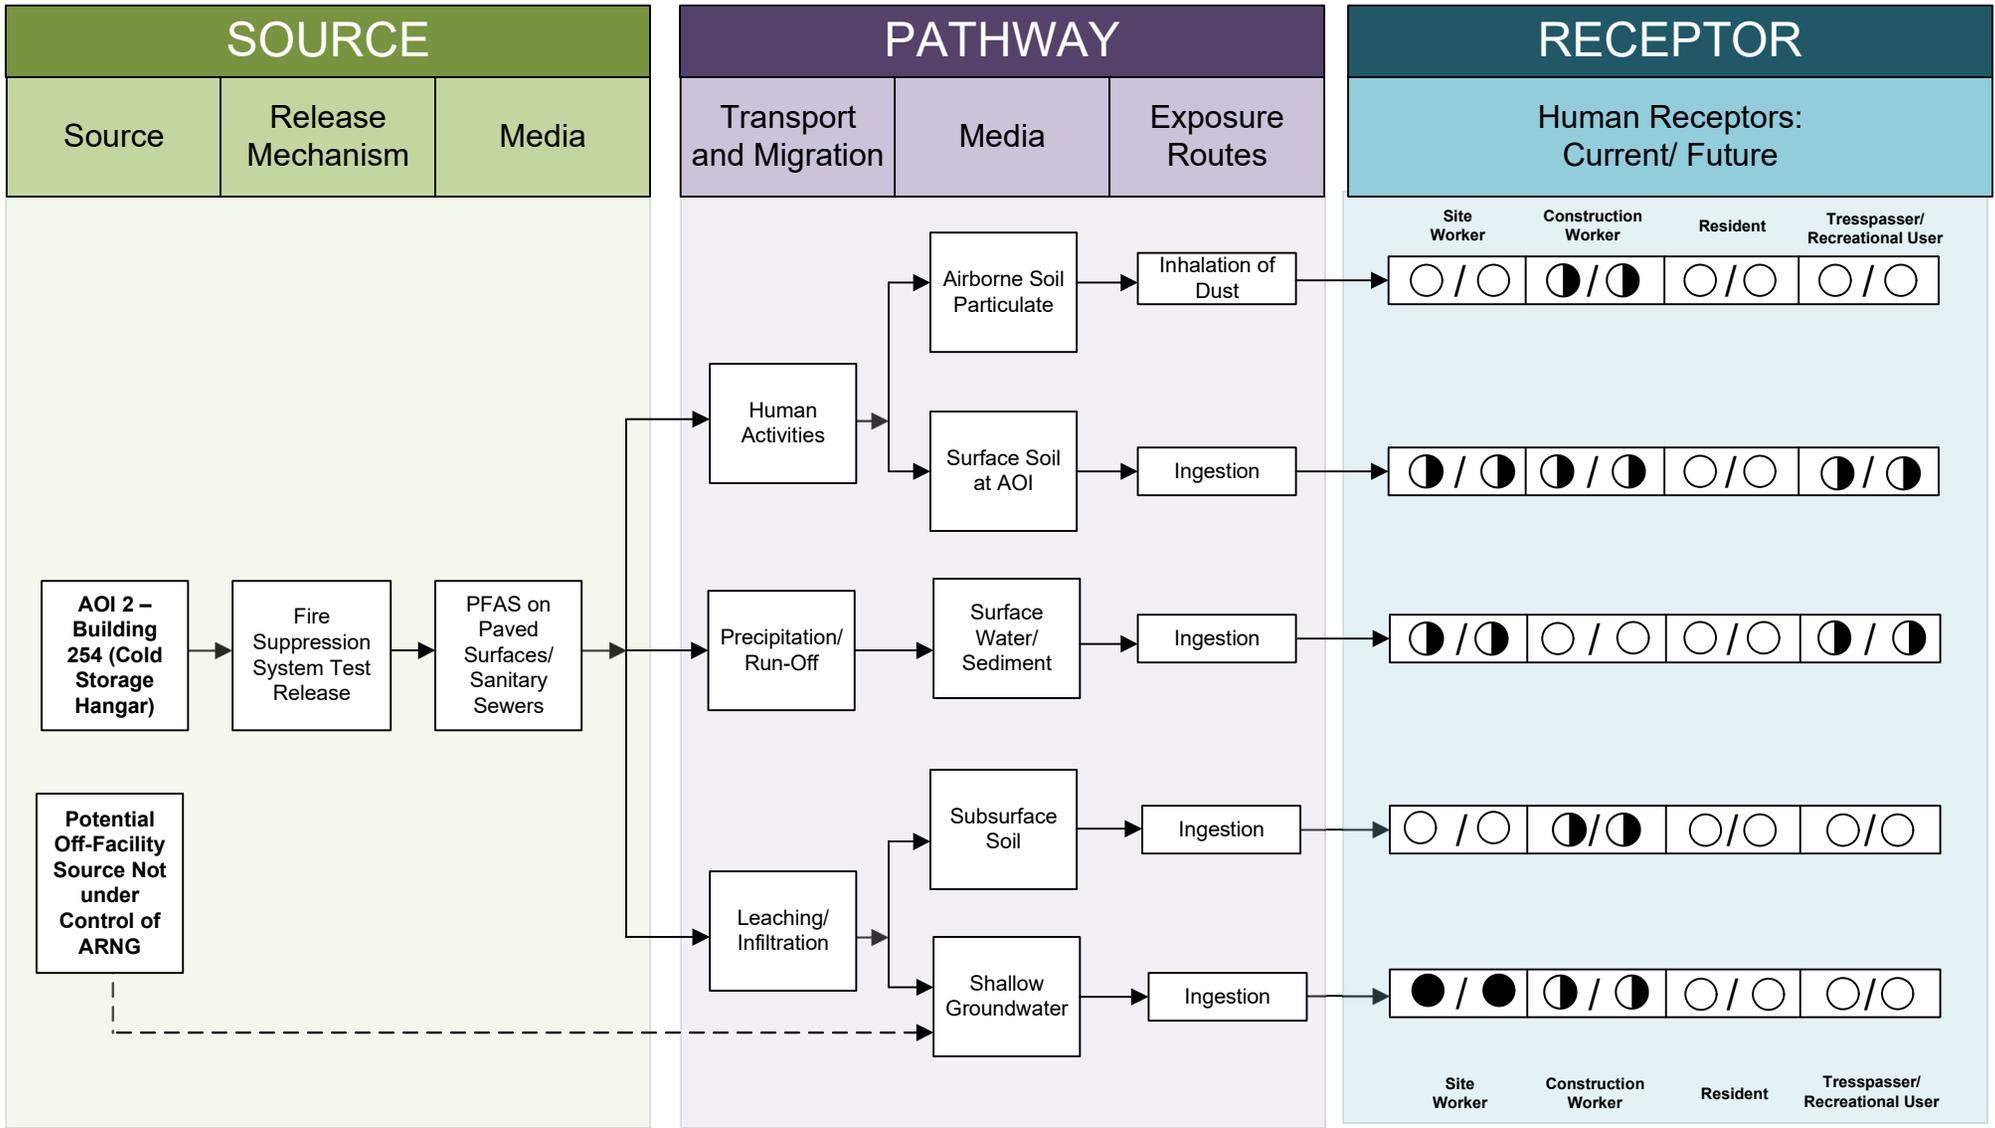
If PFAS escaped the hangar during cleanup, it is possible that is migrated via surface water runoff to catch basins south and west of the building that discharge to the Domestic Channel/Birch Stream. Surface water is considered a potentially complete pathway for site workers and trespassers/recreational users.

If Ansul Jet-X 2% High Expansion Foam Concentrate escaped via floor drains, it may have migrated to sanitary sewer drains. The facility sanitary sewer system feeds into the city of Bangor sanitary sewer system which conveys waste water to the city of Bangor WWTP. The treated water is then released into the Penobscot River. As such, the pathway for PFAS exposure to off-facility recreational users via ingestion of surface water is considered potentially complete. The preliminary CSM for AOI 2 is shown on **Figure 6-3**.
