FINAL Preliminary Assessment Report AASF 1 Green Township, Summit County, Ohio

Perfluorooctanesulfonic Acid (PFOS) and Perfluorooctanoic
Acid (PFOA) Impacted Sites
ARNG Installations, Nationwide

June 2020

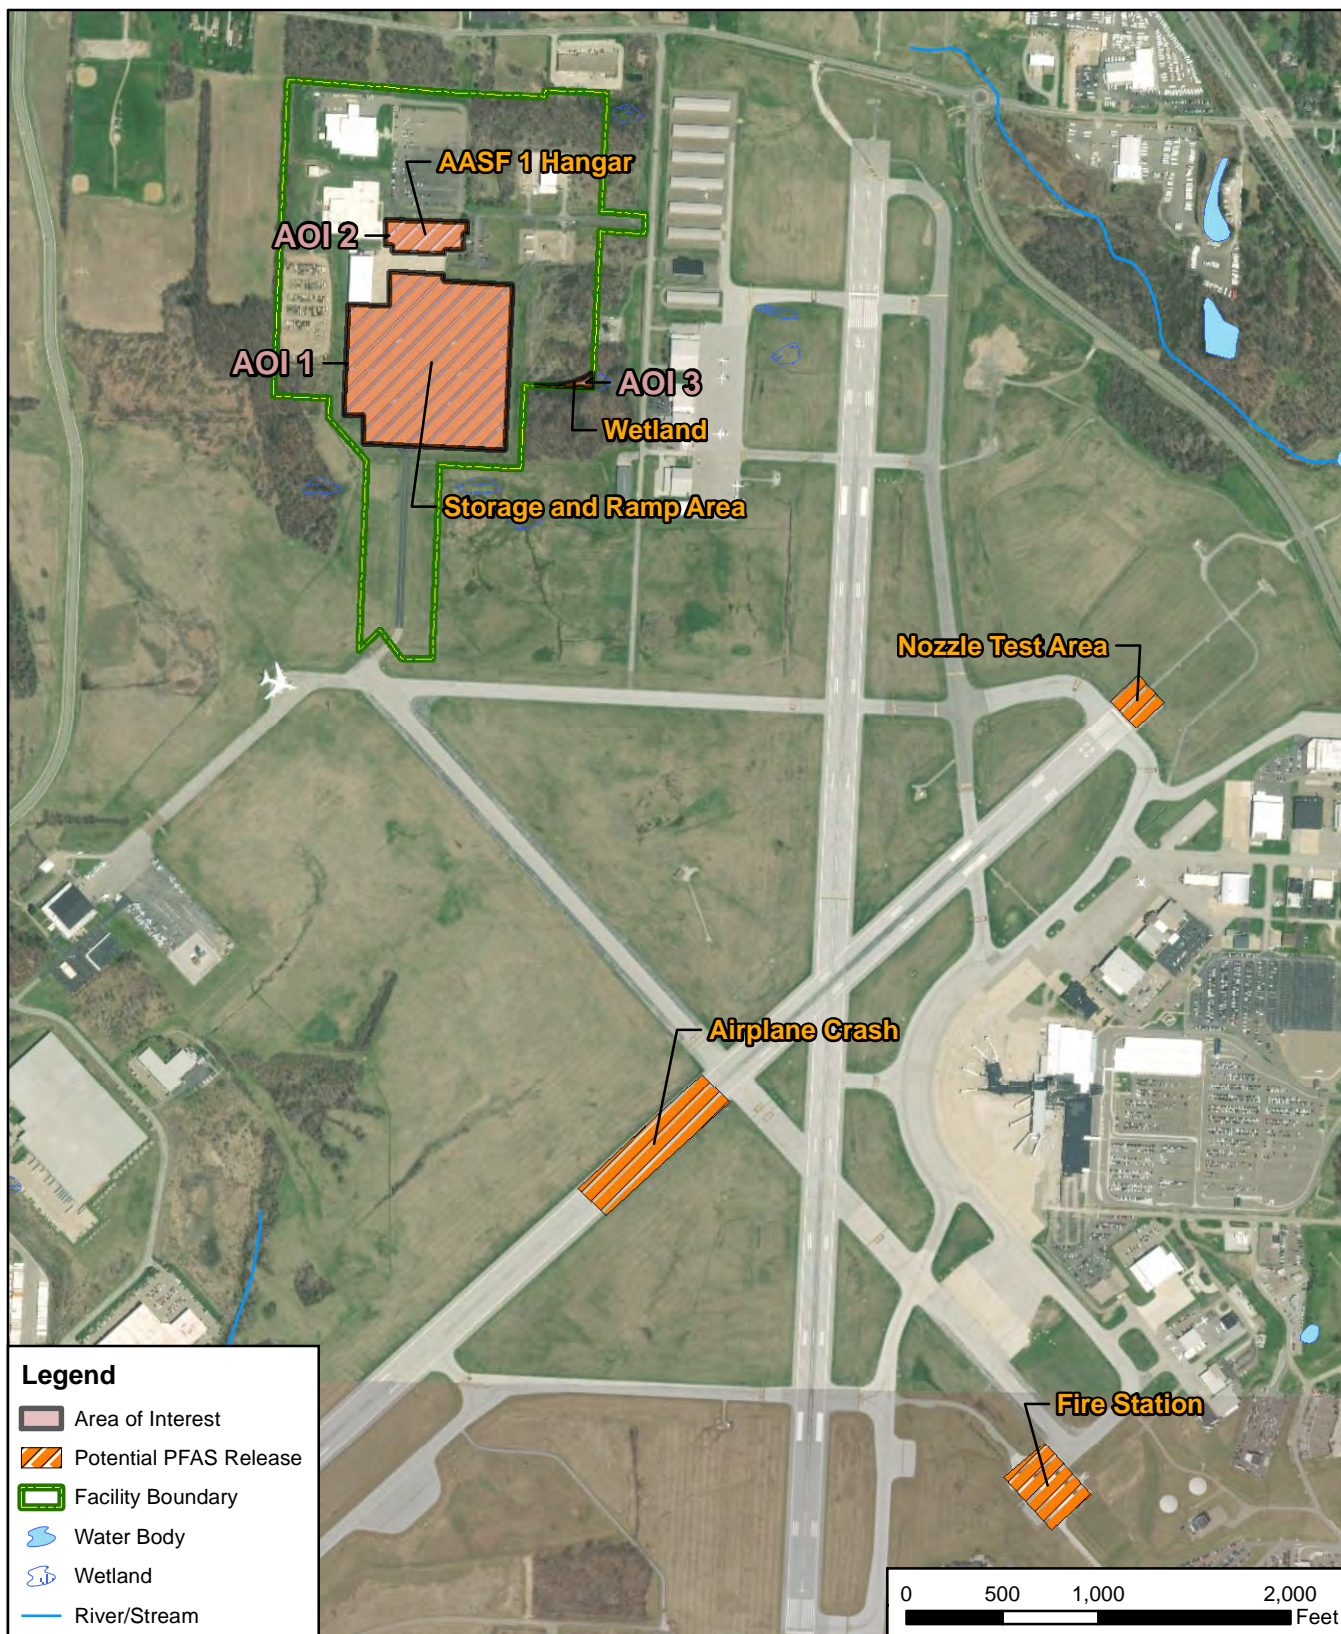
- Reviewed data resources to obtain information relevant to suspected PFAS releases
- Conducted a site visit on 24 July 2018
- Interviewed current OHARNG personnel during the site visit, including safety and aviation maintenance officer and hazardous waste manager, as well as the operations manager from the adjacent Akron-Canton Regional Airport
- Completed visual site inspection at known or suspected PFAS use, storage, or release locations and documented with photographs;
- Developed a preliminary conceptual site model (CSM) to outline the potential release and pathway of PFAS for the Area(s) of Interest (AOIs) and the facility (**Figure ES-1**)

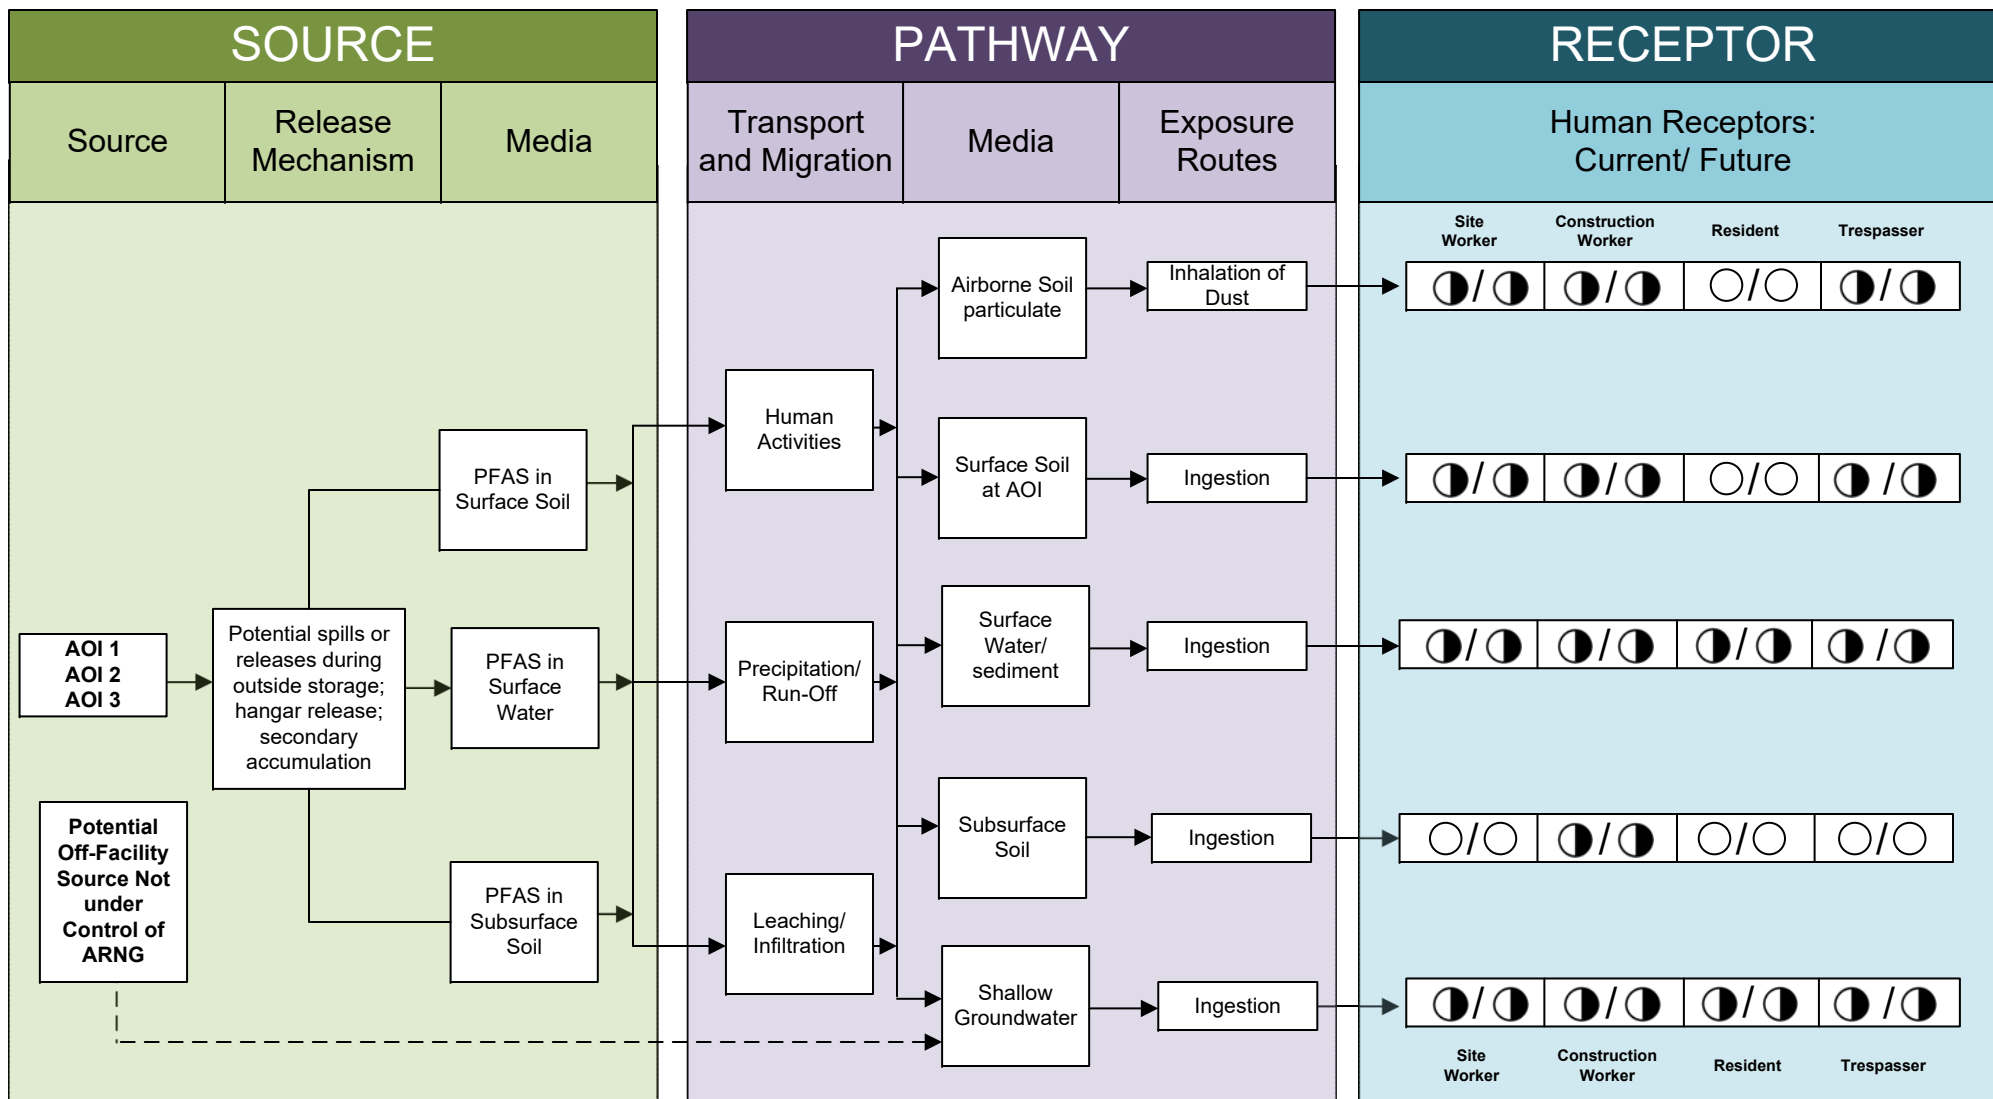
Known and potential AFFF releases to surface soil and surface water throughout the facility have the potential to migrate to the on-site wetland, on the southeast edge of AASF 1. Based on surface water flow patterns and the potential for surface drainage and runoff to flow into AOI 3, AFFF-releases to surface soil and surface water have the potential to result in PFAS exposure to site and construction workers via inhalation and ingestion of surface soil, subsurface soil, and sediment, or potential exposure to PFAS in groundwater and surface water via ingestion to site workers, construction workers, trespassers, and resident receptors at AOI 3.

A summary CSM for all identified AOIs within the AASF 1 are shown on **Figure ES-2**.

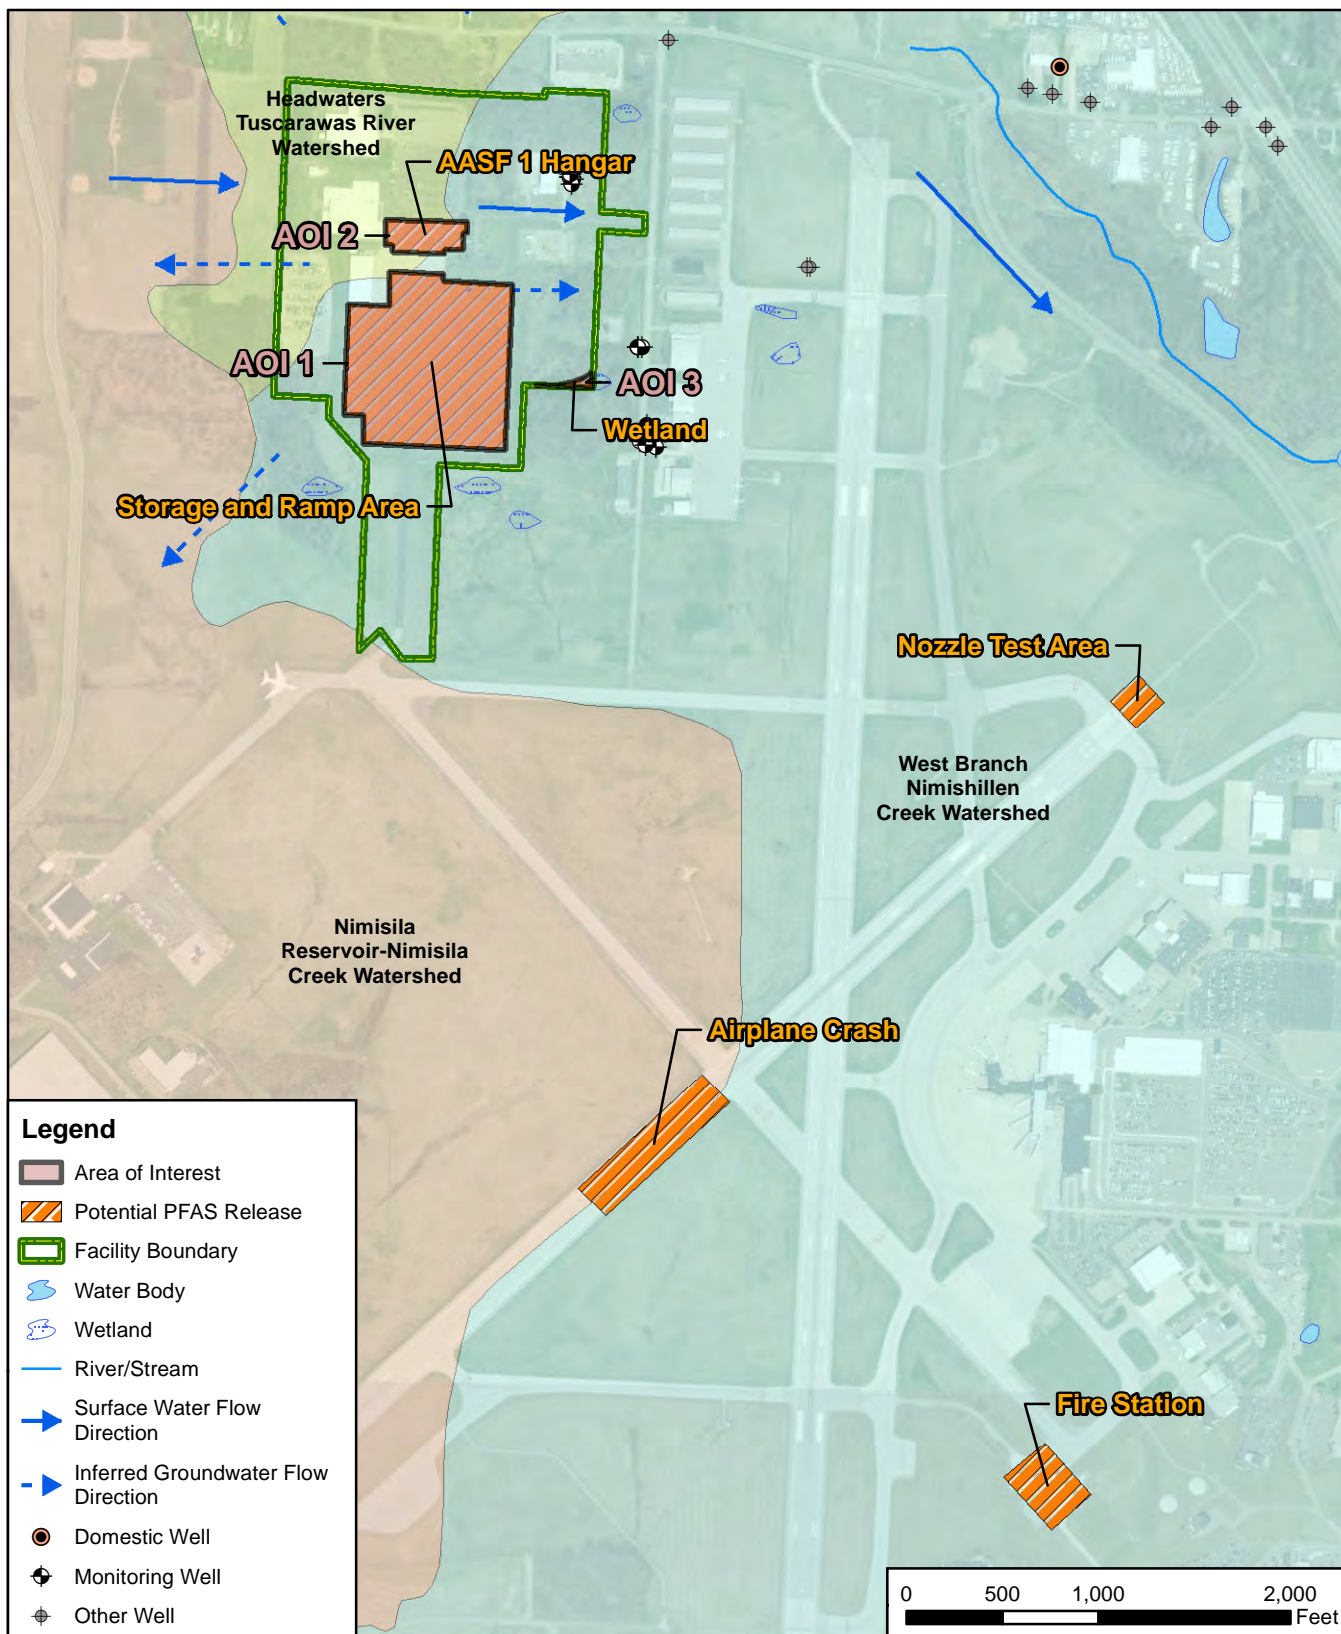
12420 Milestone Center Drive Germantown, MD 20876	Figure 6-1	
REVISED	7/30/2019	GIS BY	MS	7/30/2019				
SCALE	1:12,000	CHK BY	TK	7/30/2019				
Base Map: Source: Esri, DigitalGlobe, GeoEye, Earthstar Geographics, CNES/Airbus DS, USDA, USGS,		PM	RG	7/30/2019

Based on the PA findings, three AOIs were identified at the AASF 1: (1) AOI 1 Tri-Max™ Storage Area, (2) AOI 2 AASF 1 Building, and (3) AOI 3 Wetland. The AOI locations are shown on **Figure 6-1**. The following sections describe the CSM components and the specific CSMs developed for AOI 1 and 2. The CSM identifies the three components necessary for a potentially complete exposure pathway: (1) source, (2) pathway, (3) receptor. If any of these elements are missing, the pathway is considered incomplete.

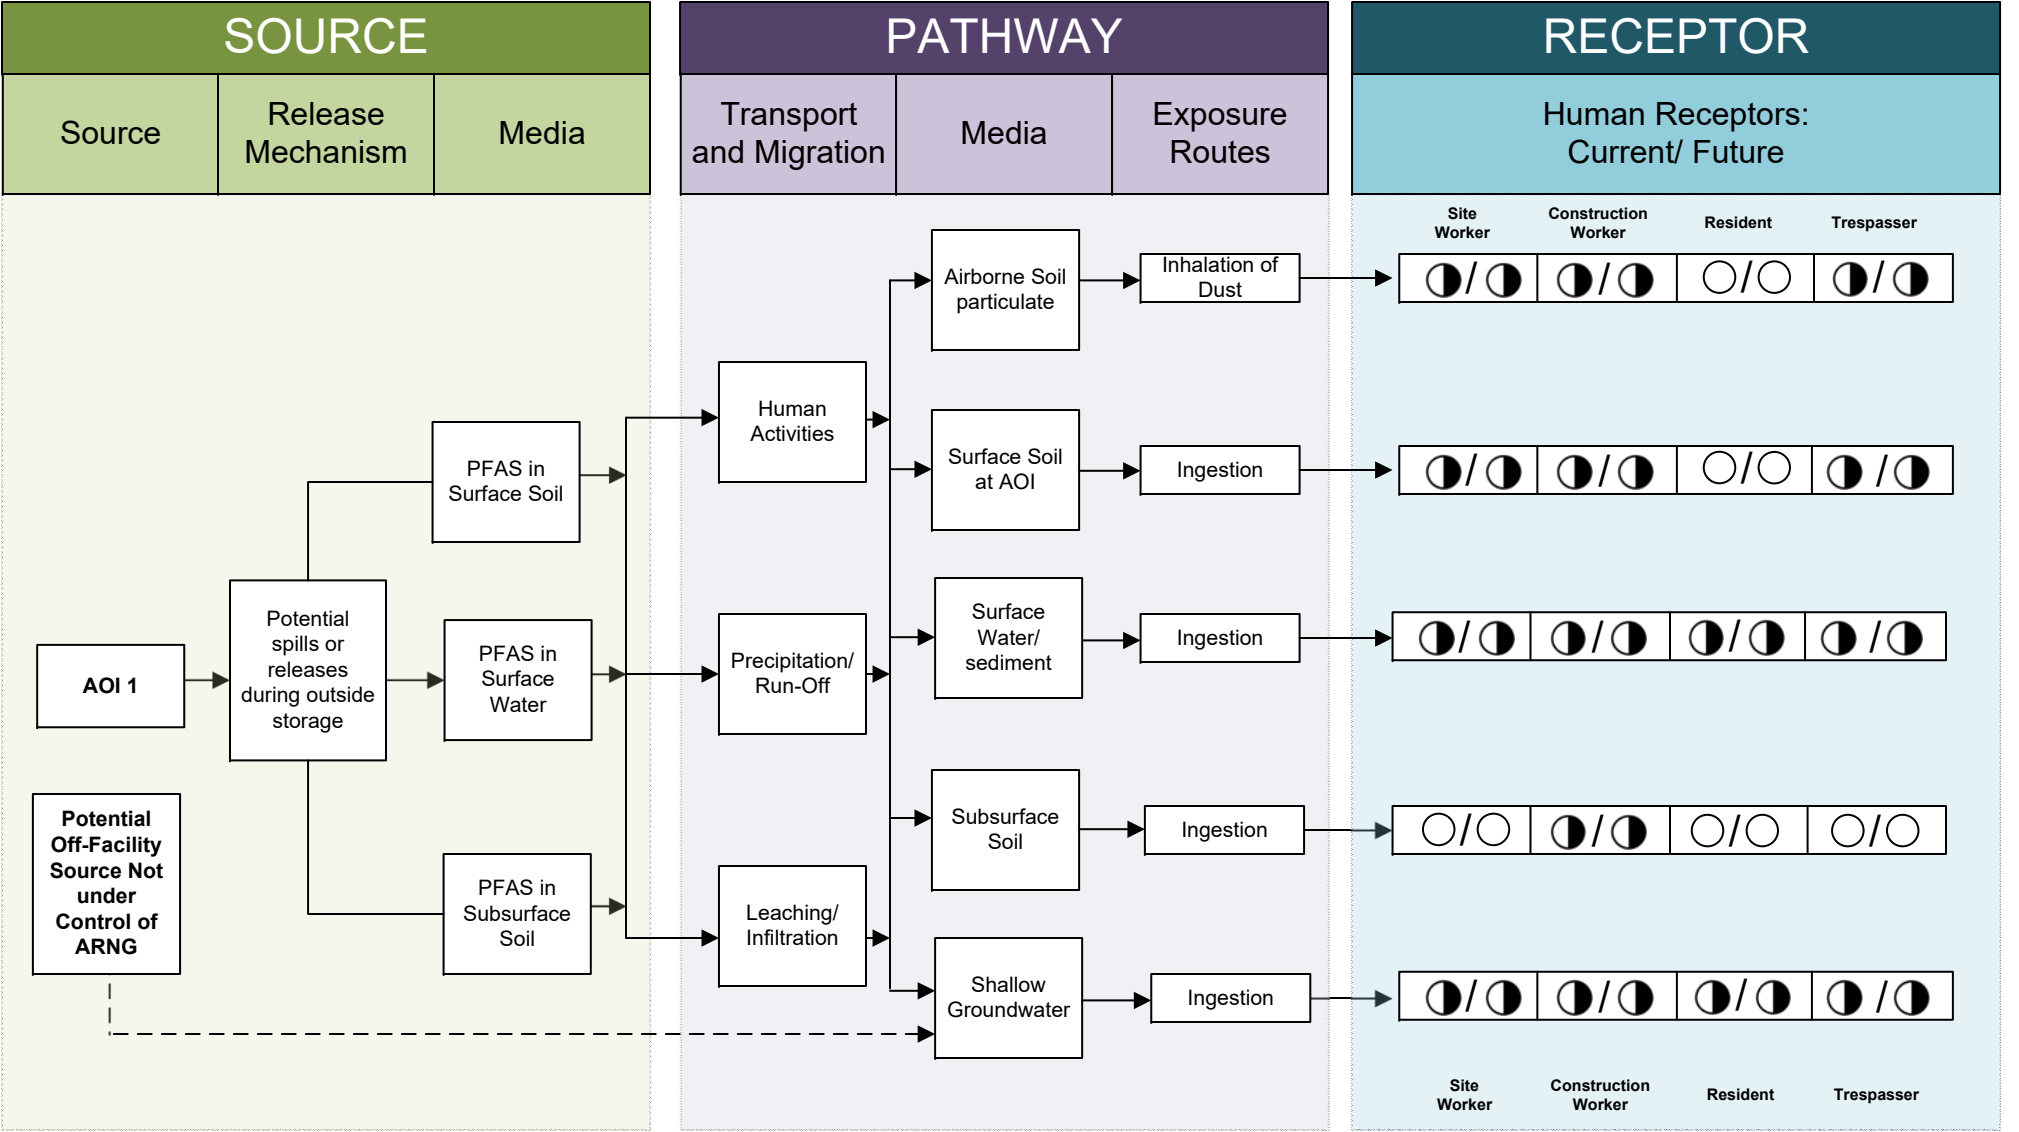
Figure 6-2
Preliminary Conceptual Site Model
AOI 1 Storage and Ramp Area
AASF1

The TriMax™ storage area is located on the edge of the paved asphalt parking ramp area, near grassy areas. The mobile fire extinguishers along the ramp area are all located in a paved area. Groundwater flow in these areas are generally to the west, towards the direction of private drinking water wells, while surface water flow is to the east. Drinking water within the facility is provided by a public water utility company; however, private drinking water wells are located within a half-mile of the facility (**Section 1.5.2**). The AASF 1 is surrounded by a public park, as well as residential, business, and industrial areas. Therefore, the ingestion exposure pathway for groundwater and surface water is considered potentially complete. The preliminary CSM for AOI 1 is shown on **Figure 6-2**.

Based on the exterior storage of AFFF-containing tanks at AOI 1, as well as documented presence and testing of the fire suppression system at AOI 2, there is potential for exposure to PFAS in groundwater and drinking water with potentially complete pathways to site workers, construction workers, trespassers, and resident receptors via ingestion. Receptors are less likely to be exposed to potential PFAS contamination through soil and air; however, some PFAS chemicals are water soluble and can migrate readily from soil to groundwater or surface water via leaching and run-off. Based on the outside, undocumented storage of TriMax™ tanks at AOI 1, there is potential for exposure to PFAS contamination in surface soils to site and construction workers, residents, and recreational users/trespassers, and in subsurface soils to site and construction workers via inhalation and ingestion. There is also the potential for exposure to PFAS contamination in surface water and sediment for all receptors via ingestion, and in shallow groundwater for all receptors due to the close proximity of private drinking water wells within a half mile of the facility. The preliminary CSM for the AASF 1 AOI 1 is shown on **Figure 6-2**.

Area of Interest	AOI Location	Rationale	Potential Future Action
AOI 1 Storage and Ramp Area	40°55'31.94"N; 81°26'54.36"W (middle of ramp area)	Long-term outside storage of TriMax™ 30 tanks from approximately 2006 until 2018.	Proceed to an SI, focus on soil, sediment, surface water, drinking water, and groundwater
AOI 2 AASF 1 Hangar	40°55'37.40"N; 81°26'54.58"W	Presence of HEF fire suppression system, long-term storage of 5-gallon buckets of AFFF, and previous undocumented storage of several TriMax™ 30 tanks.	Proceed to an SI, focus on groundwater and surface water.
AOI 3 Wetland	40°55'28.68"N; 81°26'44.68"W	Known and potential historic releases combined with direction of surface water flow leaves the potential for this area to be impacted by AFFF releases.	Proceed to an SI, focus on soil, sediment, surface water, drinking water, and groundwater

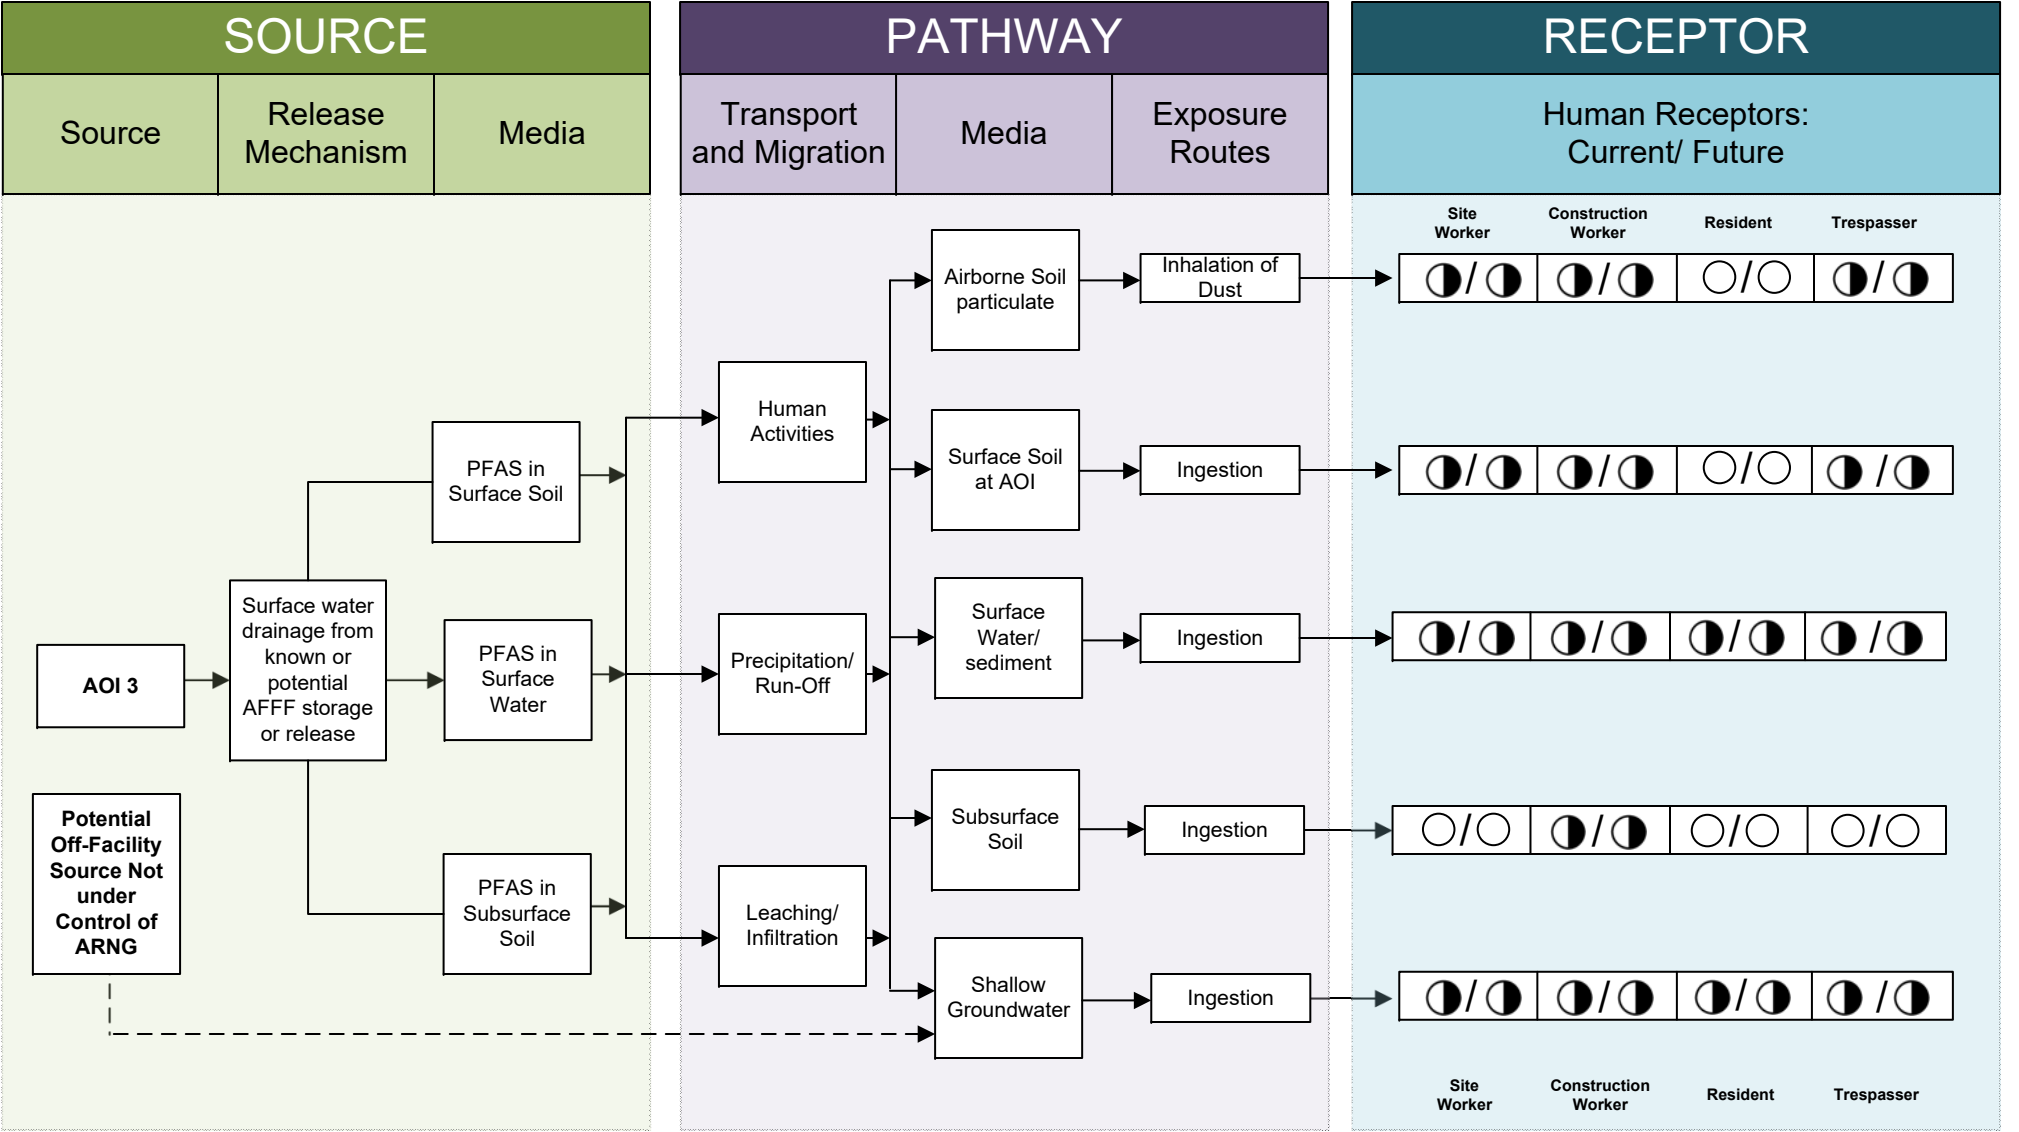
AOI 3 is the Wetland located on the southeast portion of the AASF 1. Several wetlands exist directly around the facility; however, only one wetland lies partly within the facility boundary. Surface drainage from the AASF 1 empties into various wetlands both within and directly surrounding the facility, as well as the unnamed streams to the north and east of the facility (**Figure 1-3**). While no direct releases of AFFF into this AOI have been identified, the close proximity to other potential release or storage areas as well as the known direction of surface water flow leaves the potential for AFFF residual to flow into this AOI.

Therefore, the ingestion exposure pathway for surface soil, subsurface soil, surface water/sediment and groundwater are considered potentially complete. Ground-disturbing activities at AOI 3 could result in site and construction worker exposure to potential PFAS contamination via inhalation of dust or ingestion of surface soil. Therefore, the inhalation and ingestion pathways for these receptors are considered potentially complete. The preliminary CSM for AOI 3 is shown on **Figure 6-4**.
