Preliminary Assessment Report

Stockton AASF, California

Perfluorooctane-Sulfonic Acid (PFOS) and Perfluorooctanoic Acid (PFOA) Impacted Sites
ARNG Installations, Nationwide

January 2020

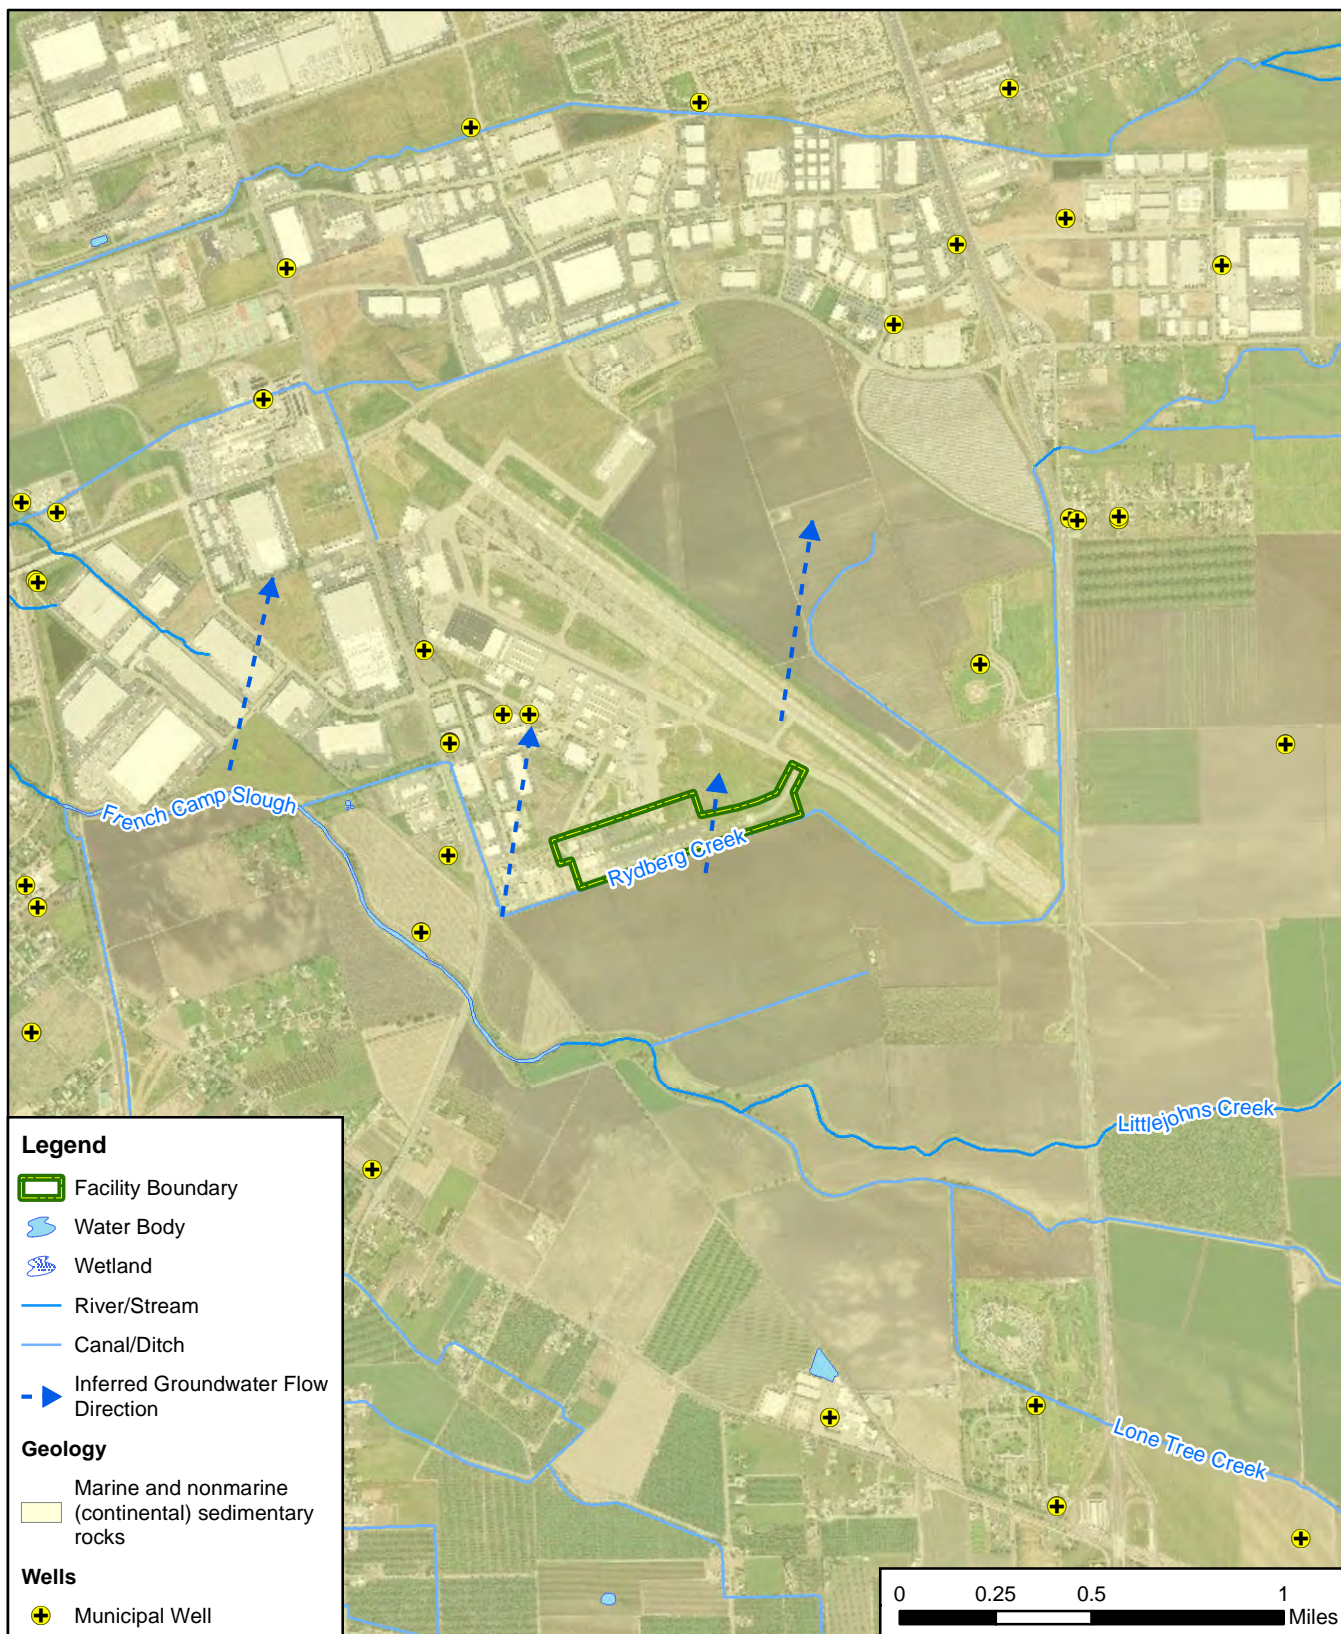
Figure 1-2

No groundwater monitoring data are available for the AASF; however, the CAARNG has been monitoring groundwater at the adjoining FMS #24 site since 2010. Depth to groundwater has been generally encountered from 30 to 35 ft bgs, and the hydraulic gradient was measured at approximately 0.0015 ft/ft in 2013 (Adanta-ECM Joint Venture, 2018). Groundwater flow has been consistently measured from nine monitoring wells and two remediation wells in the north/northeast direction (ECM Consultants, 2018). In the vicinity of the site, groundwater flow in regional unconfined conditions is generally southwesterly toward the valley (Adanta-ECM Joint Venture, 2018). Groundwater features are presented on **Figure 1-2**.

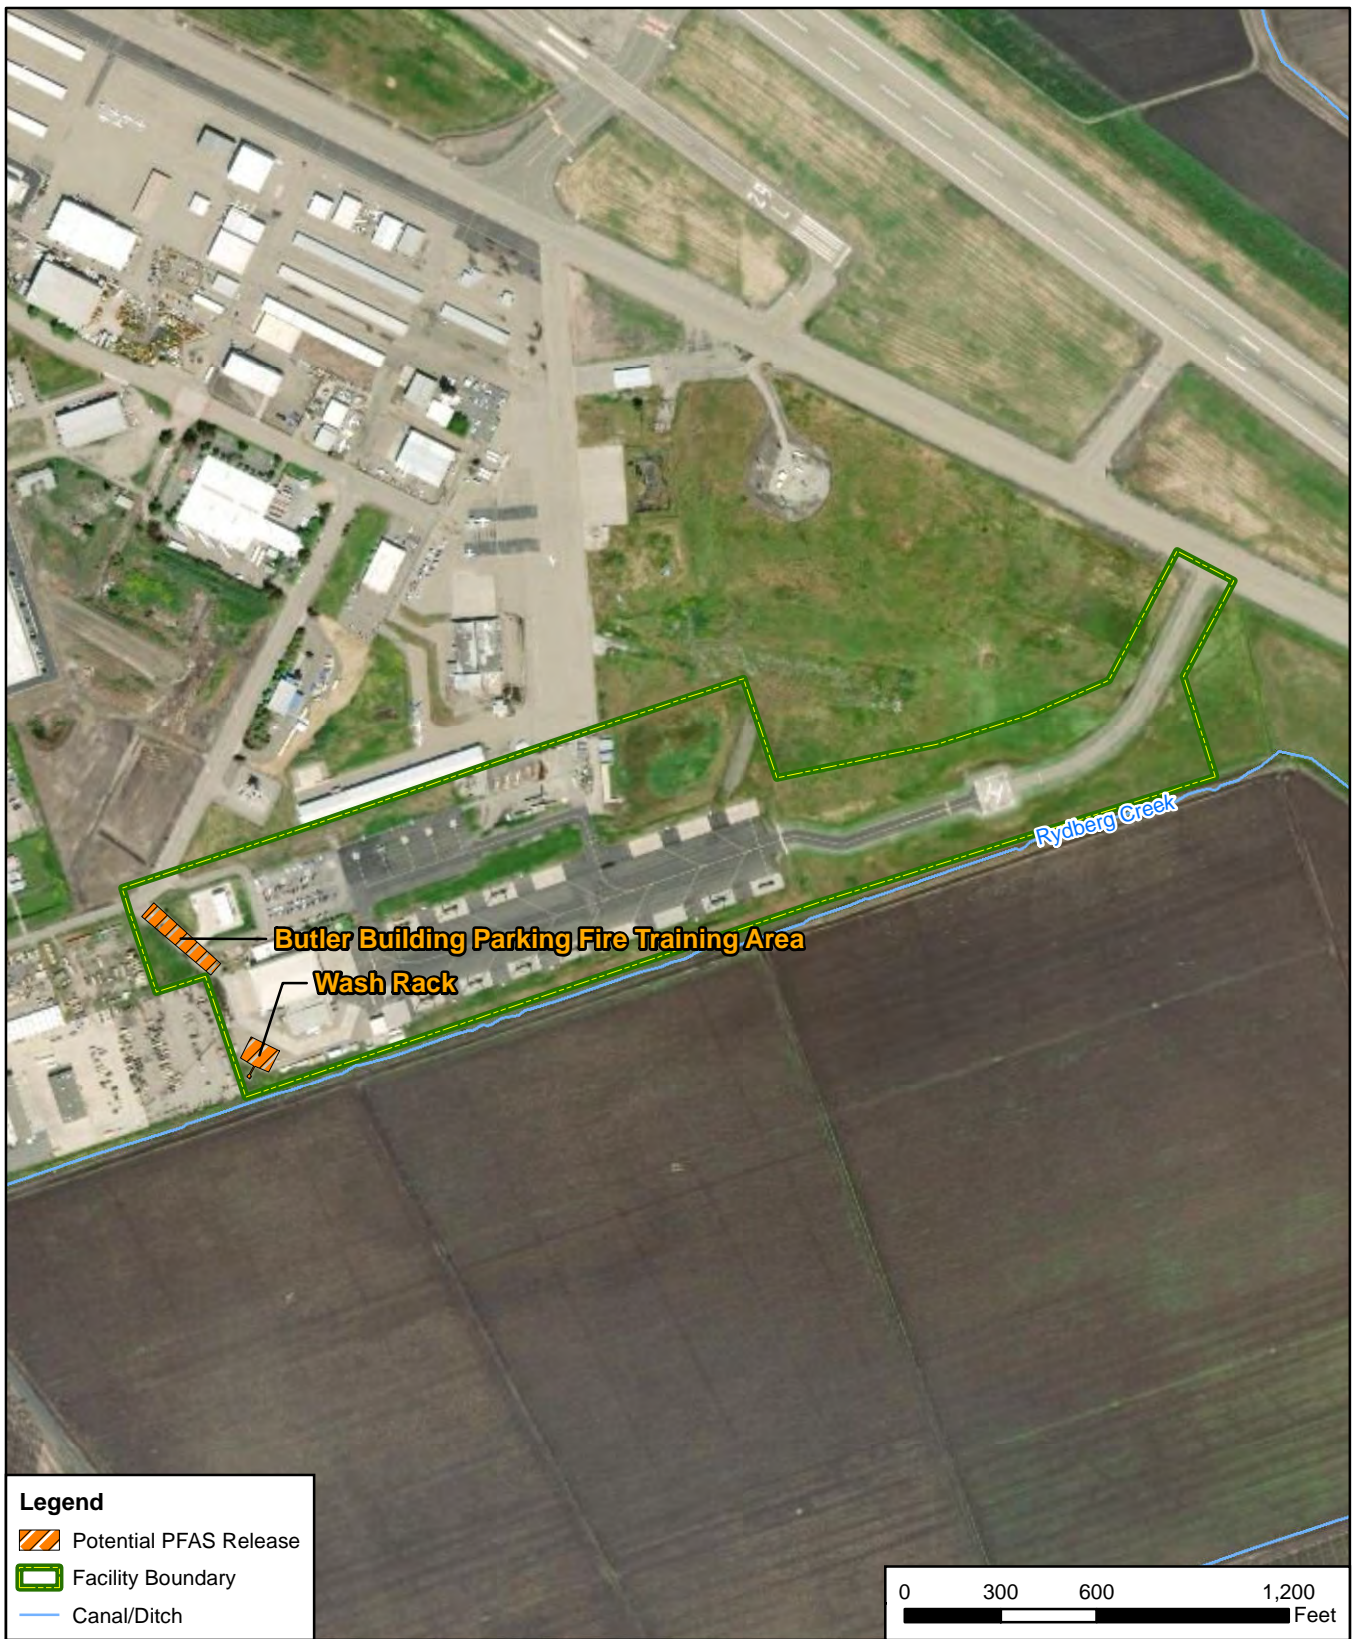
During the PA site visit, potentially distressed vegetation was observed in the grassy area adjacent to the paved parking lot. Some minor flooding was also observed leading into the area from the south. The paved parking lot is in a restricted, fenced area with an access gate located on the northwest side.

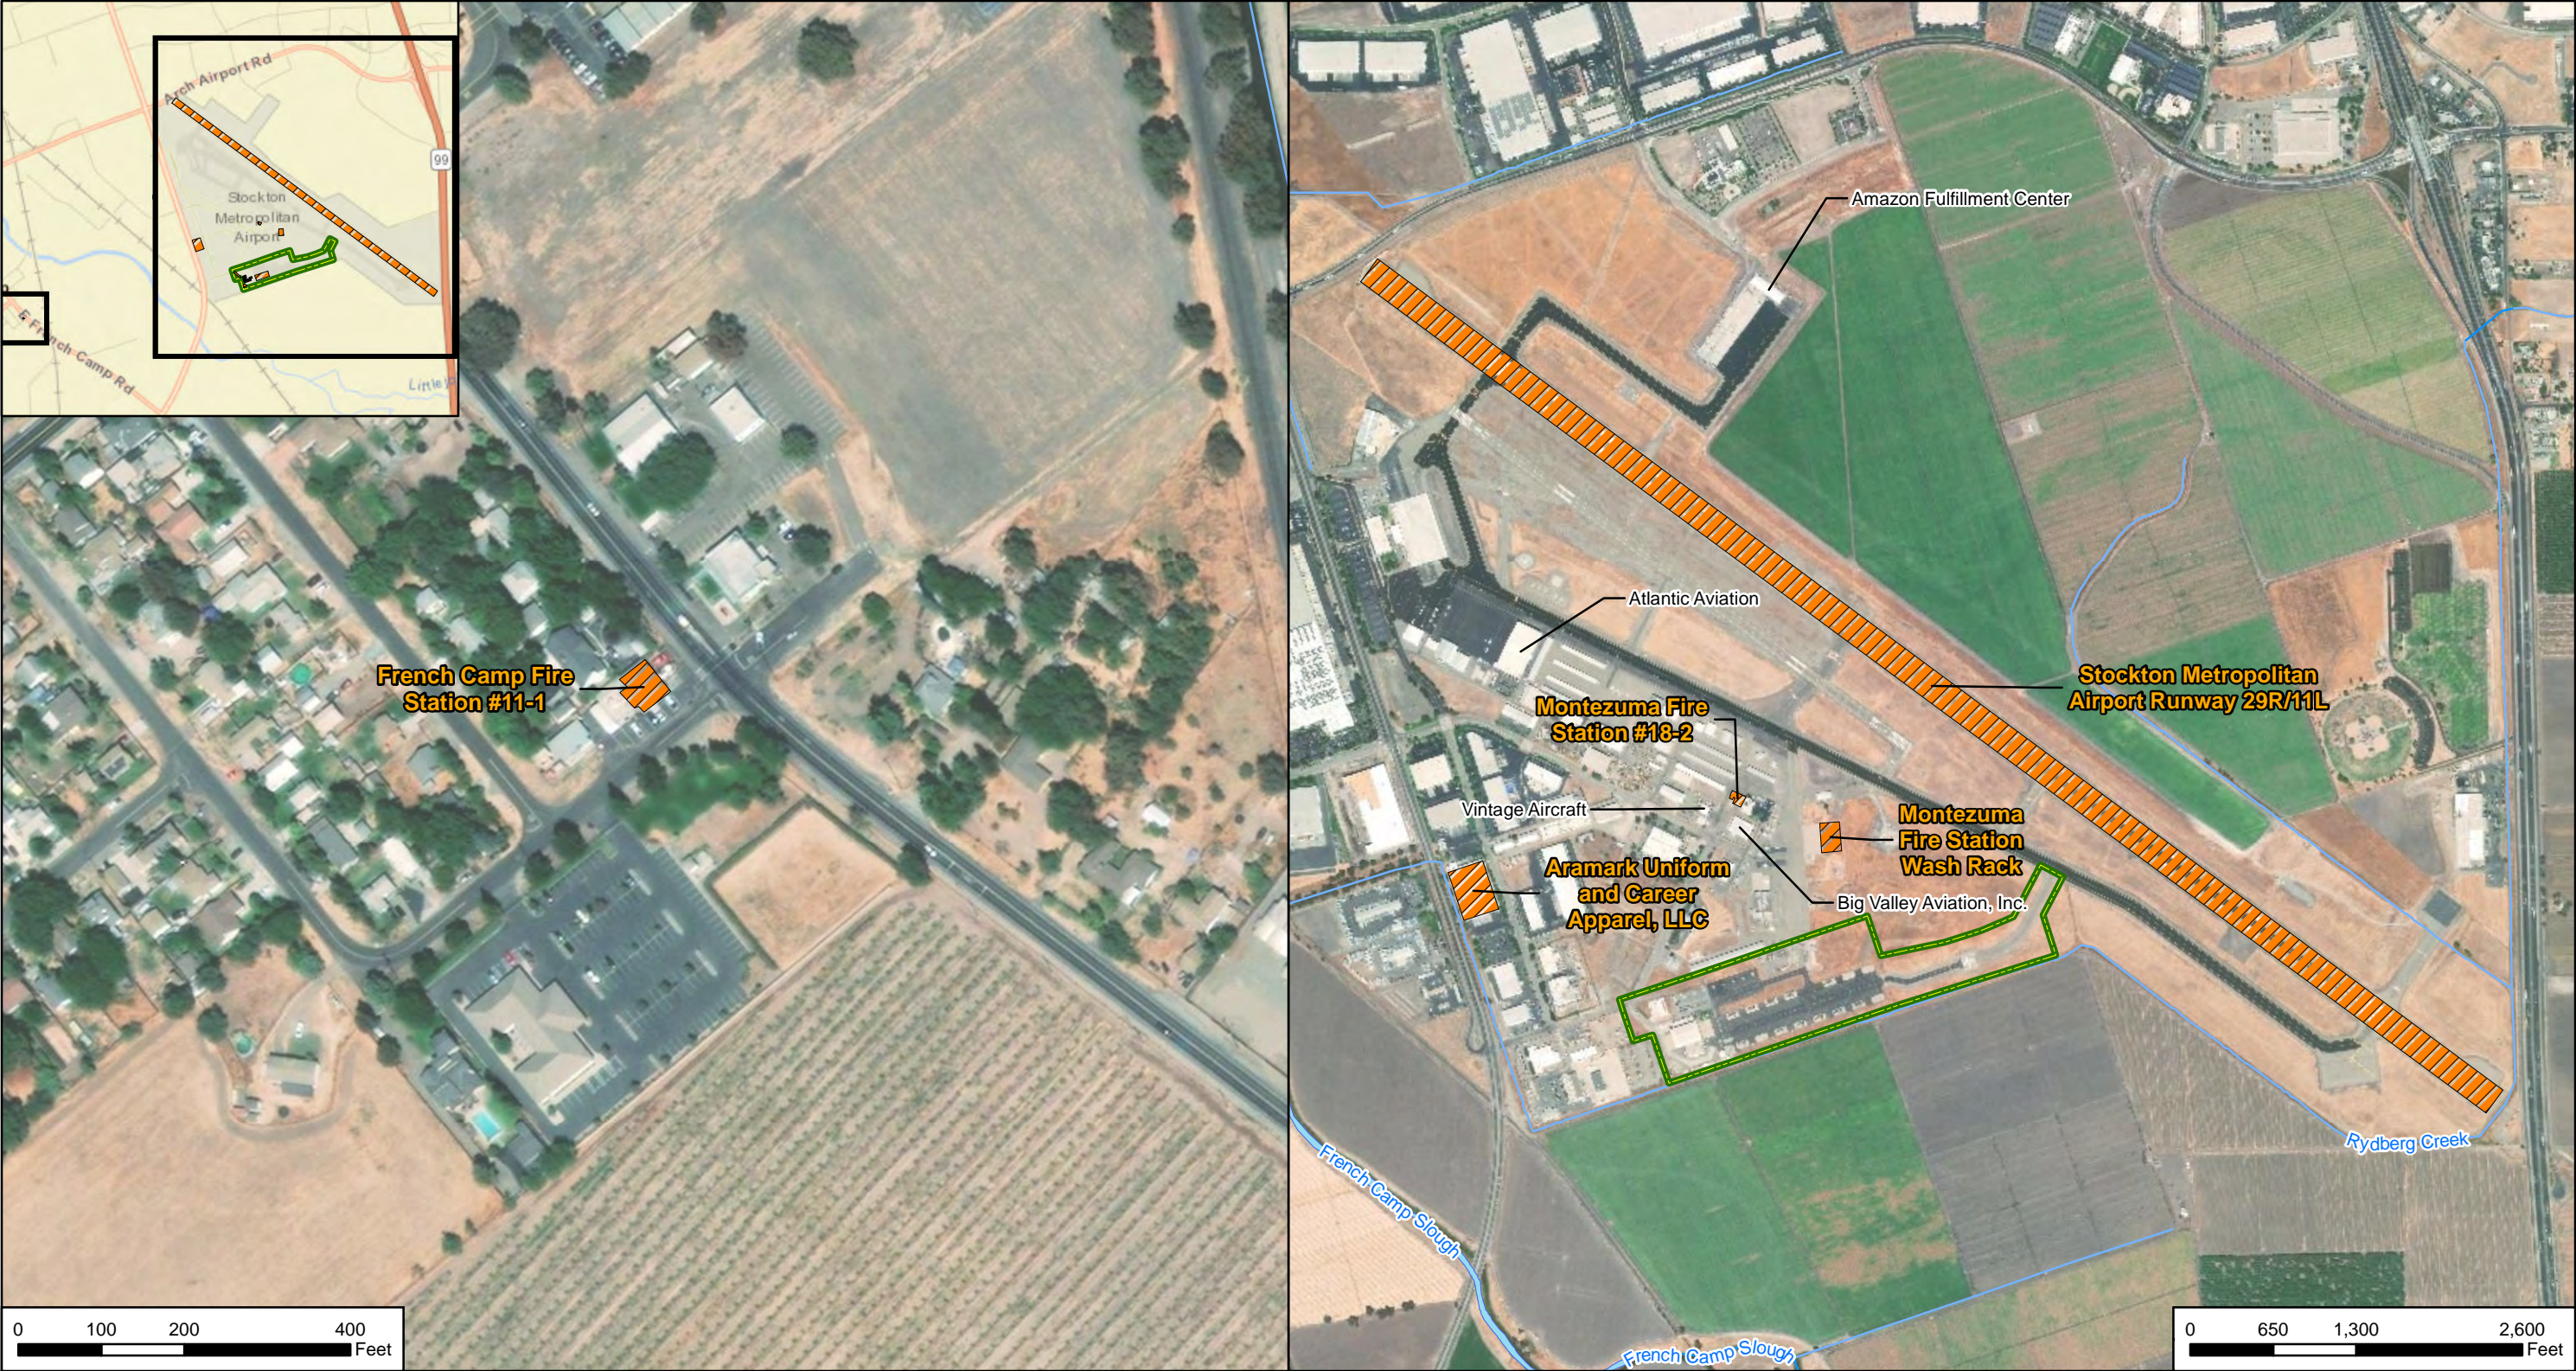
Numerous potential off-facility sources of PFAS adjacent to the Stockton AASF, not under the control of the CAARNG, were identified during the PA. A description of each adjacent source is presented below, and the adjacent sources are shown on **Figure 5-1**.

An Aramark Uniform and Career Apparel, LLC facility is located at 7679 Longe Street, Stockton, CA 95206. The facility provides uniform-related services such as uniform cleaning and fire resistant workwear. PFAS contamination from these industrial applications is unknown but possible.

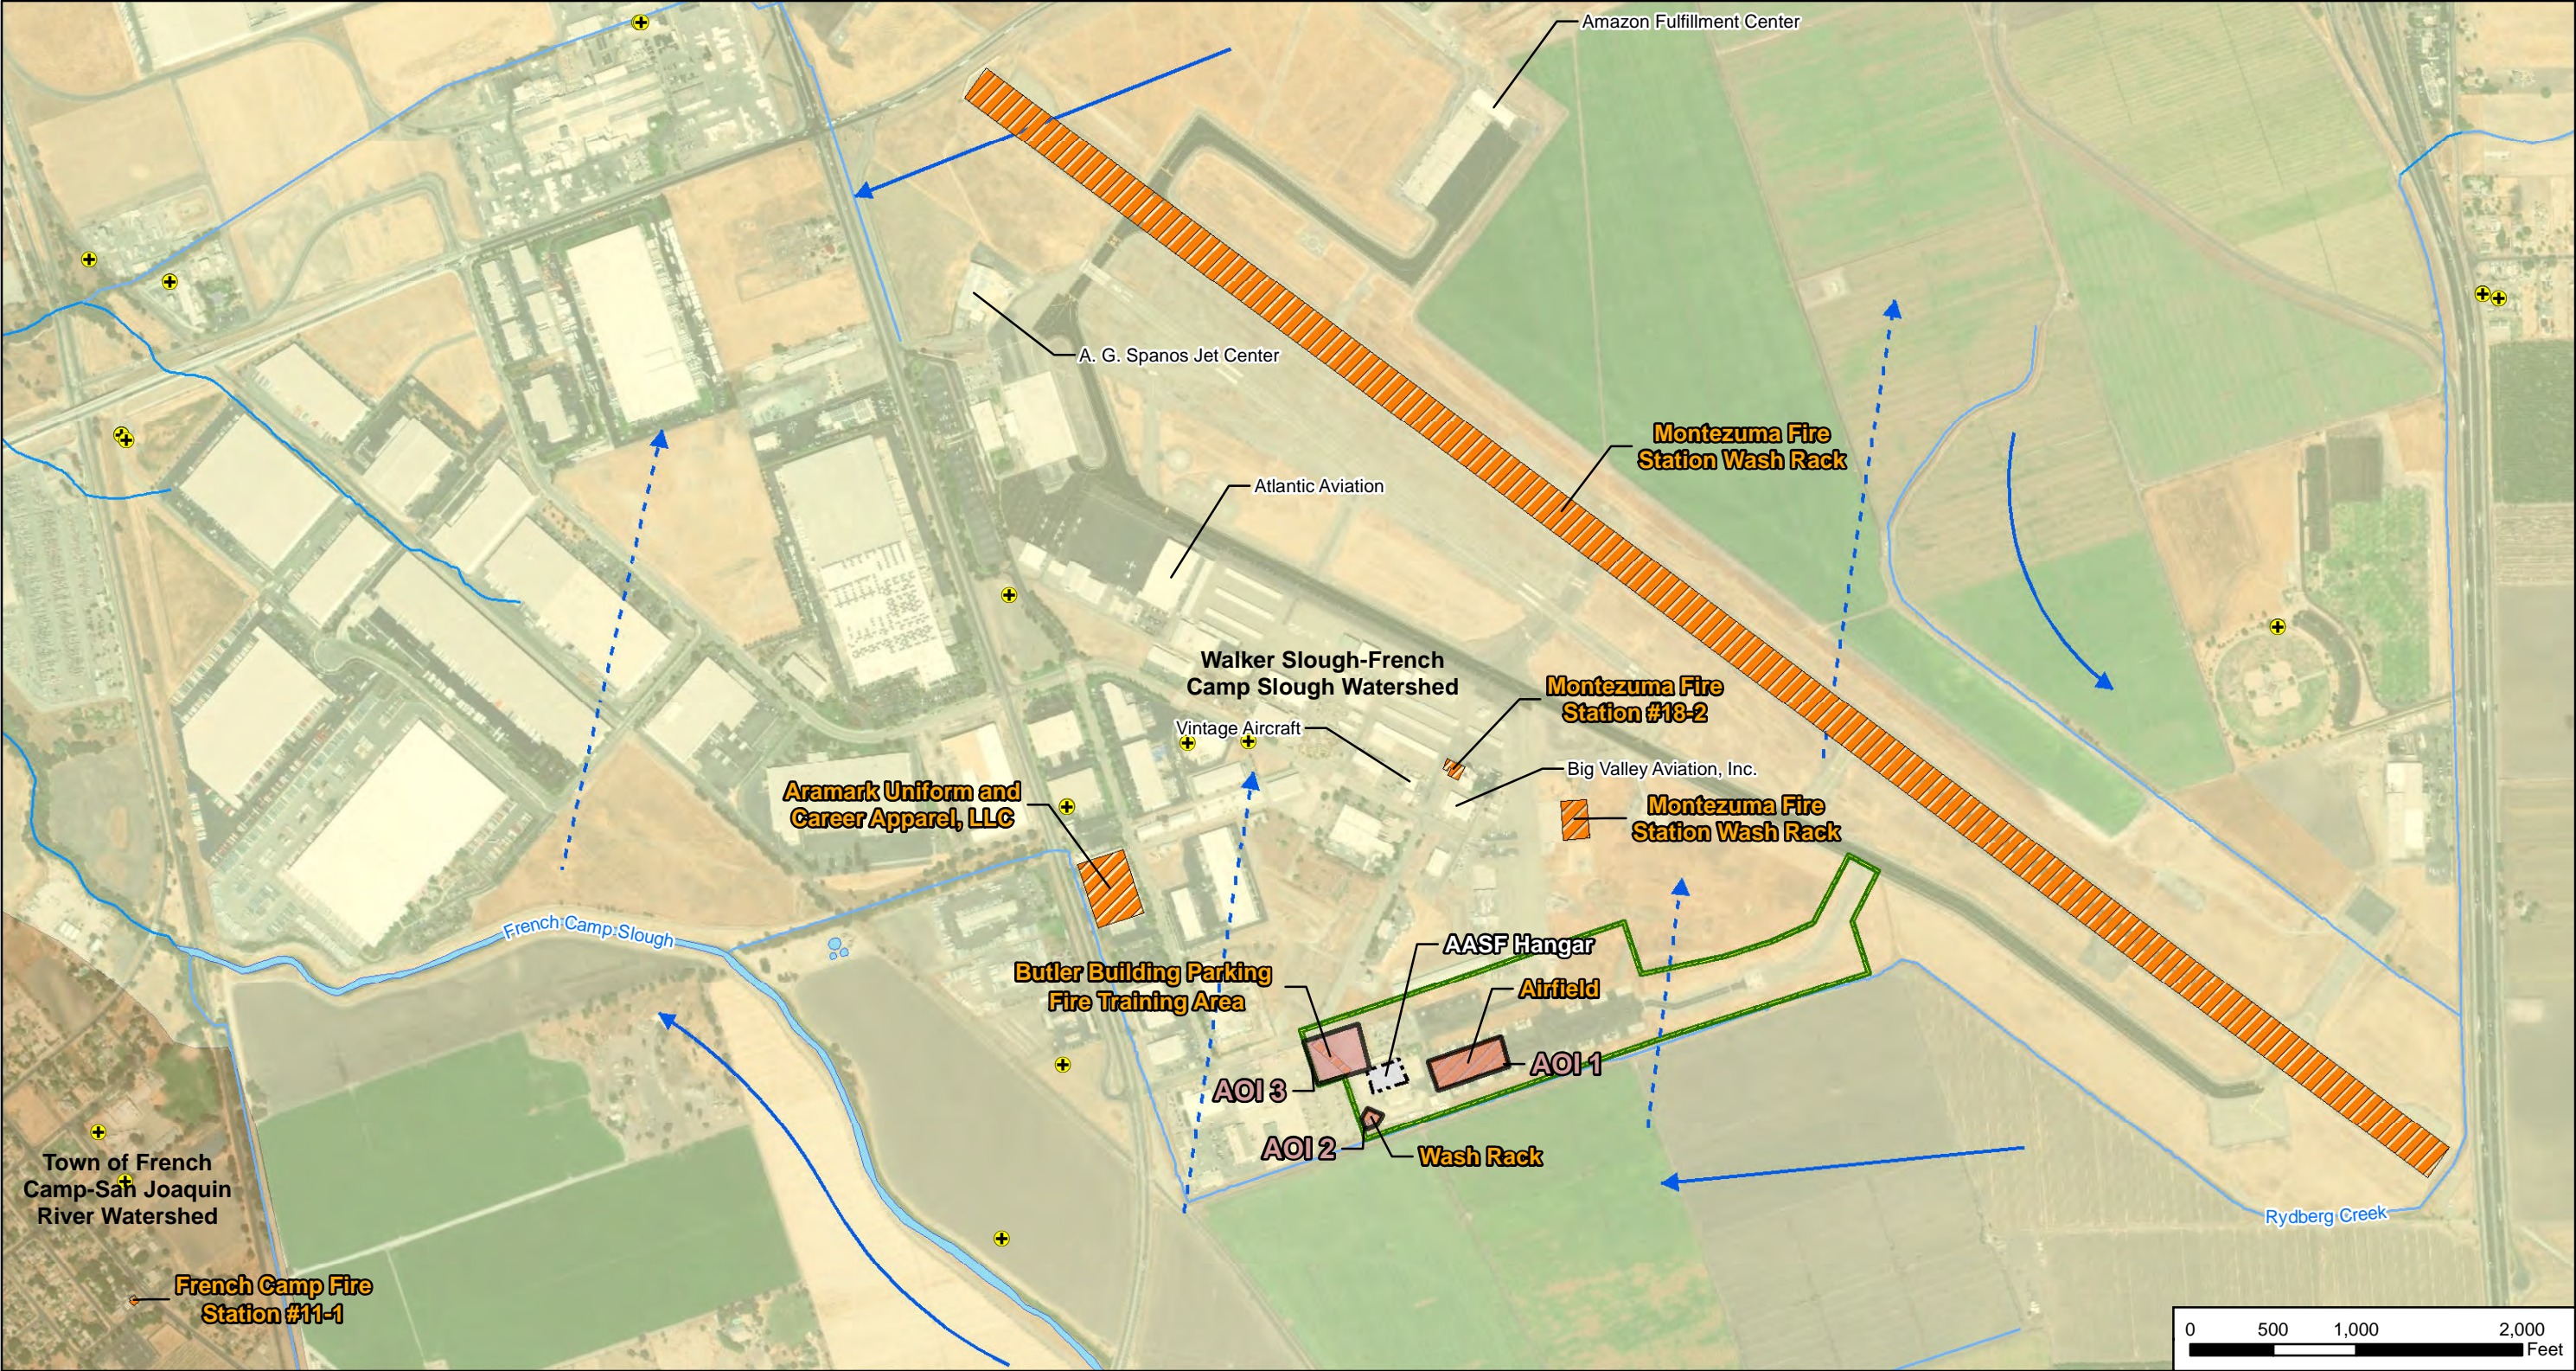
Figure 6-1

Based on the PA findings, there were two FTAs and one non-FTA where AFFF may have been incidentally spilled or discharged to the ground surface. As such, these AOIs may be potential PFAS source areas. The AOIs and preliminary CSMs for the AOIs are shown on **Figure 6-1** to **Figure 6-3** and summarized below.

AOI 3 is a former FTA at what is now the parking area located east of the Butler Building. Controlled AFFF releases through fire training activities have occurred annually, potentially as early as 1992, until approximately 2010 to 2012, when the Butler Building was constructed.

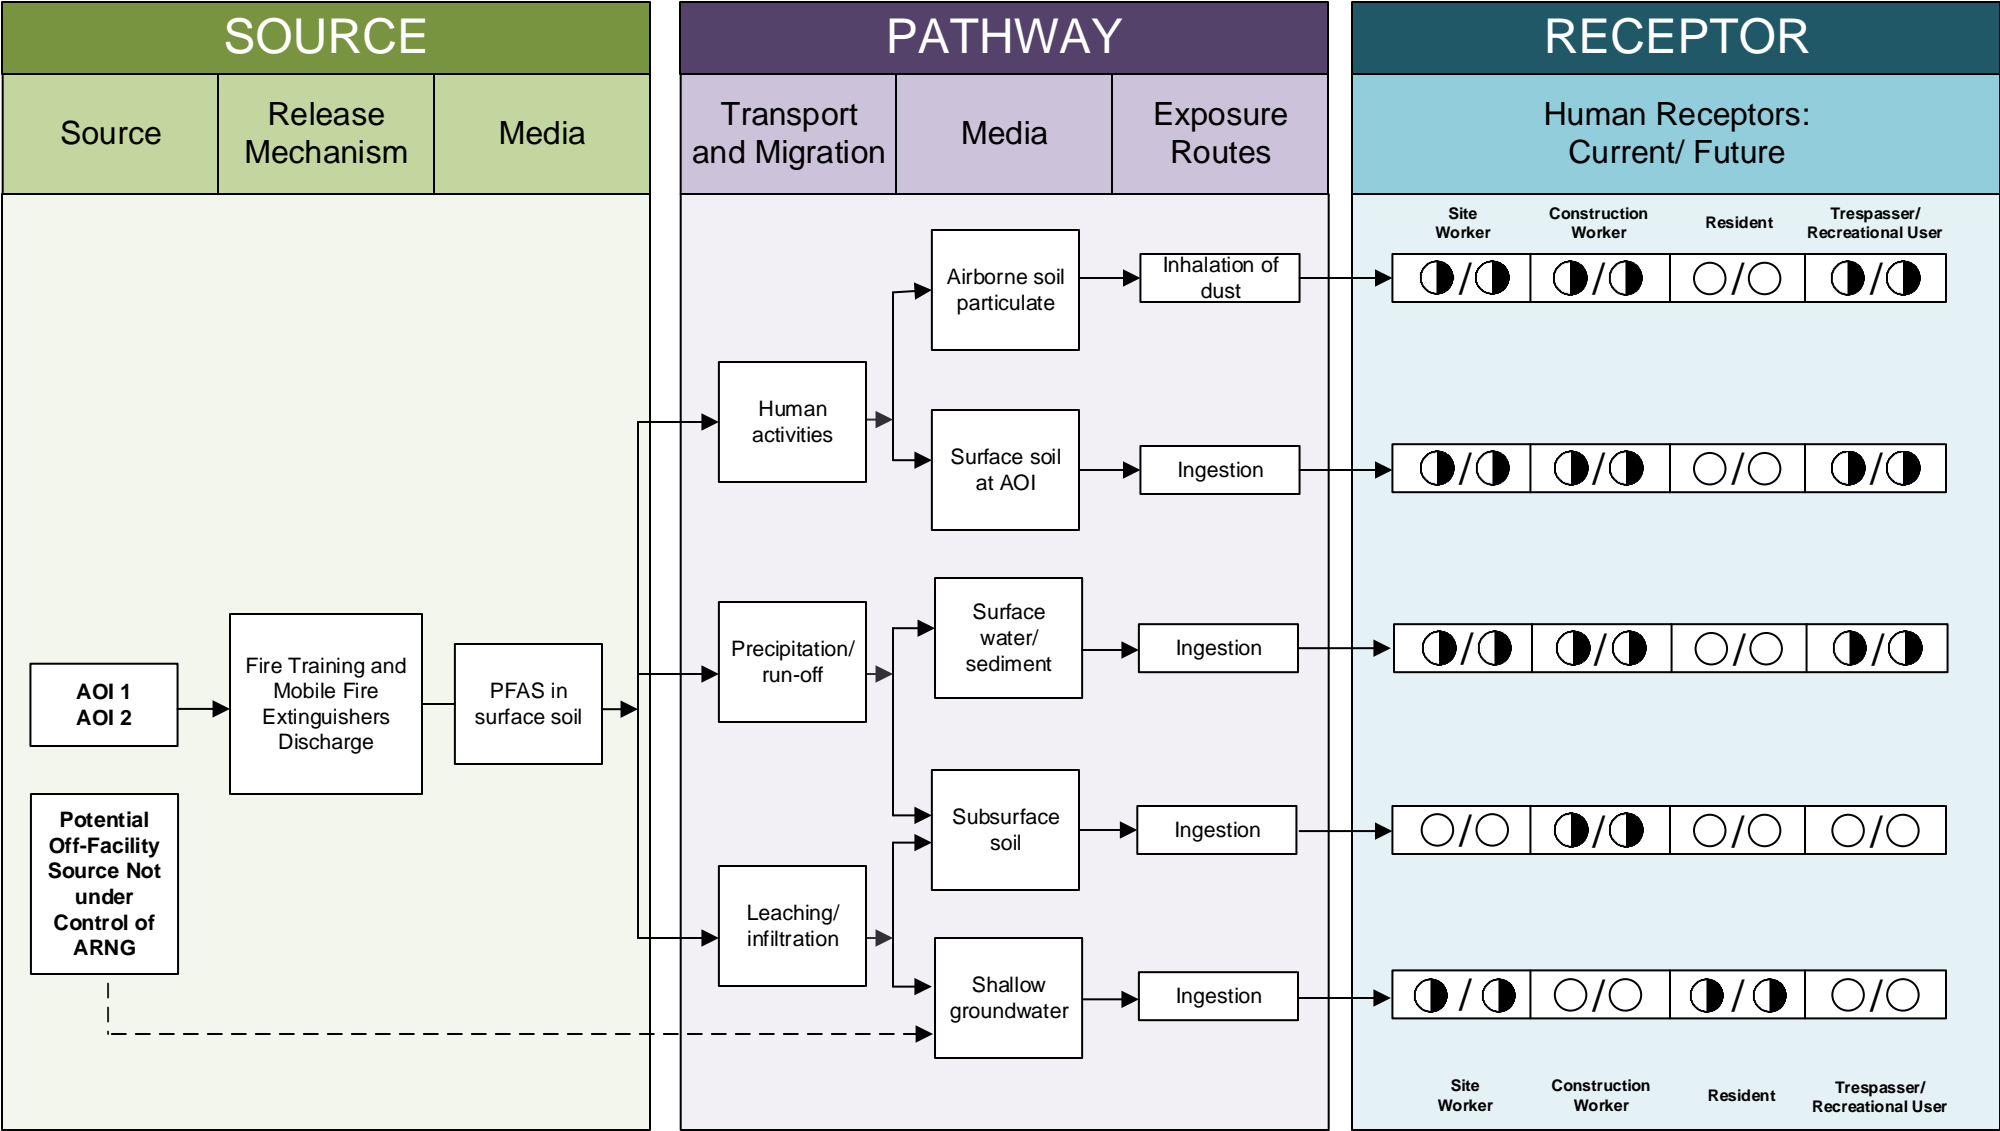
Figure 6-2
Preliminary Conceptual Site Model
AOI 1 & AOI 2 Airfield and Wash Rack

ingestion of groundwater is also considered potentially complete. The preliminary CSM for AOI 1 is shown on **Figure 6-2**.

The wash rack drains lead to an oil water separator that connects to the Stockton sanitary sewer system. Therefore, discharges of AFFF in the wash rack would release directly into the sanitary sewer system. However, the HAZMAT locker is located near unpaved, grassy areas. Potential PFAS releases nearby the HAZMAT locker drains via overland surface flow to the adjacent ditch canal (Rydberg Creek), which is a tributary to the San Joaquin River. The pathways and receptors for AOI 2 are the same as described in **Section 6.1**. The preliminary CSM for AOI 2 is shown on **Figure 6-2**.

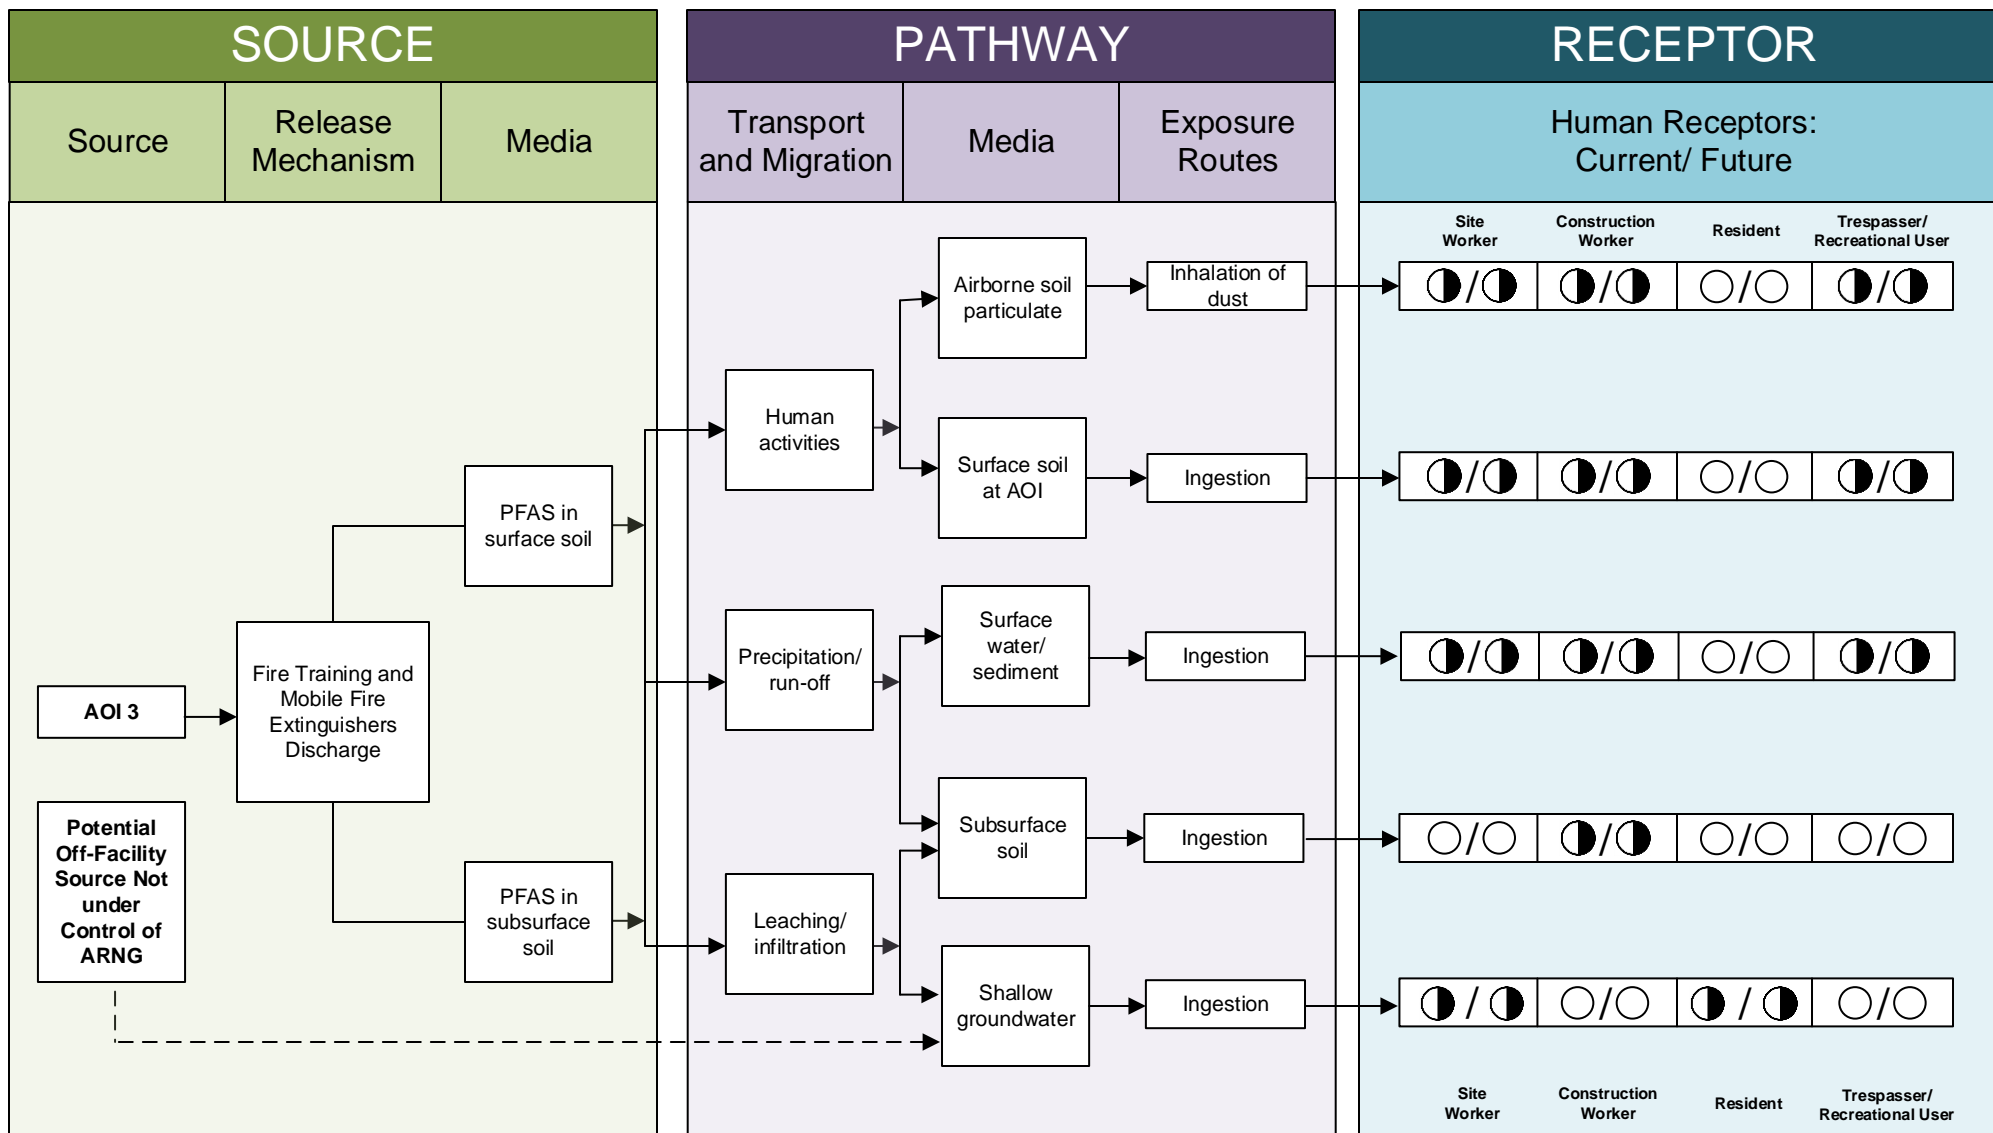
Ground-disturbing activities at AOI 3 have occurred and may have resulted in construction worker exposure to potential PFAS contamination via inhalation of dust from surface soil or ingestion of surface and subsurface soil. During the construction of the Butler Building, the soil beneath and in the vicinity of the parking lot was disturbed, and the area was regraded. The original soil was either left in place or used to fill in a depression west of the road next to the Butler Building. Therefore, potentially impacted soil remains at AOI 3. The pathways and receptors for AOI 3 are the same as described in **Section 6.1**. The preliminary CSM for AOI 3 is shown on **Figure 6-3**.
