Preliminary Assessment Report

Stockton AASF, California

Perfluorooctane-Sulfonic Acid (PFOS) and Perfluorooctanoic Acid (PFOA) Impacted Sites
ARNG Installations, Nationwide

January 2020

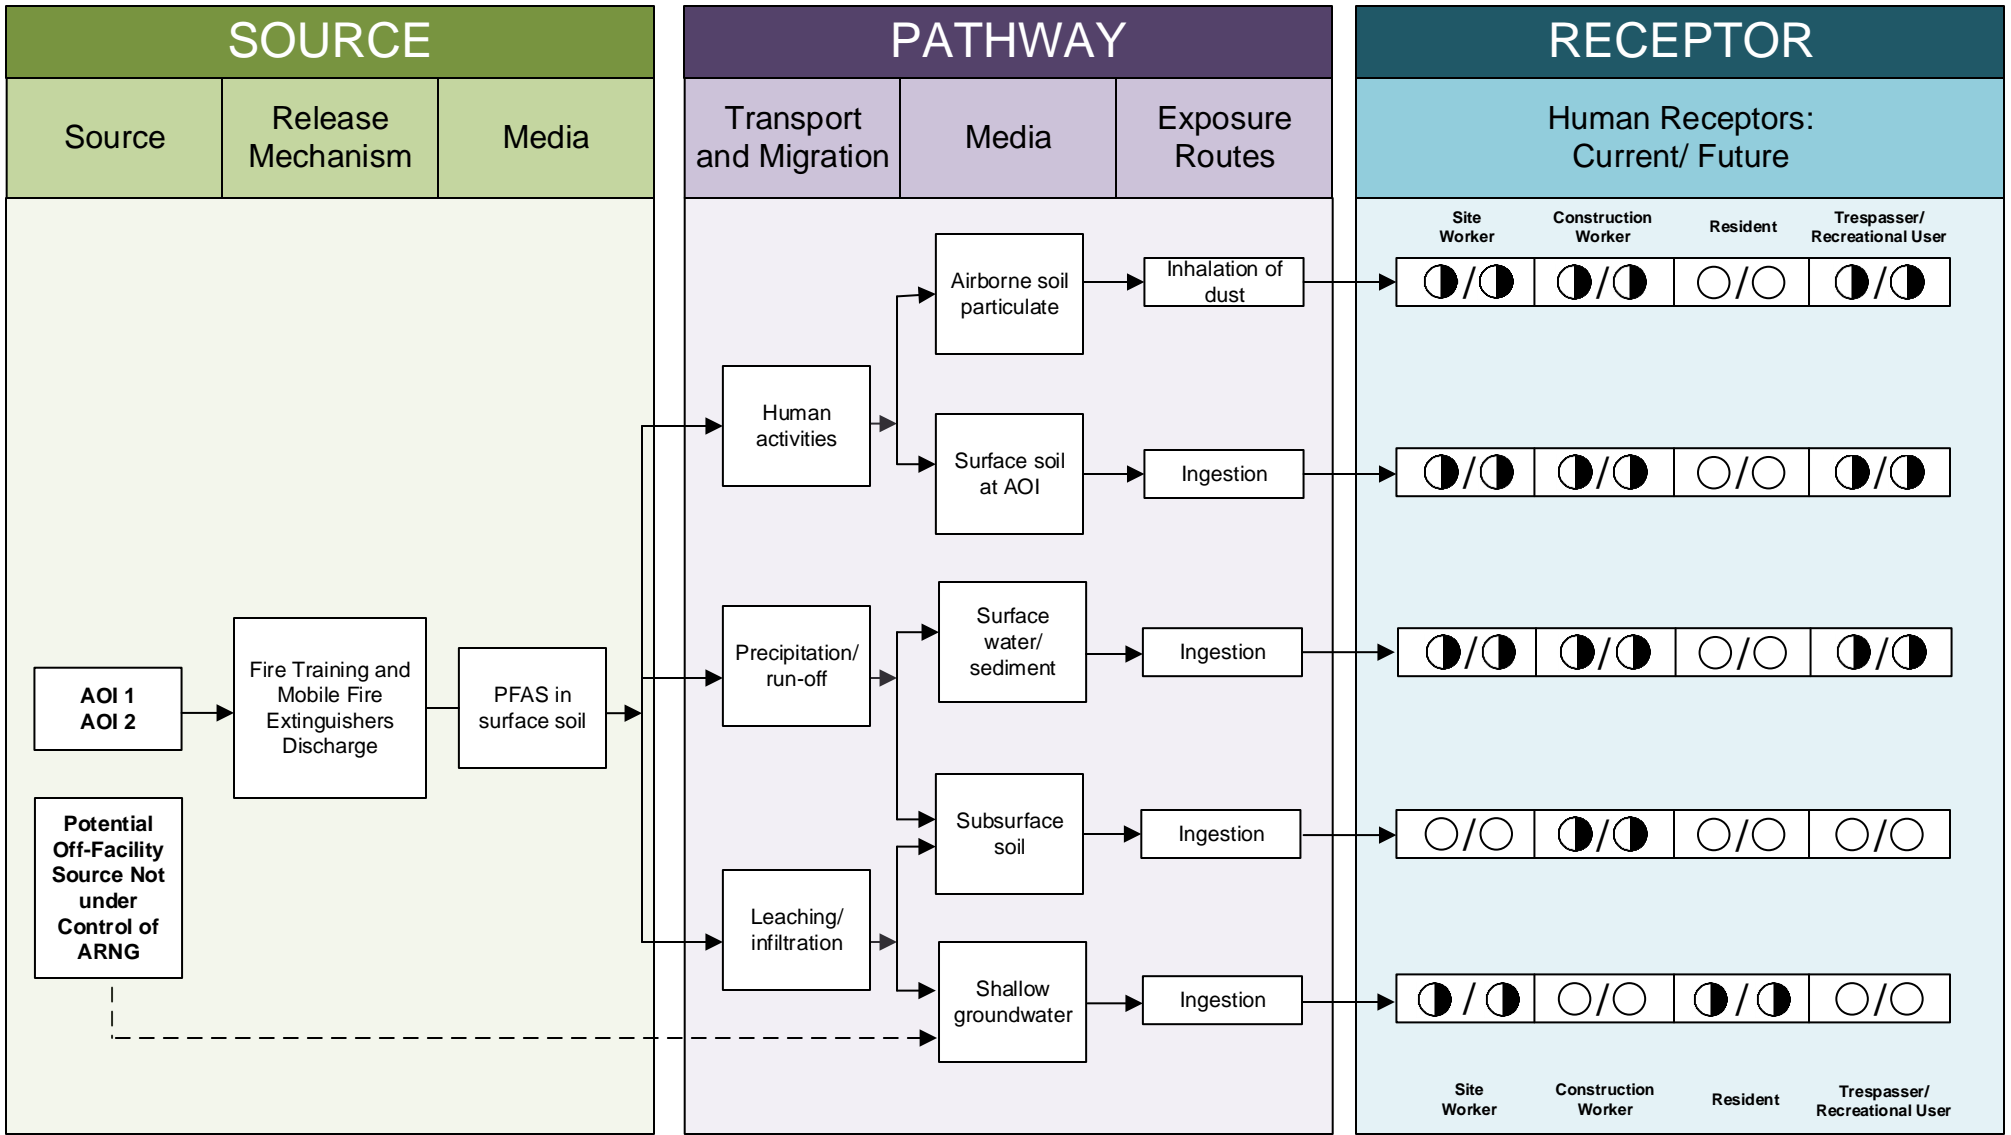
Figure 6-2
 Preliminary Conceptual Site Model
 AOI 1 & AOI 2 Airfield and Wash Rack

The wash rack drains lead to an oil water separator that connects to the Stockton sanitary sewer system. Therefore, discharges of AFFF in the wash rack would release directly into the sanitary sewer system. However, the HAZMAT locker is located near unpaved, grassy areas. Potential PFAS releases nearby the HAZMAT locker drains via overland surface flow to the adjacent ditch canal (Rydberg Creek), which is a tributary to the San Joaquin River. The pathways and receptors for AOI 2 are the same as described in **Section 6.1**. The preliminary CSM for AOI 2 is shown on **Figure 6-2**.

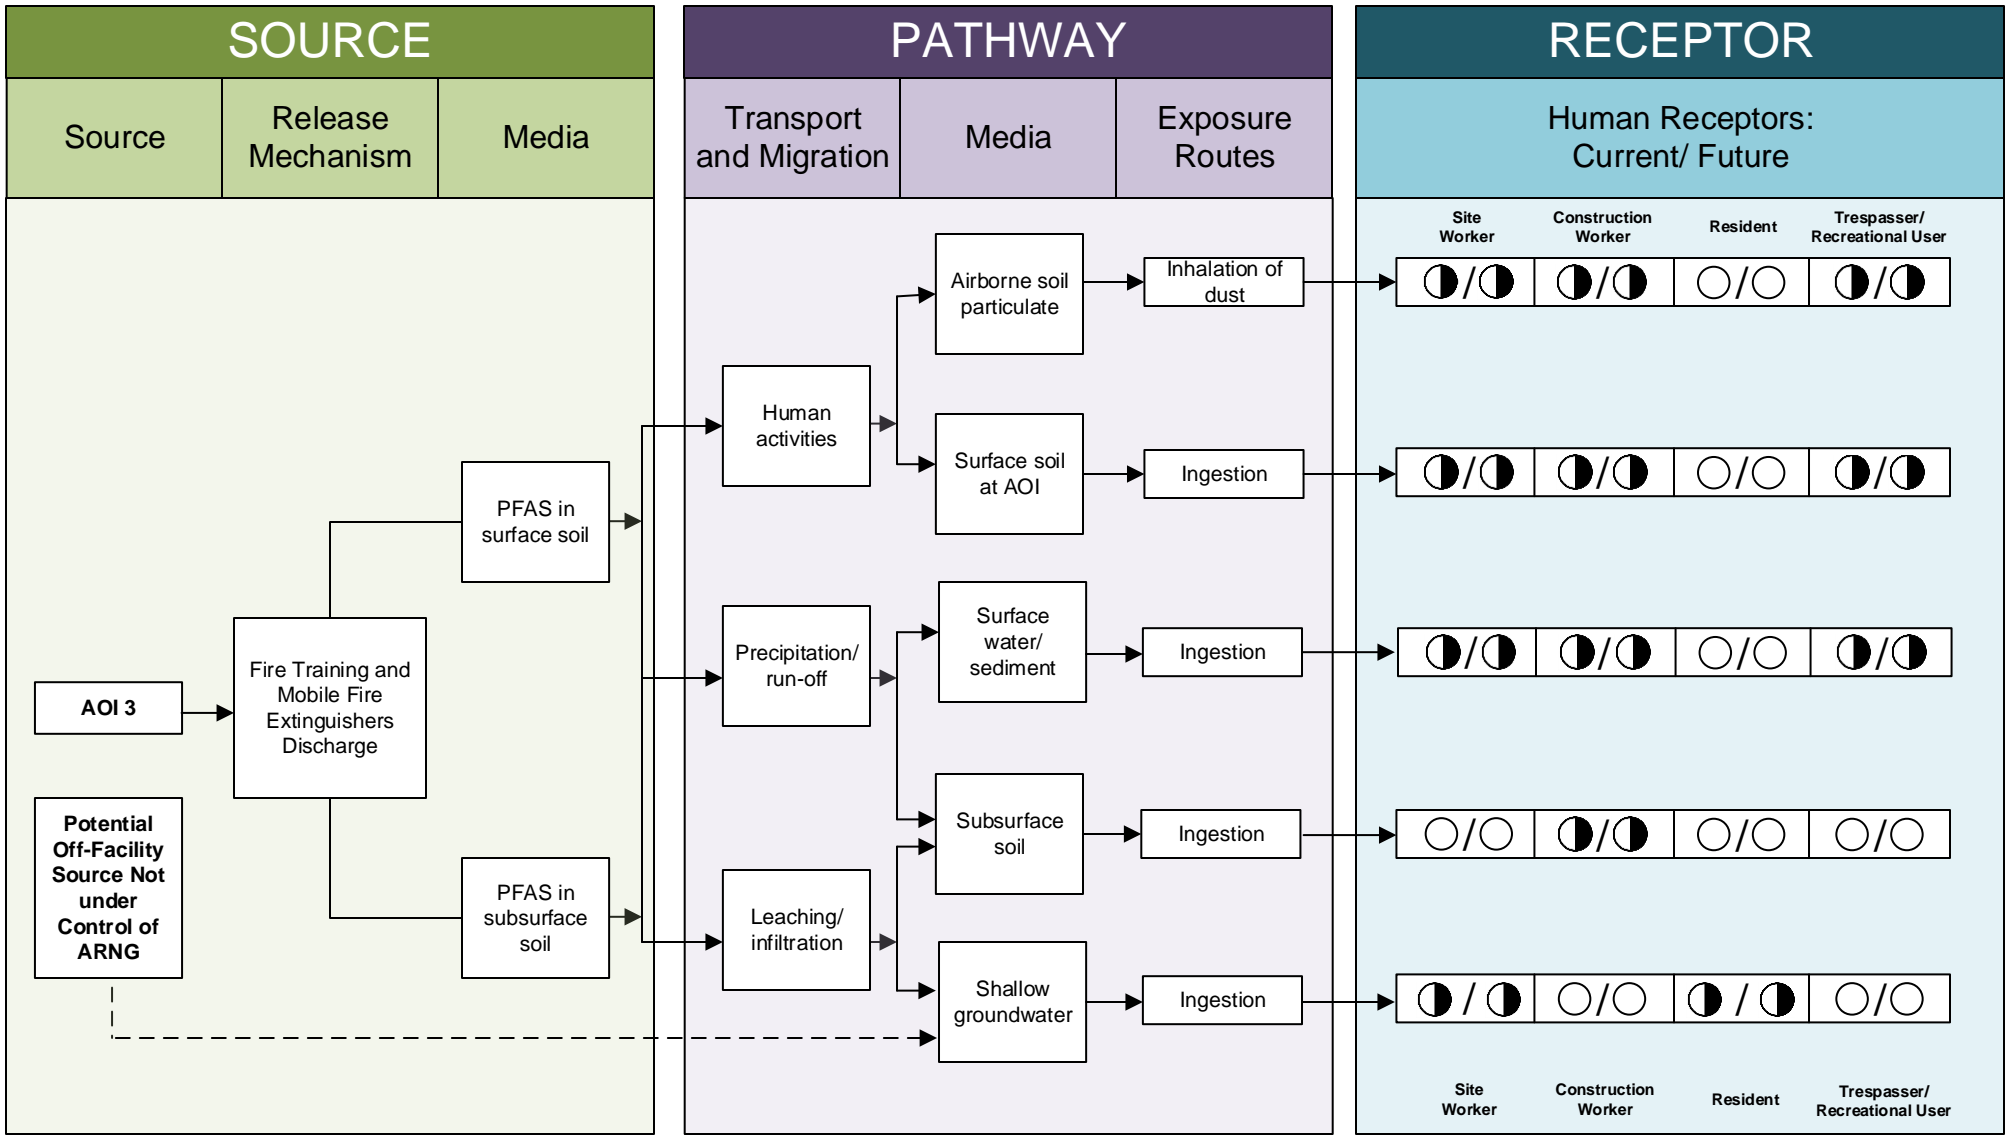
AOI 3 is a former FTA at what is now the parking area located east of the Butler Building. Controlled AFFF releases through fire training activities have occurred annually, potentially as early as 1992, until approximately 2010 to 2012, when the Butler Building was constructed.

Ground-disturbing activities at AOI 3 have occurred and may have resulted in construction worker exposure to potential PFAS contamination via inhalation of dust from surface soil or ingestion of surface and subsurface soil. During the construction of the Butler Building, the soil beneath and in the vicinity of the parking lot was disturbed, and the area was regraded. The original soil was either left in place or used to fill in a depression west of the road next to the Butler Building. Therefore, potentially impacted soil remains at AOI 3. The pathways and receptors for AOI 3 are the same as described in **Section 6.1**. The preliminary CSM for AOI 3 is shown on **Figure 6-3**.
