FINAL Preliminary Assessment Report Fort Ruger, O‘ahu, Hawai‘i

Perfluorooctanesulfonic acid (PFOS) and
Perfluorooctanoic acid (PFOA) at Impacted Sites
ARNG Installations, Nationwide

September 2020

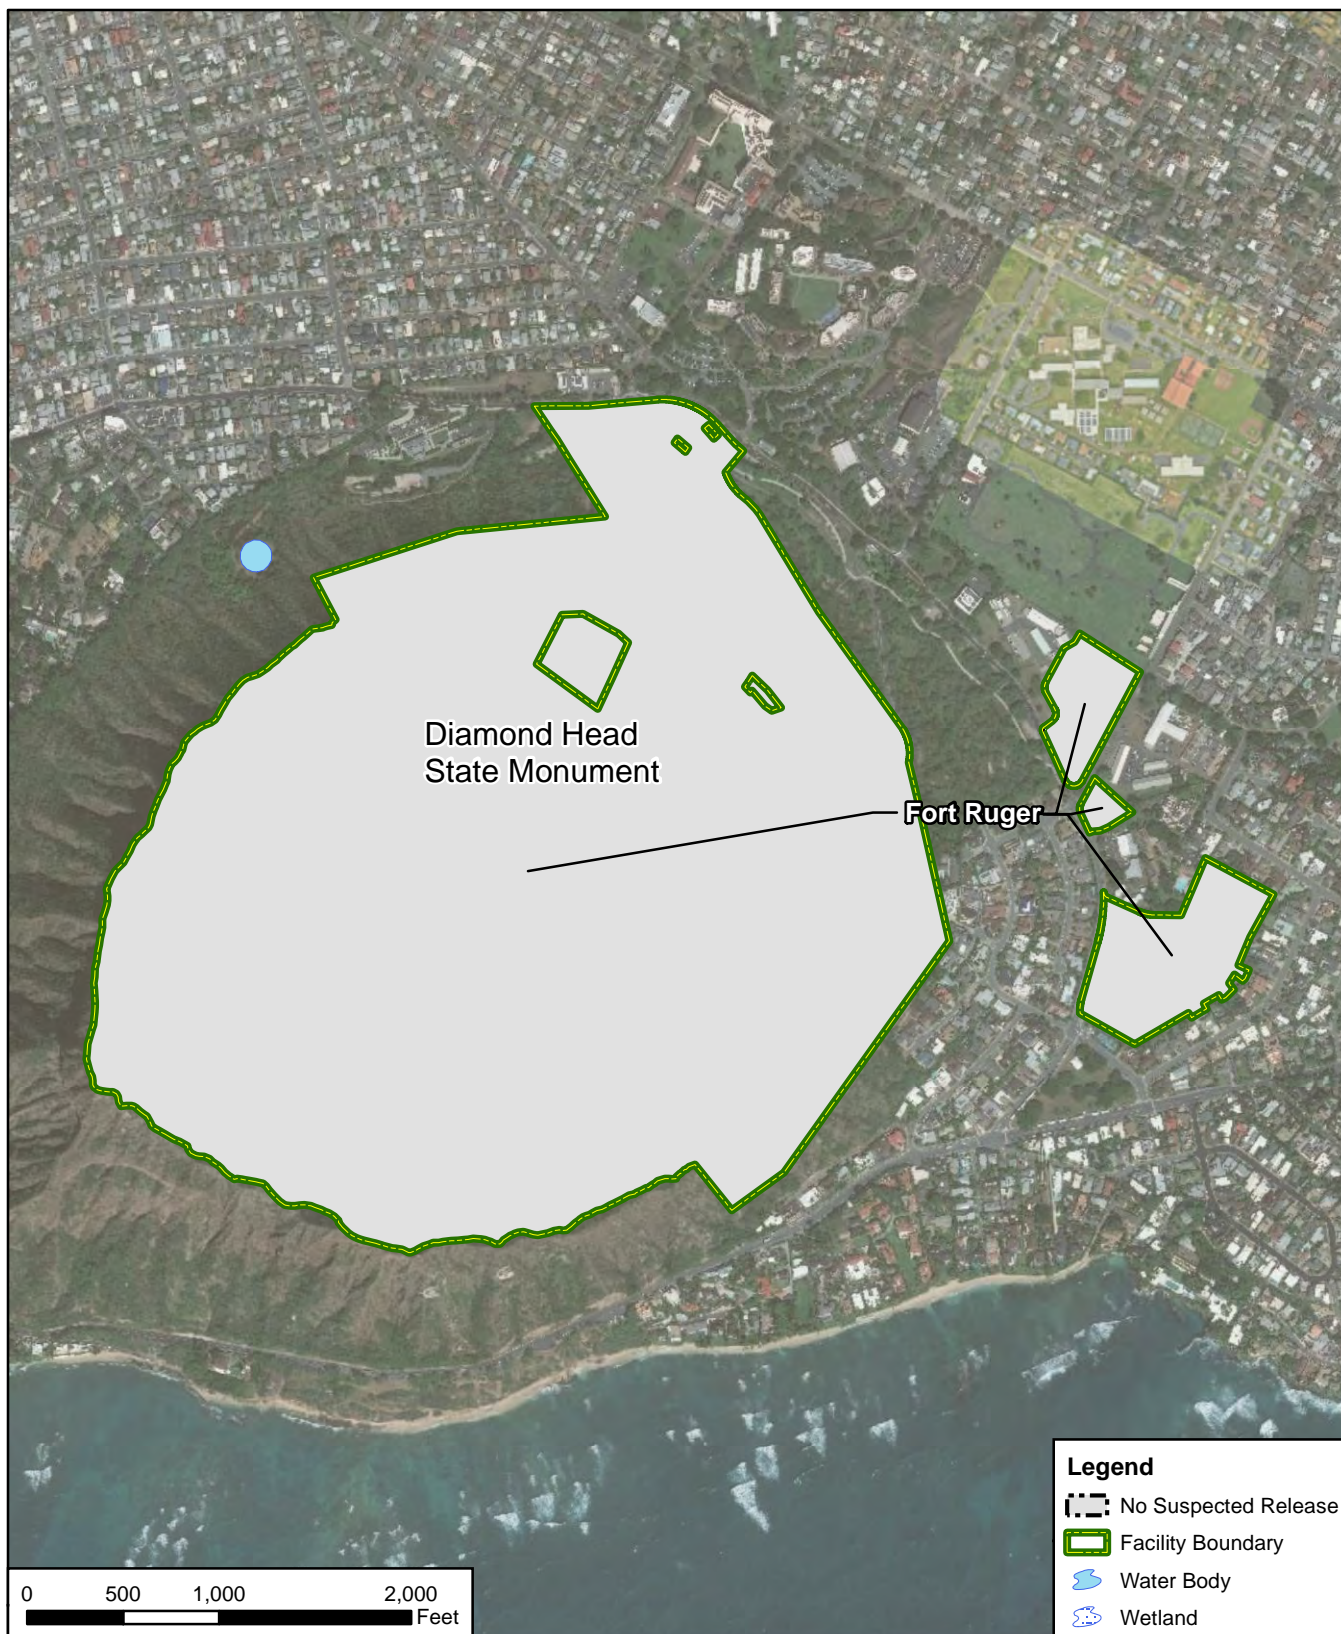
Based on the PA findings regarding historical activities concerning aqueous film forming foam use and storage at the facility, there is no potential for exposure to PFAS contamination in soil, groundwater, surface water, and sediment (**Figure ES-1**). Based on the United States (US) Environmental Protection Agency (USEPA) Unregulated Contaminant Monitoring Rule 3 (UCMR3) data, it was indicated that no PFAS were detected in a public water system above the USEPA's lifetime Health Advisory (HA) within 20 miles of the facility. The HA is 70 parts per trillion for PFOS and PFOA, individually or combined. PFAS analyses performed in 2016 had method detection limits that were higher than currently achievable. Thus, it is possible that low concentrations of PFAS were not detected during the UCMR3 but might be detected if analyzed today.
