Perfluorooctane-Sulfonic Acid (PFOS) and Perfluorooctanoic Acid (PFOA) Impacted Sites ARNG Installations, Nationwide

August 2019

AECOM 12420 Milestone Center Drive, Suite 150 Germantown, MD 20876 aecom.com

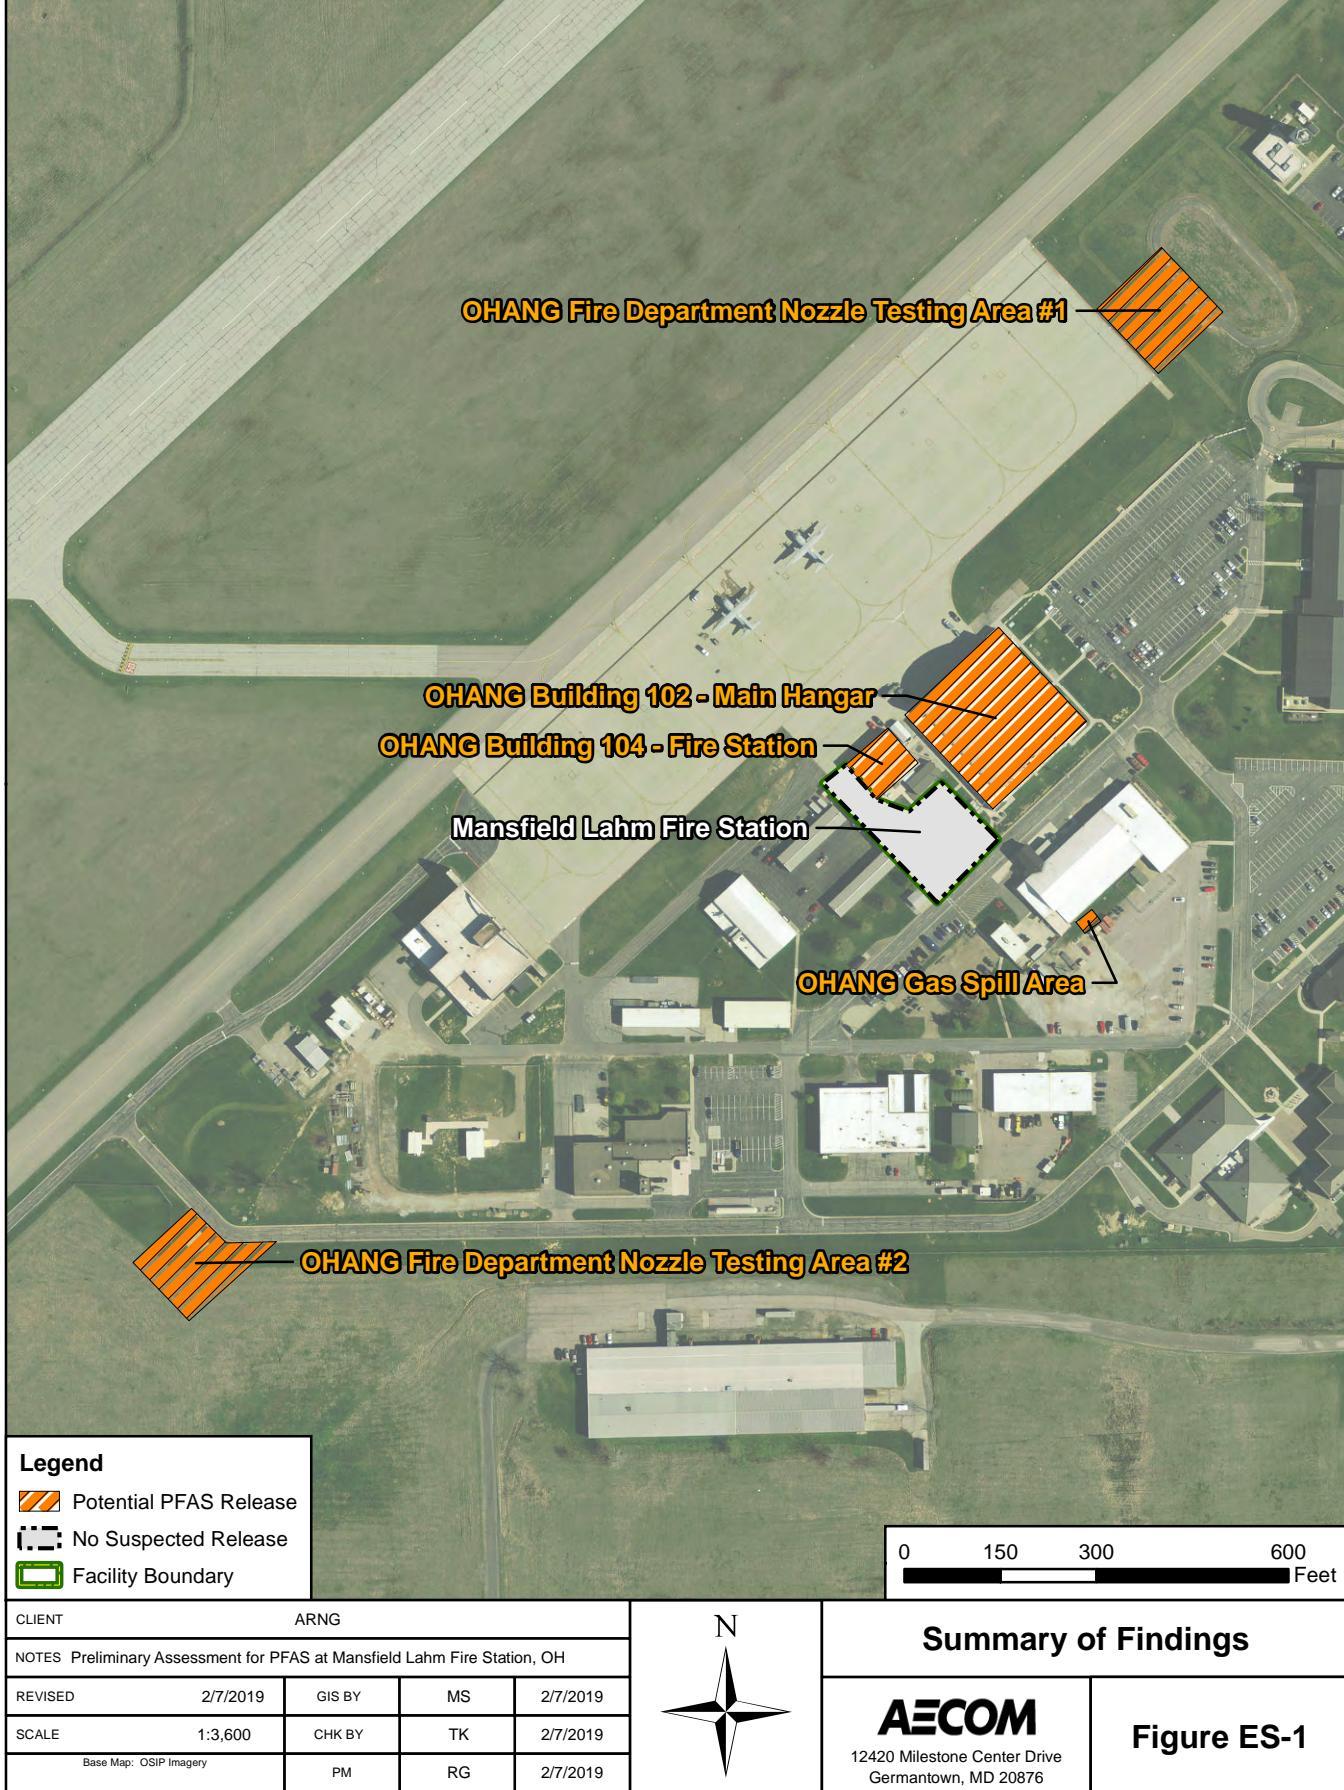
Q:\Projects\ENV\GEARS\GEO\ARNG PFAS\900-CAD-GIS\920-GIS or Graphics\MXD\OH\Mansfield_Lahm_PA_Figures\Fig_ES-1_Mansfield_Lahm_Summary.mxd

No Area(s) of Interest (AOIs) related to potential PFAS use, release, or storage were identified at the Mansfield Lahm Fire Station during the PA, although several potential PFAS sources are located adjacent to the Mansfield Lahm Fire Station, within OHANG property (**Figure ES-1**). The

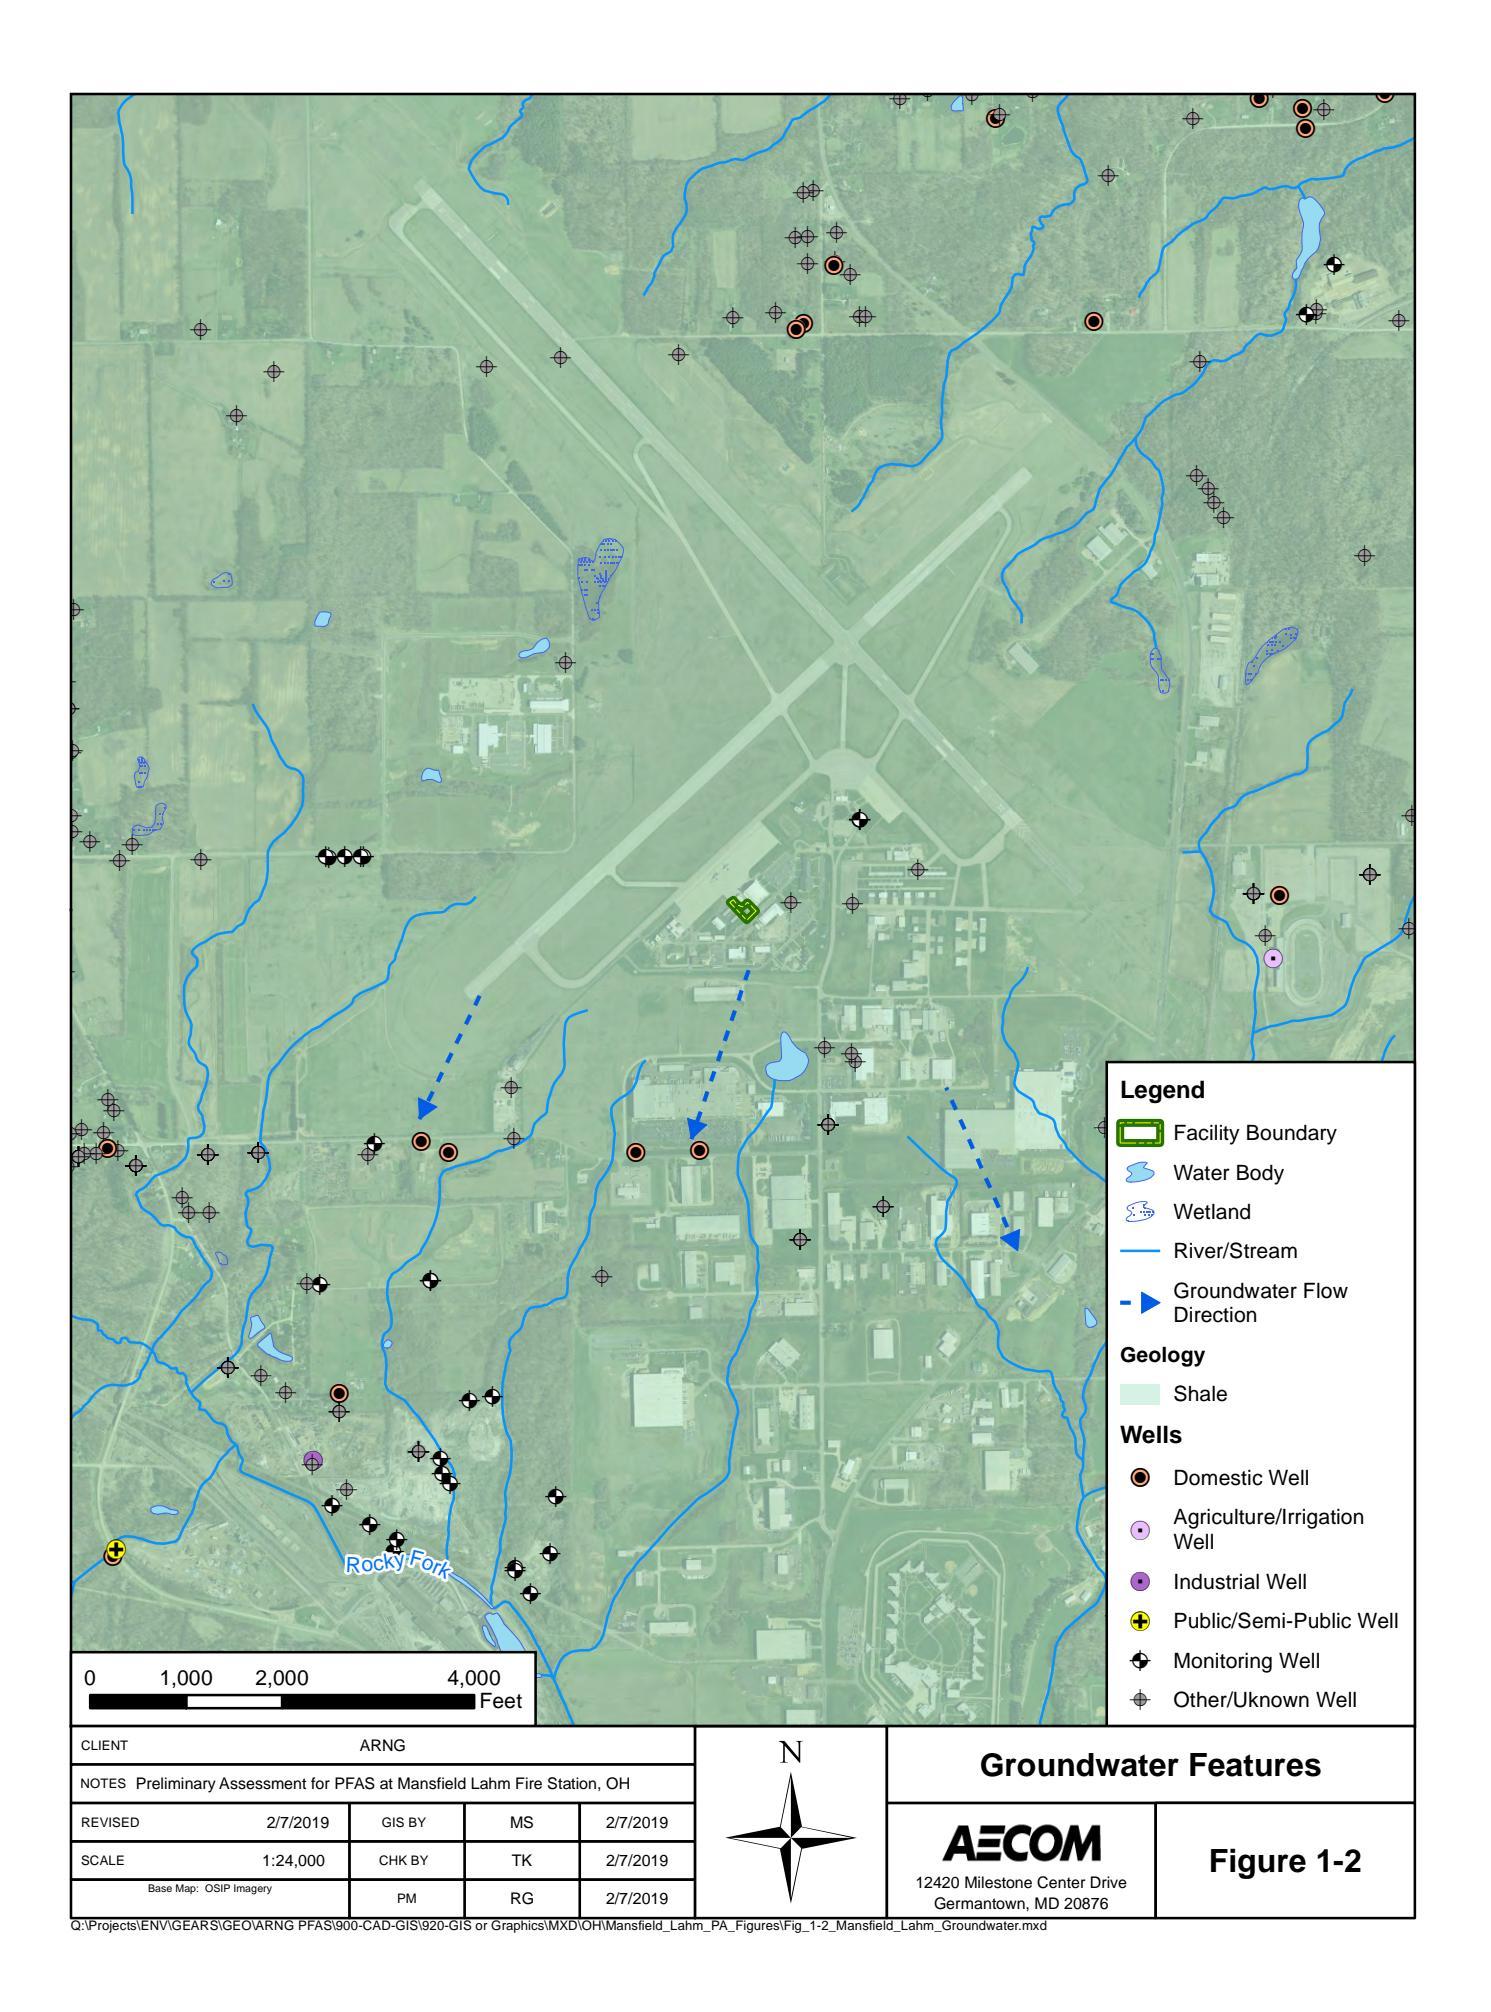
The property is located on the southwestern side of a topographic high point, and groundwater generally flows radially from the topographic high. Groundwater generally flows to the south and west in the direction of Rocky Fork, a stream located approximately 1.4 miles west from the facility boundary (**Figure 1-2**). While the water table shows variability around the facility, typical depth to water ranges from 14 to 118 feet below ground surface (ODNR, 2018). No potable water wells are located within the Mansfield Lahm Fire Station; however, domestic wells and monitoring wells exist within a mile of the facility, including at the Mansfield Lahm Regional Airport (**Figure 1-2**).

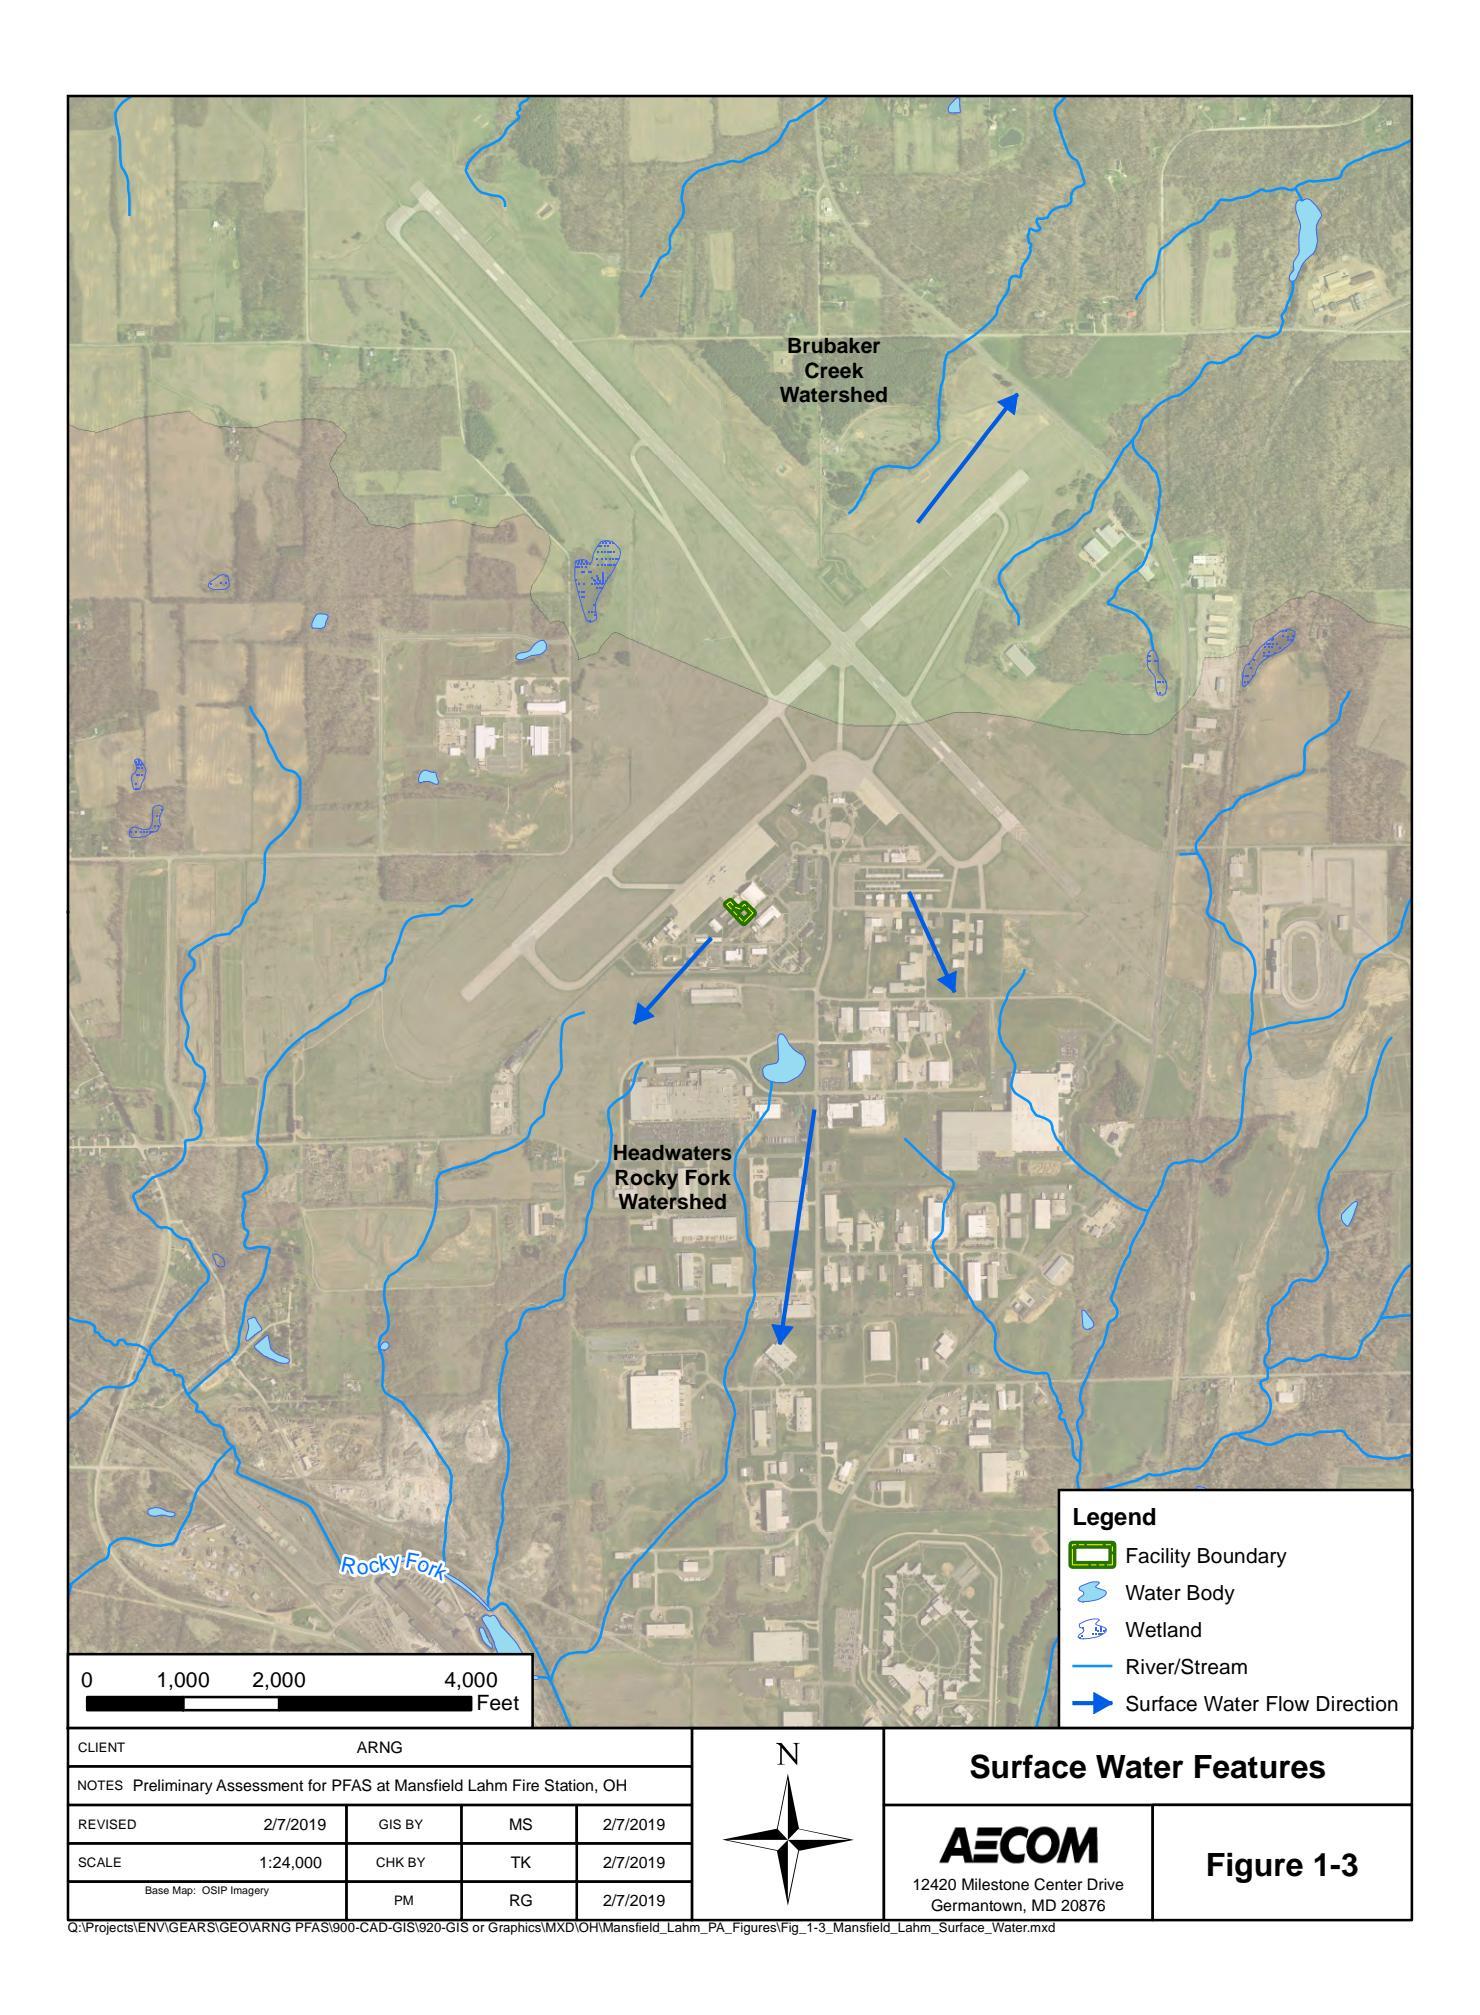
No surface water currently enters Mansfield Lahm Fire Station. Surface water runoff from the north, west, and central areas surrounding the Mansfield Lahm Fire Station collects in an underground drainage system on the southwest of OHANG property. This drainage system then discharges to an off-site outfall in Rocky Fork. Six intermittent streams originate within 3,000 feet of the facility and flow radially away from the facility from the southeast to the west. All of the intermittent streams flow into Rocky Fork. One retention pond is located approximately 1,400 feet south of the facility boundary (**Figure 1-3**).

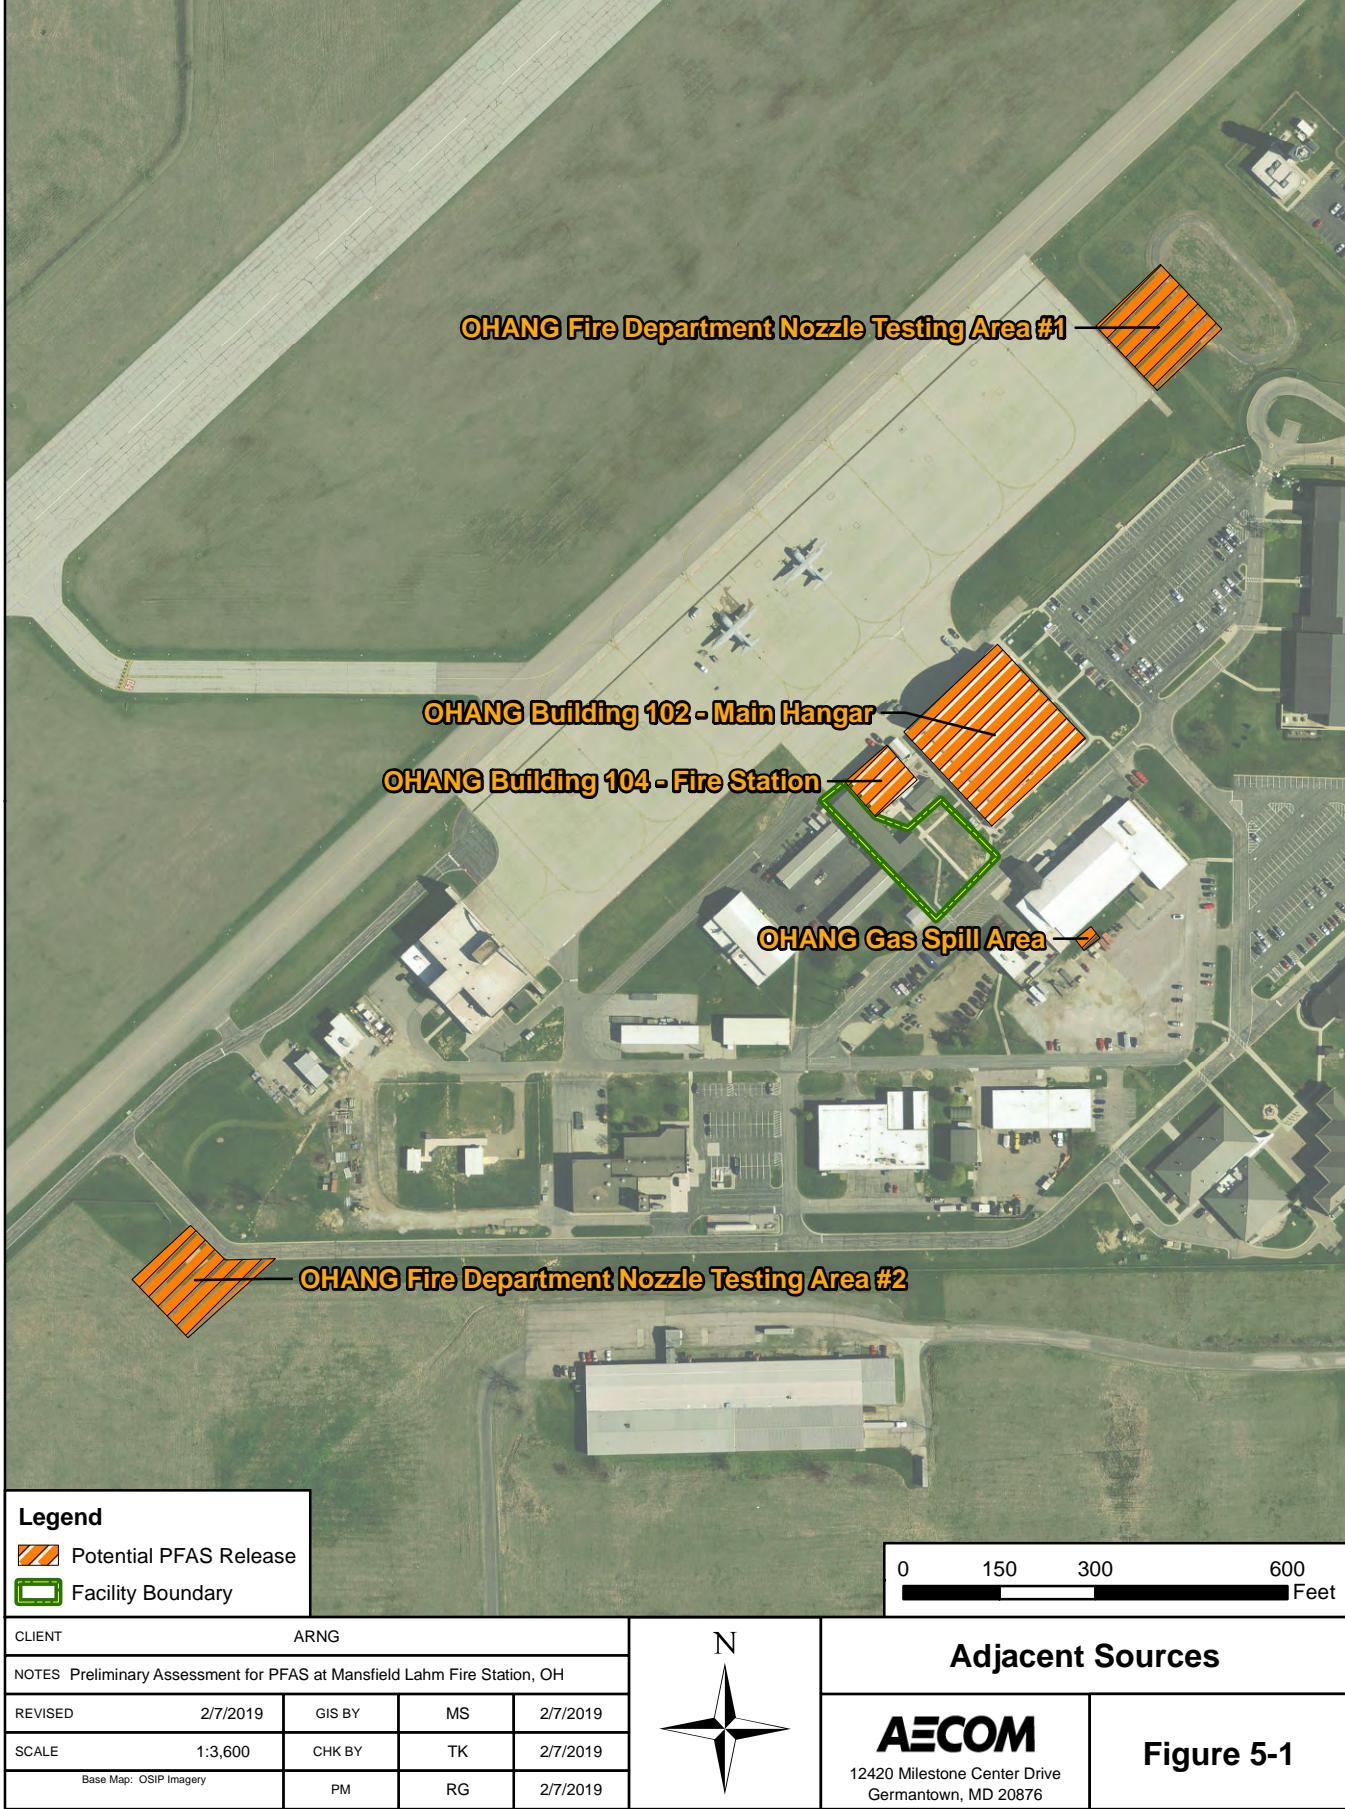
Q:Projects/ENV/GEARS/GEO/ARNG PFAS/900-CAD-GIS/920-GIS or Graphics/MXD/OH/Mansfield_Lahm_PA_Figures/Fig_5-1_Mansfield_Lahm_Adjacent_Sources.mxd

The Mansfield Lahm Fire Station sits within the OHANG's 179th Airlift Wing (179AW). During the PA, several areas of potential use, storage, or release, not under control of OHARNG, were identified within the OHANG facility. The 179AW has utilized AFFF since the 1970s; therefore, these ares have the potential to impact soil, sediment, and surface water within the OHANG property. Descriptions of the adjacent sources are presented below and are shown on **Figure 5**-**1**.

According to a PA conducted by engineering firm BB&E, several potential AFFF releases have occurred on OHANG property that are adjacent to the Mansfield Lahm Fire Station (BB&E, 2016). The Mansfield Lahm Fire Station sits within the OHANG's 179th Airlift Wing (179AW). The 179AW has utilized AFFF since the 1970s, and may be a potential source of PFAS. The OHANG is currently conducting PFAS investigations at the 179AW. Contact the 179AW for any details on the status of this investigation.

199 Based on surface water flow directions surrounding the facility, there is the potential for AFFF 200 releases from OHANG property to impact the Mansfield Lahm Fire Station. Surface water runoff 201 from the north, west, and central areas surrounding the Mansfield Lahm Fire Station collects in an 202 underground drainage system on the southwest of OHANG property. This drainage system then 203 discharges to an off-site outfall in Rocky Fork. Any surface water runoff not captured within the 204 underground drainage system has the potential to flow through the property boundary of the 205 Mansfield Lahm Fire Station, leaving the potential for AFFF releases to impact the Mansfield Lahm 206 Fire Station.

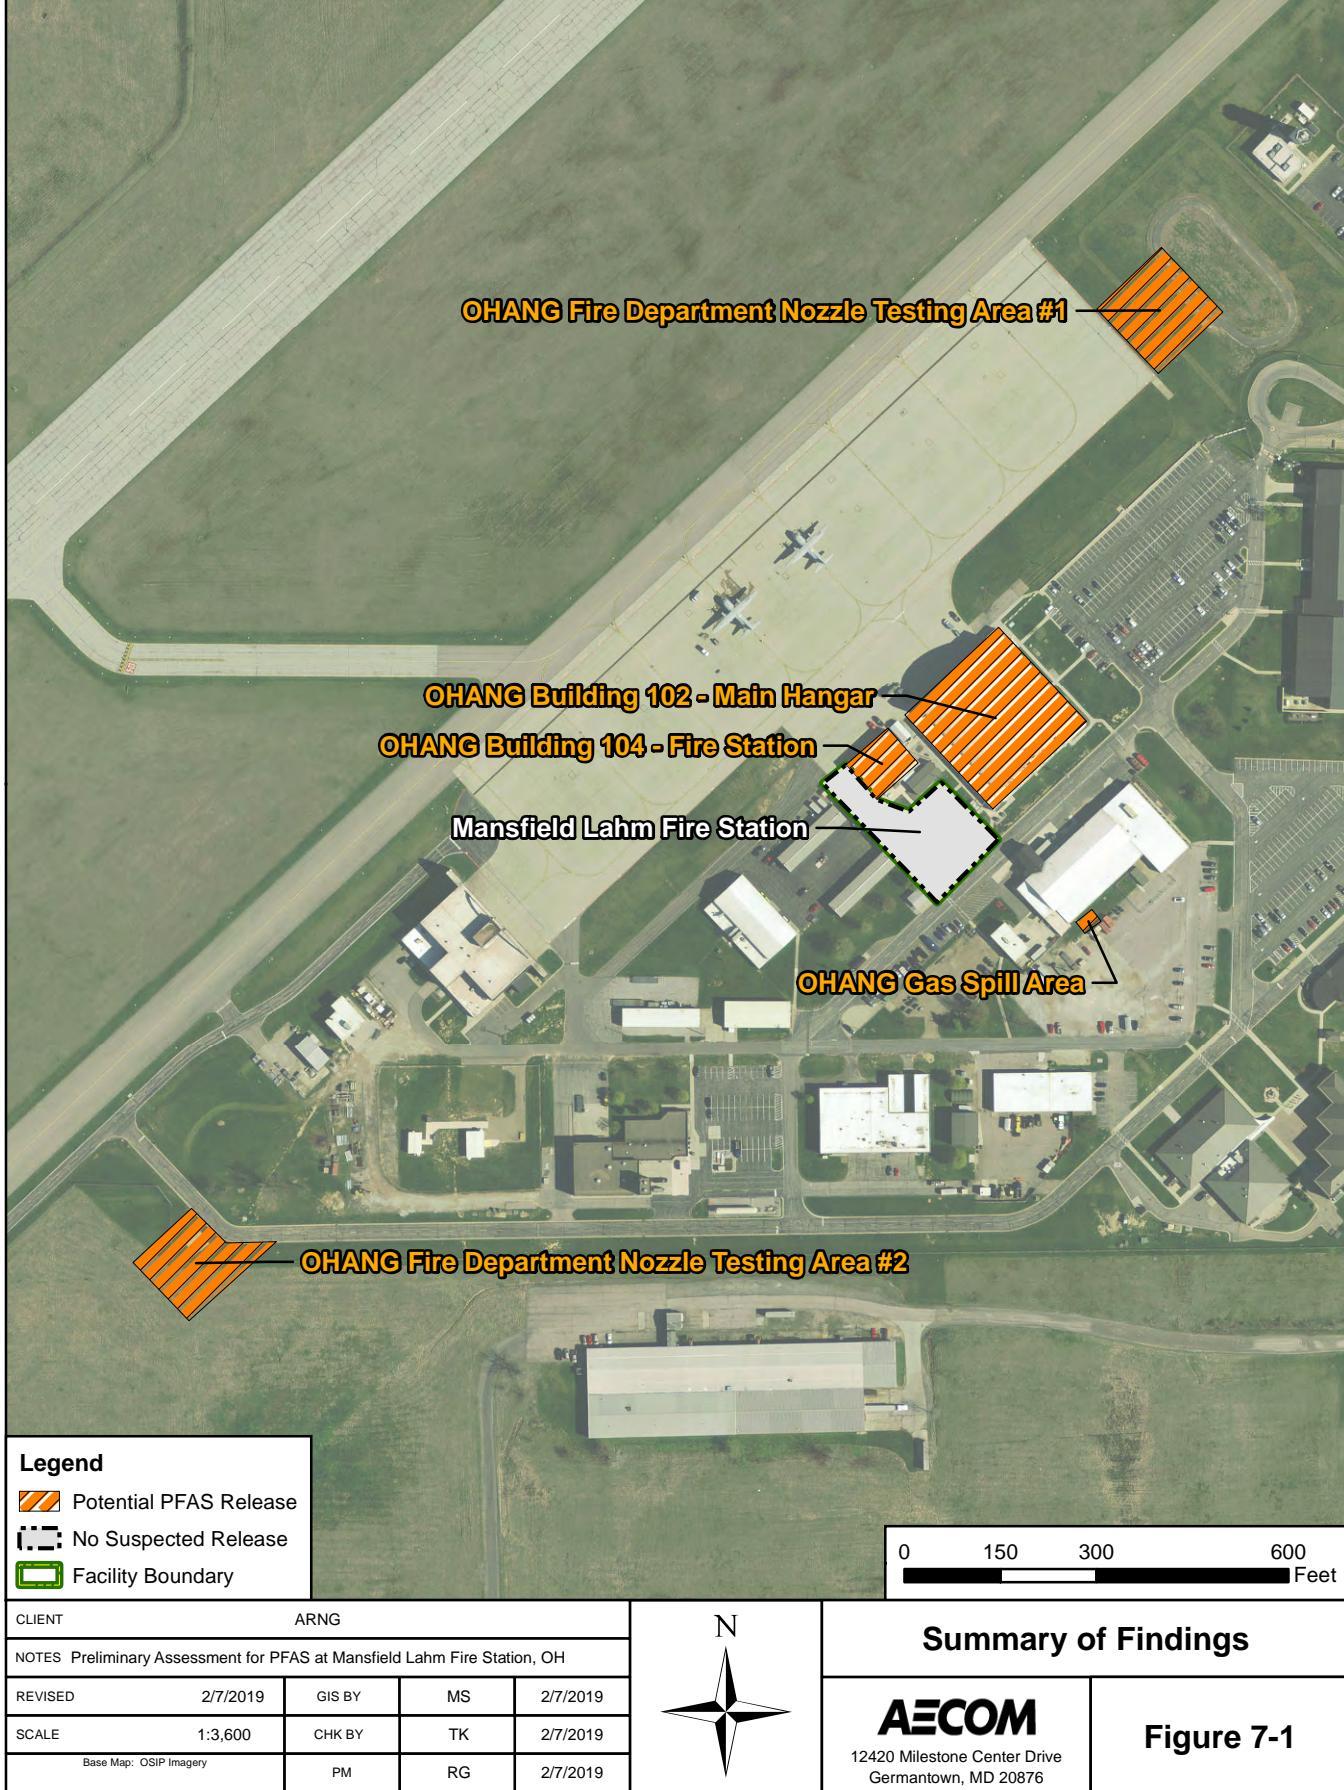
Q:Projects\ENV\GEARS\GEO\ARNG PFAS\900-CAD-GIS\920-GIS or Graphics\MXD\OH\Mansfield_Lahm_PA_Figures\Fig_7-1_Mansfield_Lahm_Summary.mxd

Based on information obtained during interviews conducted with facility personnel, facility
observations, and reviewed documentation, it is confirmed that AFFF has not been stored, used,
or released at the Mansfield Lahm Fire Station; therefore, no AOIs related to PFAS release were
identified at the Mansfield Lahm Fire Station.

Based on the documented absence (2007-present) of the use, storage, or release of PFAScontaining materials at Mansfield Lahm Fire Station, no AOIs were identified during the PA.
Evidence does not indicate that current or former ARNG activities contributed PFAS
contamination to soil, groundwater, surface water, or sediment at the facility or adjacent areas.
Mansfield Lahm Fire Station will not move forward in the CERCLA process.

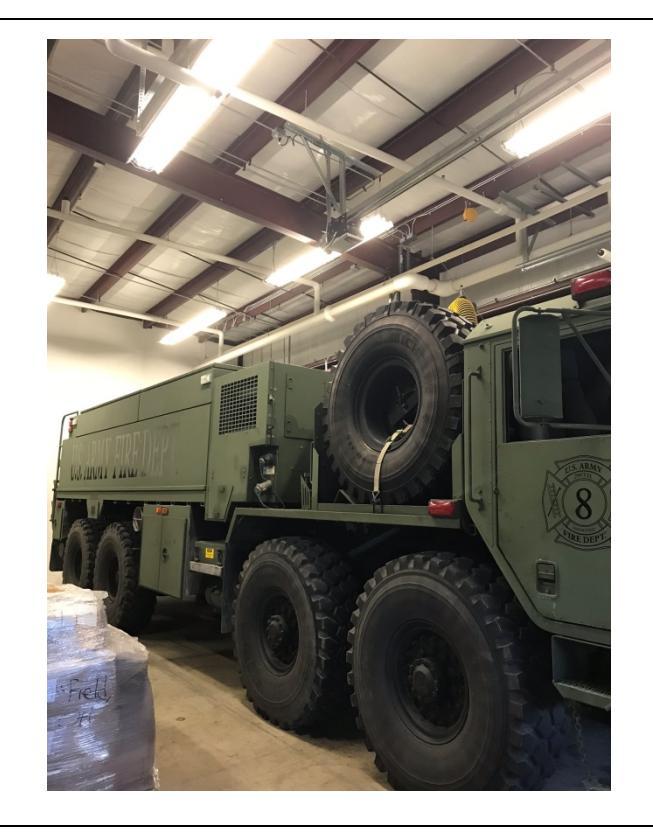
One of the firetrucks inside of the Mansfield Lahm Fire Station. This truck does not contain an AFFF-capable tank.

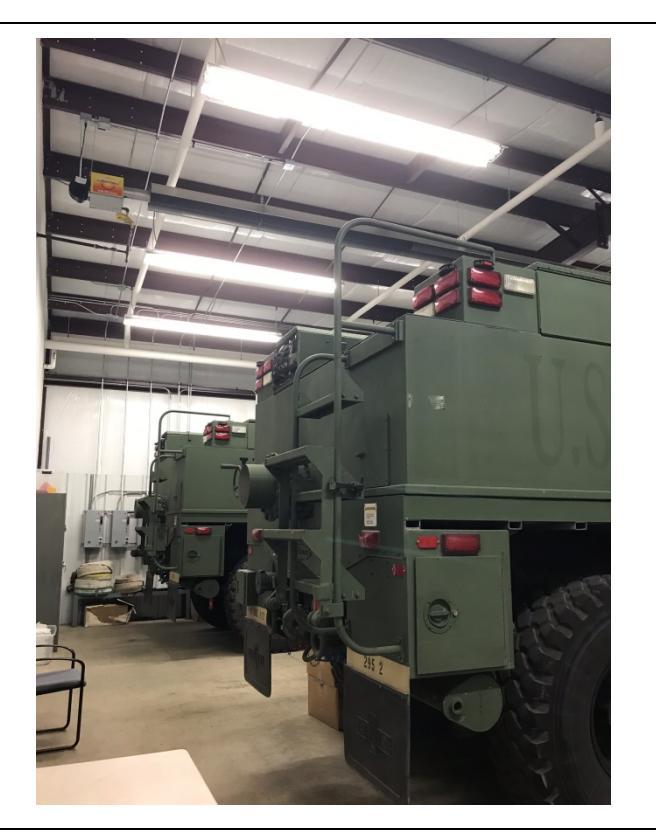
Photograph No. 2

View of two of the firetrucks from the back of the fire station. Picture was taken at the entrance door into the fire station from the administration side. No fire suppression system is present in this fire station and no storage of AFFF occurs at this location.
