Surface Lead Sampling Reports

Indoor Firing Ranges

Surface Metal Monitoring Survey Report

Survey Date: November 30, 2012

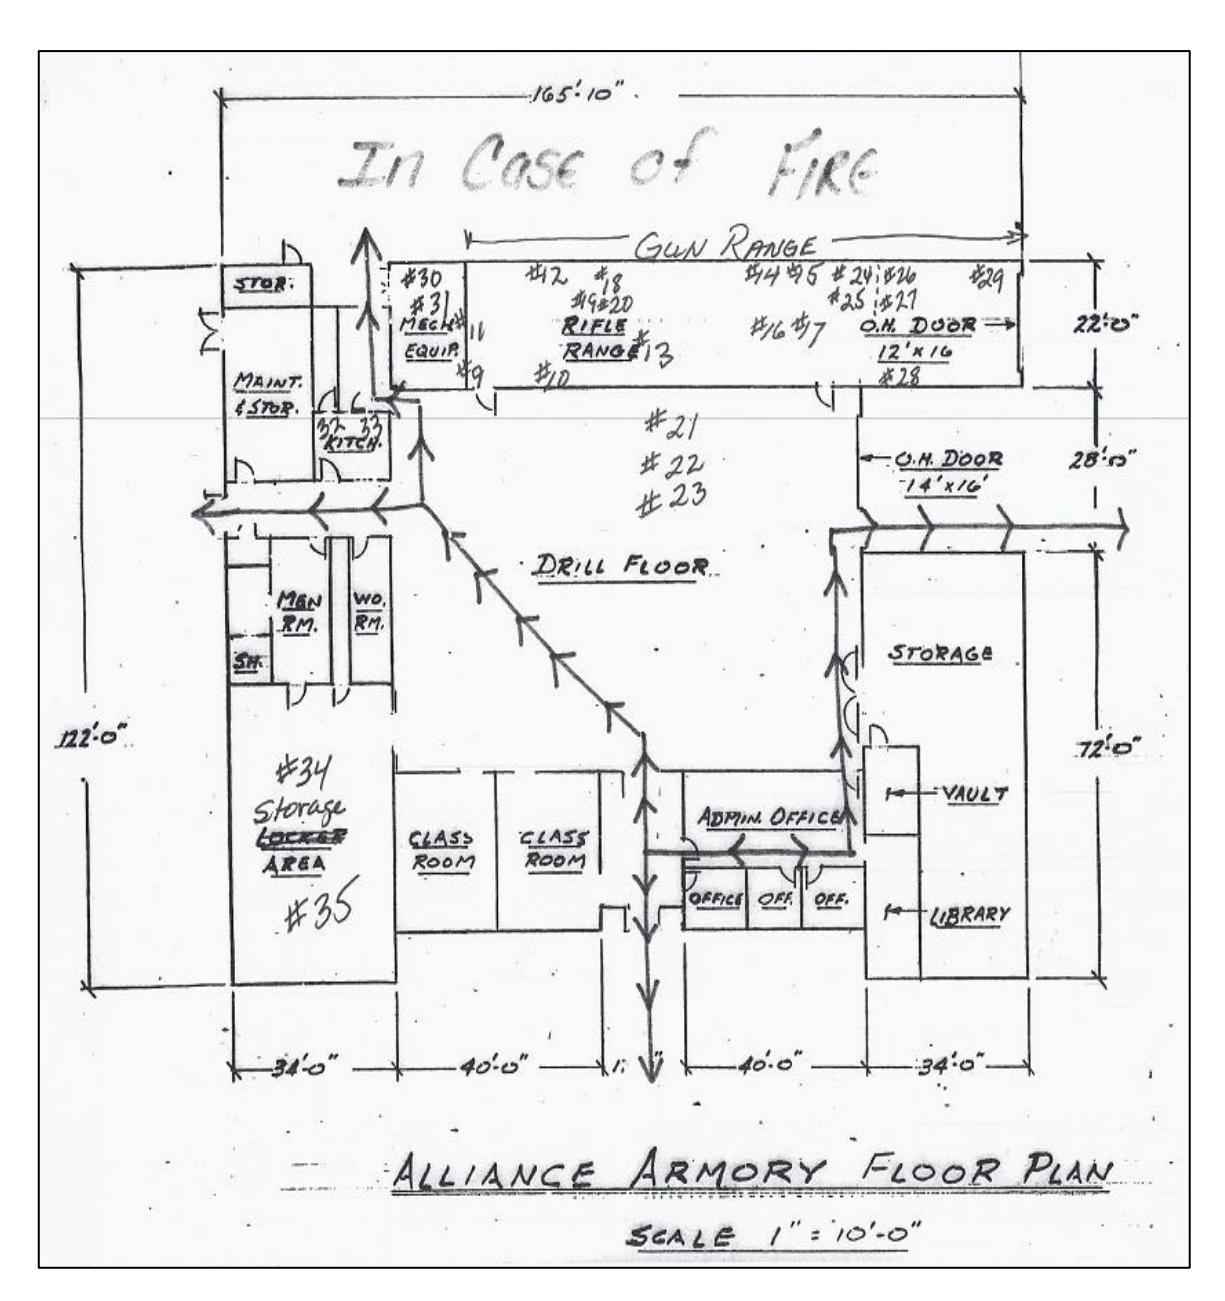
Figure 1. Alliance Armory Floor Plan with Sampling Locations (January 2015).

Lead	Contents	Structures & Furnishings
Clean <200 μg/ft ²	2	5
Moderate <1K μg/ft ²		7 (floor, wall, mat, shelf, flammable cabinet)
High >1K μg/ft²		2 (floor, light)
Very High >10K μg/ft ²		5 (angle iron, ceiling duct interior, light)
Gross > 100K µg/ft ²		1 (ceiling grille exterior)
Total Number of Results >200 μg/ft ²	0/2	15/20
Summary	 Contents: 2 samples clean (o Structures/Furnishings: 75% of gross lead contamination leve Gross contaminated found on ventilation system. Exhaust grilles, ductwork, ang contaminated. 	nly 2 samples). of results showed moderate to ls. grille exterior; very high inside le iron, light fixtures

Recommendations:

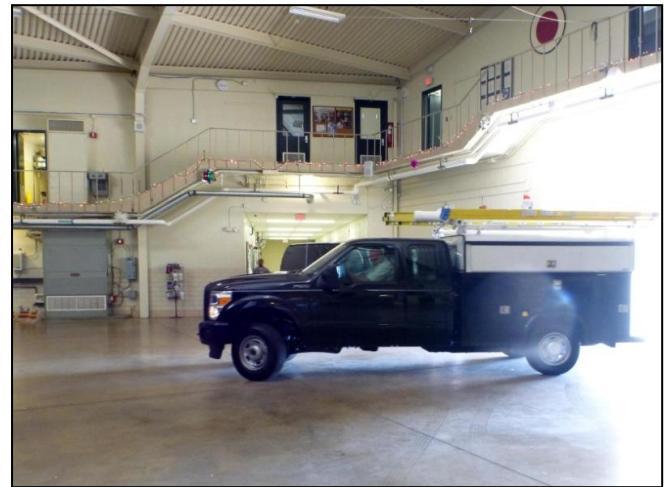
Figure 1 – Drill Floor.

Vehicles are transferred in and out of the drill floor on a routine basis (Figure 1). Carbon monoxide (CO) and oxides of nitrogen (NO_x) could potentially build up and cause indoor air quality concerns for administrative personnel assigned to offices near the drill floor. Minimize running vehicle engines indoors, increase the percent of outdoor air to the building when transferring vehicles, open the roll up doors and consider the wind direction to avoid distributing exhaust to nearby spaces. Consider installing industrial CO/NO_x detection and alarm systems to warn employees of the presence of elevated levels of contaminants. Industrial hygiene personnel may want to collect CO/NO_x data and possibly diesel exhaust samples when vehicles operate indoors to document the levels of contaminants.

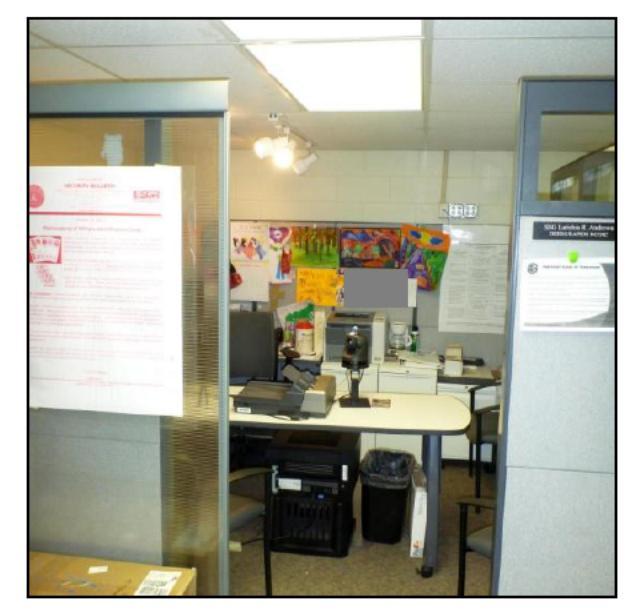
Figure 4 – Workstation with Laminator.

A noticeable odor from the laminator was observed in the DEERS office (SSG Andrews workstation, Figure 4). The laminator is a small desk top model. SSG Andrews was not available to be interviewed at the time of this survey. Other personnel assigned to this office stated the laminator remains on during the entire work shift. Two supply air vents were observed in this office, but no return air vent was located. The following recommendations are based on the initial walk-thru of this space. Verify adequate ventilation is provided to this space in accordance with ASHRAE 62.1-2010, *Ventilation for Acceptable Indoor Air Quality*, including adequate outdoor air (5 cfm/person and 0.06 cfm/square foot). Review the laminator manufacturer's data (and the MSDS for the materials if available) to determine if this process potentially produces any toxic air emissions. Determine if the laminator must remain on during the entire shift. Depending on the answers to these questions, it may be necessary to replace the laminator unit/materials, provide local exhaust ventilation, or increase the general ventilation/outdoor air supply to this office.

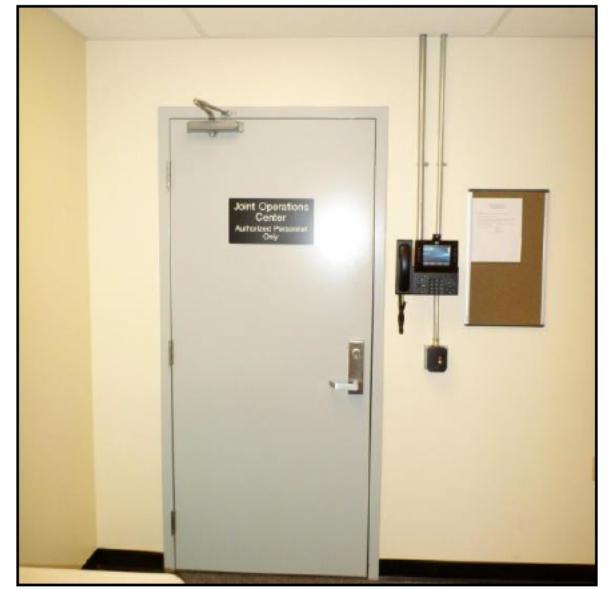
Figure 5. JOC Entry (no interior photos were permitted due to security concerns).

The basement Joint Operations Center (JOC, Figure 5) was toured and the raised floor that provides an access area for utilities and communications cable was observed. The under floor space is approximately three feet in depth and reportedly runs the full length of the JOC. This area is reportedly entered by personnel as needed to run, reroute, and maintain communications cable. There appears to be no (or limited) ventilation provided to the under floor area and lighting is not provided. Due to the size and configuration of this area, a confined space determination and evaluation in accordance with OSHA 29 CFR 1910.146 should be conducted and documented (RAC 2).

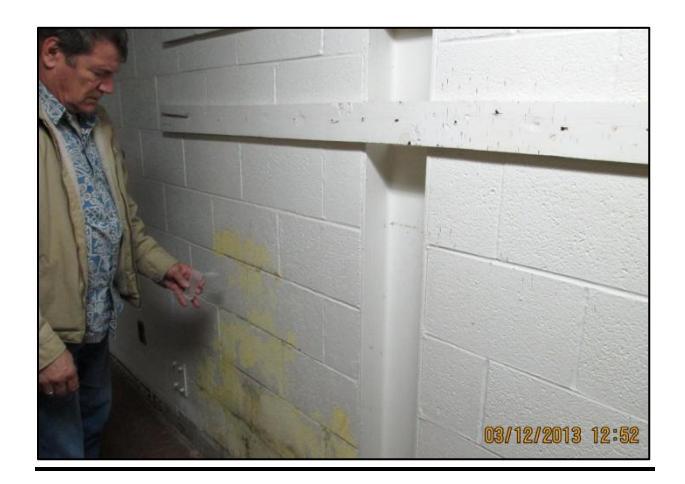
Figure 1. Paint Chip Sample Collection in the "Repair 3" Area.

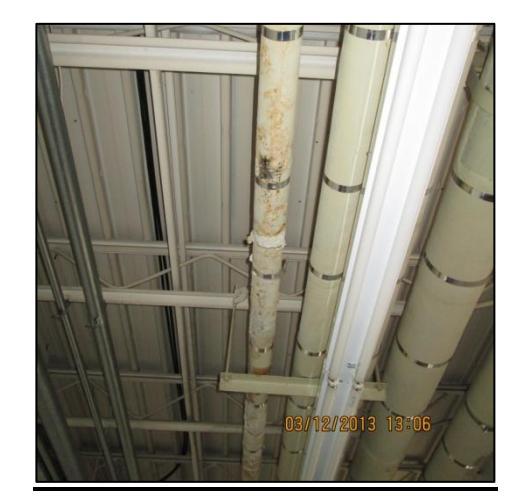
Figure 2. Damaged Overhead Pipe Insulation in 684th Medical Company Corridor.

Recommendations:

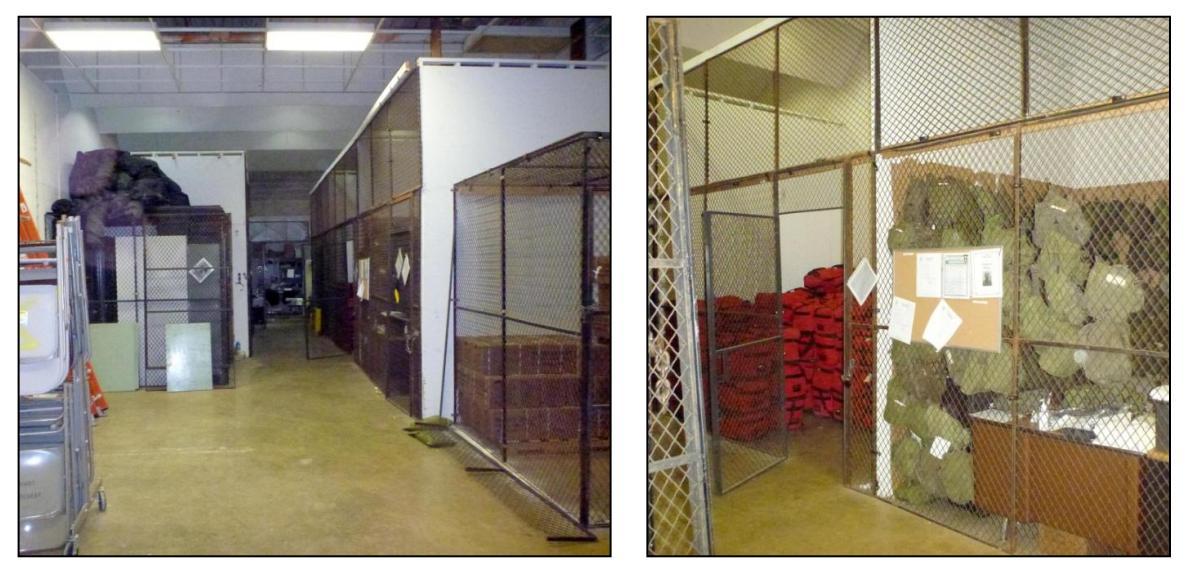
Figure 2 – Room 121 Storage Area/Old Firing Range.

The Kettering Armory had a firing range in that was converted to storage space between 1990 and 1992 (Figure 2). The old range area is currently used as a storage room for chemical, biological, radiological, nuclear and high yield explosive (CBRNE) enhanced response force packages (CERFP) team equipment and supplies. The CERFP teams have a command and control section, a decontamination element, a medical element, a casualty search and extraction element, and a fatalities search and recovery element.

He added that the metal cages were added between 1993 and 1994, the kitchen and heating ventilation and air conditioning systems were renovated in 2002, and the roof was replaced more recently. Mr. Melling also stated that the return air duct traversing above the old bullet trap area and some of the light fixtures are original range equipment.

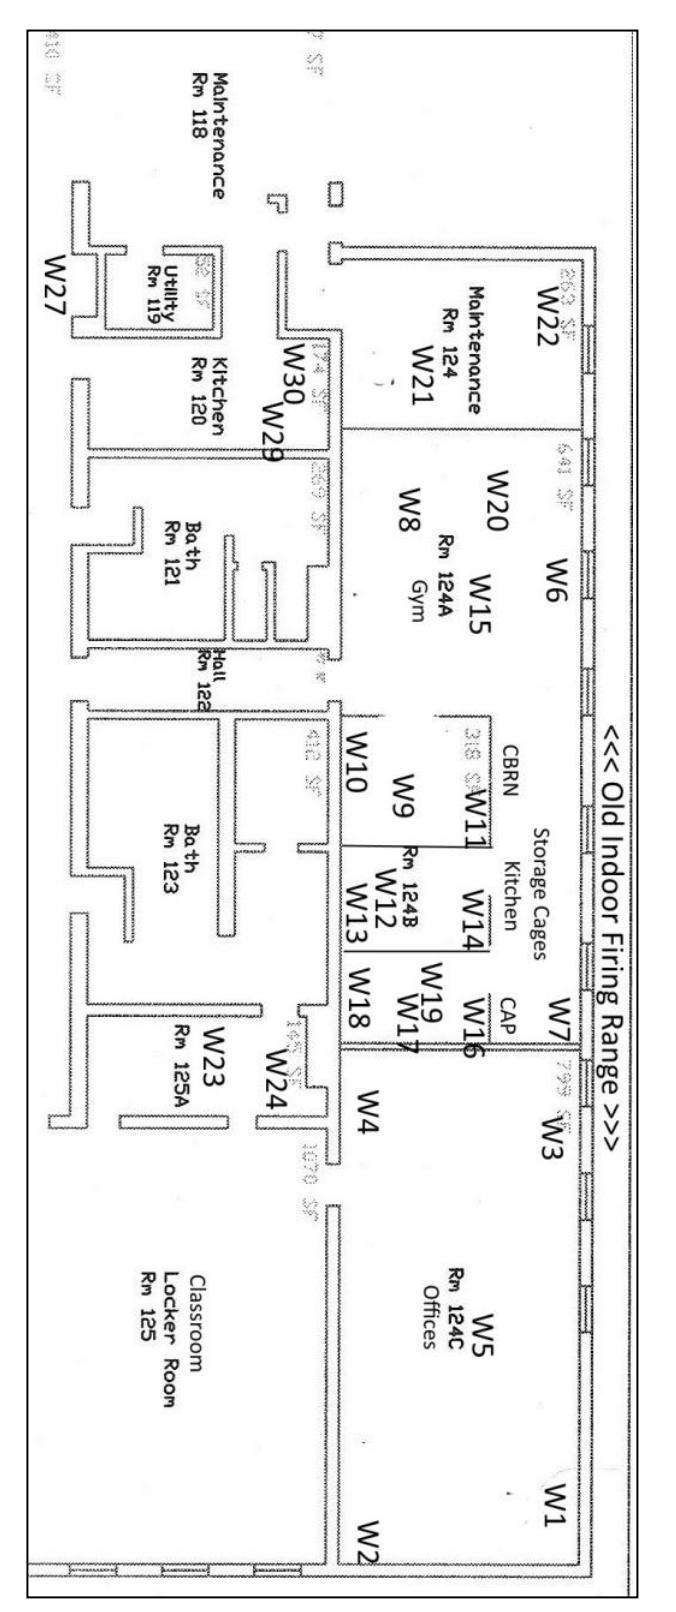
Figure 1. Newark IFR Floor Plan with Sampling Locations (January 2015).

Sample #	Location	Photo	Lead (µg/ft ²)	Sample #	Location	Photo	Lead (µg/ft ²)
NEW- W15	Old range, Room 124A, weight room, on top of chin up bar frame	NEW-WIS	<91	NEW- W20	Old range, Room 124A, weight room, on top of light fixture above ceiling		<91
NEW- W16	Old range, Room 124B, CAP cage, on top of metal storage locker		<91	NEW- W21	Old range, Room 124, maintenance shop, on metal storage shelf		<91
NEW- W17	Old range, Room 124B, CAP cage, inside metal storage locker on bottom shelf		<91	NEW- W22	Old range, Room 124, maintenance shop, on desk		<91
NEW- W18	Old range, Room 124B, CAP cage, on vinyl cover under sleeping mats		<91				
NEW- W19	Old range, Room 124B, CAP cage, on outside packaging for water bottles		<91
