1. PURPOSE OF EVALUATION. To conduct surveys at Maryland Army National Guard (MDARNG) facilities to identify and measure the existence and extent of potentially hazardous operations or conditions.

2. PURPOSE. To conduct an industrial hygiene survey at the Maryland Army National Guard (MDARNG) MG Harry C. Ruhl Armory, Towson, MD, to identify and measure the existence and extent of potentially hazardous operations or conditions. This survey will serve as a baseline so that an occupational exposure history can be compiled for each civilian or military employee.

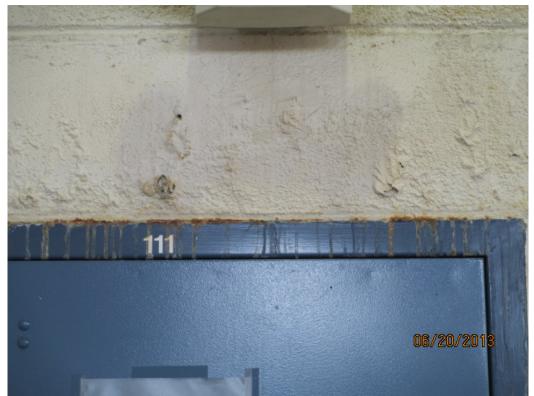
Chipped Paint above Door 111 in Drill Hall

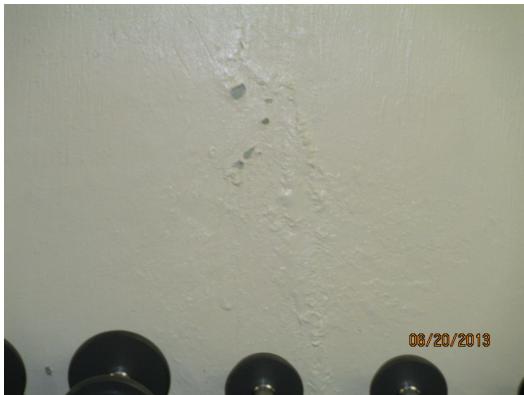
Chipped Paint on Gym Wall

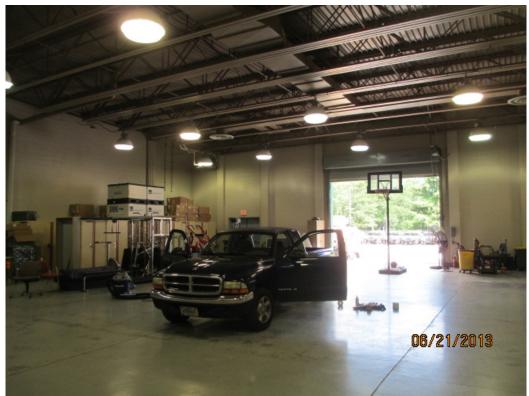
Drill Hall Open Door

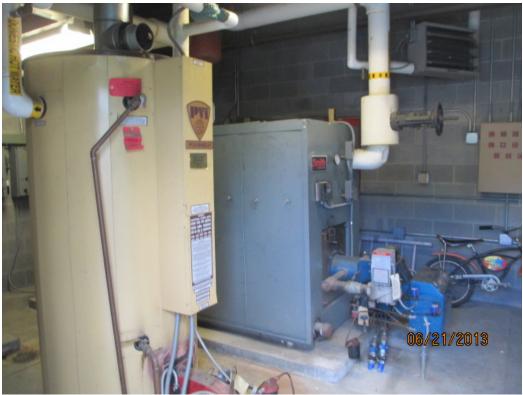
Boiler Room

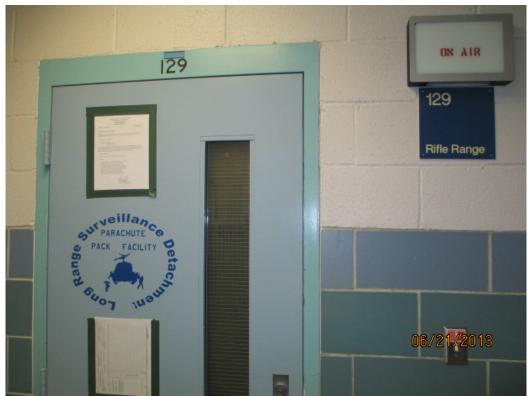
No Access to Converted Firing Range

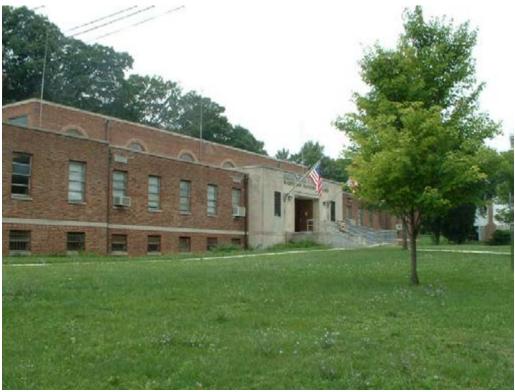
Exterior view of facility

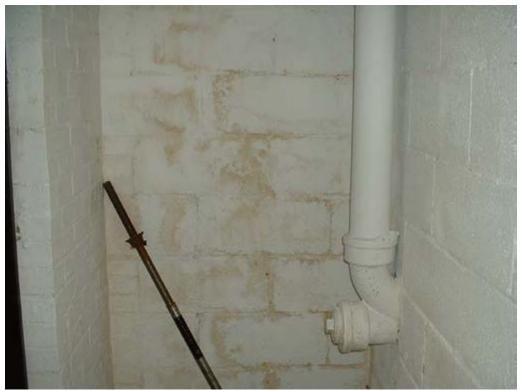
Water intrusion through subgrade wall (Room B1)

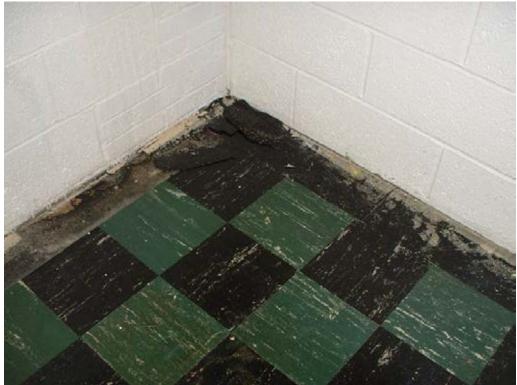
9" x 9" Floor tile located in Room 123 and 123A

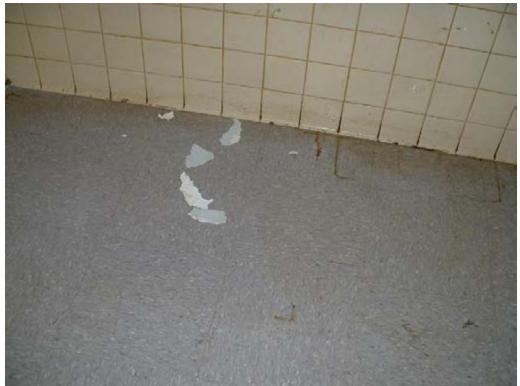
Deteriorated paint in kitchen area

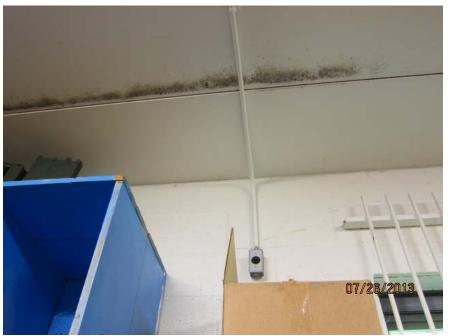
Room 122 visible fungal growth on ceiling this room has a strong mold odor

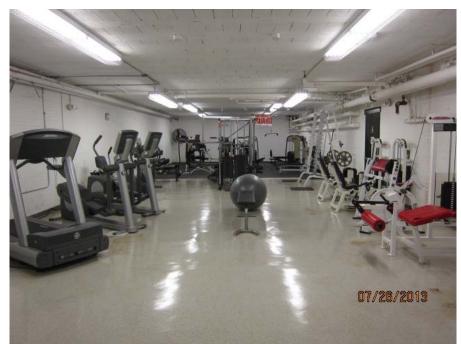
Converted firing range/weight room

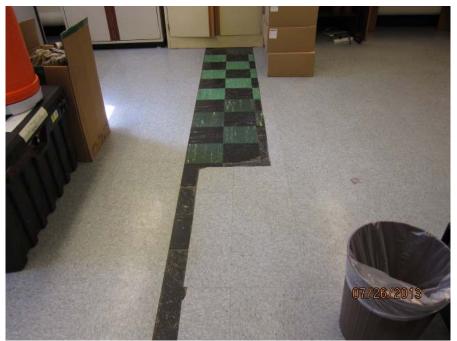
Suspect asbestos floor tile in good condition

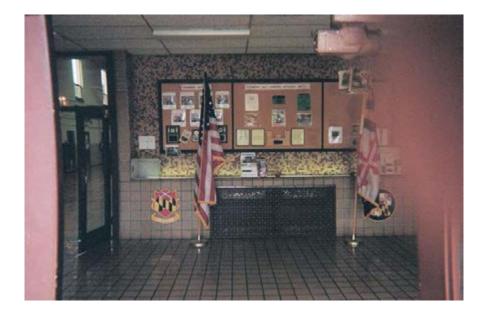
Photograph #1 – RC Lobby/Entry Area, view from entrance

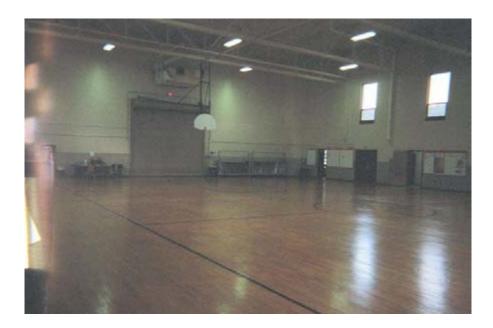
Photograph #2 – Drill Hall, general view

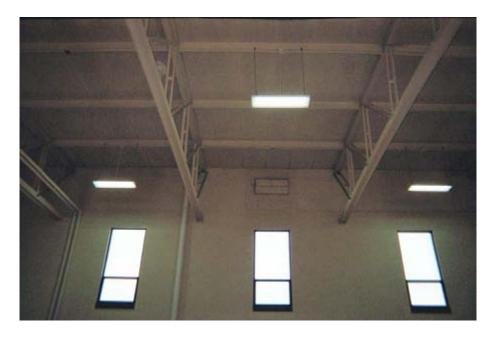
Photograph #3 – Drill Hall, wall-mounted ventilation exhaust

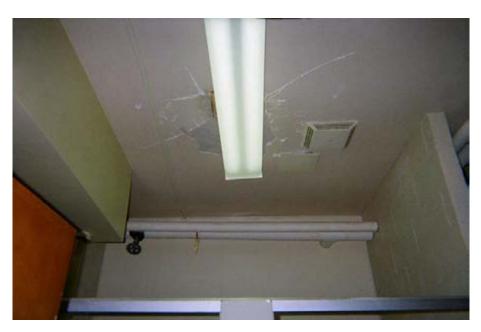
Photograph #4 – Women's Restroom, water-damaged ceiling plaster

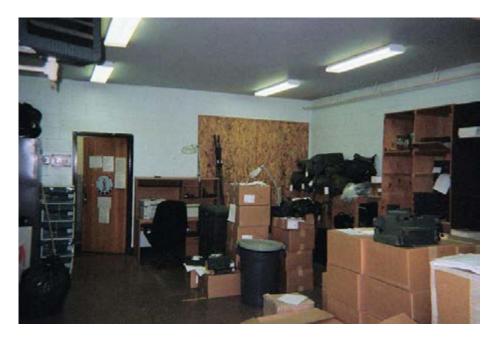
Photograph #5 – Supply Room Office/Storage, material stacked in space

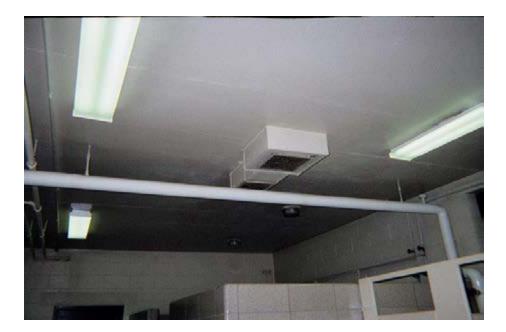
Photograph #6 – Men's Locker Room, non-functional exhaust (lead sample collected at vent)

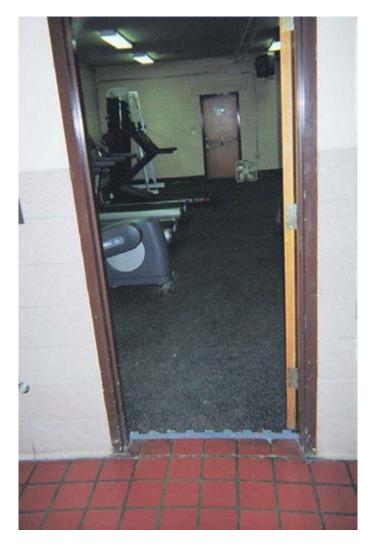
Photograph #7 – Fitness Center, rubber mat over 12 x 12 tile

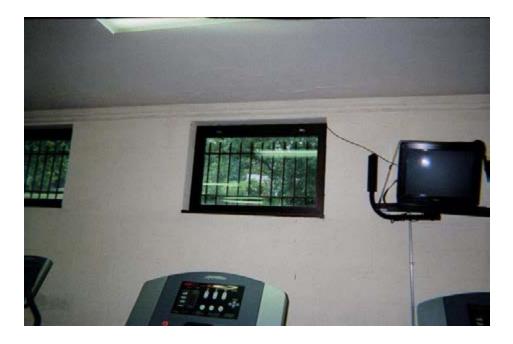
Photography #8 - Fitness Center, natural ventilation via open windows

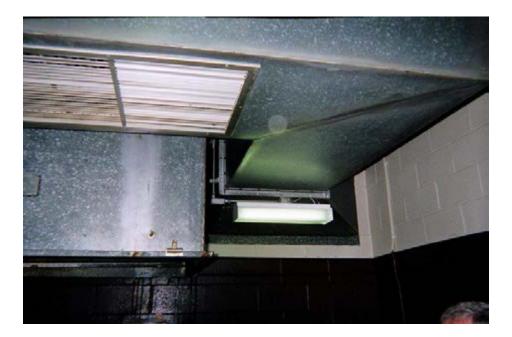
Photograph #9 – Kitchen, outdoor/make-up air duct/vent

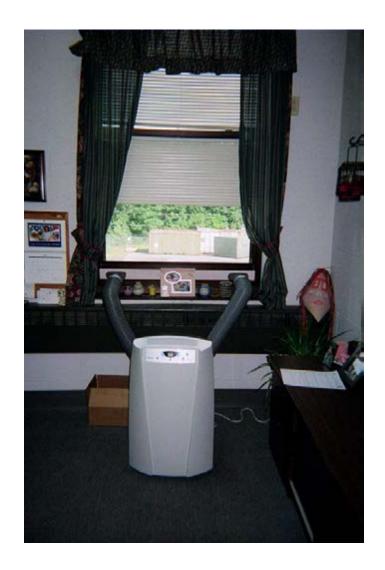
Photograph #10 – Distance Learning Center office, portable "drainless" air-conditioner, (vent intake and exhaust to outdoors)

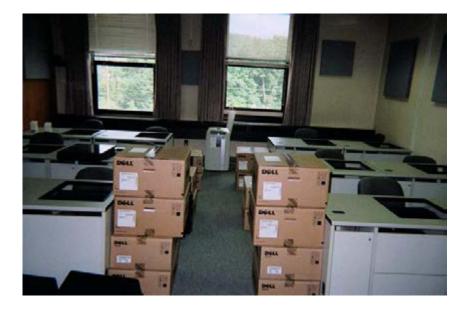
Photograph #11 – Computer Lab/Learning center

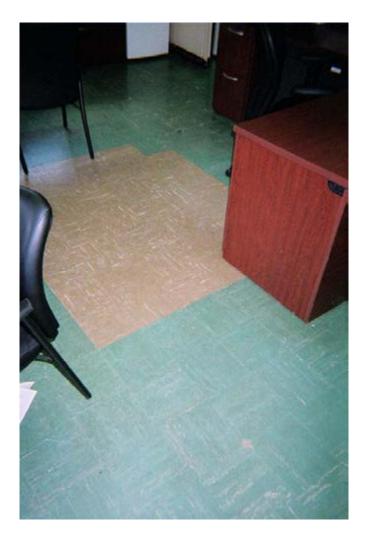
Main Floor, Administrative Office, nine inch square floor tile

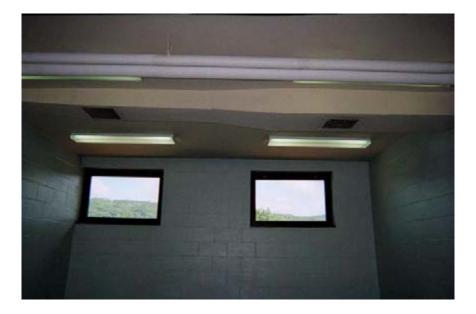
Photograph #12 – Basement, Unknown HVAC/ventilation duct

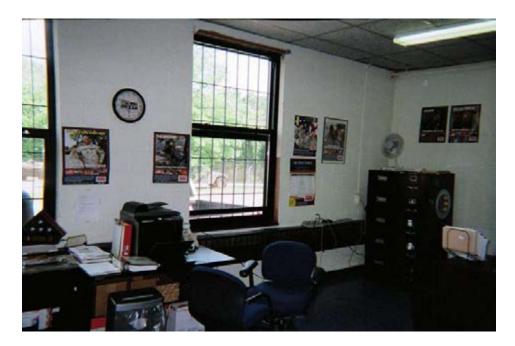
Basement, Recruiter's Office

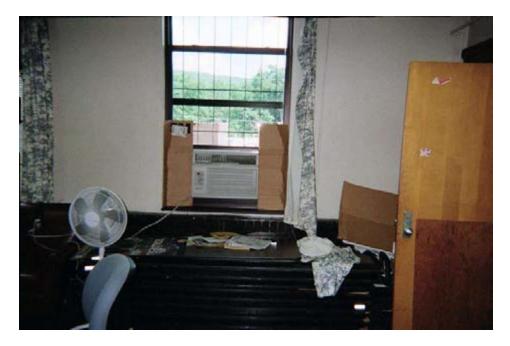
Basement, Lounge, view of window-mounted air-conditioner

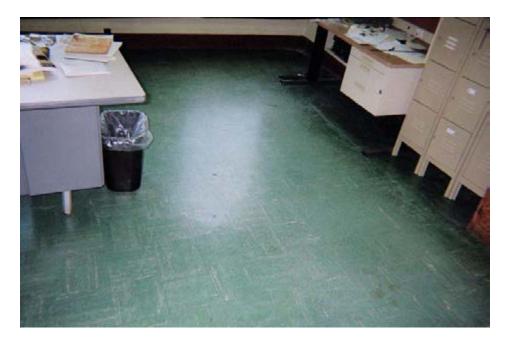
Main Floor, Old Signal Command Office, view of 9 inch square floor tile (presumed asbestos-containing)

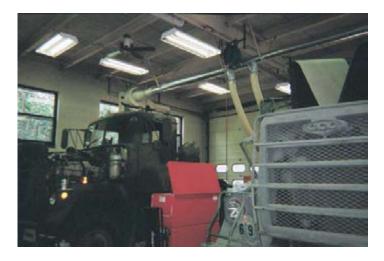
Basement, FMS 9 Garage, view of vehicle exhaust vent system

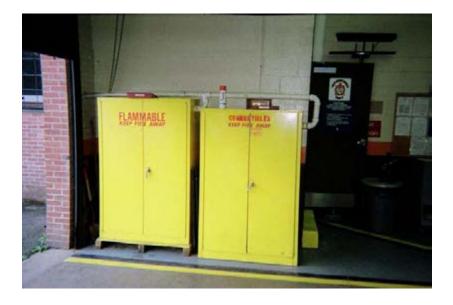
Basement, FMS 9, Flammable and Combustible storage cabinets

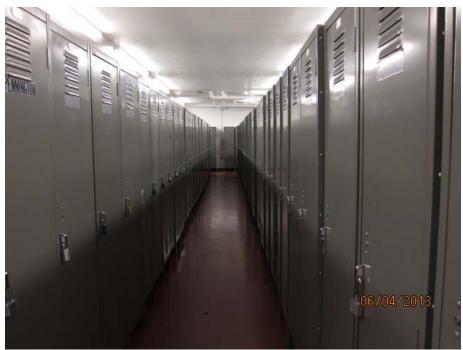
Converted firing range/wall locker storage area

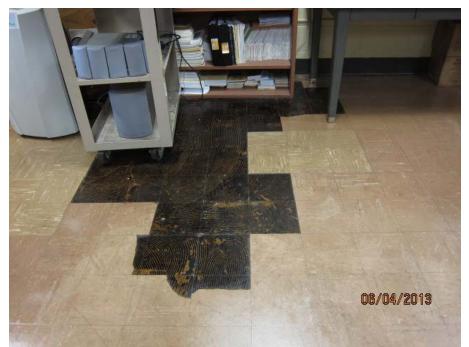
This facility has some areas of localized damaged and missing 9"X9" asbestos floor tile, < 10% of the total floor tile. The areas of missing floor tiles have exposed black mastic.

One of two locations of missing 9"X9" floor tile exposing black mastic, this location is room 2, 243rd supply room, the other location is room 12
