July 13, 2010 Project No. 1061-03

Project: Army National Guard Readiness Center, Industrial Hygiene Evaluation

Glen Burnie Army National Guard Armory

1.0 - EXECUTIVE SUMMARY

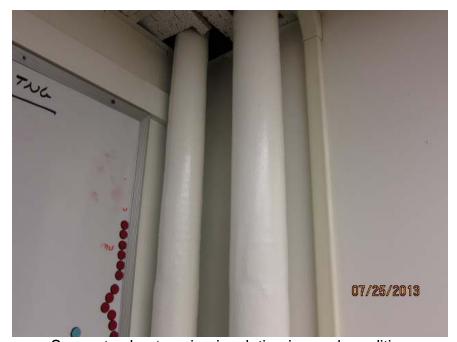
Suspect asbestos pipe insulation in good condition

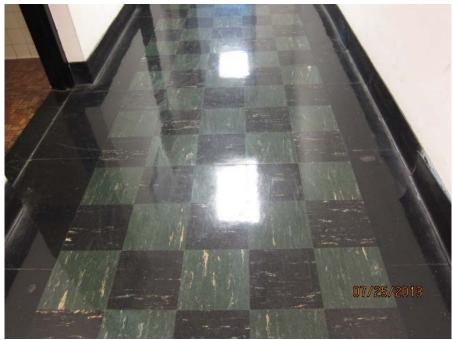
Suspect asbestos floor tile in good condition

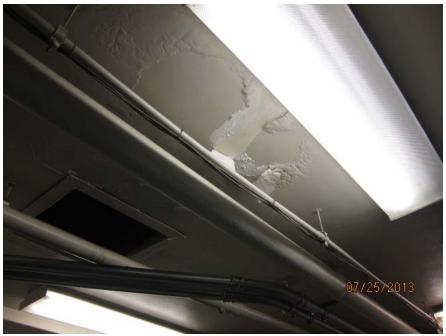
Kitchen ceiling peeling paint

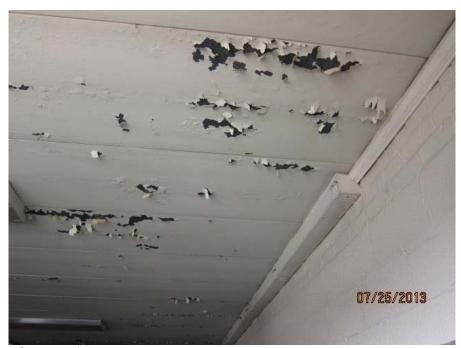
Second floor wall locker storage area peeling paint on ceiling

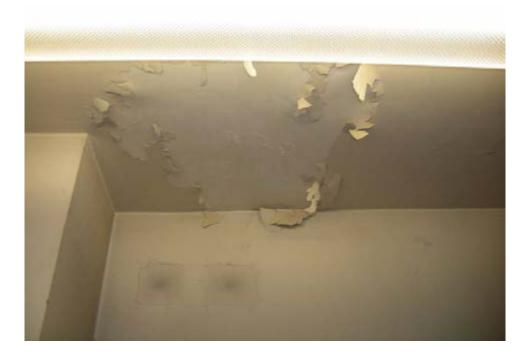
Photograph #4 – Chipping Paint in the Mail/Copy Room

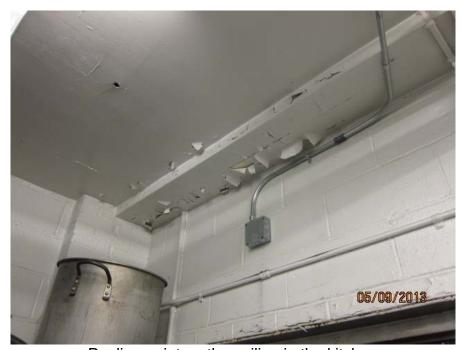
Peeling paint on the ceiling in the kitchen

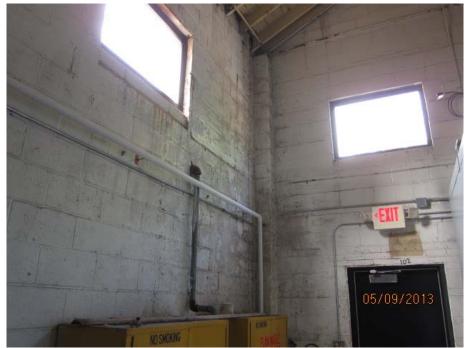
Effloresces on the exterior walls of the converted maintenance bay

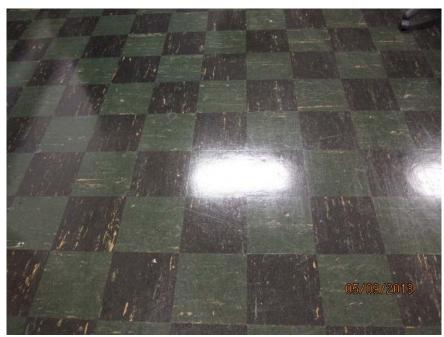
Recruiter's office 9"X9" damaged floor tile one of several locations

- 5. Damaged, suspect asbestos containing floor tile were observed in the lounge and maintenance office. Damaged areas of suspect asbestos containing material should be properly abated or repaired.

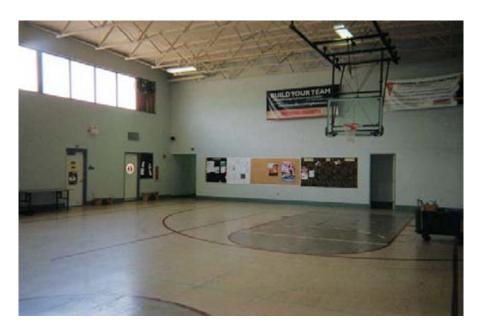
Photograph #1 – RC Drill Hall

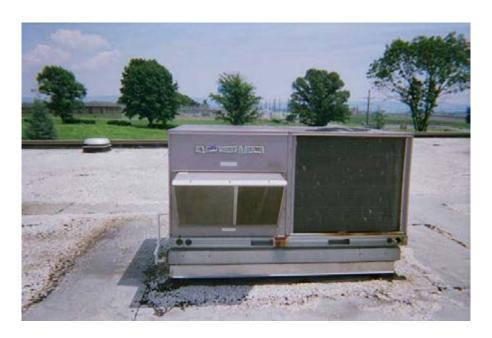
Photograph #3 – Roof-mounted Package HVAC unit, intake area

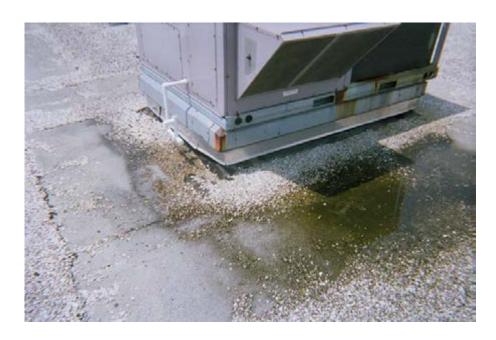
Photograph #4 – Roof-mounted Package HVAC unit, intake area, pooled water

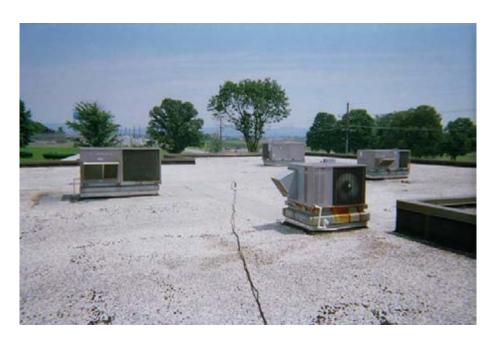
Photograph #5 – Roof, View of package HVAC units

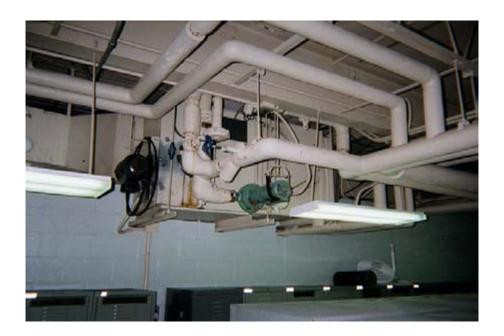
Photograph #6 – Men's Locker Room, HVAC unit at ceiling

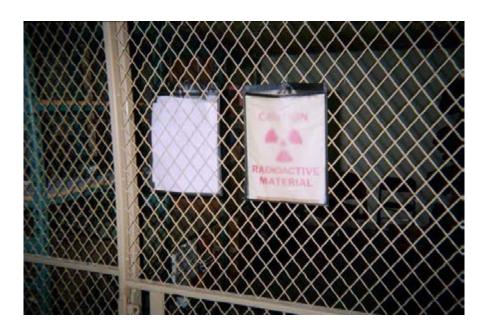
Photograph #7 – HHC Lower Level Supply Storage, questionable equipment in storage

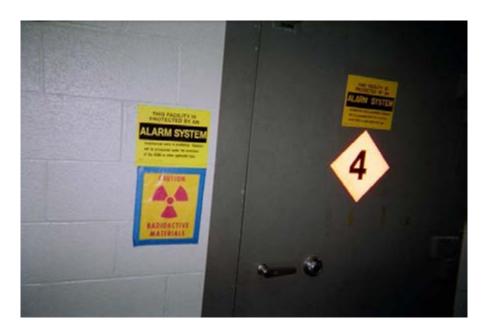
Photography #8 – Military Police Area Vault, questionable materials stored in vault

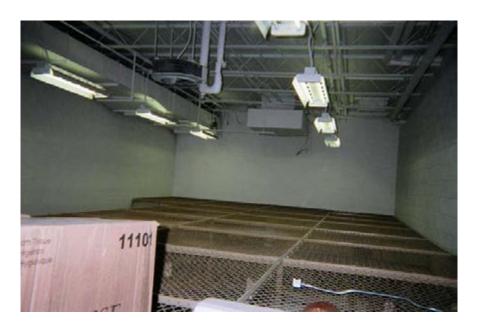
Photograph #9 – HHC Lower Level Storage – Abandoned duct from old firing range (rear wall of photo)

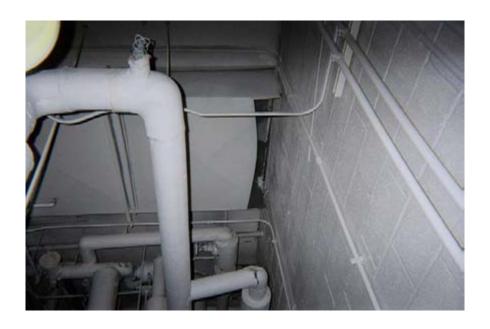
Photograph #10 – Boiler Room – Abandoned duct from old firing range (currently separated from HHC Lower Level Storage by block wall)

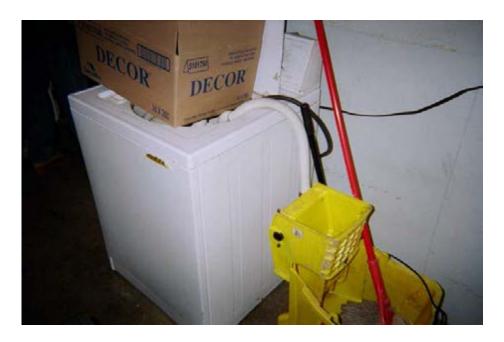
Photograph #12 – Caretaker's Office, Washing Machine

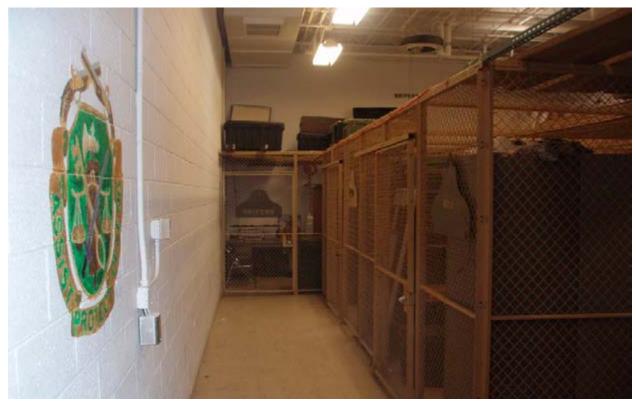
Converted Firing Range - Storage

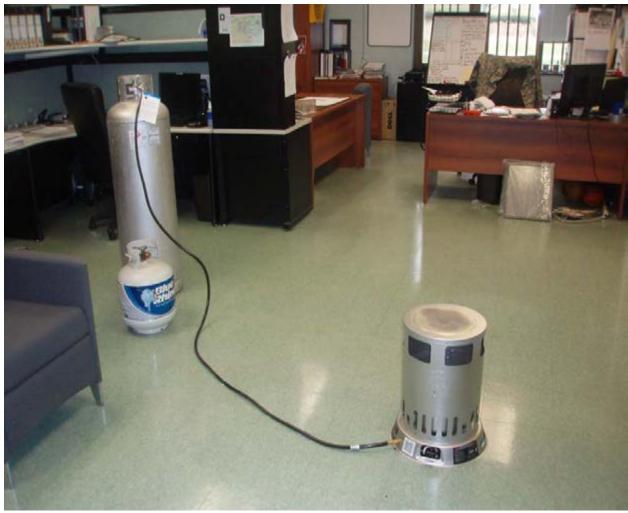
Use of Temporary Heat – Propane Heater

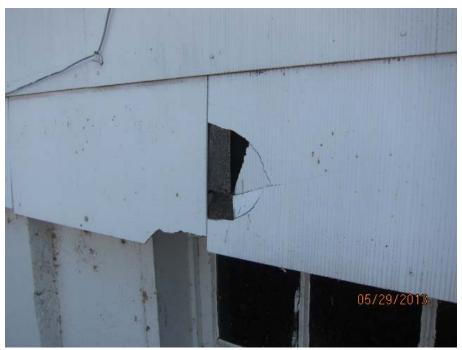
Exterior damaged suspect asbestos shingles

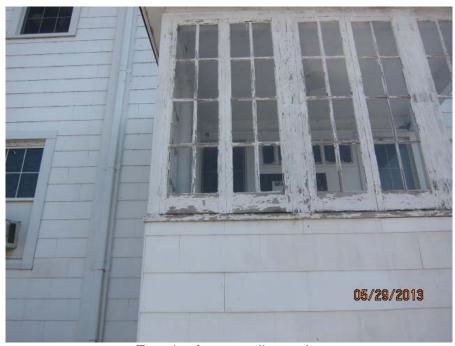
Exterior front peeling paint

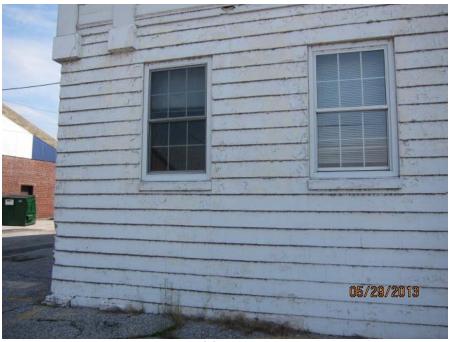
Exterior side of facility peeling paint

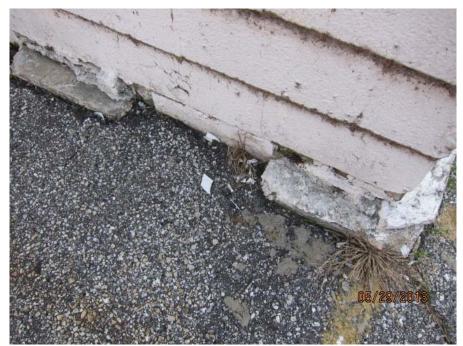
Exterior of facility suspect asbestos shingles and suspect lead-based paint on ground at drip line around the facility

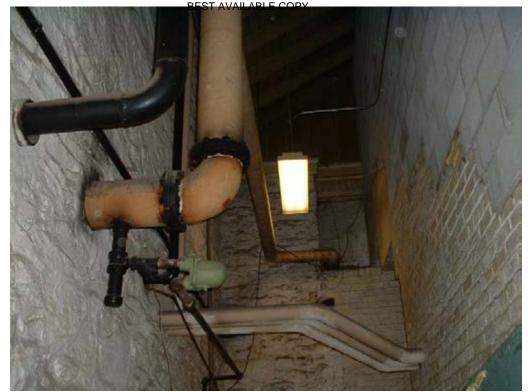
Thermal system insulation located adjacent to Room 103

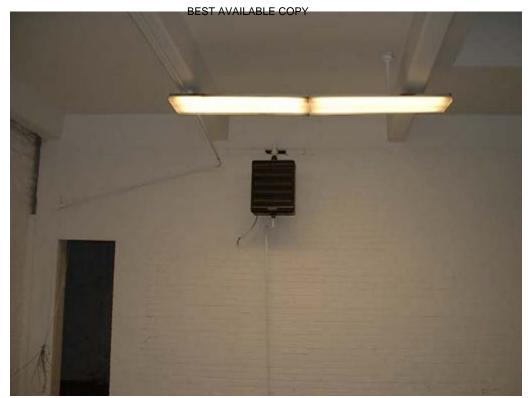
Wall mounted heater located in 212. Elevated levels of surface lead on heater blades.

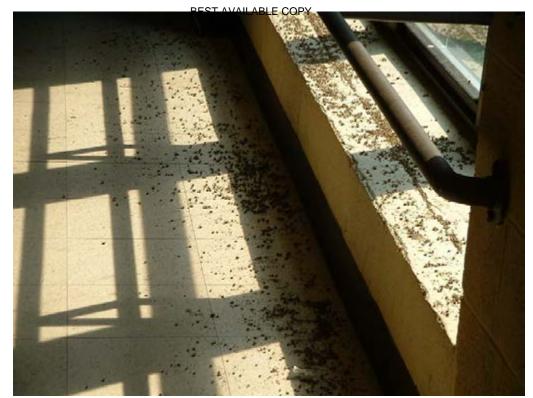
View of bees located in Room 102. Active hive present.
