NATIONAL GUARD REGION SOUTH
INDUSTRIAL HYGIENE OFFICE
510 PLAZA DRIVE, SUITE 1530
COLLEGE PARK, GA 30349

SUBJECT: Industrial Hygiene Baseline Survey of the Ada Armory.

LAE CONSULTING

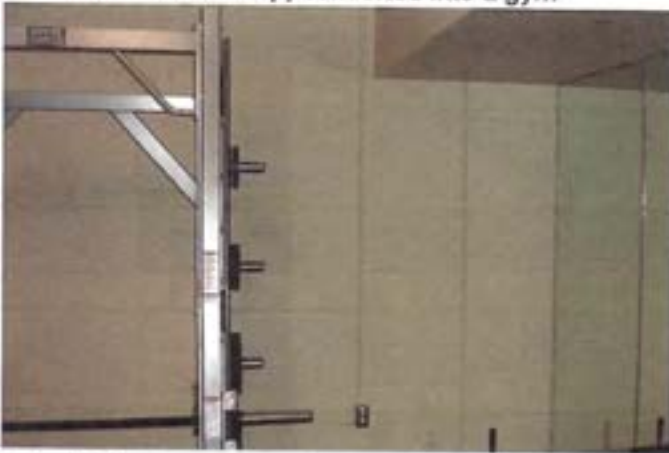
View of the side wall where a shadow of the location of the backstop can still be seen

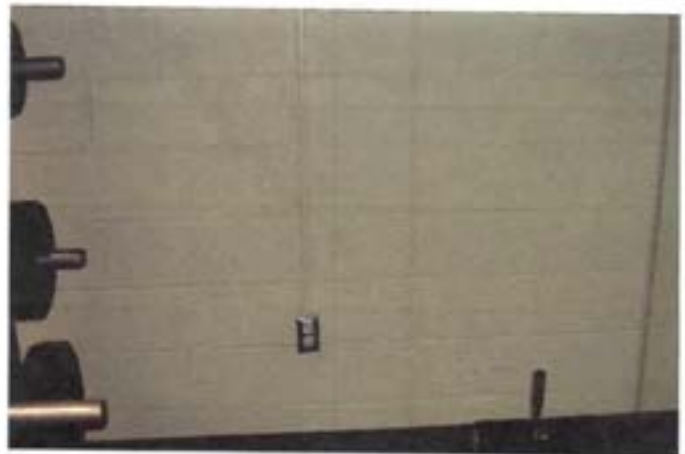
View of the side wall where a shadow of the location of the backstop can still be seen

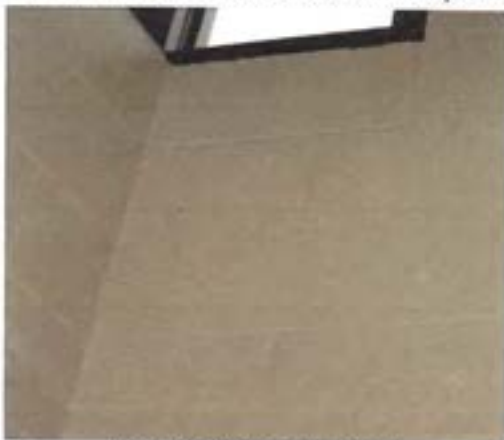
View of pain blistering in the drill hall

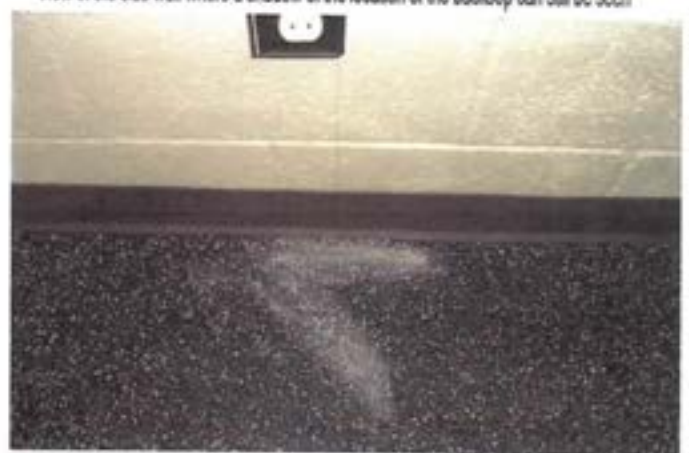
View of sand located in the drill hall

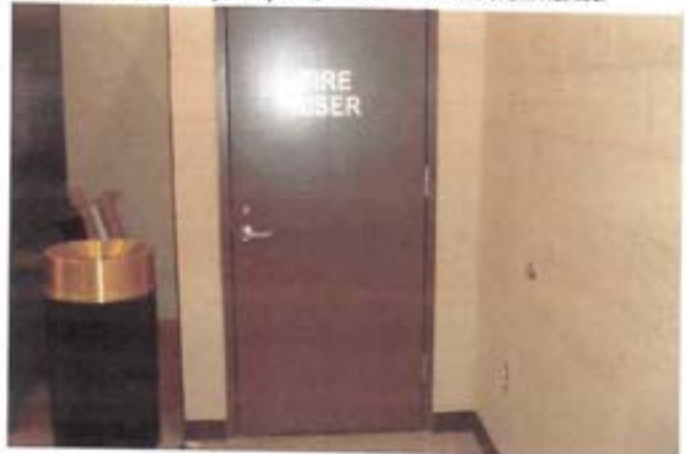
f. Water was noticed on the floor around a pipe of the fire suppression system. The area is located inside the fire suppression closet in the locker room. Water stains were noticed on the acoustic ceiling near entrance to the locker room. The construction contractor stated that the ceiling was installed during the renovation and not part of the original indoor firing range.

View of the fire suppression room

f. Contact the state Facility Engineers inspect and repair the source of the water leak. Monitor the ceiling tiles for water stains which maybe indicative to water intrusions from the roof. (RAC 4)

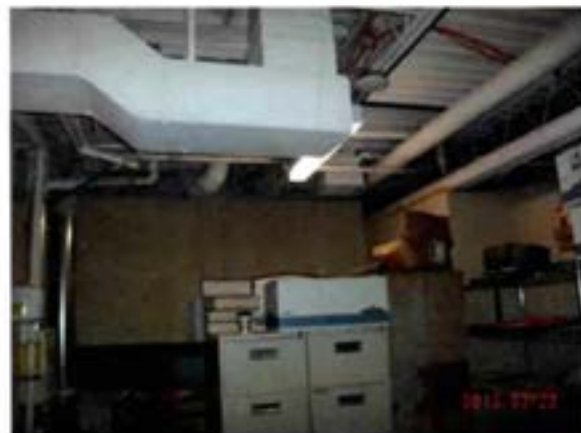
New Insulation covering pipes

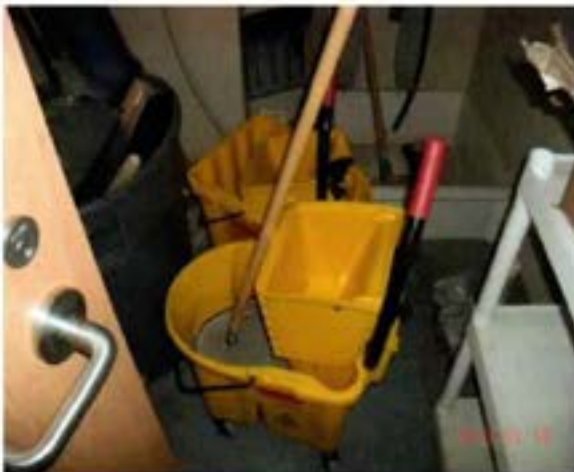
Custodial closet/door blocked

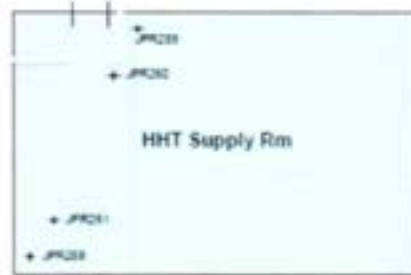
HHT Vault

APPENDIX B
Drawing of Sampled Areas
Highlighted samples indicated Lead in Dust

TOPIC	SUMMARY OF FINDINGS	RECOMMENDATIONS
Lead Dust sampling in Weapons Vaults	Low levels of lead in dust were detected in three of the samples in the HHT weapons vaults. See Table 1.	Recommend using a wet method to clean the HHT weapons vault floor, to prevent the buildup of lead. See Recommendations Pg. 9
MSDS Inventory	The MSDS inventory was in the process of being updated at the time of the survey.	Recommend to complete the MSDS inventory updates ASAP and post them on the Flammables cabinet and in the MSDS binder. See Recommendations Pg. 9

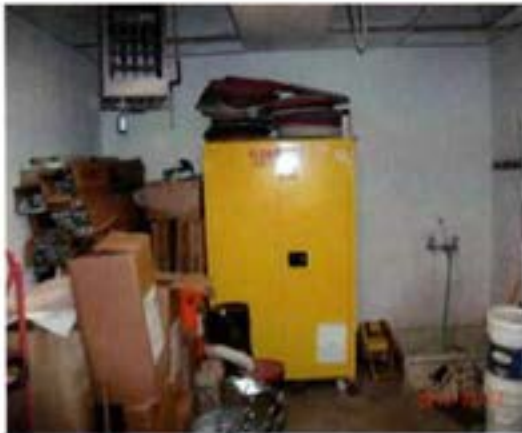
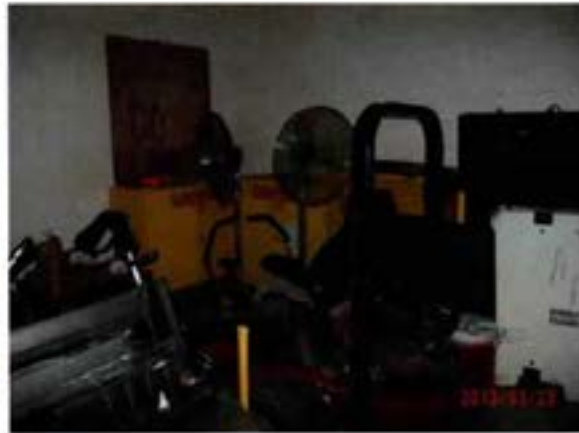
- f. Asbestos: Insulation around pipes appeared in good condition at the time of the survey. However there was an area cordoned off by the Adjunct ant Generals office due to asbestos.
- g. The flammable cabinet were blocked and binders not accessible.

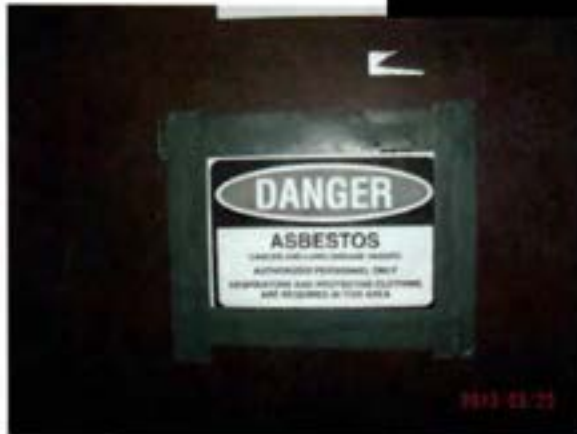
Downstairs room sealed due to Asbestos

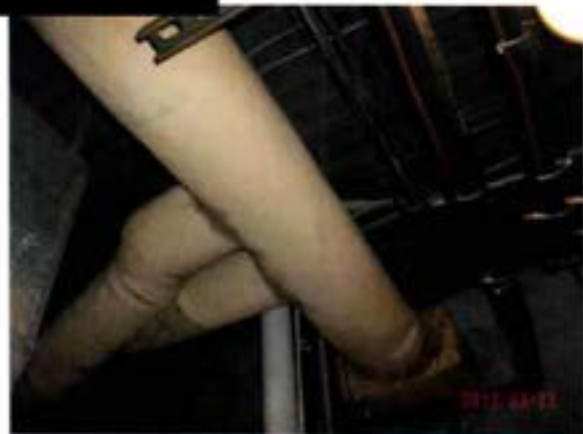
Insulation/no fraying or crumbling

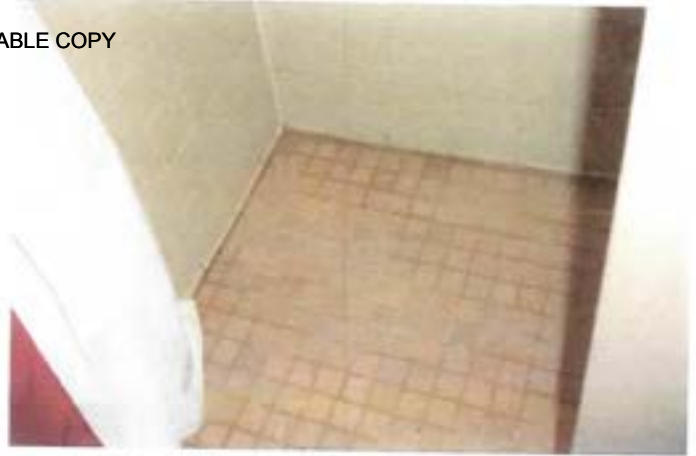
View of male latrine shower floor where water pools in the corner

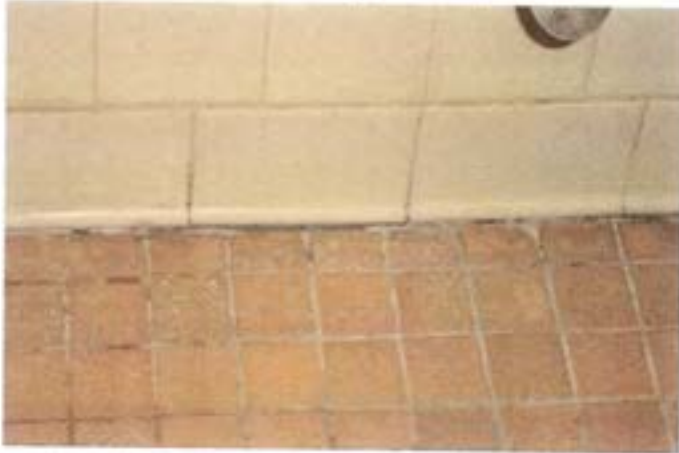
View of male latrine shower floor where water pools in the corner

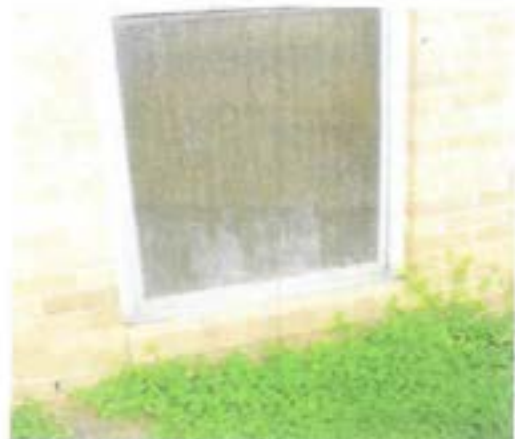
View of water infiltration under the sill in the office.

d. Recommend the state Facility Engineer office inspect and repair the window in the office. Continue to clean up water to reduce mold growth. (RAC 3)

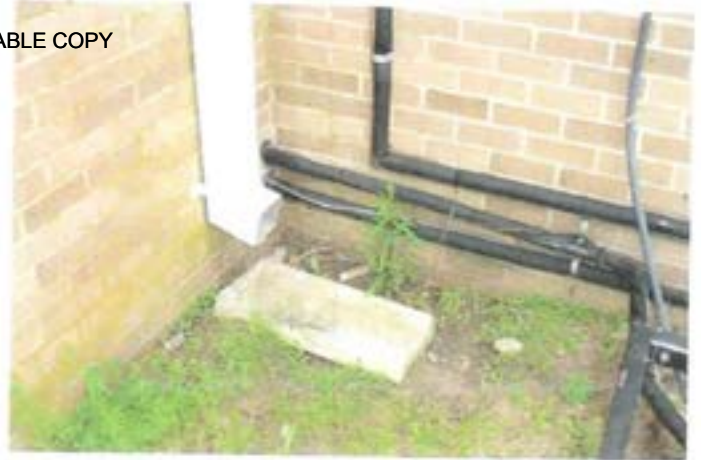
View of soil erosion at the buildings foundation

g. Recommend the Facility Engineer office inspect and repair soil erosion issues around the building's foundation.

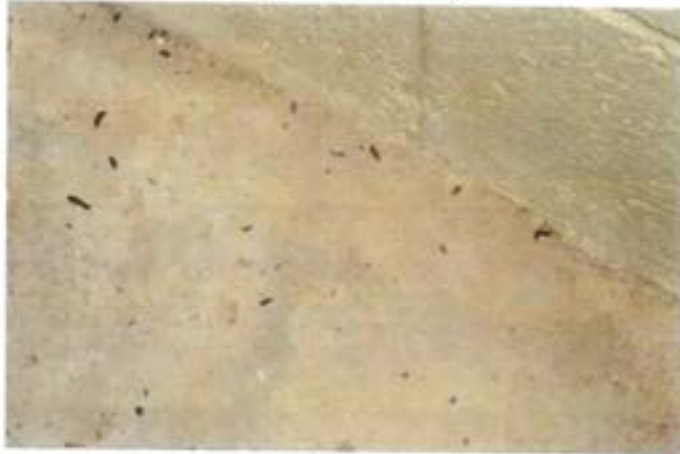
View of soil erosion

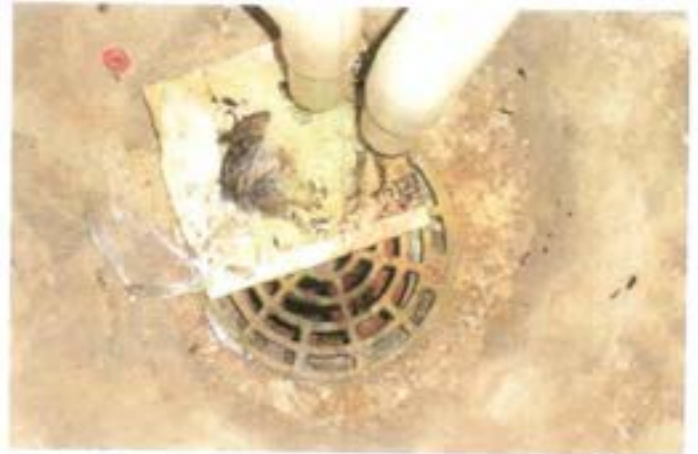
View of mouse droppings in HVAC area

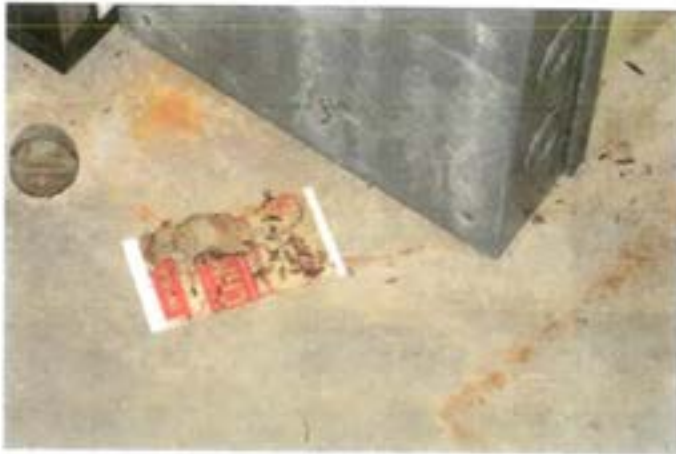
View of dead mouse in HVAC area

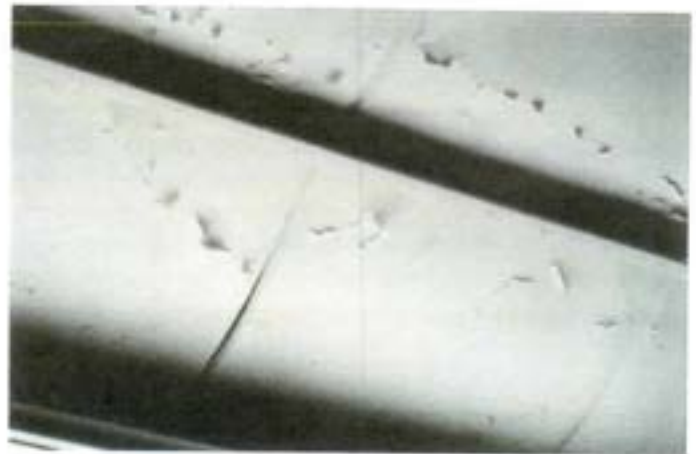
View of heavily peeling painted plastic ceiling of the drill hall.

e. Recommend the Oklahoma Facility Engineer office replace the ceiling. (RAC 4)

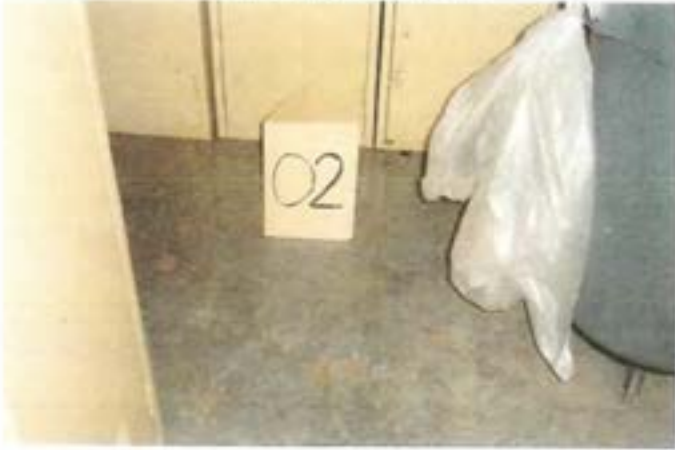
View of Lead wipe sample 1, located left rear wall backstop

d. Recommend the state Safety and Occupational Health office review the Lead wipes sample results of this facility to determine if further sampling and/or decontamination is needed. (RAC 3)

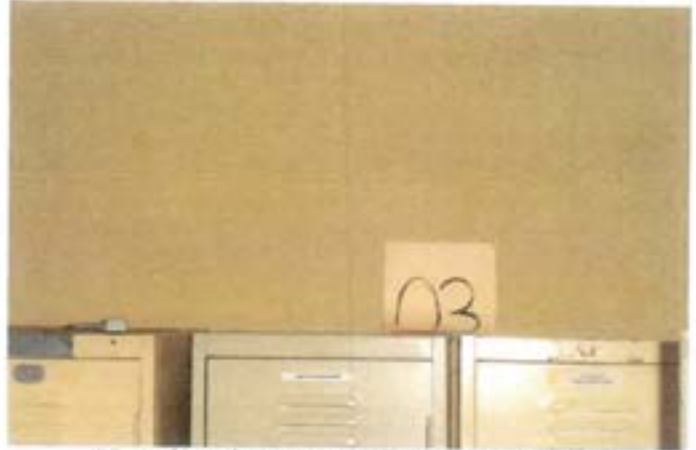
View of Lead wipe sample 2, located on left rear backstop center locker 150

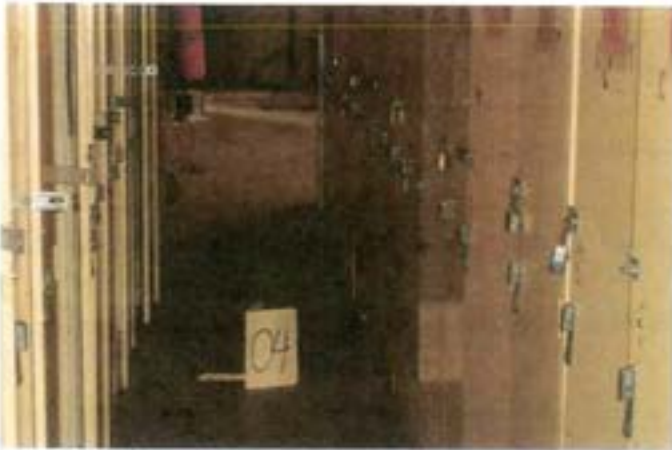
View of Lead wipe sample 3, located at right wall backstop area 5 ft up between locker 42/43

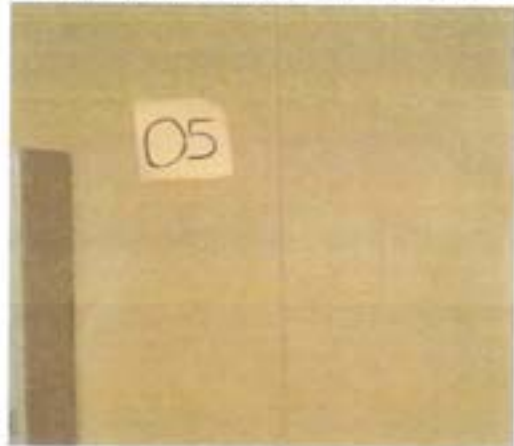
View of lead wipe sample 4, located on the floor right side center 1 ft from locker 128/105

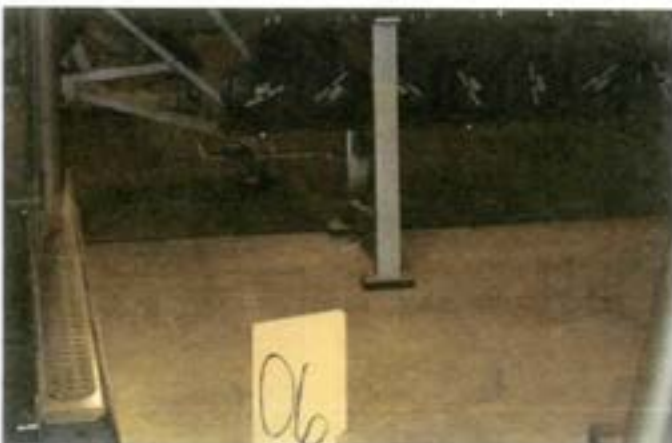
View of Lead wipe sample 5, located on the right wall end of wall locker 119 5 feet up

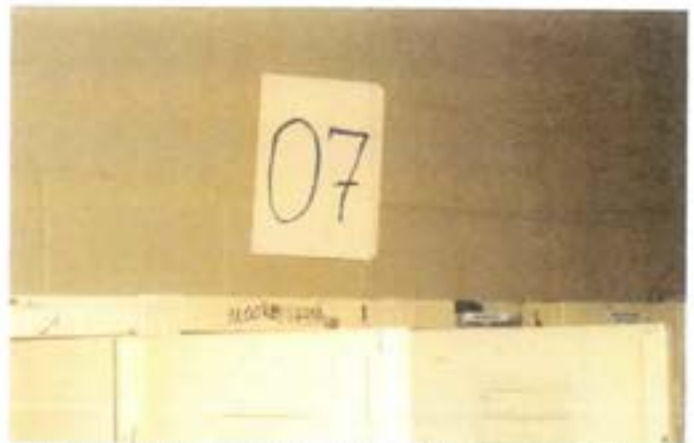
View of Lead wipe sample 6, located on the floor right side of treadmill

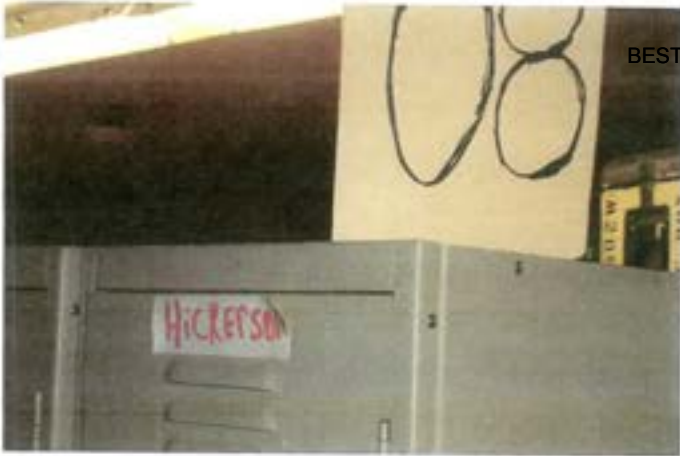
View of Lead wipe sample 7, located on the right wall end of wall locker 119 5 feet up

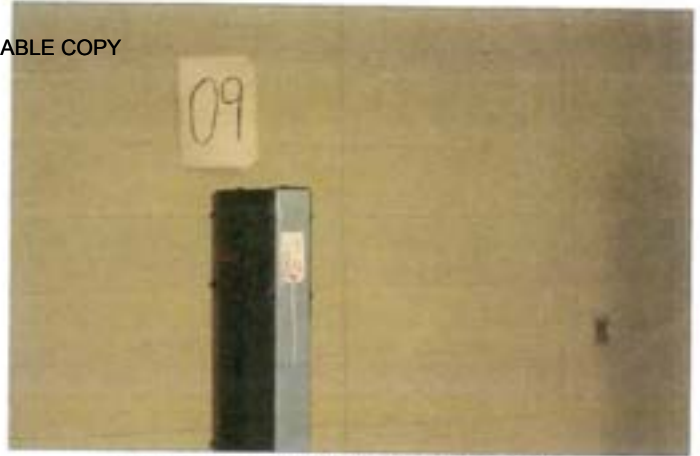
View of Lead wipe sample 8, located on top of wall locker 26

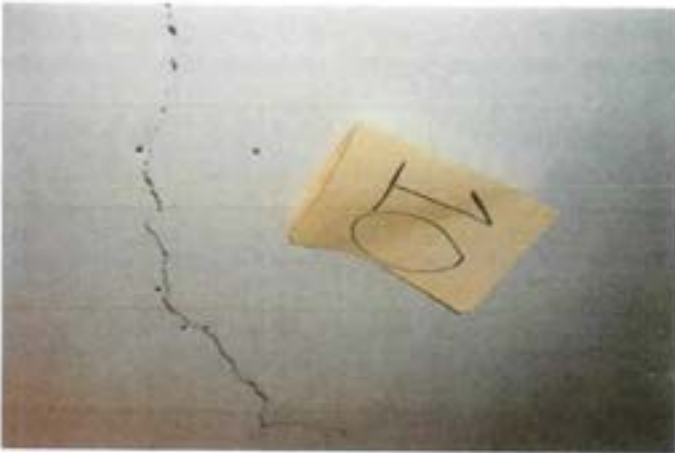
View of Lead wipe sample 9, located on the former Observation wall above chest 6 feet up wall

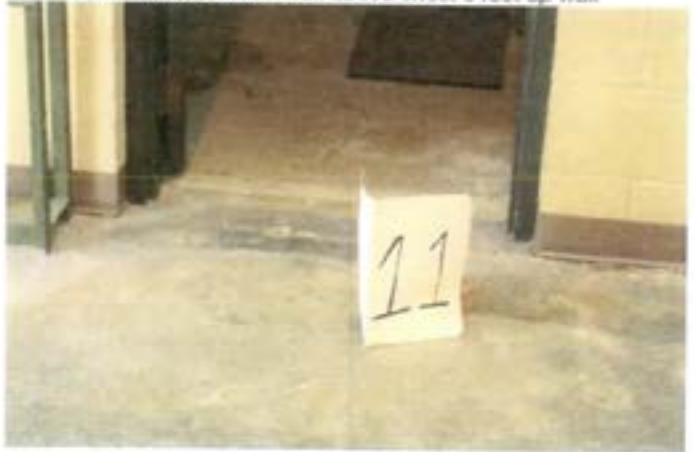
Lead wipe sample 10, located on the ceiling in the DIFR where the wharf system may have been

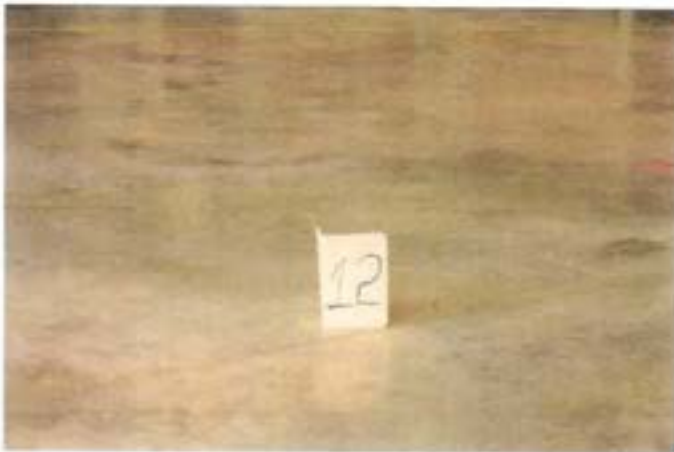
View of Lead wipe sample 11, located on the floor 1 foot outside the DIFR

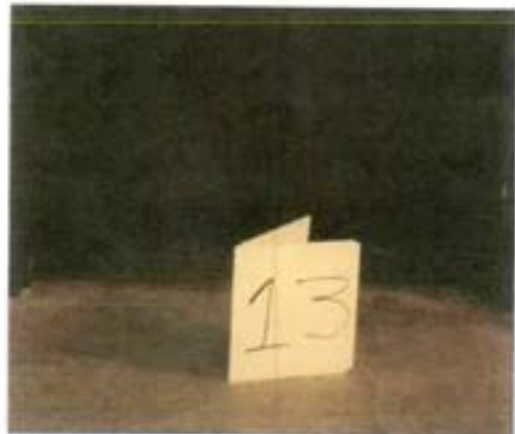
View of Lead wipe sample 12, located at the center of the Drill Hall floor

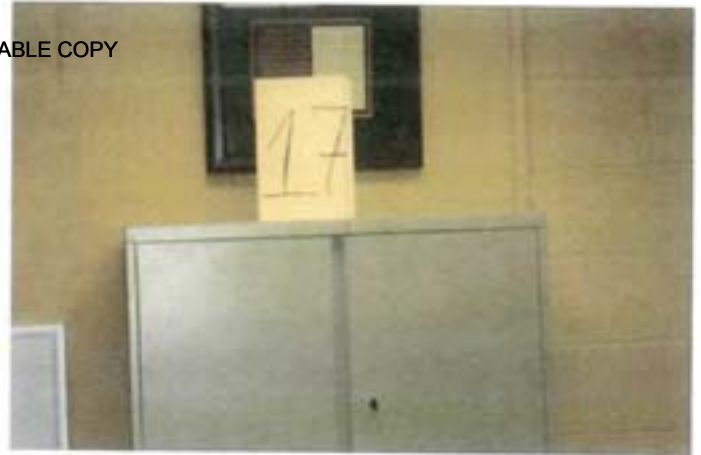
View of Lead wipe sample 16, located in the classroom on top of bookcase near hallway

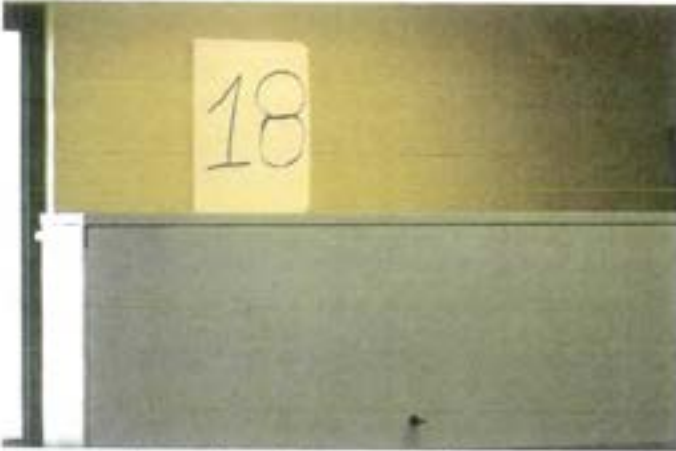
View of Lead wipe sample 18, located in room 112 on file cabinet in the Readiness NCO office

e. Recommend the state Safety and Occupational Health office review the Lead wipes sample results of this facility to determine if further sampling and/or decontamination is needed. (RAC 3)

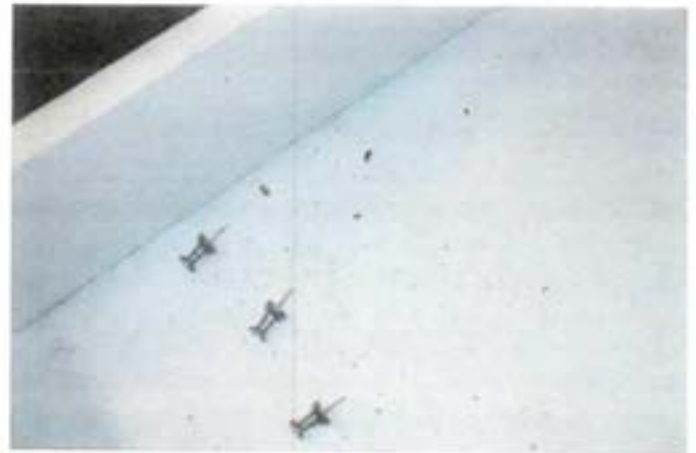
a. Mice have infested the Armory. Droppings were observed in office drawers and cabinets. A dead mouse was observed in the kitchen. Significant gaps under the exit could be allowing entrance for mice and other pest. The facility is does not have an integrated pest management (IPM) program. Contract pest control is now performed on an as needed basis. IPM programs monitor and identify pests; establish prevention methods; establish control measures when and if prevention does not eliminate the pest. Scorpions are also a concern with the Armory. Employees stated that lots of scorpions are in the hallways ^{where} they arrive to work in the morning.

View of mouse dropping in a file cabinet drawer

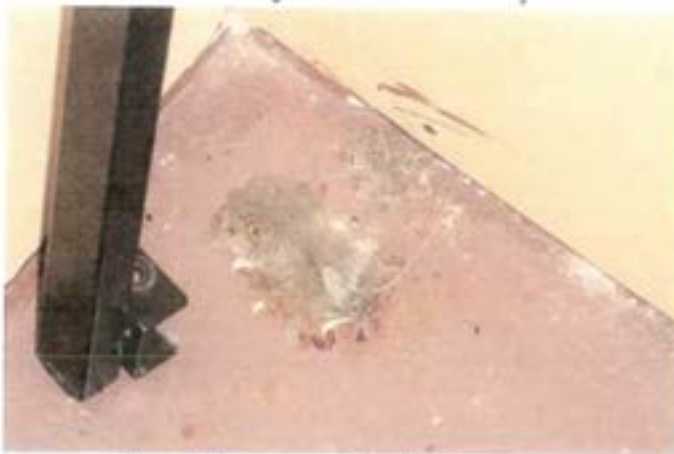
View of dead mouse in the kitchen

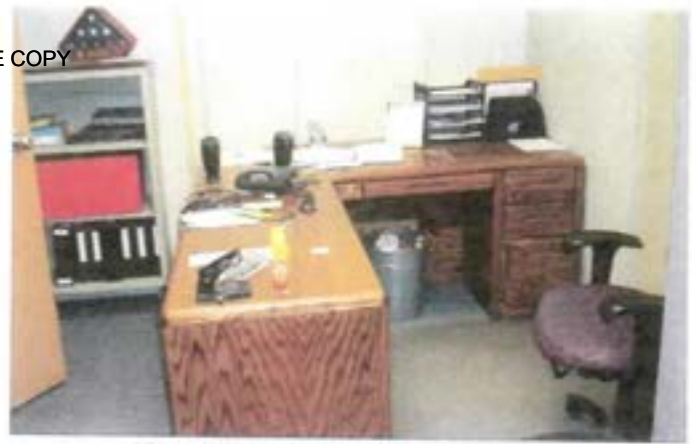
View of office with mice activity in the desk

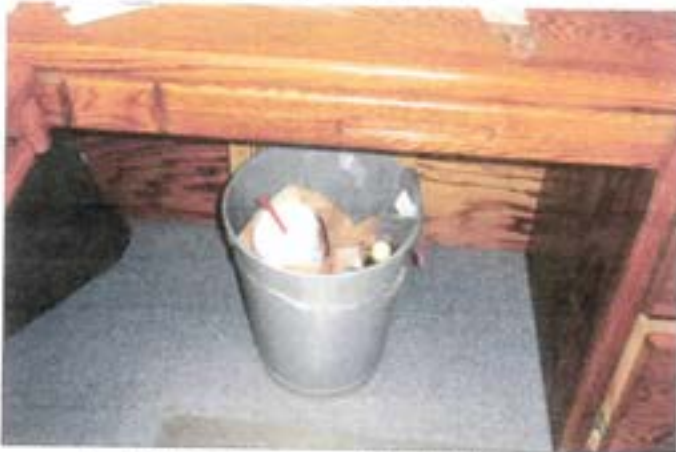
View of food trash in garbage can under desk with mice activity

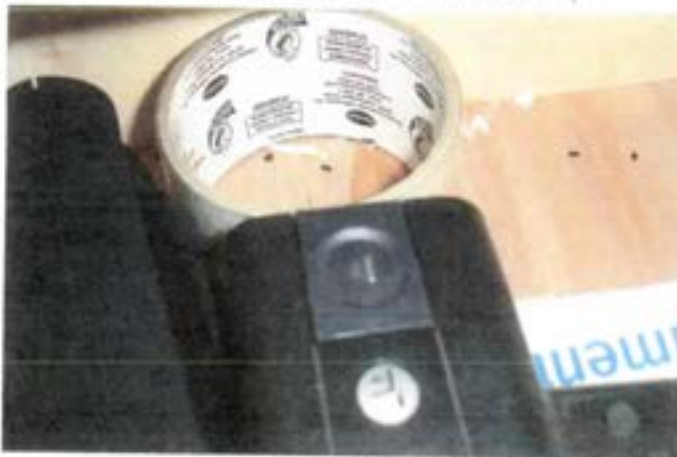
View mouse droppings within the desk

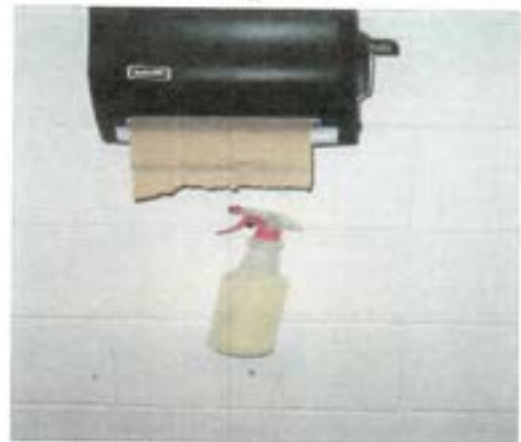
View of unlabeled spray bottle located in the gym

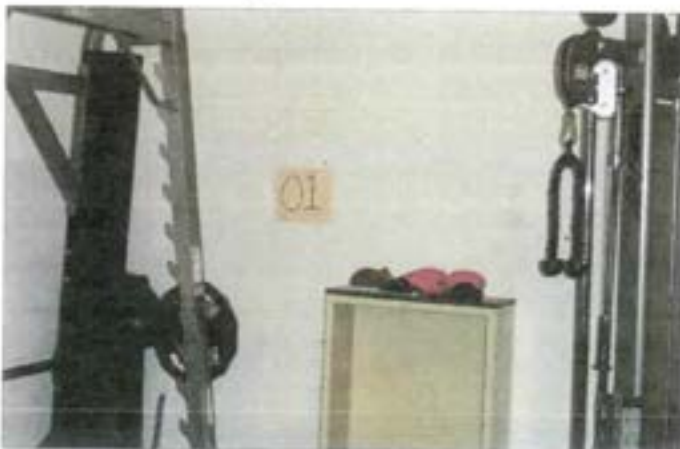
e. A deactivated indoor firing range is currently being used as a locker room and gym. All associated range equipment has been removed. The ventilation system and ducting has been removed. The date of the range cleaning is unknown. Eighteen Lead wipe samples and one blank were taken in various locations throughout the range and the Armory. Sample locations and results are in the table 2 below. A copy of the laboratory report can be found in the enclosure of this report.

View of Lead wipe sample 1, located in the DIFR on left side of backstop wall 4 feet up

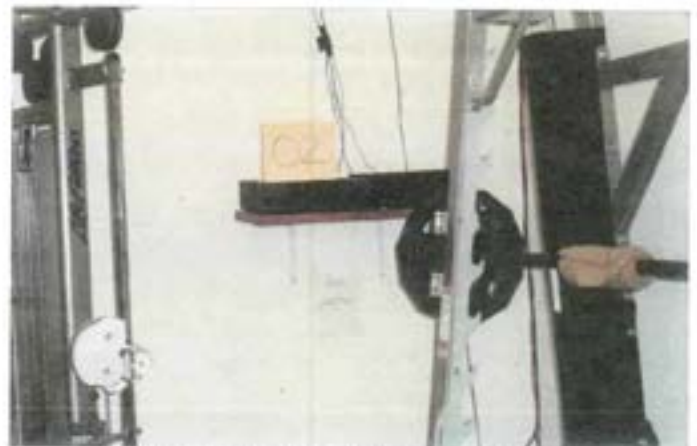
View of Lead wipe sample 2, located on top of stereo in DIFR

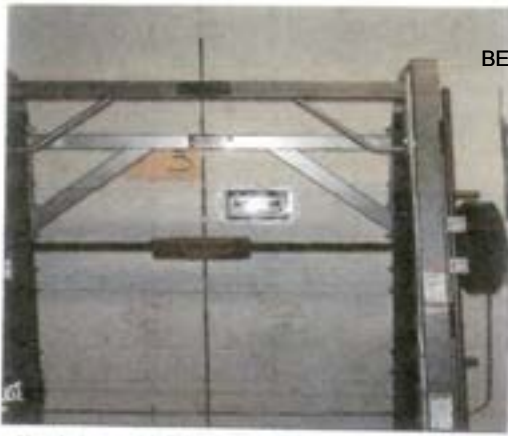
View of Lead wipe sample 3, located on right side wall at squat press 6 feet up

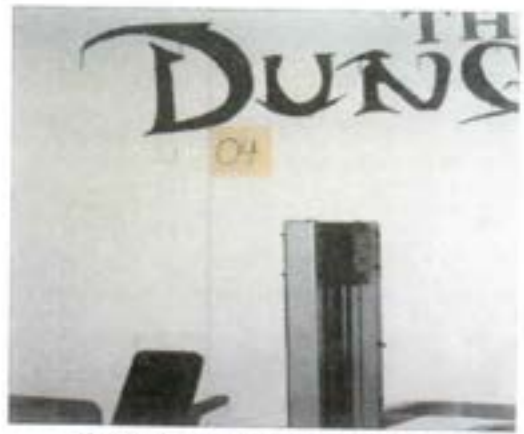
View of Lead wipe sample 4, located left wall 6 feet at leg press

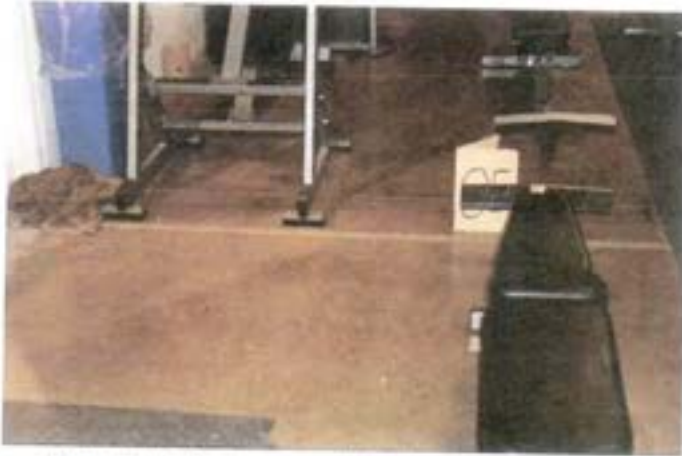
View of Lead wipe sample 5, located on the floor between hammer strength and 50lb dumbbell

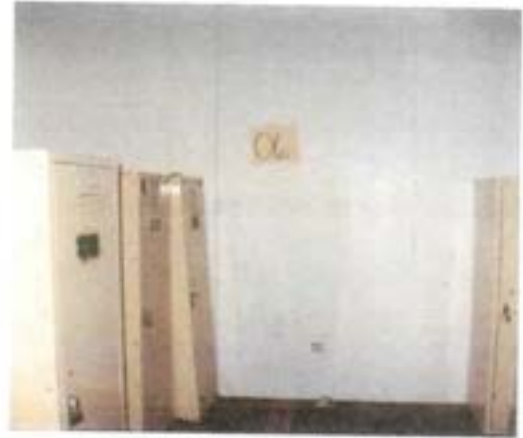
View of Lead wipe sample 6, located on the right side wall near locker 239 6 feet up wall

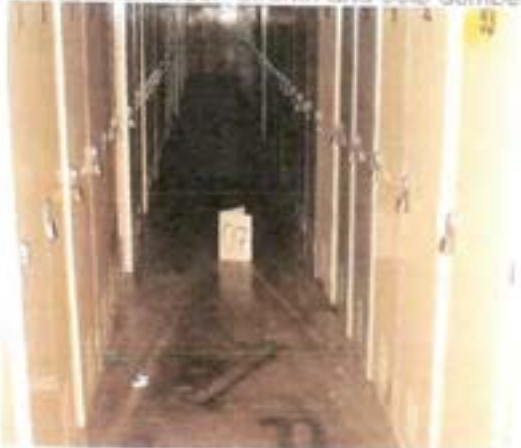
View of Lead wipe sample 7, located on the floor between locker 13 & 87

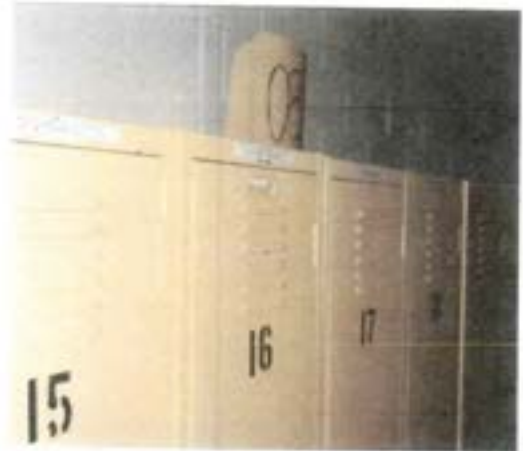
View of Lead wipe sample 8, located on top of wall locker 17

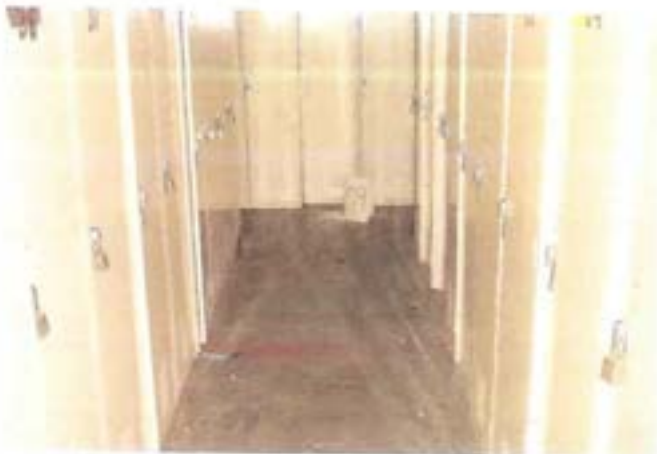
View of Lead wipe sample 9, located on the floor in front of lockers 46 & 47

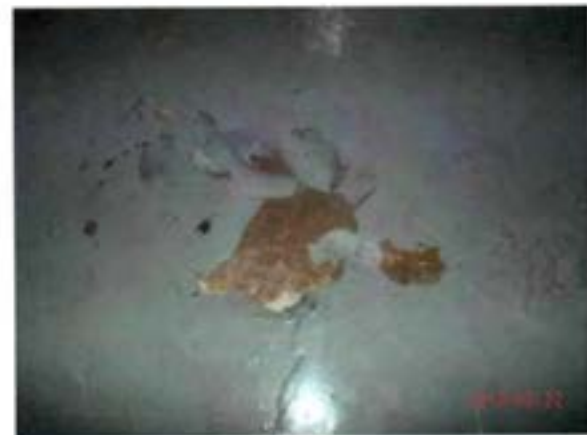
- h. The converted IFR floor was starting to chip and samples were taken. POC states they were told to not put any supplies or storage items in this area of the IFR.

Paint chipping in converted IFR

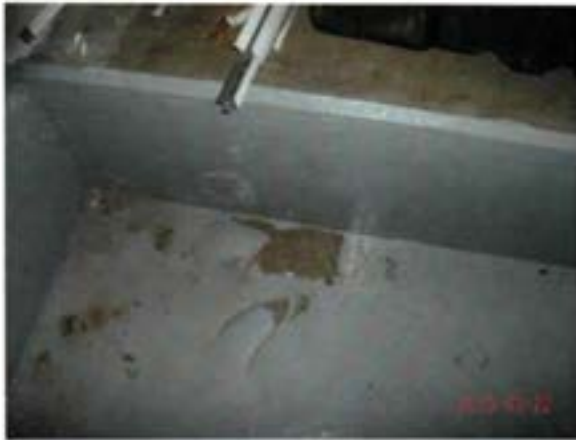
Paint chipping in converted IFR

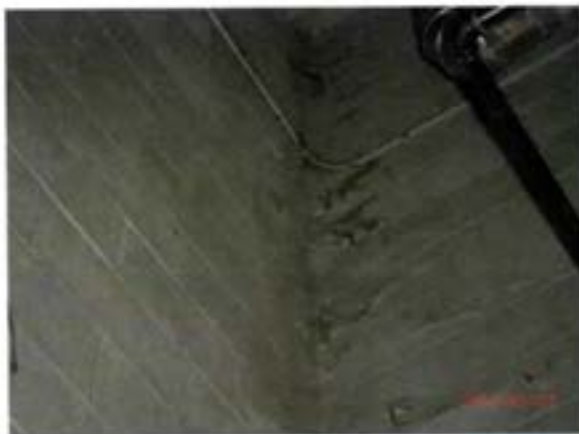
Chipping paint from drill hall

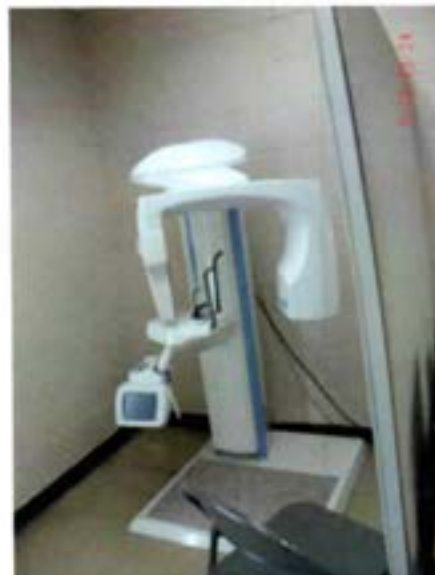
Cardboard partition by x-ray

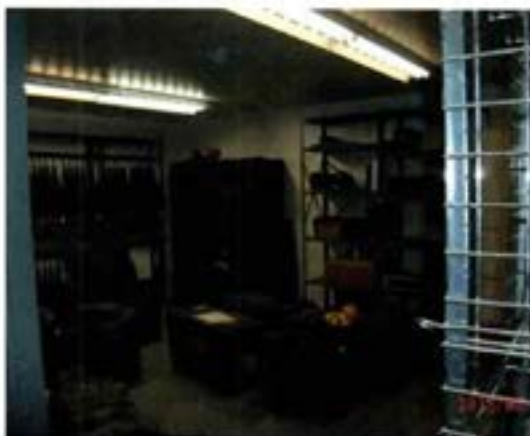
ARNG Weapons Vault

Findings: There were three spots that showed traces of lead. All three happened to be on the vault floors.

- Three areas that were tested for lead levels, showed traces of lead. The three areas were A Co. (50ug), HHC (26ug), and USAR (30ug) vault floors. The reporting limit of 200ug. **RAC 4**
- Supplemental lighting can be used in the supply areas and common work area where high shelving and cubicle walls lower illumination standards. **RAC 3**
- Determine where leaks are coming from, either from the roof, AC duct work or overhead piping. Fix the source of the water damage and then replace broken and stained ceiling tiles. Clean all vents annually or as needed. **RAC 3**

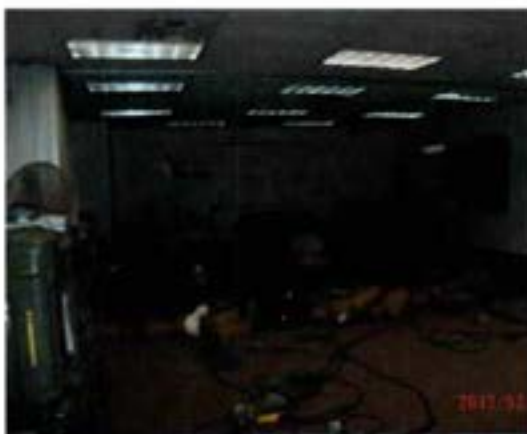
Water damage second floor storage

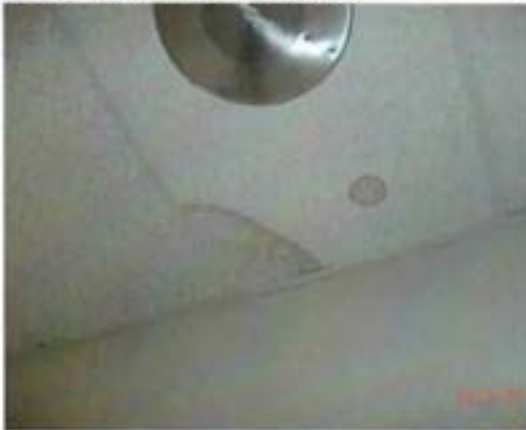
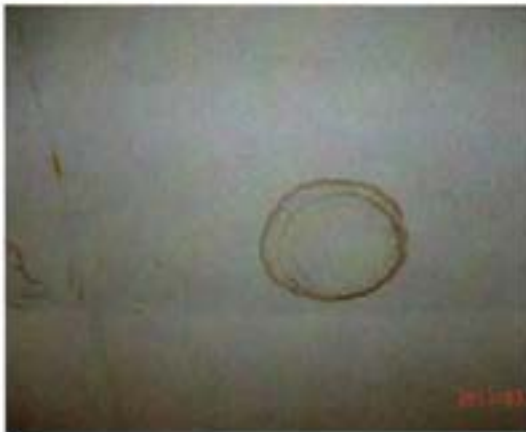
Damaged/Stained Ceiling tiles

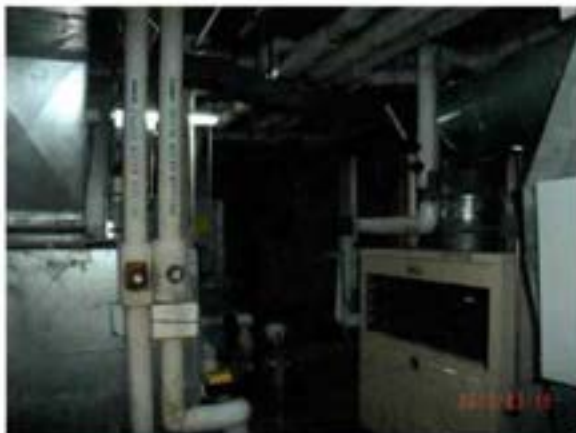
- f. Asbestos: Insulation around pipes was fraying in some areas. Samples were taken. All samples came back none detected (ND). All lab results are located in the attachments.

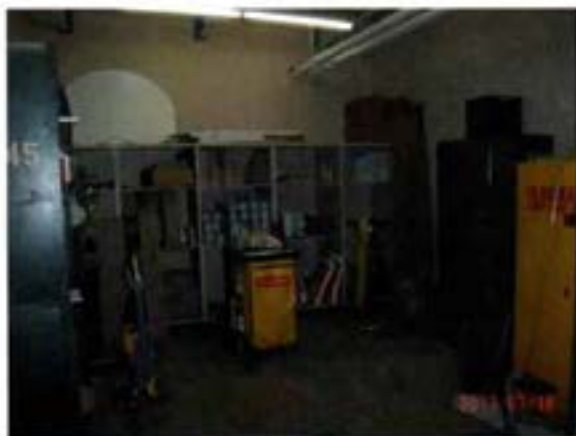
- g. The flammable cabinet was maintained. The MSDS binder was easily accessible if needed.

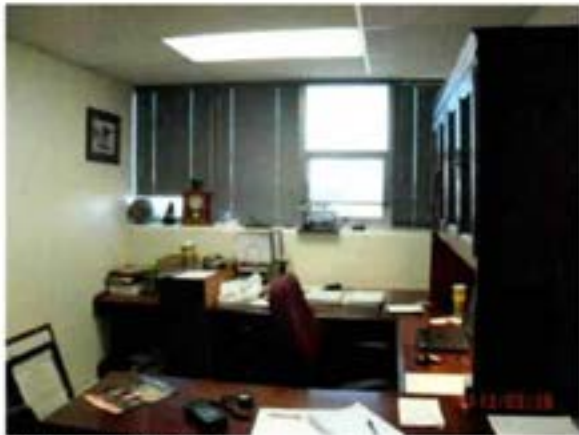
- a. Numerous ceiling tiles appeared damaged and stained. A number of the intake and exhaust covers were covered with soot.

Damaged Ceiling Tiles

- Determine where leaks are coming from, either from the roof, AC duct work or overhead piping. Then replace broken and stained ceiling tiles. Clean all vents annually or as needed. **RAC 3**
- The floor inside (263ug) the vault exceeded the recommended level of 200 ug. This area and all other areas around the vault should be cleaned and retested.
RAC 3
- For levels not meeting the illumination standard. Lights that are out or broken should be fixed. In other areas supplemental lighting could be used. **RAC 3**
- General housekeeping needs to be conducted throughout the armory and drill hall. The buildup of old boxes, papers, broken and stained ceiling tiles, provide a habitat for future pest. **RAC 3**

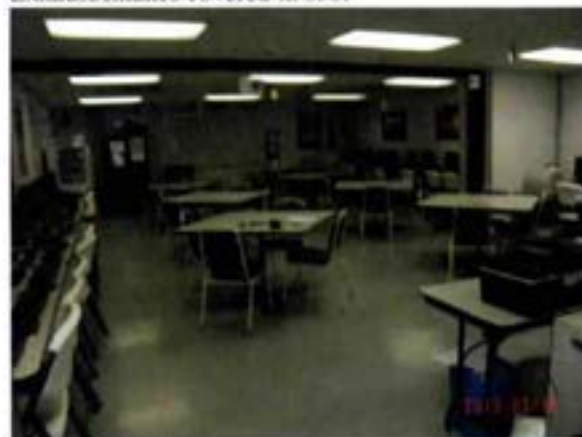
Damaged Ceiling Tiles

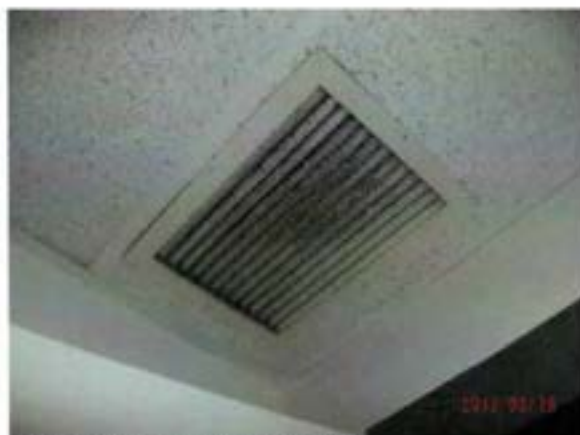
Exhaust/Intakes covered in soot

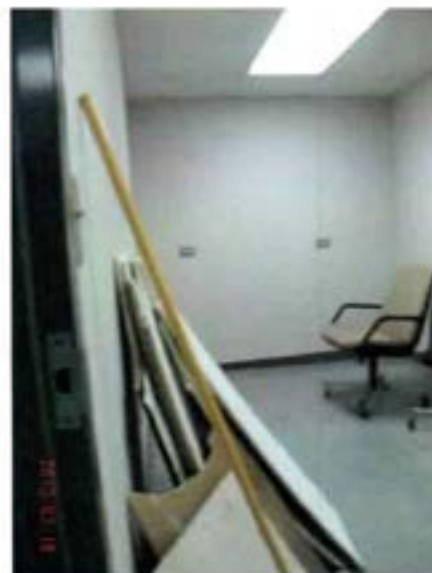
Old broken ceiling tiles
