**NATIONAL GUARD REGION SOUTH
INDUSTRIAL HYGIENE OFFICE
510 PLAZA DRIVE, SUITE 1530
COLLEGE PARK, GA 30349**

SUBJECT: Industrial Hygiene Survey of the Abbeville National Guard Armory,
Abbeville, South Carolina.

**ABBEVILLE, SC
ARMORY**

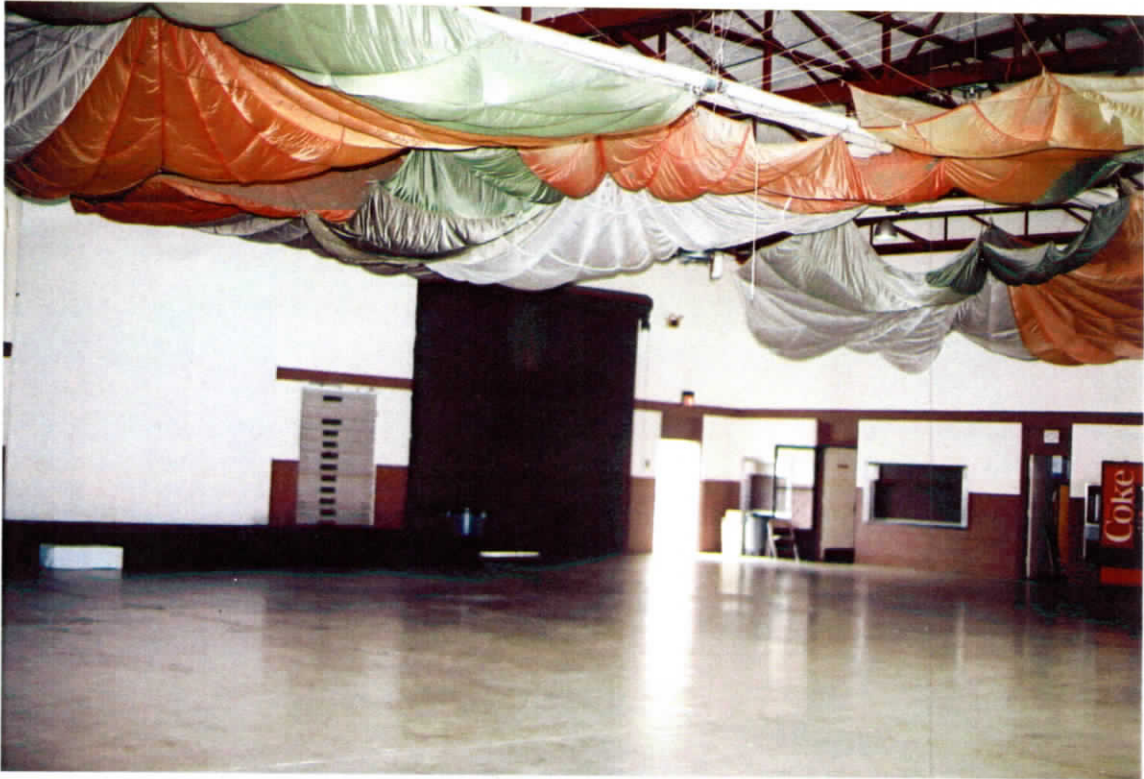
**DRILL HALL, PAINT
PEELING OFF, CEILING**

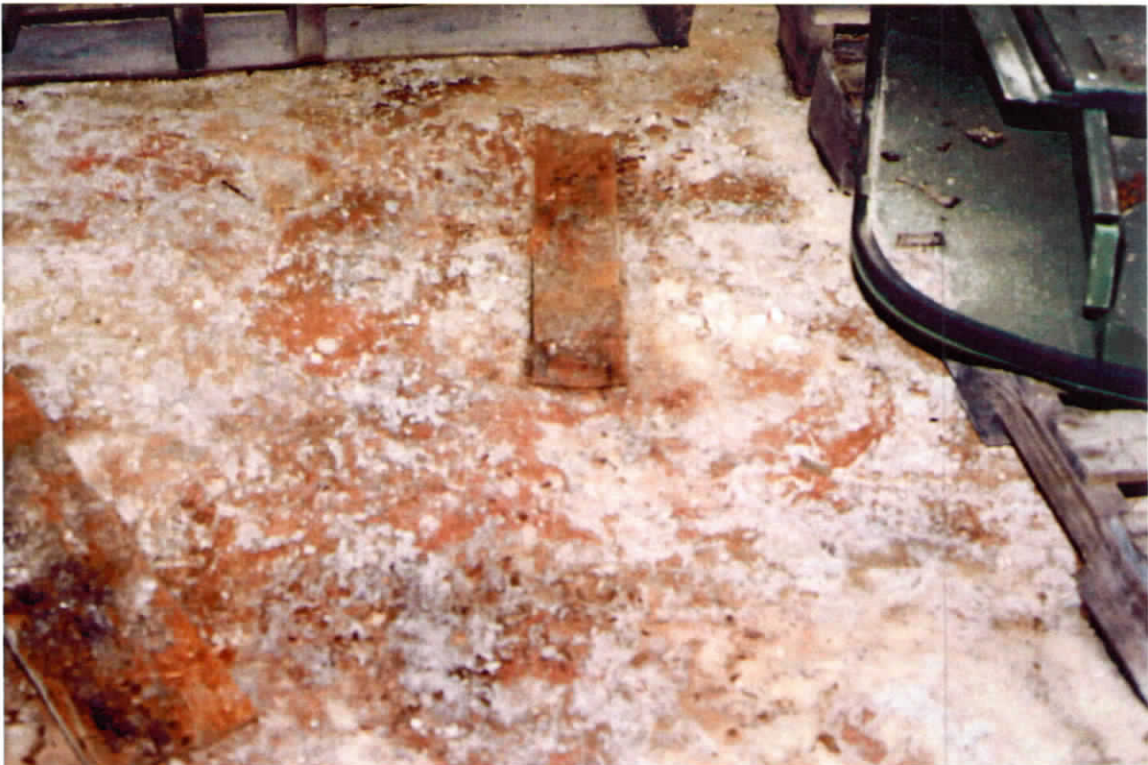
**IFR, FLOOR IN FRONT OF
BACKSTOP (SAND)**

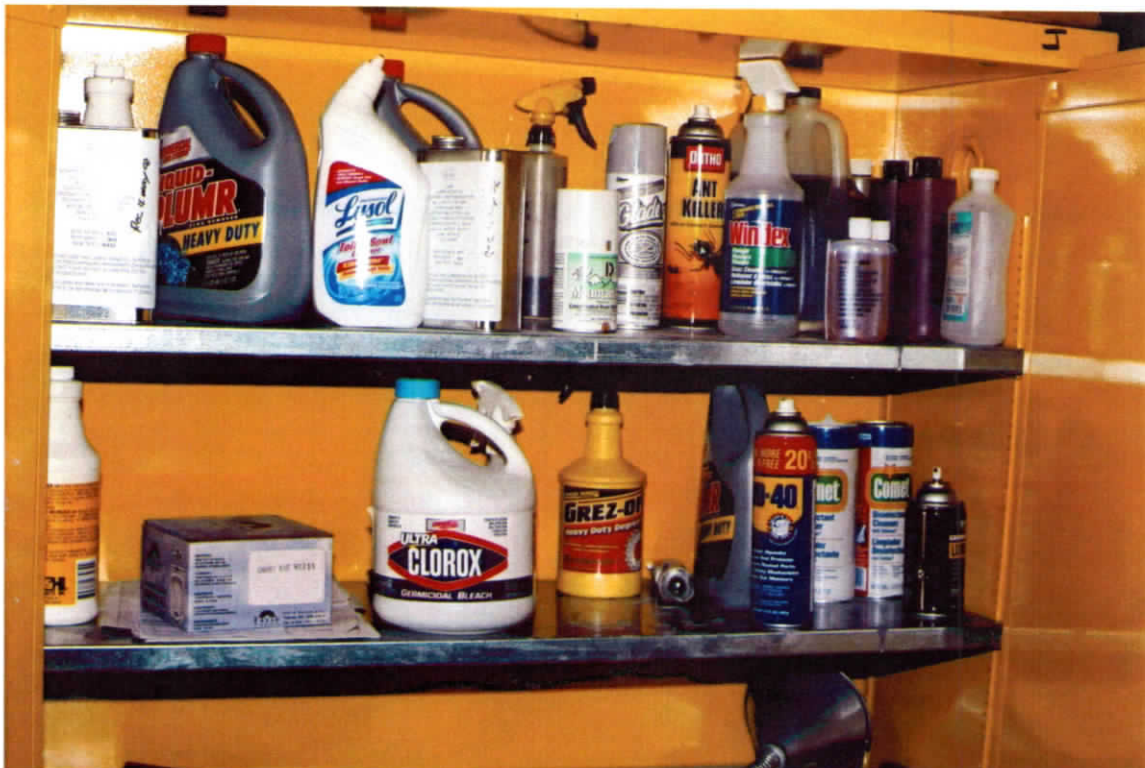
**FLAMMABLES CABINET,
INSIDE**

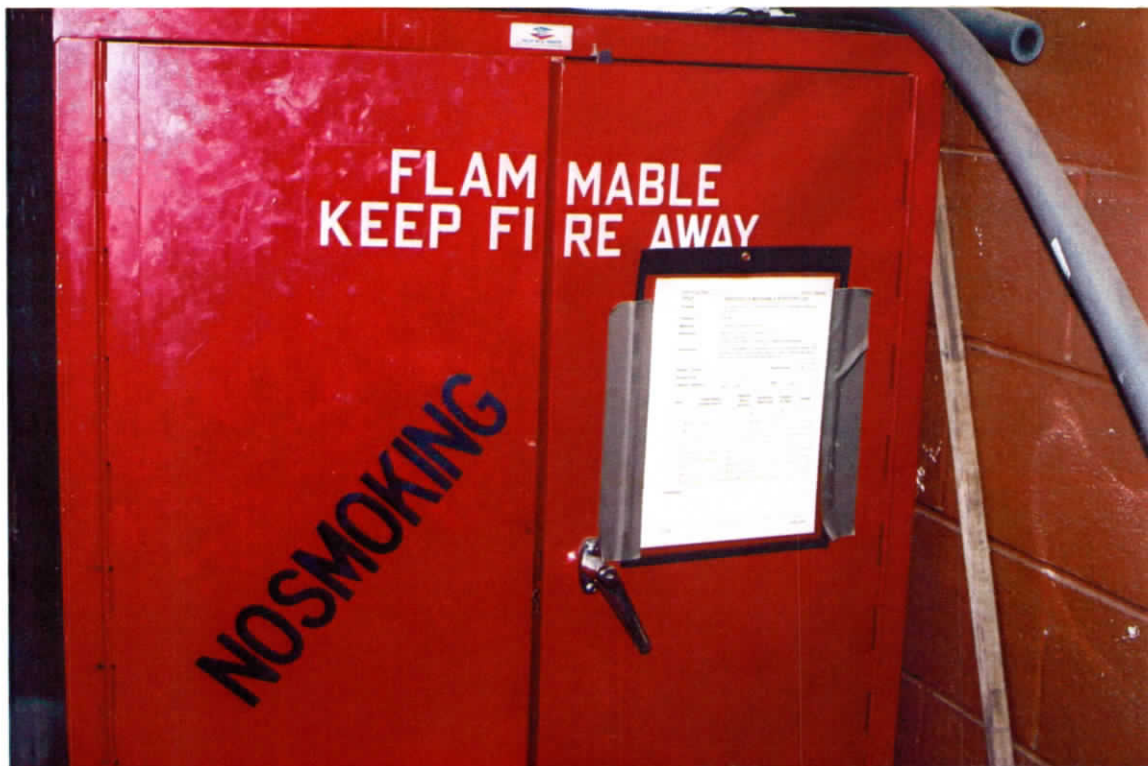
**FLAMMABLES CABINET,
MAINTENANCE AREA**

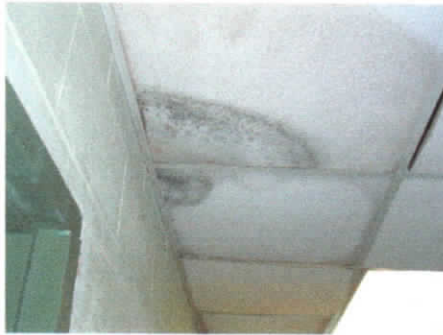
Photo # 2

The armory (Appendix 1, photo # 1) was constructed in 1947. The flooring throughout is a combination of exposed slab concrete, carpeting on slab concrete, carpeting on vinyl floor tiles, and 12 inch squared (12 in²) vinyl floor tiles on slab concrete. The ceilings in the classrooms and offices are 2 feet X 4 feet suspended ceiling tiles, some of which had mold growth and discolorations (Appendix 1, photo # 2).

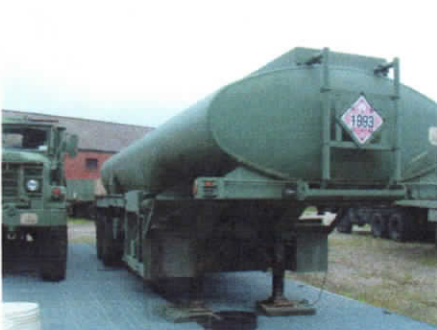
Photo # 10

Fuel is stored on site in a 5,000 gallon diesel fuel storage tank that sits on a POD (Appendix 1, photo # 10). The POD contains spilled fuel for reclamation by the appropriate SC state authority.

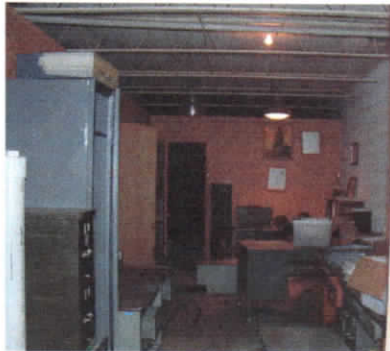
Photo # 13

The retired indoor firing range (rifr) has been converted into offices (Appendix 1, photo # 13), and storage spaces (Appendix 1, photo # 14). The bullet backstop is located in an enclosed area that is accessed through a door. The door was closed at the time of the survey (appendix 1, photo # 15). The

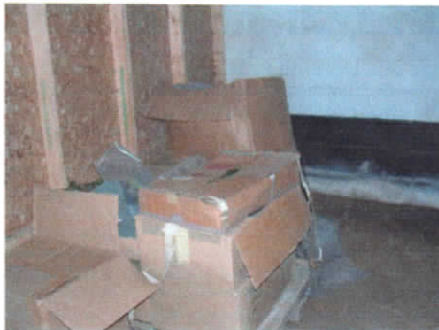
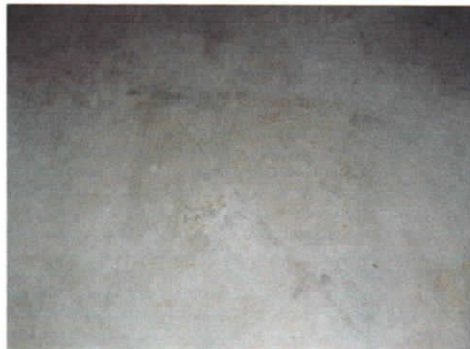
enclosed bullet backstop area was used for storage (Appendix 1, photos # 16, & 17).

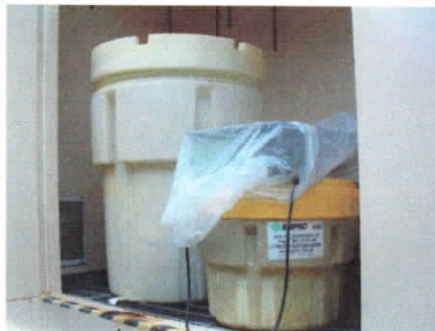
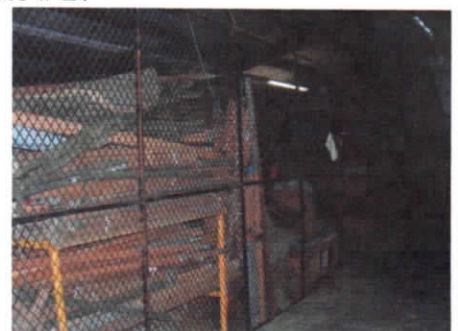
Chemicals for potable water treatment (Appendix 1, photos # 28, & 29) are stored in the chemical shed. PPEs, MSDS and HazCom materials and safety devices such as emergency showers and/or eye wash fountains were not observed inside this building.

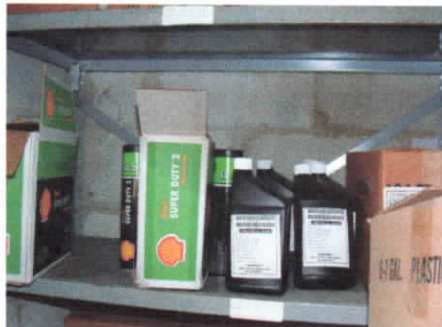
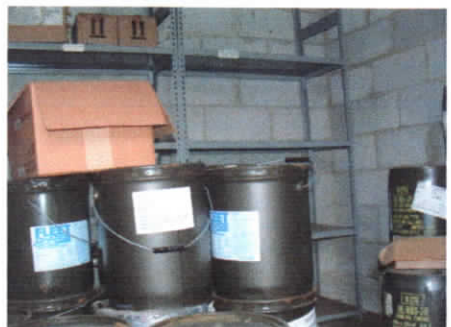
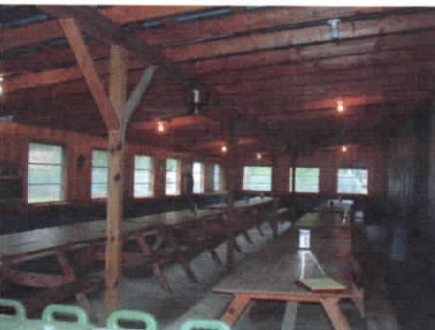
Lubricating oils and engine oils (Appendix 1, photo # 31, 32, & 33) are stored in this building. PPEs, MSDS and HazCom materials and safety devices such as emergency showers and/or eye wash fountains were not observed inside this building.

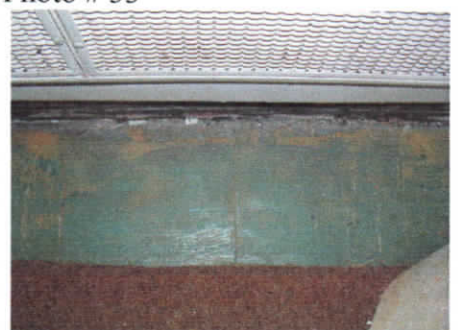
Photo # 35

Sample Bmb-pb-01 of the flaking wall paint in the kitchen (Appendix 1, photo # 35) was collected and submitted to AES for quantitative analysis for lead. The laboratory reported that the paint is not lead-based paint by definition, but the paint chip contained 0.00992 weight %, (Appendix 4) or 99.2 parts per million lead.

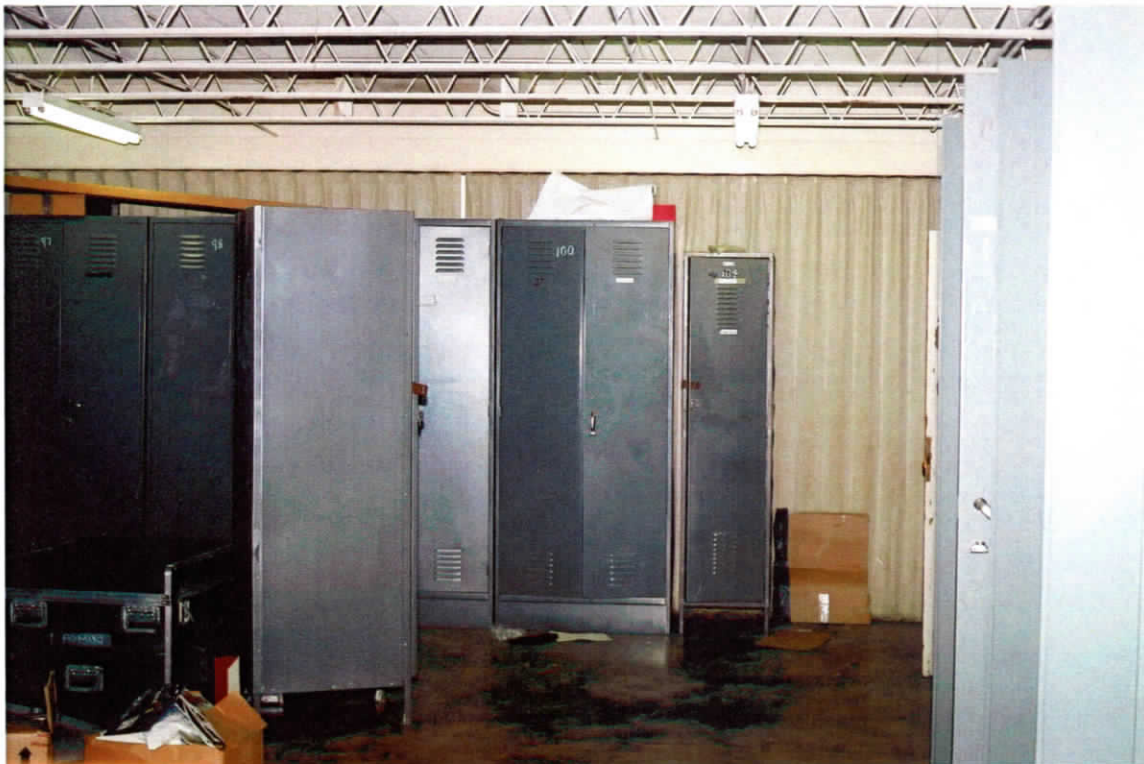
**IFR, FLOOR IN FRONT OF
WHERE BACKSTOP WAS**

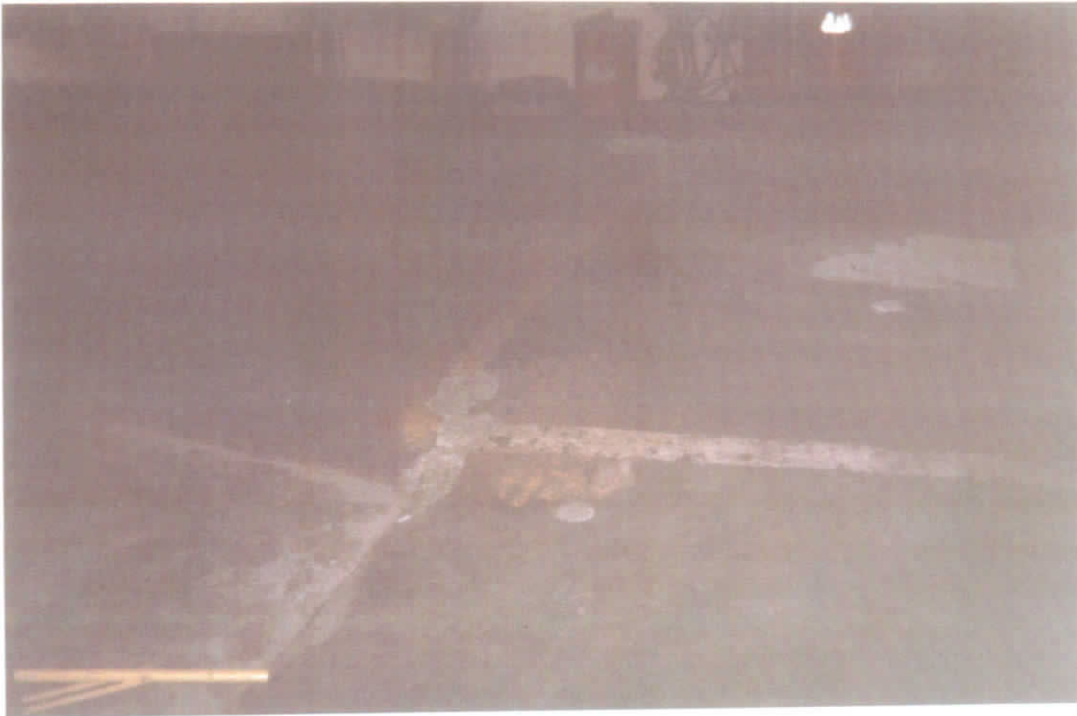
Uneven asphalt Floor in Maintenance facility

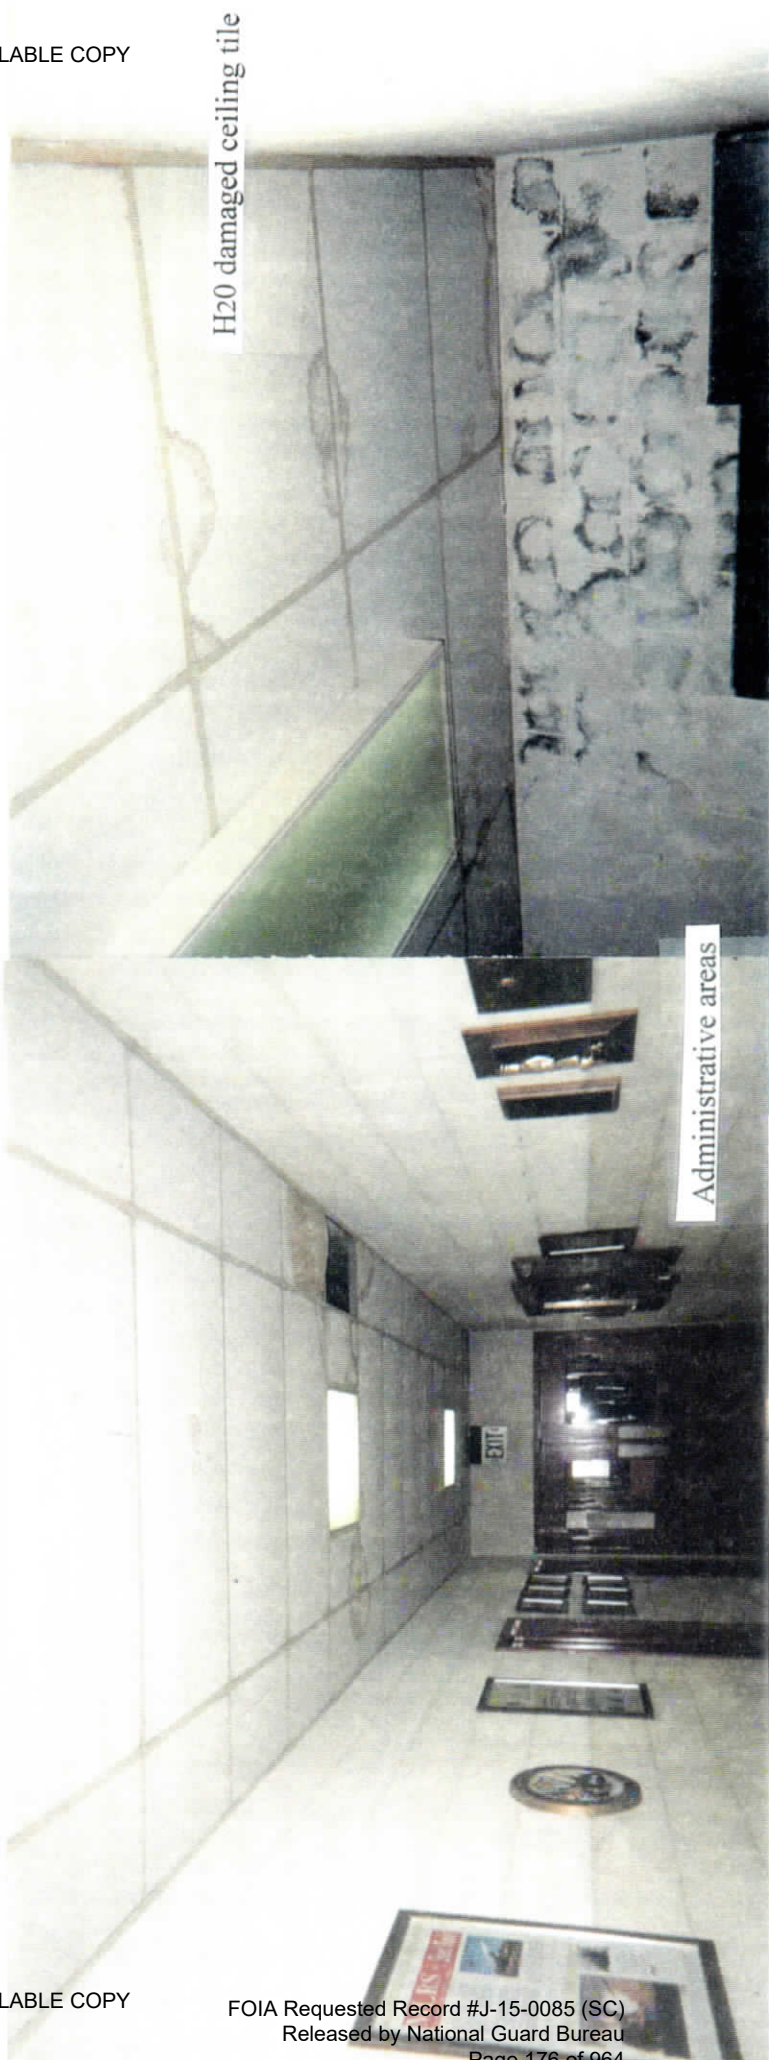
H2O damaged ceiling tile

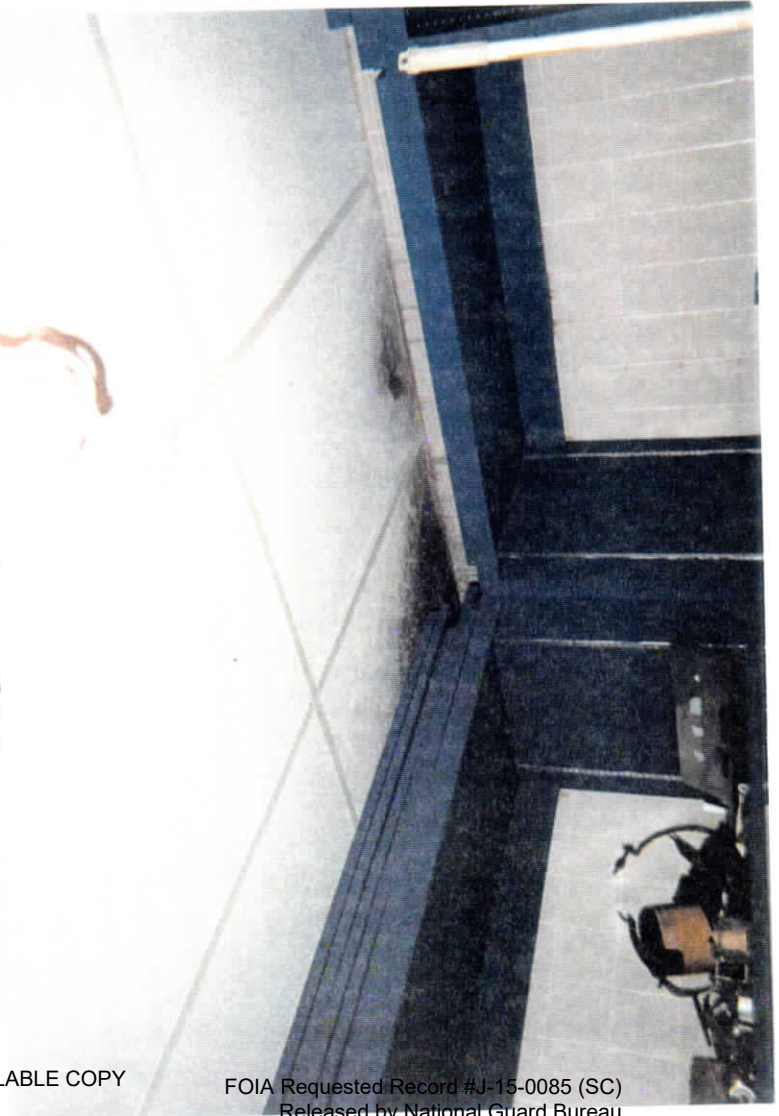
H2O damaged ceiling tile

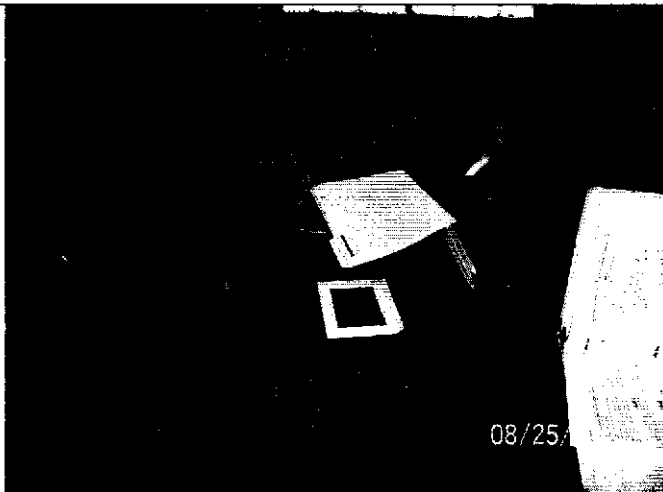
Photo # 7
Lead Wipe Sample 11 – Motor Pool:
Administration Office
