BEST AVAILABLE COPY
DEPARTMENT OF THE ARMY AND THE AIR FORCE
NATIONAL GUARD BUREAU
REGIONAL INDUSTRIAL HYGIENE OFFICE
AIRPORT PLAZA SUITE 1530
510 PLAZA DRIVE
COLLEGE PARK, GA 30349

SUBJECT: Transmittal of IH Survey, Angleton Armory 272 EN (VERT) (386EN) 1716 County
Road 428 Angleton, Texas 77515

- a. In accordance to the JFTX-H-OH Industrial Hygiene Implementation Plan of 2007, a follow-up industrial hygiene survey was performed at the Angleton Armory located at 1716 County Road 428 Angleton, Texas 77515. The purpose of the survey was to perform a follow-up industrial hygiene survey to evaluate potential health hazards present in the building.
- b. The Point of Contact during the survey was **Non-Responsive**
- c. **Non-Responsive** Industrial Hygiene Technician for the Texas Army National Guard conducted the survey on 23 January 2008.

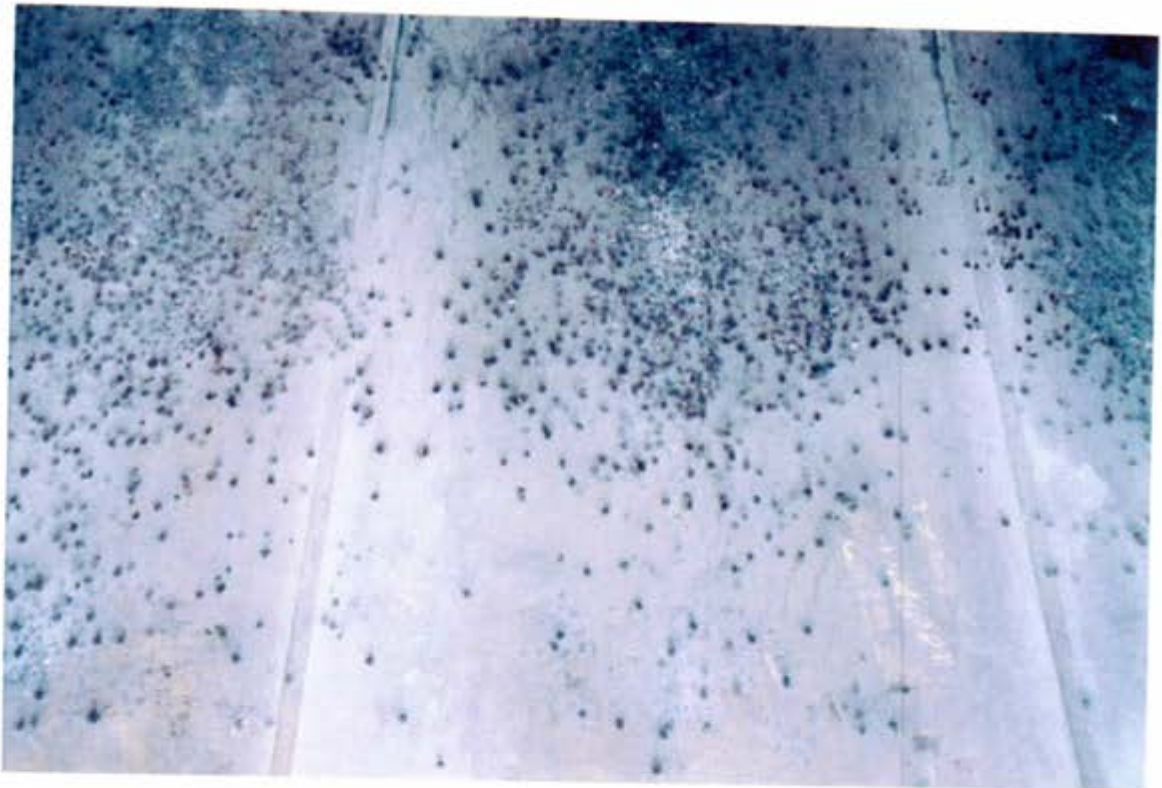
**IFR, BULLET
BACKSTOP**

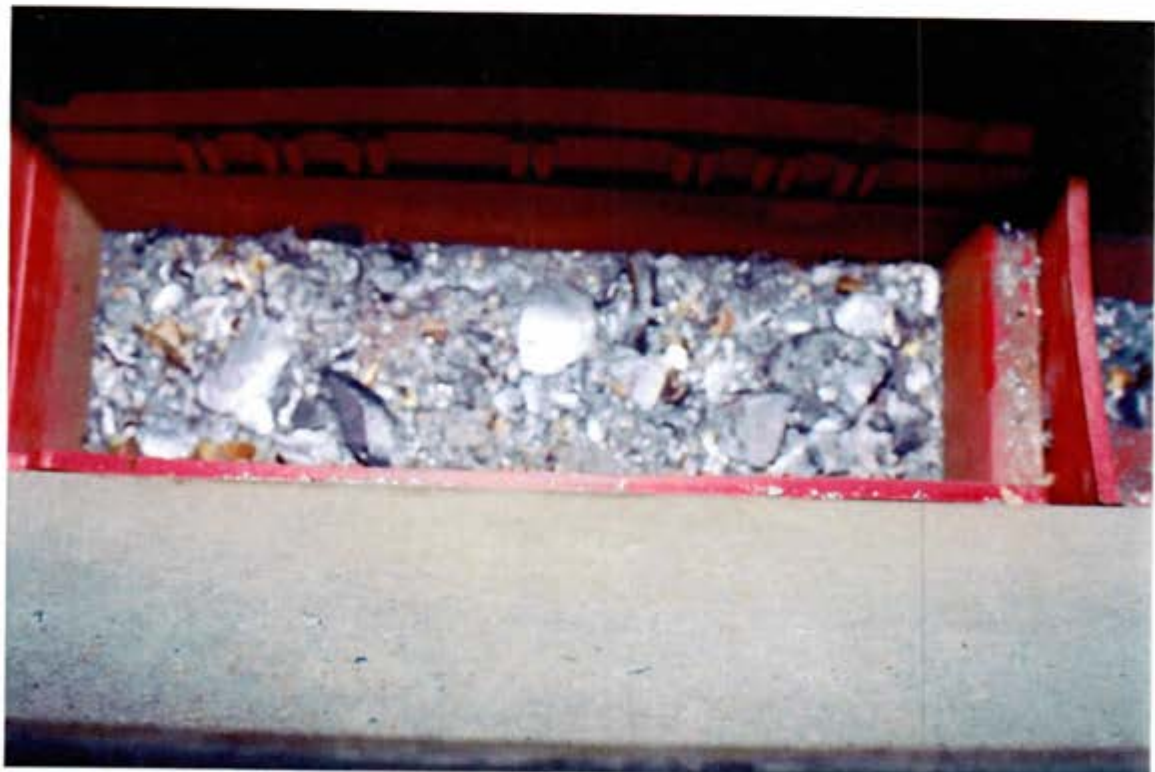
**IFR, BULLET
FRAGMENTS**

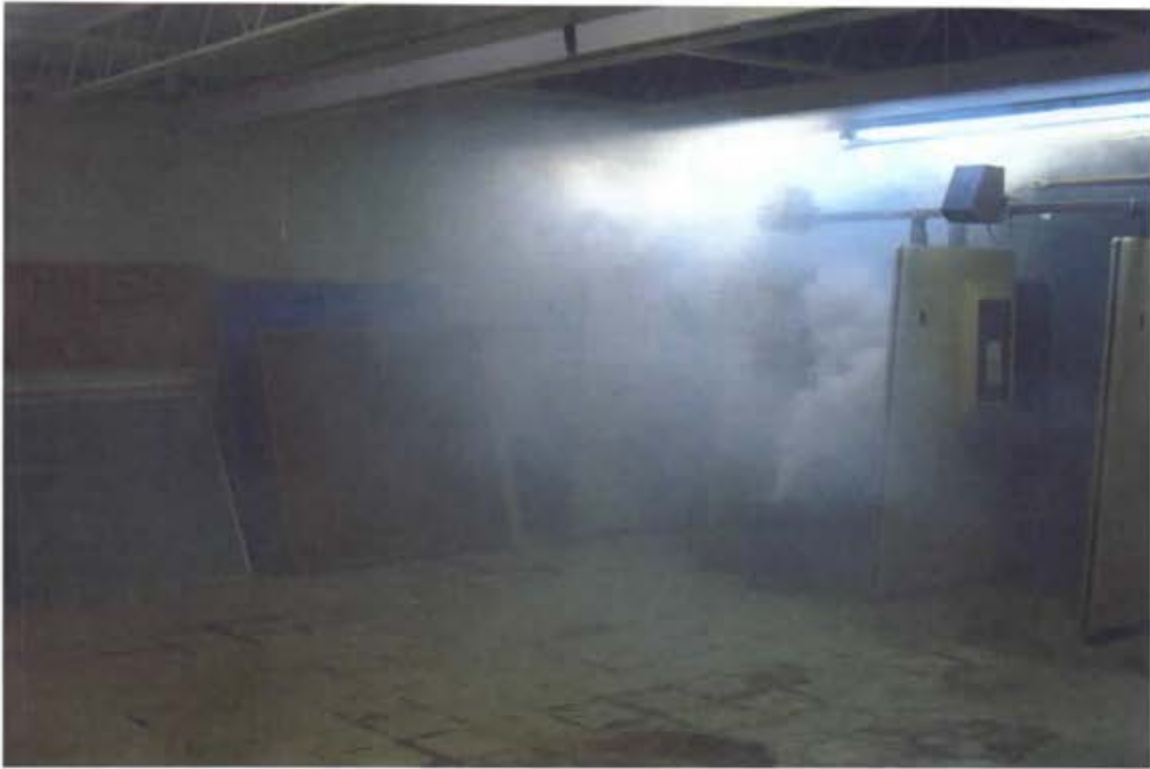
Photo 13: The smoke is being blown towards the observation deck as a result of air rushing through the dropped ceiling opening.

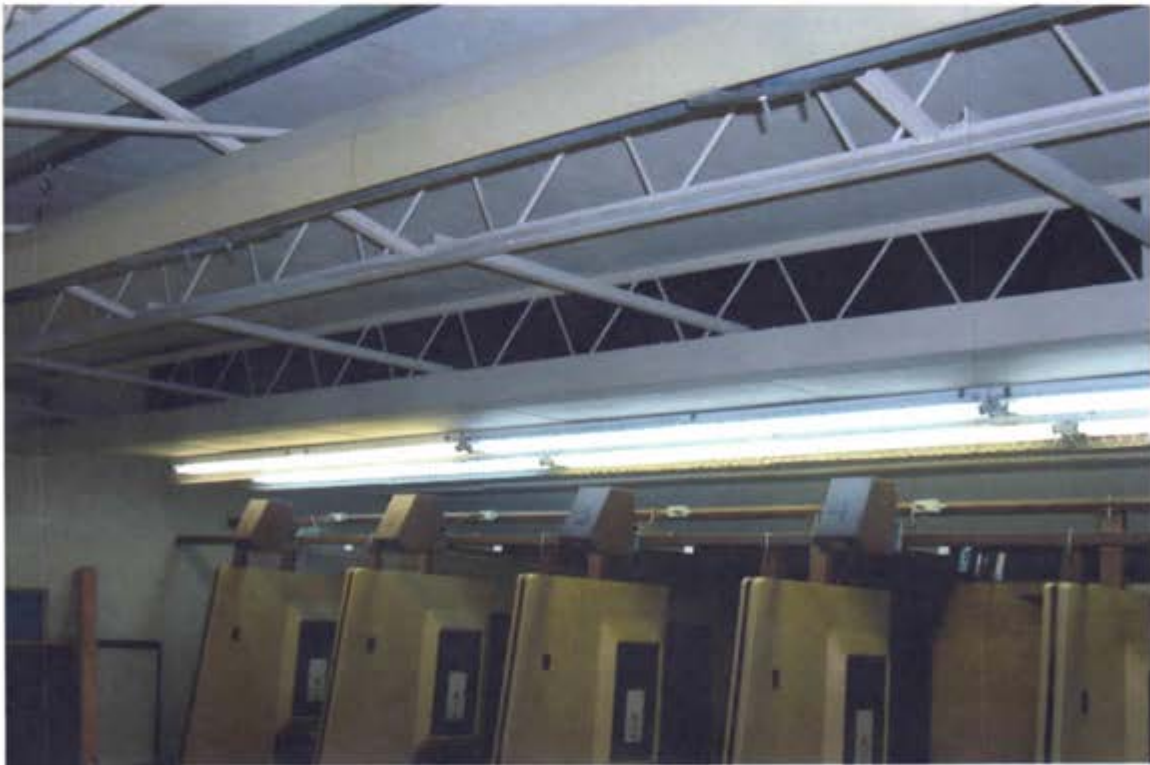
Photo 14: The dropped ceiling opening where makeup air is introduced into the range.

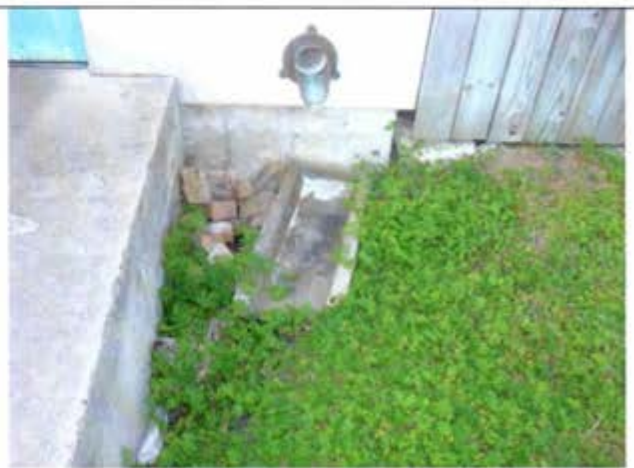
Water Drainage In Front of Sinkhole

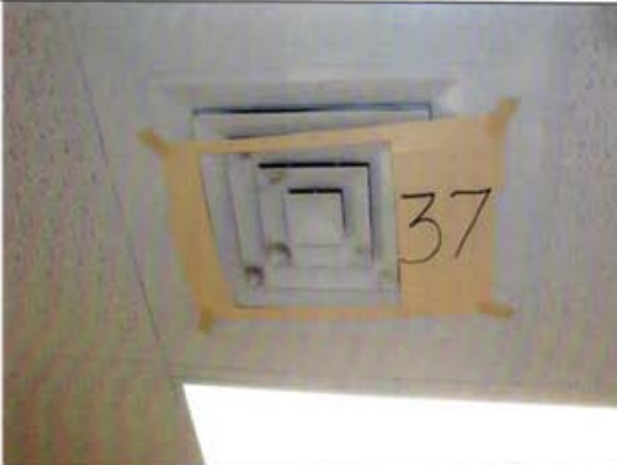
Sample, A/C-Heating Outlet

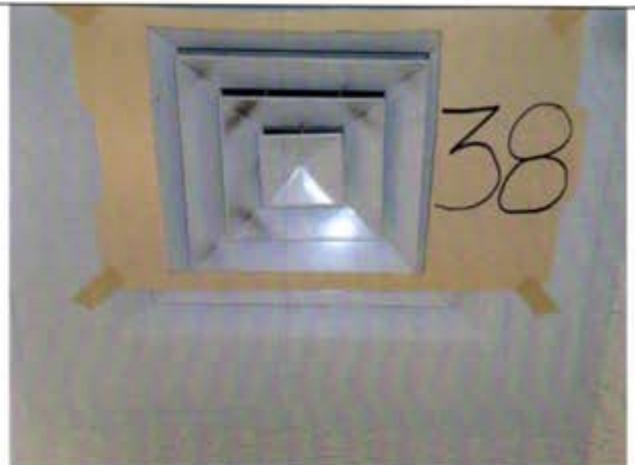
Sample, A/C-Heating Outlet

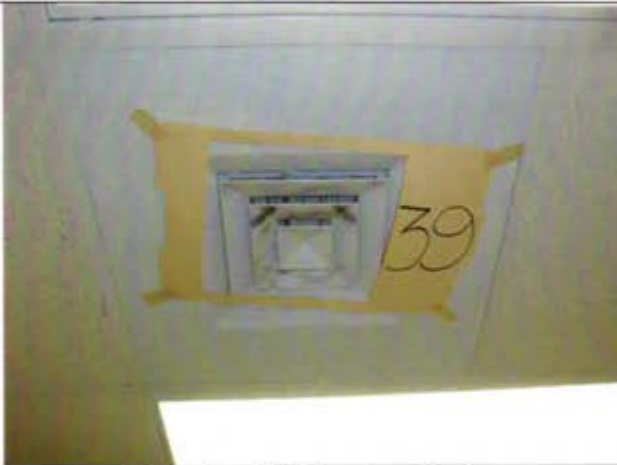
Sample, A/C-Heating Outlet

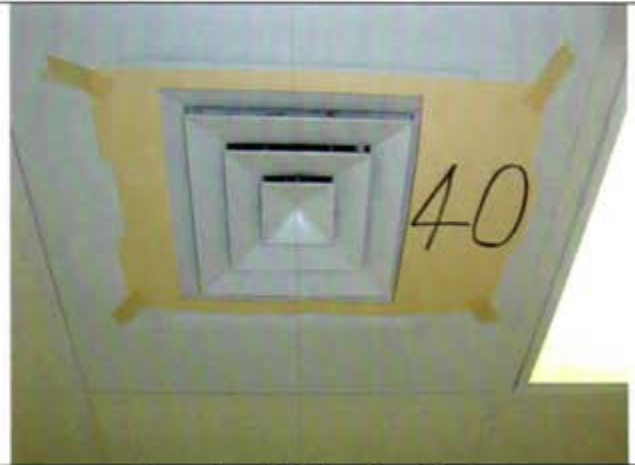
Sample, A/C-Heating Outlet

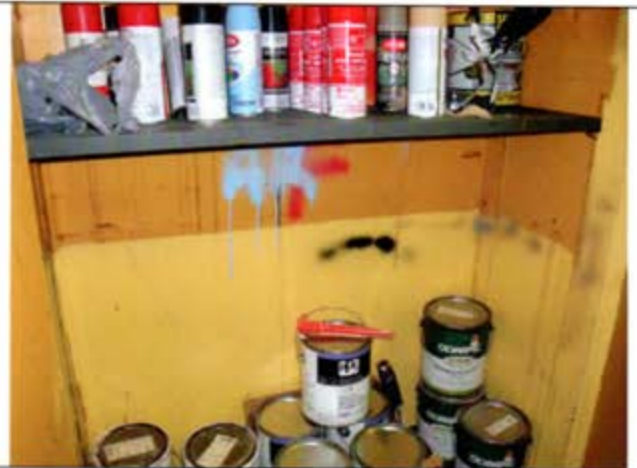
Household Chemicals On Shelves

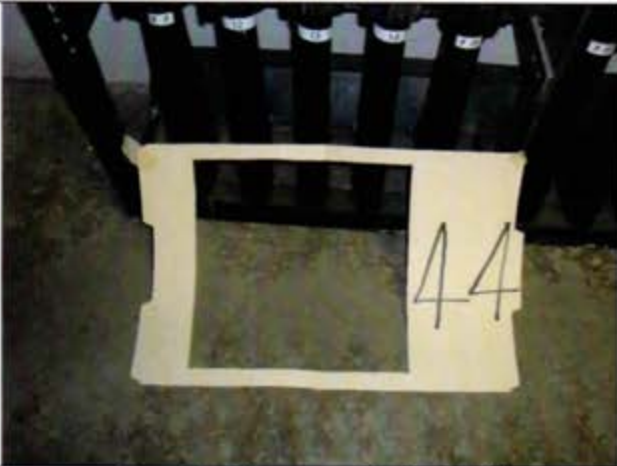
Contents, Flammables Cabinet

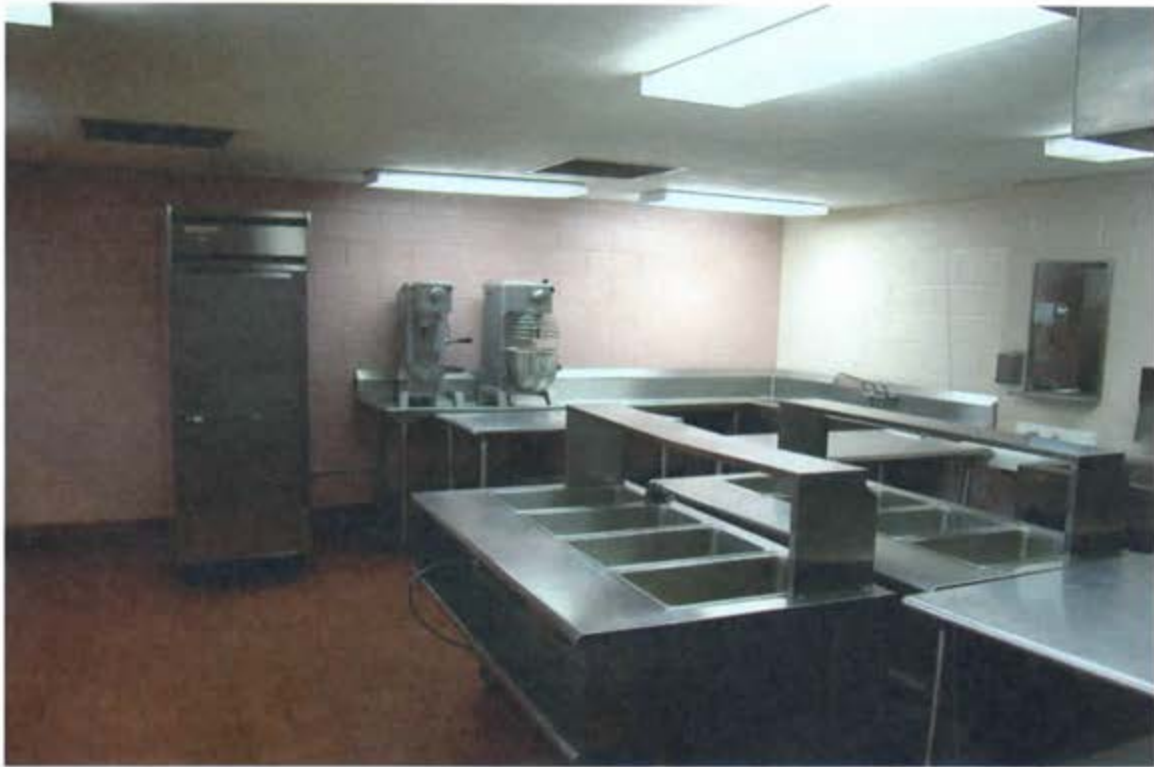
Photo #9: Armory's kitchen showing the serving line and refrigerator.

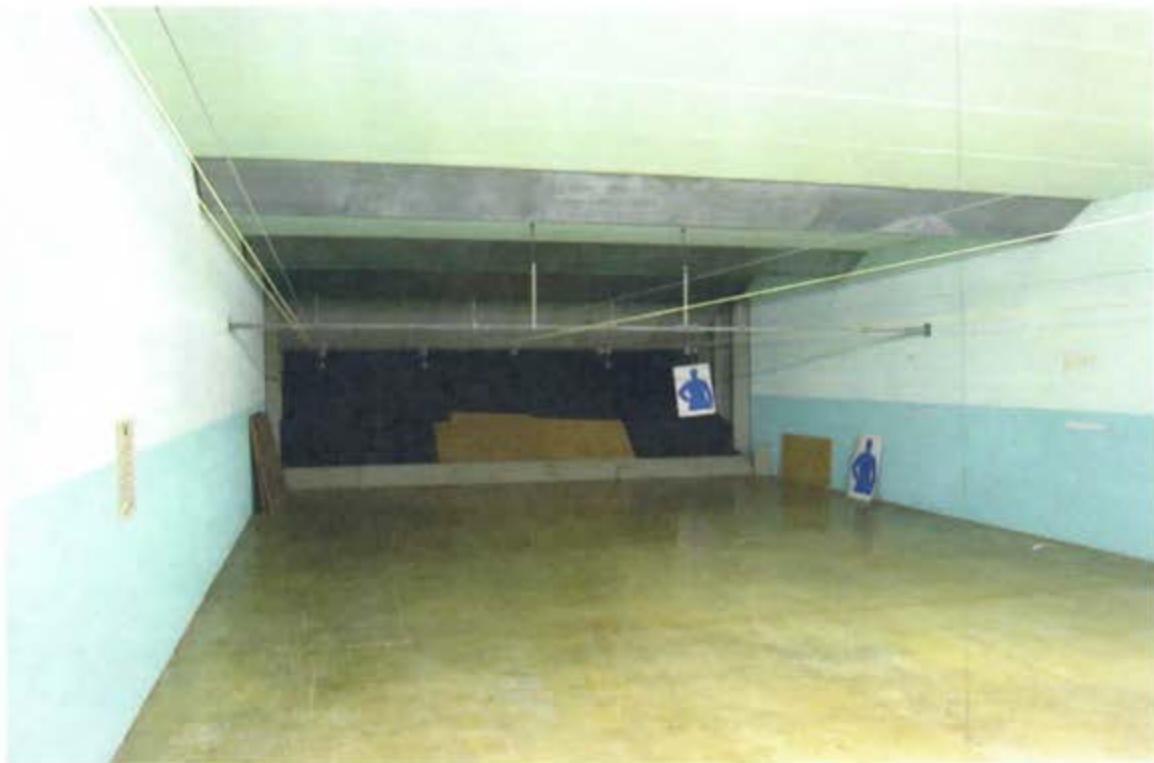
Photo #10: Indoor firing range facing bullet trap.

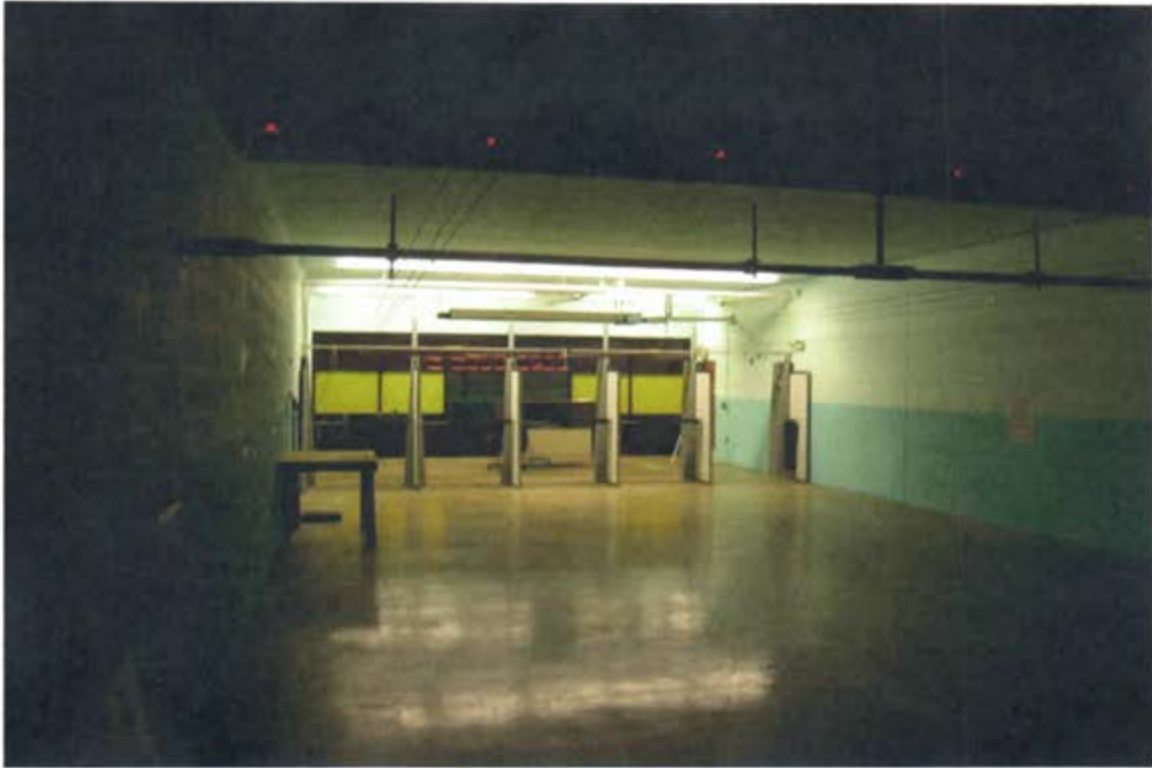
Photo #11: Indoor firing range facing the firing line

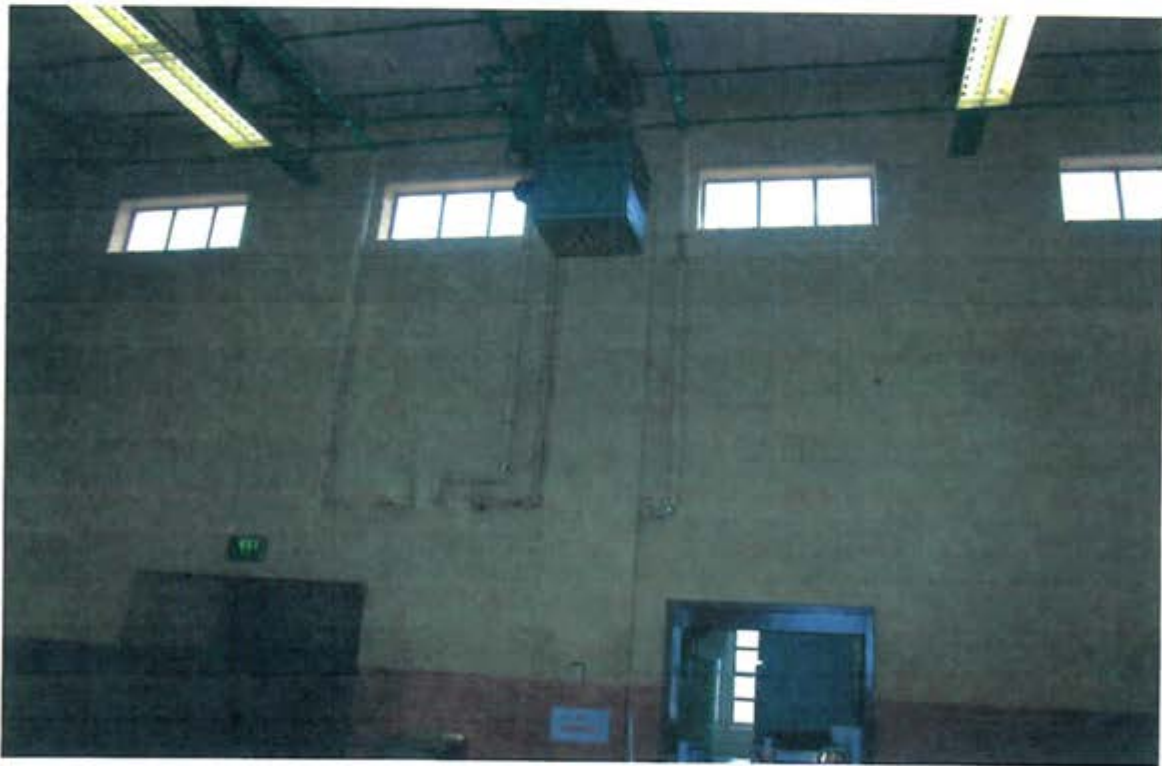
Photo 8: Thermal insulation on pipes found in the drill hall.

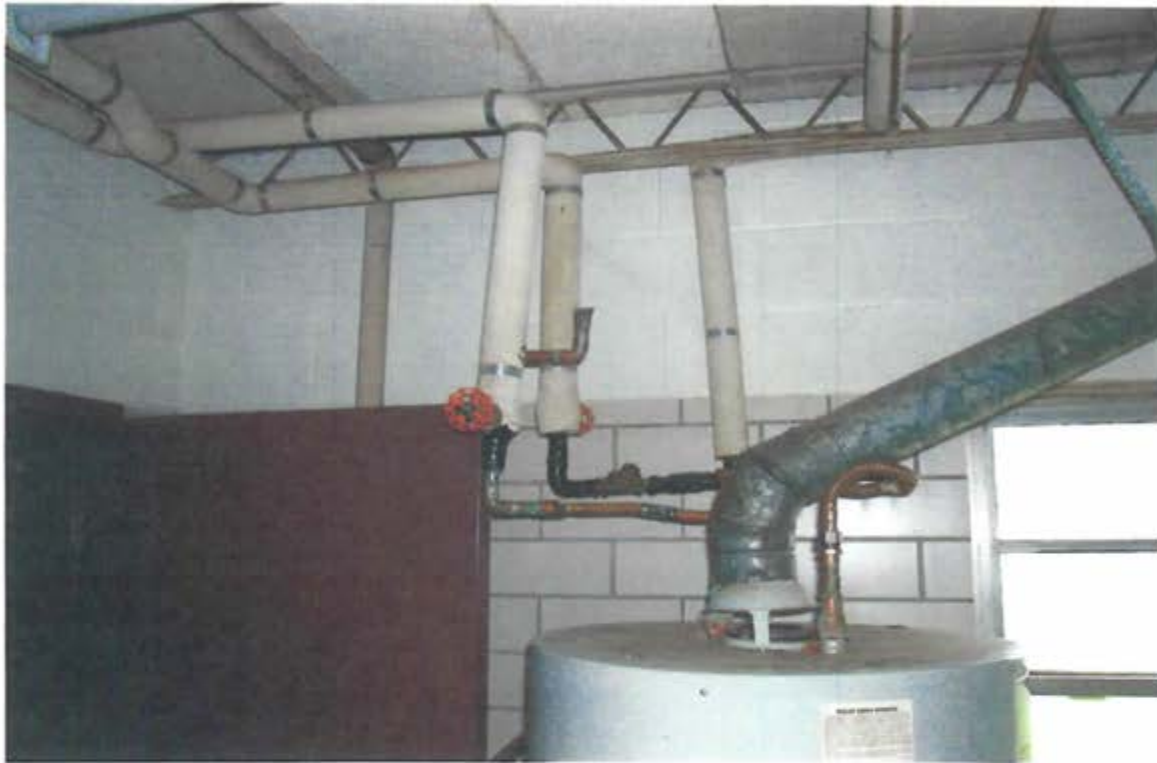
Photo 9: Hot water heater and the insulated hot water pipes.

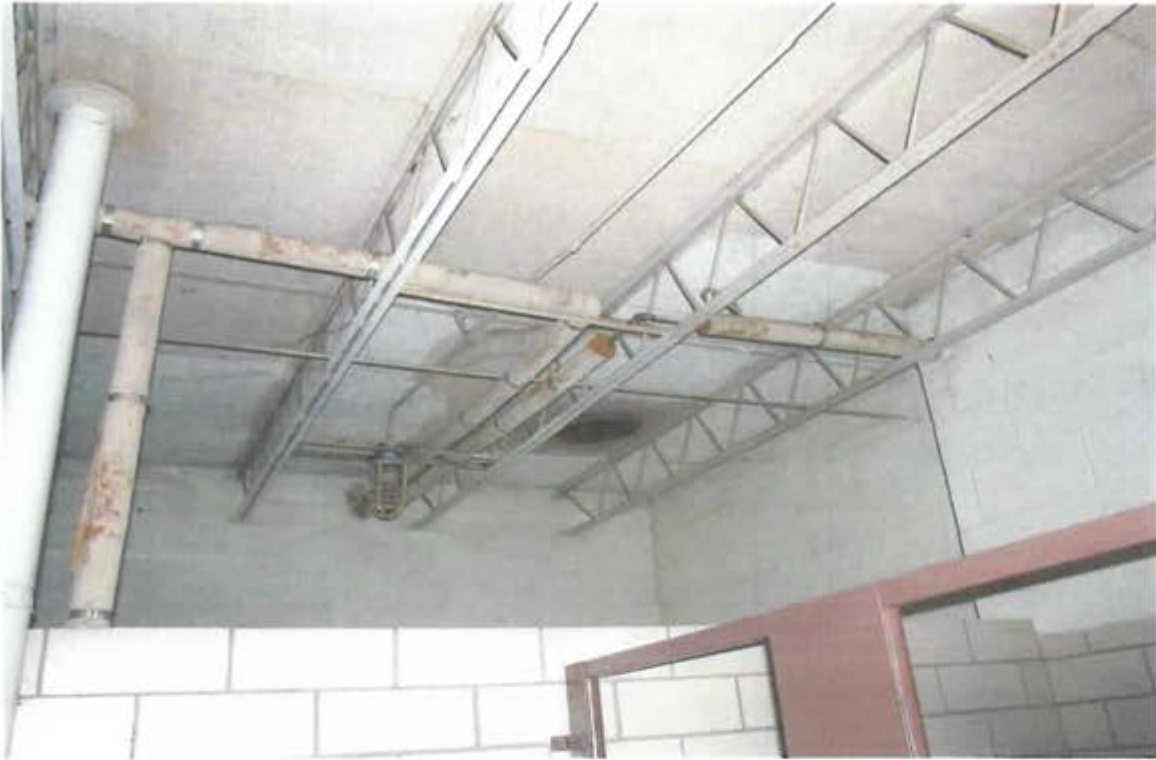
Photo 11: Insulated hot water pipes in the men's bathroom.

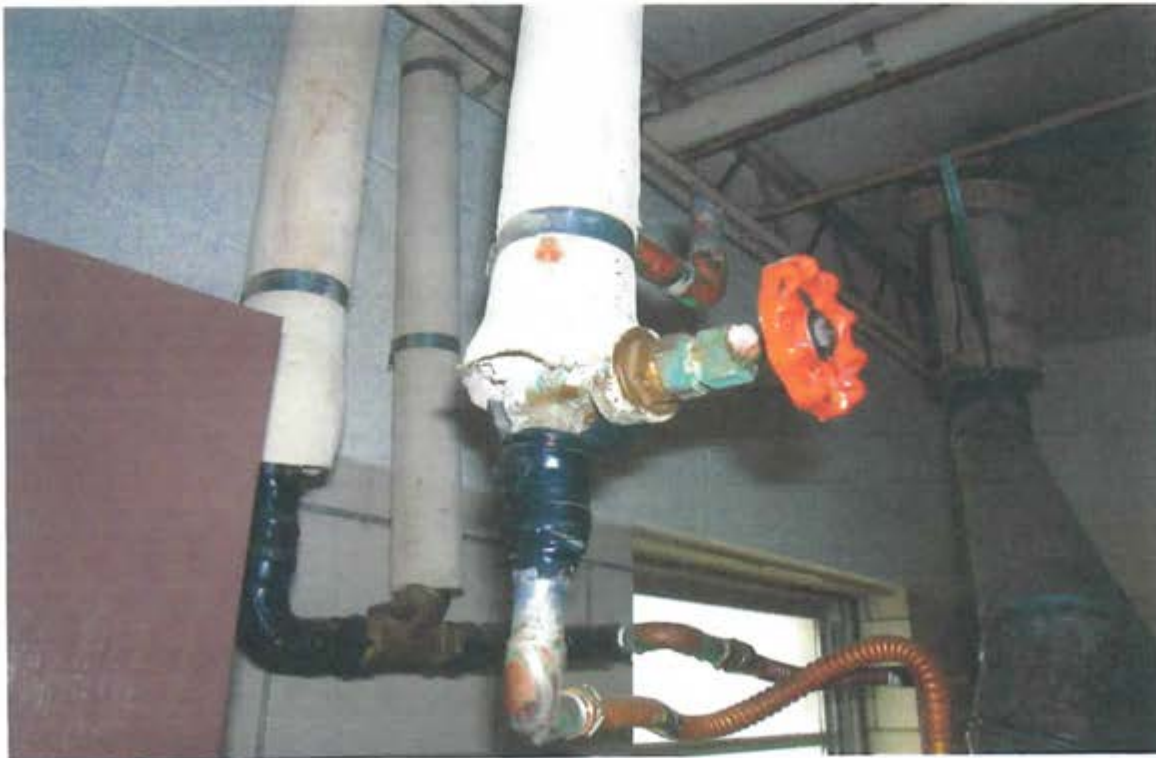
Photo 12: Sampled thermal pipe insulation found on the hot water system.

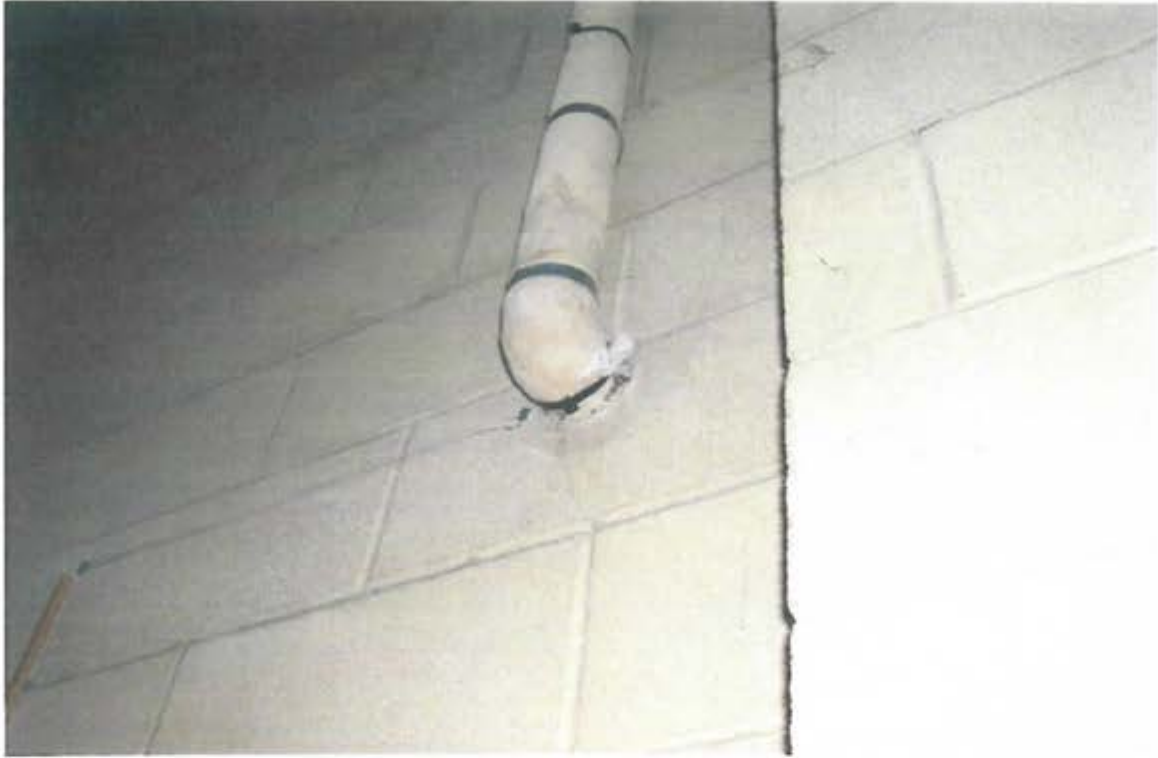
Photo 13: Sampled thermal pipe insulation found in the drill hall.

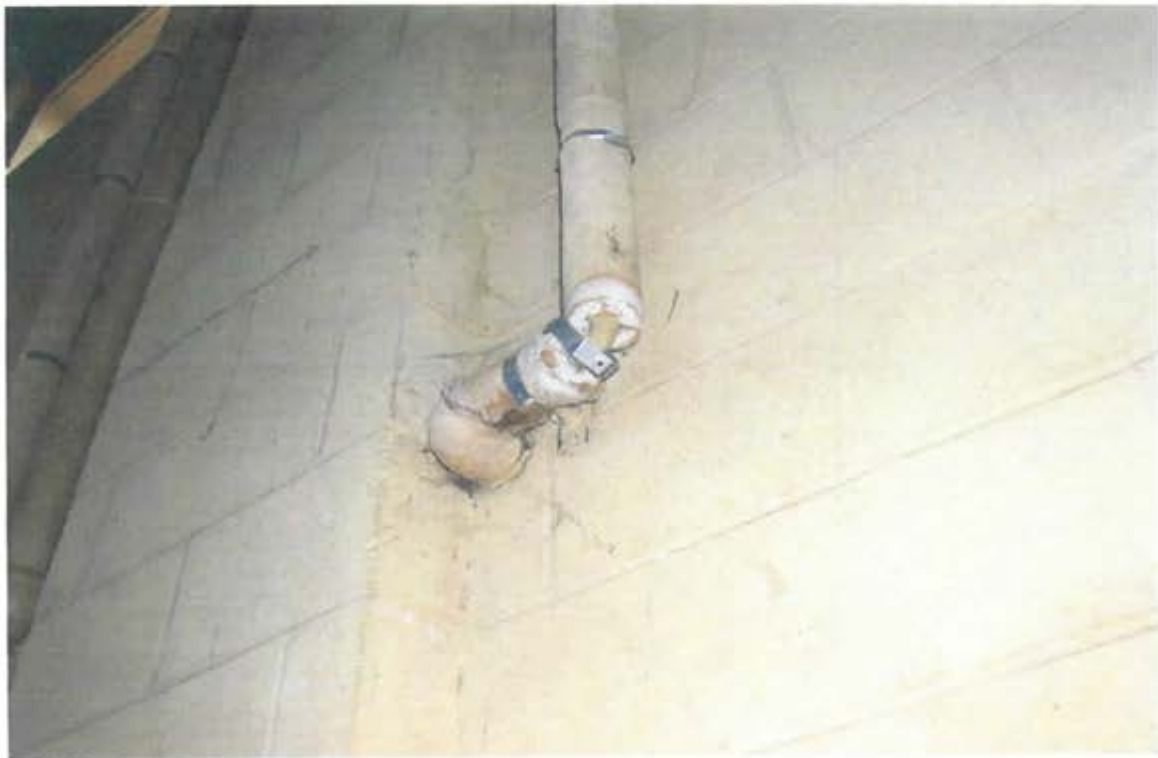
Photo 14: Thermal pipe insulation found in the drill hall.

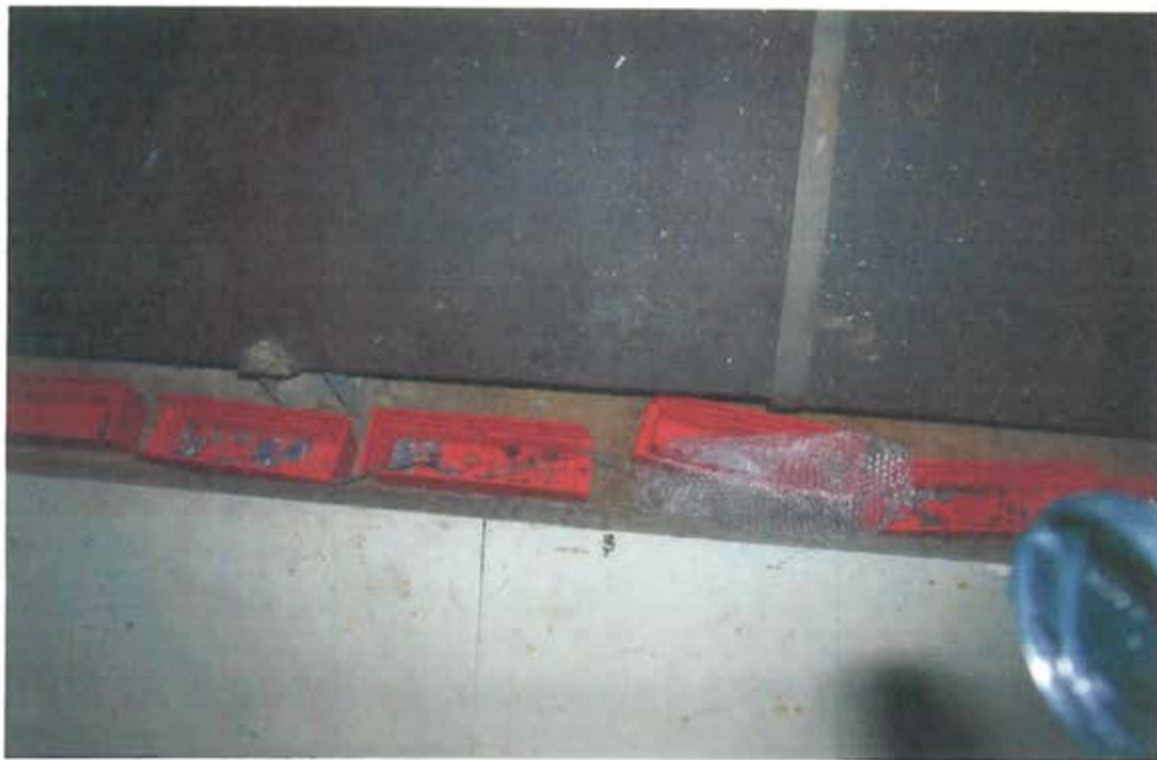
Photo 6: Bullet trap.

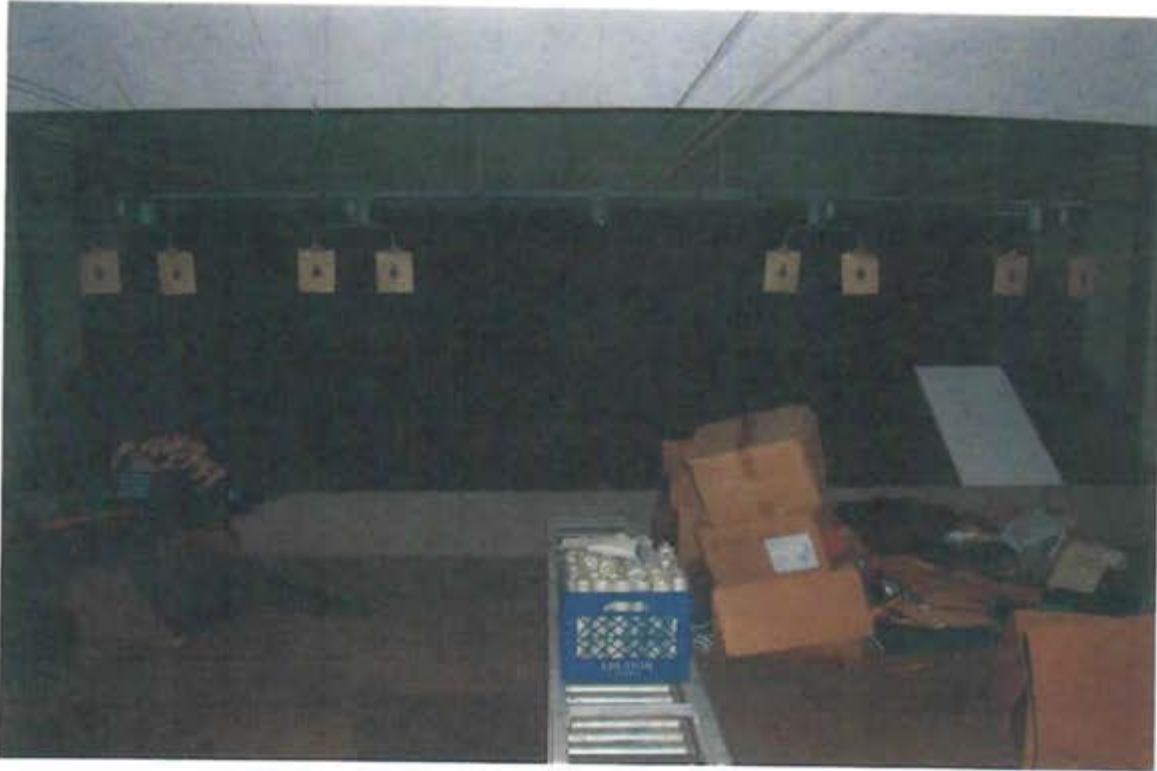
Photo 7: Bullet stop, target sheets and storage boxes.

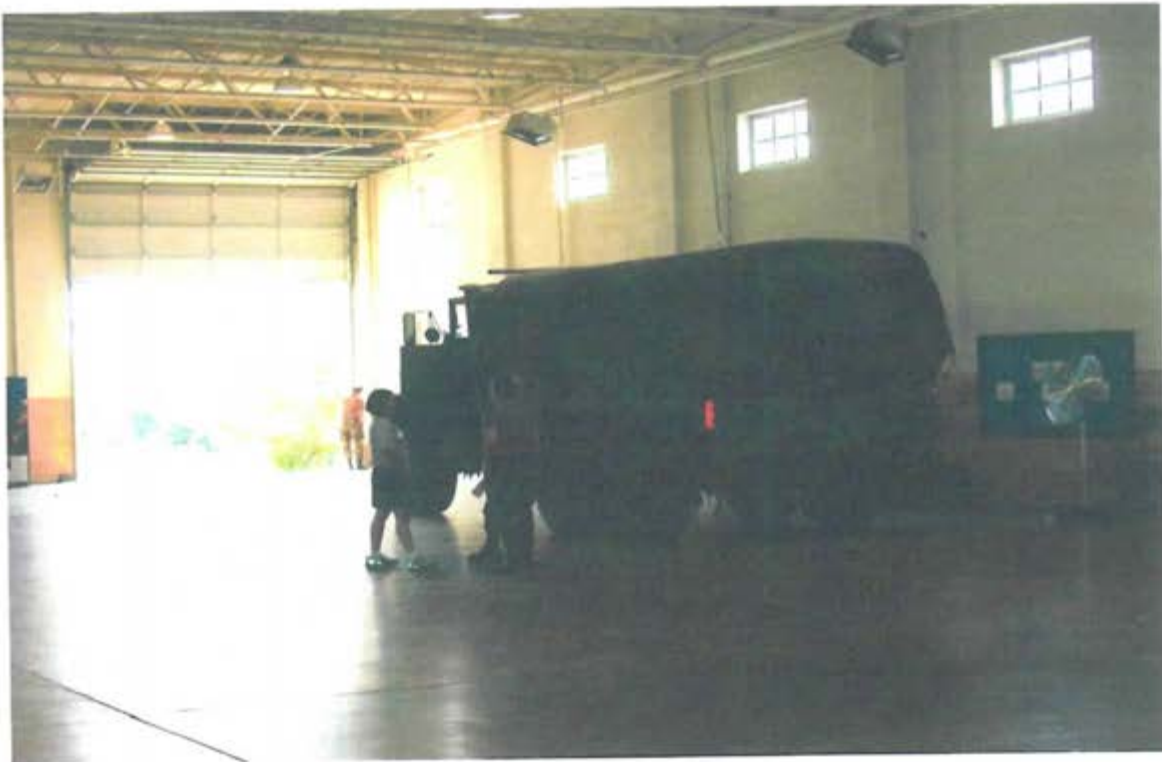
Photo 12: Drill Hall showing the overhead garage door.

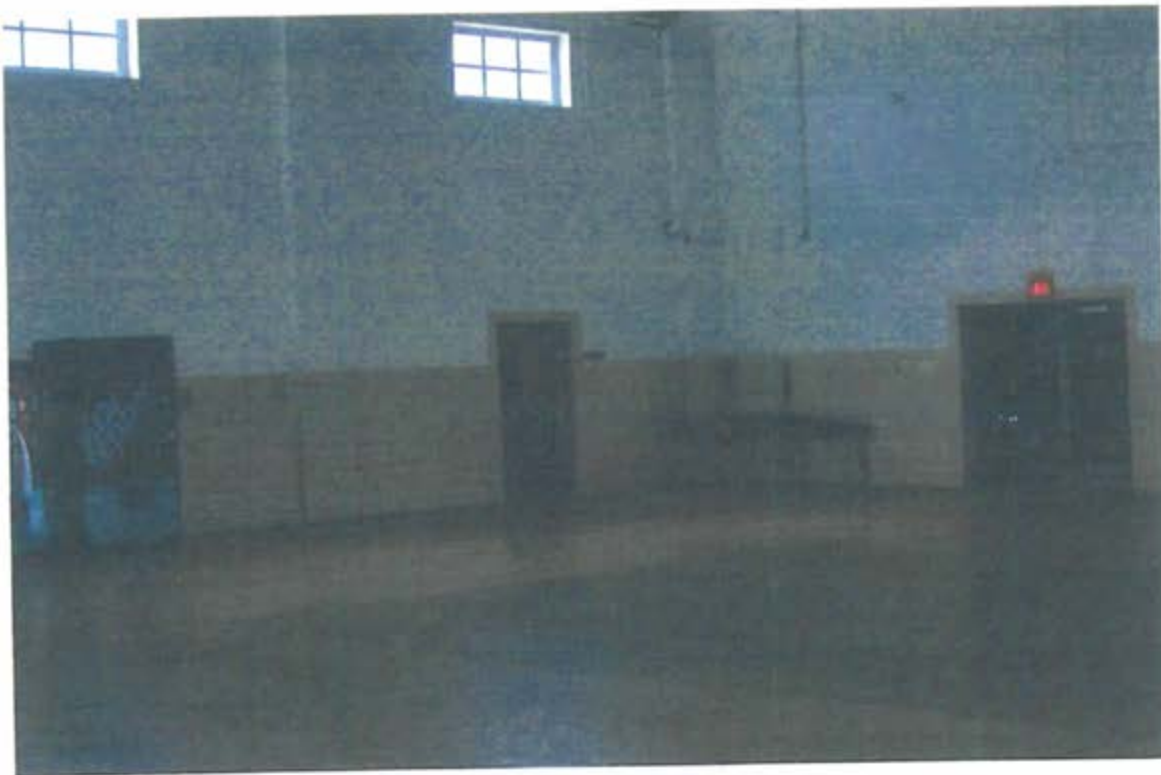
Photo 13: Drill or Assembly Hall.

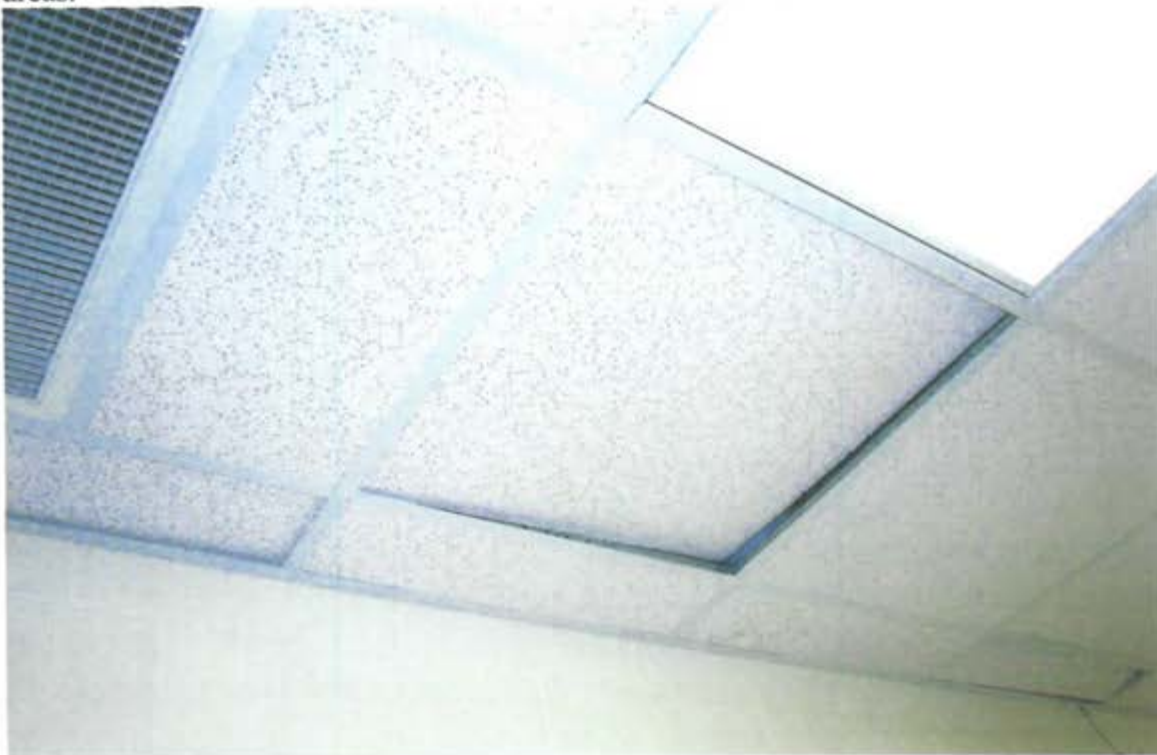
Photo 16: Photo of the ceiling tiles found throughout the administrative office areas.

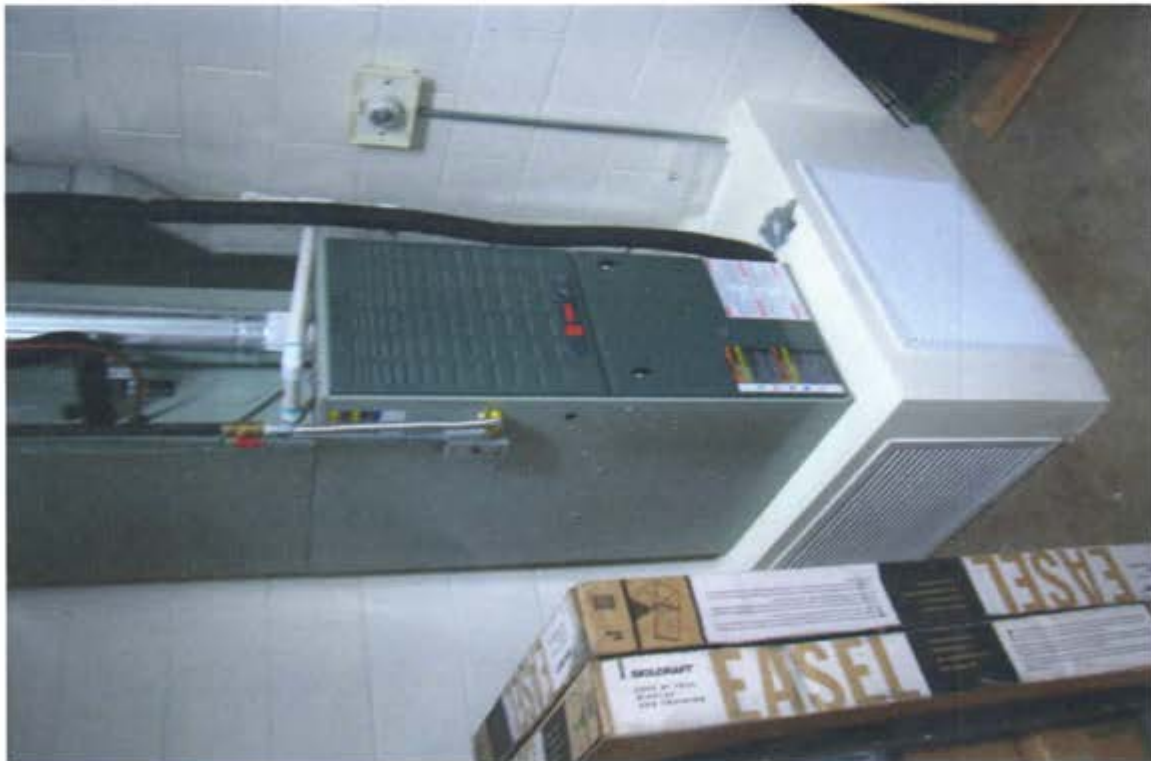
Photo #10: Furnace units showing the wooden common return plenum

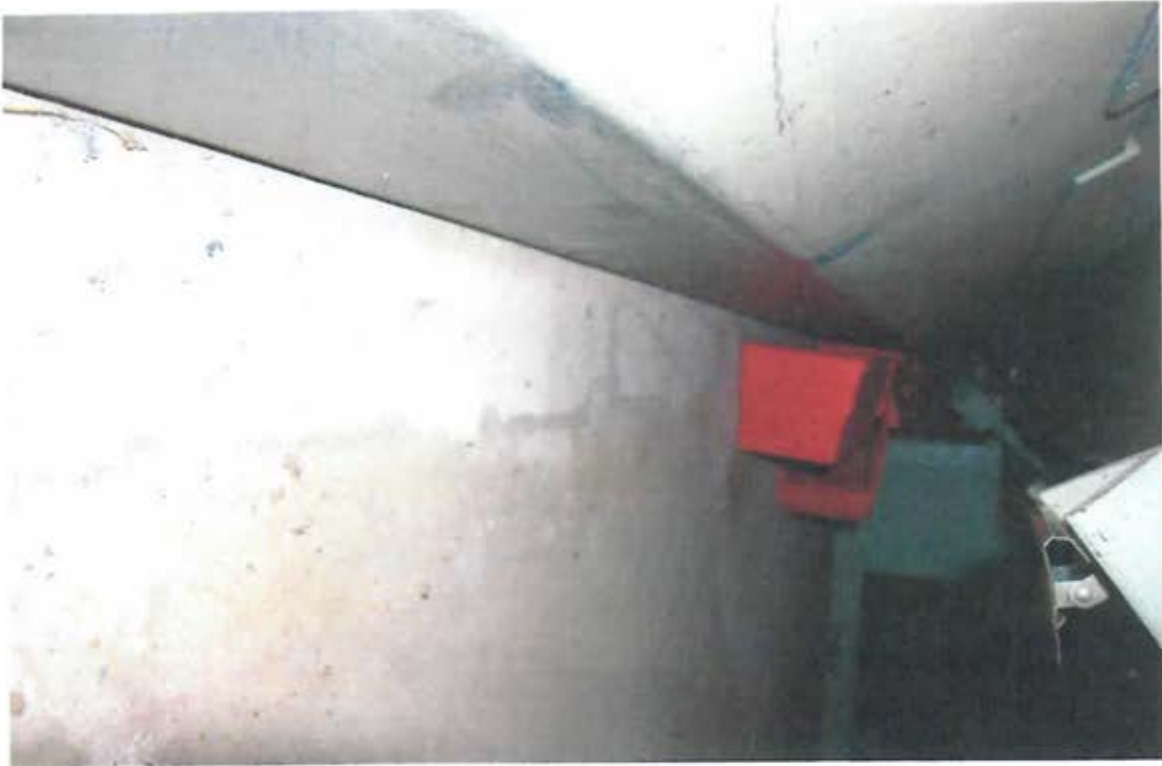
Photo 5: Bullet trap in the firing range.

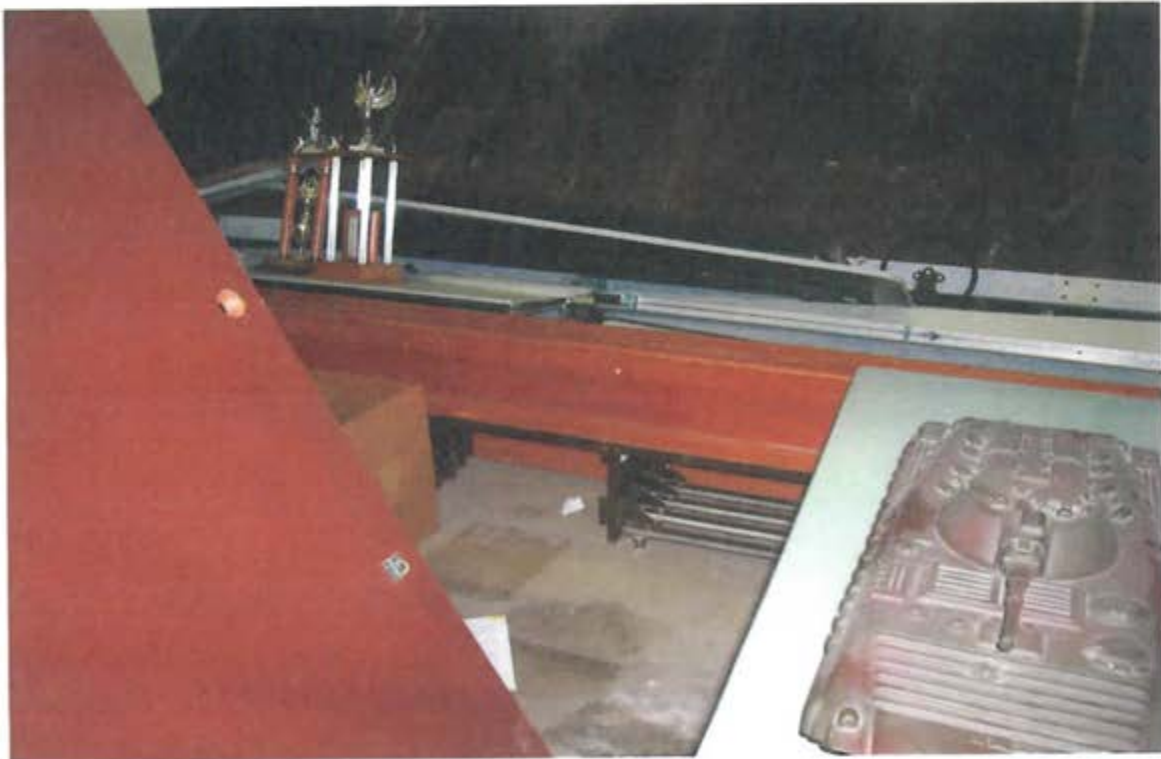
Photo 6: Floor area in front of bullet stop in firing range.

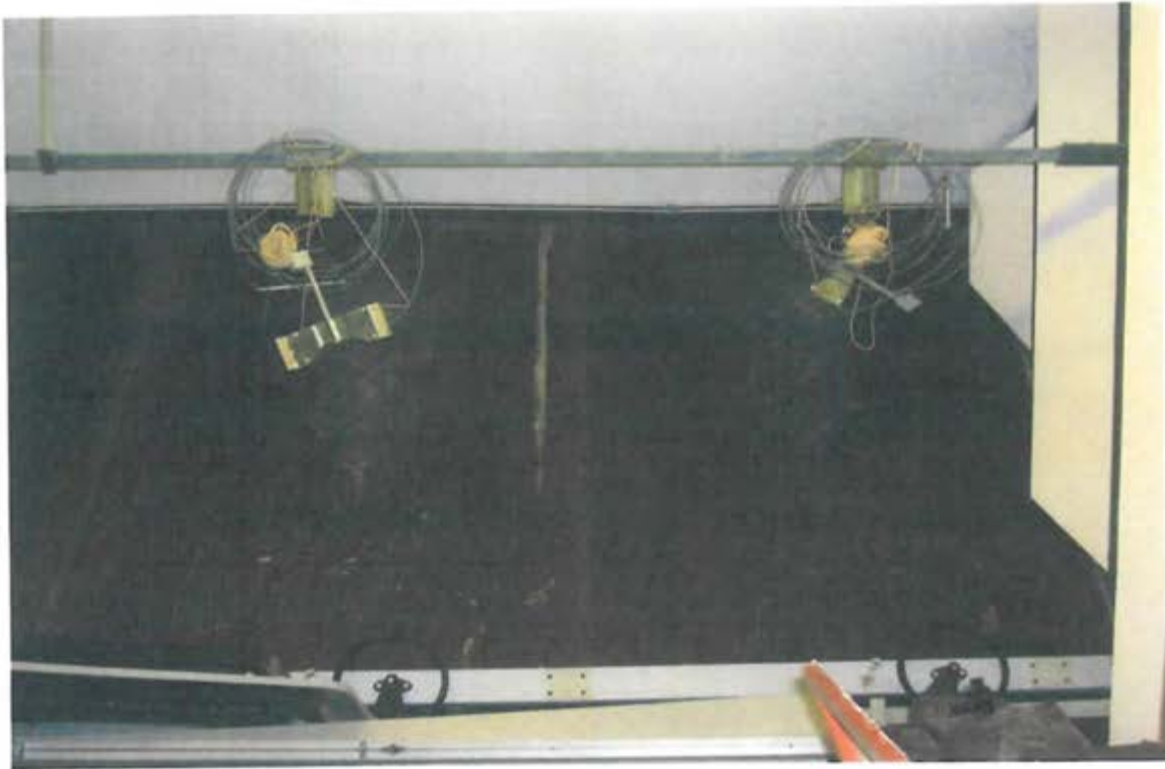
Photo 7: Bullet trap and stop in firing range.

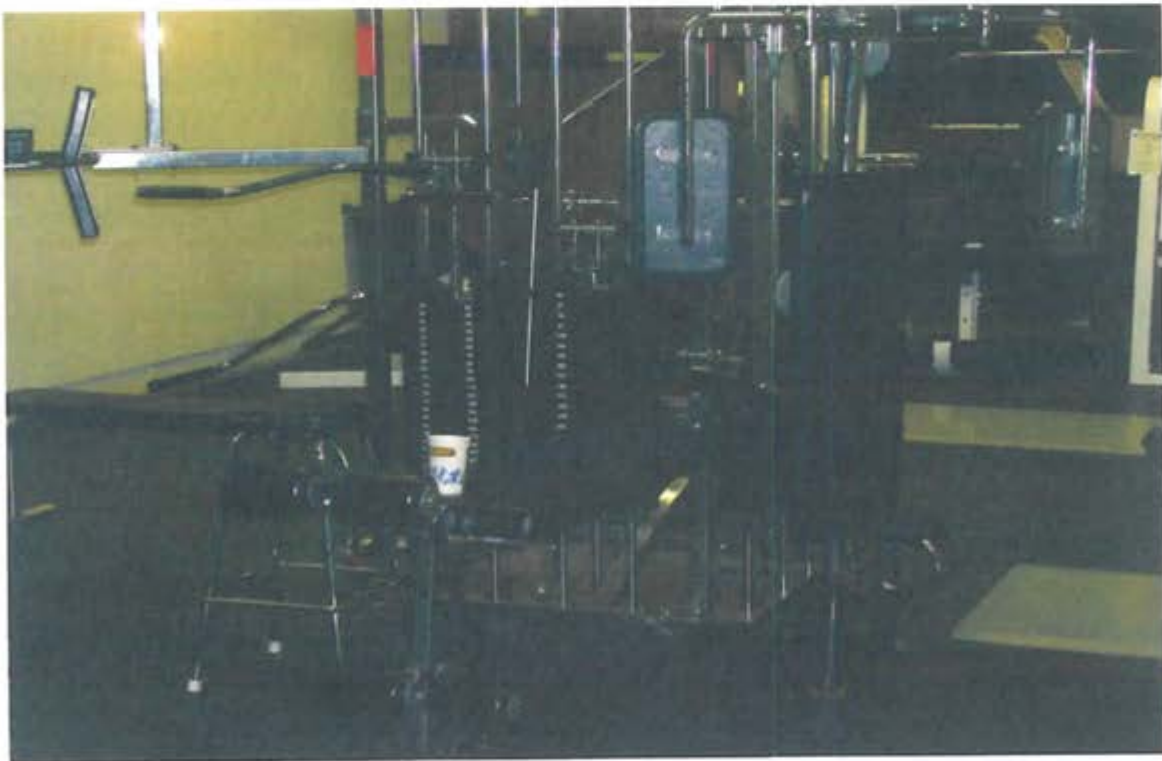
Photo 10: Weight lifting machine in range. Note the soda cup.
