BEST AVAILABLE COPY
DEPARTMENT OF THE ARMY AND THE AIR FORCE
NATIONAL GUARD BUREAU
REGIONAL INDUSTRIAL HYGIENE OFFICE
AIRPORT PLAZA SUITE 1530
510 PLAZA DRIVE
COLLEGE PARK, GA 30349

SUBJECT: Transmittal of IH Survey, Angleton Armory 272 EN (VERT) (386EN) 1716 County
Road 428 Angleton, Texas 77515

- a. In accordance to the JFTX-H-OH Industrial Hygiene Implementation Plan of 2007, a follow-up industrial hygiene survey was performed at the Angleton Armory located at 1716 County Road 428 Angleton, Texas 77515. The purpose of the survey was to perform a follow-up industrial hygiene survey to evaluate potential health hazards present in the building.
- b. The Point of Contact during the survey was **Non-Responsive**
- c. **Non-Responsive** Industrial Hygiene Technician for the Texas Army National Guard conducted the survey on 23 January 2008.

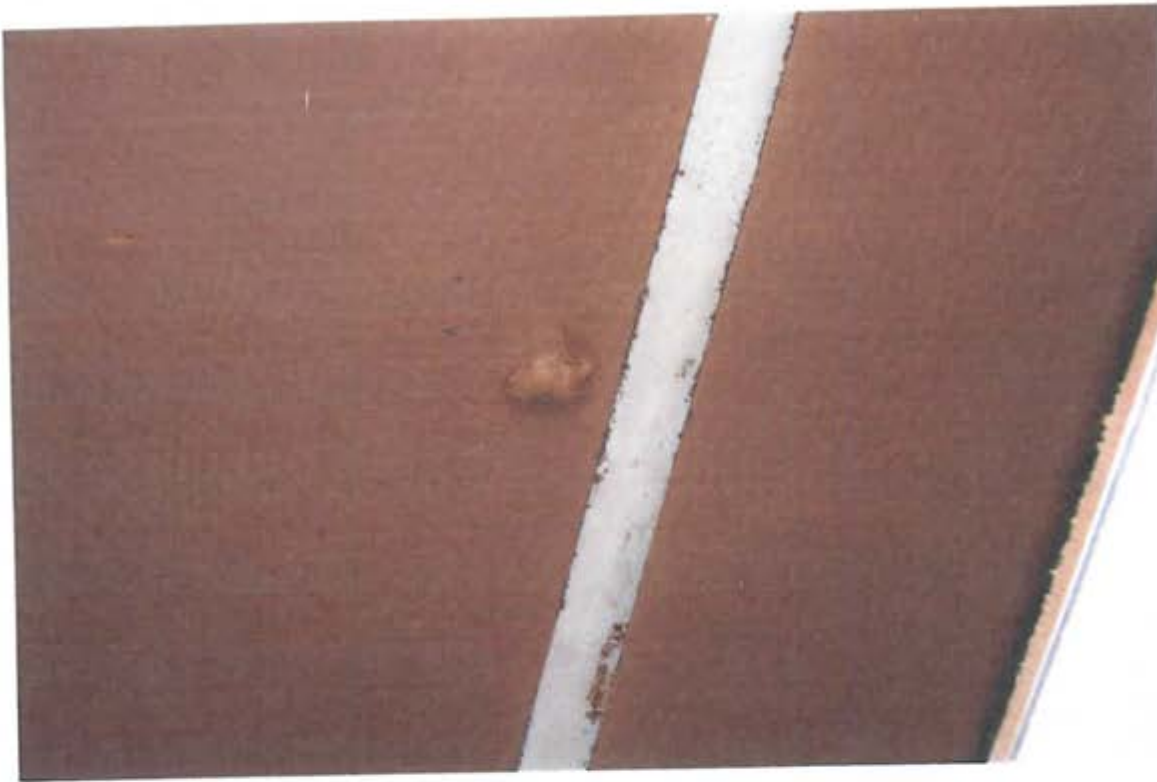
Photo 17: Photo of the fiberboard found in the supply room ceiling.

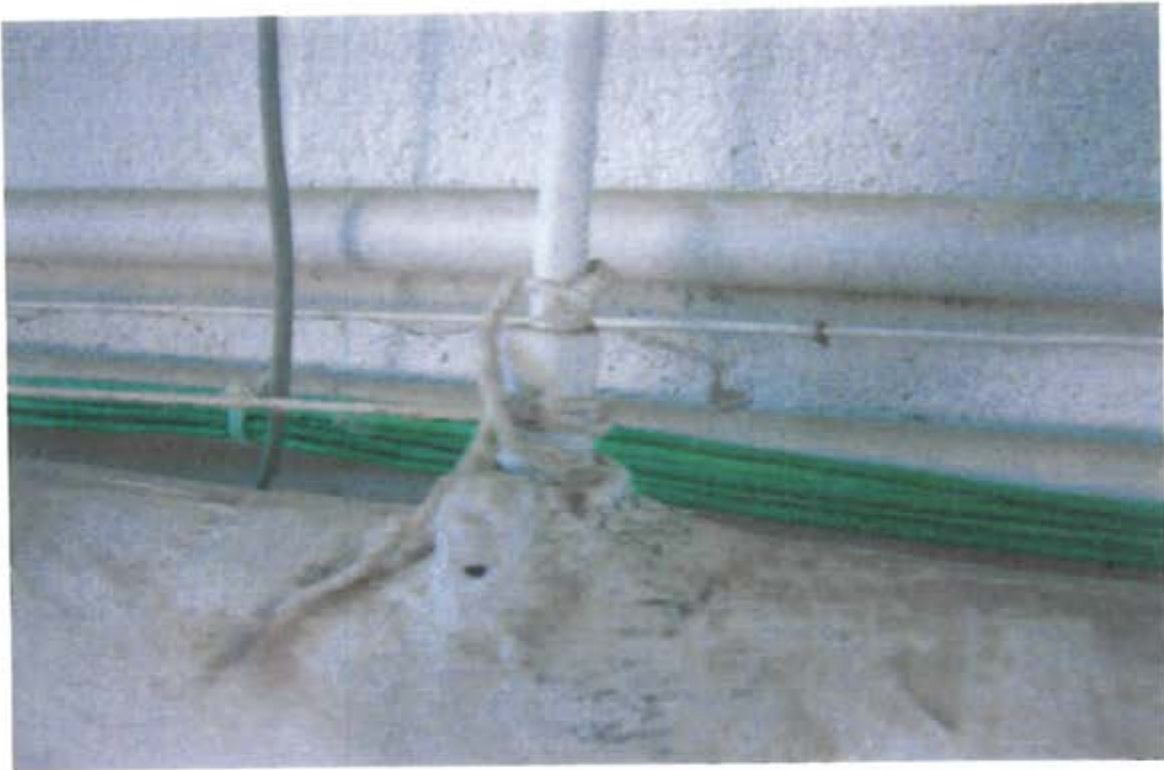
Photo 19: Thermal pipe fitting insulation in the drill hall.

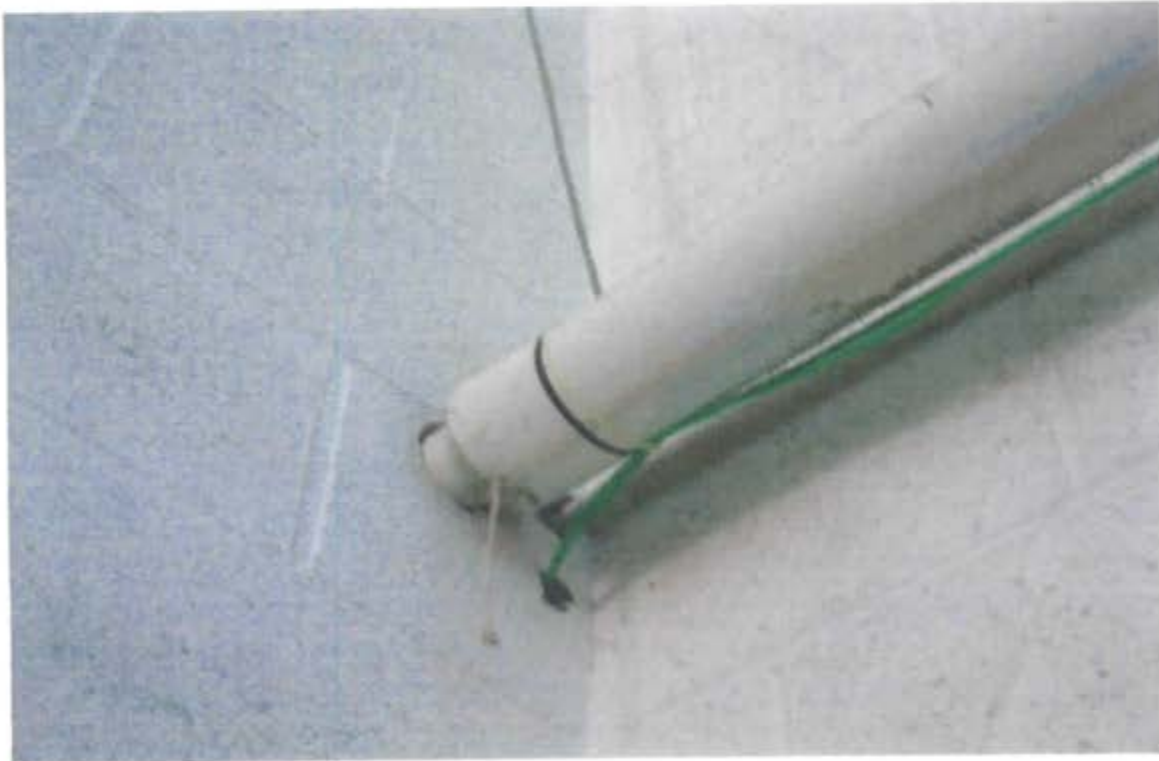
Photo 20: Thermal pipe insulation in drill hall..

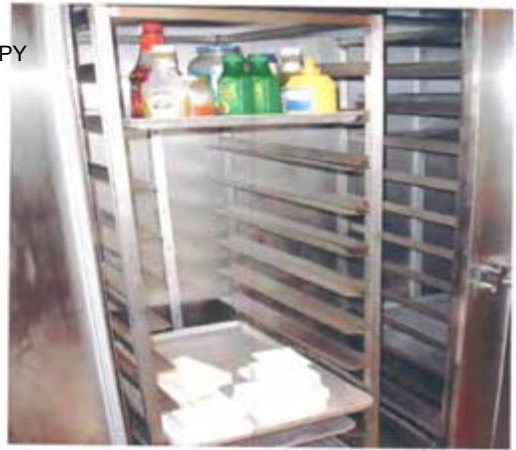
View of Flumist live vaccine (lower tray) stored with food in the kitchen refrigerator

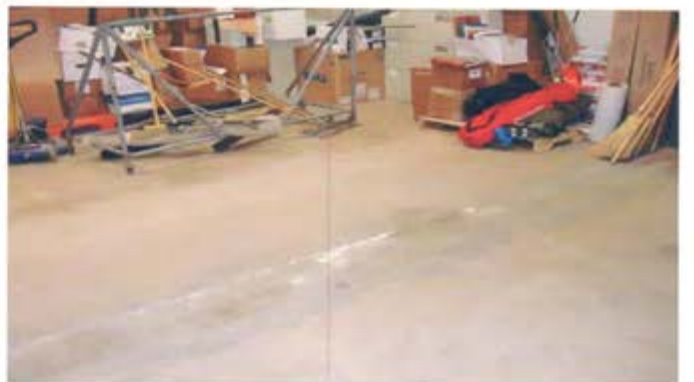
View of demarcation of the former backstop/pit area

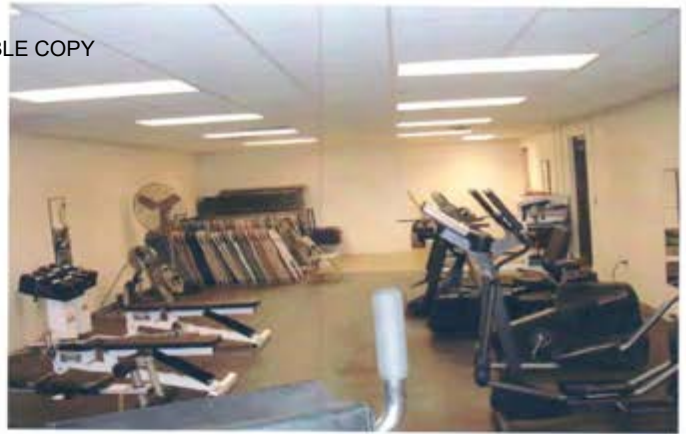
Up range view of converted indoor firing range

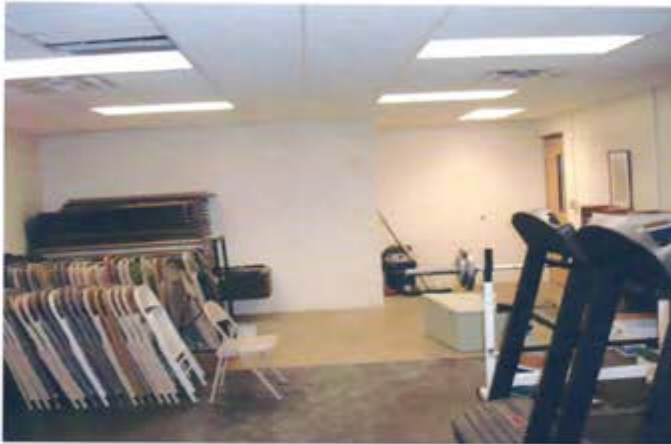
Up range view of converted indoor firing range

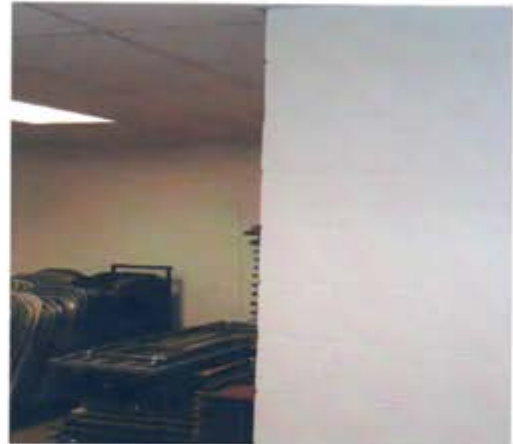
Up range view of converted indoor firing range. Back wall may have been the former observation room

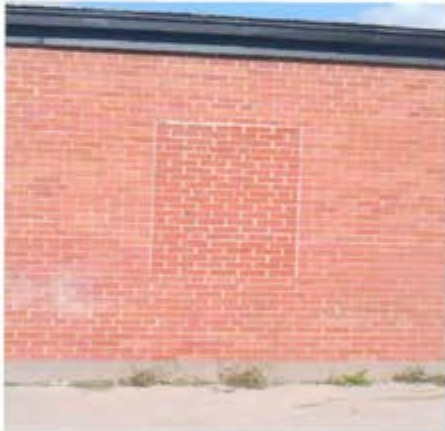
Straight line on bricks demarks possible location of former observation room

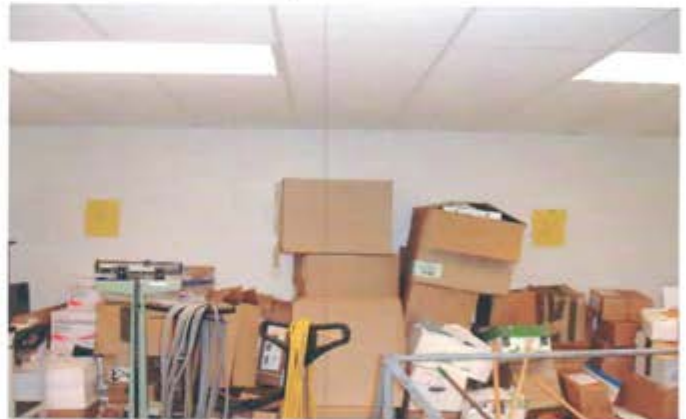
Former location of range exhaust

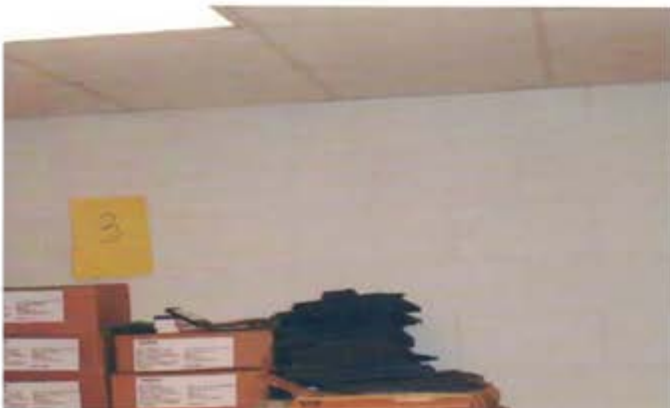
View of Lead wipe samples 1&2, located on back wall where backstop may have been positioned

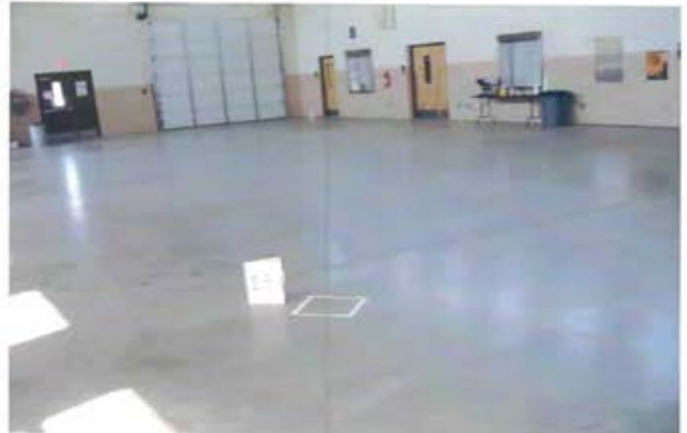
View of Lead wipe sample 18, located on floor in front of supply room in Drill Hall

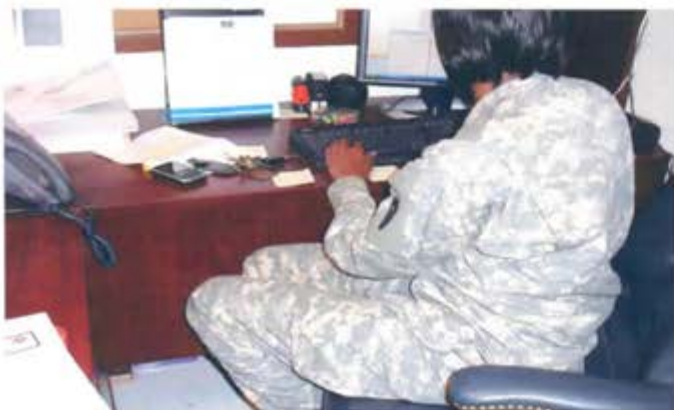
Example of ergonomic issue in the Army

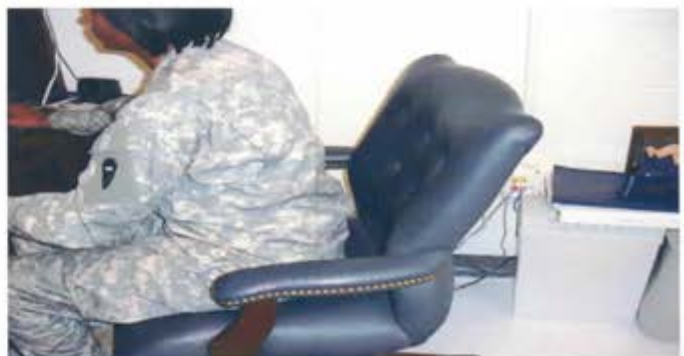
Example of ergonomic issue in the Army

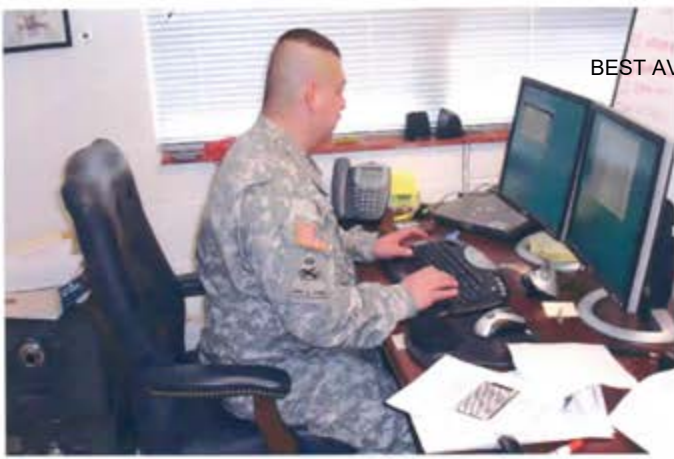
Example of ergonomic issue in the Army

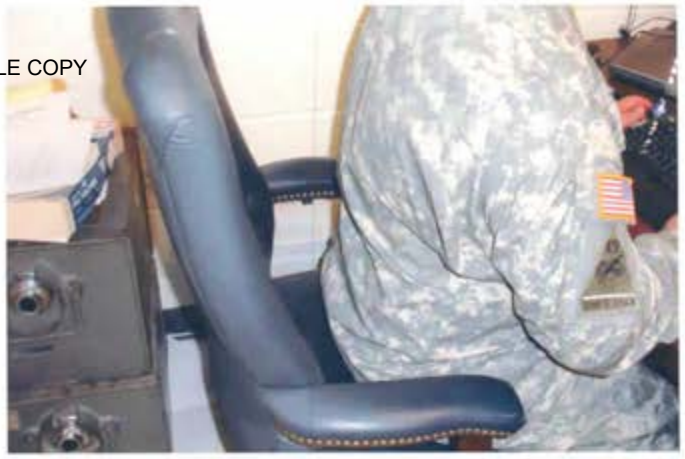
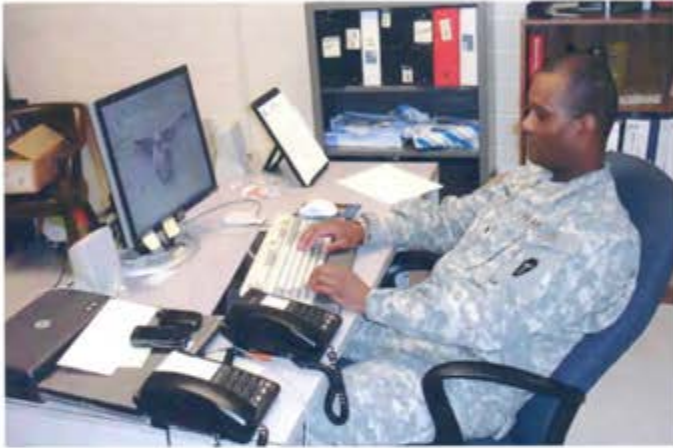
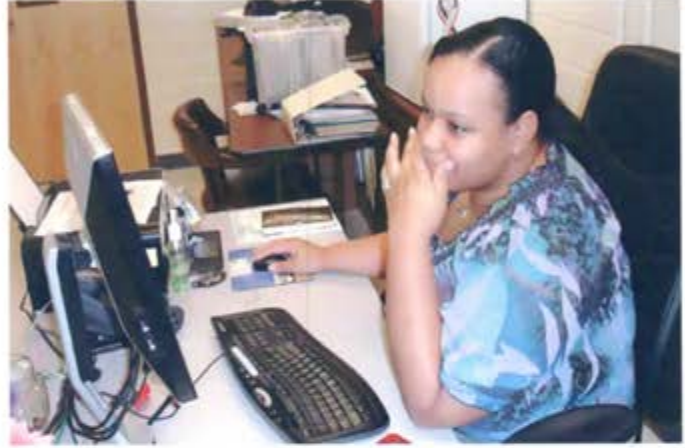
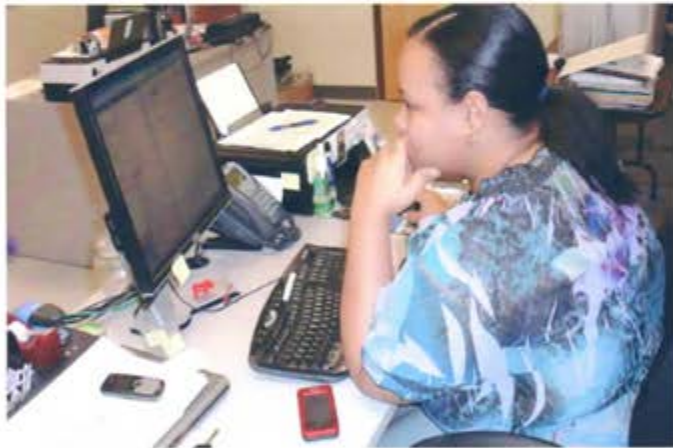
Examples of Ergonomic Issues in the Sandage Armory

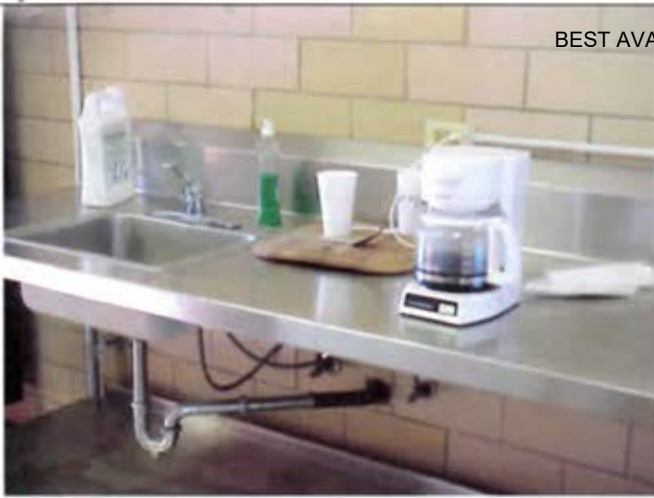
**Photo # 4**

Another view of the area that is showing signs of roof leakage in the kitchen area.

c. Control water infiltration in the armory and/or replace or repair damaged surfaces or components (ceiling and floor tiles). Building conditions that present IAQ concerns or problems not only exacerbates normally minor health issues but also tend to promote or accelerate building deterioration.
